Disk Machine Experiments to Assess the Life of Damaged Railway Track

N. Gao, R. S. Dwyer-Joyce and D. G. Grieve

Department of Mechanical Engineering

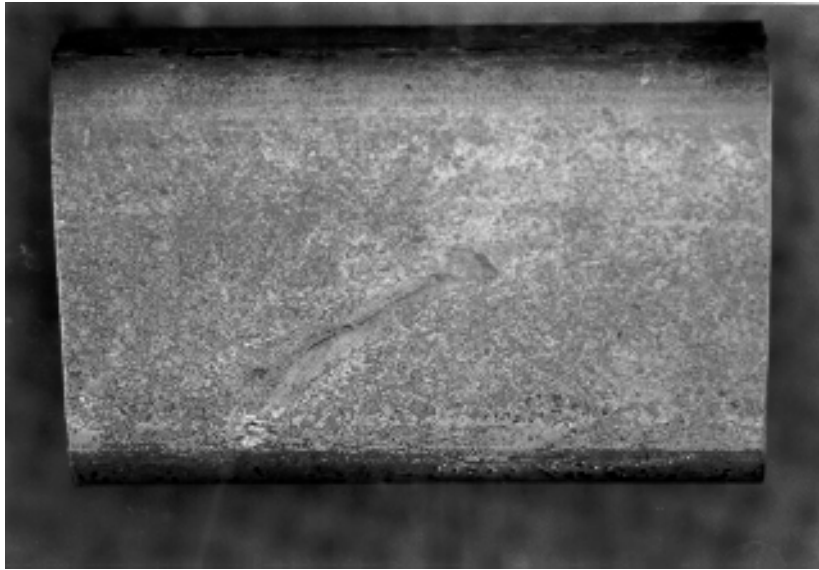
Figure 1. Sample of surface damaged railway track.

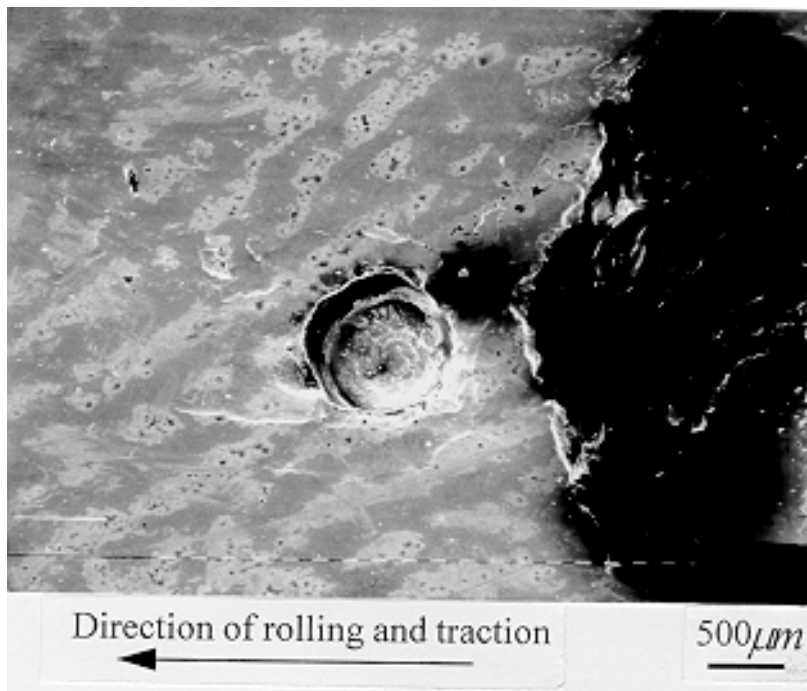
Figure 4. SEM examination showing a large spall located just behind the trailing side of a drilled hole after 1150k cycles of oil lubrication.

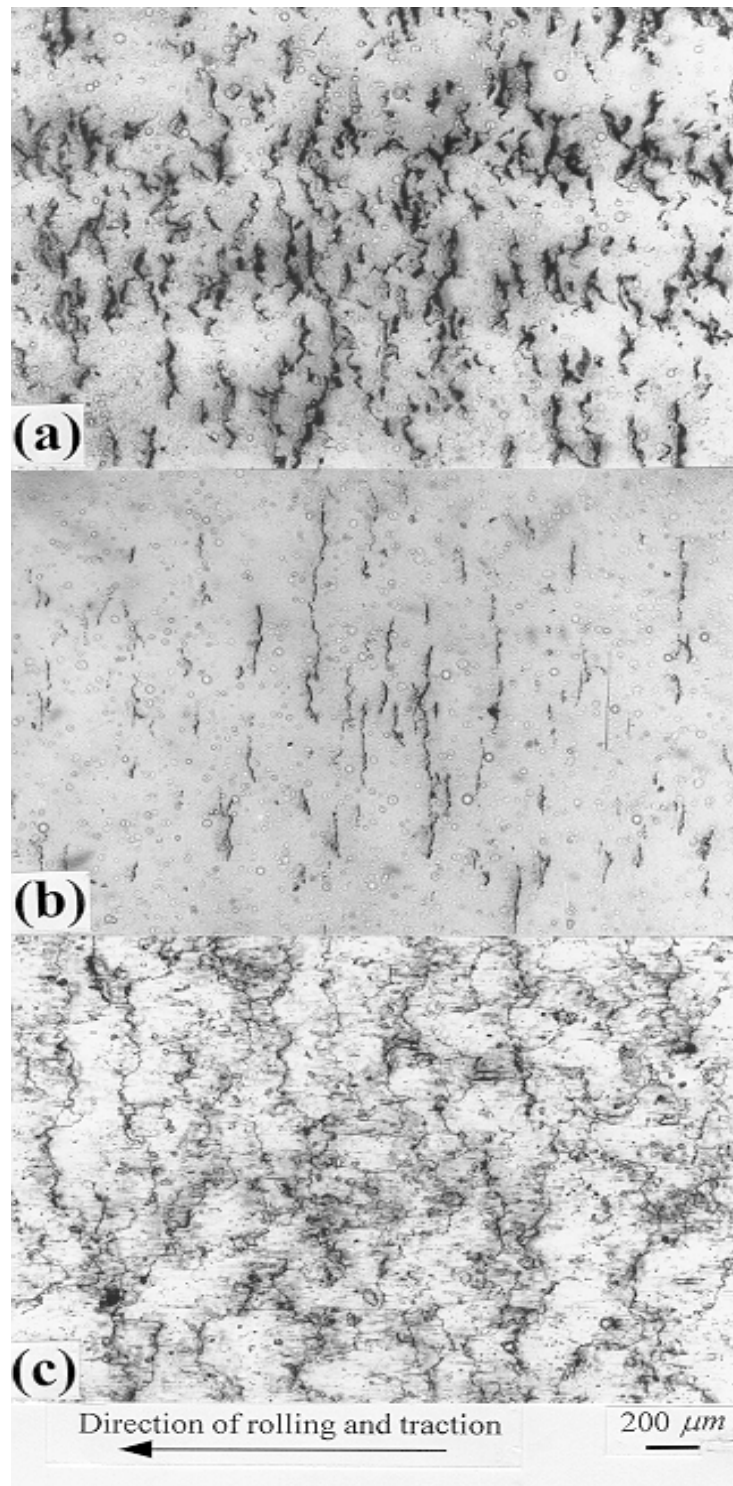
The effect of contact pressure and slip under water lubrication can be seen in **Figure 7**. A non-contact eddy current probe was used to scan continuously the full width of the rail disc during these water tests. For each test the same eddy current threshold was set (corresponding to a critical crack depth of 400-500 μm [9]). The decrease in contact pressure from 1500 to 900 MPa causes an increase of cycling life from 50k to 310k, and a decrease in crack density (see **Figures 7a** and **b**). A slip increase from -1% to -10% at the same contact pressure causes the life to decrease to 41k and surface shear obviously increases due to the higher traction (**Figures 7a** and **c**).

Figure 7. Effect of contact pressure and slip on surface RCF with water lubrication. (a) $P_0 = 1500$ MPa, slip = 1%, 50k; (b) $P_0 = 900$ MPa, slip = 1%, 310k; (c) $P_0 = 1500$ MPa, slip = 10%, 41k.

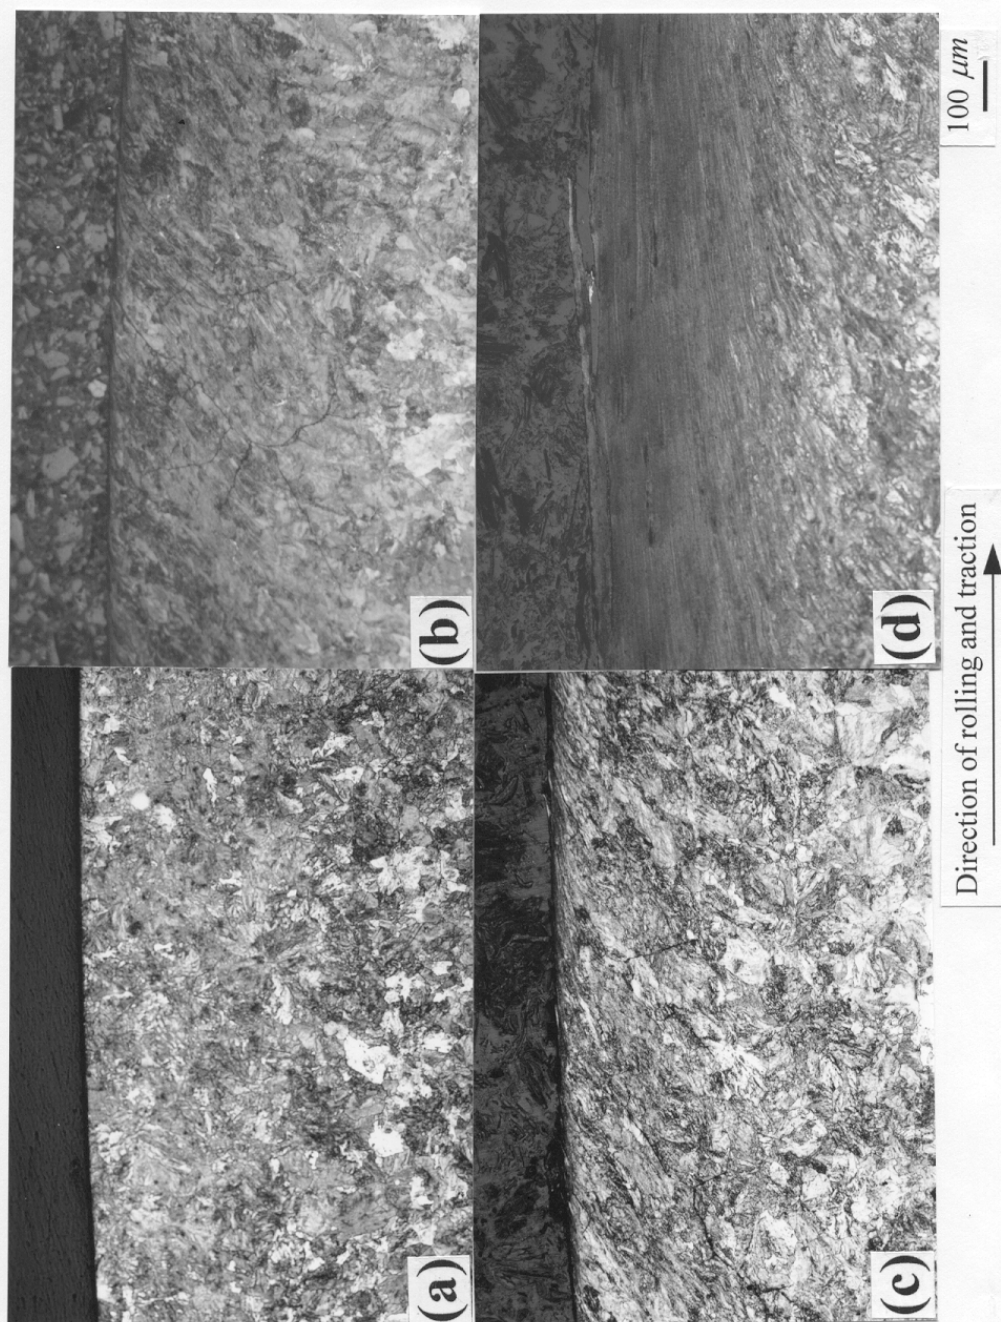
A section through the surface, in the direction of motion, revealed differences in morphology between oil and water lubricated cases. In oil lubrication, there are only a few cracks around the surface defect, which are generally located just behind the trailing side of the dent with a depth of the maximum stress in Hertzian contact [8]. On most surfaces, there are no cracks and no obvious plastic deformation [see **Figure 8a**]. However, for rail under water lubrication, there is obvious surface plastic deformation and cracks grow at many locations. As shown in **Figure 8b**, the inclined cracks grew deep into the specimen and exhibited some branching. Cracks propagate initially at an angle of 30-40° to the surface in a direction opposite to that of traction. Branches typically form at right angles to main crack at depths around 500 μm . This is a typical of surface cracking observed with water lubricated rolling contact [11, 13]. At 900 MPa cracks are prone to this type of crack branching and networking. However, at 1500 MPa, -10% slip it is typical to see isolated cracks propagating deep into the surface. Clearly, crack growth deep into surface is the dominant feature of water lubricated contacts rather than the surface spall failure observed under oil lubrication.

Flakes and cracks were found near the surfaces of both the rail and wheel discs which initiate and propagate wholly within the top heavily deformed microstructure (**Figure 8d**). Deformation of the microstructure could be seen to a depth of 1.0 mm. This type of deformation is often observed in wheel-rail contacts, where each pass of the wheel imparts an increment of plastic shear strain, which eventually forms a layer of sheared material near the surface [5]. An estimate of the accumulated strain can be found by taking the tangent of the angle, γ between the deformed microstructure and the normal to the disc surface at an (arbitrary) depth 200 μm . **Table 3** shows that the wheel steel, being slightly softer and more ductile, accumulates greater strain before fracture.

Figure 8. Cross section through the running surface showing different morphologies for lubricated and contaminated situations. (a) oil, 1150k; (b) water, 50k; (c) wet contaminant 0.5k + water 27k; (d) dry contaminant, 40k cycles.

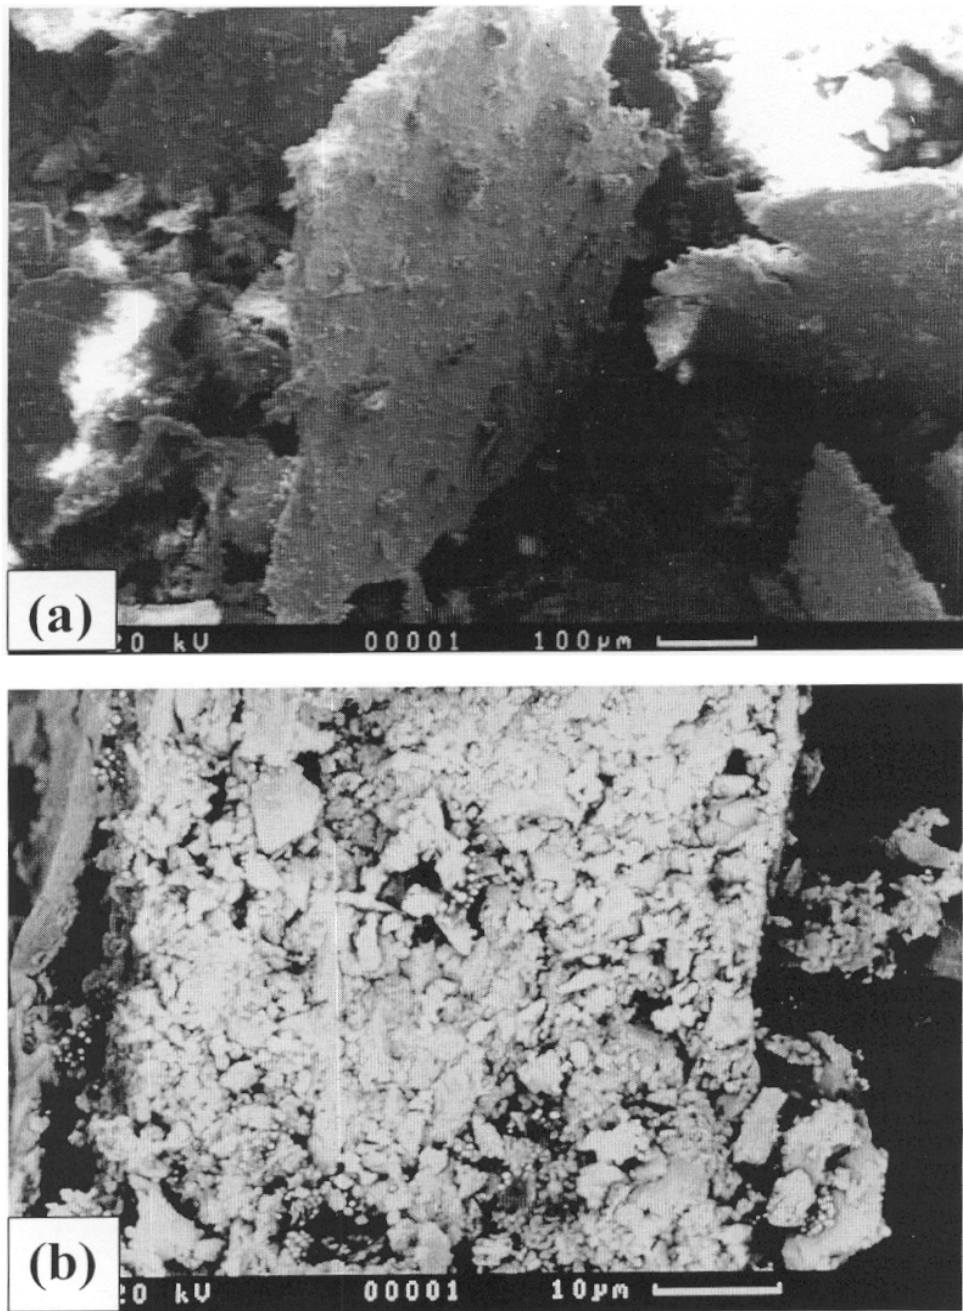
SEM examination of the wear debris revealed that it consisted of small flakes of material ~1 mm in diameter by ~20 μm thick as shown in **Figure 9a**. Closer examination of the flakes showed they are an agglomeration of loosely bounded sub-grains of granite and small platelets of steel (**Figure 9b**). An ultrasonic bath was used to break down the flakes; the size was measured and the median found to be 1.07-1.4 μm . It appears that the granite particles are initially broken down in the entry of the contact. These fragments then agglomerate, with steel

Figure 9. SEM images of granite debris after passage through the contact. (a) typical flakes of granite; (b) detail of the edge of a flake (through the thickness) revealing that it is made up from agglomerated sub-grains.

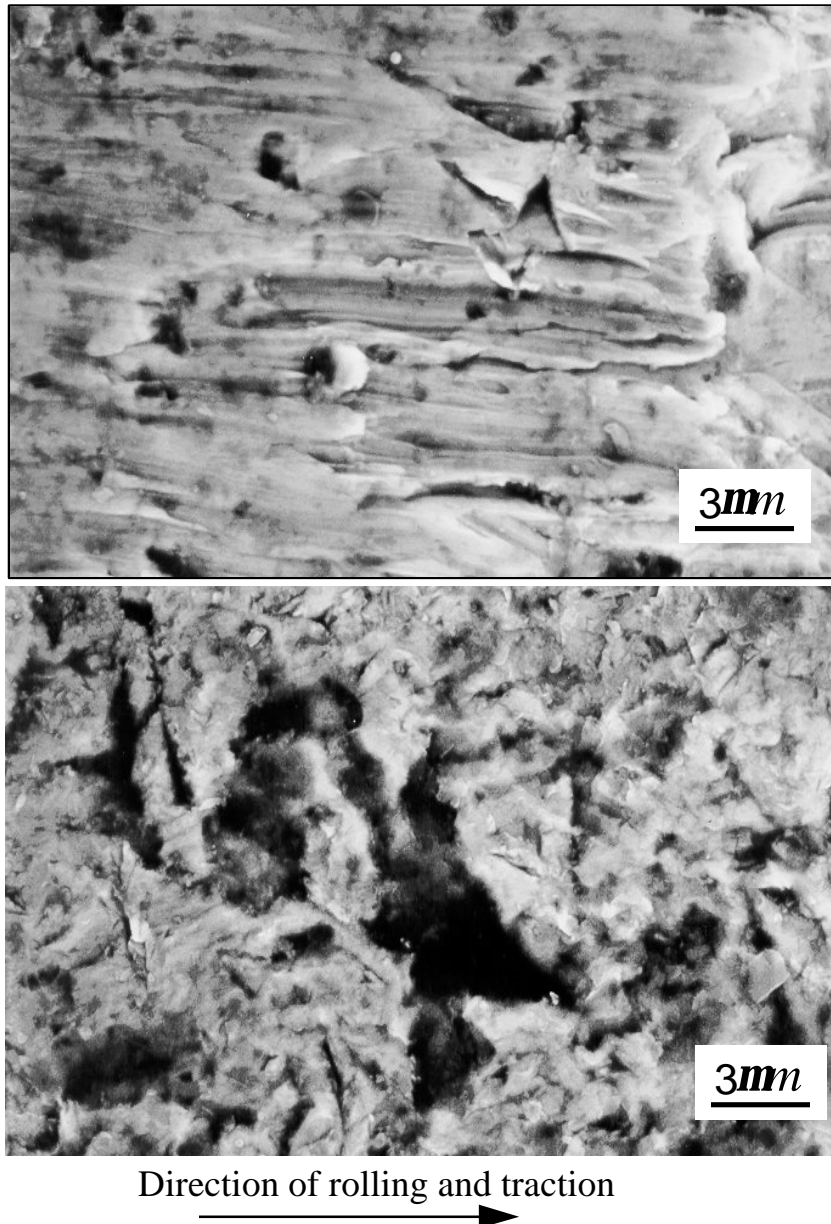
Figure 12. SEM image of rail and wheel disc surfaces from tests with ballast contamination. (a) detail of a groove on the rail disc surface; (b) detail of indentations seen on the wheel disc surface.
