Investigation into the role of electrostatics in a vapour ignition incident during refuelling at a Snax service station.

Graham Hearn, Wolfson Electrostatics, University of Southampton

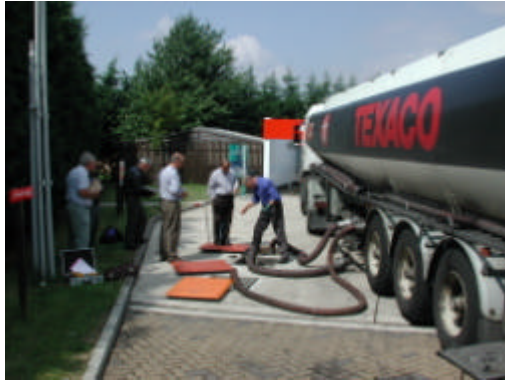
Plate 1. Tanker delivery

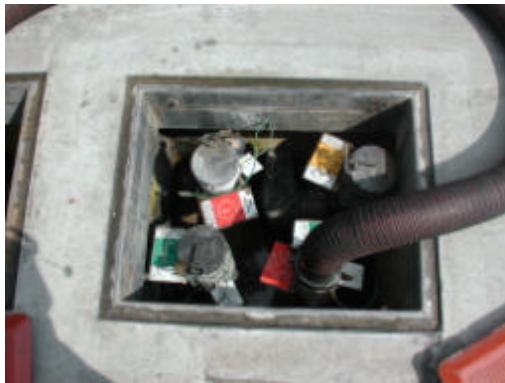
Normally the caps made from aluminium are connected to the termination fitting by means of a short length of chain but in this case the chain was broken and consequently there was no electrical continuity between the fitting and the cap. It follows that electrostatic ignition would be reliant on either the fitting to be raised to high potential or the cap/delivery driver being raised to high potential.

I visited the scene of the incident on Friday 3 August 2001 in order to make observations and measurements. A road tanker delivery was arranged for that day so that measurements could be undertaken during a fuel delivery. Plates 1 and 2 give an indication of the layout. The incident occurred with fill pipe/tank 2. This can be seen clearly in Plate 2 with the aluminium cap in place.

Plate 2. Manhole and offset fill pipes. Those not in use have caps in place.
Ignition incident occurred with No. 2 (bottom left).

Although there is no technical evidence to support ignition by electrostatic spark in this instance it was recommended that the practice of grounding the transition fittings by means of a bonding wire (as undertaken in immediate response to this incident) be continued.

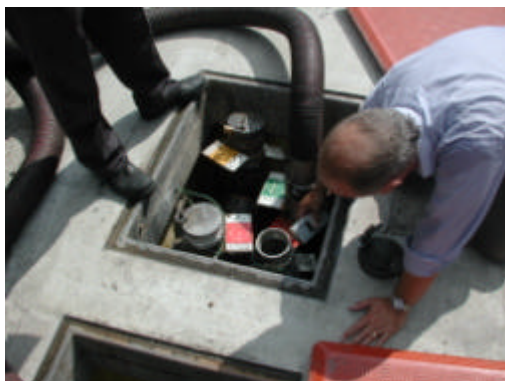
Fittings 2 and 4 did not rise above zero potential at any time during fill or removal of the hose. During the delivery of diesel to tank 5 a small but insignificant level of static potential (less than +200 V) was observed on the pipe. On completion of fill and disconnection of the hose a small reading rising to a maximum of +100 Volts was observed on the fitting. These results were not surprising in light of the rapid charge relaxation times previously calculated. Measurement of electrostatic potential on the fittings is shown in Plate 3.

Plate 3. Measurement of electrostatic potential after filling.
