Combiner Bearing Failure

Dr N.Symonds PhD BEng(Hons)

Ministry of Defence,
Fleetlands, Gosport, Hants PO13 0FL

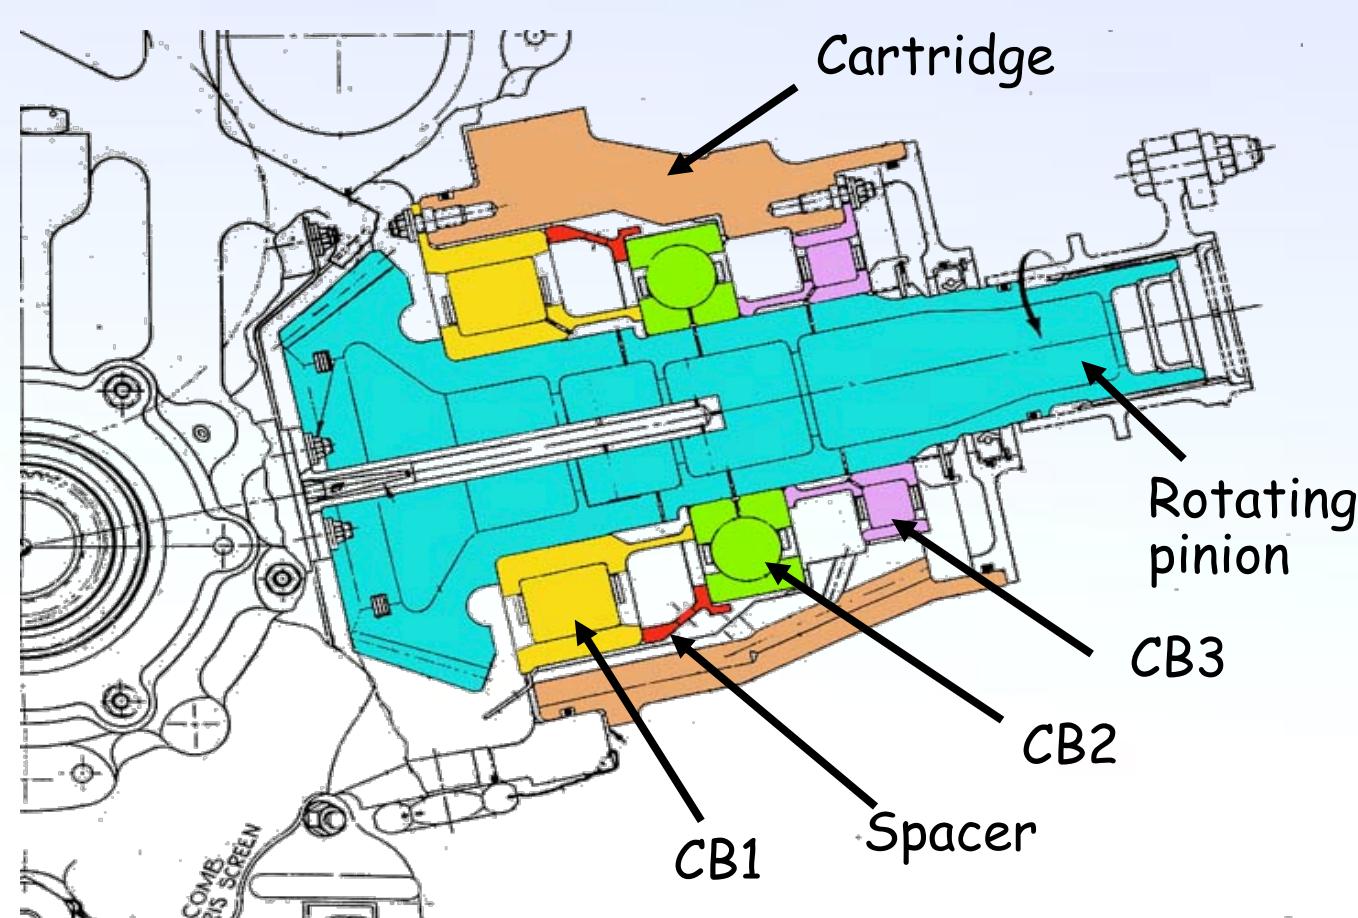
Fig 1: Schematic depicting location of Combiner Bearings 1,2 and 3.

The two input pinion stacks incorporate three bearings, CB1, CB2 and CB3, see Fig 1. As part of the HUMS system the combiner XMSN is fitted with four accelerometers, one of which is physically near the left, CB1; it was this sensor that recorded an increasing trend, above the normal for the rest of the Chinook fleet, see Fig 2.

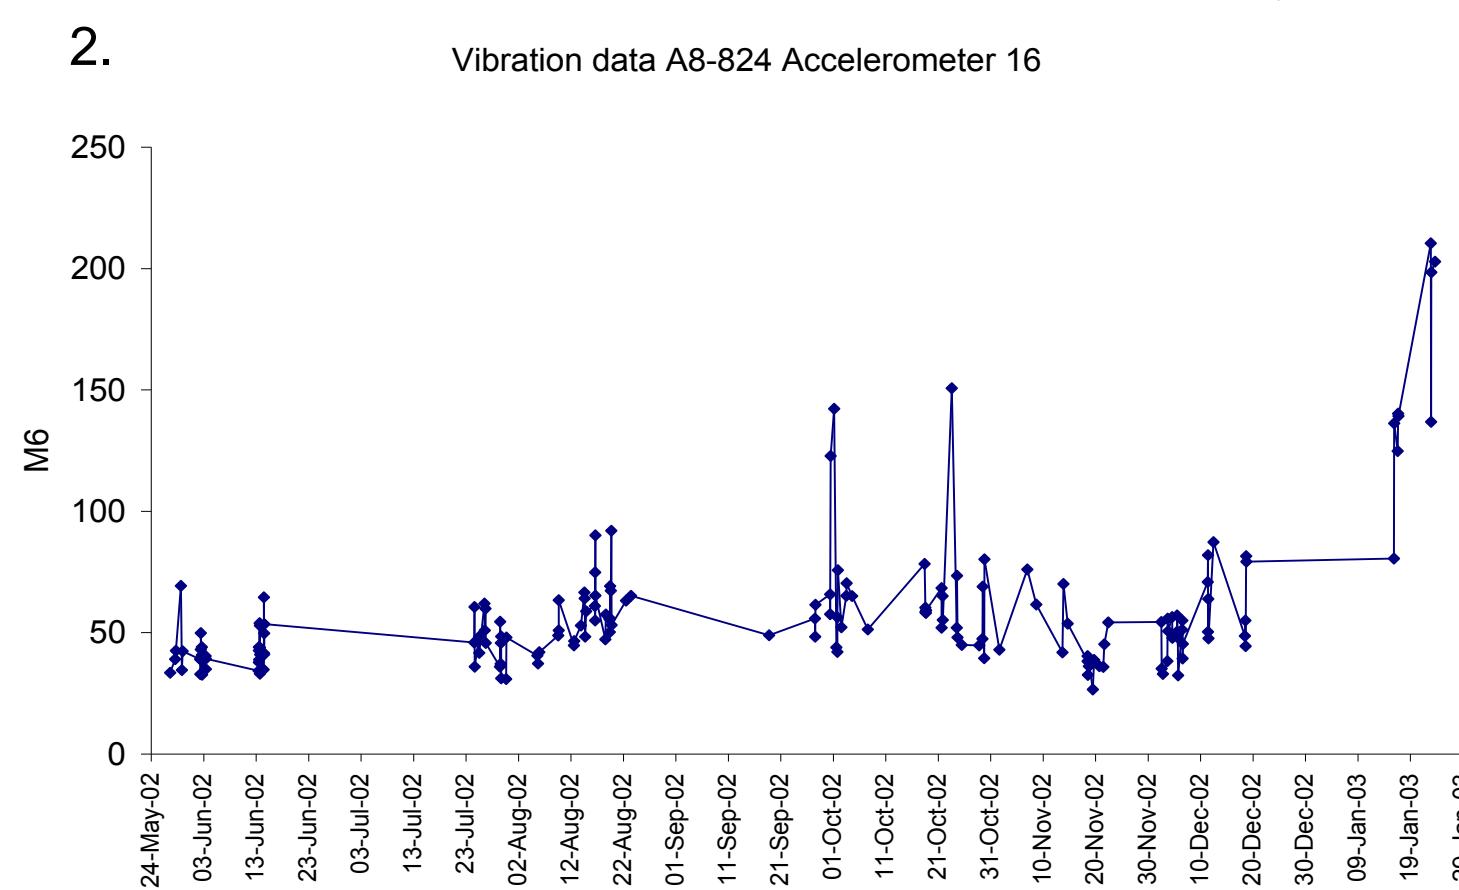
Fig 2: HUMS Vibration monitoring of CB1.

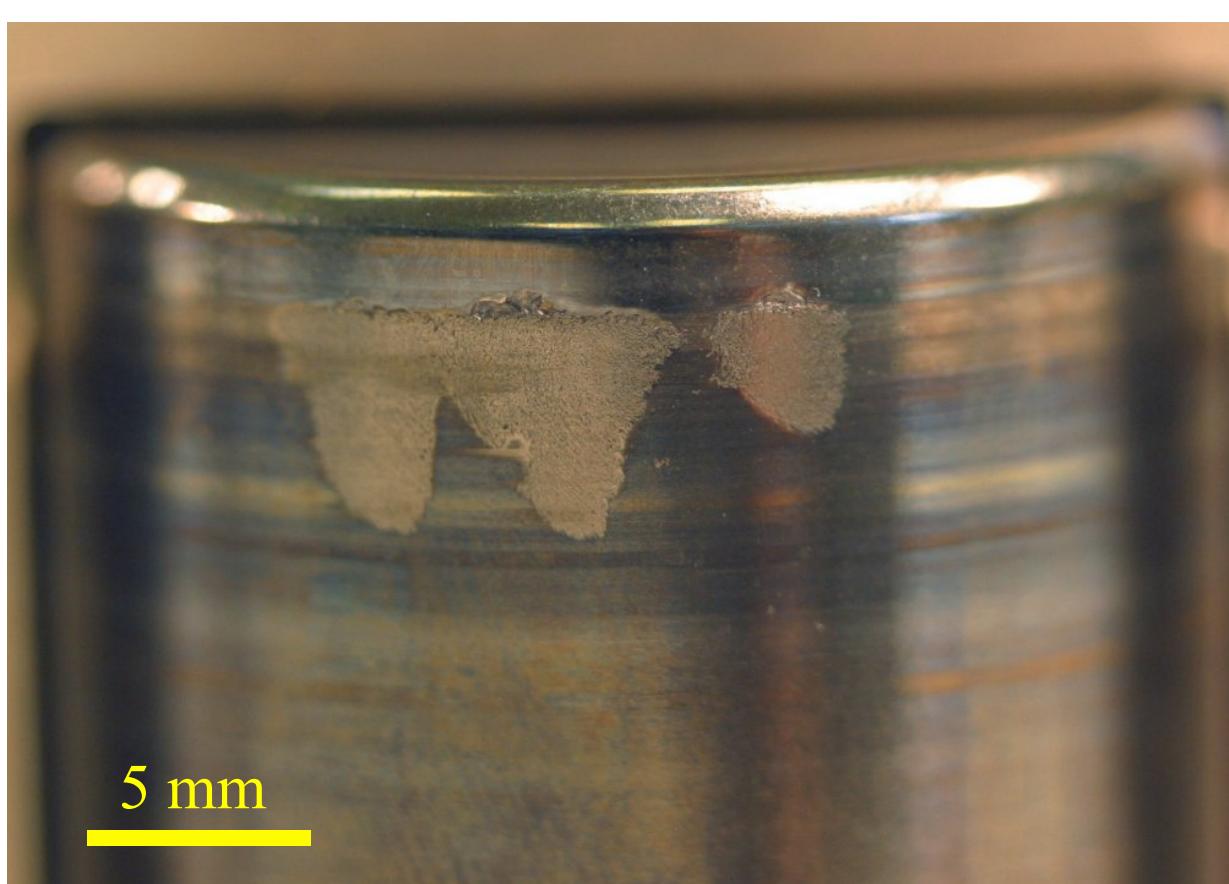
The left CB1 bearing was found to have significant damage to the rollers and outer race, see Fig 3. There was no other damage seen on the CB2, CB3 or other related areas of the XMSN.

Fig 3: Damage to surface of roller bearing.

The SEM was also used to examine the surface damage to the rollers shown in Figure 3. It was also found to be macropitting but surface origin, i.e. secondary and probably caused by debris from the inner ring. Figure 7 shows how the micro-cracking extends the damaged area.

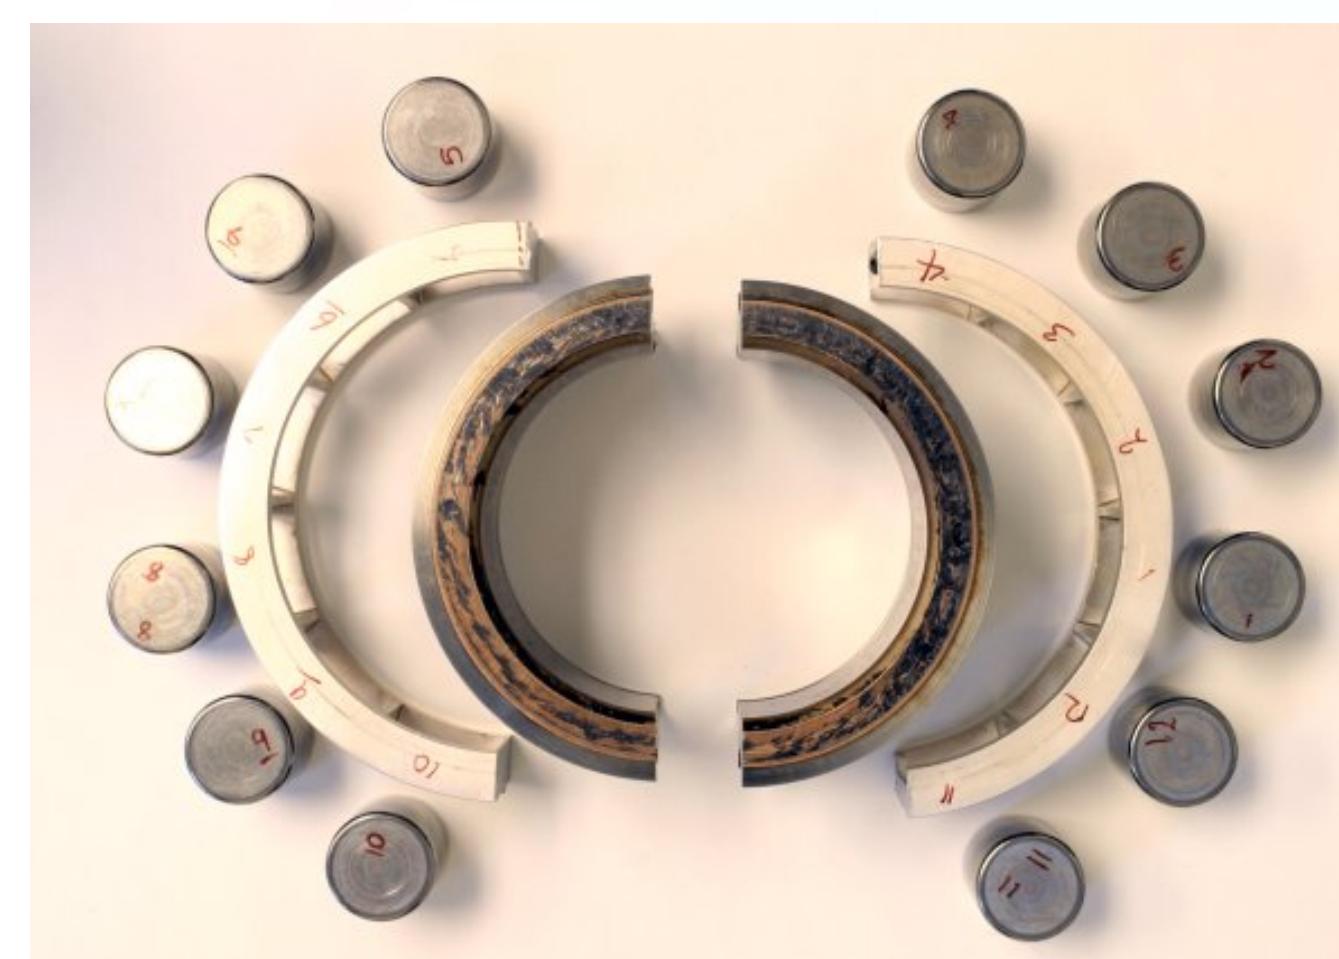
The CB1 was dismantled to gain access to the inner bearing surface, see Figure 4.

Fig 4: Dissected view of CB1.

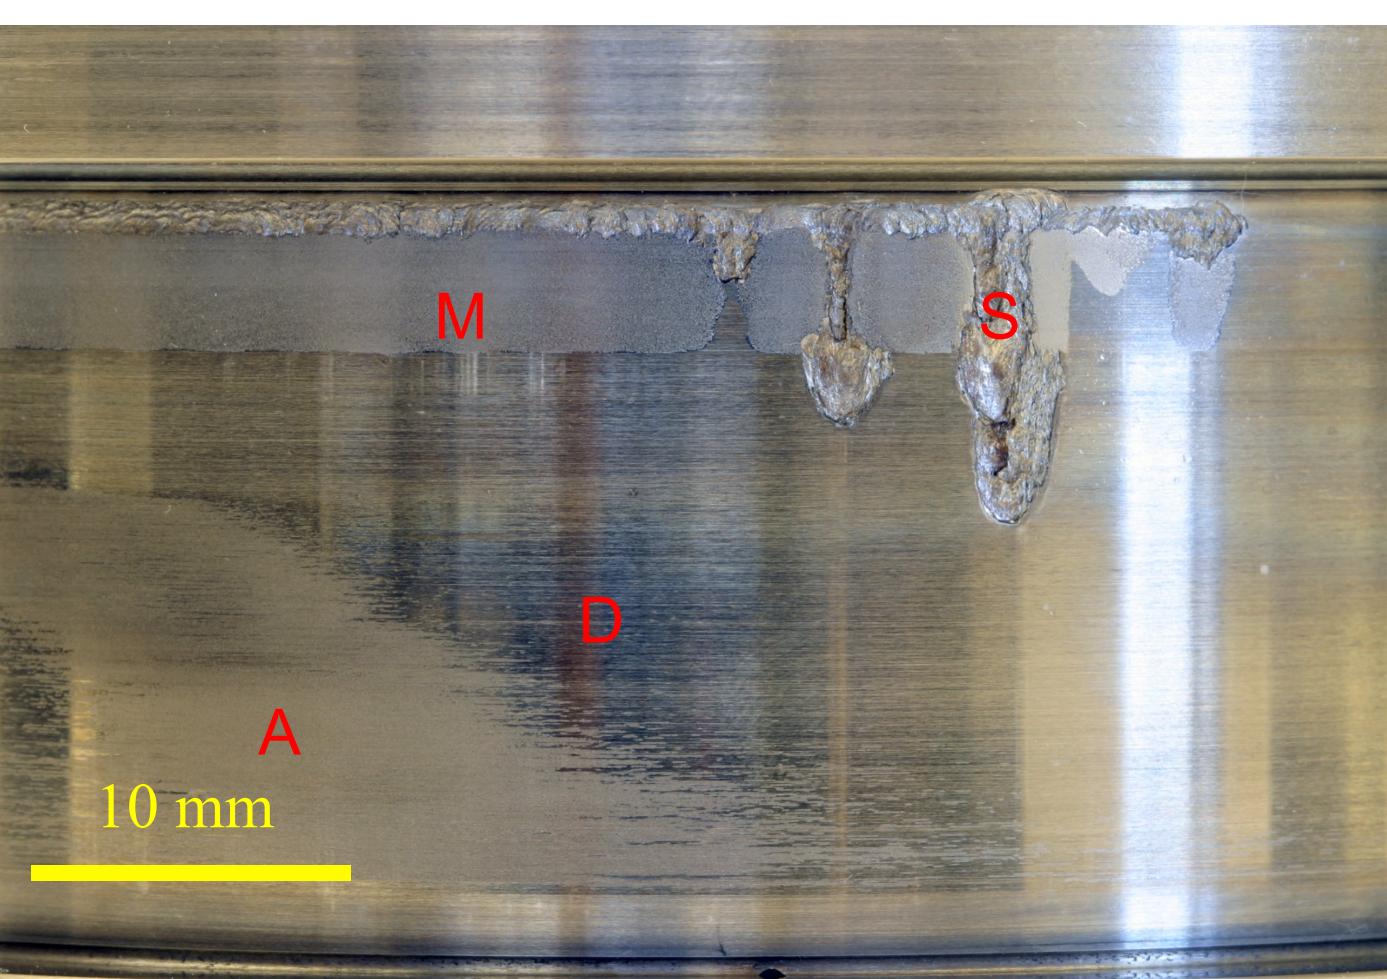
Examination of the inner race, see Fig 5, revealed:

- Macropitting subsurface origin [S]
- Discoloration [D]
- Micropitting [M]
- Sliding (adhesive) wear [A]

Fig 5: Inner bearing surface, rollers past left to right.

The cause of the subsurface macropitting of the CB1 inner ring was probably the result of an inclusion or other minor defect. Unfortunately, as in this case, it is common to lose the origin evidence as the damage spreads. RCF is an exponential effect, under the loads present in a combining transmission once pitting had begun the bearing would have been in its last 10% of life.

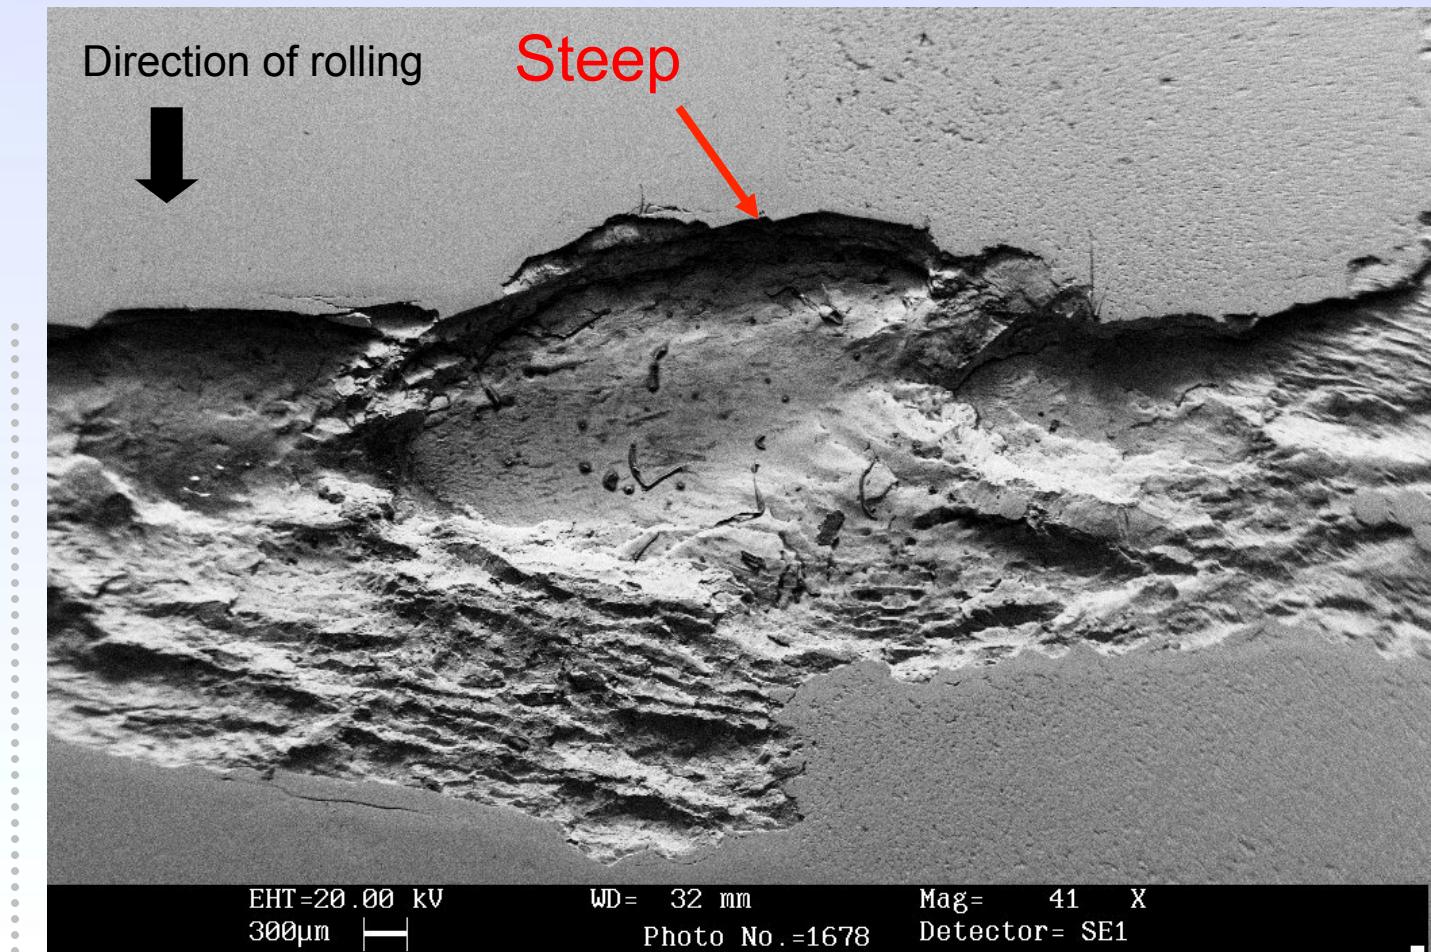
Higher magnification examination was performed using a Scanning Electron Microscope, see Figure 6, which revealed a steep entrance wall (inclined at more than 45 degree angle to the contact surface). This commonly indicates a subsurface origin to the macro-pitting.

Fig 6: SEM micrograph showing spalling on inner bearing surface.

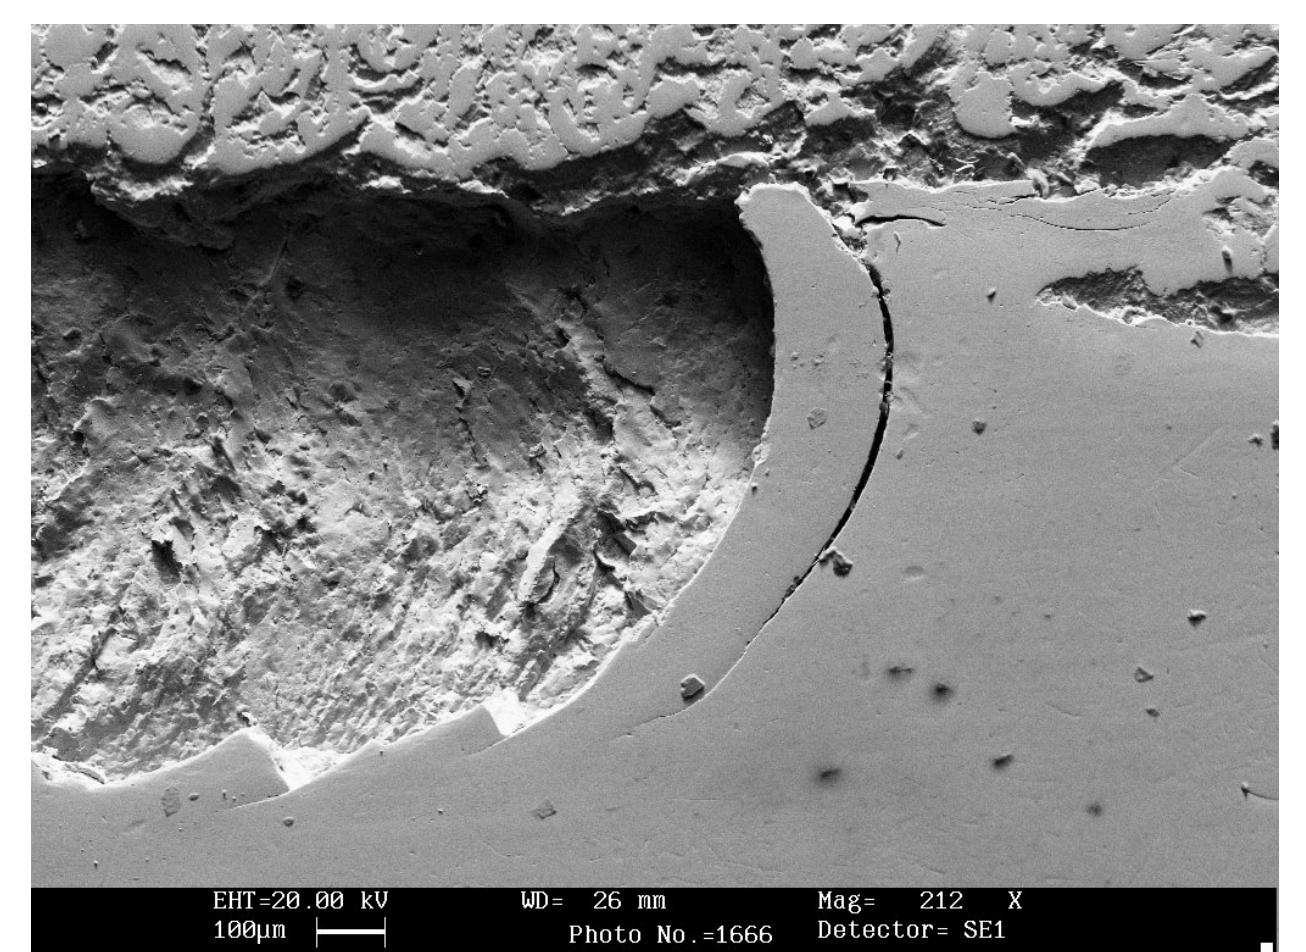
Fig 7: SEM micrograph showing spalling on a roller surface (Fig 3).
