Stabilization of a Landslide on the M25 Highway London's Main Artery

Davies J P

Loveridge F A, Perry J

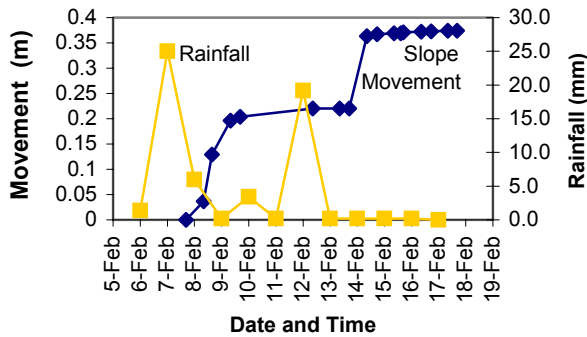
Immediately after the failure, 16 pairs of wooden stakes were installed across the toe and backscarps and their separation measured to determine if the slip was still moving. These pegs showed that the slip was marginally stable and responded rapidly to rainfall events with further movements as shown in Figure 1.

Figure 1 Rainfall & Slope Movements from Pegs

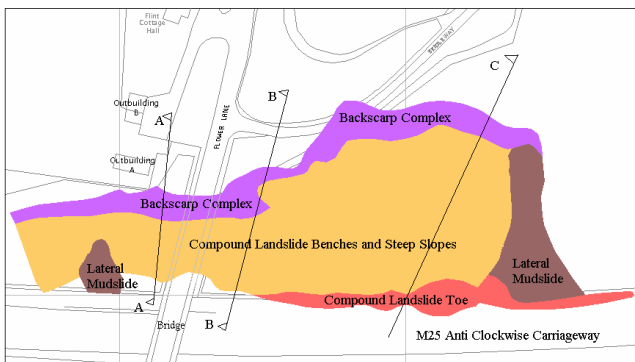
The first stage in the investigation was geomorphological mapping. This showed that the failure was of greatest extent to the east of the bridge as shown in Figure 2.

Figure 2 Geomorphological Map

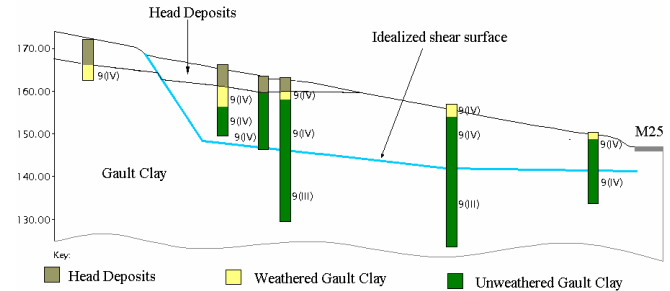
The investigation revealed the slip to be within Divisions 9(iv) and 9(iii) of the Gault, Owen, (1976), which is a stiff to very stiff gray fissured clay, with overlying Head deposits mantling the upper portion of the slope as shown in Figure 3.

Figure 3 Geological Section

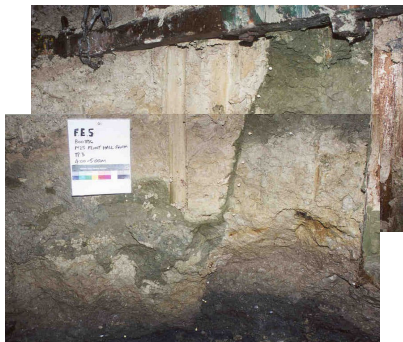
The inclinometer deflections combined with the identification of zones with increased moisture content indicated that the basal shear plane, was up to 10m below ground level. This combined with the observed steep backscarp, shown in Figure 4, and other geomorphological evidence, suggested a principally wedge shaped failure. Inclinometers installed to the south of the highway and the negligible deformation of the hard shoulder carrier drain, confirmed that the shear plane did not extend beneath the carriageway.

Trial pitting also exposed the Head/Gault boundary. This was found to be highly polished with an elevated natural moisture content suggesting that significant movement had occurred and that the two formations were acting independently.

Figure 4 Shear surface exposed in a trial pit

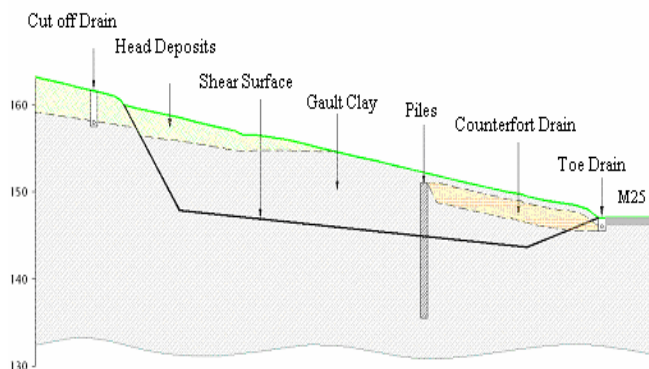
Figure 5 Schematic of Remedial Design

In order to stabilize the bottom half of the slope 3 m deep counterforts were installed at 6 m centers extending from a drain at the slope toe to between 20 and 23m up the slope. These counterfort trenches illustrated in Figure 5 also picked up the temporary pumped sumps, which had been installed in the slope toe as emergency works, to lower the water table and control the mudflows.

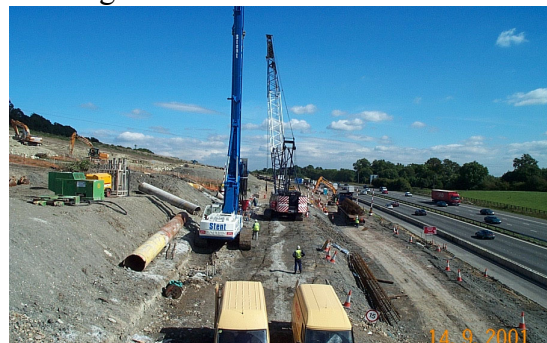
Figure 6 General view of the site from the bridge

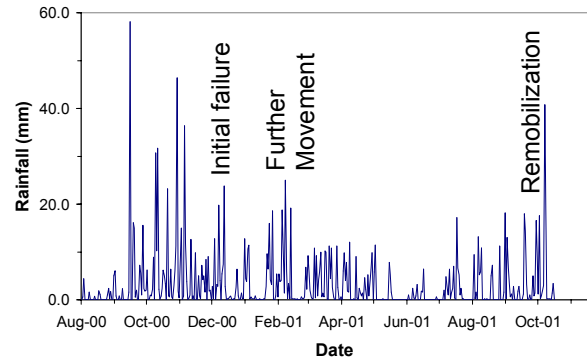
Figure 7 Daily Rainfalls from Kenley Airport

As can be seen there was a significant rainfall spike in early October comparable to the levels, which triggered secondary movements of the landslip during spring of 2001. This rainfall event and subsequent smaller events caused the perched water level in the Head deposits to rapidly rise whilst the lower water level in the Gault clay rose more slowly and stabilized after rising approximately 2m, to 8m below ground level. Subsequently the perched water level exhibited high amplitude and short wavelength variations in correlation to rainfall, but did not rise above 4m below ground level when water began to flow into the new filter drains, as shown in Figure 8.

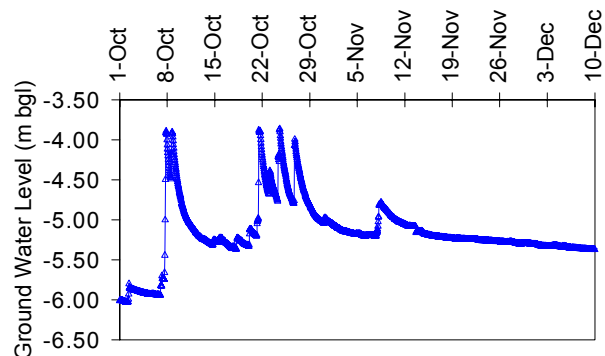
Figure 8 Water Level in BH22A

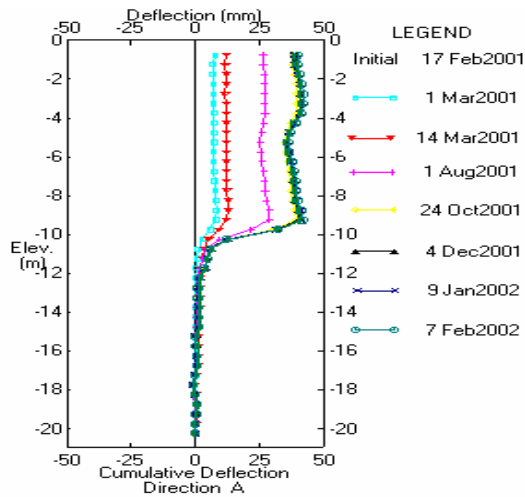
This rise in water levels as expected, caused the failed block to remobilize. Inclinometers I1 and I2 in piles 21 and 23 moved by 12mm at their head and down to a depth of approximately 9m as the piles mobilized their strength to carry the load. This pattern was repeated in the mid slope BH4 plot shown in Figure 9, which experienced

approximately 13mm of movement along the slip plane. No movement was recorded outside of the landslide or in inclinometer I3 between piles 22 and 23, confirming that the pile spacing was sufficient to promote arching and prevent flow between the piles.

Figure 9 Deflection of Inclinometer BH4

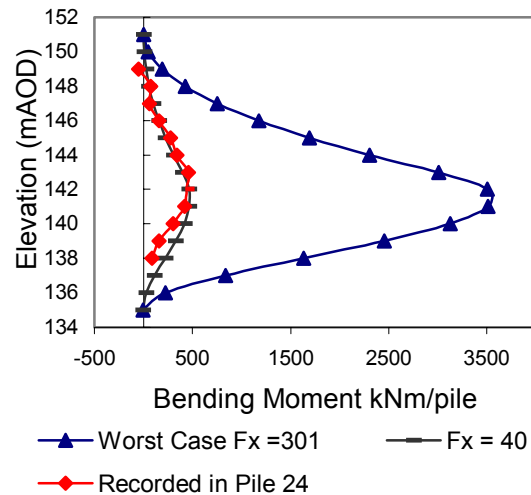
moment profile recorded by the strain gauges at this point was then compared against the bending moment profile predicted by the design method for various different values of F_x . As shown in Figure 10, the recorded profile closely matched the design profile for a F_x of 40kN/m.

Figure 10 Predicted & Recorded BM's for pile 24

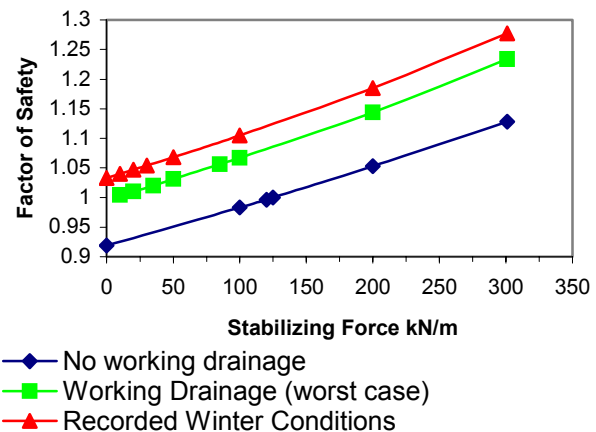
This F_x was then compared to Figure 11, which shows that under the recorded winter conditions which were less onerous than the two design cases also shown, the design model would predict a factor of safety of 1.06. This suggested that the combined instrument, design and modeling error was less than 6%.

Figure 11 F_x vs factor of safety

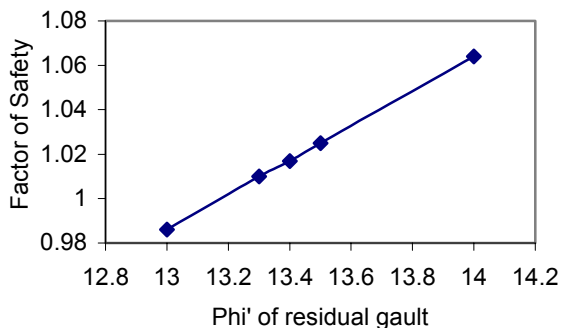
During the creation of the model the parameter with the greatest uncertainty was the residual ϕ angle of the Gault clay as literature quoted values of between 9 and 25 degrees, Forster et al, (1995). As shown in Figure 12, the ϕ value has a marked effect on the predicted factor of safety and the entire modeling, design and instrumentation error equates to approximately a 0.7 degree reduction in

Figure 12 Effect of Reducing Phi'
