Three-dimensional assessment of low velocity impact damage in particle toughened composite laminates using micro-focus X-ray computed tomography and synchrotron radiation laminography

D.J. Bull^{1*}, S.M. Spearing¹, I. Sinclair¹, L. Helfen^{2,3},

¹ Materials Research Group, Faculty of Engineering and the Environment, University of Southampton, Southampton, United Kingdom

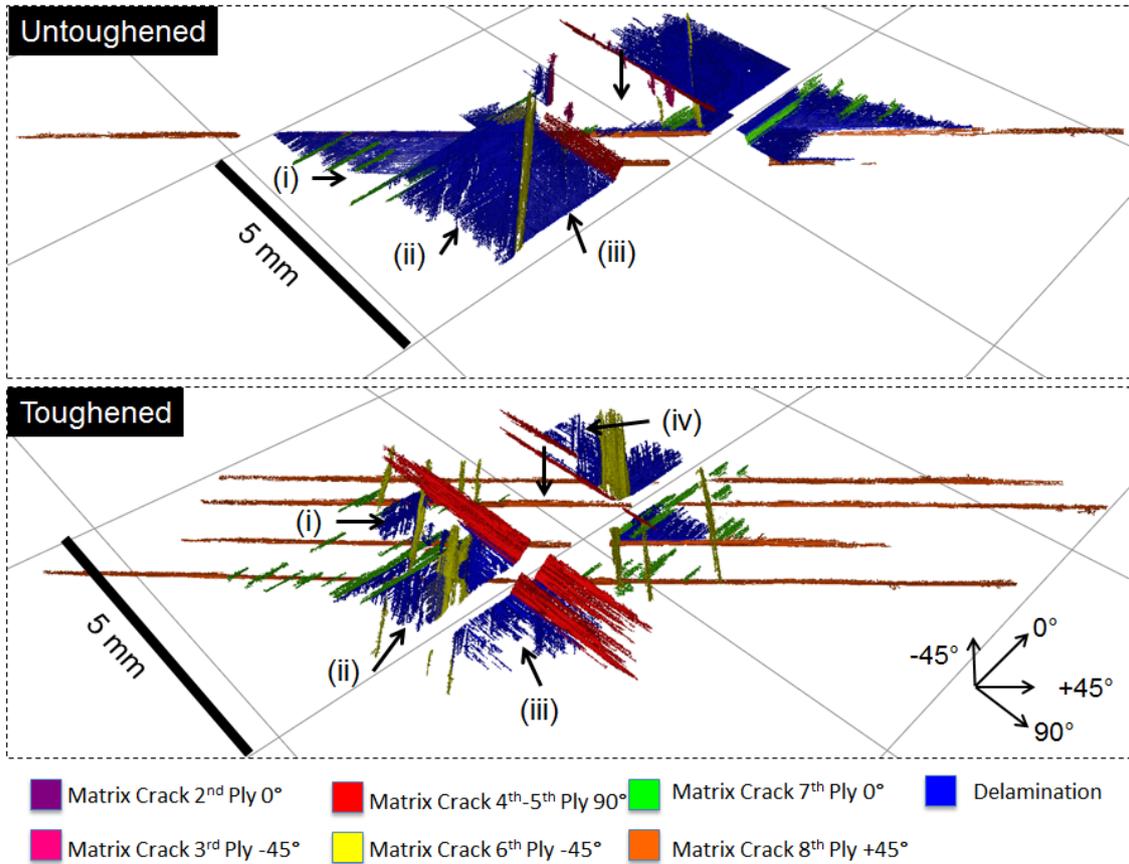
Segmentation of all detectable impact damage obtained from μ CT scans revealed the 3D impact damage morphology and is shown in Figure 5. Based on previous observations, the crack opening detectability limit of cracks was taken to be approximately 30% of the voxel resolution used (*i.e.* just over $1 \mu\text{m}$ in this case) [14]. Due to the method of cutting ‘matchsticks’, some information representative of the width of the 0.3 mm blade is absent; despite this limitation, the overall internal 3D damage structure can be identified. A colour key is shown where blue represents the presence of delamination and each of the other colours represents intralaminar damage occurring on that particular ply. For clarity, the delaminations are labelled in Figure 5 i-iv at the 7/8, 6/7, 5/6 and 5/6 ply interface respectively. In both material systems, a similar damage interaction and morphology is observed on this scale. A characteristic “cone” of impact damage is formed around the impact site, consisting of a network of delaminations interlinked by intralaminar matrix cracks. These intralaminar matrix cracks occur parallel to the direction of the fibres and form at tangents to a concentric ring surrounding the impact site. This leads to a “spiral staircase” of delaminations consisting of 45° segments that form between two matrix cracks of different orientations. This is consistent with other studies using quasi-isotropic layups *e.g.* [19, 33]. Delaminations always occur within the boundaries of matrix cracks on plies of different orientation, consistent with initiation of delaminations from critical matrix cracks, *e.g.* see [33].

Observations in Figure 5 near the outer tips of delaminations in the toughened system show discontinuities in the crack which are attributed to particle toughening behaviour.

Figure 5 – μ CT 3D damage segmentation of impacted 8 ply coupons for (a) untoughened (0.6 J) and (b) particle-toughened material (1.2 J). Point of impact is indicated by the arrow and grid lines are spaced 5 mm apart. Colour version available online.

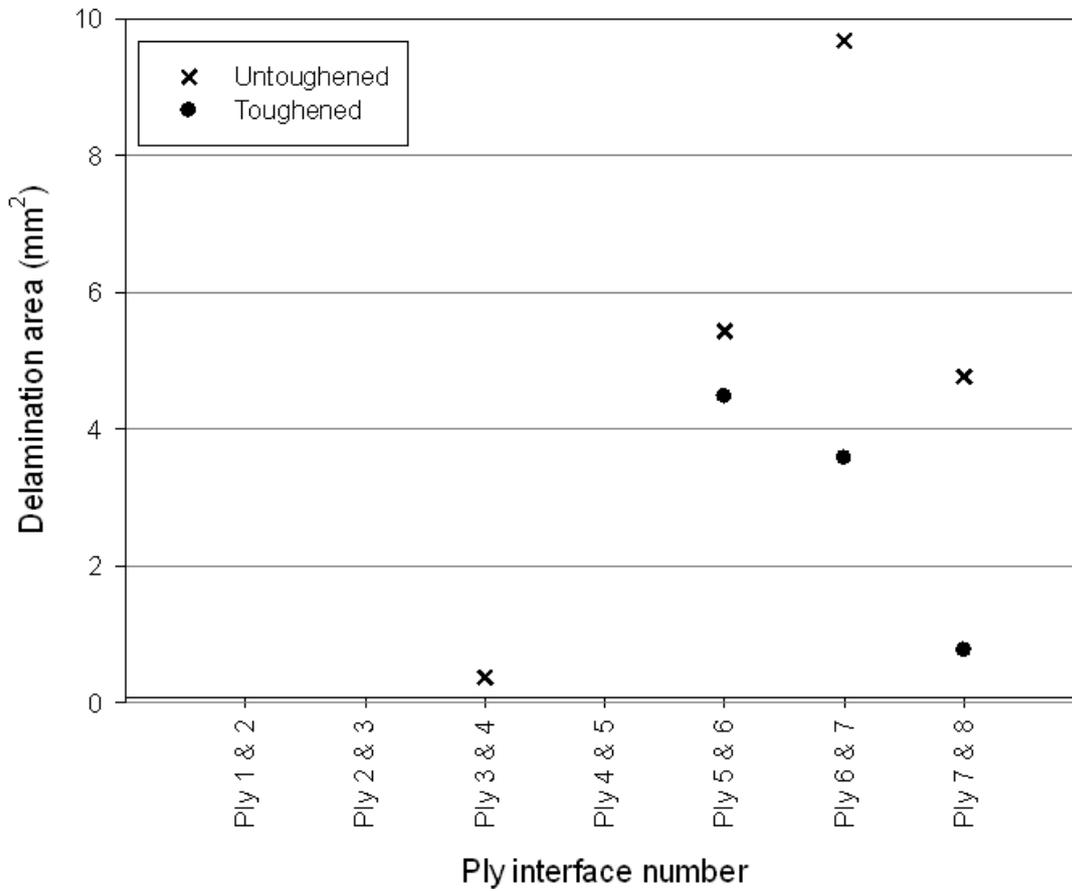
The extent of the detectable delamination areas was measured at each ply interface and is plotted in Figure 6. The total delamination areas measured by μ CT were typically lower than the projected damage areas measured by ultrasonic C-scan. There are two contributions to this; the 1 mm XY resolution of the C-scan has overestimated the damage area by including damage beneath the impact cone. This is likely due to the ultrasonic probe partially detecting neighbouring cracks at these locations. Secondly, the detectability of cracks was limited to crack openings above $\sim 30\%$ of the voxel resolution; this typically underestimates the true extent of the damage areas and crack lengths. Nonetheless, relative comparisons to the extent of detectable damage between the two material systems can be made.

Delaminations in this study were observed occurring dominantly at the rear three ply interfaces below the mid-plane on both the untoughened and toughened systems, although some delamination was also observed above the mid-plane in the untoughened system. It is probable that a combination of the Hertzian cone stress field due to the point impact load and bending stresses contributed to a greater incidence of damage on the lower half of the material.

Toughening particles constrained delaminations and in this particular case, measurement of delamination areas taken from μ CT data when plotted in Figure 6 show that the toughened coupon resulted in a lower extent of delaminations across all ply interfaces despite the higher impact energy.

Figure 6 – Delamination areas measured at each ply interface for untoughened (0.6 J) and toughened (1.2 J) systems.

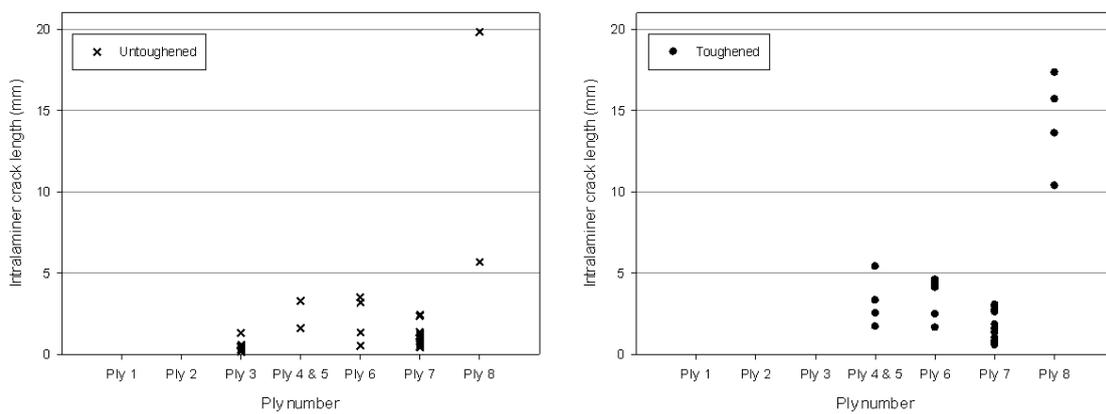
The incidence of intralaminar cracks did not appear to be equivalently controlled as delaminations in the toughened system. Intralaminar crack lengths were measured from the μ CT data and plotted in Figure 7 for both systems, for clarity these are plotted on two separate scatter plots. Despite the lower level of delaminations, there is a significantly greater intralaminar crack density, although crack lengths are of similar lengths. It is possible that particle toughening is most effective at the interlaminar regions between plies, consistent with the particles being constrained to these regions [34].

Figure 7 – Scatter plot of intralaminar matrix crack lengths on each ply measured from μ CT volumes on the untoughened (0.6 J) and toughened (1.2 J) systems. Ply 1 represents the impact side and ply 8 the back face.

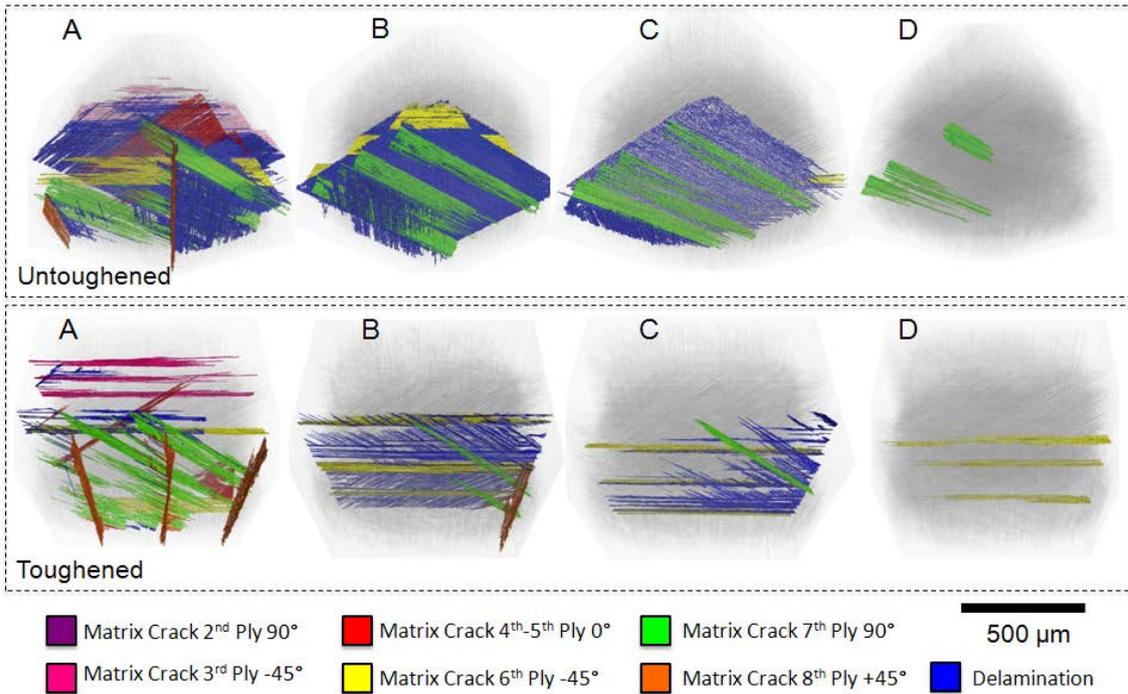
Figure 8 shows a 3D segmentation of matrix and delamination cracks at regions 'A to D' (see Figure 2) on both the untoughened and toughened system as viewed at an angle towards the back face of the coupon. Whilst exact centering of the Region 'A' scans at the mid-point of the impacts was compromised in this case by slight experimental error, ultrasonic C-scan confirmed that the ROIs in Region 'C' captured the delamination edge regions in both materials, whilst the tips of intralaminar cracks were captured in Region 'D'.

Figure 8 – 3D segmentations of interlaminar and intralaminar cracks from SRCL scans taken at region A to D for untoughened (0.6 J upper row), and toughened (1.2 J bottom row) systems.

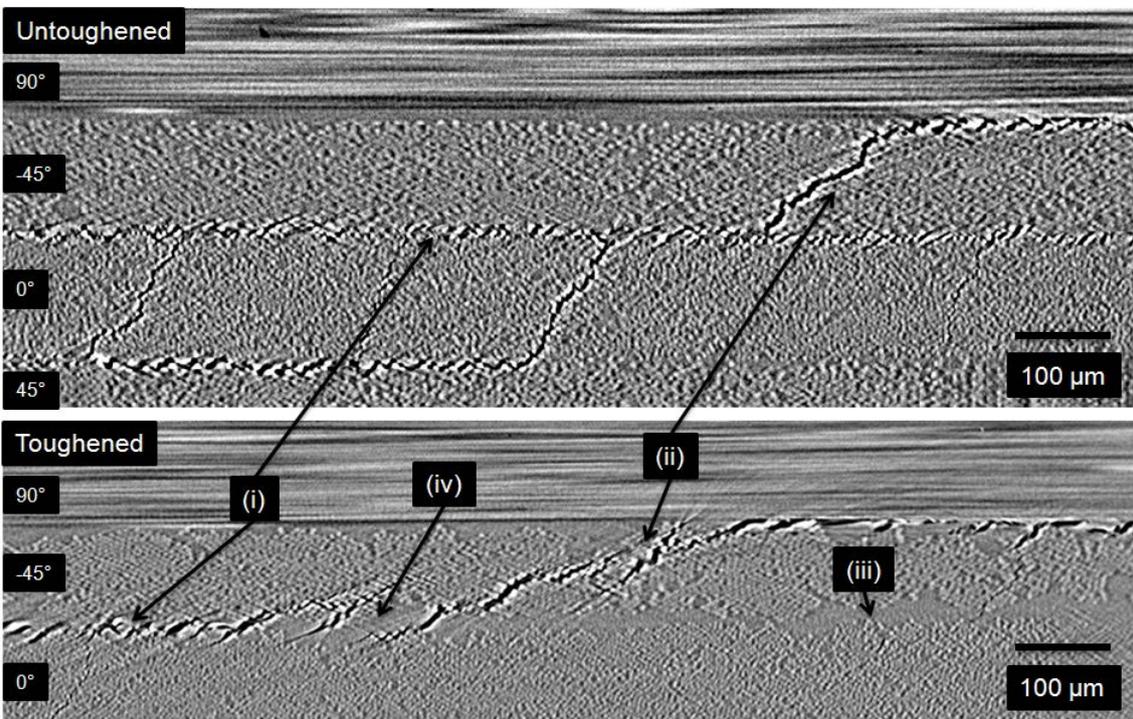
To understand the role particle toughening plays, cross-sectional slices from SRCL data are shown in Figure 9. Similarly to the μ CT cross-sections, key

damage features consist of (i) delaminations and (ii) intralaminar cracks. However an additional level of detail is revealed, the untoughened and particle toughened systems show distinct differences in the delamination micromechanisms and the presence of an approximately $20\ \mu\text{m}$ thick resin-rich region (Figure 9(iii)) in the particle toughened system. Although toughening particles cannot be directly visualised in the present scan data due to the particles being chemically closely related to the resin (in contrast to observations made on a different particle composition in a previous study with particle sizes in the order of the same magnitude [34]); it is probable particles may have induced both crack deflection and crack bridging which are clearly visible (Figure 9(iv)). The resulting ligamented behaviour of the delamination is consistent with crack deflection at the crack tip and subsequent bridging in the wake. Spacing of the order of $\sim 20\text{-}80\ \mu\text{m}$ is observed between crack segments. In comparison, delamination cracking in the untoughened system is restricted to narrow deflections on the order of a few fibres diameters, $< 14\ \mu\text{m}$. Such crack shielding and bridging mechanisms within the particle-containing matrix are consistent with reducing delamination propagation: bridging creates traction between plies, reducing the stresses at the crack tip [35], whilst crack deflection reduces the crack-tip stress intensity factor and increase the effective crack area [2]. These processes may act in conjunction with an increased process zone volume associated with the resin rich-layer [36], allowing greater energy absorption with crack propagation [5, 37, 38].

In both material cases, the delamination crack ligaments are oriented at an angles in the range $30^\circ\text{-}45^\circ$ to the plane of the plies indicating their micro-scale

formation is controlled by a combination of tensile and shear stresses; similar observations are made in [39]. Macroscopically the delaminations under low velocity impact conditions propagate in shear due to bending stresses, which is also consistent with earlier observations [32, 33].

Figure 9 – SRCL cross-section of untoughened (0.6 J) and toughened (1.2 J) taken from Region 'B'. The image shows a region below the mid-plane at the same interface plies in both systems. (i) indicates delaminations, (ii) matrix crack, (iii) ~20 µm resin rich region and (iv) bridging ligaments.

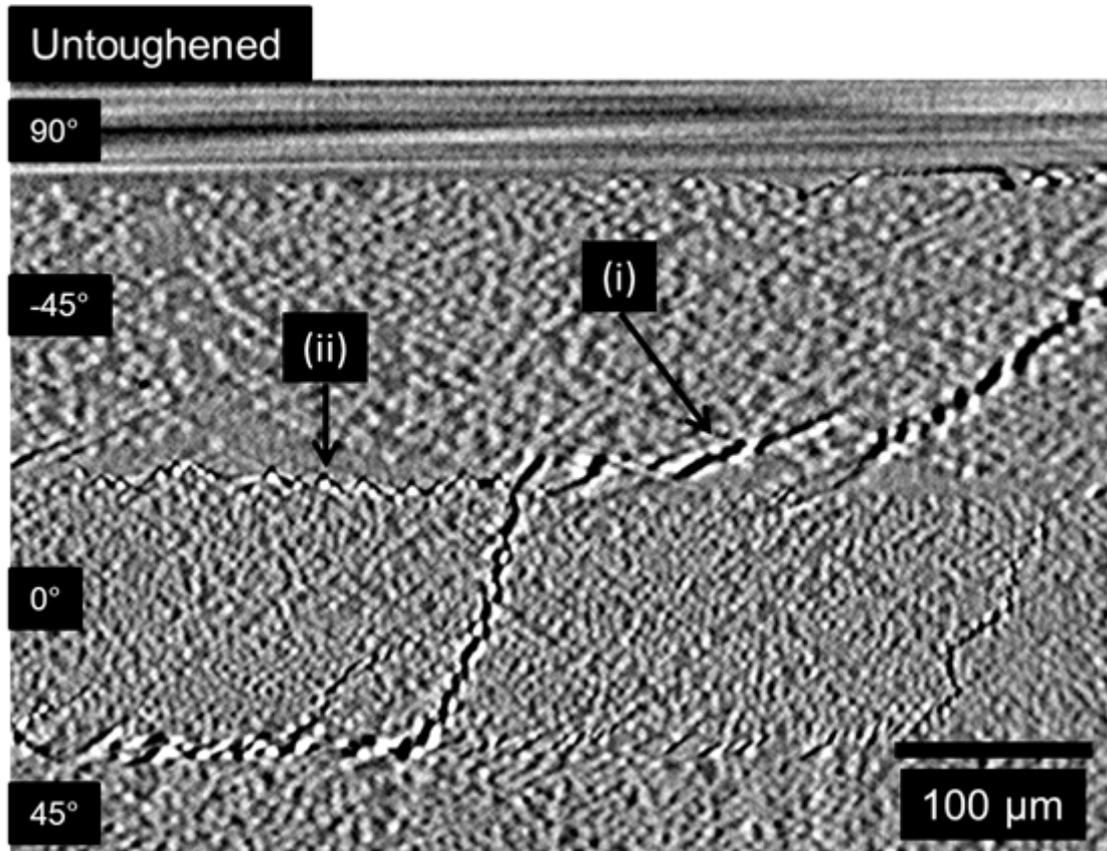
In the untoughened system, some local resin-rich regions ($> 10 \mu\text{m}$ thickness) were present between ply interfaces as shown in Figure 10(i). These were typically less than 5% of the total interface surface area. This led to cracks with local deflections of similar orders to the toughened material. Such resin-rich variations during the manufacturing process will affect the local effective toughness and may be anticipated to contribute to variability in the impact response.

Figure 10 – SRCL cross-section taken from Region 'A' in the untoughened material system. Variation in resin thickness led to a rich region present in (i) leading to ligaments with similar characteristics to the toughened system. (ii) show microscopic fibre-resin debonding.

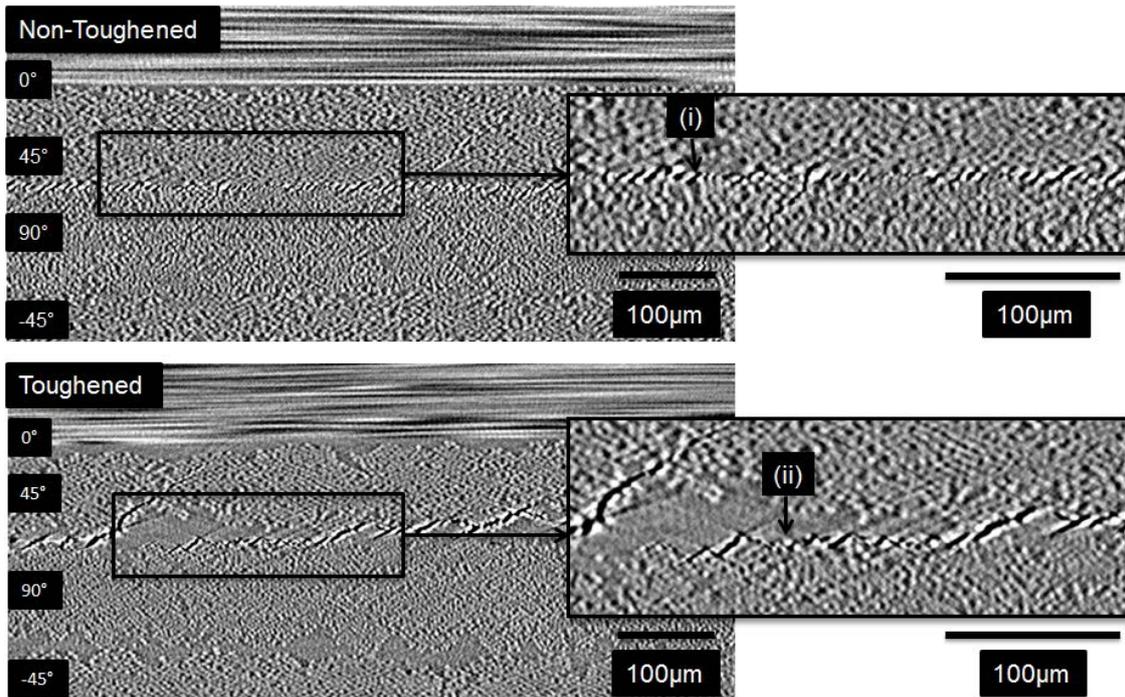
SRCL cross-sectional images taken from the edge of the impact damage region in Figure 11 (Region 'C') reveals similar delamination micromechanisms as observed near the impact site, albeit with smaller crack-openings. This consists again of crack deflections on the order of a few fibre diameters (i) in the untoughened system and larger scale crack deflection and bridging (ii) in the toughened system, demonstrating toughening micromechanisms occurring throughout the damaged area.

Some fibre-resin debonding was observed in Figure 11 (ii) between the -45° and 90° in the toughened system, similar behaviour is also shown in Figure 10 (ii) in the untoughened material system. The observed frequency of this behaviour was less than 1% of the total delamination area in the toughened material system and is therefore anticipated to have little effect on the key

Figure 11 – SRCL cross-section taken from the edge of the damaged area in Region ‘C’. (i) crack deflection on the order of single fibre diameters and (ii) fibre-resin debonding .
