Title: Observing early stage rail axle bearing damage

Observing early stage rail axle bearing damage

A novel condition monitoring system has for the first time enabled reliable extraction from service and detailed forensic examination of failing rail axle bearings, before the usual catastrophic destruction of the evidence. Computed Tomography has been used to produce a map of the damage allowing targeted sectioning of subsurface cracking. Traditional metallographic techniques have revealed large white etched layers associated with the subsurface cracking, while observations with a scanning electron microscope have confirmed rolling contact fatigue crack propagation, possibly initiated from pre-existing electrical arcing damage of the raceways.

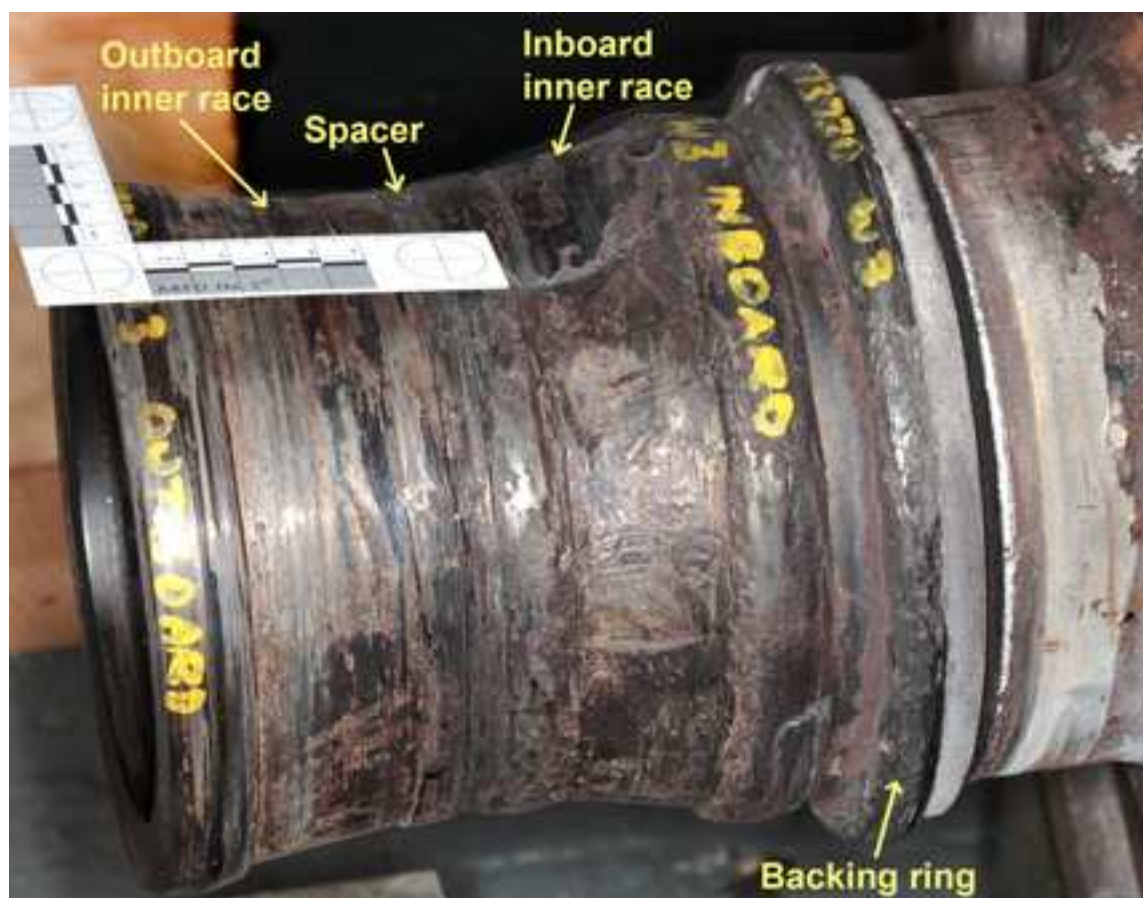
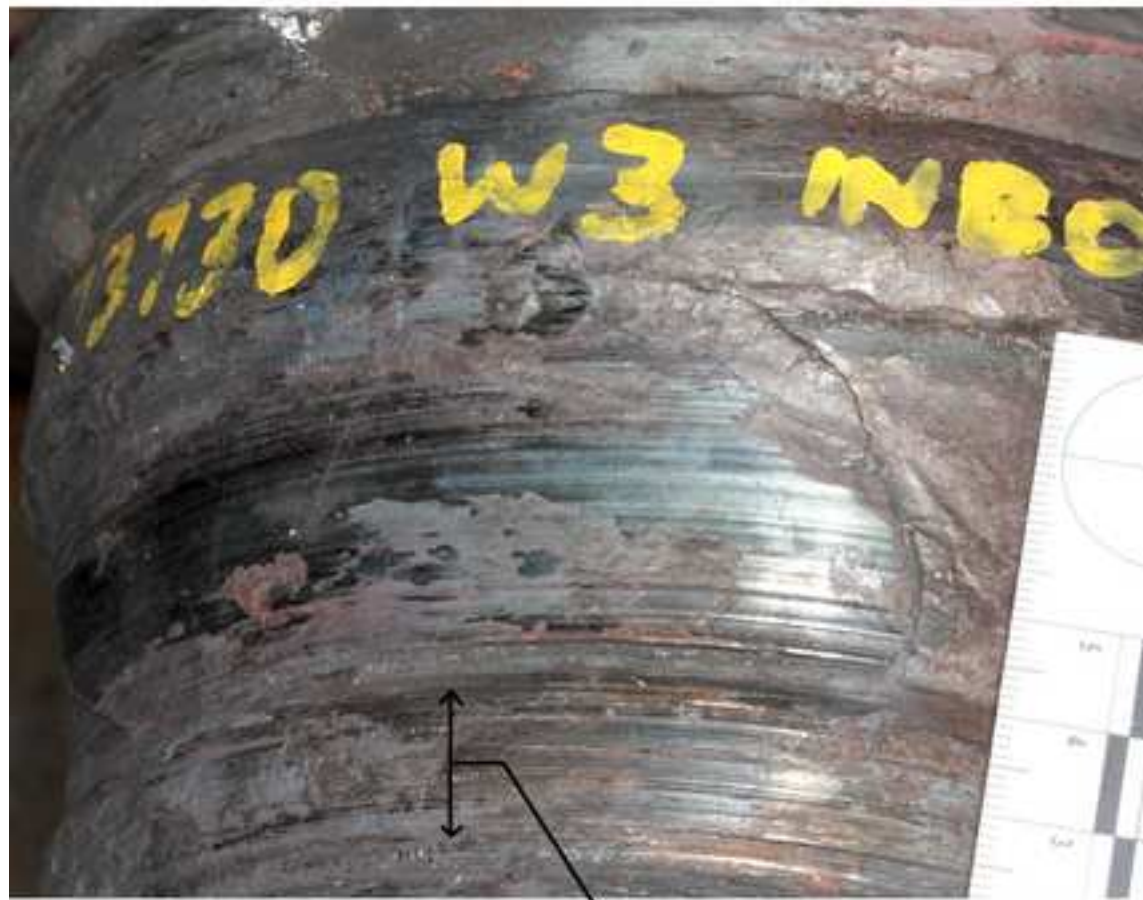
Figure 1 90mm 500dpi
[Click here to download high resolution image](#)

Figure 1 shows the condition of a bearing following catastrophic failure (one of two reported by Southeastern (LSER) over the 2012-2013 period. The outer ring has been removed; **Figure 1a** shows all that remains of the two inner (cone) rings, the central spacer, the 46 rollers and two molten polymer cages. **Figure 1b** shows a higher magnification view of the damage; it is interesting to note that the rollers have been smeared across the raceway and the shoulders of the inner (cone) rings have been worn down.

The implications for the operator and passengers of a catastrophic rail axle bearing failure have been introduced; the photographic images of [Figure 1](#) display the resulting bearing conditions. It can be assumed that during this failure the grease broke down and subsequently the bearing (through frictional heating) became hot enough to cause melting of the cage. The rollers were either expelled or smeared across the races. In this particular case, there was also a local fire in which the rubber suspension system (located above the bearing housing (see [Figure 3a](#))) burnt; fortunately the wheelset remained on the track. It is almost impossible to determine after the event what initiated the bearing failure as the bearing condition is so degraded. The trackside HABD system has a small window of opportunity to catch a bearing that has become hot enough to be detected, but still has not yet caught fire. This limitation among others has led to the decision to phase out HABD systems in favour of acoustic and vibration monitoring approaches that offer the opportunity to identify bearing failure at an earlier stage. A significant benefit of the earlier detection and removal of failing bearings is the opportunity to examine the damage prior to catastrophic failure and melting.

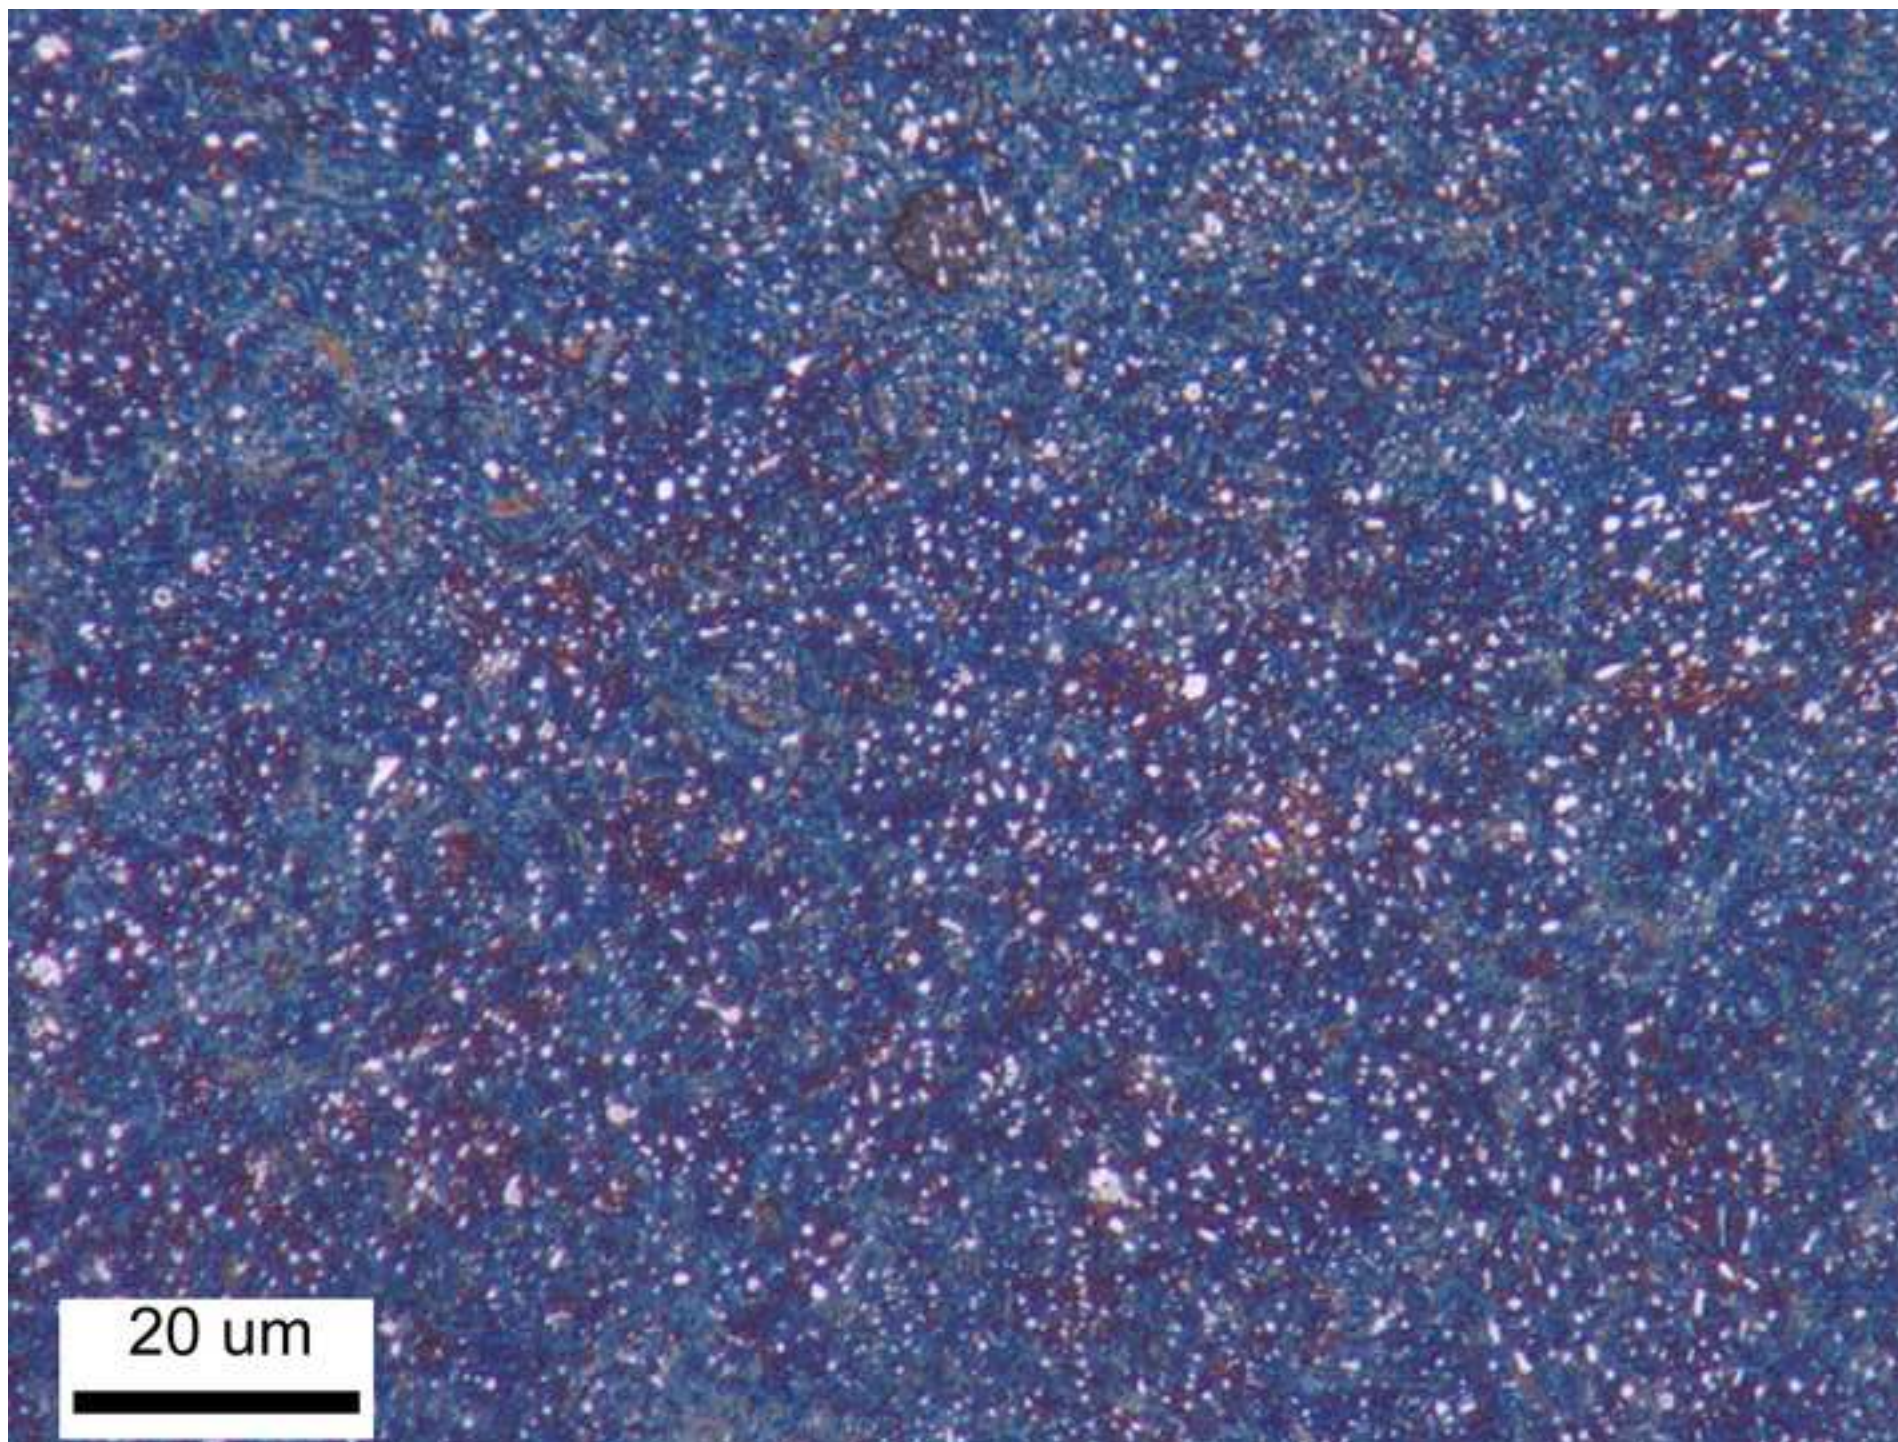
Figure 22 90mm 500dpi
[Click here to download high resolution image](#)

Micro-sections were taken through a suspected site of electrical pitting (highlighted on the right-hand roller shown in [Figure 13](#)). Etchings with Nital (Table 4) revealed evidence of microstructural changes consistent with local heating, confirming that the isolated sites of damage were due to electrical arcing, see [Figure 22](#).

All sites of electrical damage observed were 'minor', i.e. they were at discrete locations and did not surround the rollers or inner ring and only affected three rollers. The path for the electrical arcing would have passed through the outer ring, and would have created similar localized damage. The question remains: did the electrical event influence the RCF of the outer ring? It is not known when in the life (4 years and 9 months) of the bearing the electrical damage occurred. The lack of subsequent (RCF) damage to the rollers and inner ring, or to the other bearing from the same wheel-set, suggest it was a recent event, and therefore would have had not played a part in the outer ring failure. However, if the electrical event did precede the RCF, the electrical damage to the outer ring raceway combined with a heavier external loading (suggested by the recorded loads and the presence of the white etched layers) could have caused the resultant outer ring bearing failure. Equally, if the external loading was large enough, or there were regular shock loading events, RCF would have occurred even without any electrical damage.

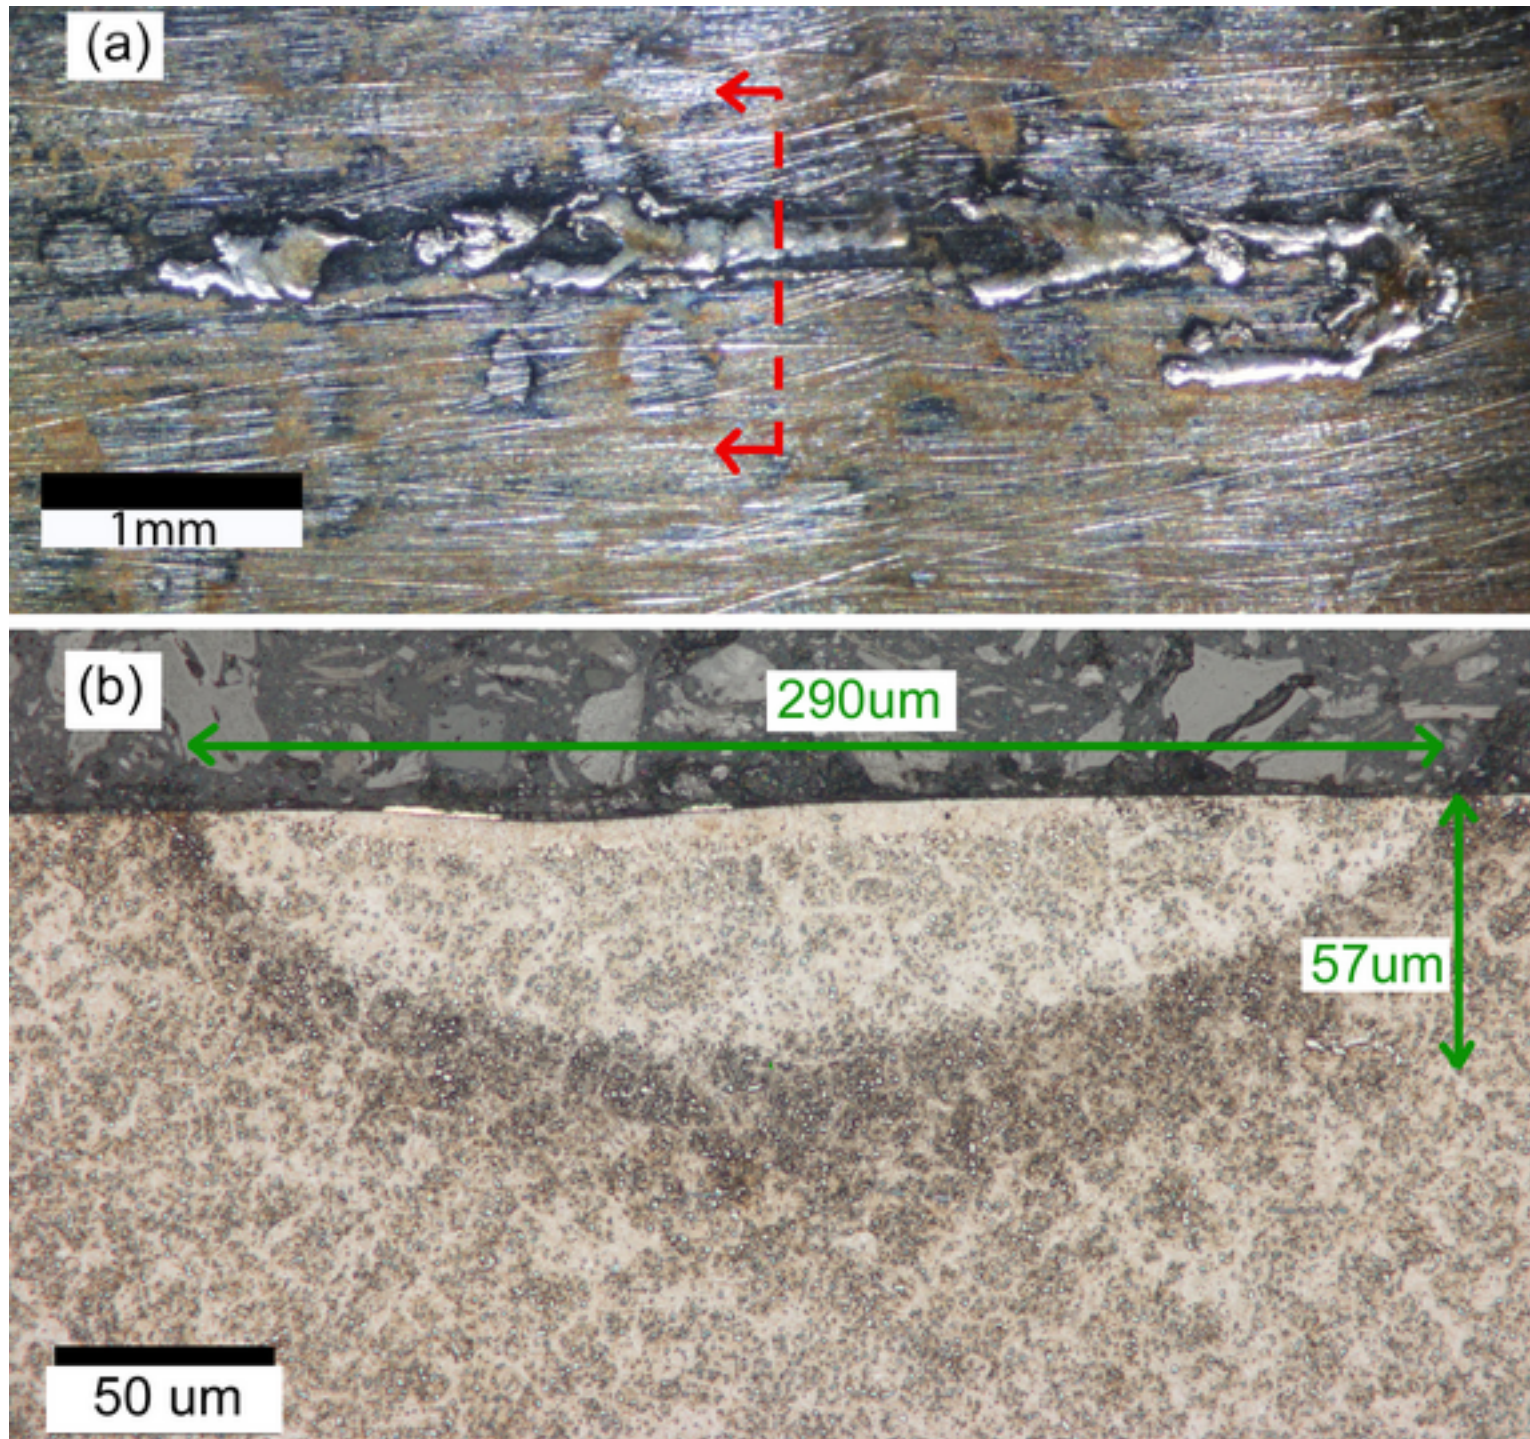
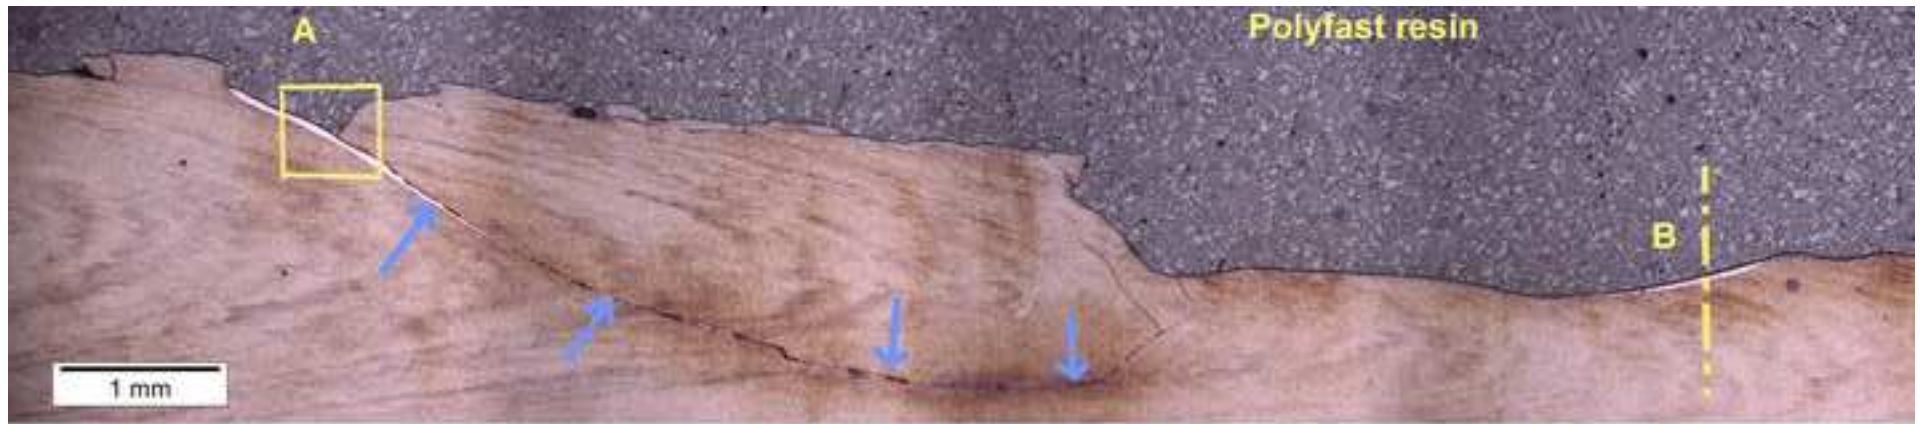
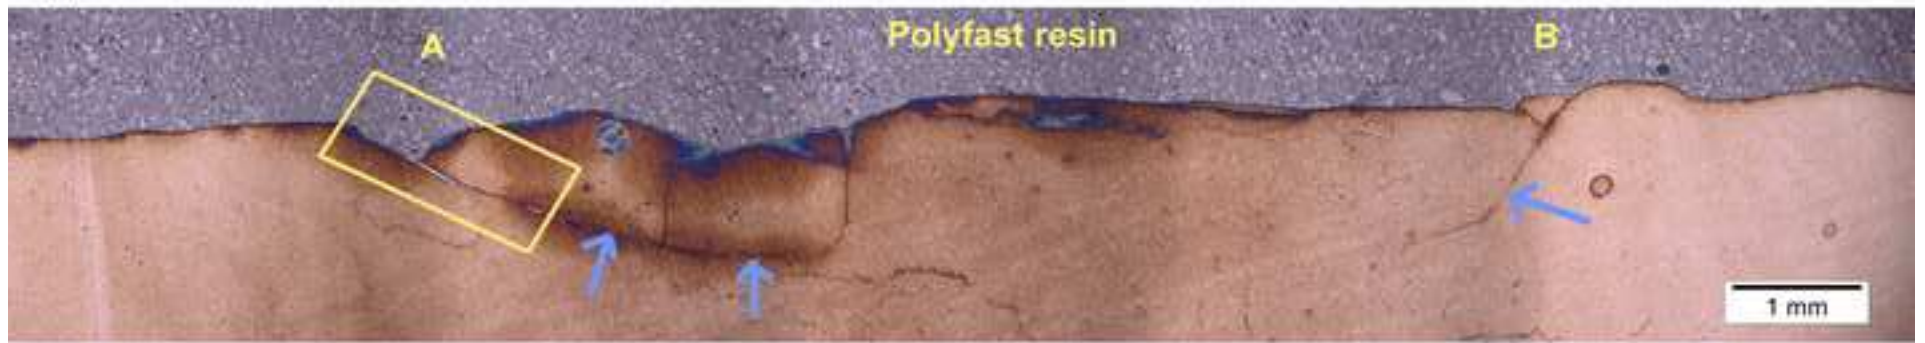
Figure 23 140mm 300dpi
[Click here to download high resolution image](#)

The same white layer (line A) found in slice 53 was also found in slice 77 (see [Figure 23c](#)), 24 mm away. The white layer (line feature A) was measured to be approximately 2 mm wide, up to 48 μm deep (see [Figure 24](#)) and orientated at about 45 degrees to the bearing surface. The second white layer shown in [Figure 23a](#) (labelled as line feature B) was measured to be 1.2 mm wide and up to 38 μm deep ([Figure 25](#)). Micro-sections were taken outside the 95 mm of damaged raceway; no evidence of the white layer was found.

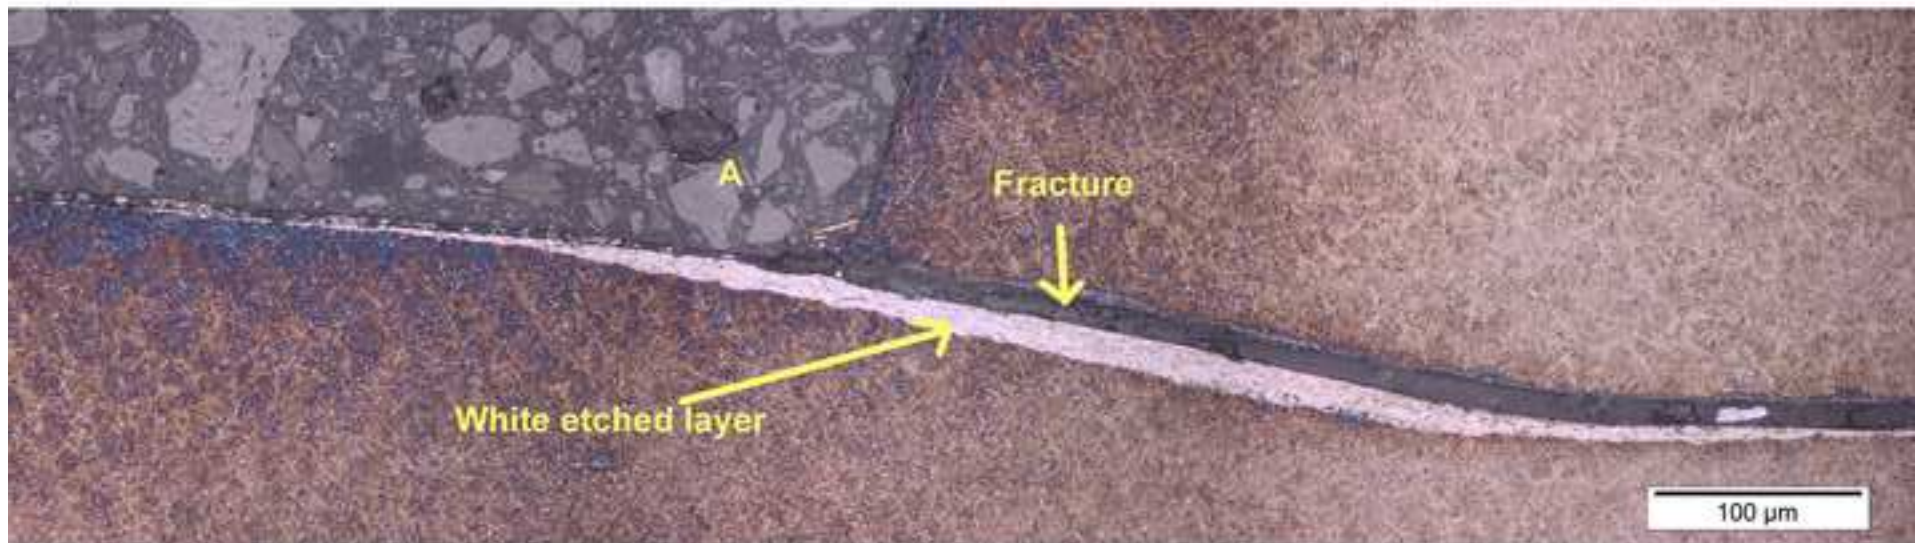
Figure 24 90mm 500dpi
[Click here to download high resolution image](#)

Higher magnification views of the white layers ([Figures 24 and 25](#)) revealed that they were associated with subsurface cracks or fracture faces in the bulk material. Moreover, the microstructure of the white layer was significantly different from that of the bulk material, this was especially evident when the micro was analysed with an SEM in secondary electron mode, see [Figure 26](#). The upper portion of [Figure 26](#) shows the white layer, while the lower portion shows the expected lath structure of retained martensite and the globular cementite of the bulk bearing material. [Figure 27](#) provides a view of the white layer and bulk material in back scatter mode.

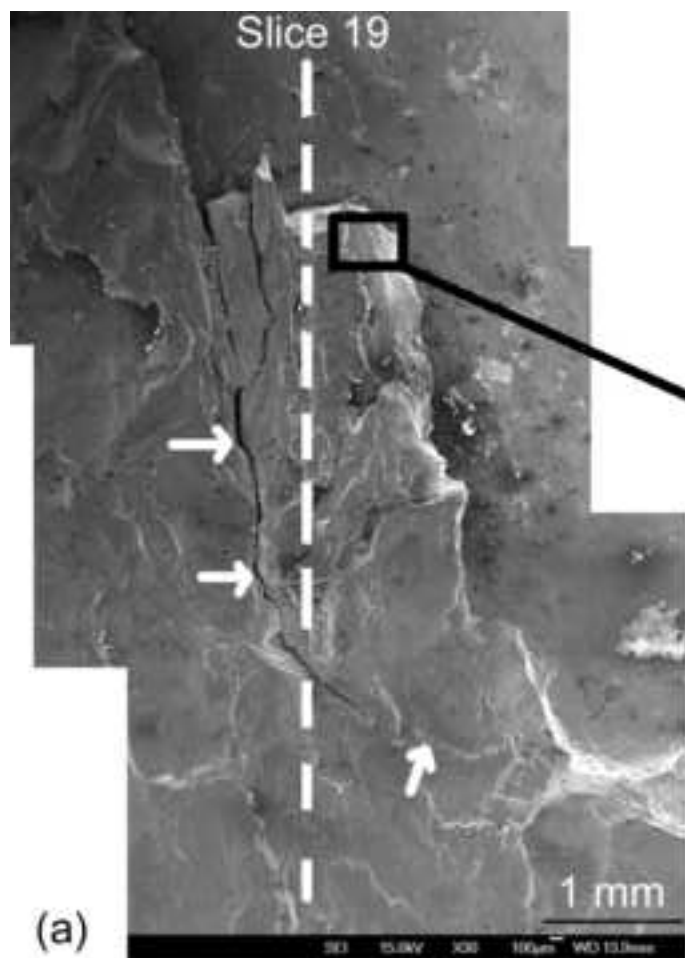
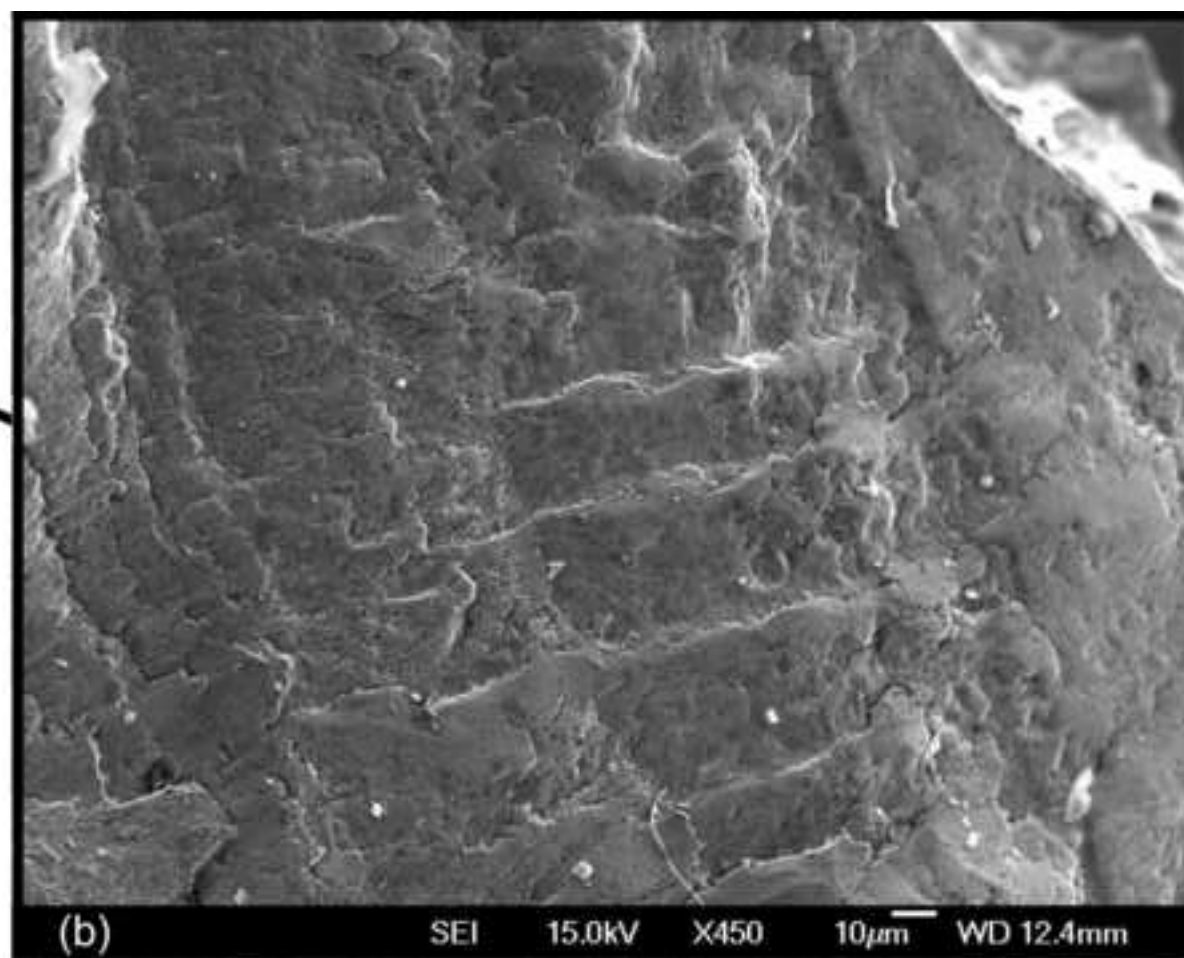
Further evidence of a fatigue propagated fracture surface was observed on the damaged rolling surface of the bearing. [Figure 29a](#) provides a montage of SEM micrographs showing a large section of bearing raceway that would have broken free if the bearing had not been removed from service. Evidence in support of this can be found in the CT image slice 19 ([Figure 18a](#)) that clearly displays subsurface cracking. Higher magnification of the fracture surface ([Figure 29b](#)) revealed step features, consistent with a cyclic (fatigue) propagation mechanism.

Figure 29. SEM micrographs a) montage and b) close-up view of the area correspondent to CT slice 19 (see [Figure 18a](#)). The clearly visible step like features are typical of RCF.
