Characterisation of the oxide film on the taper interface from retrieved large diameter metal on polymer modular total hip replacements

P. Zeng^{a,*}, W.M. Rainforth^a, R.B. Cook^b

^a Department of Materials Science and Engineering, University of Sheffield, UK

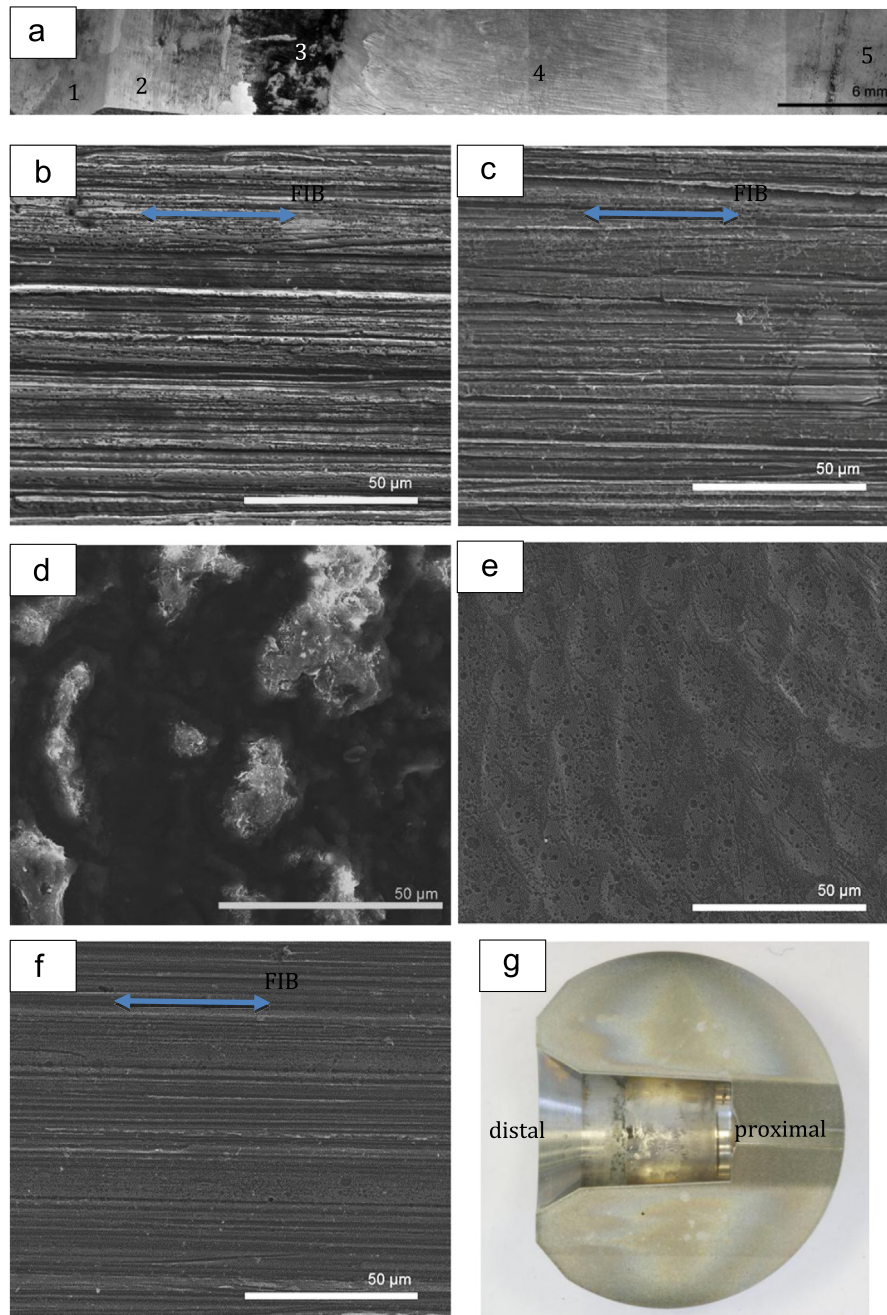
Fig. 1. (a) SEM plan-view of the CoCrMo taper interface from Case 1 (left to right: distal end of the taper to the proximal taper trunnion). Five different areas are classified due to various microstructures as: Area 1 (b), Area 2 (c), Area 3 (d), Area 4 (e) and Area 5 (f). Cross-section of the femoral head showing taper interfaces is shown in Fig. 1g with distal end of the taper in the left and the proximal taper trunnion in the right. Arrows in Fig. 1b, c and f indicate where site-specific FIB TEM cross-section were taken. Note Fig. 1b–f are taken perpendicular to Fig. 1a.

Fig. 1a is a SEM plan view of the CoCrMo taper surface of Case 1. From the distal (open) end of the surface to the proximal (central head) end (left to right) (as shown in Fig. 1g), five different areas

can be identified, labelled Areas 1–5. Of these regions, Areas 2–4 are where the taper and trunnion were overlapping. Magnified SEM images of Areas 1–5 are shown in Fig. 1b–f, respectively. Area 1 (Fig. 1b) is the distal end of the taper and shows original machining marks. Area 2 (Fig. 1c), which was about 6 mm wide, shows similar machining marks to those observed in area 1, however, there was evidence of some smoothing of the machining marks and microstructural features could be seen through etching of the grain and or phase boundaries. Area 3 (Fig. 1d), about 3 mm wide, exhibited denatured protein piling up on the surface, which obscured the underlying material. Area 4, which about 18 mm wide, was the largest area of the taper-trunnion overlap. This area exhibited evidence of extensive plastic deformation in the surface (Fig. 1a), but when viewed at higher magnification, Fig. 1e, there was evidence of pitting within the adzed texture of the surface, with all evidence of the original machining marks lost. Area 5, the proximal end of the taper trunnion, exhibited some evidence of the original machining marks, but otherwise a smooth surface with some evidence of fine scale corrosion (Fig. 1f).

interfaces. According to this scale, Case 1 and Case 2 would have scored a 4.

Five different areas were classified in this study: 1) Area 1, the distal end of the taper showing original machining marks; 2) Area 2, showing similar machining marks compared with Area 1 which is also where the taper and the trunnion started overlapping; 3) Area 3, showing denatured protein piling up on the surface; 4) Area 4, dominated by heavy deformed materials; 5) Area 5, at the proximal end of the taper showing a highly polished region. Areas 1, 2, 3 and 5 of Case 1 and Case 2 show similar surface morphologies, however, different morphologies are seen in Area 4 of Case 1 and Case 2, which might be due to machine cutting damage to Case 1.

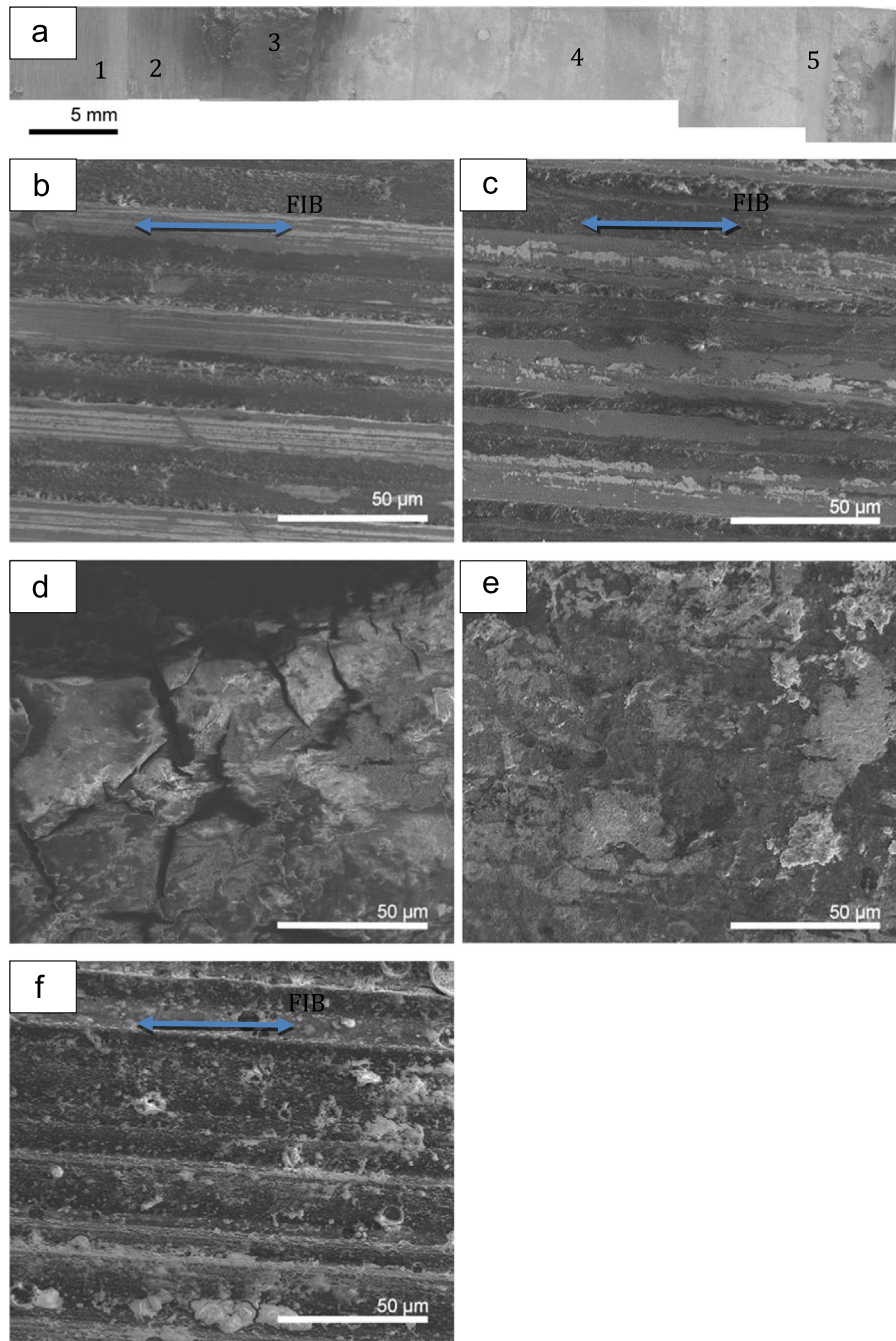
Fig. 2. (a) SEM plan-view of the CoCrMo taper interface from Case 2 (left to right: distal end of the taper to the proximal taper trunnion). Five different areas are classified due to various microstructures as: Area 1 (b), Area 2 (c), Area 3 (d), Area 4 (e) and Area 5 (f). Arrows in Fig. 2b, c and f indicate where site-specific FIB TEM cross-section were taken. Note Fig. 2b–f are taken perpendicular to Fig. 2a.

Case 2 provided similar observations to Case 1 (Fig. 2). As with Case 1, five different regions could be classified as Areas 1–5, from

the distal end of the taper to the proximal taper trunnion (left to right). Area 1 (Fig. 2b), the distal end of the taper, exhibited the original machining marks. Area 2 (Fig. 2c) was similar to Area 1, except the high points had been smoothed presumably through overlapping with the counterface. Area 3 (Fig. 2d) exhibited extensive pile up of denatured protein which obscured the metal subsurface. Area 4 (Fig. 2e) also showed extensive denatured protein, but also evidence of wear debris was observed. The wear debris (e.g. in the lower right of Fig. 2e) comprised particles that had a sheet like appearance, typically 10–30 μm in diameter. Area 5 (Fig. 2f) exhibited the original machining grooves, but with wear debris randomly distributed across the surface. Interestingly, areas 1, 2, 3 and 5 of Case 1 show similar surface microstructures to Areas 1, 2, 3 and 5 of Case 2, except more surface debris is observed in Areas of Case 2. In contrast, Area 4 looked quite different in Cases 1 and 2.

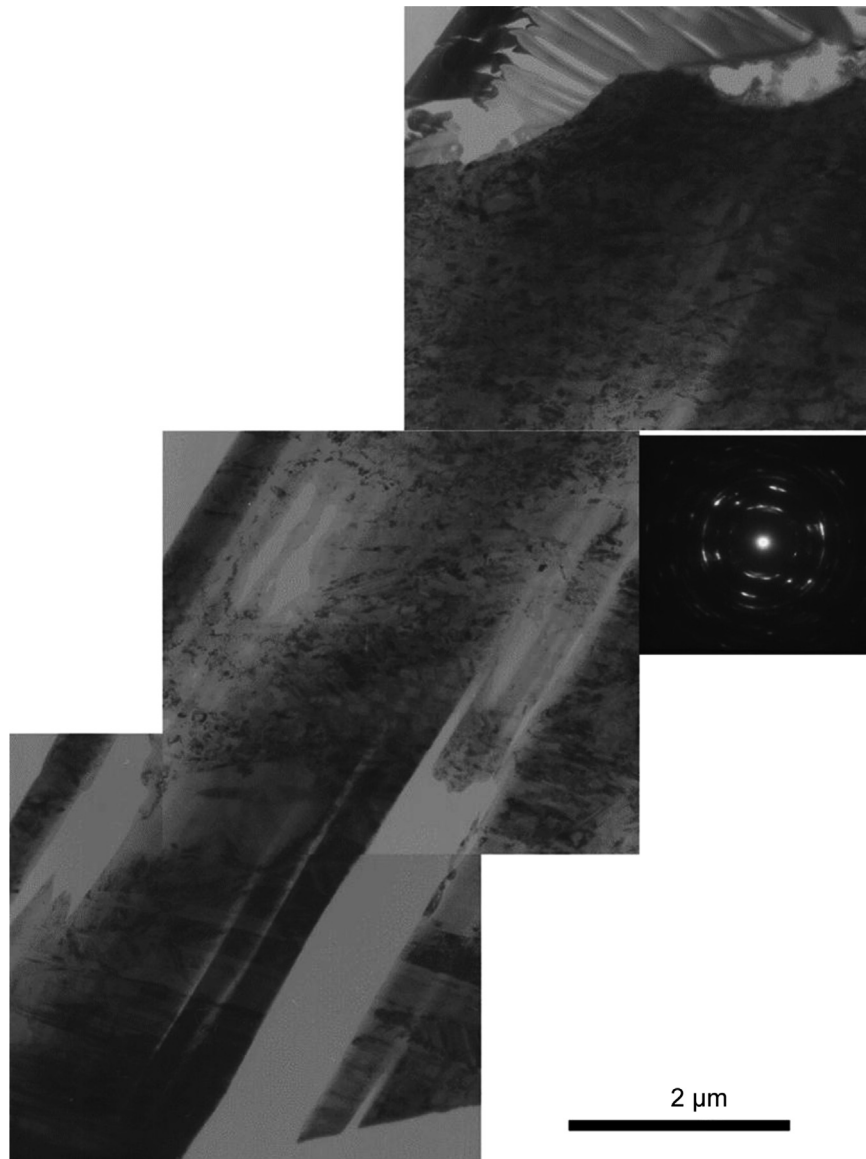
Fig. 3. A plan view bright field TEM cross-section image of Area 1 from Case 1 shows subsurface microstructure changes under the worn surface. Insert diffraction pattern suggests a nanocrystalline structure at the surface.

Fig. 3 is a bright field TEM montage taken from a FIB cross-section from Area 1 of Case 1. The sample was removed in the region indicated in Fig. 1b, i.e. parallel to the original machining marks. A nanocrystalline structure was observed under the surface, with the grain size of the order of 50 nm. The inset diffraction

pattern indicates that the nanocrystalline region exhibited a strong crystallographic texture. The nanocrystalline layer extended to about 5 μm below the surface. Beneath the nanocrystalline layer the structure was a mixture of the face centred cubic (FCC) CoCrMo with plates of ϵ -martensite, which is the classical structure of CoCrMo alloys after low strain deformation.

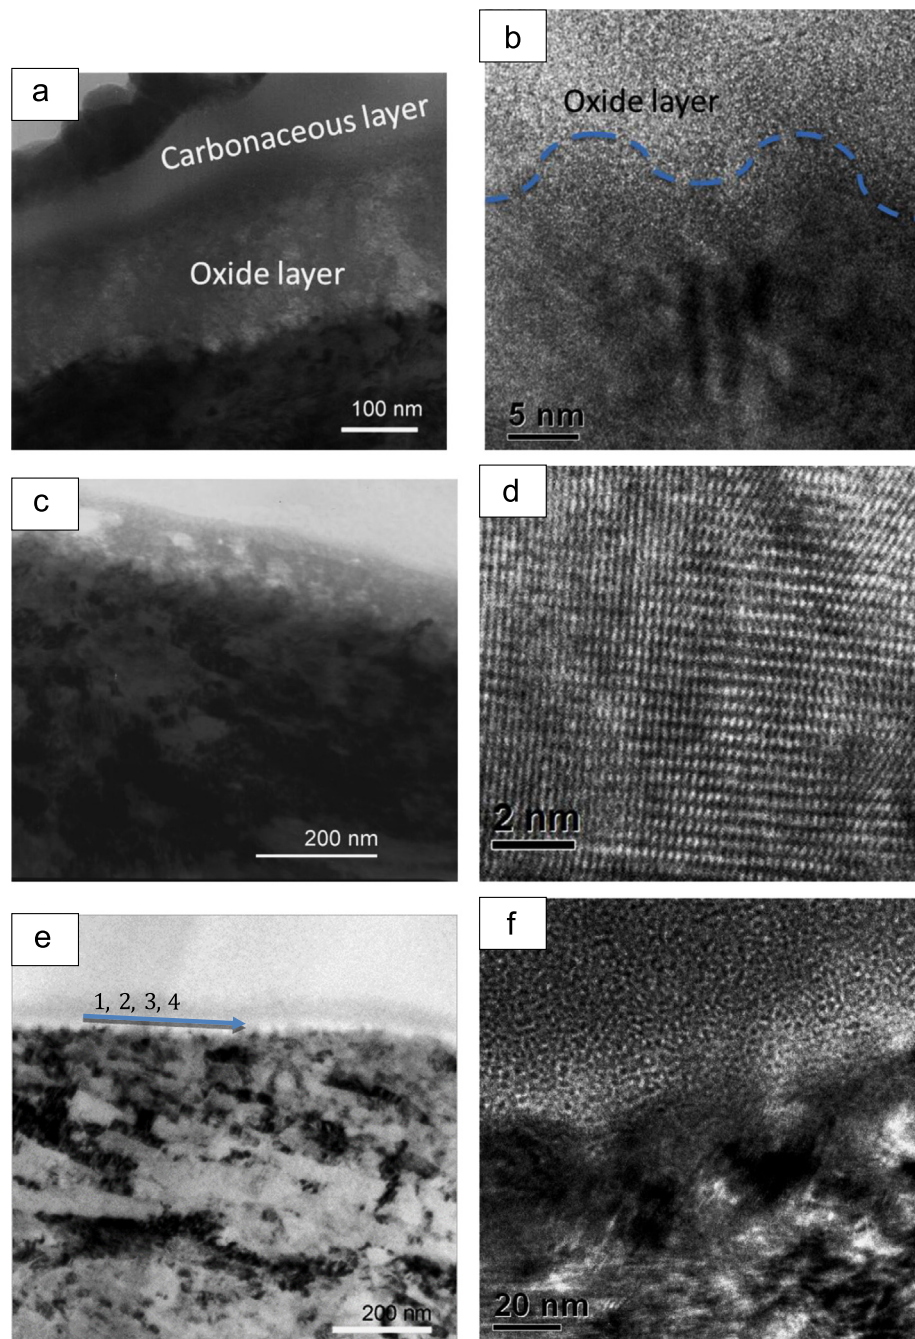
Fig. 4. Longitudinal bright field TEM images from cross-sections of Areas 1, 2 and 5 from Case 1. (a) Area 1 and (b) HRTEM of near surface zone in Area 1; (c) Area 2 and (d) HRTEM of nanocrystalline layer in Area 2; (e) Area 5 and (f) HRTEM of near surface zone in Area 5. Four regions 1–4 are marked in (e) indicating where EELS spectra (Fig. 7) were taken.

A similar nanocrystalline layer was observed in the longitudinal cross-sections of Areas 2 and 5 from Case 1 (Fig. 4). However, the thickness of the nanocrystalline layer was smaller in those regions, being $\sim 1 \mu\text{m}$ in Area 2 and $\sim 2 \mu\text{m}$ in Area 5. The sizes of the substructure in the nanocrystalline region also varied, being $\sim 100 \text{ nm}$ in Area 2 and $\sim 30 \text{ nm}$ in Area 5.

In some cases the nanocrystalline region extended up to the surface, but in most cases, the outer surface had a different structure. Fig. 4 details the surface region of Areas 1, 2 and 5 of Case 1. Fig. 4a is from Area 1 of Case 1. Two layers can be seen on the surface, namely an outer layer that appeared homogenous and exhibited uniform contrast, but with varying thickness, and beneath this a ~ 200 nm thick porous layer. EELS results, which will be presented later, suggest that the outer layer was a carbonaceous layer, while the porous inner layer was an oxide film. Fig. 4b is a HRTEM image of the interface between the oxide film and the nanocrystalline substrate, which shows that the oxide layer was amorphous.

Fig. 4c shows the near surface zone in Area 2 of Case 1. Again, an outer carbonaceous layer is present, followed by an inner oxide film, although in this case it was only ~ 100 nm thick. The oxide layer was attached directly to the nanocrystalline layer. Fig. 4d is HRTEM image of the nanocrystalline layer.

In Area 5 of Case 1, the surface layers could not be observed in conventional bright field images, with Fig. 4e just showing the nanocrystalline layer. However, HRTEM image, Fig. 4f, indicated that a thin, ~ 20 nm, surface layer existed.

In Areas 1 and 2 of Cases 1 and 2, a porous oxide film was observed, as indicated in Fig. 4a and c and Fig. 8a and c. EELS results (Figs. 5, 6, 9, and 10) show only O K-edge and Cr $L_{3,2}$ -edges, suggesting that it is only chromium oxide. However, the oxide is amorphous with unknown stoichiometry, and does not correspond to Cr_2O_3 , which has been assumed to be present by other researchers [28,30]. The thickness of this oxide film varies over small distances, being as thick as 100 nm in some Areas 1 and 2 of Case 1 (Fig. 4), but equally around half that value at ~ 50 nm, in Area 1 of Case 2 (Fig. 8) and as small as 10 nm in Area 2 of Case 2 (Fig. 8). Orthopaedic metals are artificially over-passivated [31] to build up a protective oxide film before implantation, which explains the thick oxide film observed in Area 1 of both Case 1 and Case 2. However, during service, the passive oxide film can be damaged by fretting wear, like in Area 2 of Case 2; or new passive film can be formed and serve as a barrier to further corrosion, such as Area 2 of Case 1. The extent of reformation depends on the local pH and the extent of oxygen depletion, which are not known. The passivation and repassivation of the oxide film explain the various thickness of the oxide film.

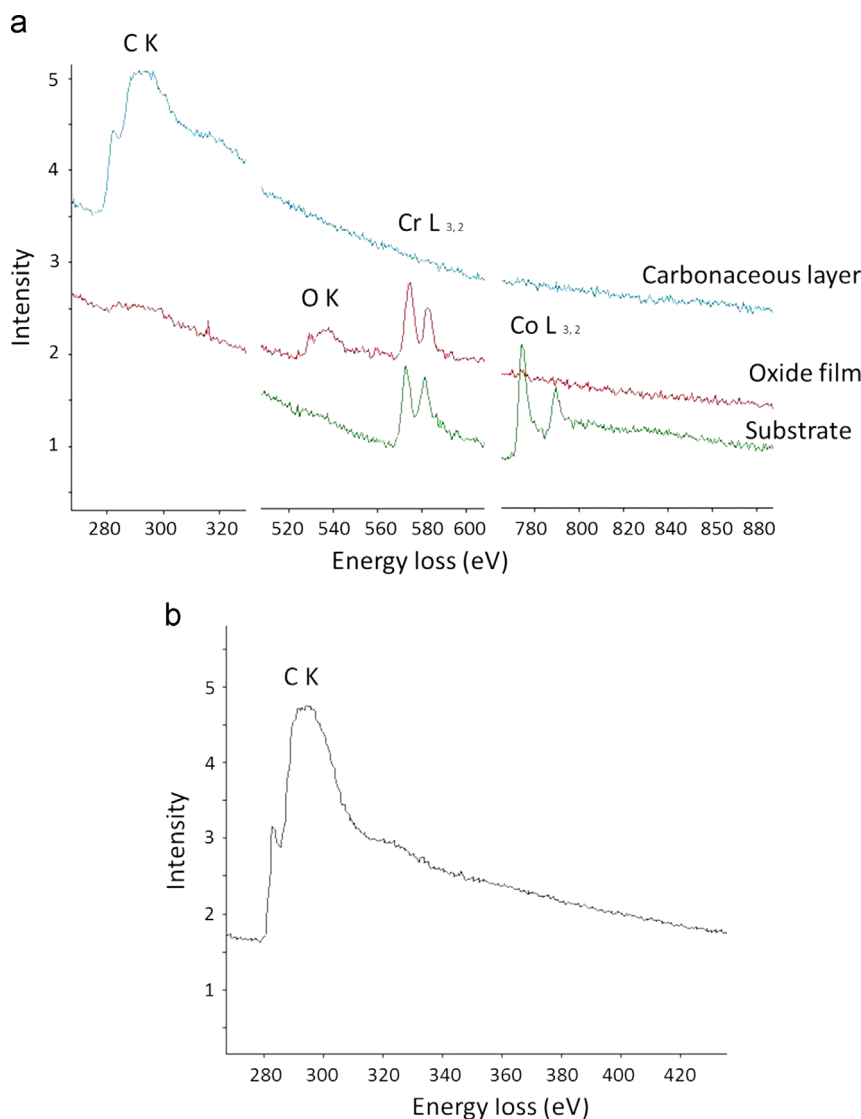
Fig. 5. (a) Normalised experimental EEL spectra from carbonaceous layer, oxide film and substrate of Area 1 of Case 1. (b) Standard amorphous carbon spectrum.

Fig. 5a compares normalised EEL spectra from the carbonaceous layer, oxide film and substrate of Area 1 of Case 1. In addition,

a standard carbon K-edge for amorphous carbon is provided in Fig. 5b. The C K-edge was only observed in the outer carbonaceous layer and was not found in the adjacent oxide film or substrate (spectrum is not shown here). The carbon K-edge observed here is very similar in fine structure to the standard amorphous carbon spectrum. This is also consistent with the high resolution imaging of this region.

Fig. 5 also shows EEL spectra taken from the oxide film. The O K-edge and Cr L_{3,2}-edge are clearly present, but no trace of Co L_{3,2}-edge was observed, suggesting the oxide film is chromium oxide. Not surprisingly, strong peaks of Cr L_{3,2} and Co L_{3,2} are seen in the substrate, with fine structure in the Cr L_{3,2}-edge similar in the substrate and oxide.

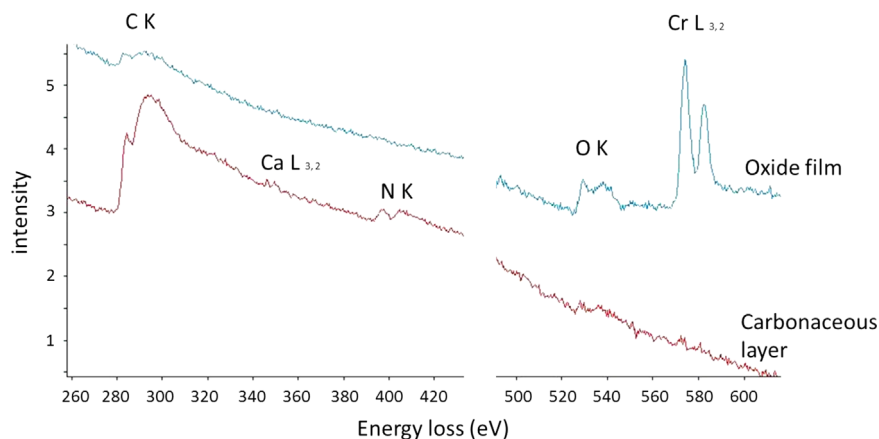
Fig. 6 compares normalised EEL spectra from carbonaceous layer and oxide film of Area 2 of Case 1. In the oxide film, clear O K- and Cr L_{3,2}-edges can be seen with small C K-edge (which might be the contamination), confirming that the oxide film is chromium oxide. In the carbonaceous layer, a strong C K-edge was observed, but interestingly, there were also small peaks of Ca L_{3,2}-edge and N K-edge.

Fig. 6. Normalised experimental EEL spectra from oxide film and carbonaceous layer of Area 2 of Case 1.

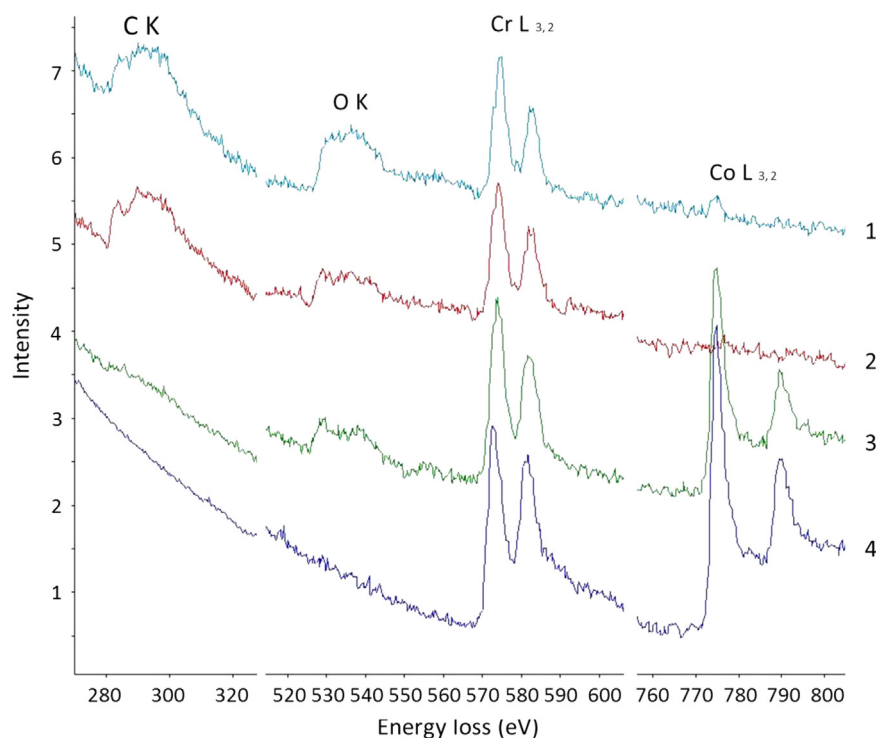
As Fig. 4e shows, no obvious surface layer can be seen in Area 5 of Case 1, therefore, random point analysis was performed on the near surface zone close to the substrate. Fig. 7 compares

Fig. 7. Normalised experimental EEL spectra of four points, as indicated as 1, 2, 3 and 4, in near surface contact zone in Area 5 of Case 1.

normalised EEL spectra from four points in the near surface zone close the substrate, as indicated in Fig. 4e. Point 1 shows clear C K-edge, O K-edge and Cr $L_{3,2}$ -edge, together with weak Co $L_{3,2}$ -edge, suggesting there is a surface layer comprising a mixture of carbonaceous material and chromium oxide. Point 2 is similar to point 1. Points 3 appears to be just chromium oxide, with no carbon present. Point 4 only shows Cr $L_{3,2}$ and Co $L_{3,2}$ peaks suggesting the spectrum came from the substrate.

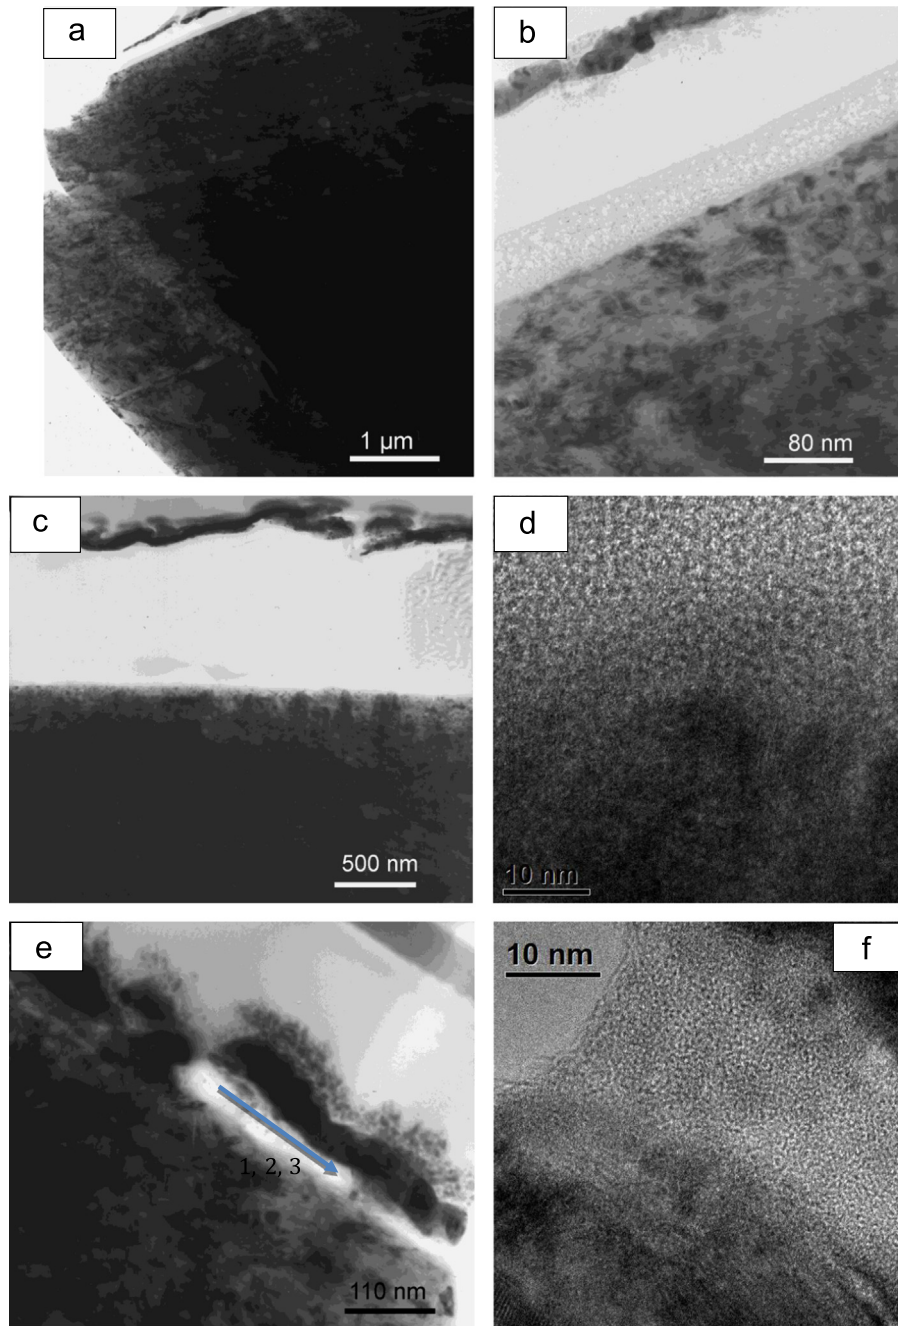
Bright field TEM images from FIB cross-sections of Areas 1, 2 and 5 of Case 2 are shown in Fig. 8. All the samples were taken in a longitudinal direction along the machining lines, as indicated in Fig. 2b, c and f. Fig. 8a and b are cross-sections of Area 1 of Case 1. A nanocrystalline layer of about 2 μm thick, with a crystallite size was ~ 50 nm, was observed under the surface (Fig. 8a). In the near surface zone, two layers were observed between the metal surface and sputtered gold coating that acted as a label for the original

outer surface (Fig. 8b). This is similar to the observation in Areas 1 of Case 1. The thickness of the carbonaceous layer was about 80 nm with oxide film about 40 nm. Again, the carbonaceous layer appeared uniform and amorphous, while the oxide layer appeared both amorphous and porous. However, in Area 2 of Case 2, only a thick layer, which is later confirmed to be carbonaceous layer by EELS (Fig. 10), was observed (Fig. 8c). HRTEM image (Fig. 8d) reveals a very thin layer, less than 10 nm, between the carbonaceous layer and the substrate. This layer was later confirmed to be oxide film by EELS (Fig. 10). Fig. 8e shows an area between the metal surface and the gold label for Area 5 of Case 2. The region of bright contrast in this image is shown at high resolution in Fig. 8f, revealing an amorphous structure to this material.

Fig. 8. Longitudinal bright field TEM images from cross-sections of Areas 1, 2 and 5 from Case 2. (a) plan view of Area 1 and (b) near surface zone in Area 1; (c) Area 2 and (d) HRTEM of near surface zone in Area 2; (e) Area 5 and (f) HRTEM of near surface zone in Area 5. Three regions 1–3 are marked in (e) indicating where EELS spectra (Fig. 11) were taken.

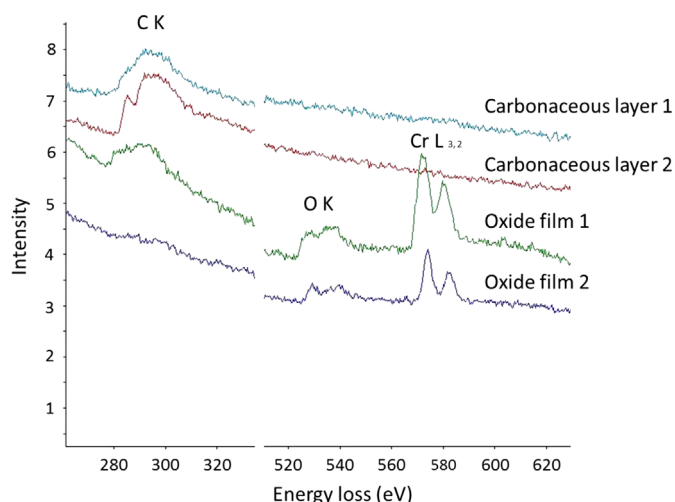
Fig. 9 compares normalised experimental EEL spectra from the carbonaceous layers and oxide films from Area 1 of Case 1. It is interesting to note that in the carbonaceous layer, the majority of the C K-edges have a π^* pre-peak (see Fig. 9 for such an example of from the carbonaceous layer 2), however, some of C K-edges do not exhibit the π^* pre peak (for example, the carbonaceous layer

1 in Fig. 9). Also in the oxide film, some only have O K-edge and Cr $L_{3,2}$ -edges, indicating chromium oxide, and some has an extra C K-edge, which might be caused by contamination.

Fig. 9. Normalised experimental EEL spectra from carbonaceous layers and oxide films of Area 1 of Case 2.

carbonaceous layer 1 in Area 1 of Case 2 (Fig. 9) which does not show the π^* pre-peak. It is difficult to say that this π^* pre-peak is a product of the wear process, however, it is commonly seen in amorphous carbon surface layers resulting from frictional surface contact [32], and is not present in carbon resulting from contamination, e.g. during sample preparation.

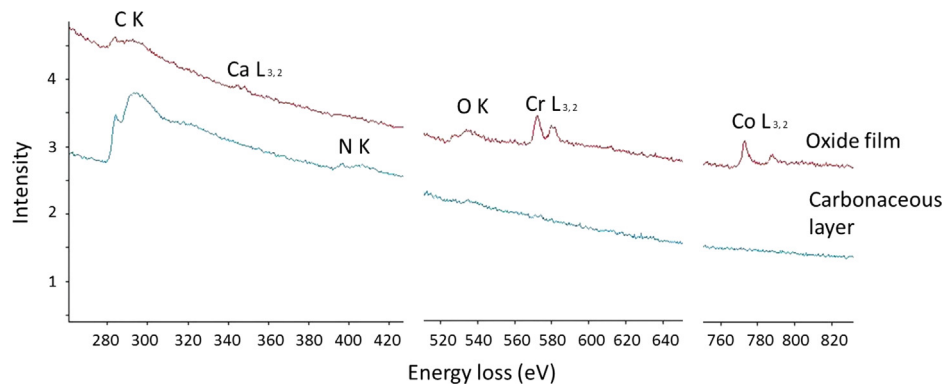
Fig. 10 compares normalised EEL spectra from carbonaceous layer and oxide film from Area 2 of Case 2. It is worth noting that in the carbonaceous layer, a weak N K-edge is seen as well as a strong C K-edge. In the oxide film, O K- and Cr $L_{3,2}$ -edges are present, but additional C K-, Ca $L_{3,2}$ - and Co $L_{3,2}$ -edges are observed (Fig. 10), suggesting tribochemical reaction between surface layers (carbonaceous layer and oxide film) and the body fluid.

Fig. 10. Normalised experimental EEL spectra from carbonaceous layer and oxide film of Area 2 of Case 2.

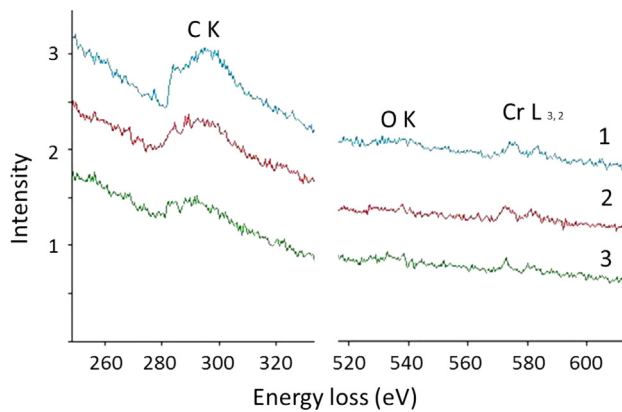
Fig. 11 compares normalised EEL spectra from three points in the region of bright contrast in Fig. 8e, taken from Area 5 of Case 2. A strong C K-edge and weak O K- and Cr $L_{3,2}$ -edges were observed

all three points, suggesting a mixture of carbonaceous and oxide material with carbonaceous material the most dominant.

Fig. 11. Normalised experimental EEL spectra of three points, as indicated as 1, 2 and 3 in Fig. 8e, in near surface contact zone in Area 5 of Case 1.

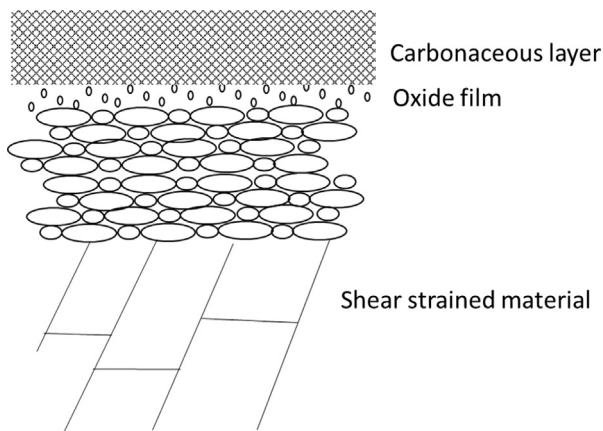
The visualisation of subsurface deformation is important if an understanding of balance between corrosion and wear process of retrieved taper surfaces are to be differentiated. Fig. 12 shows a schematic diagram of the subsurface changes on the taper interfaces. In the near surface zone, three layers were present, namely (from top to bottom): a carbonaceous layer, an oxide film and a nanocrystalline layer in the surface of the metal. The thickness of various layers is different from area to area, as summarised in Table 1. In Area 5, a tribo-layer of carbonaceous material mixed with chromium oxide was present, in contrast to the separate carbonaceous layer and oxide films seen elsewhere. The thickness of this layer was of the order of 20 nm and could only be observed in high resolution TEM, and not visible in conventional TEM (Fig. 4e and f and Fig. 8e and f). EELS results show C K-, O K- and Cr $L_{3,2}$ -edges in the tribo-layer, indicating this layer is carbonaceous material mixed with metal and oxide particles, a result in agreement with Wimmer et al. [30]. The results are also in agreement with Bryant et al. [28] who studied retrieved cemented MoM prostheses and demonstrated that films on the worn surface were a complex mixture of chromium oxide, protein and amorphous carbon.

Fig. 12. Schematic diagram of subsurface microstructure of the taper interface.
