# The influence of structural response on ballast performance on a high speed railway

David Milne<sup>1</sup>, Louis Le Pen<sup>1</sup>, William Powrie<sup>1</sup>, David Thompson<sup>1</sup>,  
Geoff Watson<sup>1</sup>, Simon Morley<sup>2</sup>, Mick Hayward<sup>2</sup>

<sup>2</sup> Network Rail High Speed Ltd, London, United Kingdom

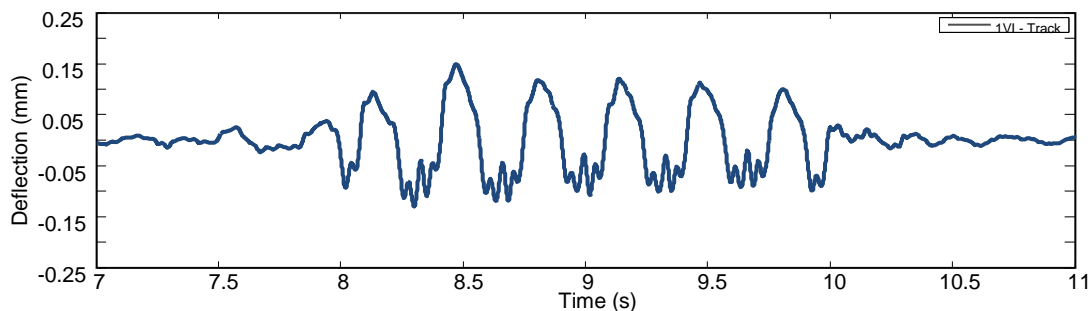
Figure 4 shows the displacement time history for a sleeper ahead of the defect on the approach span. Displacements were small: less than 0.4 mm. Similar results were obtained for a sleeper after the defect zone on the exit span. This magnitude of displacement is expected for the depth and quality of ballast, indicating the track is performing normally before and after the defect zone.

Figure 4 Track displacement time history at location 1VI, obtained from geophone data, filtered between 1.5 and 40 Hz

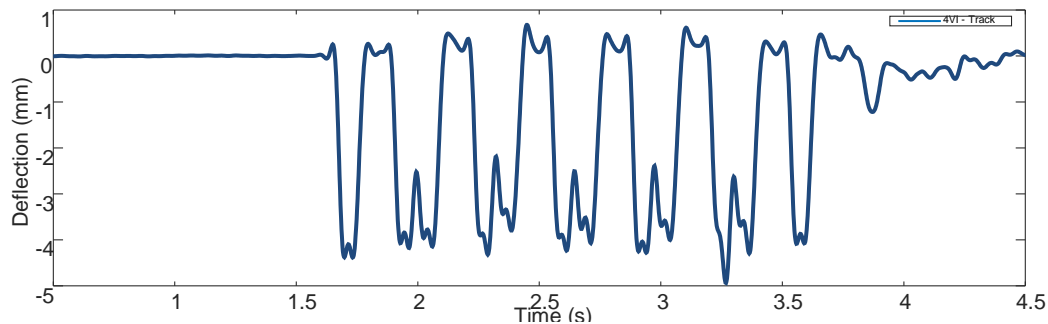
Figure 5 shows the displacement time history for a sleeper in the defect zone. Displacements were large: greater than 5 mm for this train. Similar results were obtained at another sleeper in the defect zone. These displacements are much larger than would be expected. The track is performing poorly, indicating that sleepers may be voided (un- or partially-supported) in the defect zone. These large displacements were clearly visible at the site as was movement of ballast at the surface.

Figure 5 Track displacement time history at 4VI, obtained using DIC, low-pass filtered at 40 Hz.

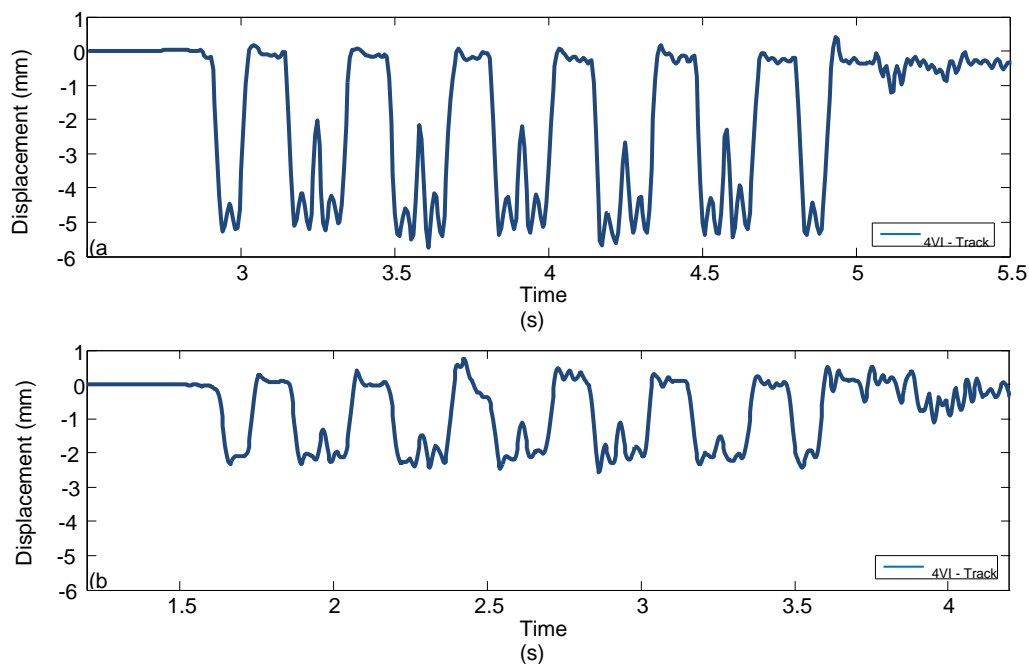
Figure 6 shows the displacement time history for a sleeper in the defect zone both before and after tamping. Before tamping displacements were large, greater than 5 mm, and these were reduced by the intervention to about 2.5 mm. Although a reduction was observed, displacements were still large compared to the measured performance outside the defect zone. The implication is that the intervention was not effective at fully restoring track performance.

Figure 6 Track displacement data at 4VI (a) before and (b) after tamping, obtained using DIC, low pass filtered at 40 Hz

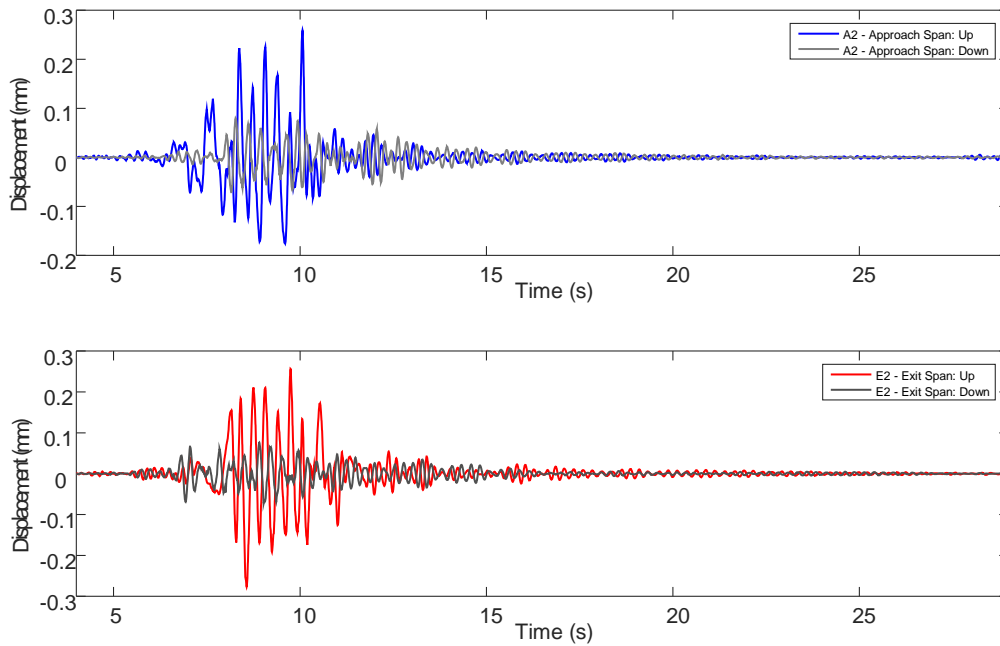
Figure 7 shows the displacement time histories of the bridge spans on either side of the expansion joint from the passage of a train on the up and down lines. For the train on the up line the amplitude of displacement varies from its largest when the train is passing over the instrumented span (about 0.4 mm), decreasing when the train leaves the instrumented span but remains on a continuous deck (about 0.1 mm) and then becomes smaller for the free vibrations when the train has left the deck and bridge. When the bridge was loaded on the down line the measured displacements were smaller whilst the train was on the instrumented spans, but similar once the train had left.

Figure 7 Bridge span displacement time history from a train passing both on up and down lines on (a) the approach span and (b) the exit span, obtained from geophone data, filtered between 1.5 and 40 Hz.

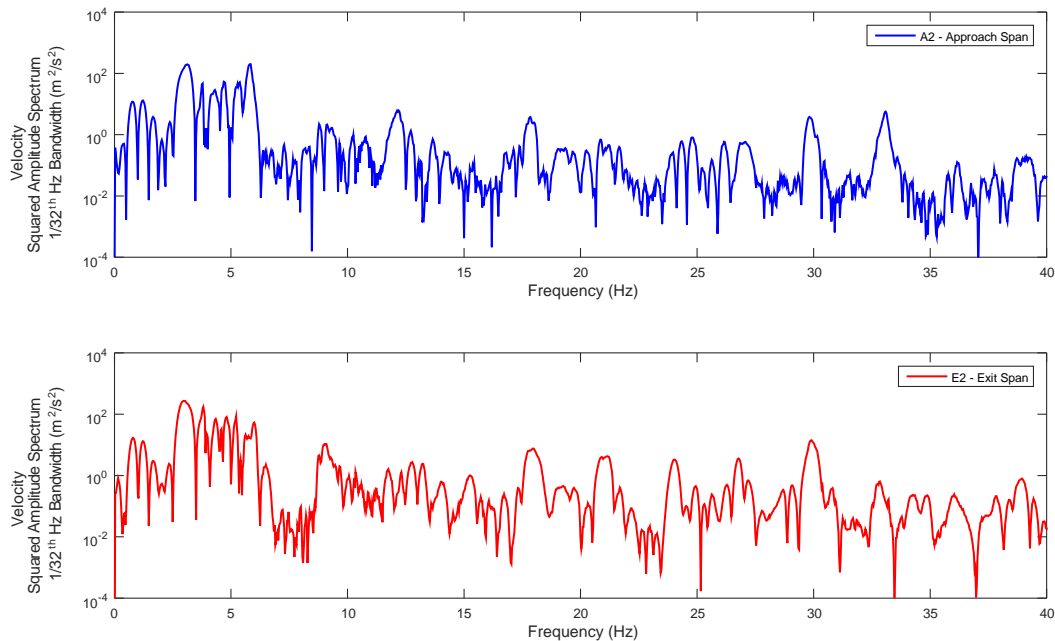
Figure 8 shows the frequency content in the entire velocity signal used to obtain displacement. It shows the frequencies of excitation from a train and of the bridge response. The peaks between about 2.5 and 6.5 Hz are of interest as this suggests the frequencies of excitation and response may be similar. This can be investigated further by computing the frequency spectrum from narrower segments of the time histories (Figure 9), when it is likely that either the frequencies of excitation (solid line for when the train was passing the instrumented span) or of response (dashed line for when the train had left the bridge) will be more significant.

Figure 8 Velocity squared amplitude spectrum with 1/32 Hz bandwidth, from a train on the up line of (a) the approach span and (b) exit span, obtained from full velocity time history of geophone data.

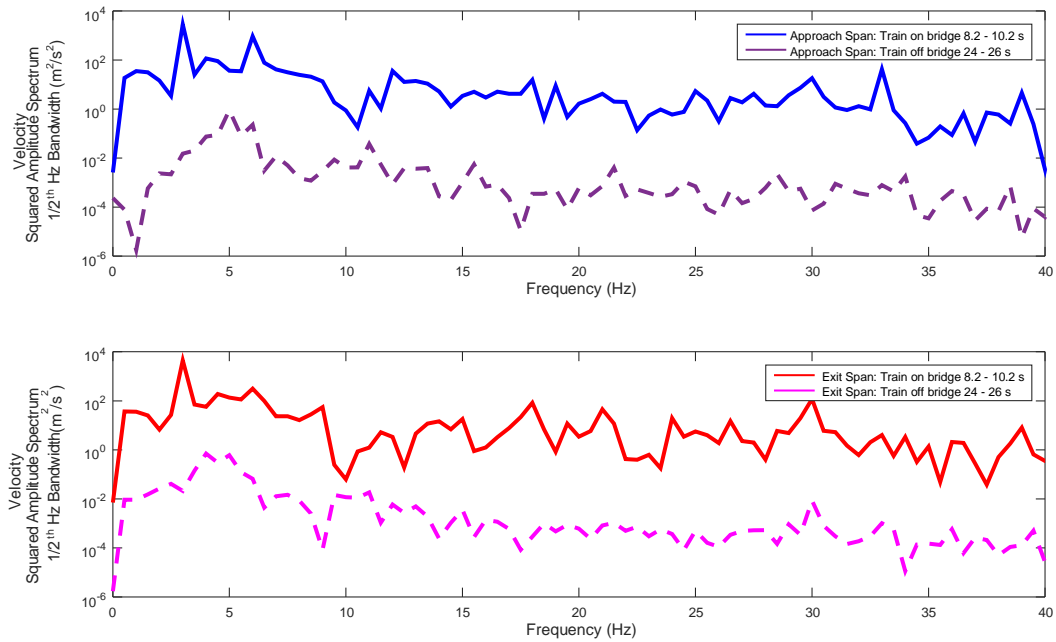
Figure 9 Velocity squared amplitude spectrum with 1/2 Hz bandwidth, from a train on the up line of (a) the approach span and (b) exit span. Obtained from truncated 2 s portion of the velocity-time history from the geophone data when the train is known to be passing over the span between 8.2 and 10.2 s into the record, and when the train is known to have left bridge between 24 and 26 s into the record.

In Figure 9 for the spectra found for when the train is passing both instrumented spans there is a distinct peak at about 3 Hz which is not present in the spectra for free vibration, suggesting that this is a significant frequency of excitation. For the operational speed of this railway 3 Hz corresponds to a wavelength of about 20 m, a typical car length. On the approach span there are other distinct peaks at 4 and 6 Hz, the 6 Hz peak being more significant. These are present yet less distinct on the exit span. The peaks in the spectra of the free vibration are most significant at 5 and 6 Hz for the approach span and at 4 and 5 Hz for the exit span.

As the significant frequencies of excitation and free response are close together, under steady state conditions dynamic amplification could be significant. As the passage of a train is a transient event, steady state excitation cannot be achieved. However, if the response of the structure to a single action (an axle load) is similar to the frequency at which that action is repeated (e.g. car passing), superposition of the exciting action and response to previous actions could still lead to dynamic amplification, during the loading event (Frýba, 2001, Xia et al., 2006).

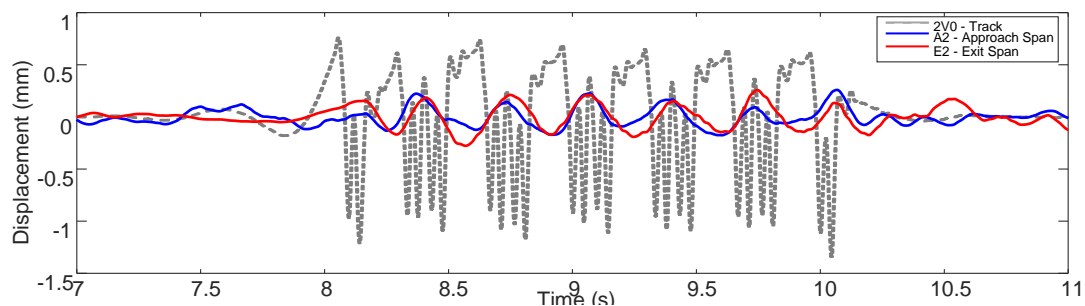
Figure 10 shows the measured bridge displacements on either side of the expansion joint over-laid with a measurement taken at a sleeper directly over the expansion joint. This allows the bridge behaviour to be inferred relative to the position of the train. This suggests that the maximum downward displacements of the bridge spans on either side of the joint occur in-phase and the track above the joint is unloaded when this occurs. This process appears to occur close to the car passing frequency.

Figure 10 Displacement time history of both bridge spans measured at A2 and E2 and the sleeper over the expansion joint at 2V0, obtained from geophone data filtered between 1.5 and 40 Hz

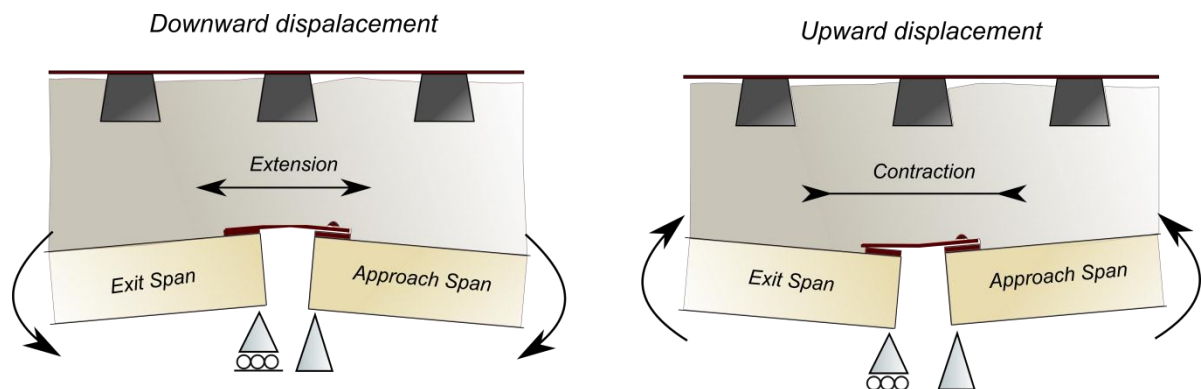
The data also suggest that the maximum displacements of the bridge spans on either side of the joint are in phase, at the car passing frequency. This process will lead to simultaneous deck end rotations, which will cause a cyclic expansion and contraction of the joint. This behaviour has been confirmed using displacement measurements. As the ballast is continuous over the joint the bridge behaviour should cause extension-contraction in the ballast (Figure 11), which could result in mechanisms responsible for or conditions favourable to the formation of track defects. However this behaviour may occur at all the joints on the bridge.

Figure 11 Illustration of extension-contraction behaviour in ballast due to rotation at decks ends. Rotations exaggerated

As the joint design means that the ballast is continuous over the joint this cyclic extension-contraction behaviour could cause localised settlement. If permanent, this may lead to voiding beneath sleepers at this location. Alternatively it could result in a dilative process, which might locally affect structure of the ballast such that it is unable to provide adequate resistant to loads from passing trains or is more susceptible to vibration. Further research into the effects of the bridge behaviour on the ballast is needed to establish in detail how defects may form due to interaction with the bridge.

Both the state of the track and bridge/ballast interaction have implications for maintenance and mitigation. Although the bridge behaviour may have initiated the defect it is likely that the current state of the track influences the rate of defect recurrence. As it is likely to be difficult and costly to alter the bridge behaviour, mitigation which restores and maintains the track in a stable state, removing and preventing voids, may be more effective. Clearly the bridge may affect any mitigation, but this will depend on how the bridge affects the ballast, any permanent effects and the detail of the mitigation. If it does, it may be that the only mitigation that is reasonably practicable is one which the reduces rate of defect recurrence.
