UNDERSTANDING THE SEQUENCE OF DAMAGE IN COMPLEX HYBRID COMPOSITE-METALLIC STRUCTURES SUBJECT TO OUT-OF-PLANE LOADING INVESTIGATED USING COMPUTED TOMOGRAPHY

T. Allen*, S. Ahmed, P.A.S. Reed, I. Sinclair, S.M. Spearing

¹Faculty of Engineering and the Environment, University of Southampton, United Kingdom
Email: tma1e12@soton.ac.uk

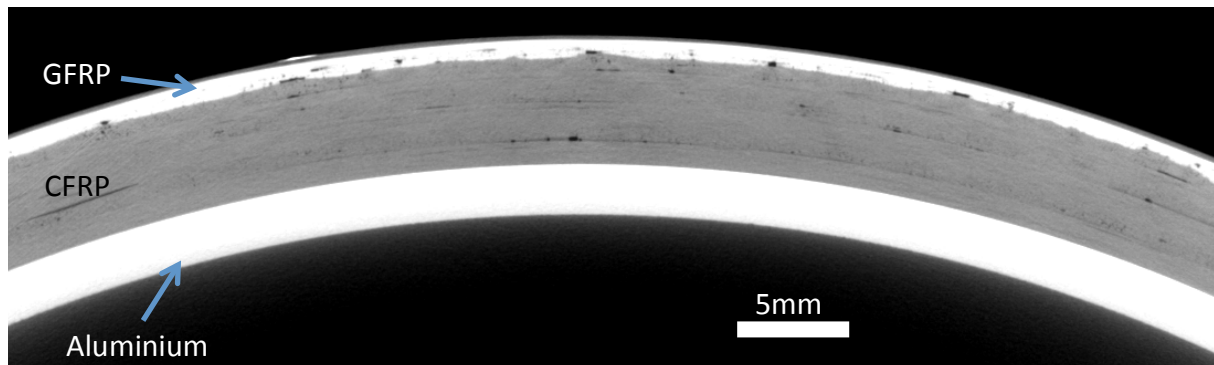
The first scan point was of the sample in the unloaded virgin condition. A cross section in the longitudinal plane shows a typical as manufactured-condition for these HCMS. Due to the out-of-autoclave process a void content of $\sim 3.5\%$ is typical for these structures [10].

Figure 3: Unloaded reference sample

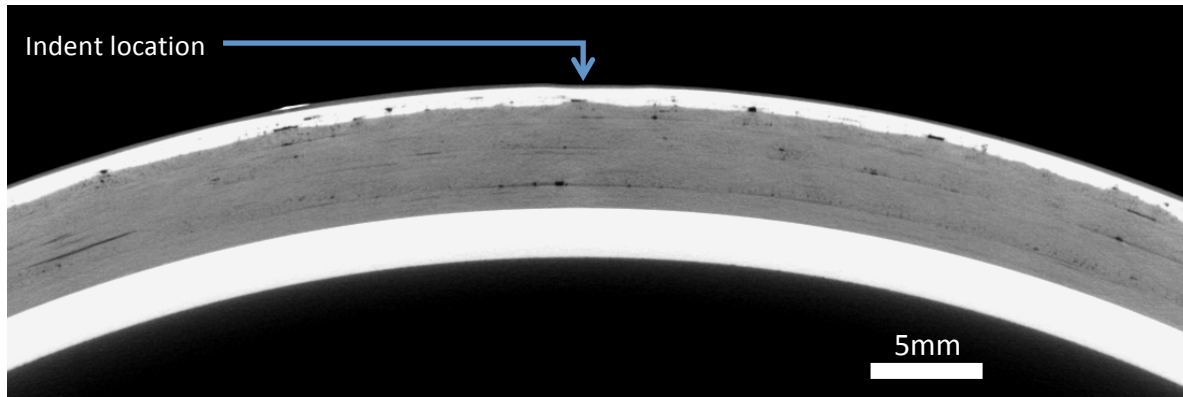
The first load step indicates a largely elastic response (Figure 2), however some permanent indentation was present on the surface of the sample. This was attributed to local indentation in the external gel coat layer and GFRP. No evidence of damage was present in the main structural components of the aluminium and CFRP (Figure 4); this was also the case in the 0.45 load step.

Figure 4: 0.40 load step – centrally located hoop cross section.

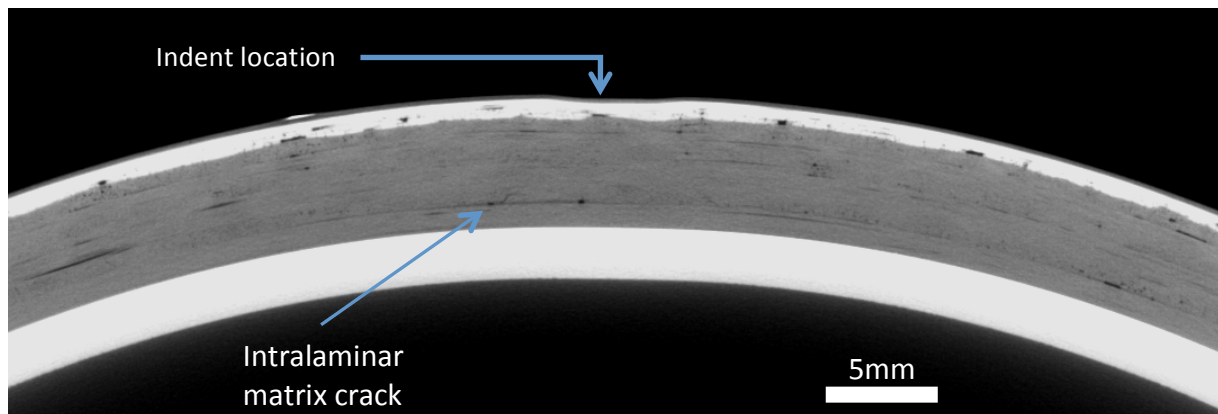
When taken to the first load step after the initial structural stiffness change multiple damage mechanisms are present. Plastic deformation of the aluminium substrate and matrix damage to the CFRP and GFRP occurred (Figure 6). The bond between the CFRP and aluminium was maintained at this load step. The residual deformation in the aluminium was measured at 0.2mm (4 voxels) at the indent centre. A “pine tree” damage profile can be seen to be forming with 45 degree shear cracks and the onset of delamination between the innermost and second CFRP ply (Figure 5). There is no evidence of fibre breaks in either the CFRP or GFRP in the scan data. The residual dent on the surface of the specimen can be seen under the indent site in Figure 5, this was clearly visible surface inspection following the loading step.

Figure 5: Central cross section at the 0.50 load step

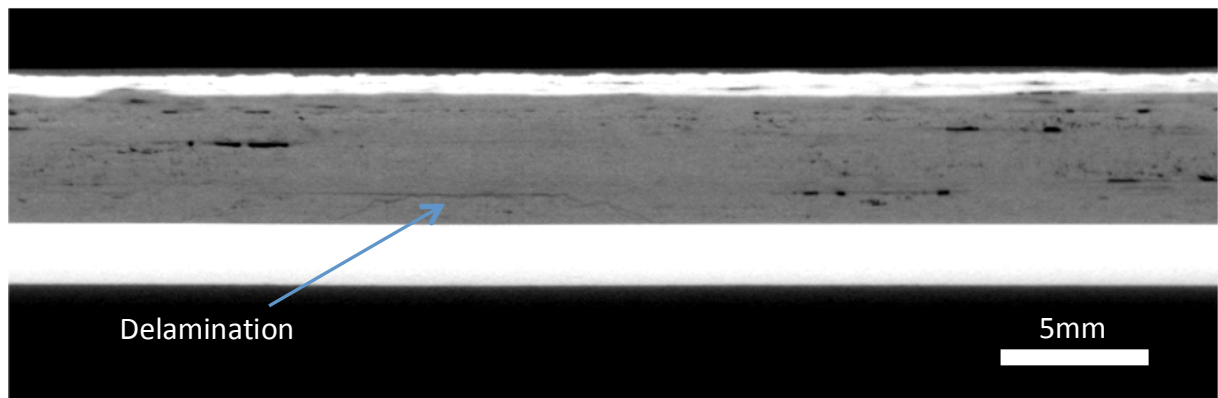
Figure 6: Longitudinal cross section, 5mm from indent centre at the 0.50 load step

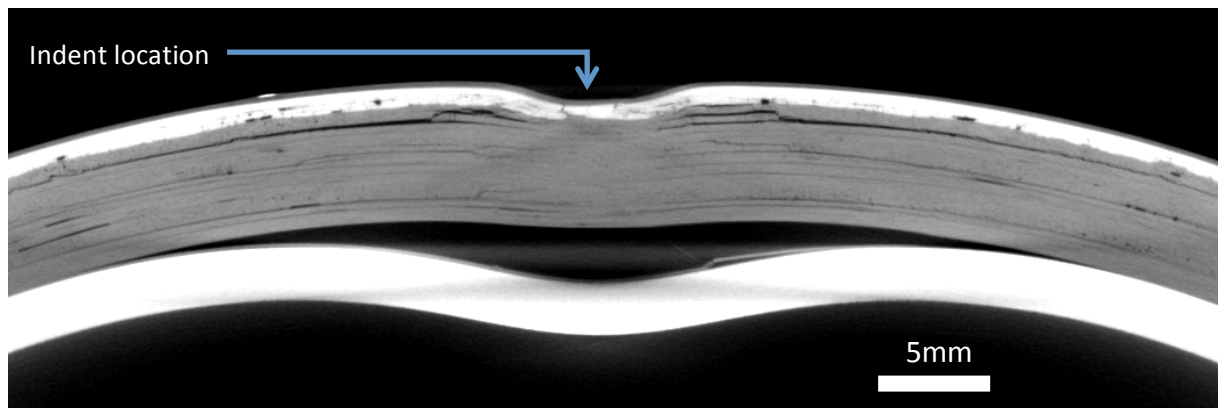
A centrally located slice directly under the indent location is presented in Figure 7. Matrix damage is present throughout all plies in the CFRP, with an undamaged central “cone” directly underneath the indent location, the damage profile (Figure 8) shows broad similarity to CFRP plate impacts [11]. No sign of fibre breaks are present in the CFRP, however directly under the indenter evidence of fibre fracture in the GFRP was present. This was confirmed by looking at a planar slice through the material thickness (Figure 9). Substantial whitening of the GFRP layer was visible from the surface of the specimen and a large residual local indentation.

Figure 7: Central hoop cross section after 0.95 load step

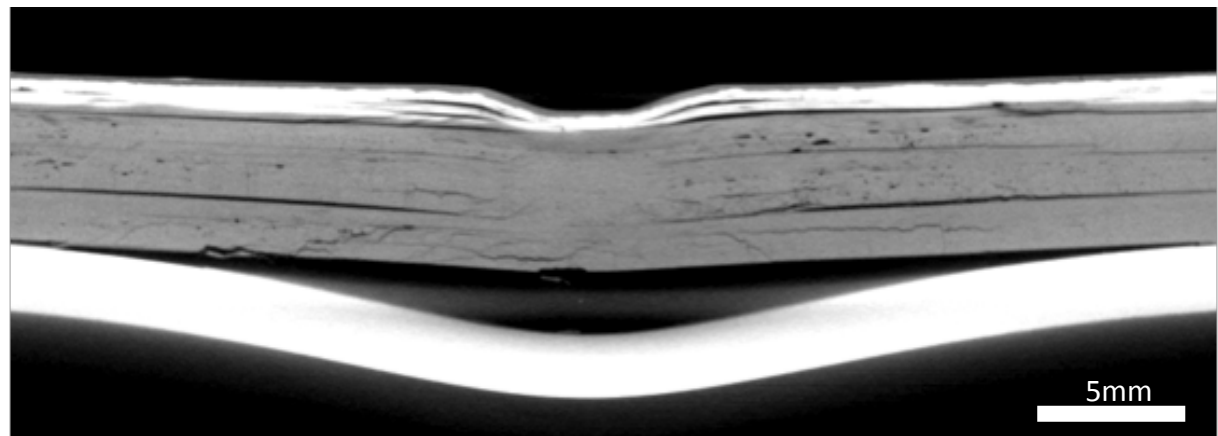
Figure 8: Central longitudinal cross section after 0.95 load step

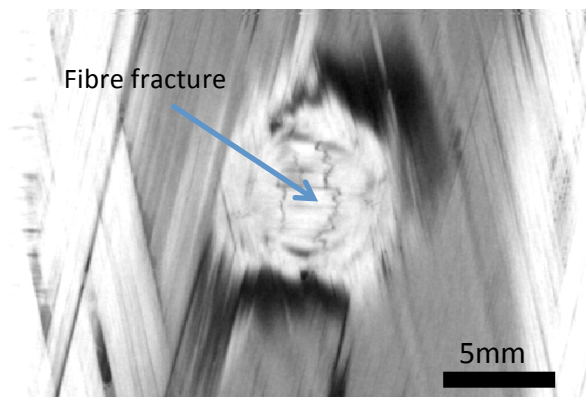
Figure 9: Planar slice at the 0.95 load step showing evidence of GFRP fibre fracture

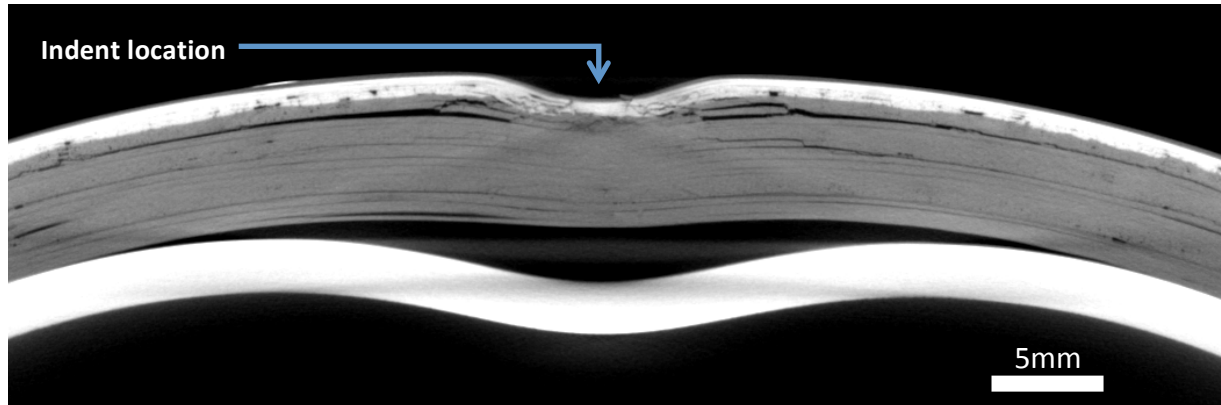
The purpose of the inspection point at the top load step was to identify the cause of the load drop present in the load-displacement curve. Figure 10 presents a cross-section for comparison with Figure 7 at the previous load step. The CFRP damage shows no sign of progression attributable to the load drop in this plane. In the longitudinal axis of the specimen however the delamination opening at the outermost ply interface in the CFRP increased; highlighted (i) Figure 11. This delamination was present, on both sides of the indenter, in the previous load step in Figure 8 but is distinctly larger at the higher load step. Directly under the top fibre fracture in the CFRP occurred. This was not present at the previous load step, shown by the comparison between Figure 12A (0.95) and Figure 12B (1.00).

Figure 10: Central hoop cross section at the maximum load step

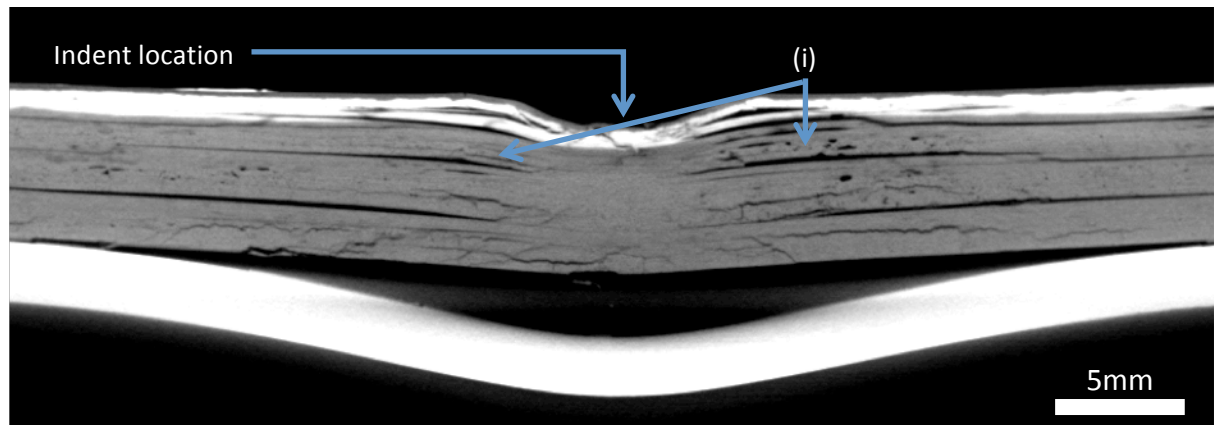
Figure 11: Central longitudinal cross section at the maximum load step

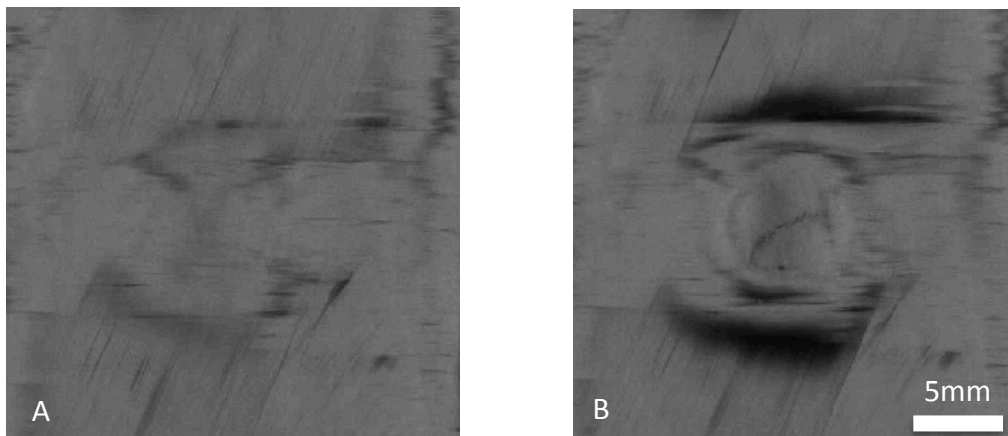
Figure 12: Comparison through material thickness under the indenter in the outer most CFRP ply
A: 0.95 load step; B: Maximum (1.00) load step
