Remote assessment of tsunami damage in Japan by means of Google Street View images

Project Report

Jessica Miles and Alan G. Bloodworth

University of Southampton

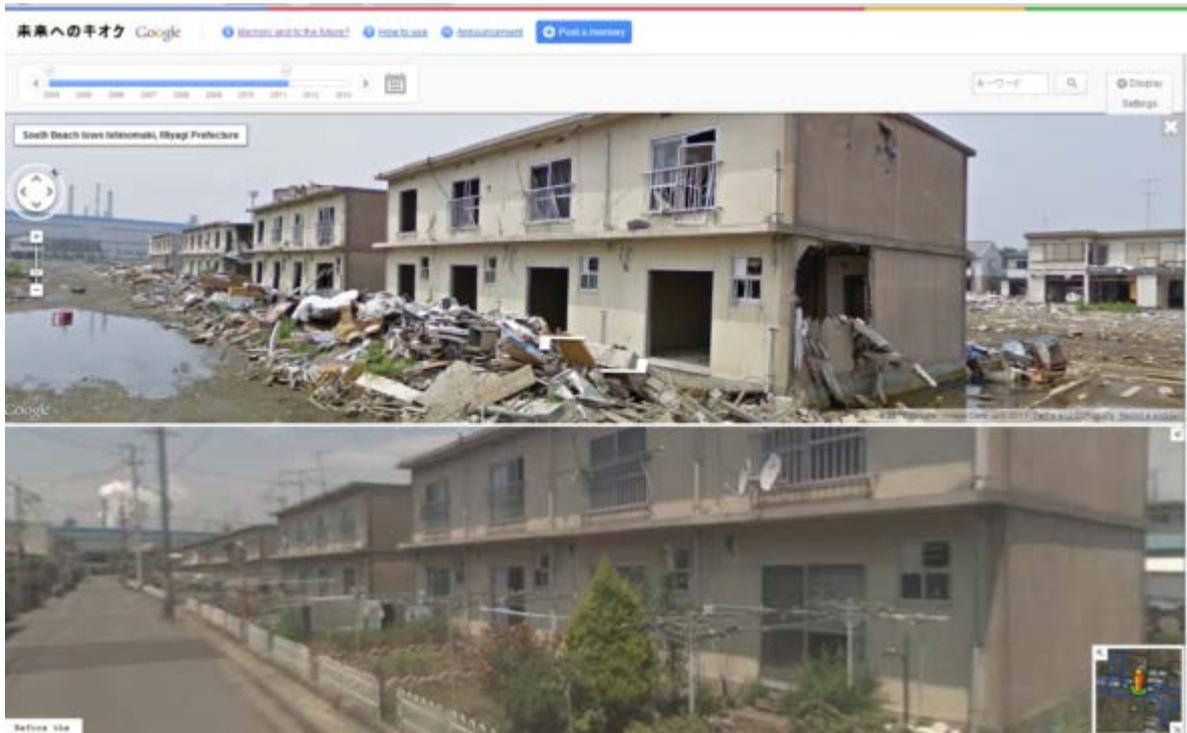
Figure 1 'Before' and 'After' Google Street View image (Google Street View, 2013a)

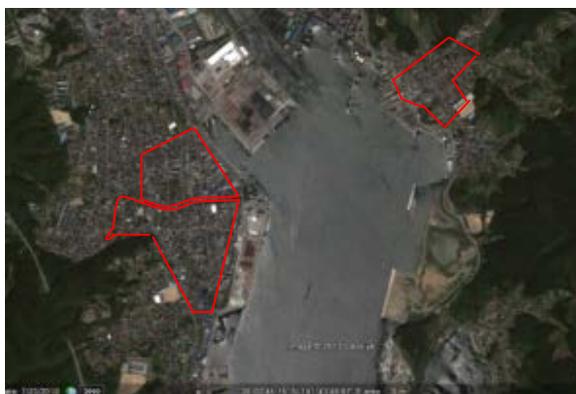
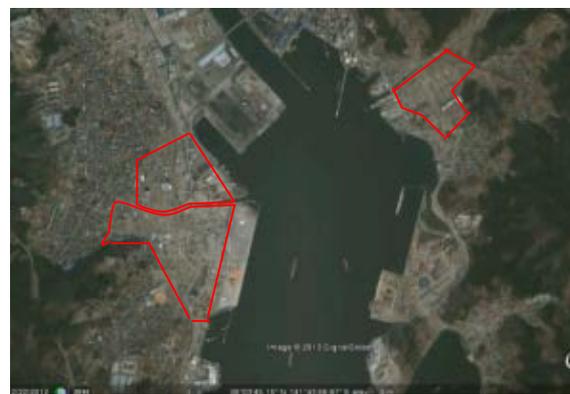
Ofunato is a city on the ria coastline, located in a narrow bay bounded by steep hills. Despite the wave funnelling to an inundation height of 13.13m at the shoreline, the steep rise in topography meant that 69% of housing escaped inundation (EEFIT, 2011). The harbour front is occupied by commercial buildings. Sample zones were chosen either side of the bay (Fig. 3) containing a total of 696 buildings before the tsunami, of which 108 (15.5%) remained standing sufficiently to be surveyed.

Figure 3 Sample zones at Ofunato 'Before' and 'After'- 04/04/10 (Google Earth 7.0, 2010a) (left) and 03/04/12 (Google Earth 7.0, 2012a) (right)

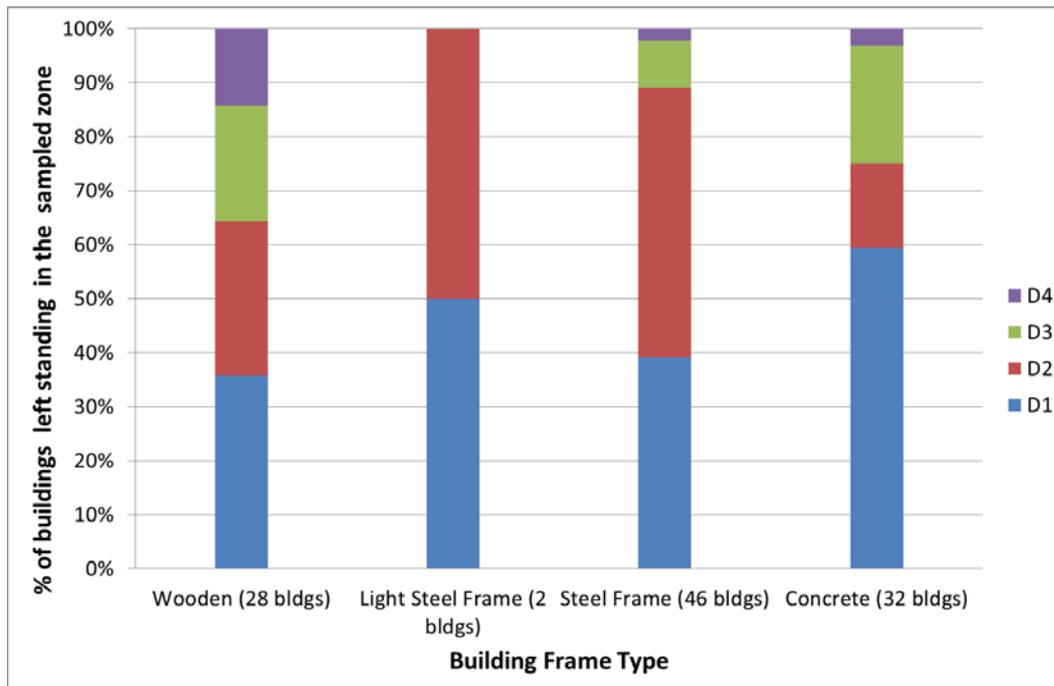
Data for the three sample zones were aggregated for analysis as they showed similar building distributions. Figure 4 shows that timber buildings were most heavily affected, with 36% of those left standing suffering D3 or D4 damage, followed by RC (25%), followed by steel (11%). More data on light steel framed buildings is available from Ishinomaki.

Figure 4 Damage levels by building frame type for Ofunato (aggregated for all sample zones)

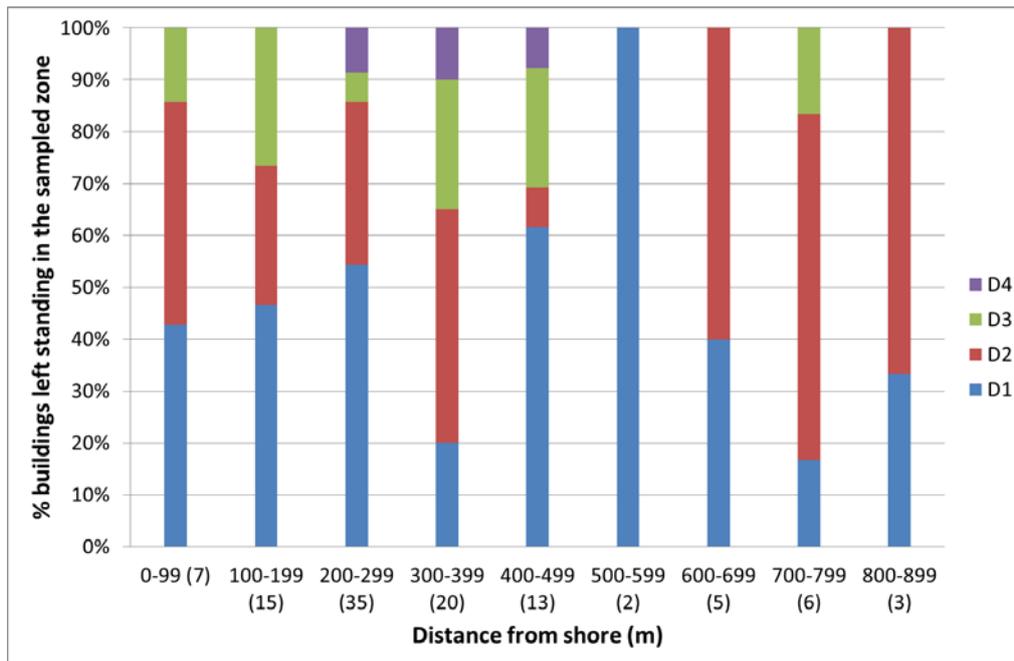
Figure 5 shows damage level with distance from shoreline, for all structure types. Only beyond 500m from the shoreline did the proportion of D3 and D4 buildings decrease (although the number of buildings is small at that distance). In the first 500m there is no clear damage trend, even though as the wave travels inland its speed and energy would be expected to decrease. A possible explanation is that accumulation of debris at the wave front, as noted by eye-witnesses, contributed to damage as the wave moved inland.

Figure 5 Damage levels with distance from shoreline – Ofunato (aggregated for all sample zones and building types, number of buildings at each distance in brackets)

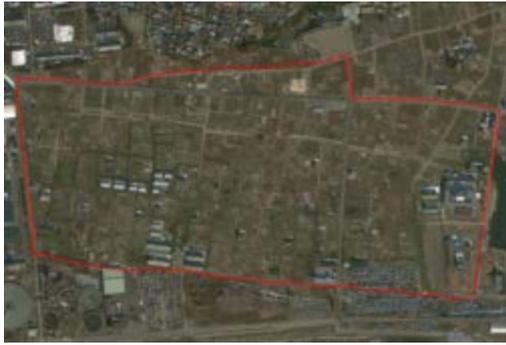
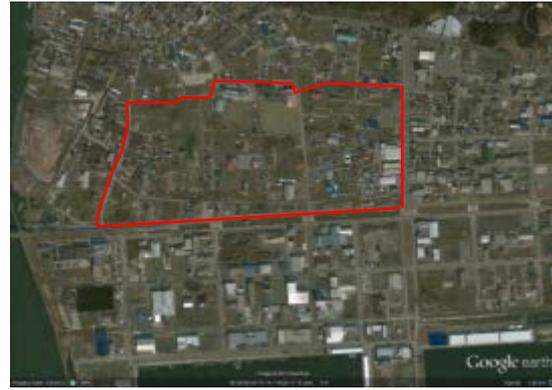
Figure 7 shows the sample zones in more detail after the tsunami. Although both contained mainly residential and small commercial buildings, their situation relative to the shoreline is different, with Area A in close proximity but Area B set back about 400m behind the port. Area A experienced approximately 91% obliteration of buildings compared to 68% in Area B. This is likely to be due to shielding by the port area that was densely filled with large industrial steel framed buildings, many of which remained standing to some extent.

Figure 7 Ishinomaki: Area A 'After' - 03/04/12 (Google Earth, 7.0, 2012b) (left), Area B 'After' - 03/04/12 (Google Earth, 7.0, 2012c) (right)

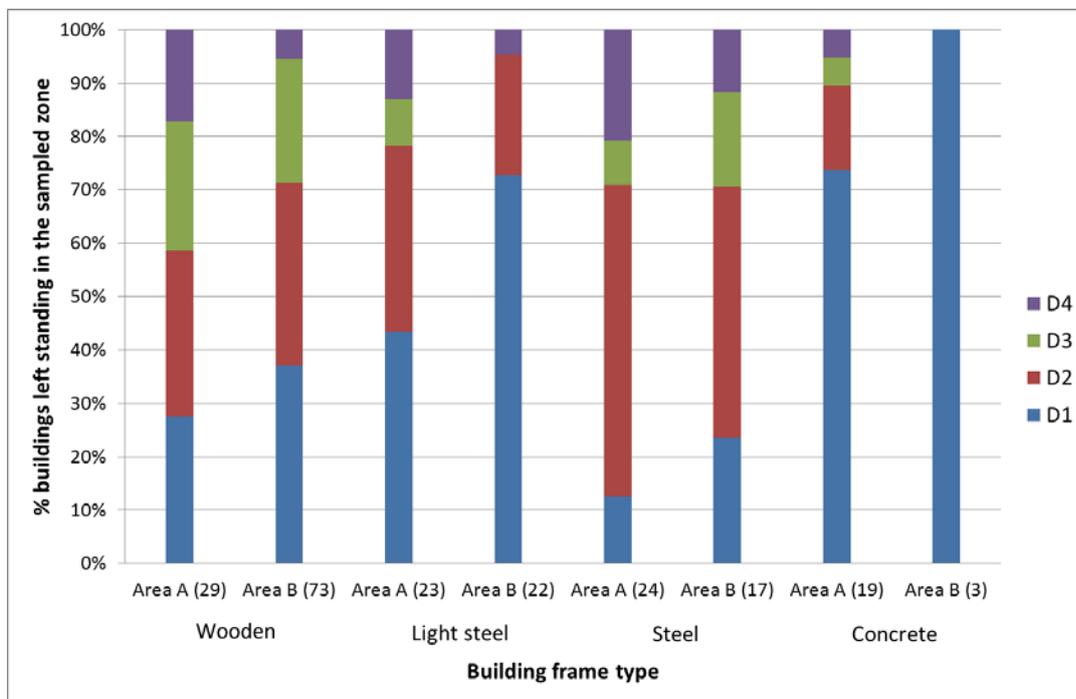
From the relationship between structure type and damage categories (Fig. 8) it can be seen that as the strength of the building frame increases (from timber to light steel to RC), damage severities decrease. Light steel performed better than timber. There is an unexpected trend of greater damage to steel-framed buildings, where it was noted that 61% of surveyed buildings suffered partial or complete loss of cladding and subsequent damage to the non-structural components of the building. 42% of steel buildings were commercial/industrial with light panel cladding, which proved to be insufficiently robust against the tsunami impact.

Figure 8 Damage levels by building frame type for Ishinomaki (Areas A and B) (number of buildings of each type in brackets)

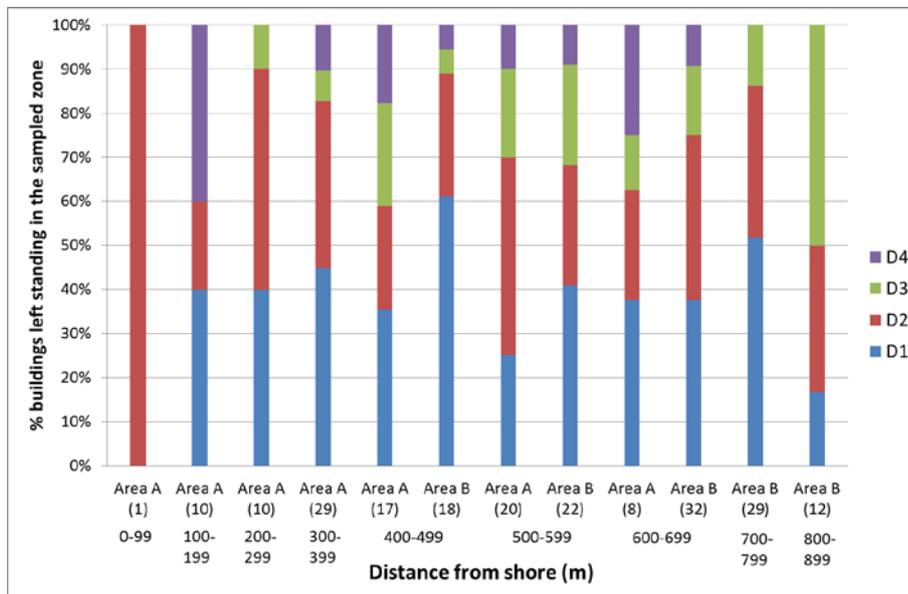
Thus, although lighter construction forms such as timber and light steel do not survive well under tsunami impact, the noticeably better outcome in Area B (Fig. 9) suggests that positioning major infrastructure and larger structures on the shoreline can significantly improve performance in zones inland.

Figure 9 Damage levels with distance from shoreline – Ishinomaki (Areas A and B)

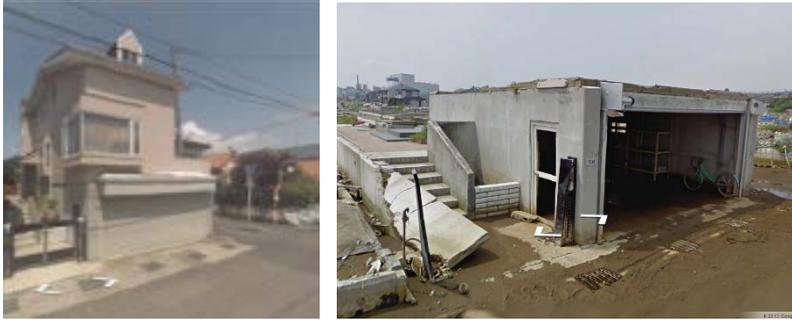
Dual Frame Construction is a noticeable design feature of housing in Ishinomaki, where a number of buildings remained standing with an RC or steel-framed ground floor and timber-framed construction for the upper floors (Fig. 10). The ground floor was often used as a garage, or sometimes commercial space in a mixed-use structure. In Ishinomaki, the inundation height was equivalent to two storeys and in the majority of cases observed, the RC/steel ground floor survived virtually undamaged, while the timber upper floors were heavily damaged or washed away (suggesting insufficient strength or connection to the ground floor frame). These buildings performed better overall than pure timber frames that were either completely destroyed or suffered collapse of the ground floor. This was also noted by EEFIT (2011, p101), referring to them as ‘raised dwellings’.

Figure 10 Dual frame construction building A25 in Ishinomaki ‘Before’ (GSV, 2013d) (left) and ‘After’ (GSV, 2013c) (right)

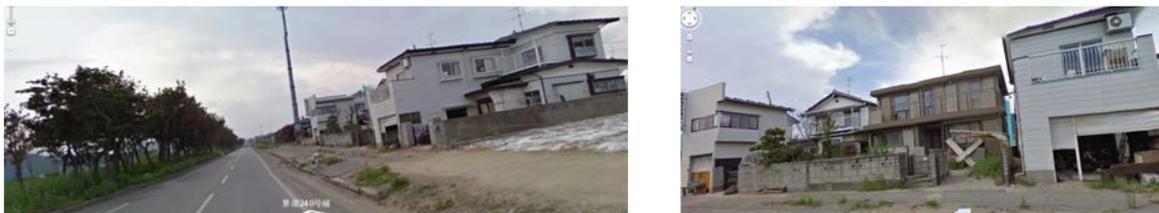
Sheltering by trees. A group of small commercial and residential structures of light frame construction (probably timber) were identified with damage rating D1, 435m from the shoreline in Area B (Fig. 11). Behind and to the right when viewed from the shore, very few buildings were left standing or not heavily damaged. The only clear reason for this group of buildings’ survival is sheltering from a line of trees still standing directly in front of them, between the residential area and the port. These trees relied in turn on a degree of sheltering from the port area buildings, as trees at other locations along the shorefront were uplifted from their roots and did not survive the tsunami.

Figure 11 Buildings in Area B behind the port in Ishinomaki showing evidence of sheltering by trees (GSV, 2013c)

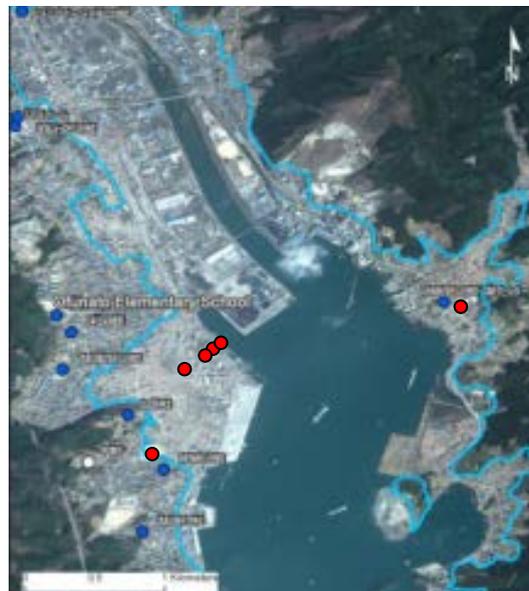
from the survey to be potential multi-purpose VE Shelters (Fig. 12) as they were steel or RC framed, three or more storeys in height with damage level D1. Locations ranged from 65-450m from the shoreline, contrasting with the city's designated shelters, all but one of which were positioned outside the inundation zone indicated by the blue line in Figure 12.

Figure 12 Locations of possible multi-purpose VE shelters (shown in red) within inundation zone at Ofunato, superimposed on map of designated VE shelters (in blue) (IIS, 2011)

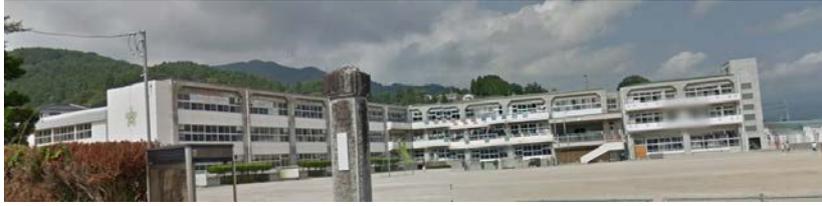
Ofunato Elementary School is a three storey RC structure (Figure 13), located 490m from the shoreline with damage level D0. The school is well positioned on higher ground to serve as a shelter. Schools are commonly designated as VE shelters in Japan because they are built to high seismic standards and have capacity for large numbers of evacuees.

Figure 13 Potential VE Shelter: Ofunato Elementary School (GSV, 2013b)

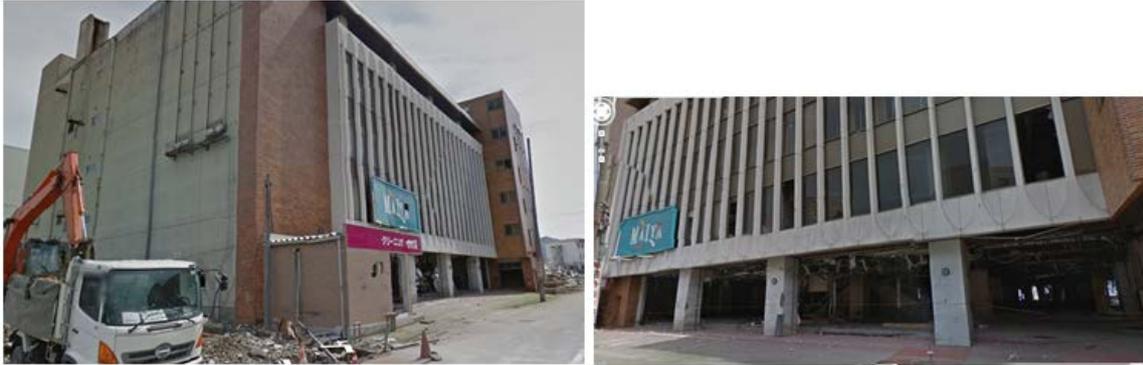
The five-storey steel-framed Maiya Shopping Centre was at the forefront of the tsunami, 100m from the coastline, yet survived with damage level D2 (Figure 14) despite inundation to third floor level (9m). Under FEMA guidelines, it had sufficient height to serve as a shelter. The ground floor is relatively open (serving as a customer car park), allowing water to pass through. This was also the case with an open plan construction car park directly in front of the shopping centre that suffered damage D1.

Figure 14 Potential VE Shelter, Ofunato: Maiya Shopping Centre (GSV, 2013b)

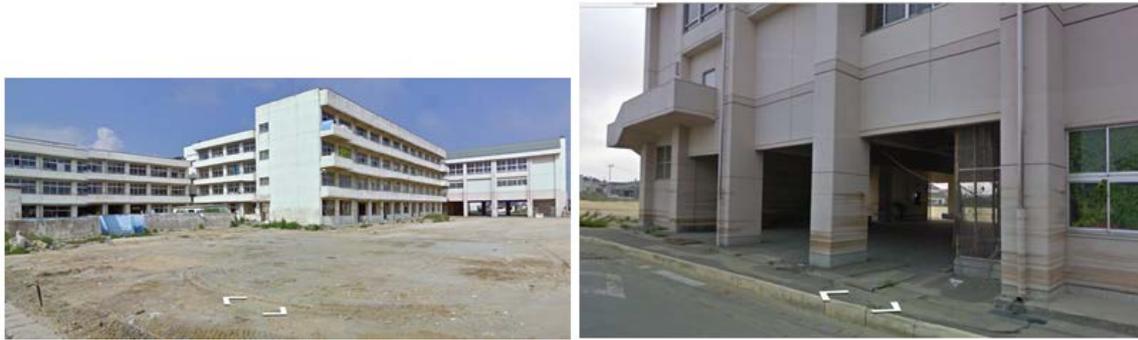
Minati Junior High School is located 750m from the shore and suffered damage D1. The size of the structural columns suggests the school is RC construction (Figure 15). Parts of the ground floor are open plan, used for car parking, and the school has a number of external staircases (possibly fire escape routes) to the uppermost floors that would enable evacuees in the surrounding houses readily to use it as a VE Shelter.

Figure 15 Potential VE Shelter, Ishinomaki: Minati Junior High School (GSV, 2013c)
