Damage mechanisms at the cement-implant interface of polished cemented femoral stems

Journal:	Journal of Biomedical Materials Research: Part B - Applied Biomaterials
Manuscript ID	JBMR-B-15-0703.R2
Wiley - Manuscript type:	Original Research Report
Date Submitted by the Author:	n/a
Complete List of Authors:	Shearwood-Porter, Natalie; University of Southampton, Bioengineering Science Research Group Browne, Martin; University of Southhampton, Bioengineering Sciences Milton, James; University of Southampton, School of Ocean and Earth Science Cooper, Matthew; University of Southampton, School of Ocean and Earth Science Palmer, Martin; University of Southampton, School of Ocean and Earth Science Latham, Jeremy; University Hospital Southampton NHS Foundation Trust, Orthopaedics Wood, Robert; University of Southampton, nCATS Cook, Richard; University of Southampton, nCATS
Keywords:	bone cement - PMMA; acrylic, implant retrieval, failure analysis, cobalt-chromium (alloys), corrosion

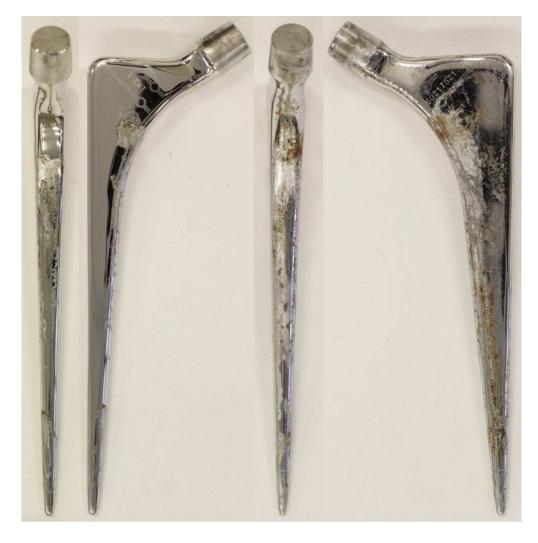
- 3 3. RESULTS
- 4 Stem Surface
- 5 The location and severity of damage varied between stems. All stems showed evidence of
- 6 macroscopic material loss on the posteromedial aspect, ranging from one or two isolated

- 7 spots a few millimeters in diameter, to extensive patches extending to the under neck region,
- 8 as shown in Figure 1.Damaged regions were also frequently observed on the anterolateral

Figure 1: Photographs of the posterior and medial views of two stems demonstrating the variation in severity of damage to the stem surfaces 72x73mm (300 x 300 DPI)

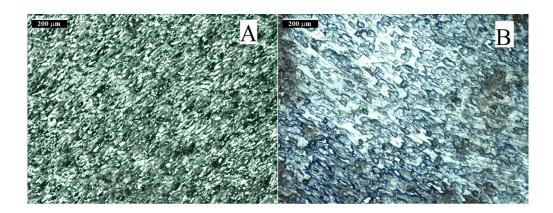
- 9 regions of the stems, and occasionally on the anterior face. Surface deposits, in the form of
- 10 black or brown plaques, were also noted.
- Microscopically, the appearance of damaged regions at the proximal end of the cement stem

- 12 interface was indicative of fretting corrosion (Figure 2). Extensive deformation and damage
- of the stem surface was noted, with 'islands' of apparently undamaged material. Damaged

- 14 regions occurring on the medial side of the posterior surface frequently demonstrated a
- unidirectional alignment, approximately 45° to the long axis of the stem (Figure 2).

Optical micrographs of damage to stem 4 (A) and stem 8 (B) surface showing directionality to the proximal surface damage.

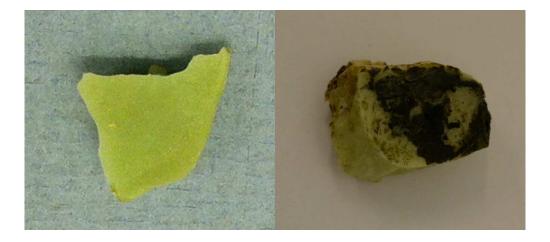
- 16 Cement Surface
- 17 Fragments of the full thickness cement mantle were obtained. The surface of the cement in
- 18 contact with the stem was easily identified by the presence of a typically smooth, uniformly

- 19 flat or curved surface (Figure 3a) and/or black deposits with a flaky appearance(Figure 3b).
- The green colouring of the cement is consistent with the formulation of Palacos R+G due to

Figure 3: a) Cement fragment from a region of low cement and stem damage showing a smooth and uniformly flat surface b) Cement fragment from a high damage region with corrosion product visible on the surface of the cement.

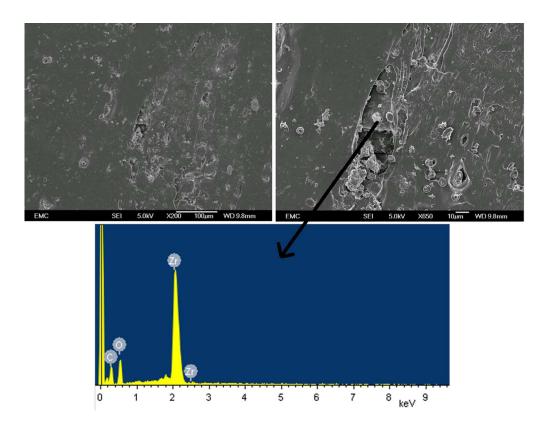
- 5 using EDX. The undamaged regions showed evidence of micropores at the surface of the
- 6 cement (Figure 4). EDX within the pores showed evidence of ZrO₂ particles (Figure 4).

Figure 4: SEM and EDX demonstrating the presence of zirconium dioxide particles within the surface voids of the undamaged regions of the cement $97x75mm (300 \times 300 DPI)$

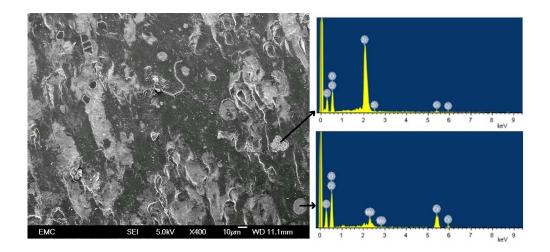
- 7 On the moderately damaged regions of the cement (Figure 5) both radiopacifier and metallic
- 8 debris were identified via EDX. Although traces of Co and Mo were noted, Cr was found to

Figure 5: SEM and EDX of the moderately damaged cement surface showing deformation of the cement and the presence of ZrO2 particles and transferred Cr and Mo 192x89mm (300 x 300 DPI)

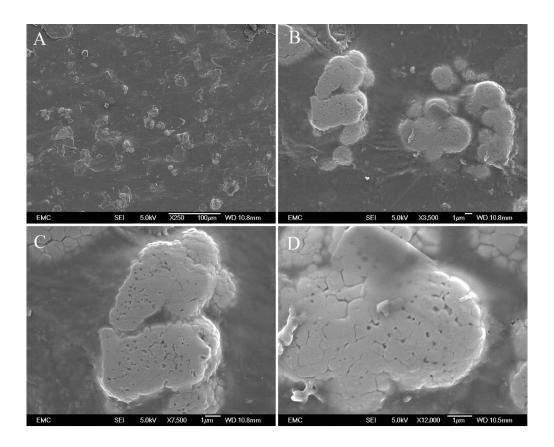
- 9 be the dominant metallic species. Inspection of the highly damaged regions showed the ZrO₂
- agglomerates standing proud from the underlying cement (Figure 6a, b), with the surfaces of

- the agglomerates flattened (Figure 6c, d); the cement also appeared to have been abraded,
- with evidence of directional wear (Figure 6a).
- 13 The sample of corrosion product analyzed by ICP-MS identified a number of metallic

- 4 dioxide radiopacifier agglomerates not only protruding from the surface, but also worn flat.
- 5 The hard, abrasive radiopacifier agglomerates would have been in direct contact with the

- 6 stem surface and would have had the ability to plough and plastically deform the stem
- 7 surface, disrupting the passive oxide film and repassivation process, increasing the

Figure 6: SEM micrographs the cement surface from a highly damaged stem, showing the ZrO2 particles protruding from the surface of the cement. Images are increasing magnification of the same particle A: x250 magnification, B: x3500 magnification, C: x7500 magnification, D: x12500 magnification 217x175mm (300 x 300 DPI)
