# Damage mechanisms at the cement–implant interface of polished cemented femoral stems

**Abstract:** The occurrence of damage on polished femoral stems has been widely reported in the literature, and bone cement has been implicated in a tribocorrosive failure process. However, the mechanisms of cement-mediated damage and the impact of cement formulation on this process are not well understood. In this study, 13 Zimmer CPT polished femoral stems, and the corresponding cement specimens were retrieved at revision surgery and analyzed using high-resolution imaging techniques. Surface damage attributed to tribocorrosion was observed on all stems. Corrosion product, in the form of black flaky surface debris, was observed on the surface of cement specimens; both energy-dispersive X-ray spectroscopy and inductively coupled plasma mass spectrometry (ICP-MS) confirmed the presence of cobalt and chromium, with the ICP-MS showing much higher levels of Cr

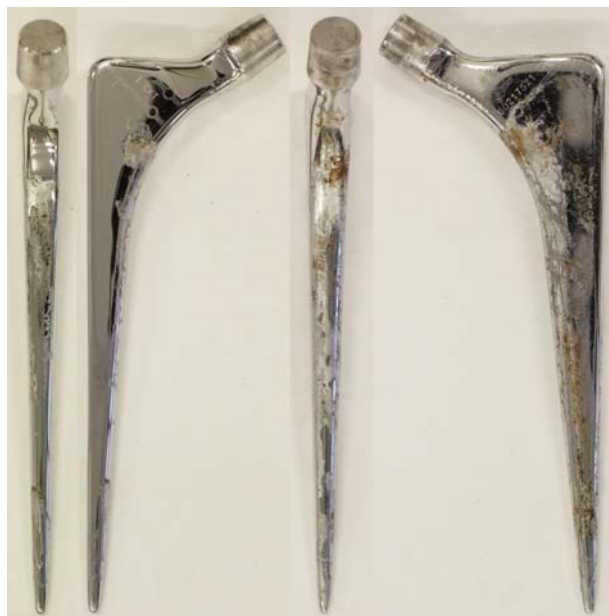
**FIGURE 1.** Photographs of the posterior and medial views of two stems demonstrating the variation in severity of damage to the stem surfaces.

The location and severity of damage varied between stems. All stems showed evidence of macroscopic material loss on the posteromedial aspect, ranging from one or two isolated spots a few millimeters in diameter to extensive patches extending to the under neck region, as shown in Figure 1. Damaged regions were also frequently observed on the anterolateral regions of the stems and occasionally on the anterior face. Surface deposits, in the form of black or brown plaques, were also noted.

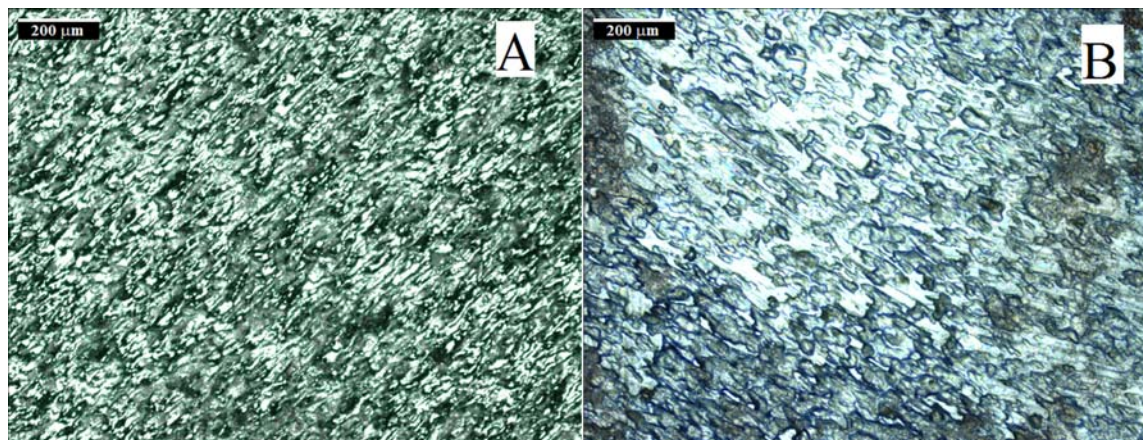
Microscopically, the appearance of damaged regions at the proximal end of the cement stem interface was indicative of fretting corrosion (Figure 2). Extensive deformation and damage of the stem surface was noted, with “islands” of apparently undamaged material. Damaged regions occurring on the medial side of the posterior surface frequently demonstrated a unidirectional alignment, ~45° to the long axis of the stem (Figure 2).

**FIGURE 2.** Optical micrographs of damage to stem 4 (A) and stem 8 (B) surface showing directionality to the proximal surface damage.

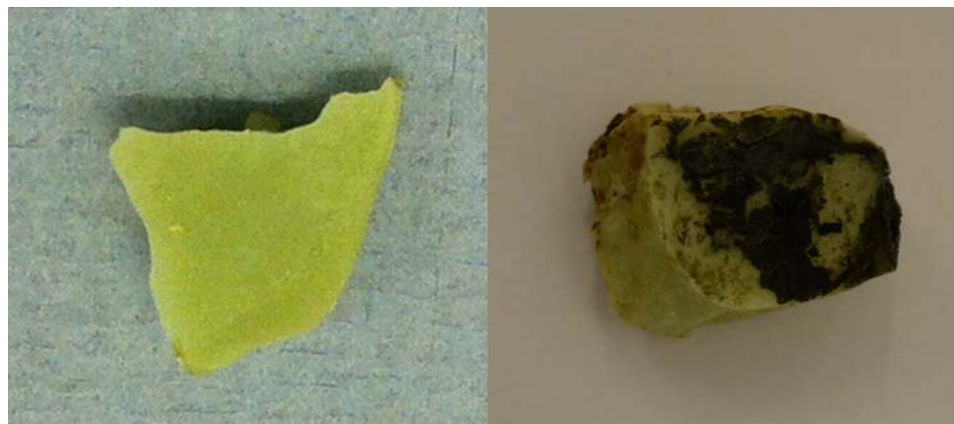
Fragments of the full thickness cement mantle were obtained. The surface of the cement in contact with the stem was easily identified by the presence of a typically smooth, uniformly flat or curved surface [Figure 3(a)] and/or black deposits with a flaky appearance [Figure 3(b)]. The green colouring of the cement is consistent with the formulation of Palacos R + G due to the addition of chlorophyll.

**FIGURE 3.** (a) Cement fragment from a region of low cement and stem damage showing a smooth and uniformly flat surface. (b) Cement fragment from a high damage region with corrosion product visible on the surface of the cement.

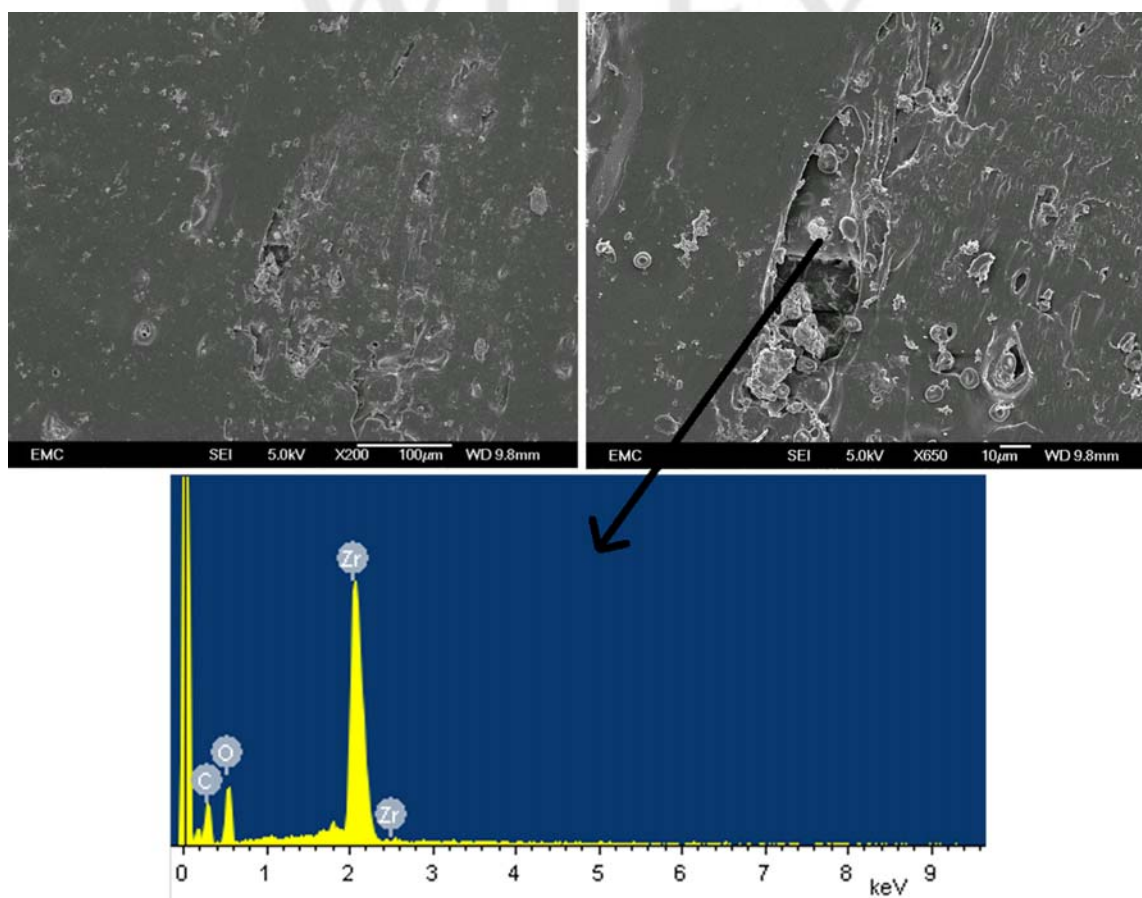
Examination of bone cement fragments using SEM demonstrated differing degrees of damage at the cement surface according to the region of contact with the stem. Agglomerates of zirconium dioxide (ZrO<sub>2</sub>) particles, typically 5 μm in diameter and with a cauliflower-like appearance, were visible within the cement; the identity of these agglomerates was verified using EDX. The undamaged regions showed evidence of micropores at the surface of the cement (Figure 4). EDX within the pores showed evidence of ZrO<sub>2</sub> particles (Figure 4).

**FIGURE 4.** SEM and EDX demonstrating the presence of zirconium dioxide particles within the surface voids of the undamaged regions of the cement

The undamaged regions of the cement within this study revealed voids at the stem cement interface. The origins of these voids are not clear, but as the cement was vacuum mixed, they are likely due to shrinkage during the curing of the cement after insertion. Investigations of the surface voids in this study showed the presence of radiopacifier particles in the voids and in close proximity to the surface. However, there was no damage on the stems of this study that matched the reported damage patterns presented by Zhang et al.<sup>13,17,21-24</sup> and Blunt et al.<sup>25</sup>

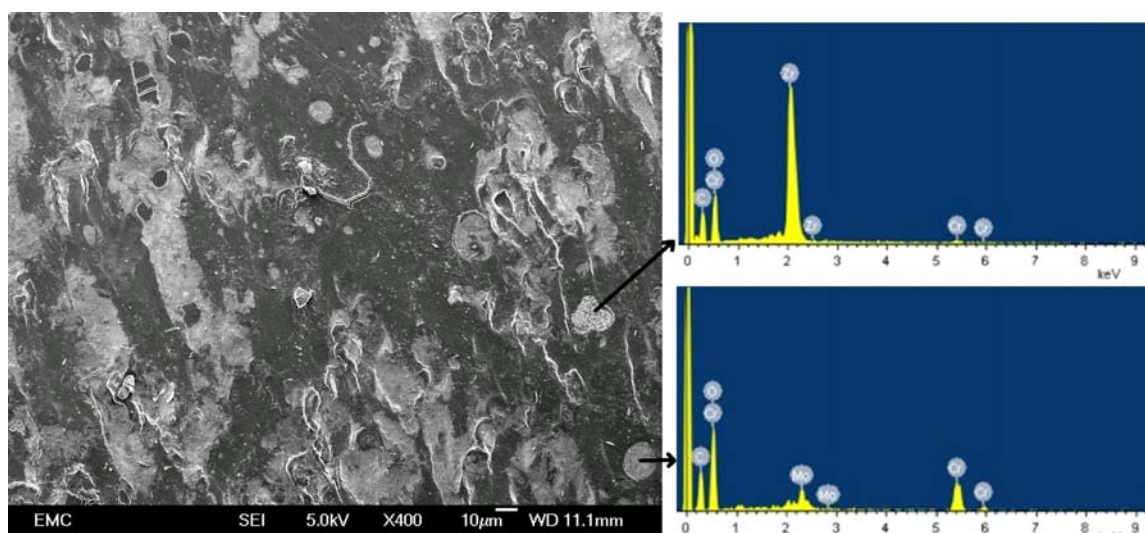
On the moderately damaged regions of the cement (Figure 5), both radiopacifier and metallic debris were identified via EDX. Although traces of Co and Mo were noted, Cr was found to be the dominant metallic species. Inspection

**FIGURE 5.** SEM and EDX of the moderately damaged cement surface showing deformation of the cement and the presence of  $\text{ZrO}_2$  particles and transferred Cr and Mo.

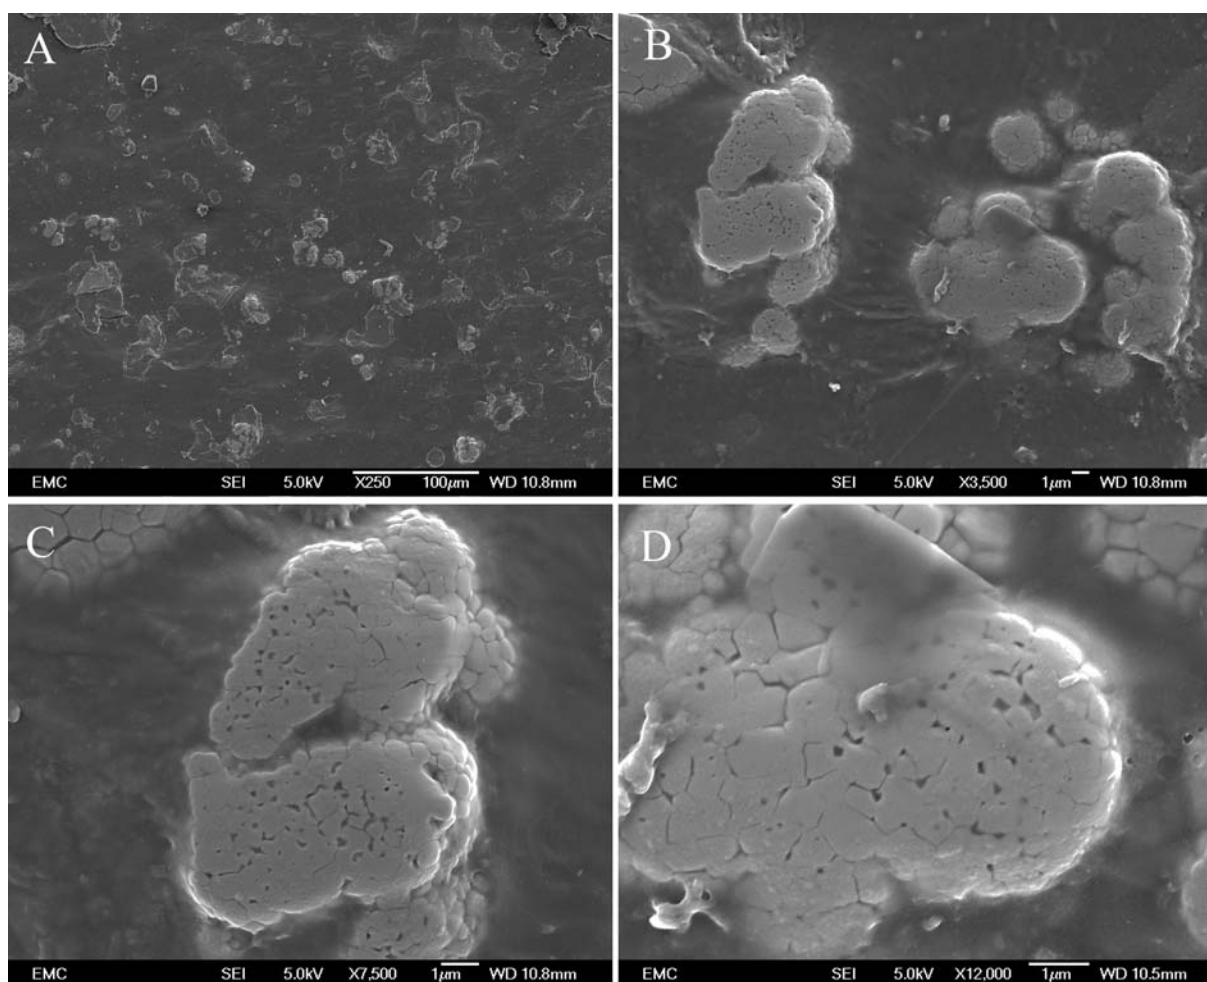
of the highly damaged regions showed the  $ZrO_2$  agglomerates standing proud from the underlying cement [Figure 6(a,b)], with the surfaces of the agglomerates flattened [Figure 6(c,d)]; the cement also appeared to have been abraded, with evidence of directional wear [Figure 6(a)].

**FIGURE 6.** SEM micrographs the cement surface from a highly damaged stem, showing the  $\text{ZrO}_2$  particles protruding from the surface of the cement. Images are increasing magnification of the same particle (A) 250× magnification, (B) 3500× magnification, (C) 7500× magnification, and (D) 12,500× magnification.

The cement from the areas of high stem surface damage had rough surfaces with zirconium dioxide radiopacifier agglomerates not only protruding from the surface but also worn flat. The hard, abrasive radiopacifier agglomerates would have been in direct contact with the stem surface and would have had the ability to plough and plastically

deform the stem surface, disrupting the passive oxide film and repassivation process, increasing the susceptibility to corrosive attack.
