VERIFICATION OF THE USE OF MICRO-CT SCANNING TO ASSESS THE FEATURES OF ENTIRE SQUAT TYPE DEFECTS

Keywords: Squats; Studs; Rolling Contact Fatigue; microstructural analysis; surface defects; X-ray micro-computed tomography scanning.

Abstract

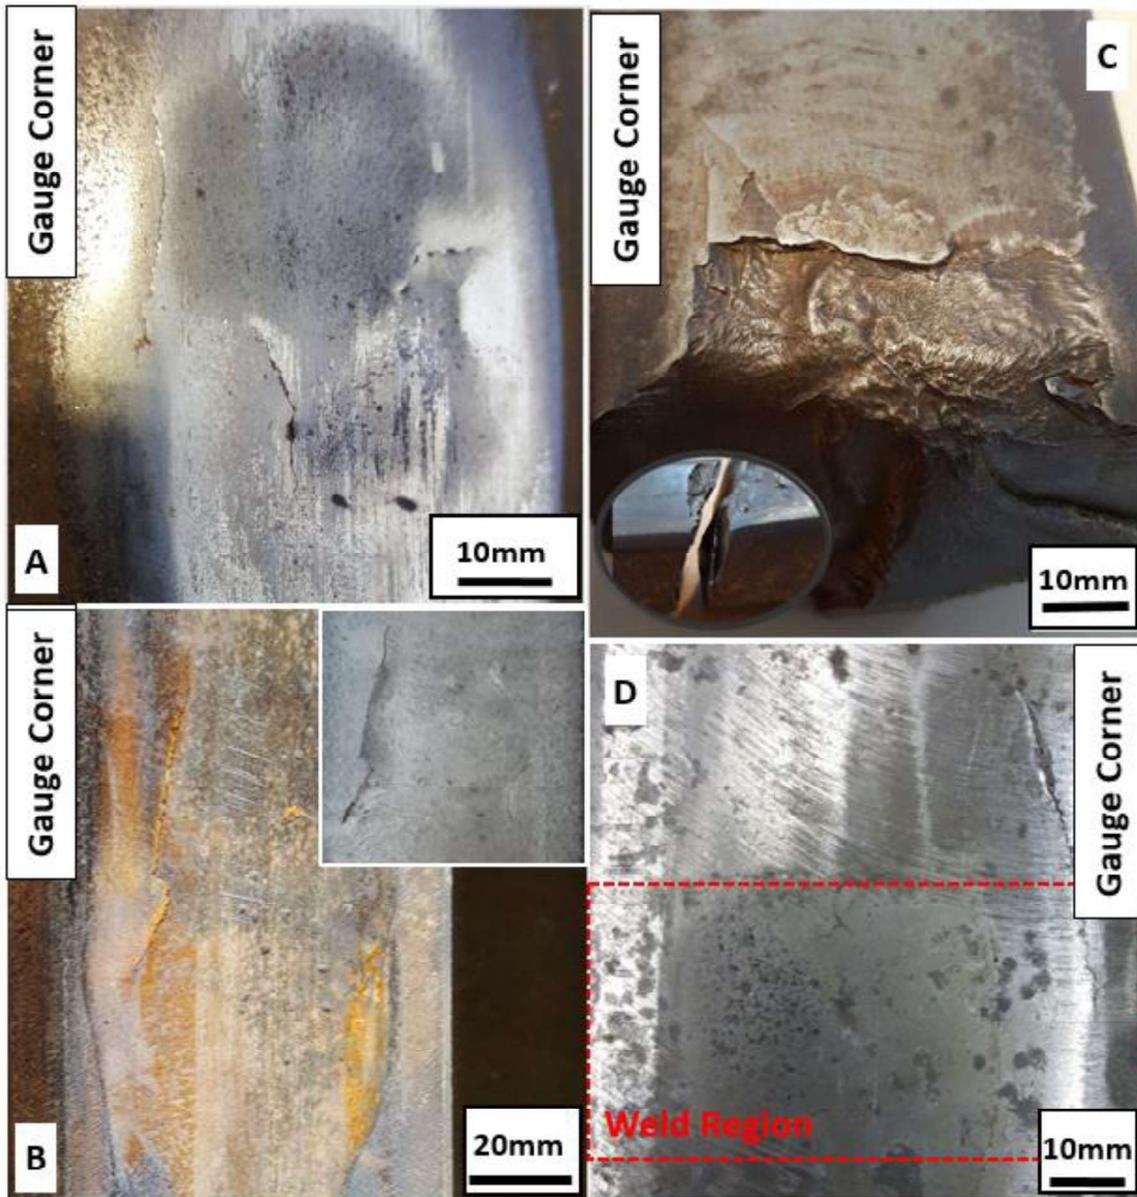
146 94 Not much is known about the track location and traffic experienced by sample 1 other than it was from an inclined track
147 95 near a station on a metro line. Sample 1 is shown in Figure 3a. It shows signs of sliding surface damage and the dark spots
148 96 are quite well developed. It contains a lot of surface damage including four obvious surface cracks, streaks of what is
149 97 assumed to be white etching layer (WEL), a pit in one of the cracks, what seems to be ‘snakeskin’ damage just outside
150 98 the widened running band. WEL is shown in results. ‘Snakeskin’ is also known as running surface checking or flaking
151 99 and is a precursor to spalling of the rail surface [12]. There is also the very common V-shaped crack that squats are known
152 100 to exhibit, although the angle within the V in this crack is more obtuse than expected. There is also a faint series of small
153 101 cracks along a ridge that extends from the apex of the V-shaped crack out between the two lobes which is often observed

164 114 Sample 2 is shown in Figure 3b, and is post MPI (magnetic particle inspection): a non-destructive test that uses magnetic
165 115 ink on a white contrasting background to highlight defects in the surface. The long crack seen on the left of Figure 3b,
166 116 seems to be a combination of the long cracks found at the edge of the running band in samples 1 and 4 (Figure 3a and d
167 117 respectively) and the expected V-shaped crack typically seen in a classic squat. The crack also has sharp edges unlike the
168 118 embedded cracks found on the other samples, possibly a sign that the crack is very recent. Sample 2 also has significant
169 119 discreet material removal. These look like corrosion pits, but are more likely localised delamination and flaking
170 120 characteristic of “ratchetting” [14]. Ratchetting is incremental plastic deformation of the upper surface of the rail material
171 121 due to cyclic strain build-up. Unique features in sample 2 are possibly because of traction control being used by the rolling

Figure 3: Images of the samples, all of which are a full rail width (~75mm wide) a) Sample 1 b) Sample 2 with magnetic particle inspection image inset to show apex cracks on field side c) Sample 3 with the other half of the defect inset d) Sample 4 with the weld region highlighted

Sample 3 is a broken rail of unknown MGT, which failed due to a transverse defect, within a squat defect, shown in Figure 3c. Most of the squat was damaged in the break, removing any surface evidence of the expected V-shaped crack. There was not much information to be gained from the shelled lobe either. However, the unbroken lobe of the squat was still available to view. The second lobe was very close to shelling and so presented the opportunity to remove the almost separated plate of surface material from the top of the defect. This allows the inspection of the crack plane below the squat. This plane was covered in oxide but the presence of water may have come from the cutting process due to the coolant flooding the sample. The plane was dry ice blasted to remove the oxide. The plastic flow shown by the folded material right next to the shelled section makes this most likely to be a squat.

Sample 4, shown in Figure 3d, was initially identified as a squat on an alumina-thermic weld and following an ultrasound test, was believed to be a combination of a squat interacting with a weld defect. The longitudinal crack that runs along the edge of the sample shows that the squat is slightly elongated, possibly linked to the higher train speeds [16]. The lack of deformation in the squat and the traffic total of ~28MGT makes it likely that this is in fact a stud, although a study has shown that 17% of squats are found at welds [17].

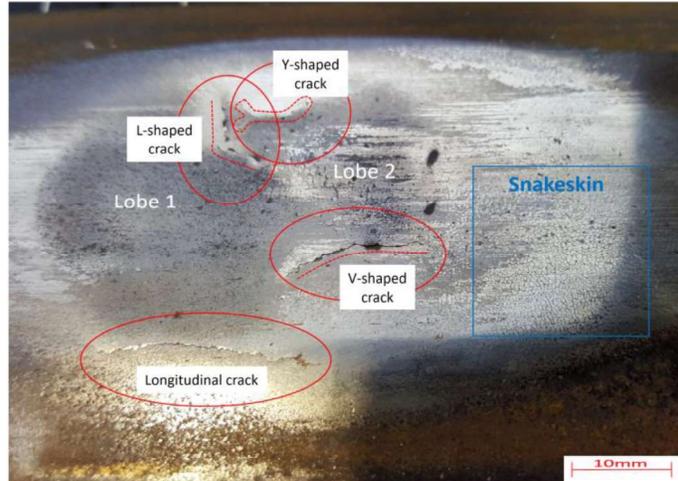
On sample 1 there were quite a few differences in surface finish, such as the shiny running surface next to the dark corroded region of the black spots, as well as the cracked 'snakeskin' region. There are four obvious cracks on the surface that are identified in: Figure 4 and the scanned images of them are in Figure 5. The longitudinal and obtuse V-shaped crack are found in the other samples, but the L-shaped and Y-shaped cracks are not (shown in Figure 4). The Y-shaped crack has been seen before in a squat sample reported on previously by Tata Steel [20] along with the 'snakeskin' surface damage (see Figure 6). In the Tata Steel report the snakeskin was also found on an area of the rail that did not contain a squat. The dark spot within the V-shaped crack is believed to be a spalled piece of snakeskin as the snakeskin can be faintly seen close to the crack (Figure 5c).

Figure 4: Sample 1 with the cracks marked in red and the snakeskin marked in blue

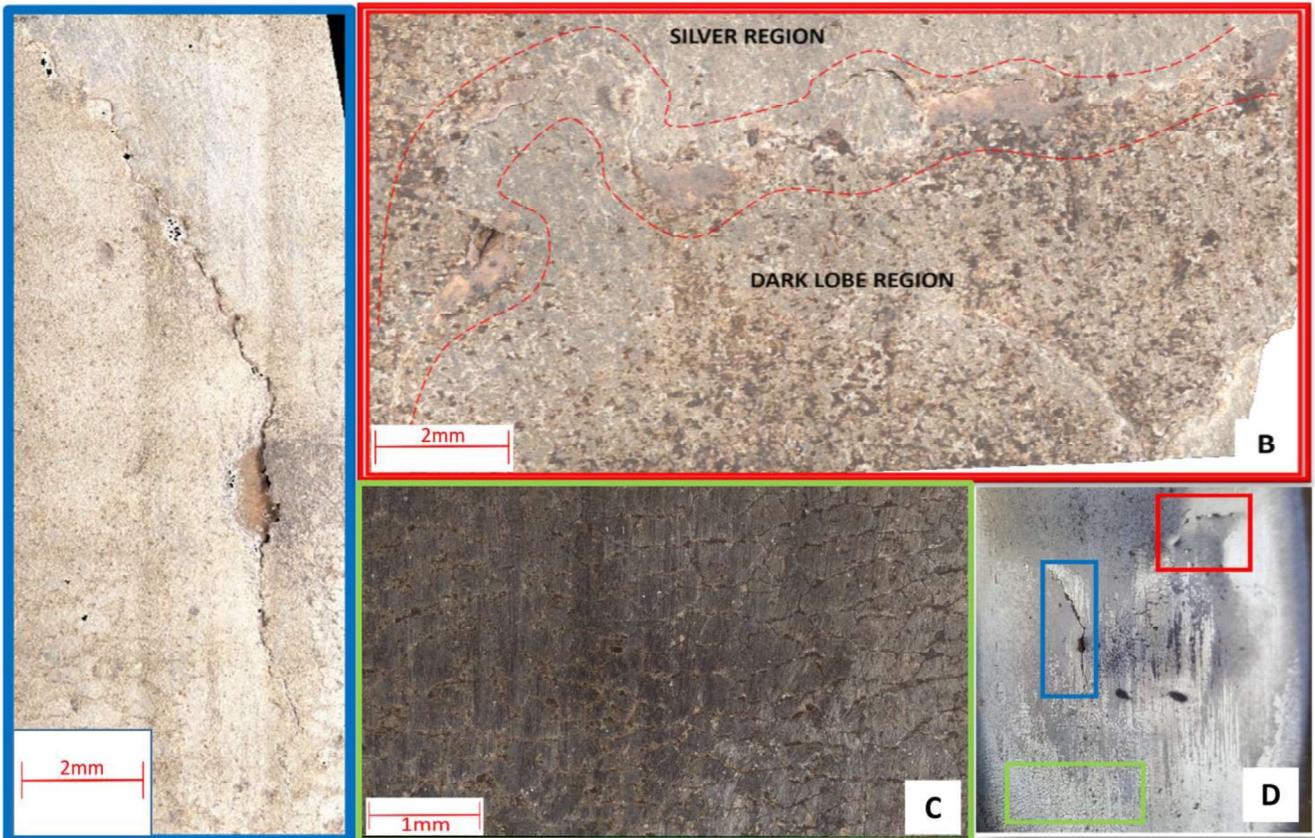
Figure 5: Some of the surface features imaged from sample 1 a) The L-shaped crack with 'islands' that appear pink in the scan b) The V-shaped crack with a pit that penetrates into the substructure c) 'Snakeskin' microcracks across the surface of the rail just beyond the defect d) A colour coded overview showing where the images are taken from

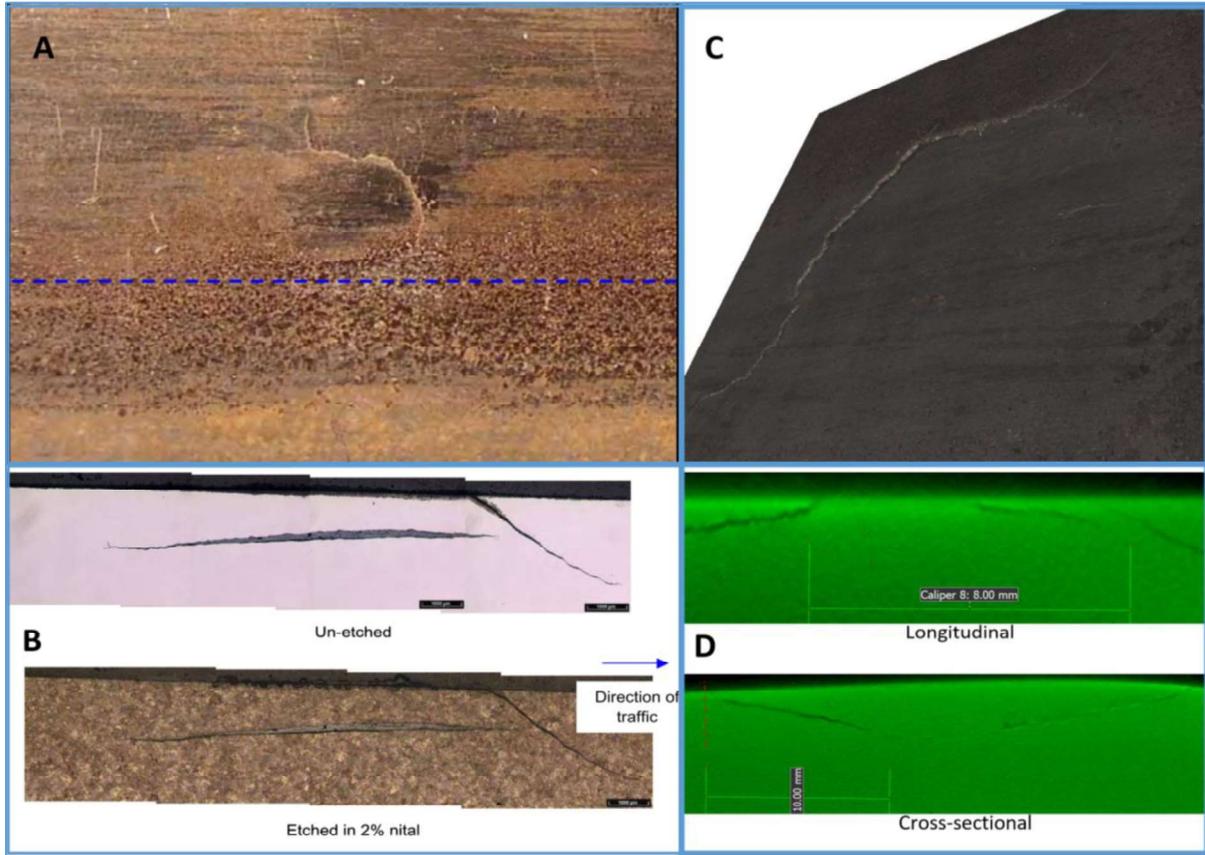
Figure 6 shows the Y-shaped cracks in sample 1 and the Tata Steel report as surface and subsurface defects. As the Y-shaped crack was the only surface crack in the Tata Steel report it can be assumed that this crack forms first. The shallow depth of the defect in the report compared to sample 1 also suggests that sample 1 is much more developed. Both samples are believed to be from the same metro network. The presence of the two cracks suggests the possibility of one crack initiating subsurface whilst the other initiated on the surface. Using the x-ray scanned volume that Figure 6d was taken from, it can be seen that moving through the sample towards the field corner shows that the cracks stay separate, although they may have connected within the region that was worn away. Moving through the sample towards the gauge corner shows the two cracks connecting as a very shallow crack parallel to the surface that makes up the bottom portion of the Y shape (when viewing the Y as written here).

432
433
434
435
436
437
438
439
440
441
442
443
444
445
446
447
448
449
450
451
452
453
454
455
456
457
458
459
Figure 6: Comparison of features of a squat from a Tata Steel report [20] with scan results from sample 1. a) The surface of the squat from the report, b) Longitudinal cross sections from the report, c) Surface scan from Alicona of sample 1, d) Longitudinal and cross sectional x-ray scans of sample 1 (red dotted line shows where orthogonal slices cross)

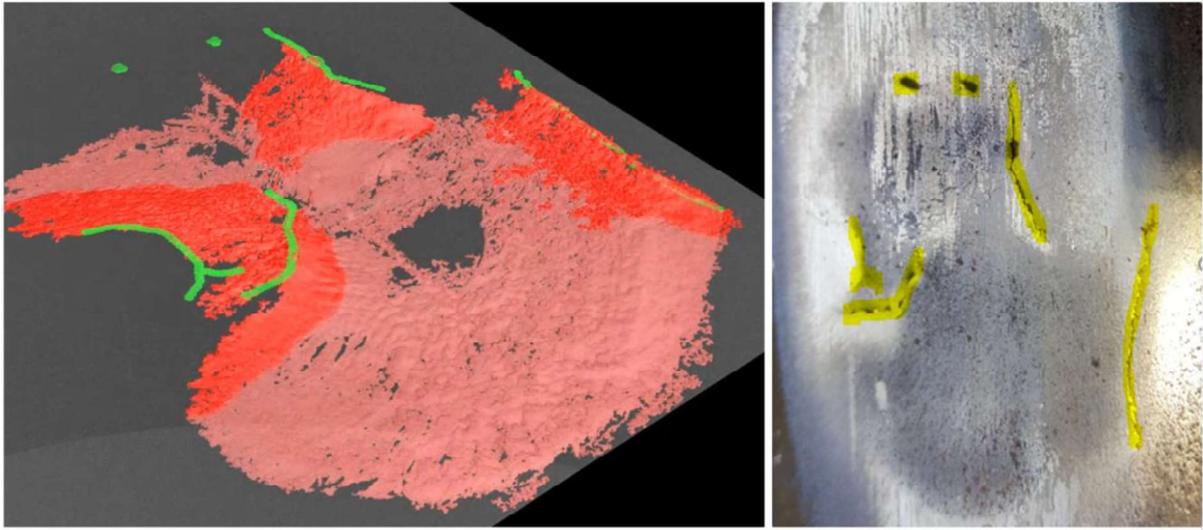
Comparing the report to the scans makes it highly likely that the initiation was in this area, and the branching of the longitudinal crack occurs within 4mm of the longitudinal slice in Figure 6d, moving towards the gauge corner. Being that the Y-shaped crack is closer to the field corner than the gauge corner suggests that a two point contact between the wheel and the rail may have been responsible. High surface temperatures occur with lower creepage and train speed when the contact patch is reduced like in a two point contact [21]. Sample 2 also contains a similar Y-shaped crack in a similar region but the clarity of the two cracks is not as clear, although a higher resolution scan of that area is planned for future work due to the branching of a possible transverse crack being in the same region. The L-shaped crack tracks the boundary between the dark lobe of the squat and the shiny surface of the running band, it also appears to contain islands of a different phase of steel, possibly martensite. This crack will be the subject of further investigations. For each of the 3 samples scanned, a 3D model was created both in Avizo and in VGStudio MAX. The model shown in Figure 7 was created in VGStudio MAX. The crack plane continues through the hole in the centre of the model: that region was not detected by the automatic construction module, but the crack was discernible manually. The crack plane also extends slightly further beyond the two green dots on the model.

499 **Figure 7:** Left) The model of the crack network in sample 1 created in VGStudio MAX showing a plane that runs parallel to the running surface to give
500 a gauge or depth Right) a photographic reference of the surface cracks that are green in the model and yellow in the photograph

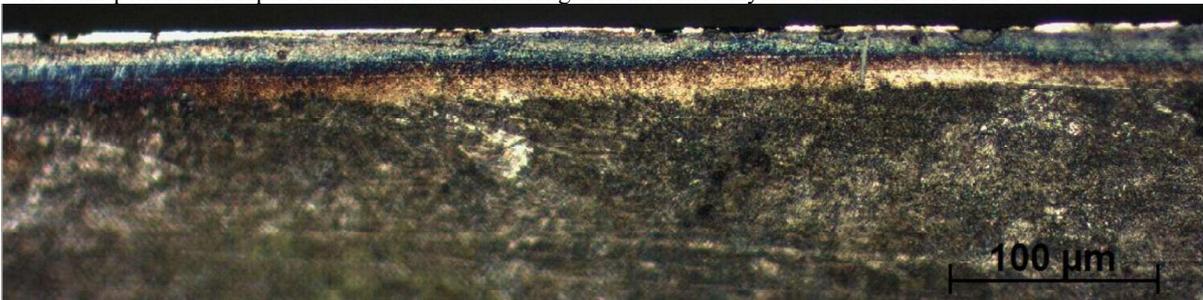
Figure 8: Three layers of WEL. The upper brighter WEL and middle duller WEL are fairly continuous for ~15mm of the 25mm sample. The upper layer is ~5 microns thick and the middle layer is ~19 microns thick. The lower, more yellow layer is a patch not much larger than the image and is ~14 microns at its thickest. A grey crack can be seen growing vertically through all 3 layers to the right of the image.

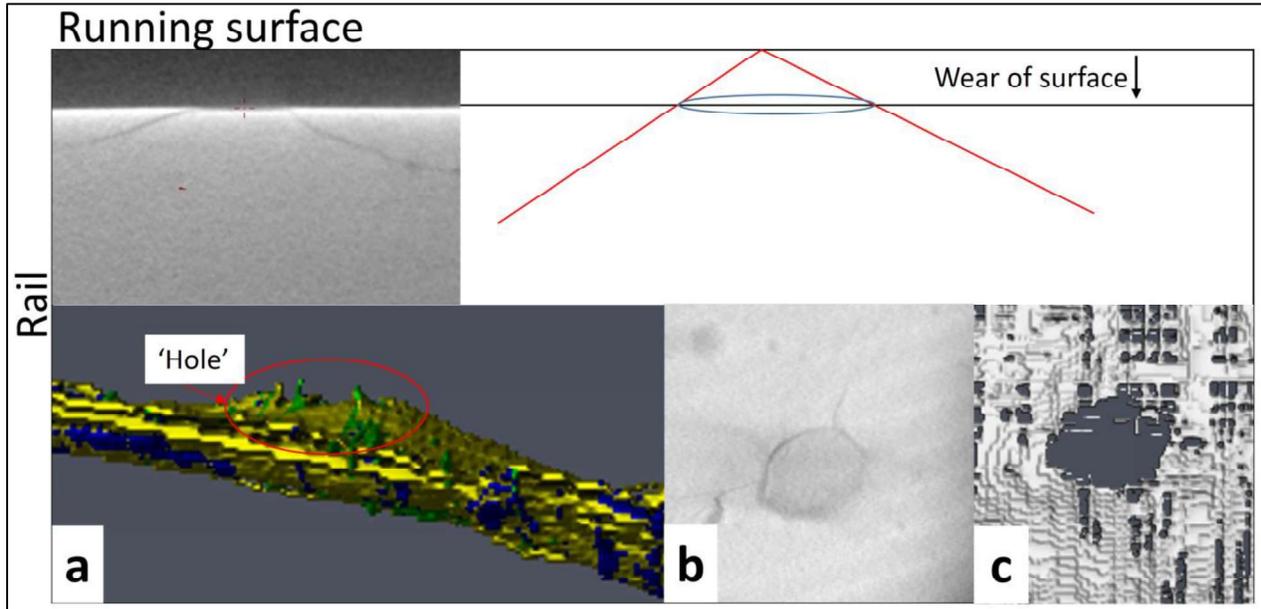
Another detail that showed through the full construction of the models was that the 'C' and 'O' shaped cracks found in the centre of the surface of samples 2 and 4 were the location where the inverted v-shaped crack had been truncated by wear (Figure 10). Sample 1 did not have this feature but sample 3 had a surface breaking crack in the same region but of a different morphology.

565
566
567
Figure 10: A diagram showing how wear truncates a pair of cracks to leave what is seen in the scan slice. Inset; a) The 'hole' from the longitudinal view as modelled in the Avizo model of sample 2, b) The original scan image of the surface of sample 2, c) The same view as (b), but of the Avizo model

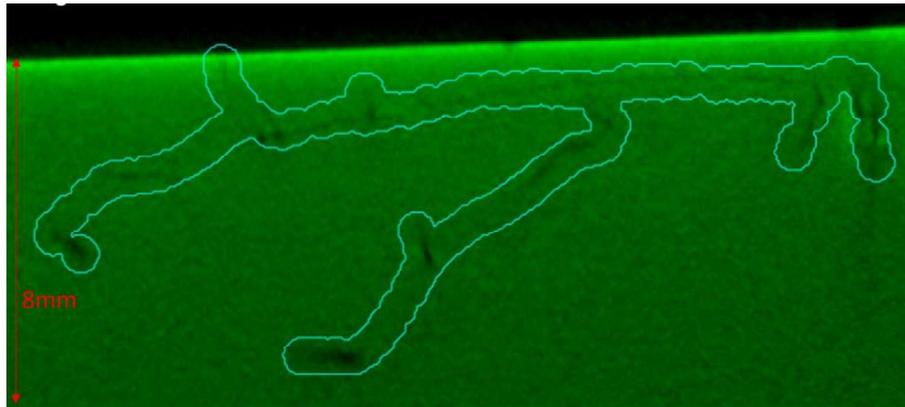
580
581
Figure 9: Longitudinal orthoslice of sample 2 showing the branching cracks

Sample 2 had much more damage than expected. Figure 9 shows a longitudinal section from the scan: although the resolution of the scan is low due to the size of the sample, parts of the transverse crack can be discerned up to 8mm deep into the railhead. Cracks can be seen reaching 10mm deep in other regions of lower clarity. A higher resolution scan will be conducted on this region to clarify the structure of the deeper crack and hopefully identify the region that caused the crack to start growing into what could become a transverse defect. WEL was found at a fairly consistent depth of 5-10 μm in some locations inside and outside the defect. There were some locations where the thickness of the WEL varied even in a very small area such as in Figure 11. Figure 10 also shows one region that was found very close to the field side of the running band, where the widened band started to narrow again. This region contained WEL with the ferrite on the grain boundary still visible as shown in the first documentation of a stud [5].

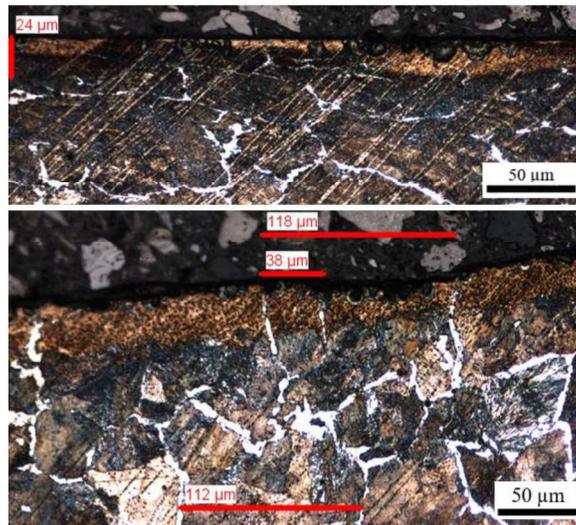
Figure 11: Above) WEL thickness varying from 1- 24 microns thick in sample 2. Below) Ferrite grain boundaries still visible within the WEL.

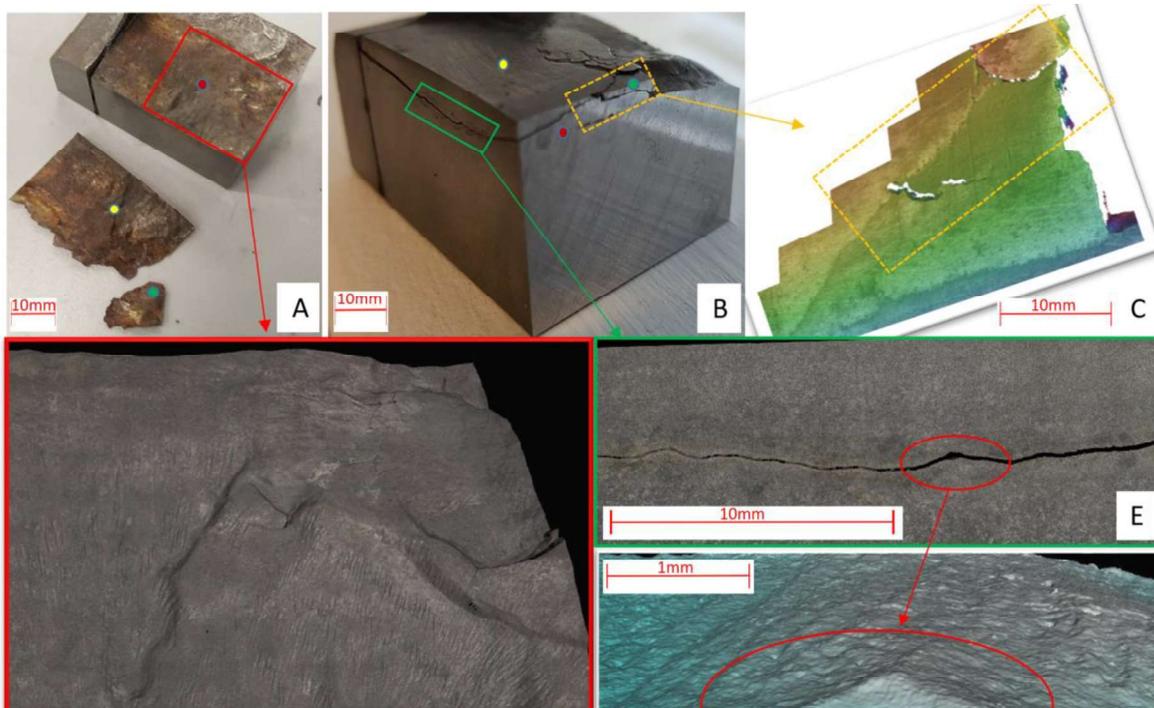
628 340 remnant of the initiation site. Judging by the amount of folded over material just next to the ‘white holes’ there were high
629 341 contact forces in this area. The material may have flowed from the ridge that often occurs between the two lobes of a
630 342 squat as this ridge experiences very high contact forces. Figure 12e shows what appears to be a small void in the crack in
631 343 area highlighted by the orange box in Figure 12b. This area was scanned (Figure 12f) and the morphology suggests that

642
643
644
645
646
647
648
649
650
651
652
653 **Figure 12:** The fracture surface under the remaining second lobe/ spot of the squat in sample 3. A) The fracture surface immediately after removing the
654 upper surface. B) The sample before the removal of the surface showing the two cracks propagating down into the rail from a possible initiation point.
655 C) The 3D model of the possible initiation area taken before cutting with the orange box showing the common area D) The 3D model of the crack plane
656 shown in A. E) An enlarged view of the green box in B showing where material has spalled away during cutting. F) A 3D model of the ‘pore’ in E

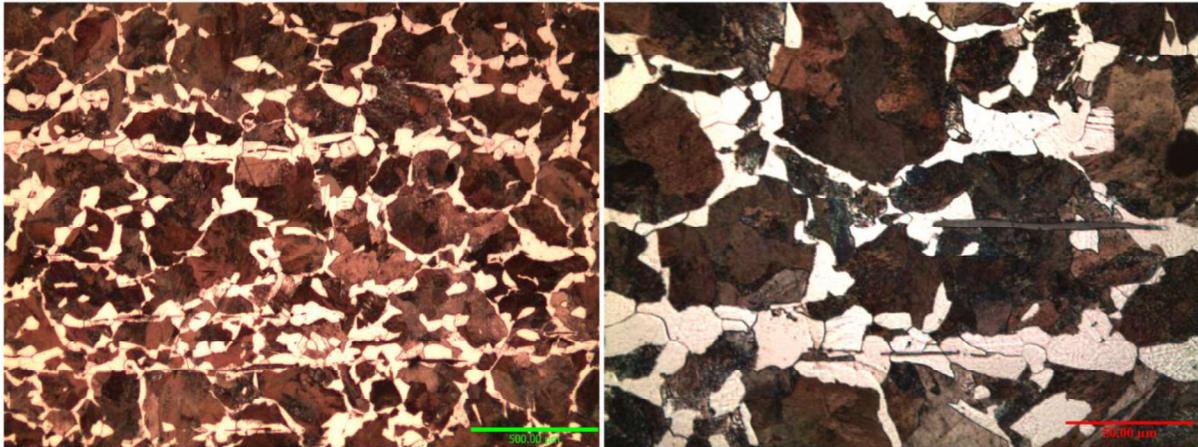
674
675
676
677
678
679
680
681
682
683
684
685
686
687 *Figure 13: Micrographs of sample 3 at two different magnifications, showing the unusual microstructure and the inclusions found throughout the steel*

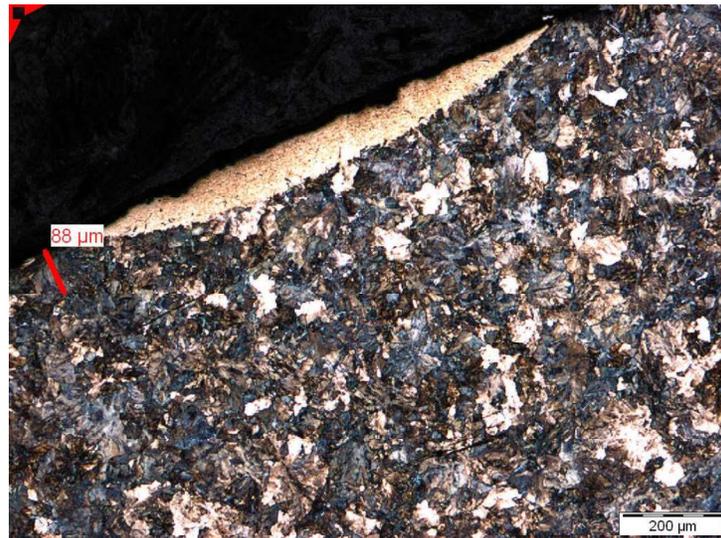
688
689
690
691
692
693
694
695
696
697
698
699
700
701
702
703
704 356
705 357
706 *Figure 14: Thick white etching layers on the gauge corner of sample 3*

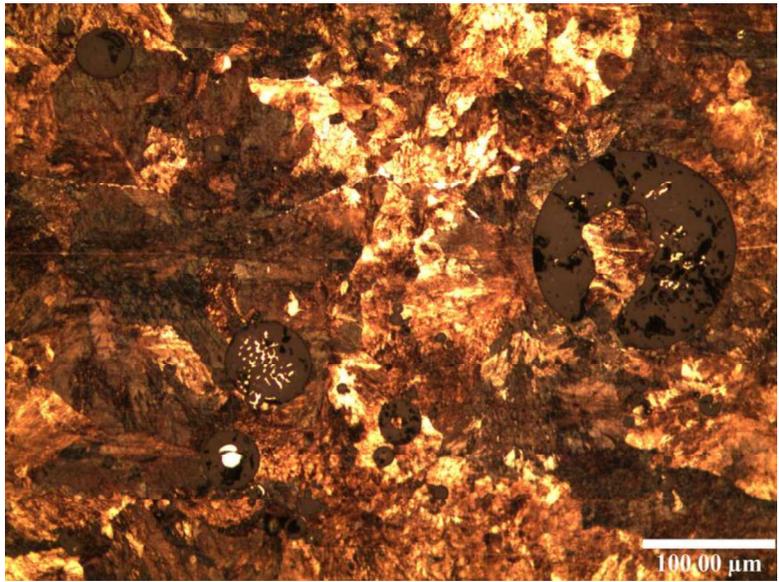
711 362 The initiation is believed to have been due to the spheres/ bubbles found above and below the proposed initiation site (Figure 15). Small cracks were seen travelling between these spheres in the region directly below the cracks. Sample 4 was the most benign of all of the samples as it was the only crack network that did not branch.

Figure 15: Spheres or bubbles found in the microstructure of the weld edge of sample 4 from within the green box in Figure 18. Probably either gas trapped in the melt or slag from the welding process

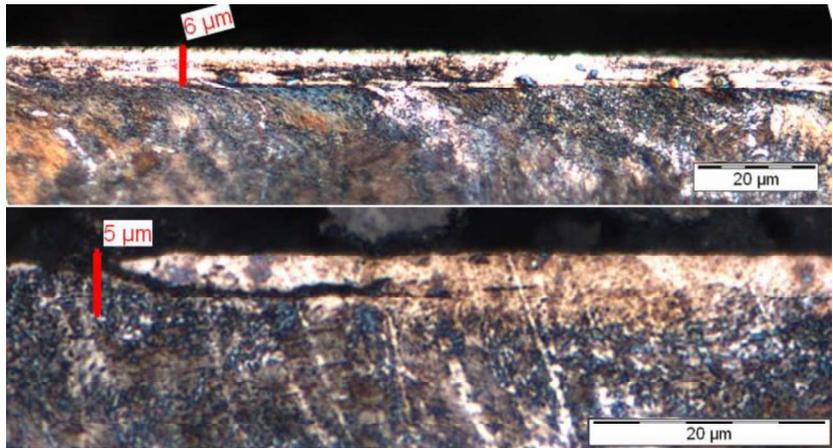
Figure 16: Above) WEL from within the defect. Below) WEL outside the defect

WEL was also found at a very consistent depth of 5-7 microns inside and outside the defect (Figure 16). The visible grinding marks on the surface make it probable that this WEL is due to the grinding process. The WEL inside the defect had a more distinct boundary with the parent material compared to outside the defect.

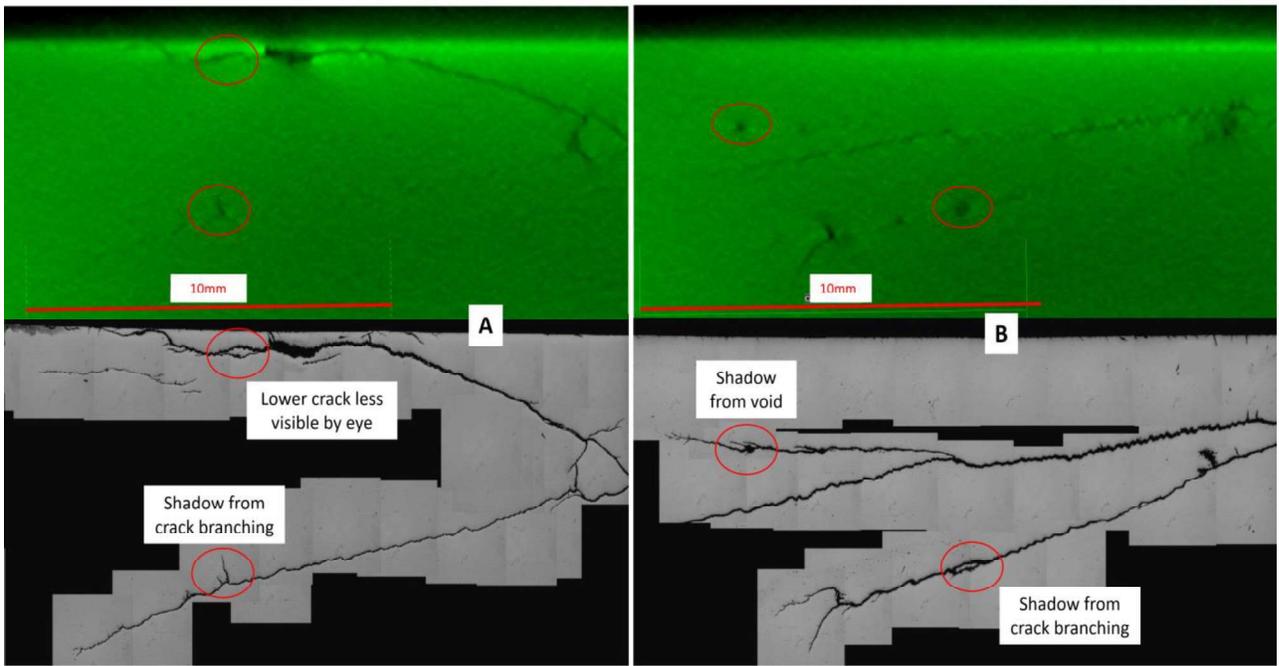
In sample 1, an orthoslice of interest was one that showed a crack branch down from what appeared to be a small void on the surface, which was visible from the surface scans. The crack then displayed interesting behaviour by branching in a circular shape as though propagating around something that it could not penetrate. There were also small shadows on the scans, which were investigated to see how real they were. Figure 17 shows the two comparisons of the scan slices mentioned and their accompanying micrograph. The upper red circle shows a region where the finer crack does not show but the larger crack does and the lower circle shows how a branching crack can create a shadow.

Figure 17: Comparison of longitudinal CT scan orthoslice to longitudinal section in sample 2 a) The surface void visible from the surface scans with a shadow and its cause highlighted b) Branching that shows shadows in the scan and the same cause as (a) in the micrograph.

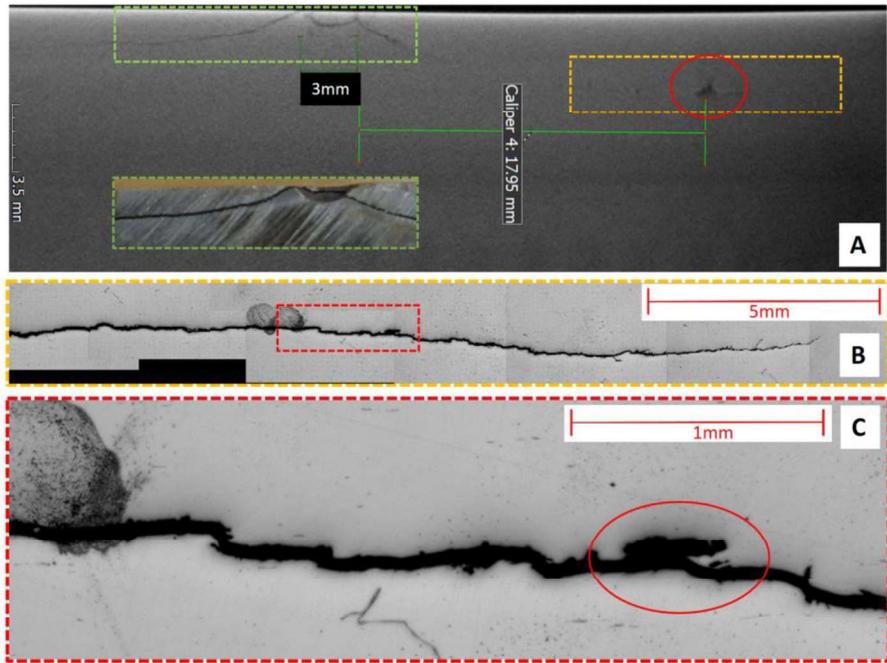
Sample 4 also showed a shadow near the surface breaking feature in the centre of the rail and the verification of that scan is shown in Figure 18. Figure 18 shows; a shadow found on the crack within the CT scan, the cause of that shadow and verification of the structure shown in the green box, which is responsible for the C shaped crack that breaks the surface of the running band. It also shows a zoomed image of the area that caused the shadow to appear: a small void. These voids are believed to develop from the small 'islands' like the one labelled "shadow from crack branching" in Figure 17b due to rubbing of the crack surfaces wearing away and eventually breaking up the 'island'. The broken debris from the island could cause variations in the x-ray interaction that, when reconstructed into a CT volume, would appear like a void. The broken debris would then be washed out during sample preparation.

Figure 18: Longitudinal slice through the c-shaped crack in the centre of the surface of sample 4. a) CT scan orthoslice showing the surface breaking crack highlighted in the green box with a photo of the sectioned sample inset in the lower green box b) An unetched micrograph of the area highlighted in the orange box c) An expanded view of B, with a red circle showing the cause of the shadow in the CT scan orthoslice (a).

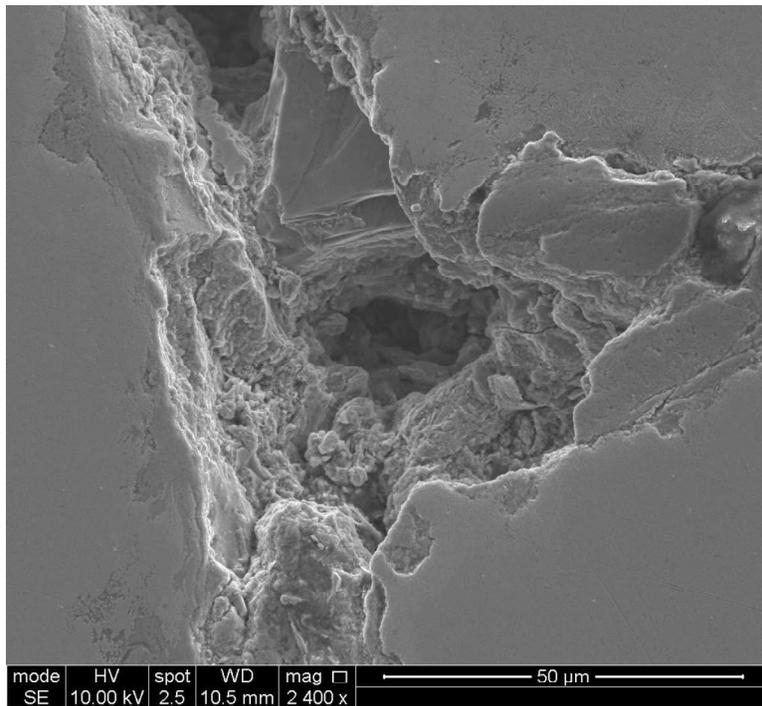
These voids are possible branching points for the crack as features like these voids have been noticed at the junction of crack boundaries as shown in the SEM image in Figure 19. The void is from the circular crack in Figure 17a, and may have been why a crack branched down from the main crack, or may be due to fretting after the crack branched. It is hard to be sure due to so much damage and corrosion. Sample preparation will also cause some material loss from the area shown.

Figure 19: SEM image of a junction where a crack branched off deeper into the rail.

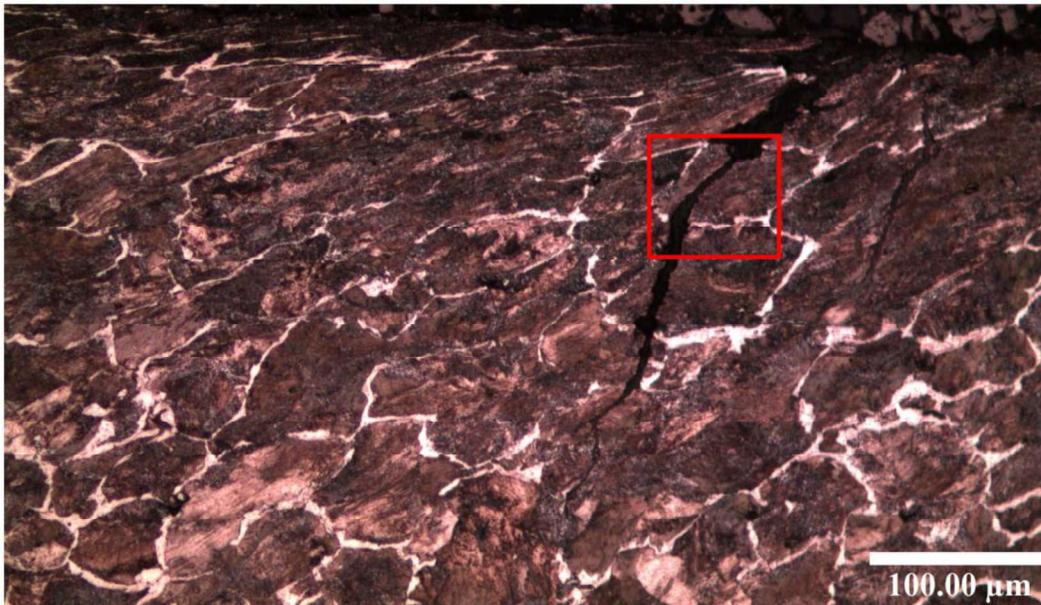
Figure 20 shows an optical micrograph of sample 3 with a surface breaking crack. The crack travels fairly vertically through the material rather than at an acute angle to the surface as is usually expected from RCF cracks. This is seen in thermally damaged steel [22]. The interesting behaviour regarding the crack path is that unlike squats, which typically follow inter-granular ferrite, this crack seems to cut across the grain as documented by Grassie et al. [5]. However, unlike the studs investigated by Grassie et al. this behaviour also occurs within 450 microns from the surface as well as below.

Figure 20: Optical micrograph of sample 2 showing a surface crack with apparent non-sensitivity to microstructure. The red box shows where SEM images were taken from (shown in Figure 21)

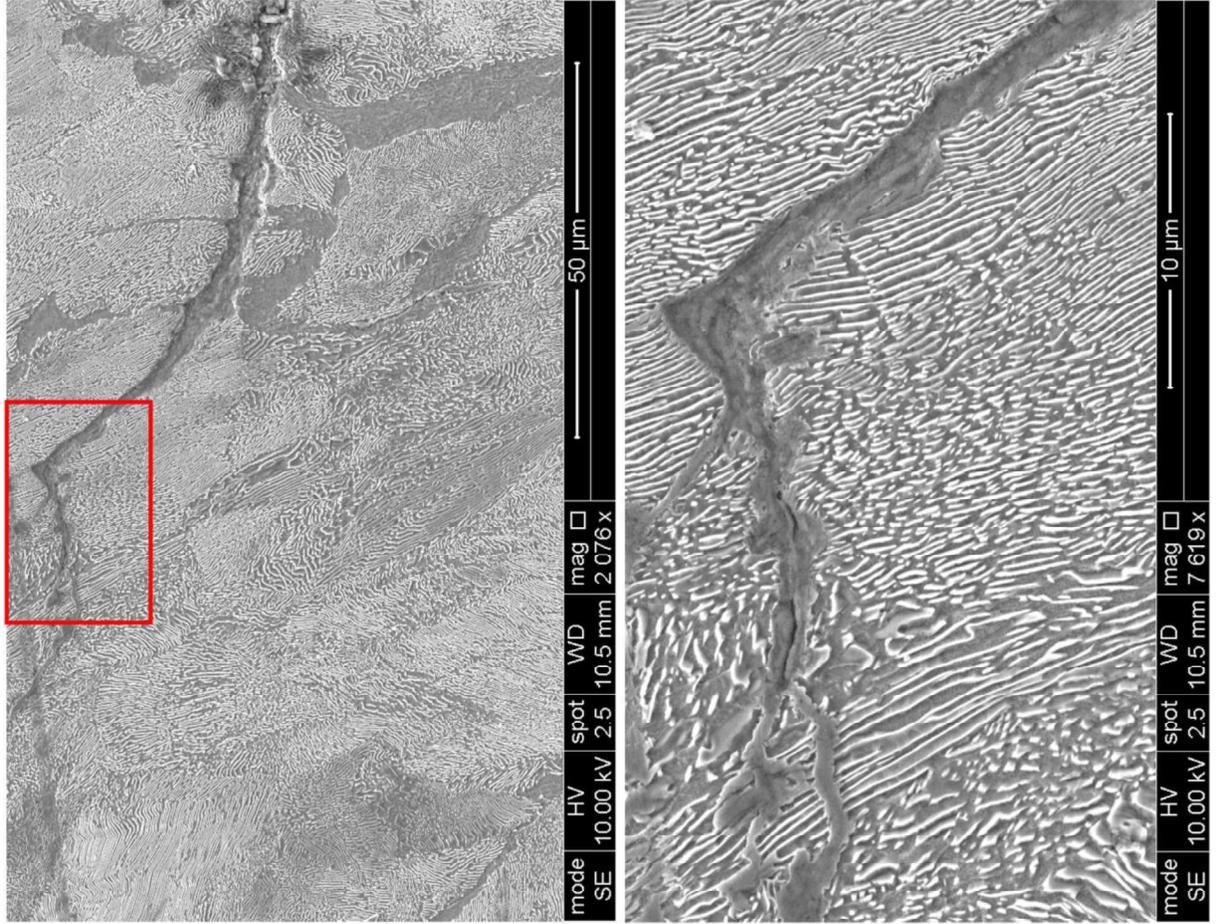
As seen in Figure 21, the cracks travel between lamellae plates a majority of the time but not always. They seem to be able to change direction when the plates become small and more spheroidal. There are places where this is not true such

as the bottom of the right SEM image where the cracks cut straight through plates. This could be because the crack was well developed in orientation to the lamellae of a neighbouring grain and so continued in that orientation as it widened. This would mean that the crack did not initially grow within this slice following these grain orientations. Looking at the CT scan data in 3D the crack plane grows down into the rail and diagonally across the rail as it propagates longitudinally and laterally at the same time. This means that the initial crack path cannot be viewed in its entirety, with regards to the microstructure, within one micrograph. Many thin slices will need to be taken around the possible initiation site to investigate the relationship between microstructure and the crack path to its full extent. This will be part of further work.

921
922
923
924
925
926
927
928
929
930
931
932
933
934
935
936
937
Figure 21: Left) SEM image of the box from Figure 20 showing that the crack still prefers to travel between the lamellae plates of the pearlite when cutting across grains. Right) magnified view of the box in the left image.
