It's worth cleaning – The examination of the female taper could identify a particular cause of trunnionosis at revision 16 years after total hip arthroplasty

Trunnionosis after total hip arthroplasty identified by examination of the female taper

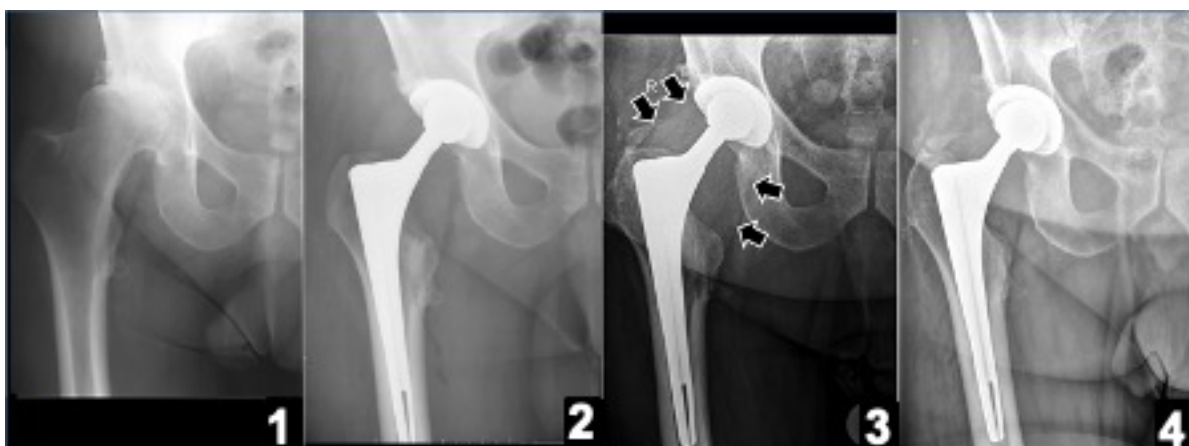
Approximately 14 years postoperatively, the patient started complaining of new onset hip pain on the right side, interpreted as an abductor tendinopathy at that time. Analgesia with NSAIDs and repeated series of physical therapy brought short-term improvement every time, but the hip complaints slowly increased over time. Two years later the patient presented again due to the pain in his right hip. Pain was located in the groin and increasing on flexion and abduction. Conventional radiographs (Fig. A) showed a well-oriented, uncemented THR without signs of loosening, but identified a soft tissue tumor around the joint. A computed tomography of the pelvis demonstrated an osteolysis in the posterior trochanter and a soft tissue tumor, located mainly anteriorly to the hip. Retrospectively, this soft tissue tumor was also identifiable on the radiographs performed 2 years earlier.

Figure A – Section of interest, showing the right hip, of the conventional anteroposterior radiographs of the pelvis of the initially 65 years old male patient. Contrast is impaired on all images due to the patient's corpulence. Preoperative osteoarthritis of the hip is visible in 1. Cranial flattening of the femoral head due to wear is present, and the hip is laterally subluxated. The bone of the acetabulum and of the femoral head are in contact, with no more

cartilage in between, which would be radiolucent. Osteophyte formation is visible both on the lateral femoral head, as well as on the acetabulum. The postoperative control radiography is shown in **2**. Note important leg lengthening, particularly the position of the lesser trochanter compared to the ischium, caused by the implant. The orientation of the cup is correct, both in inclination and anteversion. The inlay is a metal cup/polyethylene sandwich (Metasul 28 mm), the outer contour of the inner metal cup giving the cylindrical shape around the ball head. Radiographs 16 years postoperatively are shown in **3**. Black arrows mark the contours of a soft tissue tumour around the joint. No signs of loosening are visible, both around the cup as well as along the stem. Results at one year post-revision are shown in **4**. The soft tissue tumor is no longer visible. Note exchange of the inlay and of the head (now 36 mm mixed ceramics head with highly crosslinked polyethylene liner).

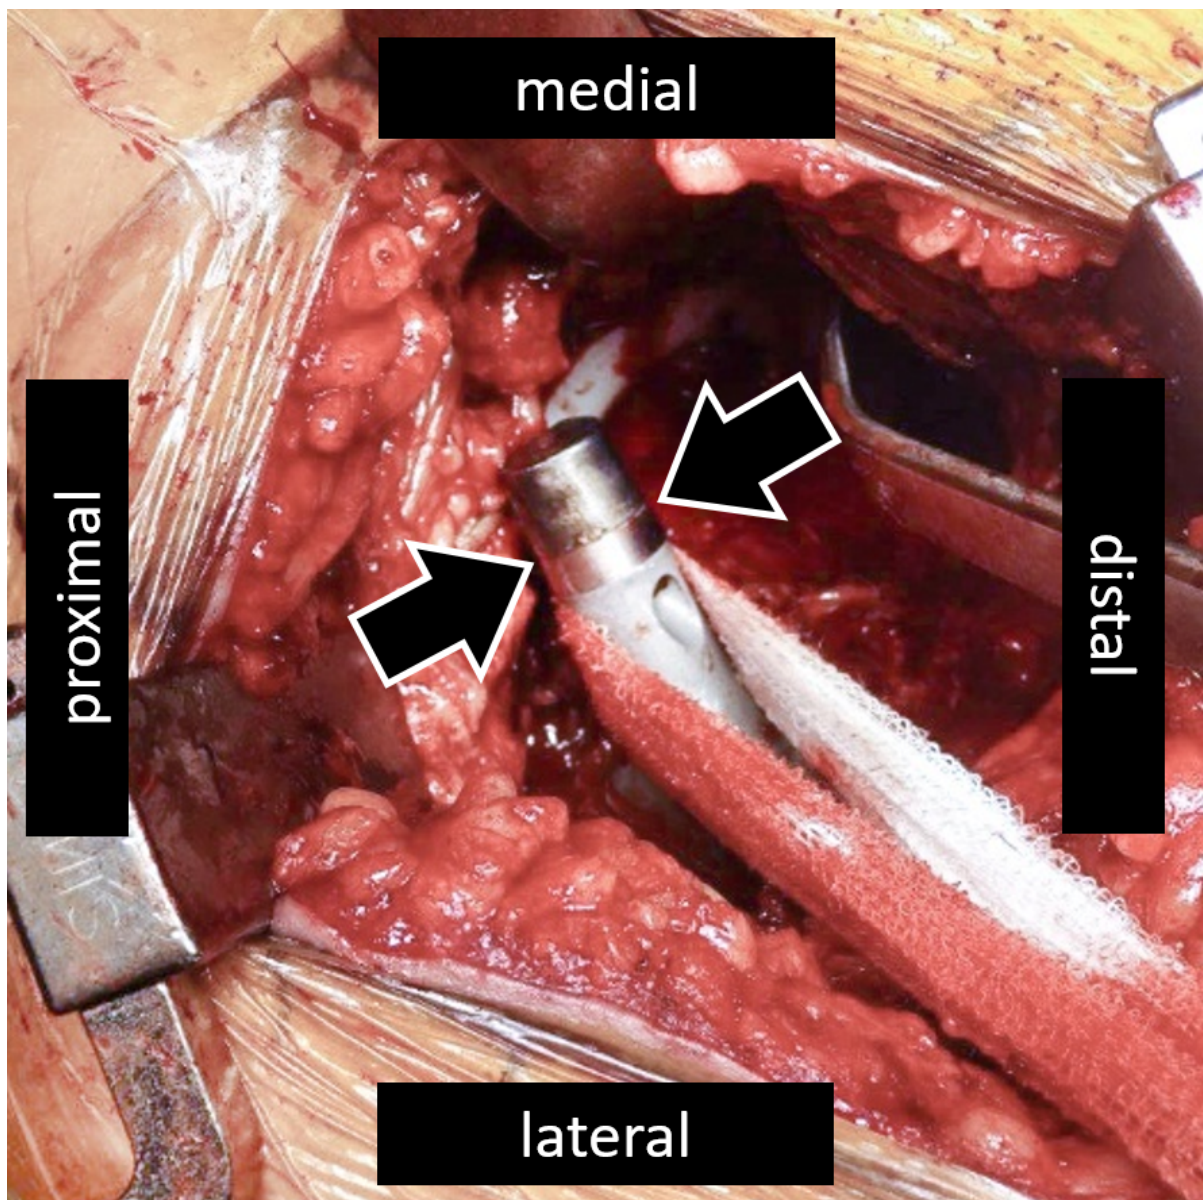
Following an anterior approach to the hip, debridement of the soft tissue tumor and exchange of the inlay as well as the head (Durasul alpha, Biolog option 36 mm; Zimmer Biomet) was performed. Approximately 1'000 ml of partially fluid necrotic tissue could be removed. While the metal cup and the surface of the head showed no macroscopic damage, the taper showed

severe corrosion and wear (Fig. B). Despite this finding, it was decided to stay with the initial plan, retaining the stem. A ceramic head with inner metal sleeve was chosen for reconstruction, instead of a CoCr head, as the softer titanium-aluminum-vanadium sleeve was expected to adapt better to the damaged male taper.^[14, 15]

Figure B – Intraoperative view through an anterior approach to the hip. The semi-fluid necrotic tumor of ~1'000 ml already has been evacuated, the prosthesis is dislocated in external rotation, and the ball head component has been removed. The male taper had been cleaned as well as it is possible with wet gauze. The contact zone of the taper is corroded, well shown by dark discoloration compared to the non-affected distal part, as well as worn, with slight volume loss of the affected area, compared to the angle of the distal part of the taper. As the ball head had a L/+4 mm taper, the male taper was not entirely engaged. The contact zone on the distal taper is well identifiable.

In case of trunnionosis, well-fixed stems do not necessarily require revision. In a series of 73 retrievals with more than 10 years follow-up after taper corrosion diagnosed at head and liner revision with retaining of the stem, only 8% had been revised in the interval and all of these for other causes, even when severe corrosion was present.^[40] Corrosion and wear have to be assessed thoroughly. To the best of our knowledge, no recommendations are available regarding tolerance of wear and deformation of the male taper. In this case, a ceramic head with a titanium-aluminum-vanadium alloy inner sleeve (BioloX Option, CeramTec, Plochingen, Germany) had been chosen, expecting this material to better adapt to the deformation of the trunnion (Fig. B) compared to harder cobalt-chromium alloys.^[14, 15]

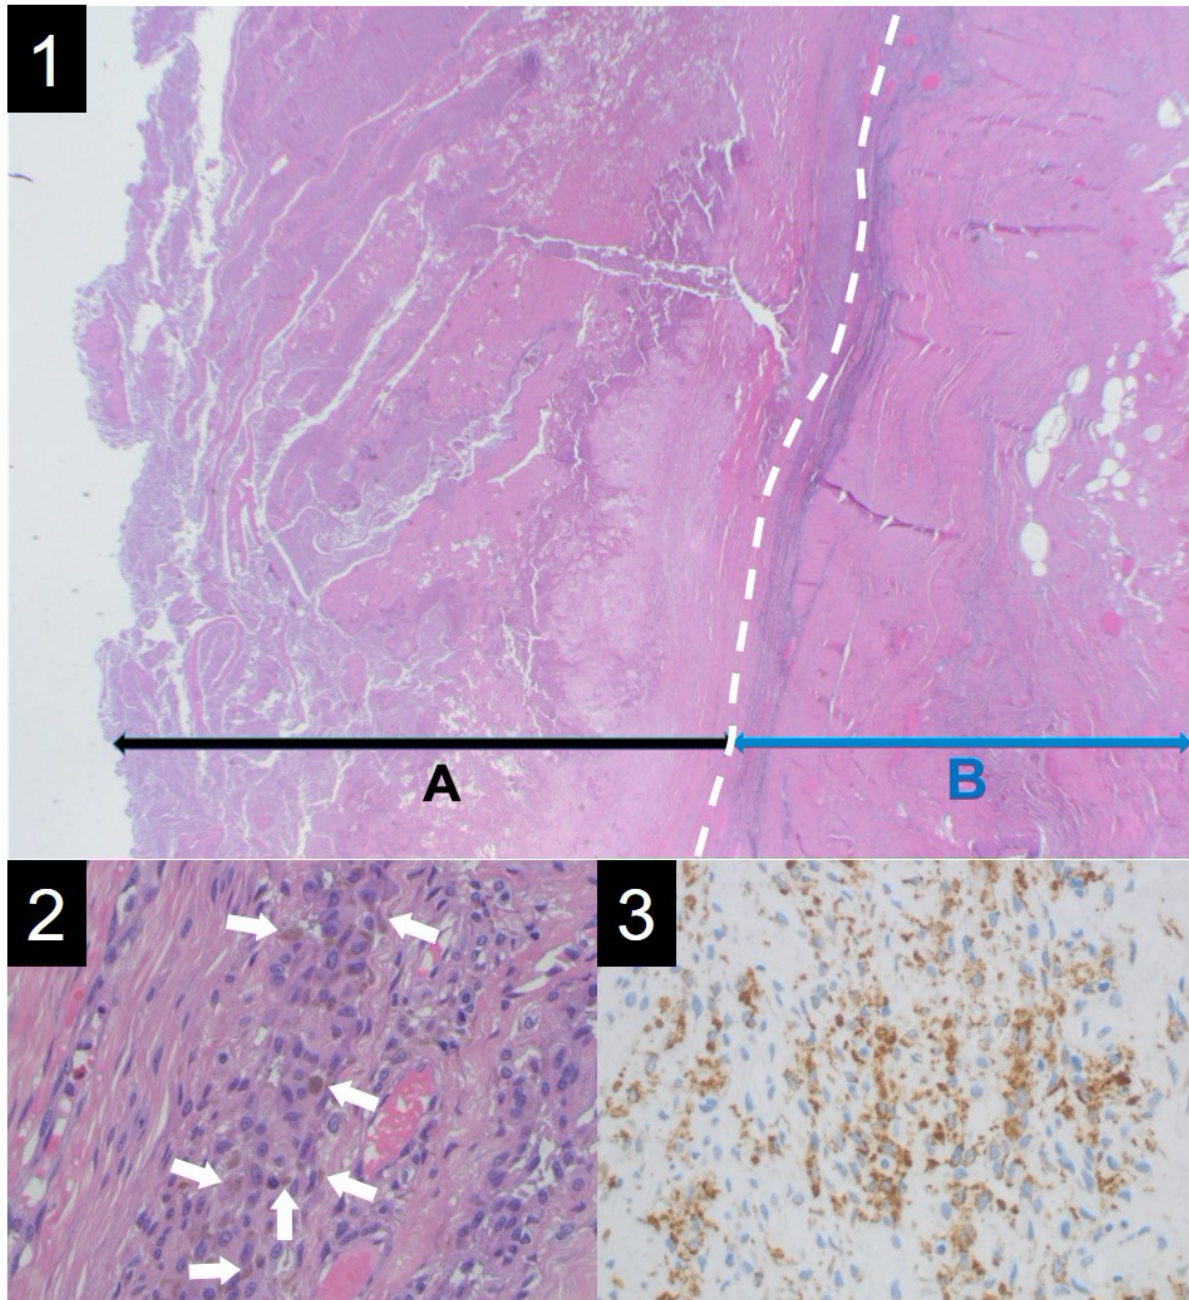
Histology confirmed extensive necrosis in the samples from the pseudotumor, demarcated by a well-identifiable vital neocapsule (Fig. C). Within the rather thin-layered and mostly distended neocapsule, a macrophagic reaction was observed (Fig. C-2 and 3) demonstrating phagocytosis of golden-brown granules taking up Prussian blue stain (not shown), thus corresponding typically to hemosiderin. No metallic particles were identifiable. Microbiological workup with prolonged incubation of 14 days followed by subculture of the thioglycolate broth identified no microorganisms in any of the 5 tissue samples. The postoperative radiographs were inconspicuous and recovery was uneventful.

Figure C – Microphotographs of the histology of the periarticular neocapsule. **1:** Overview (hematoxylin eosin (HE) staining, magnification x12,5) showing an extensive necrosis of the innermost layer (area marked A), adjacent to a deeper layer of vital fibrous tissue (area marked B) comprising some adipocytes (at the right edge of the picture). The border between necrosis (A) and vital tissue (B) is demarcated by a macrophagic reaction (marked by a dashed white line). **2:** Higher magnification (HE, x400) of proliferated macrophages at the border of the necrotic tumor showing numerous intracytoplasmic golden-brown granules (white arrows) corresponding to hemosiderin. **3:** CD68 immunohistochemistry (x400) with positive brown staining of macrophages.

The pseudotumor around the joint was mainly fluid and composed of acellular necrosis, as confirmed by histopathology. Only the neocapsule showed vital fibrous tissue (Fig. C). Large necrotic reactions are usual in trunnionosis, whereas lymphoplasmocytic infiltrates are more commonly seen as reactions to wear particles from the bearing surfaces.^[1, 10-12, 24, 25] No wear particles were identifiable on optical microscopy, the macrophagic reaction present within the neocapsule showing inclusions corresponding typically to hemosiderin, resulting probably from microhemorrhages. While wear was also present and measurable on the bearing surfaces, the wear volume corresponds to expectations in revision for other causes, together with the tissue reaction present indicate trunnionosis as principal cause of the ARMD. Nevertheless, submicroscopic wear and corrosion particles may be present. Further typisation by electron beam microscopy might be indicative of their origin, as being either from the bearing surfaces or from any taper connection.^[24, 25] However, electron beam microscopy is not available in clinical routine, routine embedding of samples in paraffin would need time-consuming re-embedding in epoxy resins with a notable risk a loss of the structure of the tissues, and the final yield of such a work-up might well be disappointing, considering the rather low density of

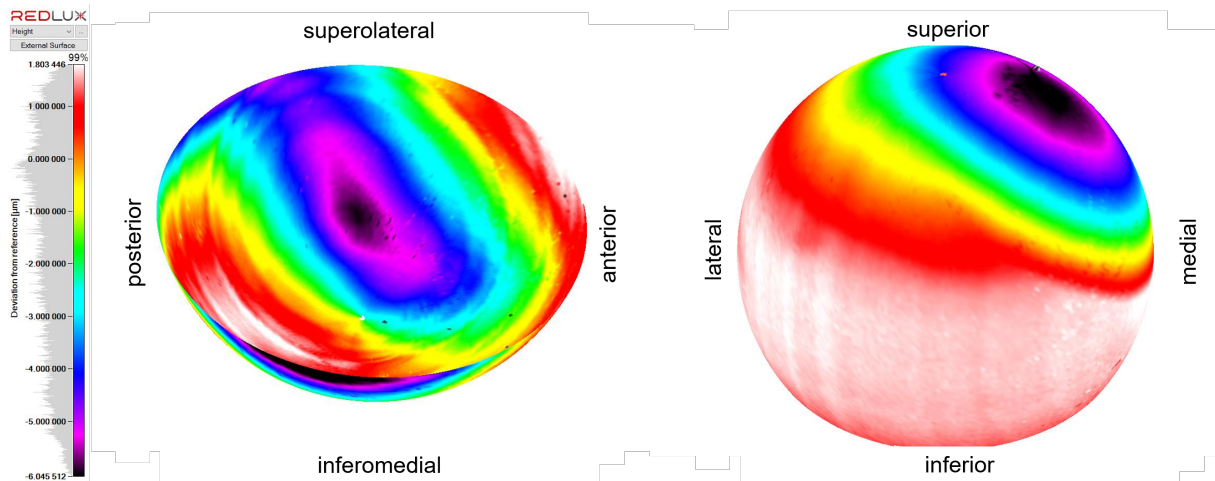
The analysis of the ball head showed total volumetric wear of 6.74 mm³, which corresponds to 0.43 mm³/year. The wear of the cup was similarly analyzed (1.53 mm³ total volumetric wear, 0,0095 mm³/year). Wear on both components was predominating in the superomedial main contact area (Fig. D).

Figure D - Three-dimensional reconstruction from the data acquired by direct measurement by the RedLux CMM from the bearing surface of the cup (left) and the ball head (right). The measured inner diameter of the cup was 14.042 mm, and the outer diameter of the head 13.990 mm. The measured clearance between cup and ball head thus is 52 µm, corresponding closely to the 50 µm minimum diametral clearance specified by the manufacturer. Wear is mainly present at the superomedial contact point, as expected. Despite 16 years in situ, wear remains within some µm.

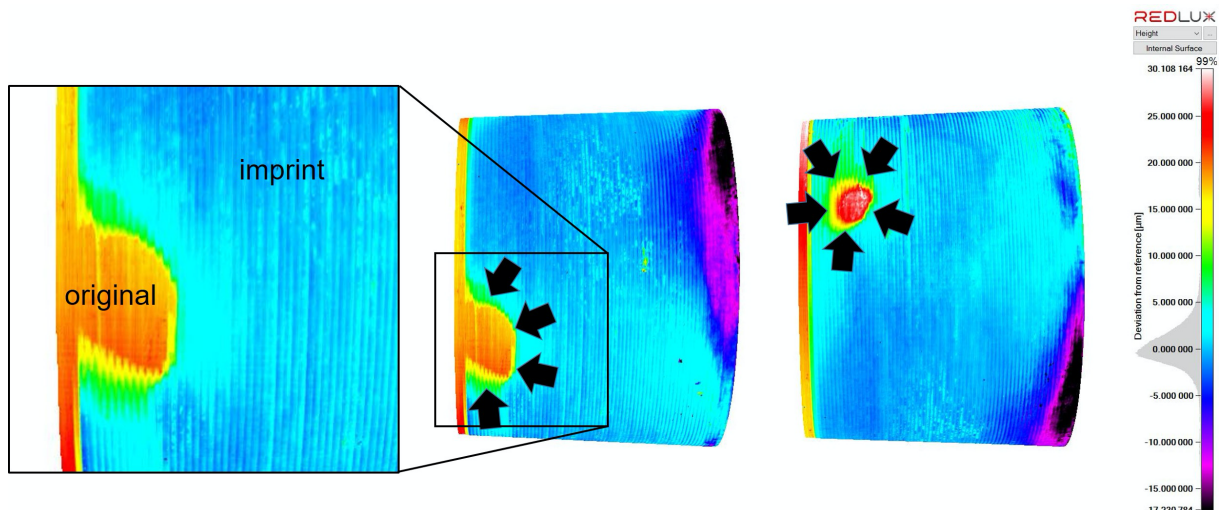
The analysis of the imprint identified 2 localized defects on the female taper (Fig. E). No reliable determination of volumetric loss was possible, as not enough undamaged taper was available for adequate referencing, due to important imprinting from the trunnion as well as due to material loss in the contact area, and as in this design the female taper stops short above the contact zone, with the contact-free clearance above being a cylindrical bore not usable as reference, due to software limitations. The defect of the softer male taper, made of titanium alloy, was macroscopically more pronounced (Fig. B) than the one identified on the firmer CoCr counterpart of the head. However, this could not be further quantified, as the stem had not been revised.

Figure E – Three-dimensional reconstruction from the data acquired by the RedLux CMM from the Microset 202 imprint of the female taper. The taper angle measured at 5.668° is very close to the specifications of the manufacturer, ranging $5^\circ29'00''$ to $5^\circ46'30''$ ($5.483^\circ - 5.775^\circ$) for CoCr-head female taper, illustrating the high degree of data fitting. Both views show opposite sides of the taper. The red/orange stripe at the tip of the taper corresponds to the native taper outside of the contact zone. The rest of the bore, corresponding to the clearance above the contact zone, is cylindrical in this design, and could not be used for referencing. A magnification is provided (black square on the left) to show the difference in the surface pattern between the manufacturing marks on the female taper, visible in the red/orange areas, compared to imprinting on the rest of the contact zone, showing a wider spacing corresponding to the pattern on the male taper. Two localized defects (marked by black arrows) are identifiable, appearing as positive relief on the imprint. Note that the scale is larger than in Fig. D by an order of magnitude. As the component fixation was uncemented, and as both the cup and the stem had no coating such as hydroxyapatite, bone fragments most probably caused these defects. No other material hard enough to indent the CoCr alloy of the head was present. Interposed bone fragments are known to weaken a taper assembly and to contribute to trunnion failure.

As illustrated by the current case, taper failure may also affect small diameter THR. The stability of a taper connection depends mainly on frictional forces at the interface.^[2] This depends on the taper angle, given by the implant design chosen, the static friction coefficient, which is related to surface properties of the taper connection, and the assembly force.^[2, 26, 28-30] Two factors are of the utmost importance for the surgeon. The taper has to be cleaned and dried before seating the head, as interposition of soft tissues or even wetting of the surfaces greatly weakens the connection.^[2, 29, 31-33] Just leaving the surface of the taper wet may critically reduce the coefficient of friction.^[30, 32] The relation between disassembly force and coefficient of friction is not linear, but if it drops to 0.05, the taper does not hold anymore.^[2, 26, 29] Under ideal conditions, the coefficient of friction is approximately 0.2.^[2, 29, 34] Interposition of soft tissues literally greases the interface, respectively causes incongruences, with consecutive weakening of the connection.^[31-33] In this case, two hard particles could be identified, which reasonably can only be bone fragments, as no other material present in this THR is hard

enough to indent metal. Interposed hard particles hinder proper alignment of the pairing tapers, further reducing the strength of the connection. The other important factor in taper connections is the impaction force. Two blows, axially aligned with the taper are recommended, with a strength of approximately 6'000 N or more.^[2, 28, 35-37] This takes into account the fact that the femur gives way under the blow, contrary to the setting of mechanical tests with dynamometers fixed on hard surfaces, and that the impactor dissipates 20% or more of the impaction force.^[38, 39] Larger heads cause greater torque on the taper connection, and thus require greater assembly forces for initial stability.^[26] Greater impaction forces are also required to ensure rotational stability around the axis of the taper, which is a more probable failure mode than axial disconnection.^[28]

Overall, trunnionosis due to interposition of residual particles within the taper connection might well be an underreported issue in THR. Meticulous cleaning of the taper before seating the head may reduce its incidence. Some degrees of ARMD, as well as corrosion and wear of the taper, might well be overlooked at revision. If the stem is revised, the head usually is not disconnected, and thus the taper is not inspected. In case of sole revision of the ball head, advanced techniques, as reported here, are required to quantify wear of the taper, but this is routinely neither available nor necessary. Detailed analysis of any failure after THR might identify specific and avoidable causes. Ten-year revision rates under 5% should be aimed for after THR.^[43] Considering revision rates for infection and dislocation, which are not in direct relation to technical specificities of the implants, aseptic failures should not simply be accepted as such, as probably the largest potential for reduction of revisions is to be found among this group of failures. Each case should be analysed in detail, in order to optimize future patient care.
