INSTRUMENTATION SYSTEMS FOR AND FAILURE MECHANISMS OF
AN
INDUCED SLOPE FAILURE PROJECT

Document presented for PhD in the Department
of Civil Engineering, University of Southampton.
February 1996.

ABSTRACT

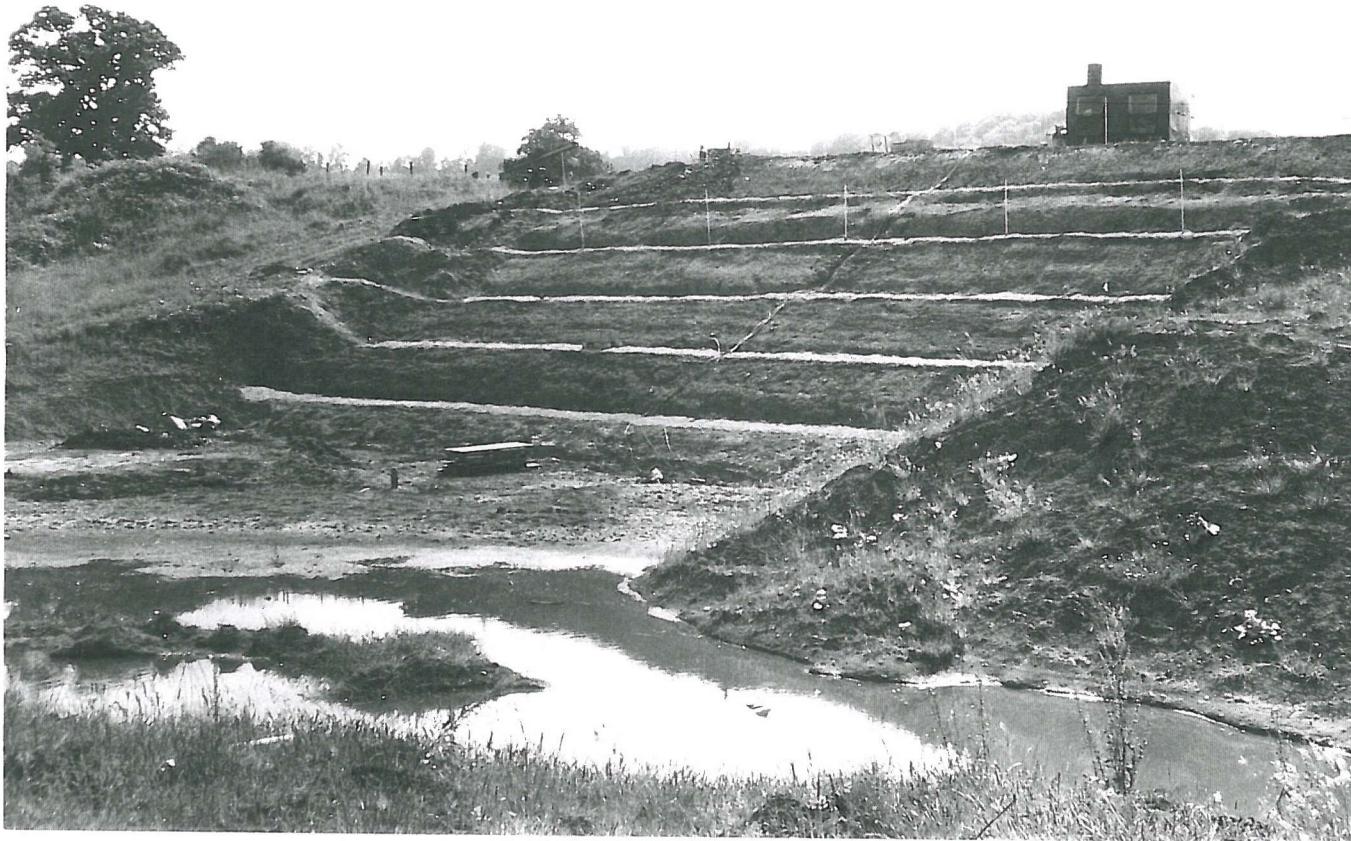
Plate 5-1. Selborne cut slope prior to failure

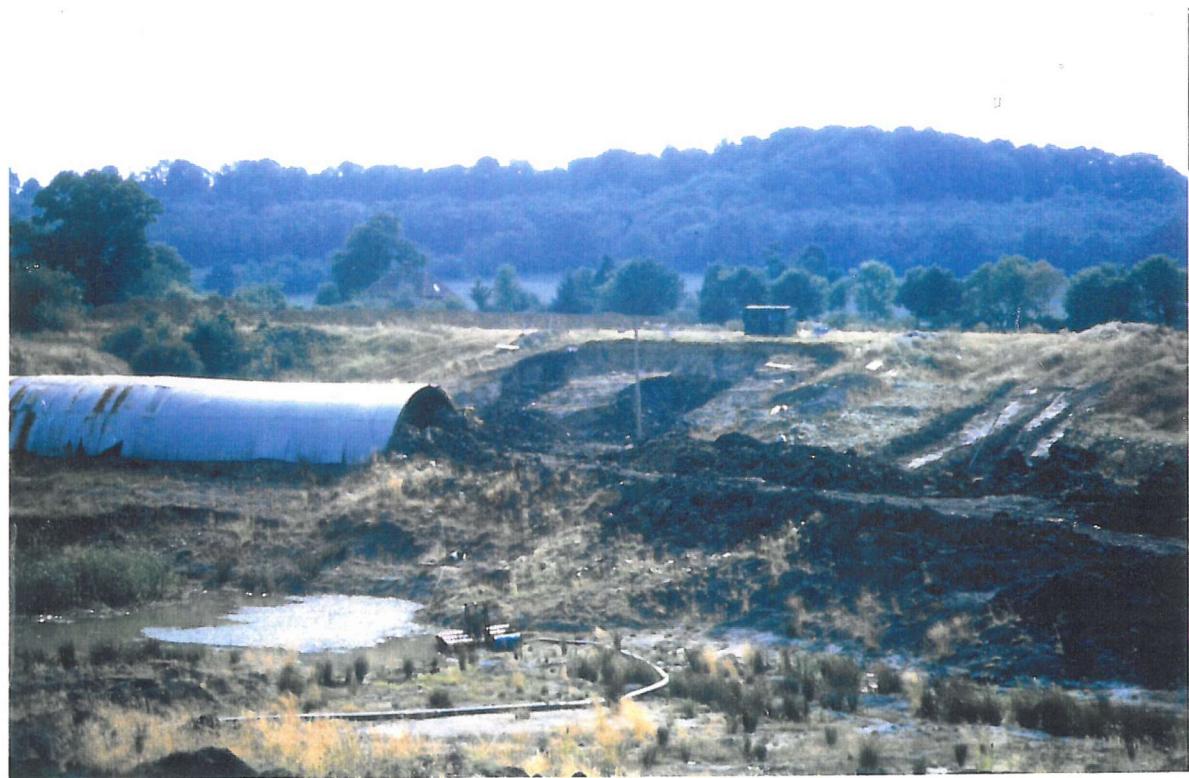
Plate 5-3. Post-failure investigation trenches.

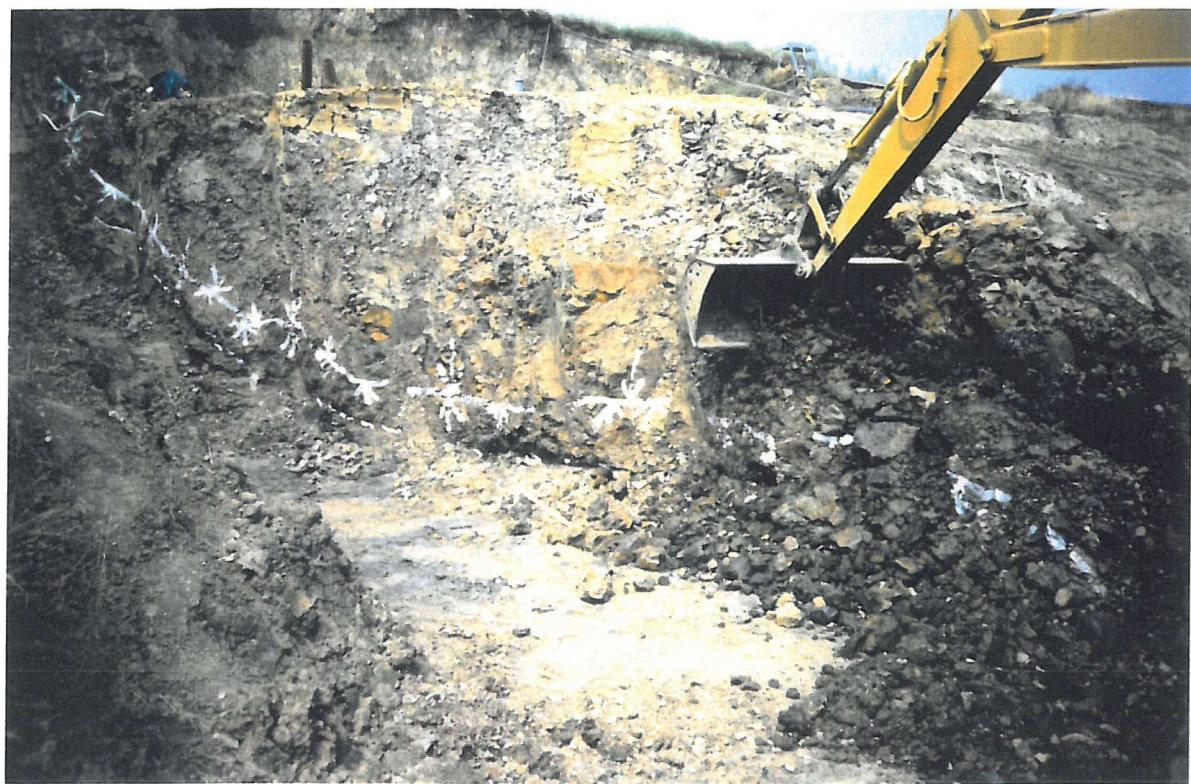
Plate 5-4. Highlighted slip surface Trench 1.

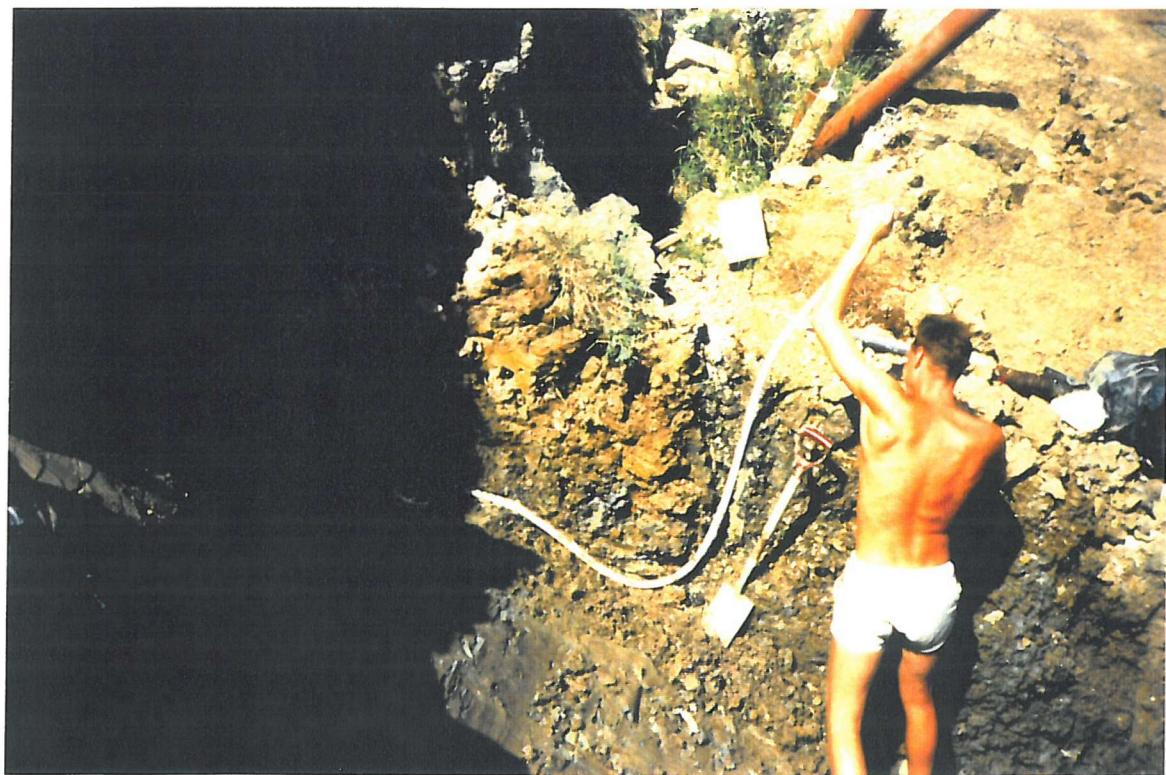
Plate 11-3. Deformed recharge well as exposed during the post-failure dig out.
Note no rupture of the pvc piping or connections took place.

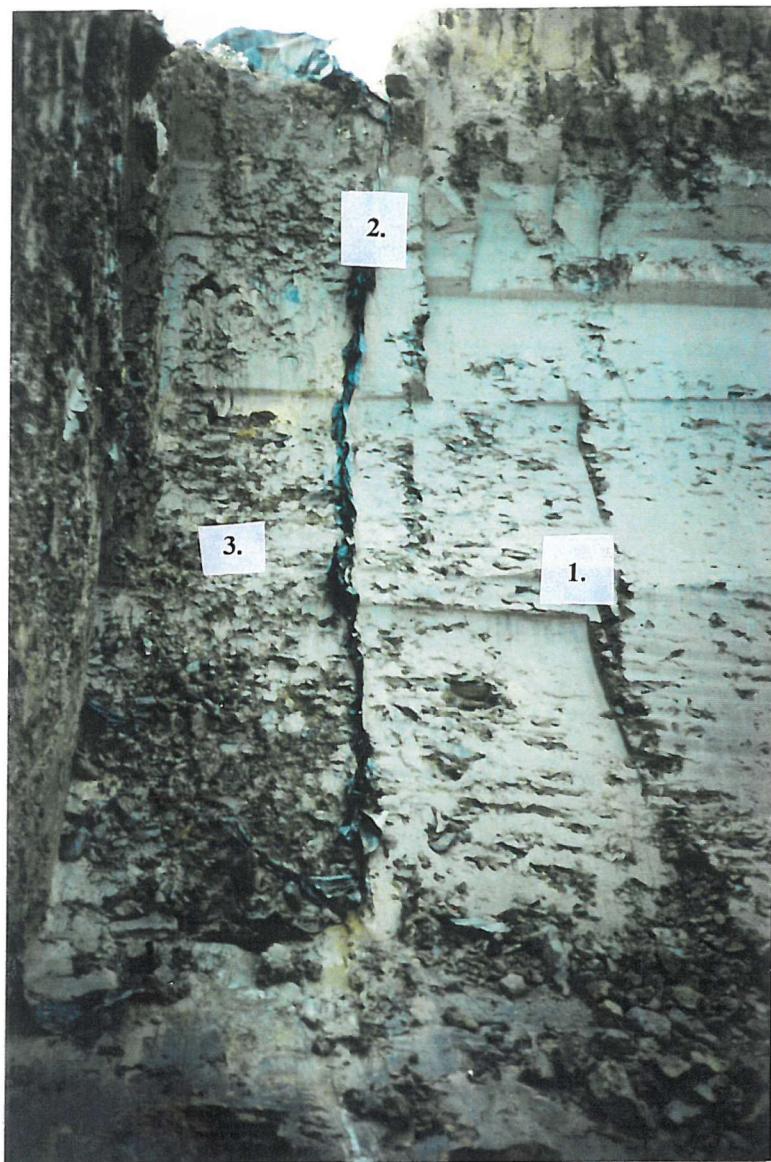
Plate 12-1. Southern side shear break exposed during the post-failure dig out.

1. Slope
2. Double layer of plastic sheeting
3. Backfill to side shear break

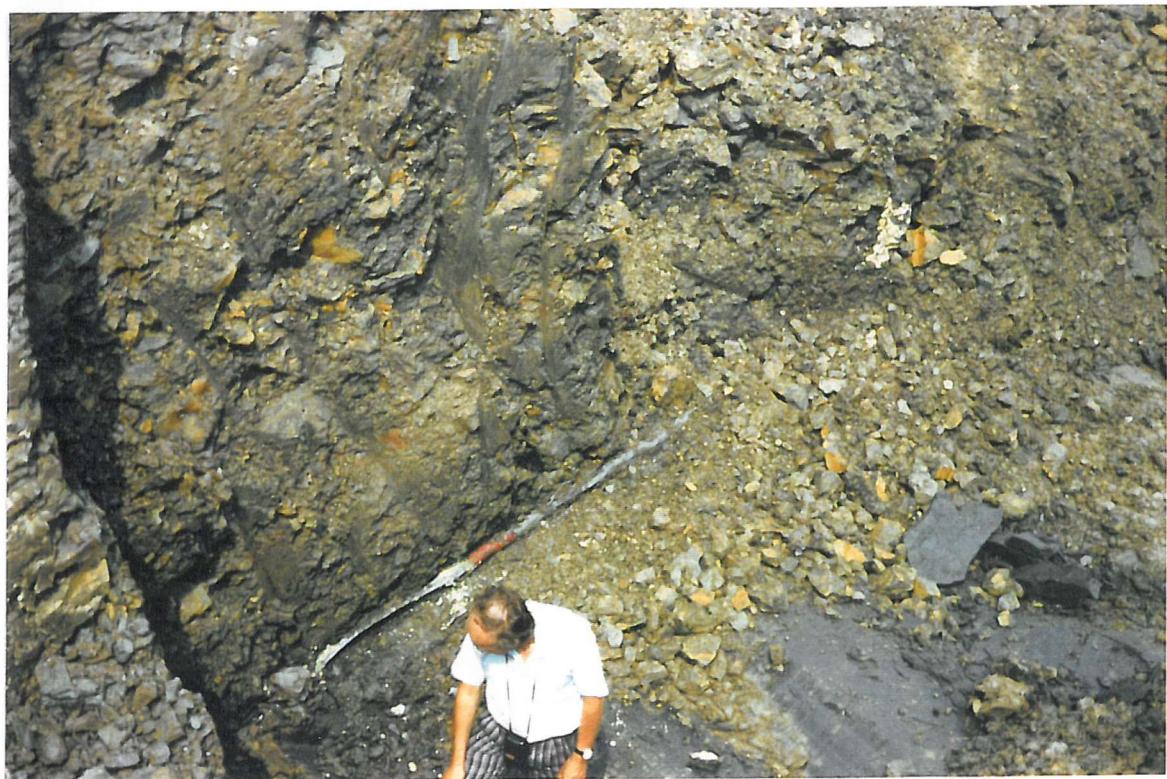
Plate 14-1. Inclinometer 07 post failure. Note the access tube laid flat along the slip surface and the empty grout stack still visible towards the upper right of the plate.

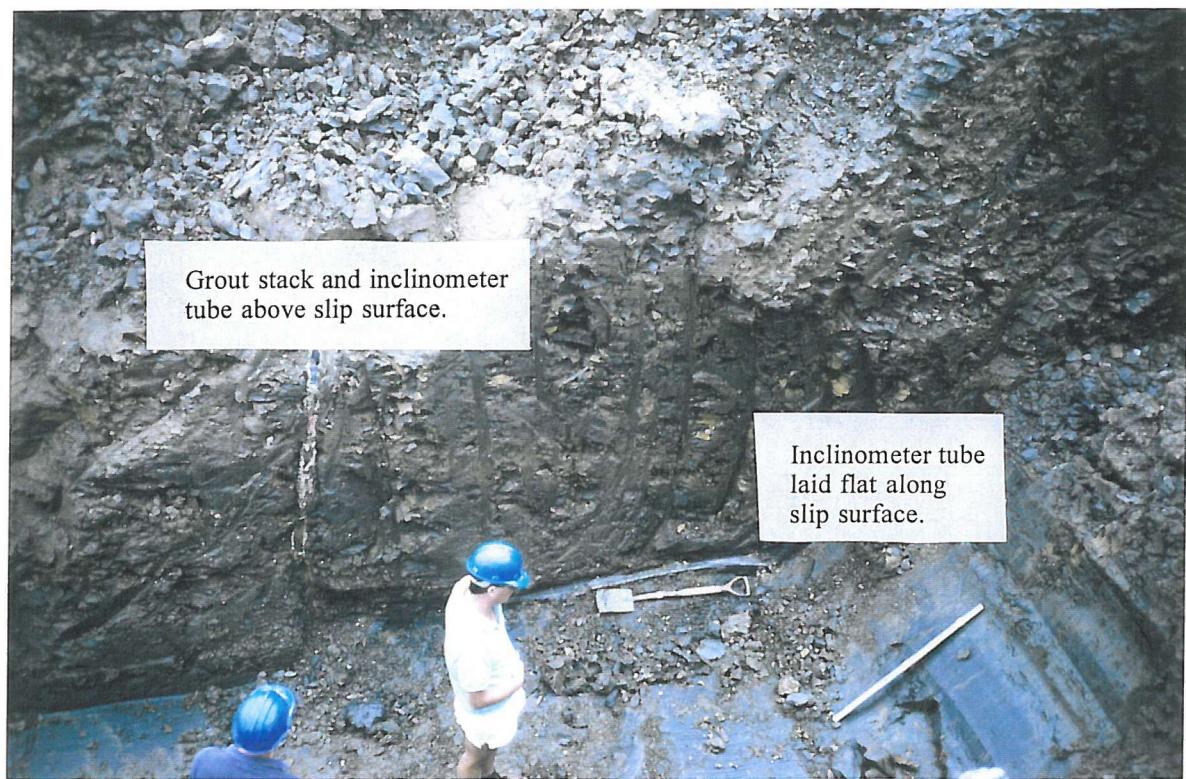
Plate 14-2. Inclinometer 09 post failure.

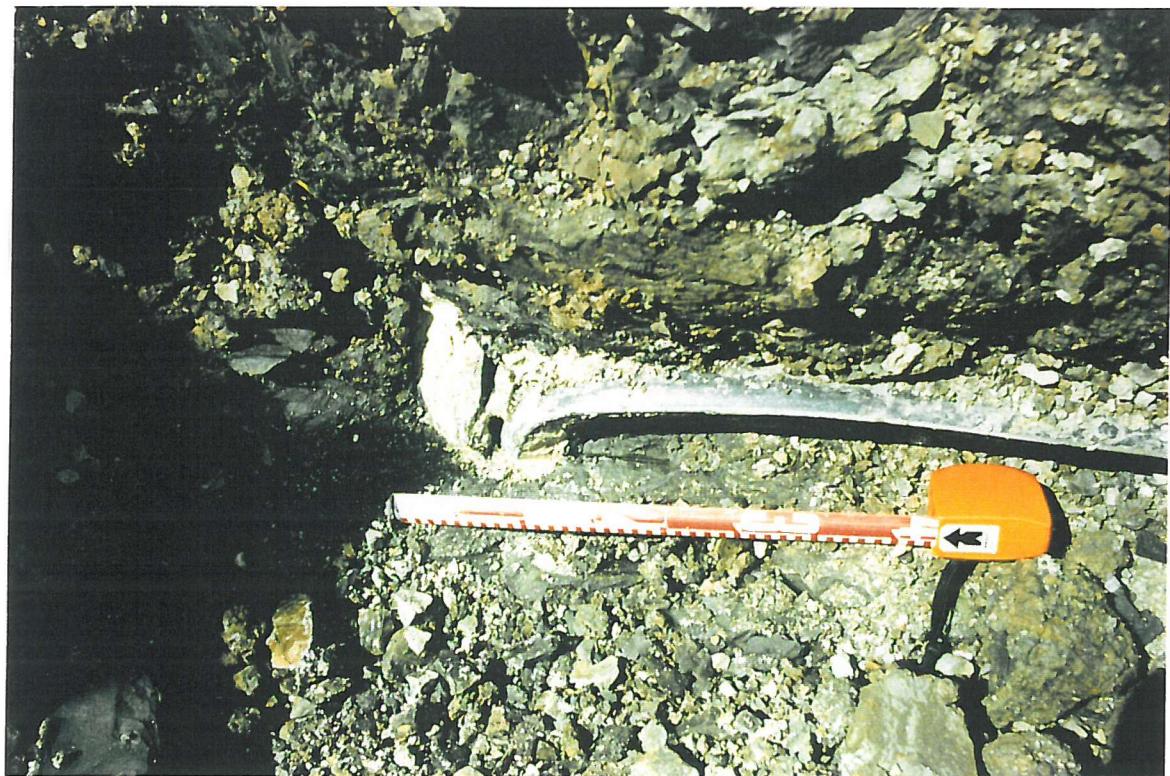
Plate 14-3. Close up of Inclinometer 07 post failure.

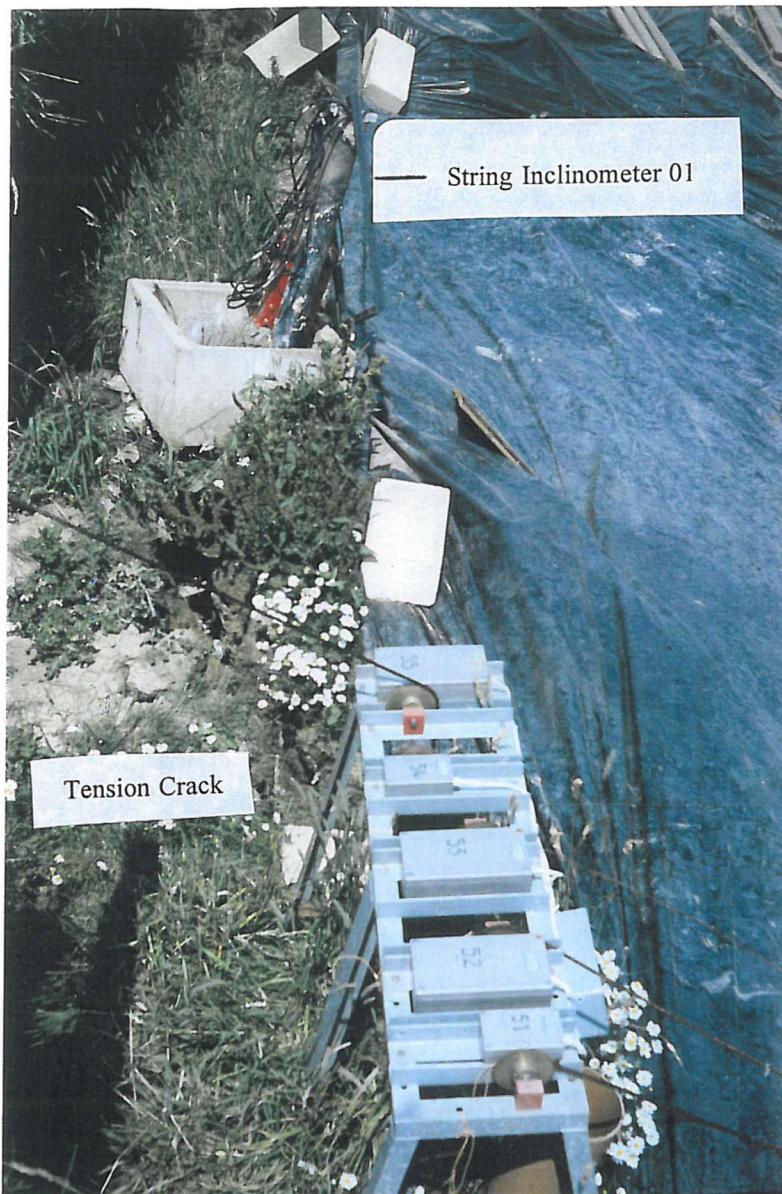
a) cica 2:00pm

Plate 14-4 Slip surface adjacent to String Inclinometer 01. 16 July 1989 (day 196).
