**FAILURE MECHANISMS FOR SMALL
DIAMETER CAST IRON WATER PIPES**

Phillipa Jane O'Shea

**A THESIS SUBMITTED FOR THE DEGREE OF DOCTOR OF
PHILOSOPHY**

AUGUST, 2000

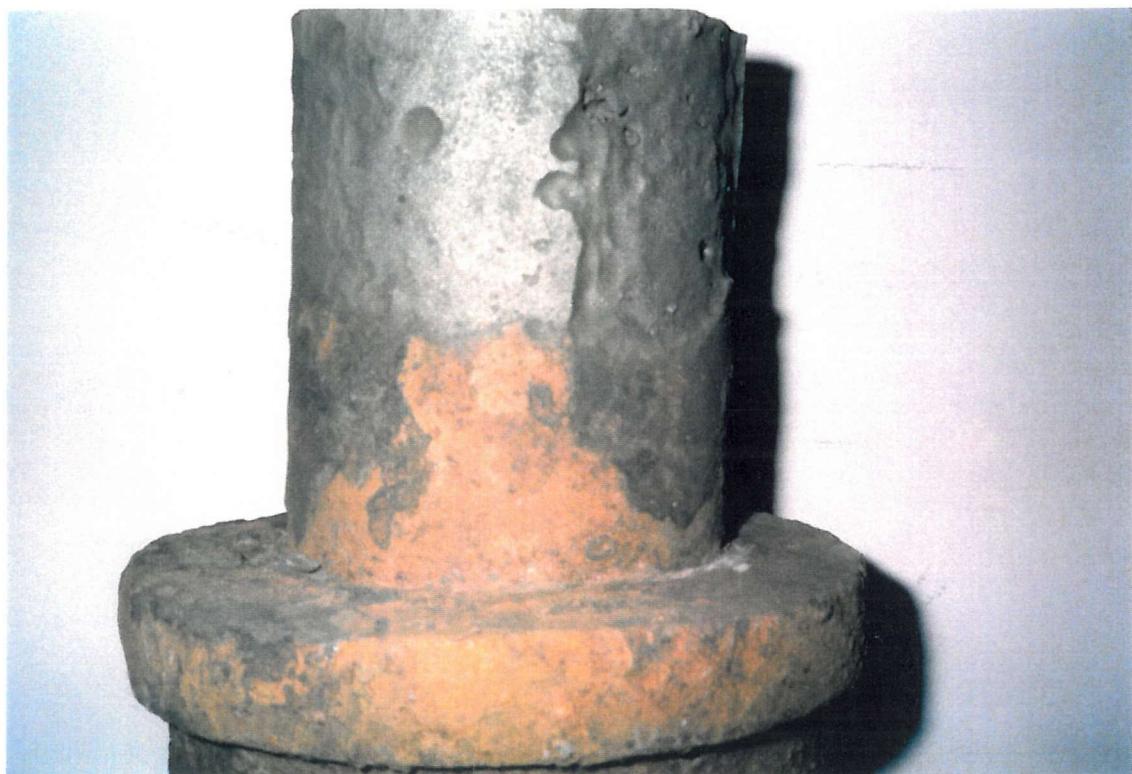
Figure 3.11: Photo of Embelton Road Joint#1 showing extensive corrosion pitting.

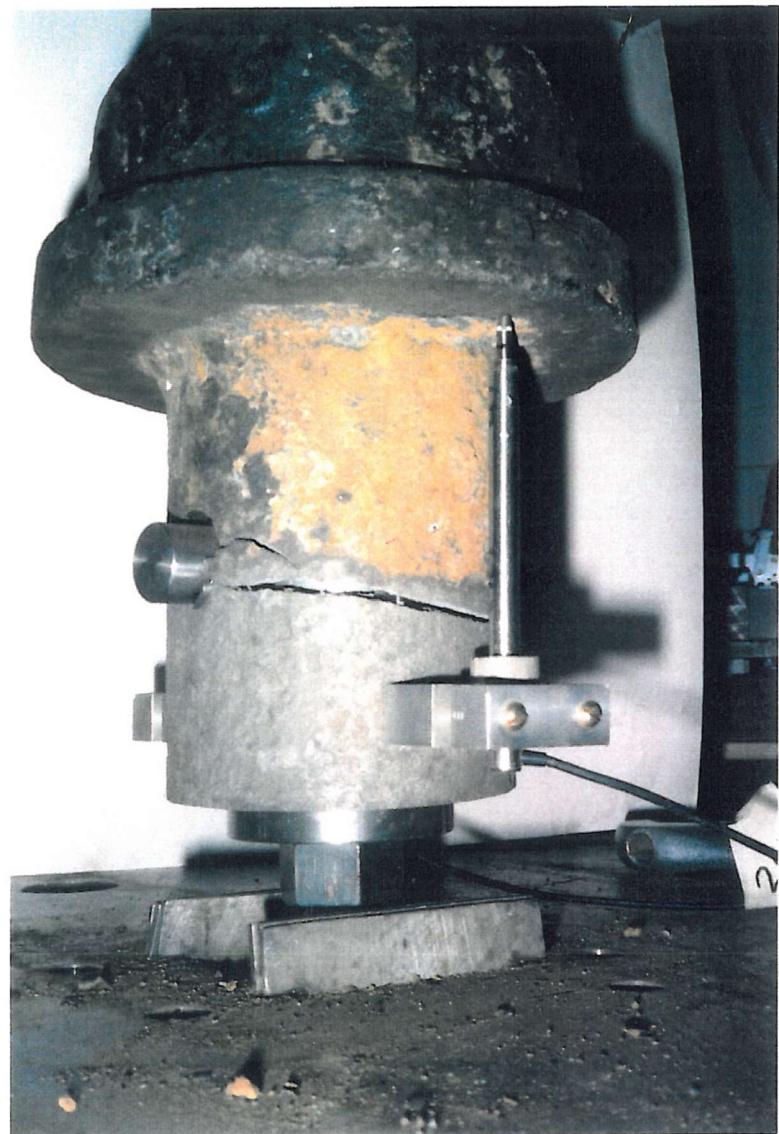
Figure 3.13: Photo of Embelton Road Joint#2 showing crack initiation of joint failure.

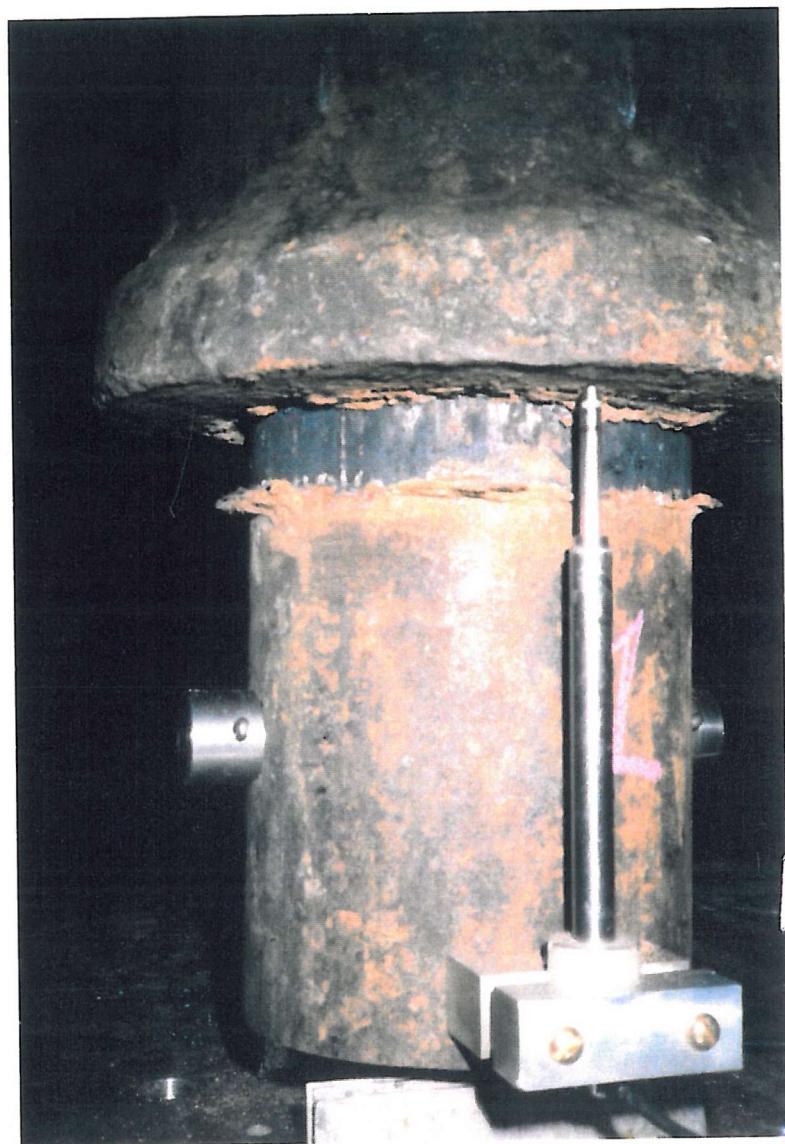
Figure 3.14: Photo of Embelton Road Joint#7 showing displacement of spigot from bell.

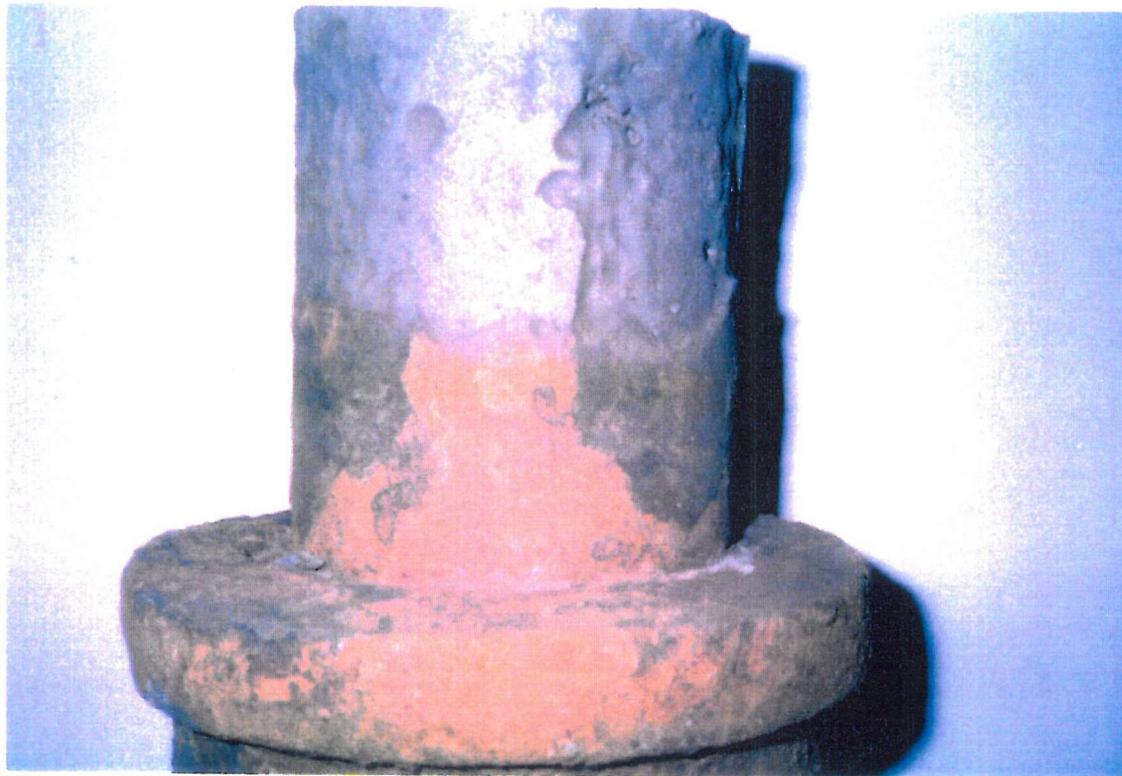
Figure 4.20: Photo of cast iron pipe with corrosion pitting

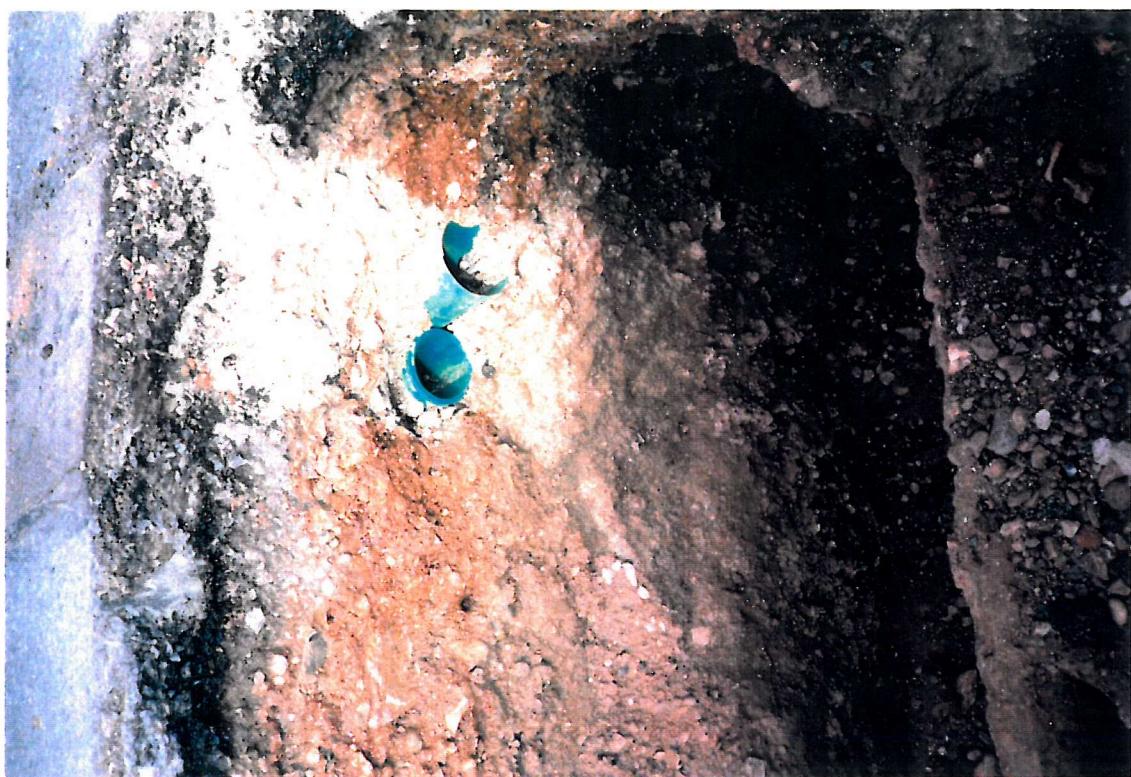
Figure 7 Patch repair, showing pea gravel

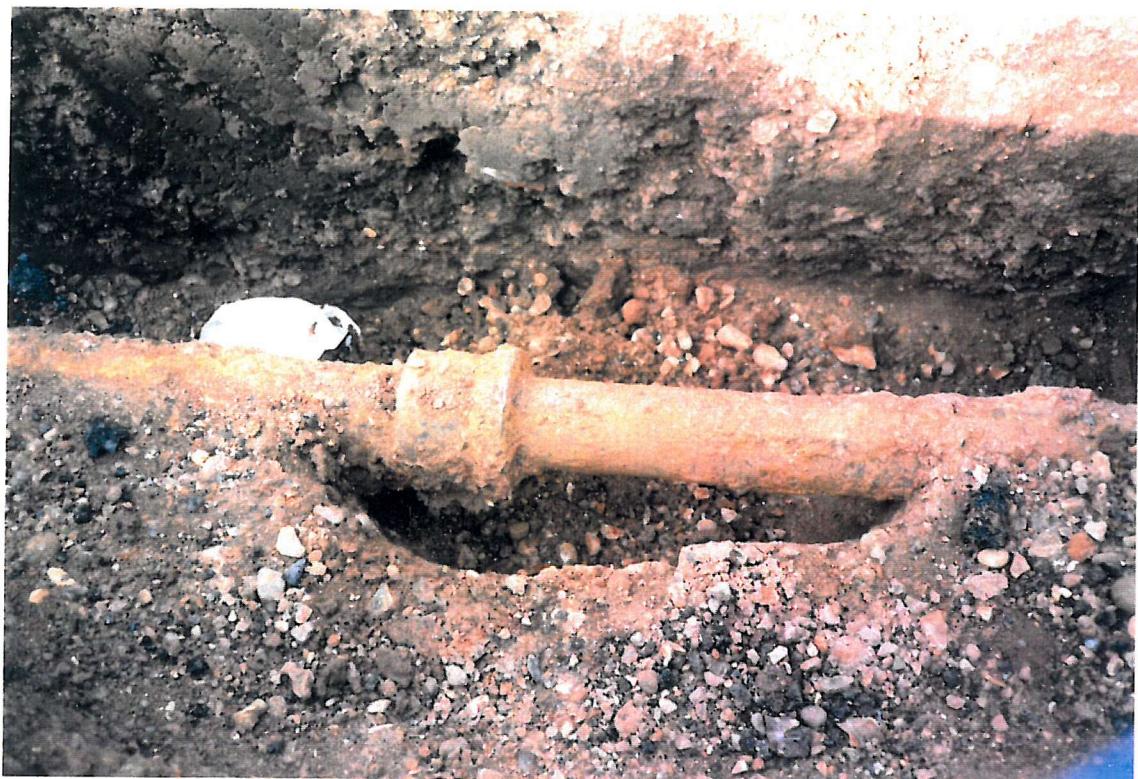
The trench was dry when the samples were taken (Figure 14). This is in contrast with the condition of pipe trench excavations for burst repair. Figure 15, taken after the pipe was cut and the water in the shut-off pipe escaped, shows the typical condition of a wet trench. It should be noted that soil samples from wet trenches would be affected by loss of fine material.

Figure 14 Dry trench conditions

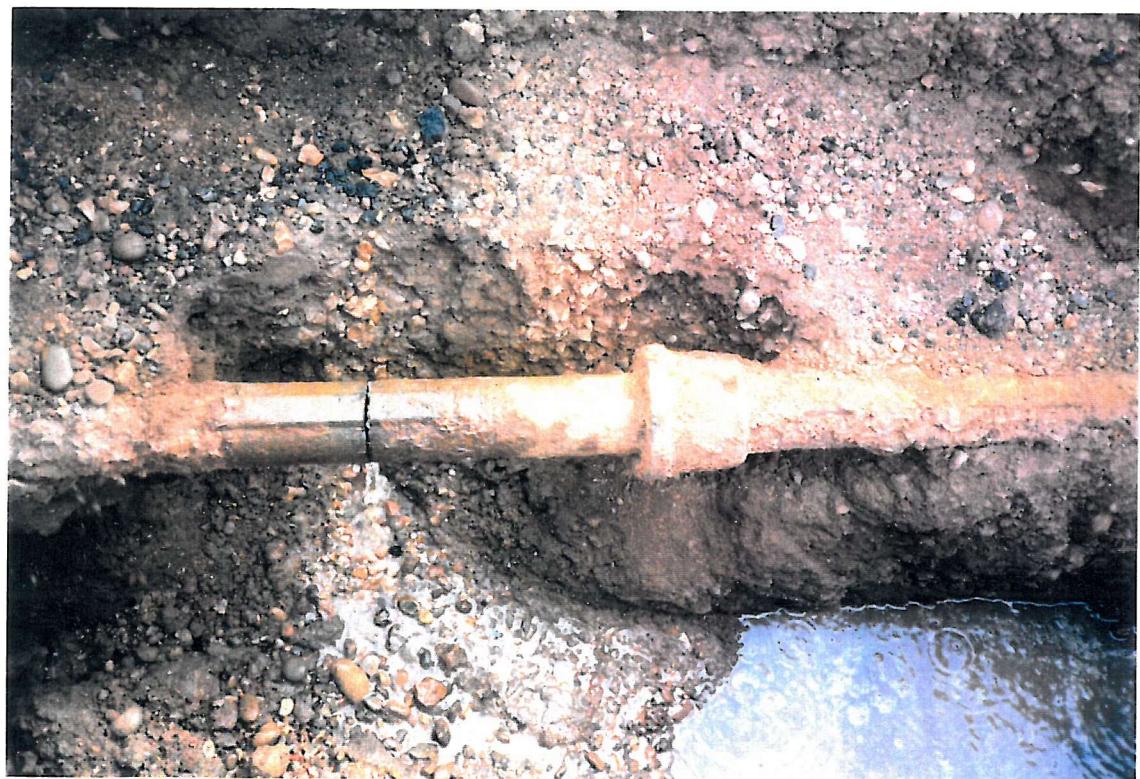
Figure 15 Wettet trench conditions, after cutting pipe
