Tribocorrosion damage of a Jethete M152 type stainless steel

S.C. Wang ^{a,*}, S. Quinn ^b, M.J. Starink ^a, R.J.K. Wood ^{a,b} and J.A. Wharton ^a

Abstract

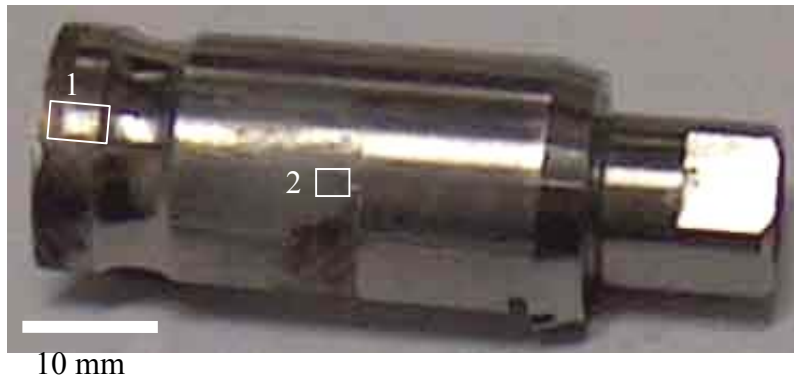
Fig. 1 shows a macrograph of an insert which failed in-service. There are several scratches from top to bottom, which were formed during assembly of the insert into the sleeve component. Heavy stains (dark red by visual appearance) were associated with these scratches, although some stains occur on the insert surface where no scratches exist.

Fig. 1: A photograph of a failed insert after service.

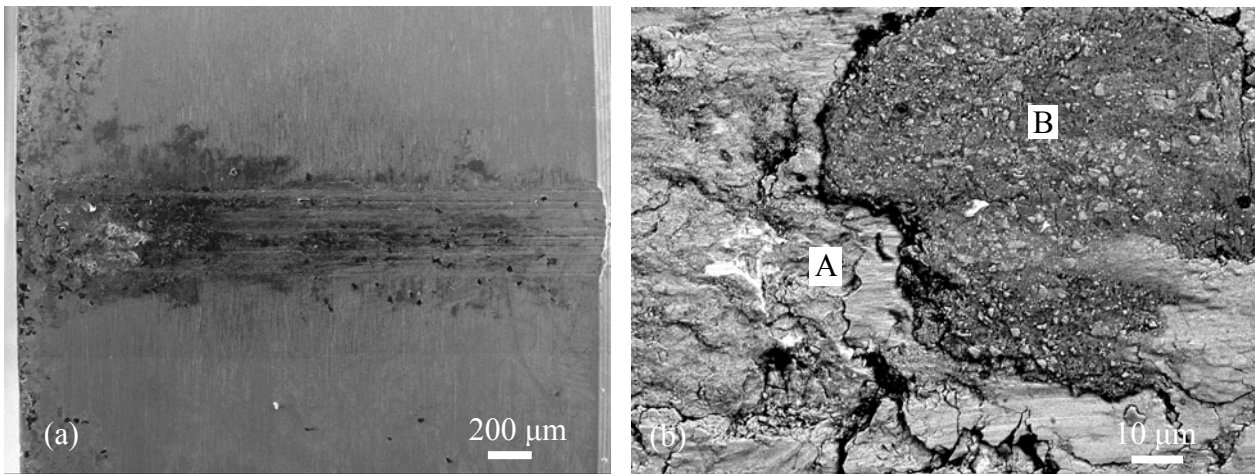
Fig. 2a shows a secondary electron image (SEI) of one corrosion area on the insert, which corresponds to area 1 in Fig. 1. It appears that corrosion products are occurring preferentially in the scratches. Oxidation is present around the vast majority of the circumference of the outer rim of the insert and it varies in length along the insert at different circumferential positions. However, there was no evidence that oxidation/corrosion occurred preferably at grain boundaries. The backscatter electron image (BEI) at higher magnification (Fig. 2b) shows two kinds of morphologies: one is relatively bright (area A) and covering a substantial part of the surface, and the other is debris-like (area B). EDS confirms that the chemical composition at both areas have high oxygen contents, and the ratios of (Fe + Cr) / O are about 0.77 and 0.66 respectively, see Table 2. Such oxidation products are similar to those found on Nd-Fe-B alloys [2], where a Fe₃O₄ (magnetite) will form first and then transform into Fe₂O₃ (hematite) under further oxidation (including a small amount of Cr₂O₃). Therefore, it can be concluded that serious oxidation occurs in the scratches formed during operation.

Thus the above explanation is consistent with the observation that the oxidation is caused by the scratches which damage the thin oxidation protection layer. Indeed, significant corrosion/oxidation is noted to only occur within the scratches. In addition, for the failed inserts, oxidation was also present around a significant proportion of the outer rim circumference of the inserts, with or without scratches. This phenomenon can be related to a tribocorrosion mechanism in which a combination of oxidation and abrasive wear occurs (i.e. abrasion de-passivates within scratches followed by oxidation of nascent scratch areas in oxygen environment). Oscillation of two metallic surfaces produces tiny metallic fragments that oxidise and become abrasive particles. Subsequent wear proceeds by mild adhesive wear in combination with abrasive wear.

Fig. 2. SEM micrographs of area 1 of Fig.1 on the insert. **(a)** SEI at low magnification; **(b)** BEI at higher magnification.

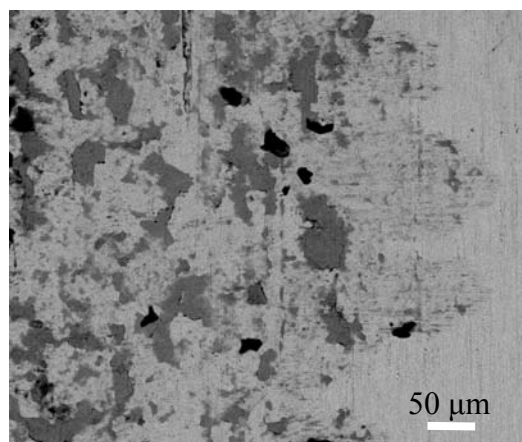
It was also noted that some oxidation products occur on the insert surface, that are not associated with scratches, as shown in area 2 of Fig. 1. The corresponding BEI micrograph is shown in Fig. 3. The areas of dark colour were determined to be oxidation products of Fe₂O₃. The black particles were carbon rich, which was assumed to be due to contamination from polymer products manufactured at high temperature.

Fig. 3. BEI micrograph of area 2 of Fig.1

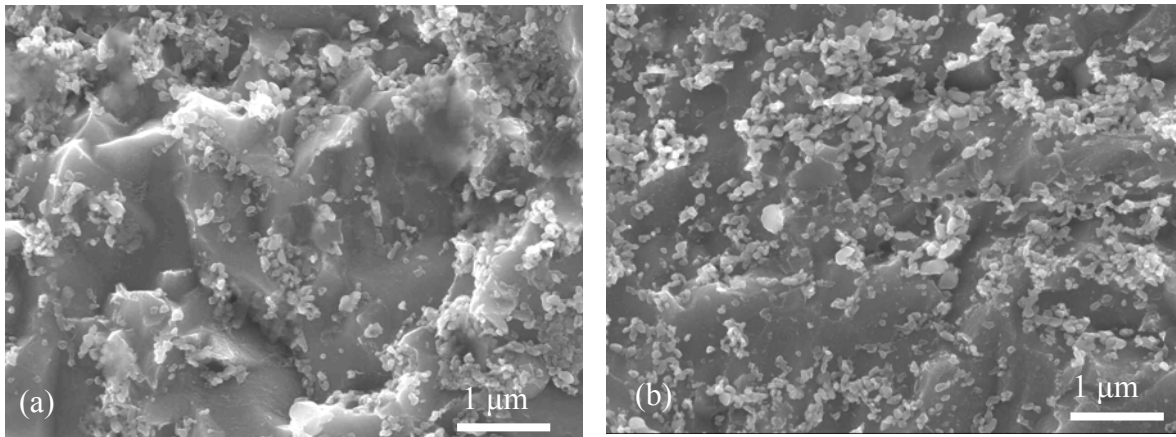
After etching, distinct particles in the range of 50–200 nm are visible in an insert which failed during service, as shown in Fig. 4(a). EDS in SEM shows that the particles are chromium enriched. To help determine when this chromium enrichment occurs, an as-manufactured insert was also investigated. A transverse section was prepared from this virgin material. The high magnification micrograph in SEM (Fig. 4b) shows that there are chromium particles in the same size range as the virgin material. This indicates that the precipitates are introduced in the heat treatments during production of the raw material.

Fig. 4. SEI micrographs from the centre of the transverse sections (a) insert that failed in service; (b) virgin insert (prior to service).

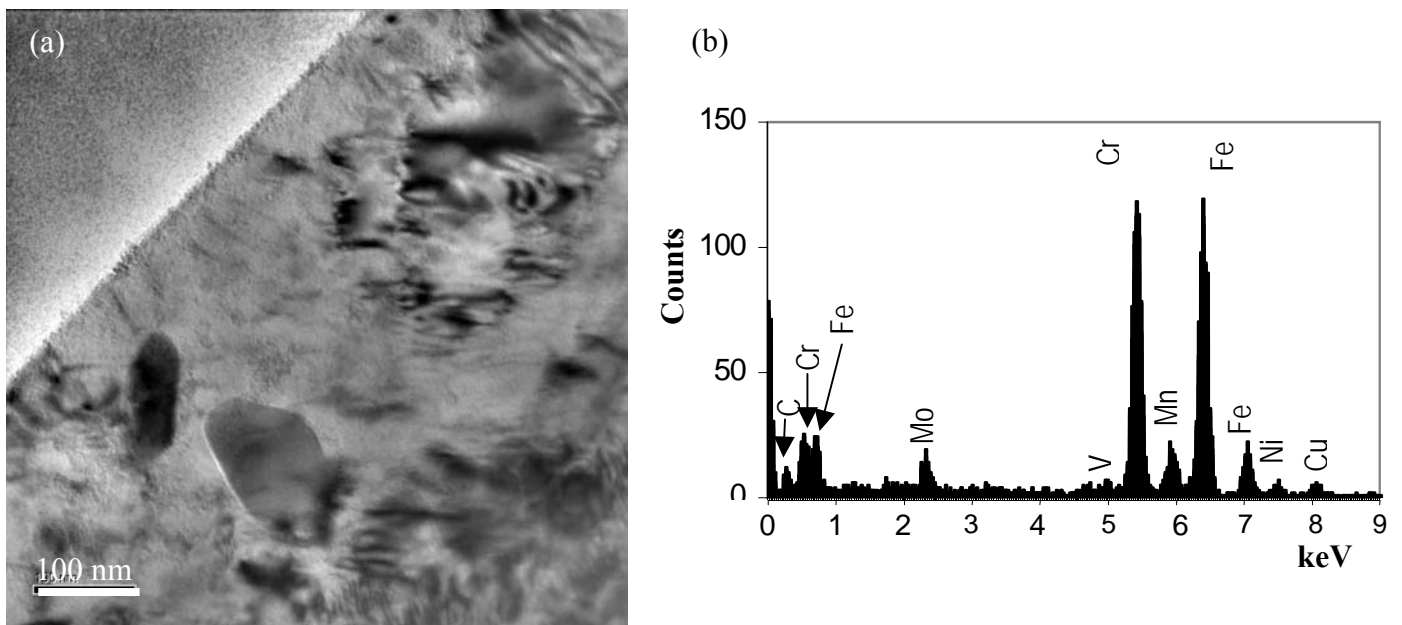
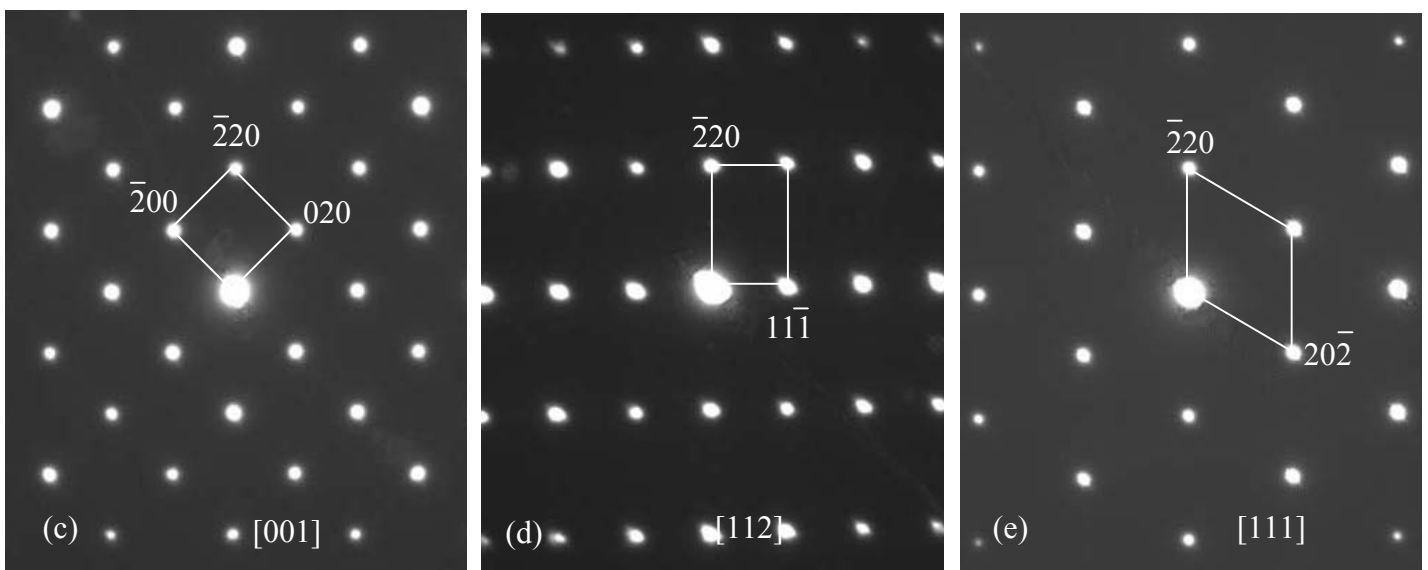
As X-rays activate an area (0.5–1.0 μm in steel bombarded at 15 kV) that is much larger than the dimension of the precipitates (50–200 nm), the composition of the precipitates cannot be determined accurately in SEM. The structure of these small precipitates is also difficult to identify by electron backscattering diffraction (EBSD) in SEM. TEM has therefore been utilised to analyse the structure information and the chemical composition of the precipitates. Fig. 5(a) shows two precipitates in bright field mode. The EDS spectrum in Fig. 5(b) confirms these particles are Cr rich, and also significant amounts of C, Mo, Fe and some V are detected. Table 3 shows the composition from EDS for one precipitate as well as the matrix. The composition of C is detected in variable from 13 to 20 at.%. Figs. 5(c-e) show three selected area diffraction (SAD) patterns of the precipitate. These are fully consistent with [001], [112] and [111] zones in a face-centred cubic (fcc) structure. No forbidden reflection was observed. The corresponding lattice parameter (*a*) was measured to be 1.07 ± 0.03 nm (using the Al matrix as a reference).

Fig. 5. TEM bright field image and the selected area diffraction pattern from the precipitates. (a) bright field image; (b) EDS analysis of the precipitate (c-e) [001], [112] and [111] diffraction patterns of the precipitate, respectively.

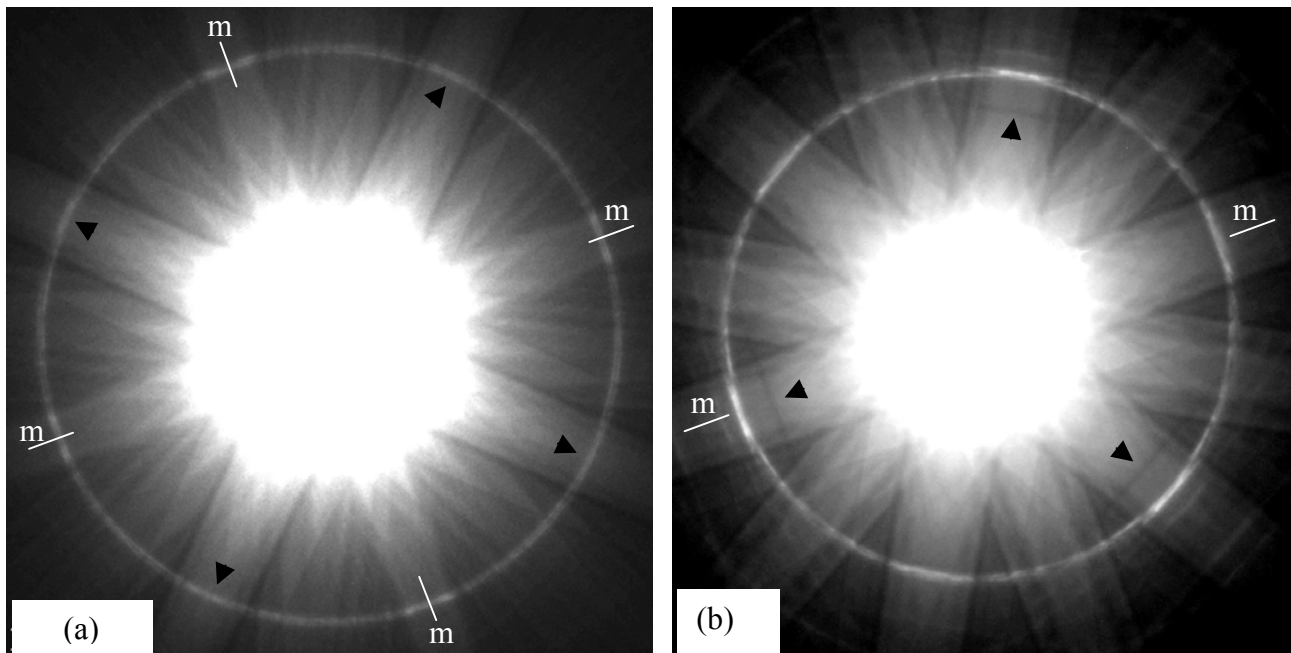
lines and zero-order-Laue-zone (ZOLZ) Kikuchi lines in the pattern as a whole. From the BF and WP symmetries of CBED patterns obtained from several prominent zone axes, it is possible to find one of 31 diffraction groups, and then the possible point group, based on Steeds and co-worker's work [3,4]. A [001] zone CBED pattern is shown in Fig. 6a. According to the principle of HOLZ line formation [5], HOLZ lines in BF disc correspond to those in higher order Laue ring, therefore the latter's symmetry refers to the BF symmetry. Kikuchi lines and bands show the ZOLZ symmetry. Consequently the symmetries of both Kikuchi and HOLZ lines represent the WP symmetry. As indicated by the arrow and m (mirror) in Fig. 6a, the BF symmetry and the WP symmetry both show 4-fold axis and mirror, i.e. $4mm$. The [111] zone CBED pattern is shown in Fig. 6b. Similarly, the symmetries of both BF and WP are $3m$ because the HOLZ ring and the array of HOLZ-deficient Kikuchi lines show threefold symmetry with one mirror plane reproduced every 120° . The results are summarised in columns 2 and 3 of Table 4. Further possible diffraction groups and point groups can be deduced according to the work of Refs [3,4] as shown in Table 3. The point group for the precipitate, therefore, is $m\bar{3}m$ as it satisfies the symmetries of both [001] and [111] zones. Combined with the Bravais lattices, it is possible to identify the space group of the crystal of $Fm\bar{3}m$.

Fig. 6. Convergent beam electron diffraction patterns of (a) [001] and (b) [111] zones, which are corresponding to the SAD patterns of Figs. 5(c) and 5(e), respectively. m represents a mirror symmetry.

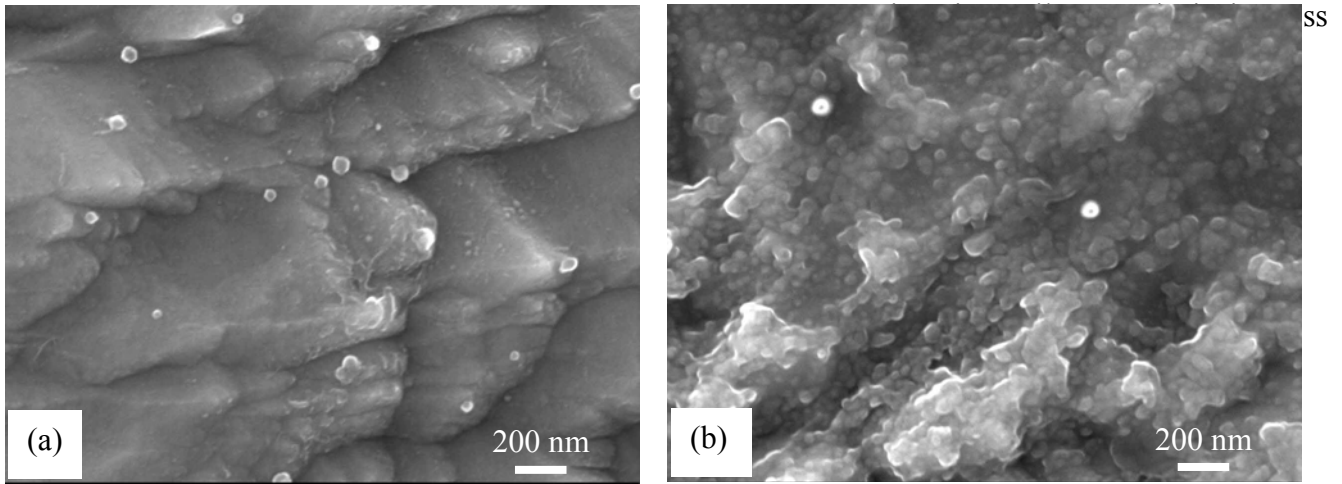
In fact, the precipitates could be as small as 10 – 20 nm in oil quenched samples as shown in Fig. 7(a). These precipitates will grow up to 50 nm after heating 560°C for 3h (Fig. 7b). Further SEM analysis of samples subjected to additional heat treatments show that precipitation depends on the cooling rate; the faster the cooling rate, the larger the precipitates that form. The precipitates could be avoided at slow cooling speeds, such as air-cooling (Fig. 8) although they might be formed in the further heat treatment.

Fig. 7. SEI micrographs of one insert after (a) solution treatment at 1050°C for 1 h, oil quenched and (b) further heat treatment at 560°C for 3 h.

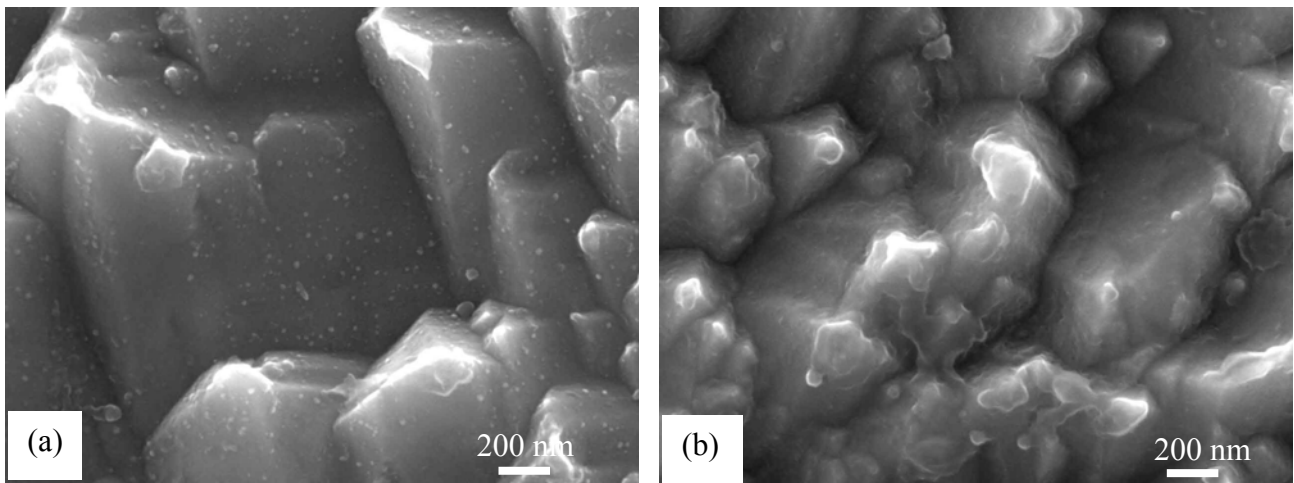
Fig. 8. SEI micrographs of one insert after (a) solution treatment at 1050°C for 1 h, and subsequent water quenching and (b) air cooling.
