Influence of white etching bands formation on integrity of rolling element bearings

Abstract

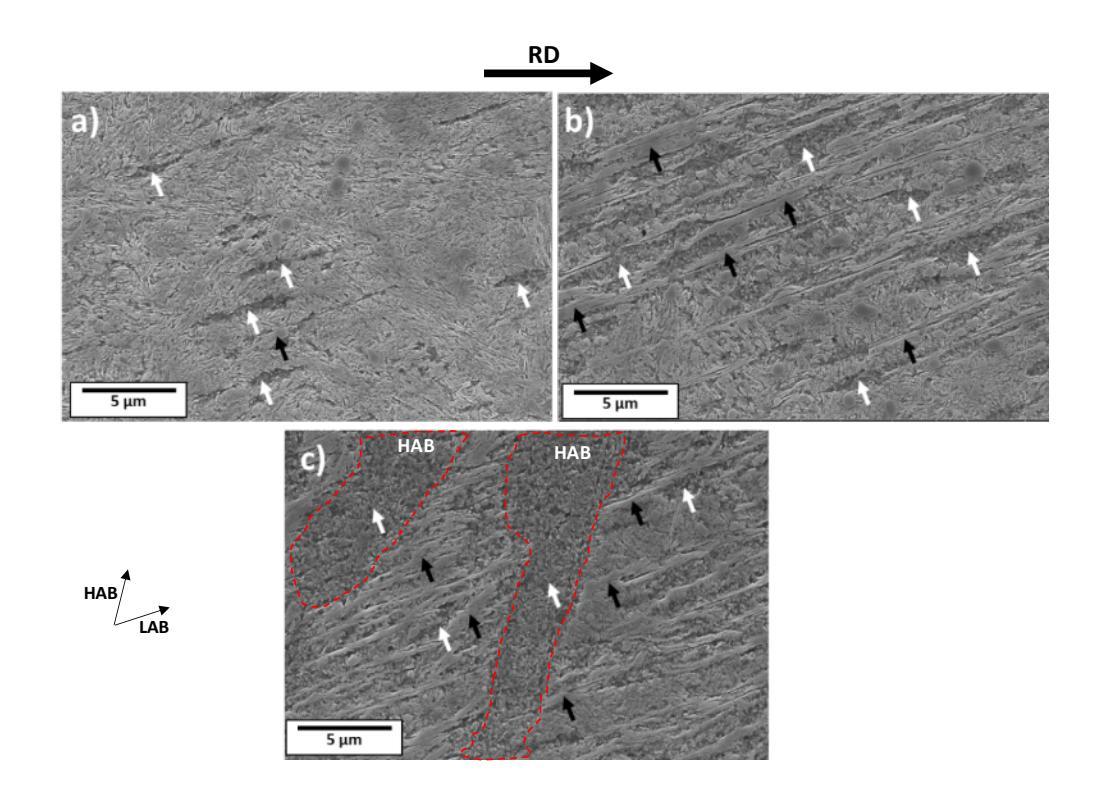
Figure 1 shows the various stage of microstructural alterations from early stage LABs, shown in Figure 1a), through densification of LAB regions, shown in Figure 1b), to HAB formation, shown in Figure 1c). These images were captured from three samples without any damages (e.g. voids or cracks) detected between the WEBs which consists of lenticular carbides and ferrite regions (pointed by black and white arrows respectively in Figure 1). Details of the WEB stages have been previously discussed in [24] by the authors of this paper.

Figure 1: SEM images showing LABs and HABs without damages a) Early stage LABs (1116 million cycles). b) Late stage development of LAB (3016 million cycles). c) HABs formed from fully developed LABs) (4141 million cycles). Black and white arrows point to lenticular carbides and equiaxed ferrite regions respectively. Region highlighted in red corresponds to HABs. While the majority of WEBs develop without any damages (i.e. cracks or voids) as shown in Figure 1, voids or micro-cracks have however been observed across LABs in several samples, see examples given in Figure 2 and Figure 3 in late-stage LABs from samples run for 4141 and 3016 million cycles respectively. Both bearings have developed voids/micro-cracks parallel to LABs between the lenticular carbide and ferrite interface as shown by the black and white arrows respectively. The micro-cracks observed are of 1 to > 10 μ m in length and < 2 μ m in width.

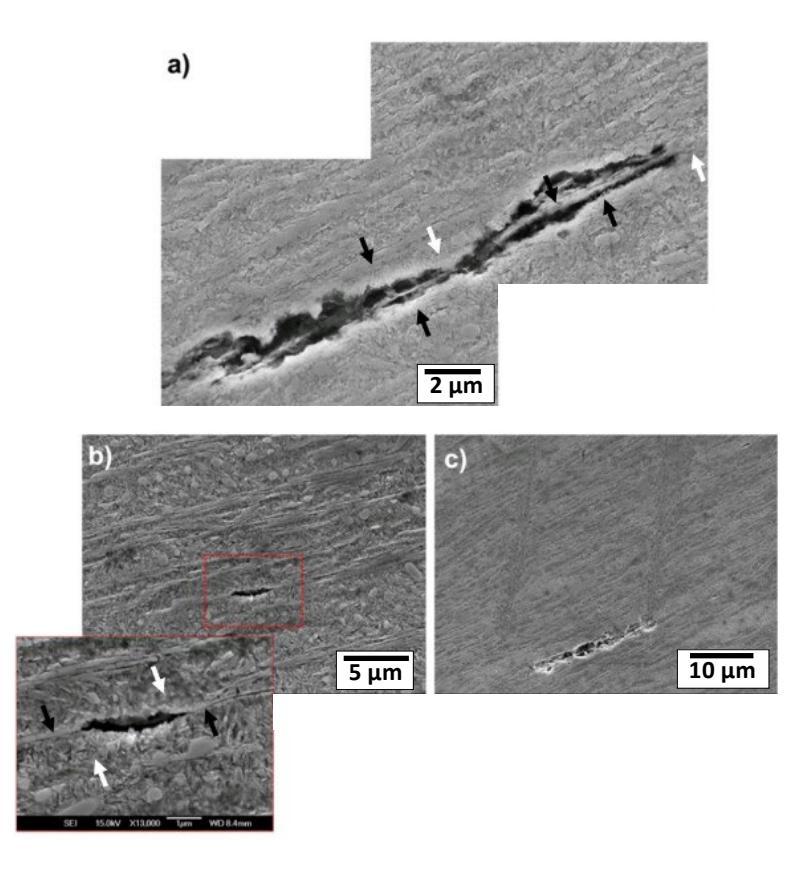
Figure 2: SEM images showing various cracks observed across LAB features in a bearing sample run for 4141 million cycles. Black and white arrows indicate lenticular carbides and equiaxed ferrite grains respectively.

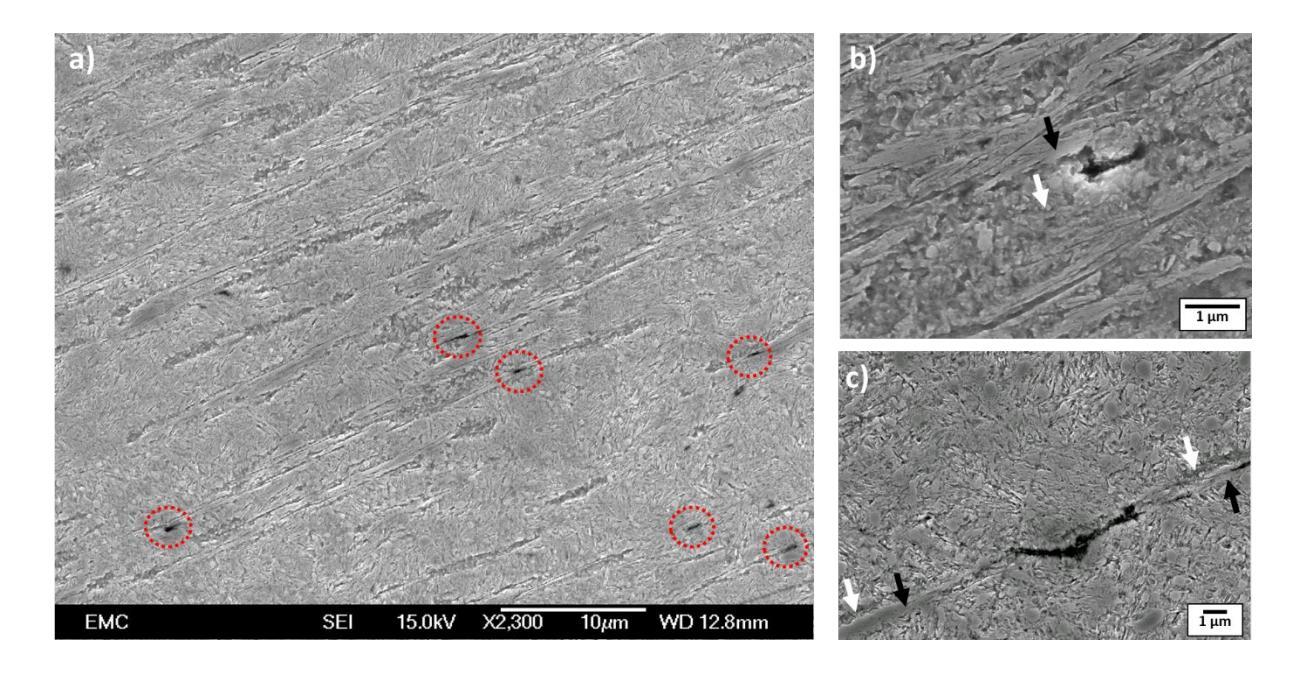
Figure 3: SEM images showing voids/cracks across LABs in the sample tested for 3016 million cycles a) multiple sub-micron voids formed across LABs (indicated by red circles); b) A zoom-in image showing one of the small voids at ~1 μ m length .c) a larger void/crack of a few μ m length. Black and white arrows indicate lenticular carbides and equiaxed ferrite grains respectively.

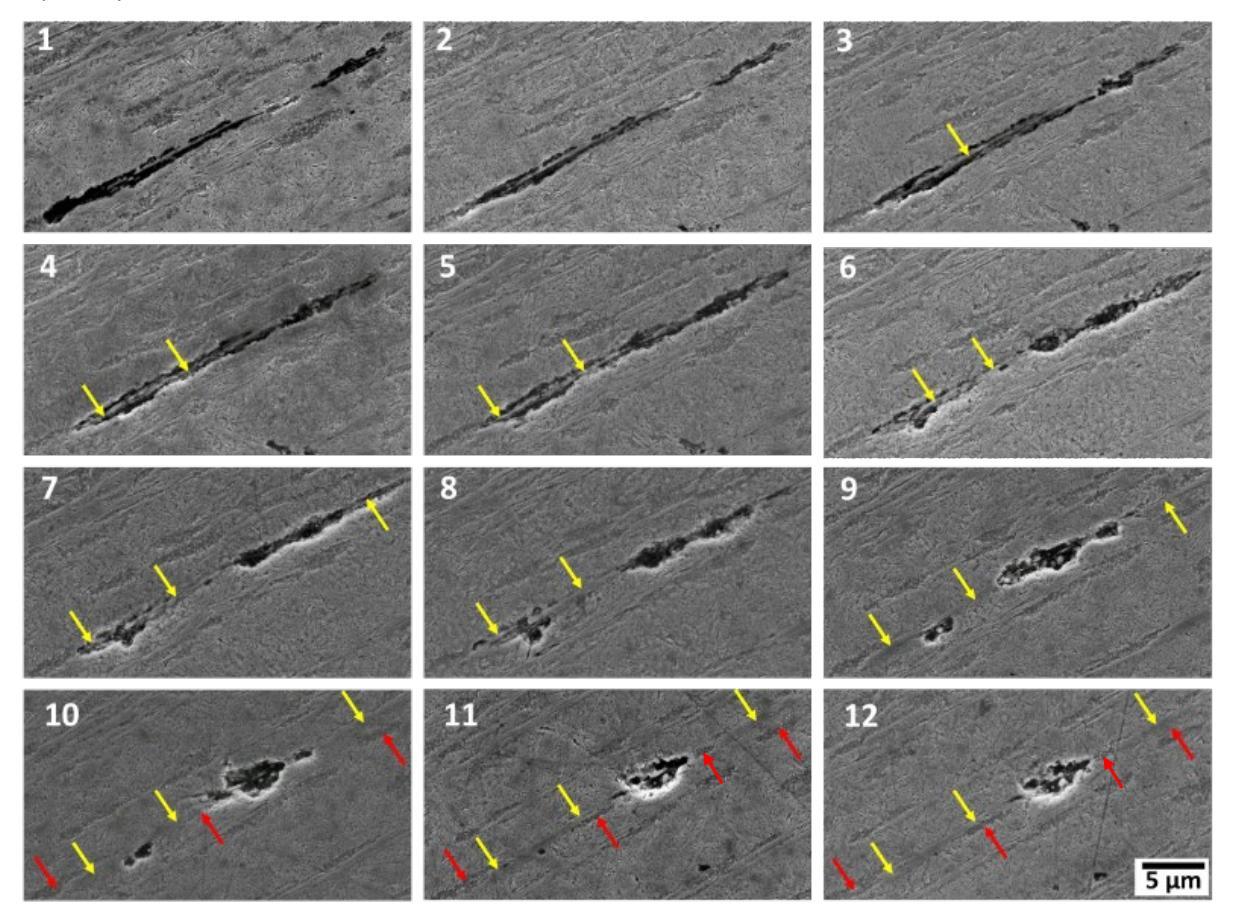
Figure 4: SEM images from a serial sectioning of a crack feature observed in LABs in a sample from the 4141 million cycles bearing, showing 12 consecutive sections at 1 μ m intervals. Yellow arrows show the lenticular carbides while red arrows show equiaxed ferrite regions.

The formation of these cracks at the interface of the lenticular carbide/ferrite is strong evidence that these weak

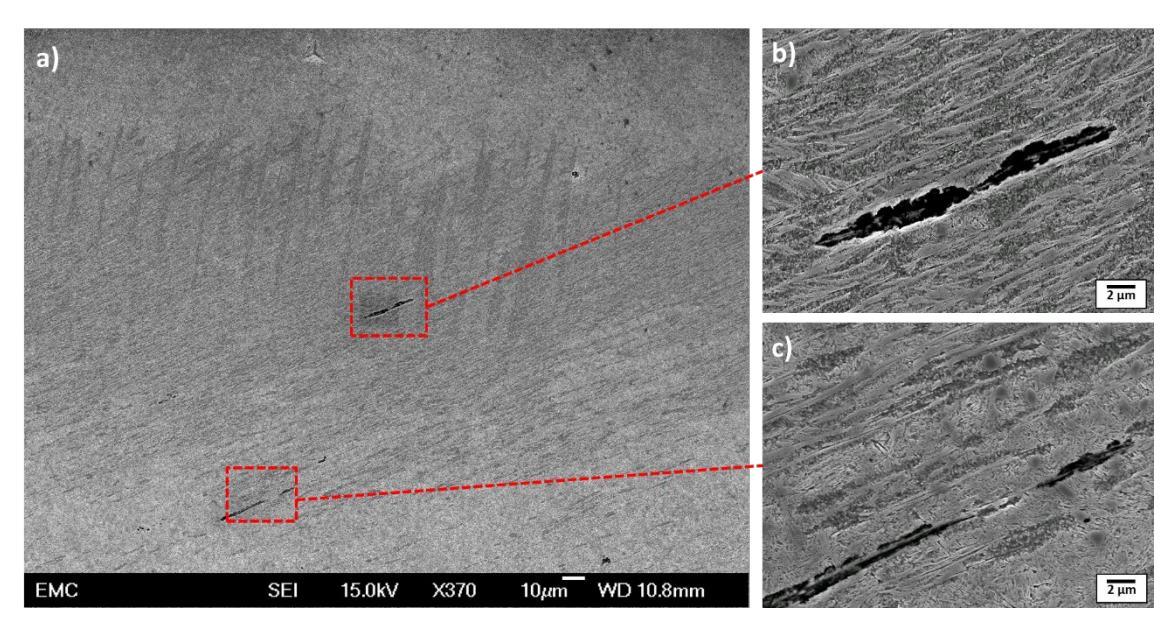
planes can impact the integrity of the microstructure during RCF as the LABs develop. These voids/cracks have been observed in both dense and sparse regions of LAB as shown in Figure 5 (details on dense and spare WEBs is discussed in [22]). However, they are more frequent in the regions with dense LABs compared to spare regions. This coupled with that earliest stage bearing test in this study (run for 1116 million cycles) presenting no voids across LABs confirms these subsurface cracks are a consequence of LAB formation and densification rather than metallographic preparation where stress point accumulation at these weak planes could reach a critical point when dense LAB regions/areas develop. As evidenced from Figures 2-5, these voids/cracks are observed to the LABs rather than HABs. This could be linked to the formation mechanism reported in [24] where the LABs are associated with a build-up of energy in the microstructure stemming from the unstable geometry of the carbides while the HAB is a form of energy release.

Figure 5: Voids formed in WEB regions in a sample from the 4141 million cycles bearing with zoom-in images b) in a dense region and c) in a region of sparse LABs.

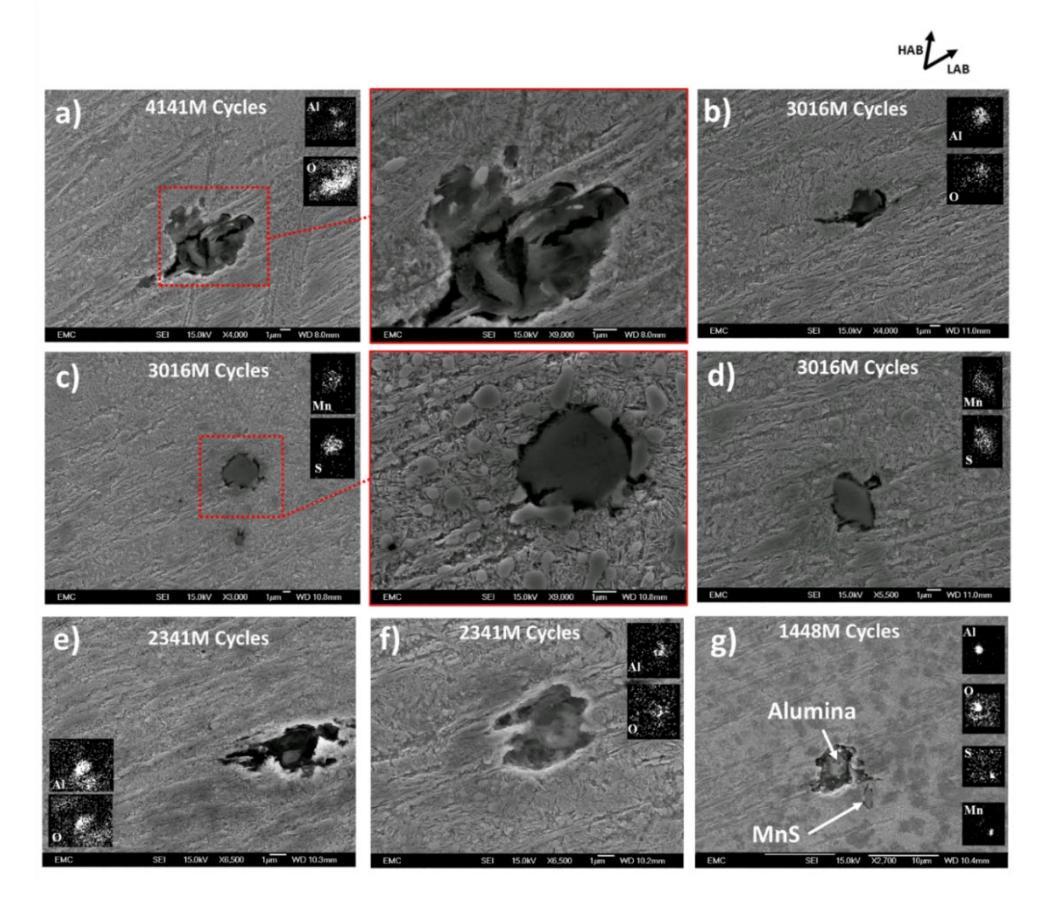
between a LAB and HAB with micro-cracks observed within the inclusion at orientations similar to LAB and HAB. A similar observation is recorded in Figure 6c for an MnS inclusion, where a small crack is seen to stem from the edge of the inclusion and a LAB penetrates. This indicates that micro-cracks develop within inclusions when they are penetrated by WEBs. All inclusions have shown to have de-bonded from the surrounding microstructure (forming cavities between inclusion/matrix), which are potential failure initiation sites in bearings and have been more commonly observed in inclusions surrounded by WEB compared to inclusions surrounded by the parent matrix. Therefore, they are potential failure sites in the bearing microstructure as the coherence of inclusions with surrounding microstructure is compromised. On the other hand, inclusions positioned away from WEBs have not shown such cracks or cavities as presented in Figure 7, which was captured from the late stage bearing sample run for 4141 million cycles. For both duplex (consisting of alumina and MnS) and pure MnS inclusions in Figure 7a and Figure 7b respectively, good coherence with the surrounding microstructure is preserved. It should be noted that inclusions observed in this study have a diameter < 10 μ m, which are smaller than those typically investigated reported in other features such as butterflies [3, 32].

Figure 6: SEM and EDX elemental maps of different inclusions located within the vicinity of WEB from different samples run for different stress cycles. *a*,*c*) Shows microcracks developing within the inclusions at orientations similar to surrounding LAB and HAB. *b*,*d*-g) shows loss of coherence between the inclusion/microstructure interface when surrounded by LAB. Inclusions *a*,*b*,*e*,*f* are Alumina while c,d are MnS inclusions. g) shows seperate MnS and Alumina inclusions in close proximity.

both Alumina and MnS inclusions which are the most common types in bearing steels (Figure 6a,c).

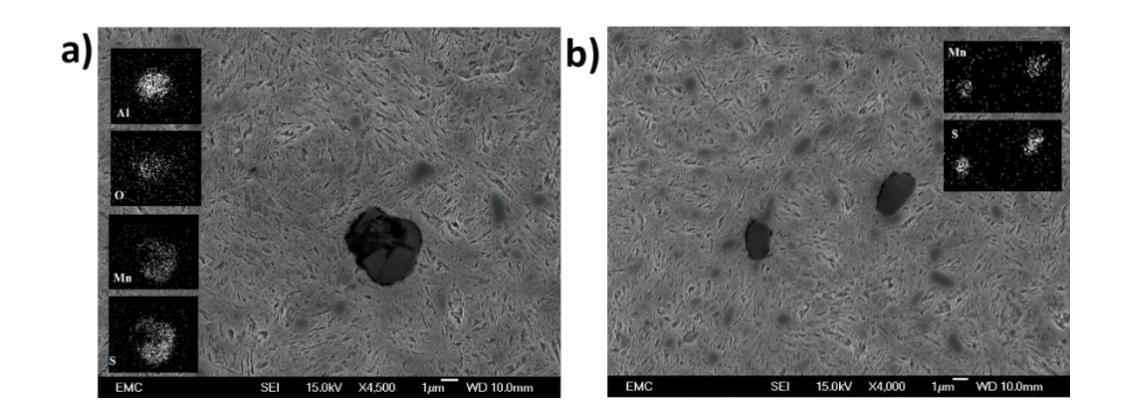
Figure 7: SEM and EDX map of inclusions developing away from the WEB region showing a) Duplex inclusion from sample run for 2341 million cycles and b) MnS inclusions from sample run for 3016 million cycles.

The crack formation at edges of inclusions (see Figure 7) is similar to that observed in butterflies. These observations are typically observed at hard inclusions under rolling conditions where cavities develop at the interfaces due to de-bonding of the two parts [1, 28]. This suggests that the inclusions removed in Figure 7 are likely to have been hard inclusions such as alumina. Nonetheless, it is frequently observed that cavities form and inclusions lose their coherence in the region of WEBs compared to areas without WEB formation, as evidenced in Figure 6 -10. The deformation of these inclusions is more pronounced when surrounded by WEBs which is likely due to the volume reduction associated with the microstructural transformation of martensite to ferrite, hence tensile stress build-up in the region could be a factor enhancing the deformation of inclusions compared to inclusions surrounded by the parent matrix as mentioned previously. FE modelling of MnS inclusions under RCF has shown stress concentrations accumulating at the edges of the inclusions in a similar geometry to that observed in butterfly wings [39]. It is also shown that loss of coherence between inclusion and surrounding matrix can lead to an increase of stress concentration of up to 167% at the edges. The cavity formation around inclusions is also heavily dependent on the relative hardness difference between the inclusion and surrounding matrix [40]. Hence, multiple factors appear to contribute to the observed phenomena in this study to explain both the debonding of inclusions surrounded by WEBs, and the propagation of voids/micro-crack from the inclusion/matrix interface towards the carbide/ferrite boundary in the WEBs.

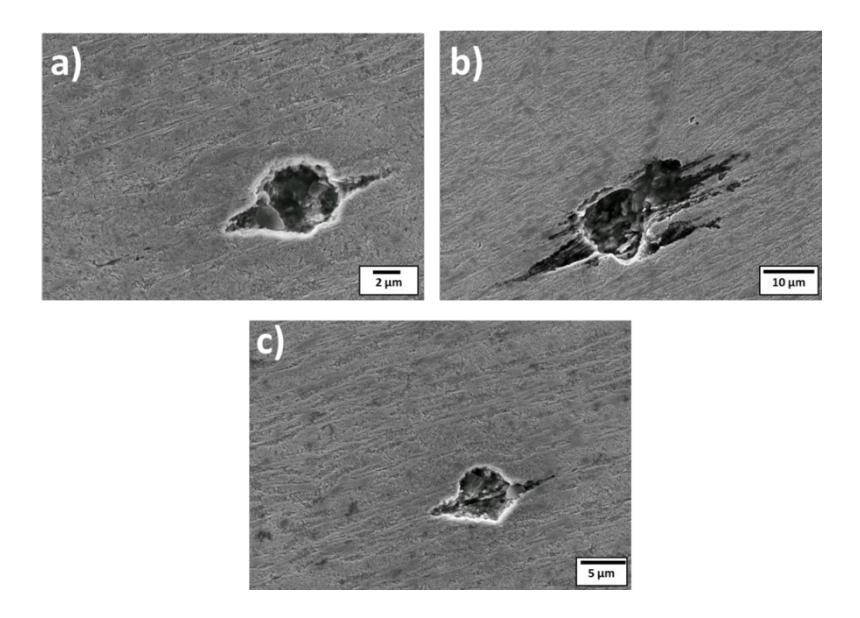
De-bonding of inclusions from the WEB affected surrounding microstructure is also found to lead to easily removal of the inclusions during metallographic preparation (see examples shown in Figure 8). This loss of coherence and cavity formation may be linked to the reduction in lattice volume during the transformation of martensite to ferrite [33, 34]. As the cavities develop around inclusions embedded within the LABs, Figure 8 suggests cracks propagate from the interface of the surrounding matrix/inclusion to the weak planes across the LABs (lenticular carbide/ferrite interface). The crack formations at the edge of inclusions (see examples shown in Figure 8a,c) resemble that associated with butterflies. However, no microstructural transformation is observed along the crack other than LABs. The cracks at the edge of the inclusions in Figure 8a,c also resemble the voids/cracks observed across LABs shown in Figure 2-4.

Figure 8: SEM images of cracks in the etched surface of samples where inclusions embedded within WEBs have been removed due to crack formation parallel to LAB and loss of coherency with surrounding microstructure. Images a) and c) where captured from bearing sample run for 2341 million cycles and b) was captured from sample run for 4141 million cycles.

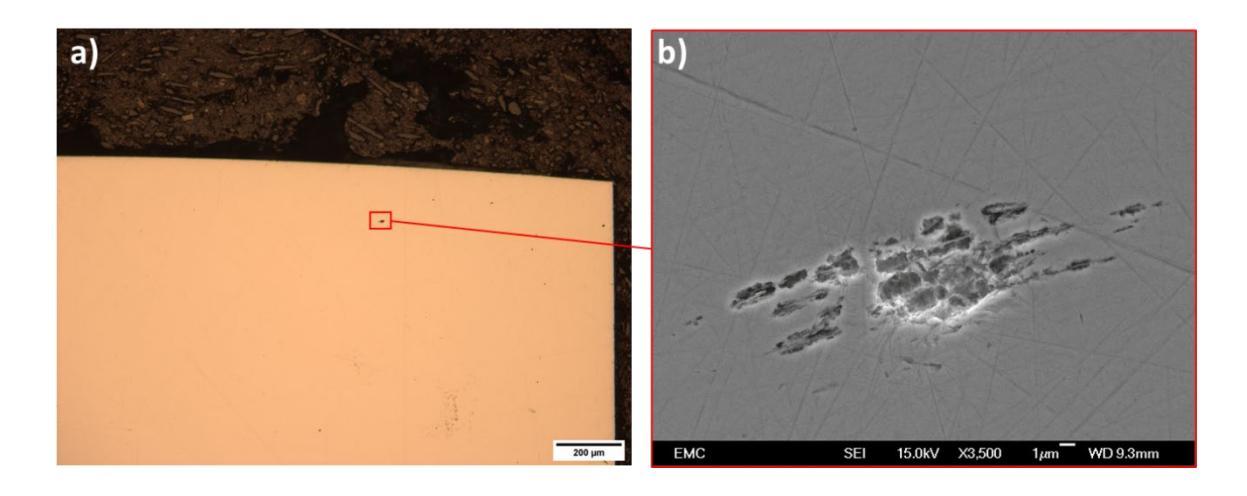
Figure 9: a) An optical image of unetched surface from a sample of the bearing run for 4141 million cycles. b) An SEM image of voids captured within the depth range of LAB where an inclusion was removed during polishing.

To confirm the origin of these features, these cracks have been observed prior to etching on polished surfaces, where similar cracks are seen (compare the images in Figure 9 with those in Figures 6 & 8). This proves conclusive evidence that the voids/micro-cracks are real and not an artefact of the surface preparation (etching). To show this further another sample (4141 million cycles) was optically imaged in an unetched state (Figure 10a), then imaged after etching (Figure 10b), followed by higher resolution SEM imaging of four sites/features showing crackss (Figures 10c-f). Figure 10c and Figure 10d show SEM images of cracks surrounding NMIs while Figure 10e and Figure 10f show cracks developing directly at the weak planes of the LABs discussed in section 3.1. Comparing the position of these cracks in Figure 10a and Figure 10b demonstrates the development of these features in the region where WEBs exist rather than regions without WEB.

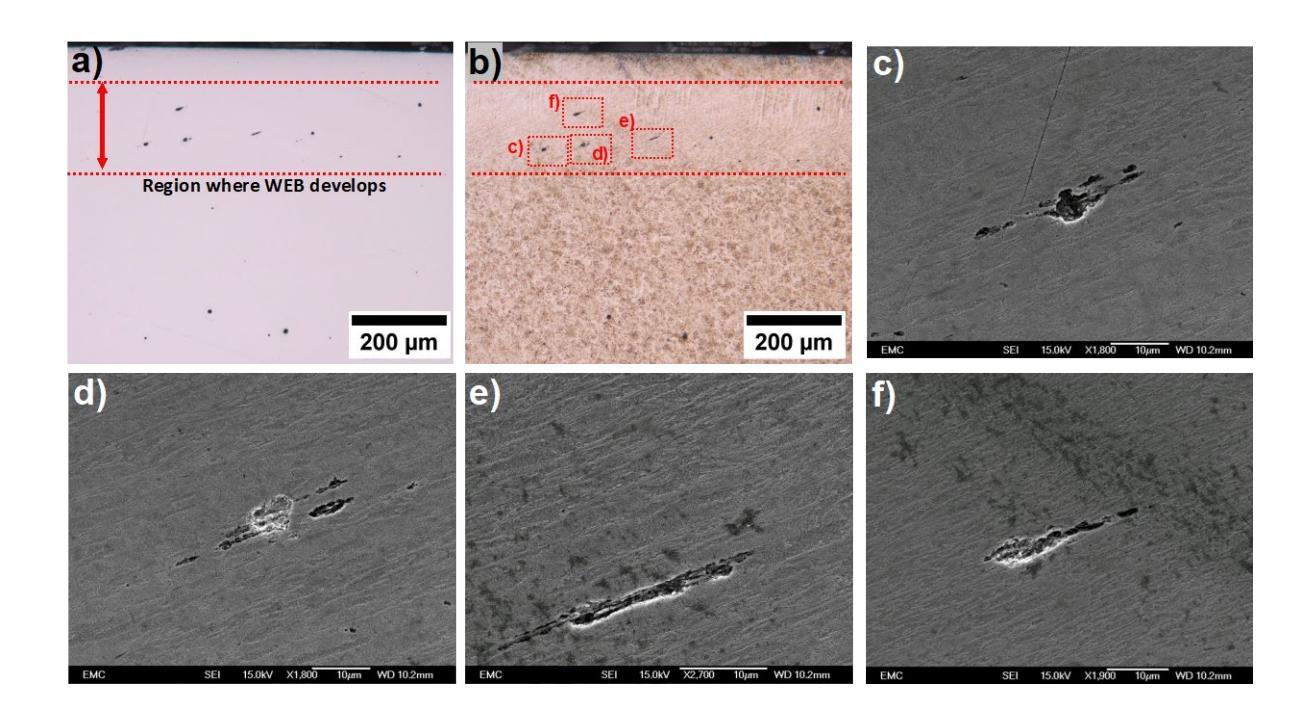
It is thus concluded that in the bearing samples, without surface damage, cracks are developed with the WEB region in the subsurface. Cracks are shown to originate from the weak planes of the lenticular carbides and ferrite regions of the WEBs which is more frequent in late LAB stages (dense regions) and the interaction of WEBs with inclusions has also shown to contribute to both micro-cracks and loss of inclusion coherence that may lead to eventual surface spallation. However, since the bearings investigated in this section do not have surface damage or even crack propagation. The next section will focus on a failed bearing test to investigate the links between these cracks and bearing failures.

Figure 10: Examination of bearing sample run for 4141 million cycles showing voids developing within the WEB region in a) unetched surface and b) etched surface. c-f) SEM images of voids from etched surface in b).

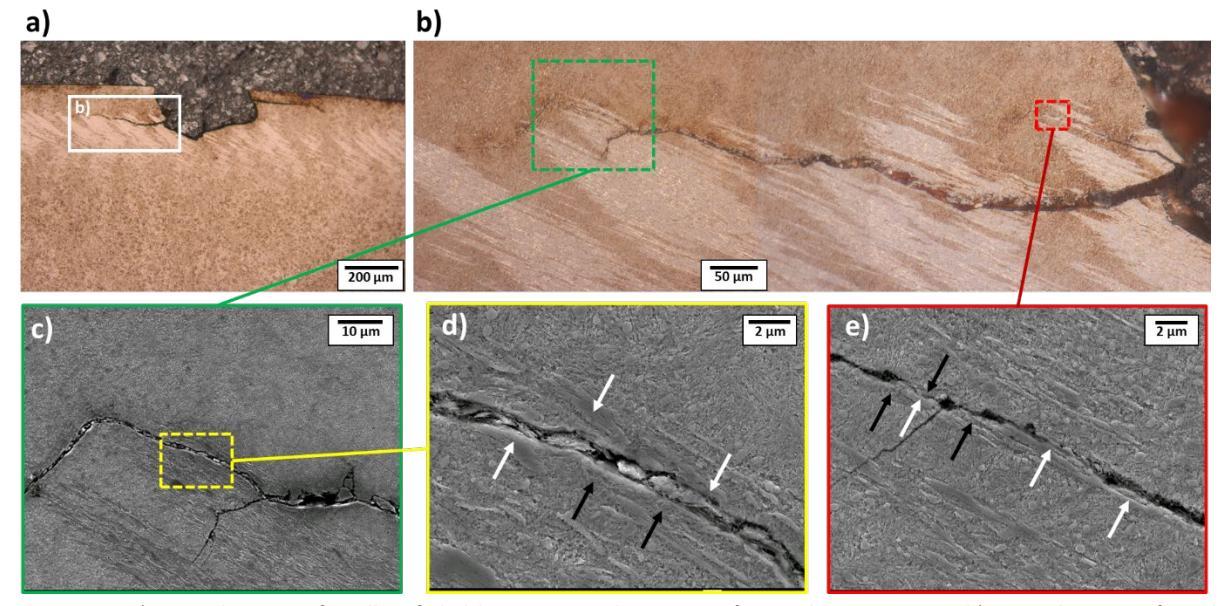
Figure 11 presents optical and SEM images of a circumference cross-section of an inner ring sample from a bearing with surface spalling failure. Figure 11a shows that the surface spall interacts with the WEBs with a crack running through the bands in the bearing subsurface. Close inspection of the area has shown that the micro-cracks propagating across the WEB region parallel with LABs from the SEM images in Figure 11c-e. The microcracks are observed to align with the interfaces between lenticular carbides (LCs) and the ferrite phases of the LAB as indicated by the white and black arrows respectively. This is similar to the subsurface cracks observed in the undamaged bearing samples above. Again, this suggests there are weak planes in the steel at the interface of between lenticular carbides and equiaxed/elongated ferrite grains contributing to the crack formation, and ultimately final spallation of the bearing. Details on identifying LCs and ferrites can also be found in [24, 35]. While the study of the suspended samples (non-failed) showed evidence of crack initiation at the weak planes of the WEBs, the study of the failed sample shows that crack propagation may occur across LABs, reaching the surface.

Figure 11: a) Optical Image of spall in failed bearing sample in circumferential cross section. b) Optical image of crack connected to spall bottom and LAB. c) SEM image of microcrack tip showing interaction between crack position and LAB features. d) Enlarged SEM from c) showing crack propagating between ferrite grains and lenticular carbides of LAB. e) SEM image of microcrack parallel to lenticular carbide of LAB. Black arrows indicate ferrite grains in the LAB while white arrows show the lenticular carbides in the LAB.
