**Development and Assessment of Embedded Acoustic Emission  
Technology for Non-Destructive Assessment of Cemented Hip  
Replacement Constructs**

Mark Noel Mavrogordato

Thesis for the degree of Engineering Doctorate

January 2010

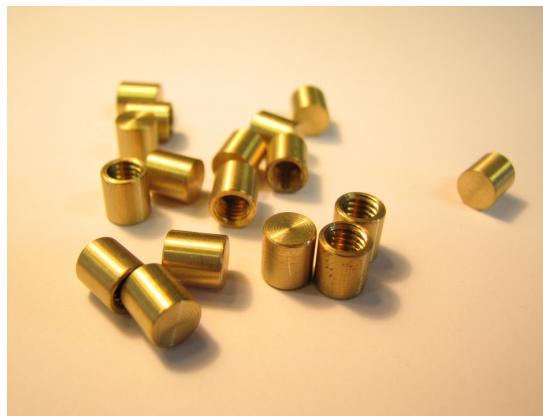
The casing for these sensors was machined from 6mm diameter brass rod. The internal bore was machined to include an M5 thread and flat bottomed using a 2 flute over-centre slot drill. It was essential to ensure that the PZT could rest on a flat surface and that the machining process did not leave a centre "pip".

**Figure 22 - Machined brass sensor cases**

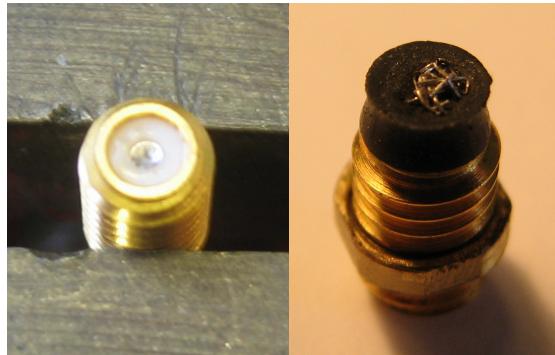
The microdot extension was held in a vice with a small amount of flux placed into the centre conductor. A small amount of solder was then applied to the centre conductor. In the case of top mounted microdot sensors a 10mm length of RG178 coaxial cable was cut and stripped to the inner insulation, a further 2mm of insulation was stripped off one end and the 7 core wires tinned with solder. The tinned wires were then soldered to the centre

conductor of the microdot extension and the remainder of the insulation removed. The 7core wires were then fed through the rubber disc and separated into a star pattern on the exposed side of the disc. Any excess wire was carefully trimmed.

**Figure 25 - Microdot extension (a) soldered and (b) with rubber disc and wire in place ready for final assembly**

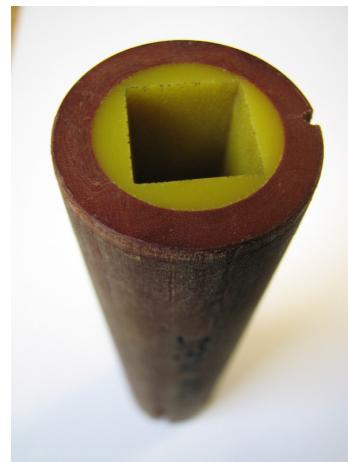
The system was designed such that it may be disassembled, leaving just the stem mounted in a uniform layer of bone cement and held in the Tufnol tube. The components of the jig itself could all be removed from the system once the bone-cement has cured.

**Figure 32 – Photograph showing uniform Technovit layer following removal of centralising jig and stem.**

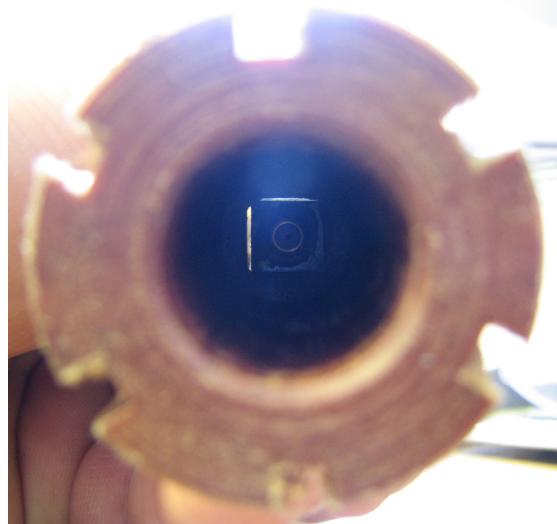
**Figure 39 - Photograph looking up the distal end of a stem construct. The stem has been re-inserted by hand following removal prior to  $\mu$ -CT scanning. Air gaps are visible indicative of poor interfacial conformity.**

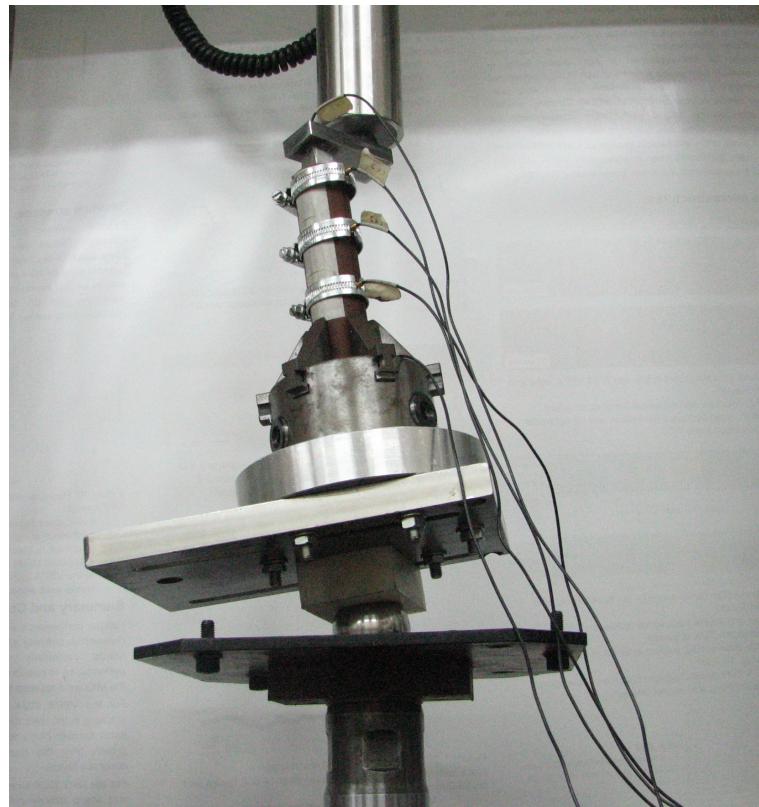
The experiment was set up in an Instron 8502 hydraulic testing machine with the construct held between two ball and socket joints to allow minimal constraints to be imposed on the construct under compression loading (Figure 53). ISO 7206-4 states that the implant should be inclined at 10° in adduction and 9° in flexion to induce torsion as well as bending and compression during loading. This configuration was followed for this experiment and the correct angles on inclination were achieved through the use of a

**Figure 53 - Photograph showing stem construct mounted in an Instron 8502 hydraulic testing machine**

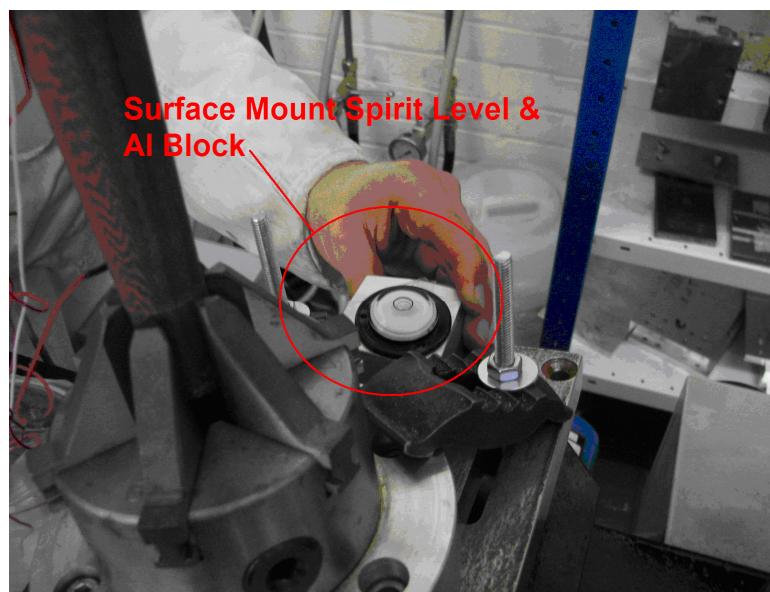
**Figure 54 – Photographs showing faced off aluminium block and surface spirit level to ensure correct angles.**

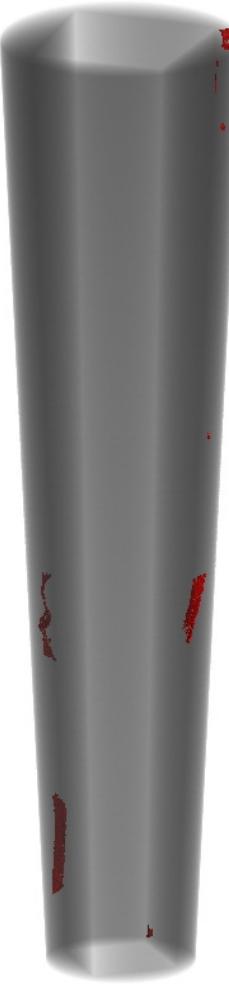
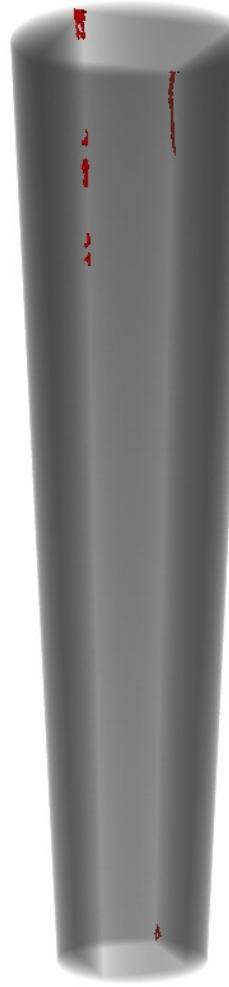
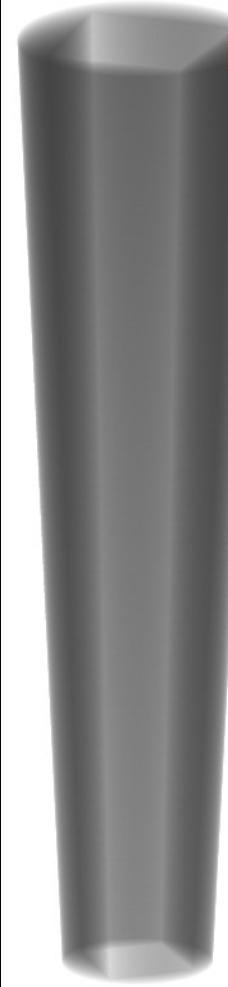
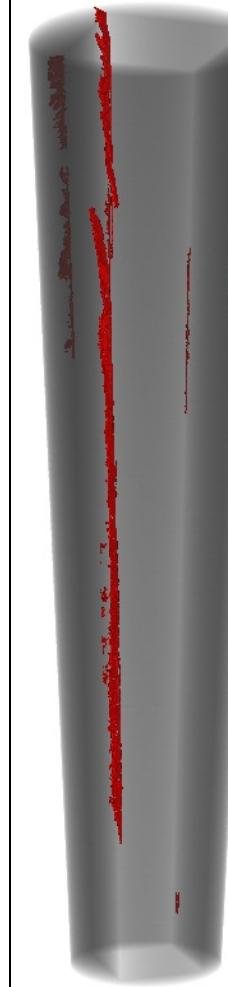
Felicity Test Load Induced Cracking			
Test 6	Test 7	Test 8	Test 9

Split volume = $4.52\text{mm}^3$ Split Surface Area = $131.98\text{mm}^2$	Split volume = $3.92\text{mm}^3$ Split Surface Area = $61.51\text{mm}^2$	Split volume = $1.45\text{mm}^3$ Split Surface Area = $19.48\text{mm}^2$	Split volume = $52.27\text{mm}^3$ Split Surface Area = $784.78\text{mm}^2$

**Figure 70 – Images highlighting load induced cracks within the technovit layer together with measurements of their volume and surface area.**

Quantitative measurements of the fracture surface area of the load induced cracks obtained by the extraction and segmentation process described in the methods section are shown below (Figure 70) together with the cumulative energy for each test as detected by the external and embedded sensors (Table 6). However, with only 3 data points for comparison between the embedded and external sensors, it is difficult to draw any meaningful correlation.

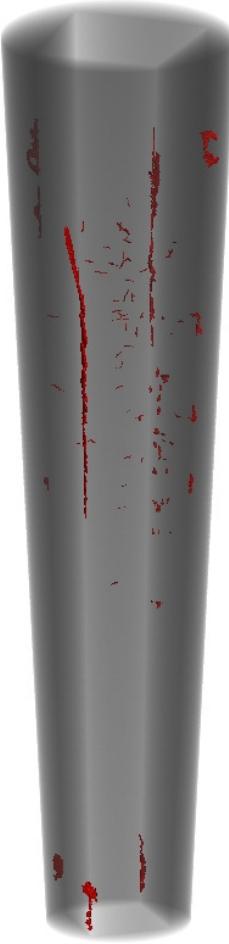
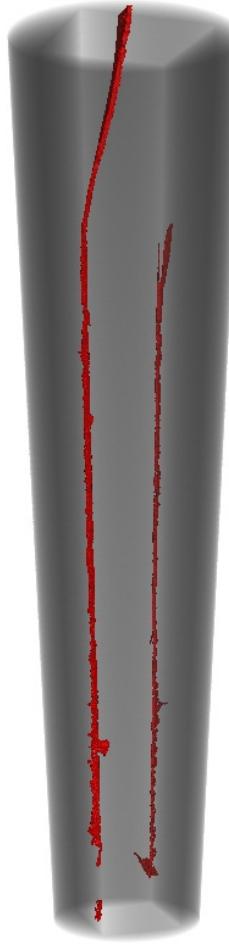
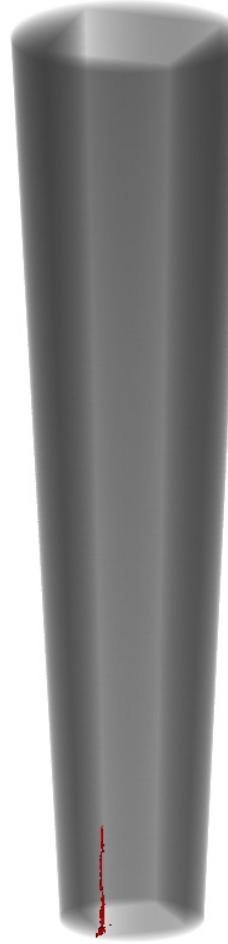
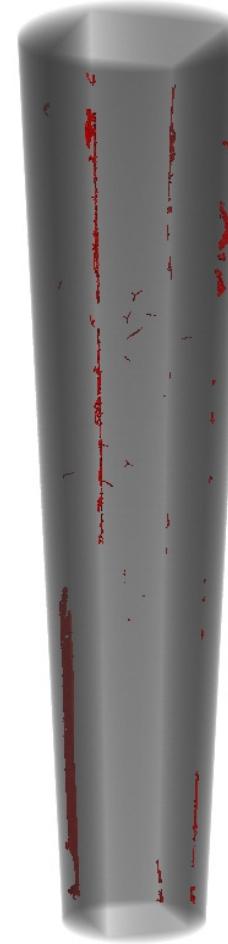
Fatigue Test Load Induced Cracking			
Test 1	Test 2	Test 3	Test 4

Split volume = $21.46\text{mm}^3$ Split Surface Area = $361.35\text{mm}^2$	Split volume = $83.45\text{mm}^3$ Split Surface Area = $720.98\text{mm}^2$	Split volume = $0.86\text{mm}^3$ Split Surface Area = $21.47\text{mm}^2$	Split volume = $17.95\text{mm}^3$ Split Surface Area = $302.05\text{mm}^2$

**Figure 73 – Images highlighting load induced cracks within the technovit layer together with measurements of their volume and surface area for fatigue tests 1-4.**

3D segmented images of the load induced cracks observed from the CT scans and subsequent image processing are shown in Figure 73 & Figure 74.

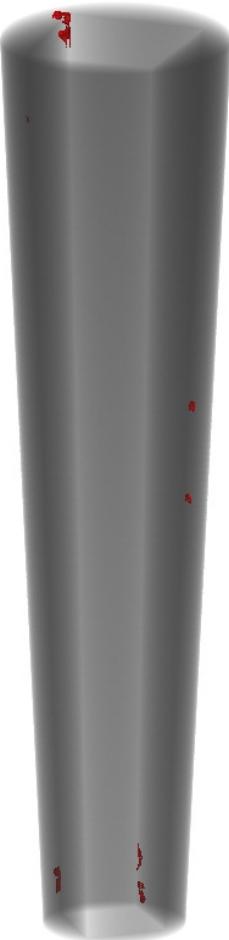
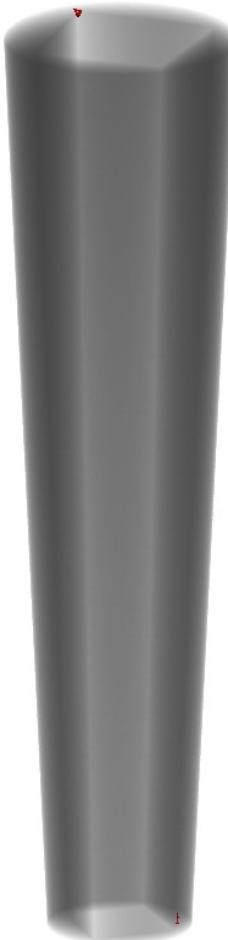
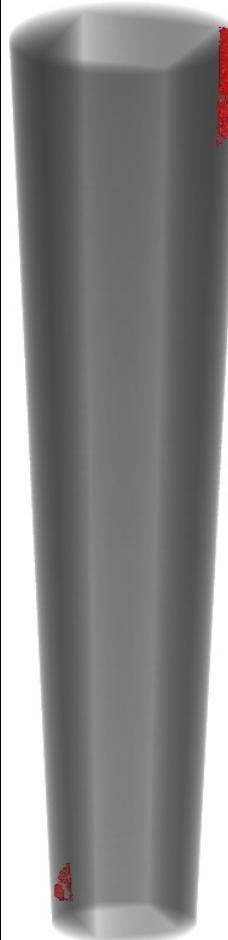
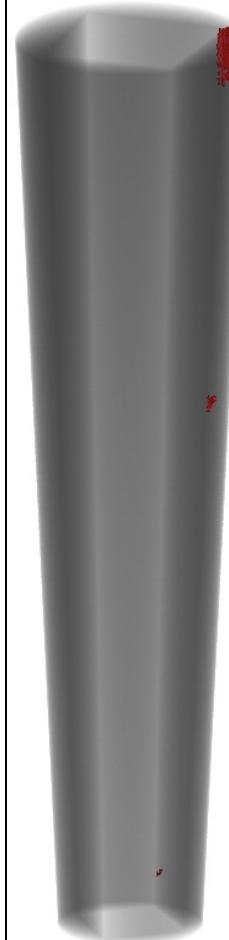
Fatigue Test Load Induced Cracking			
Test 5	Test 6	Test 7	Test 8

Split volume = 1.85mm <sup>3</sup> Split Surface Area = 34.38mm <sup>2</sup>	Split volume = 0.14mm <sup>3</sup> Split Surface Area = 3.24mm <sup>2</sup>	Split volume = 4.27mm <sup>3</sup> Split Surface Area = 70.14mm <sup>2</sup>	Split volume = 3.55mm <sup>3</sup> Split Surface Area = 42.28mm <sup>2</sup>

**Figure 74 - Images highlighting load induced cracks within the technovit layer together with measurements of their volume and surface area for fatigue tests 5-8.**

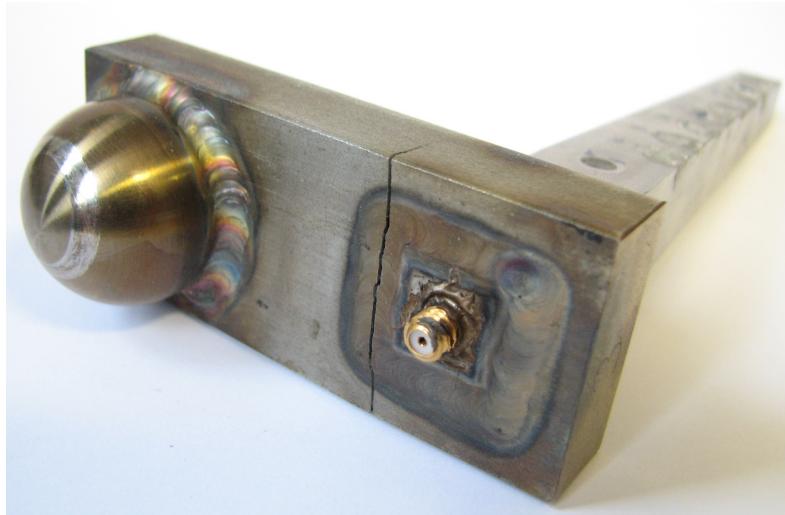
**Figure 75 - Photograph showing development of fatigue crack across welded joint during testing - Producing high levels of proximally located events.**

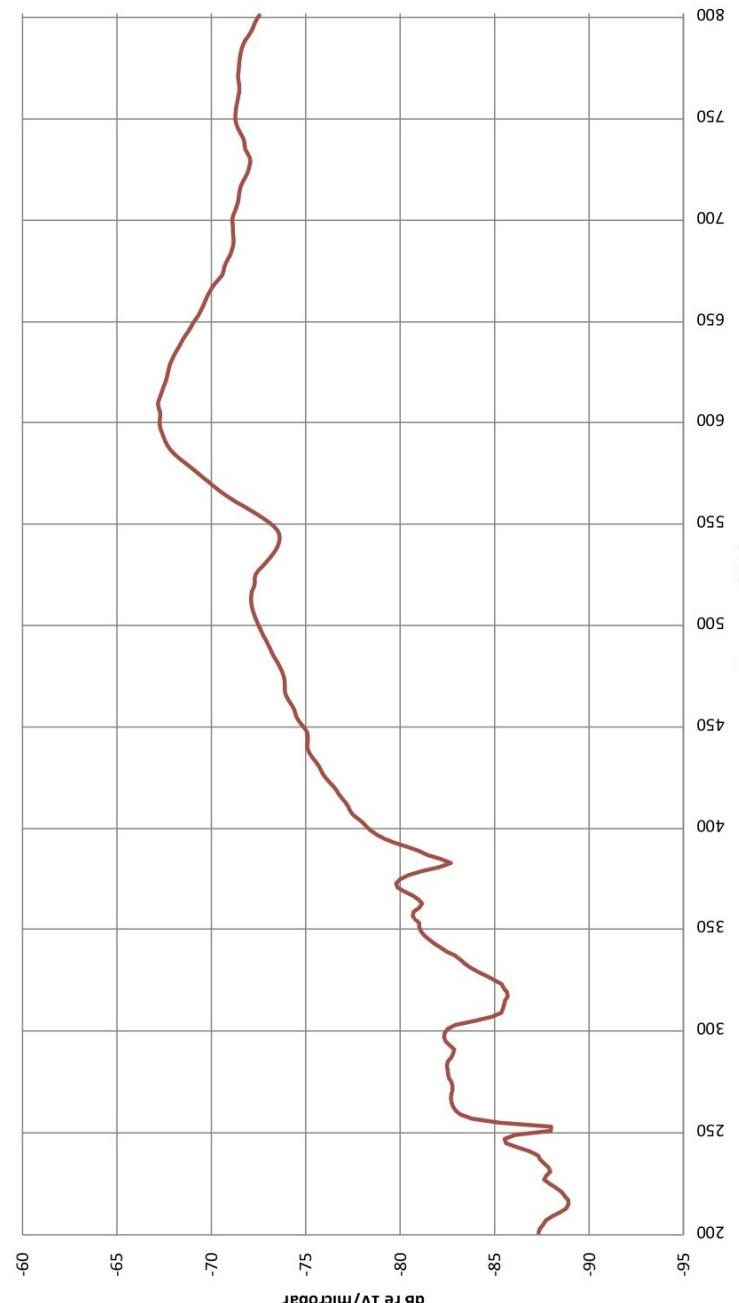
TEST CERTIFICATE  
Mavro\_01

Calibration method based upon ASTM standard E976. Face to Face excitation: 0.1Vrms at V103 (No 577274) 50 ohm loaded, preamplifier AEP3,  
filter bandwidth 110kHz-1MHz

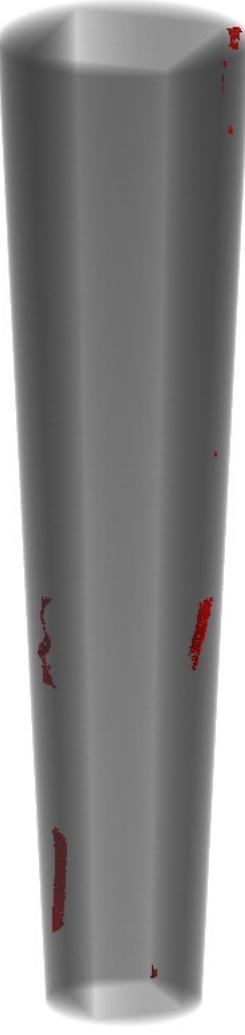
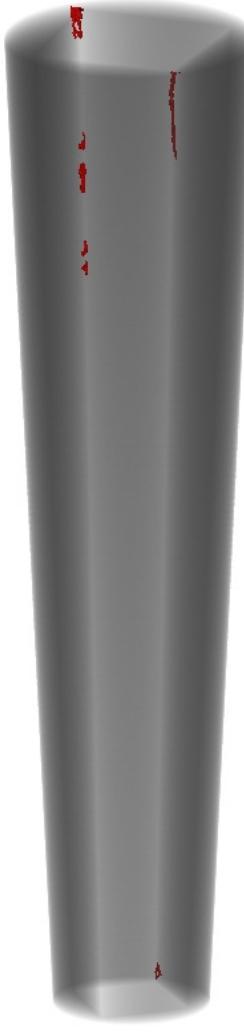
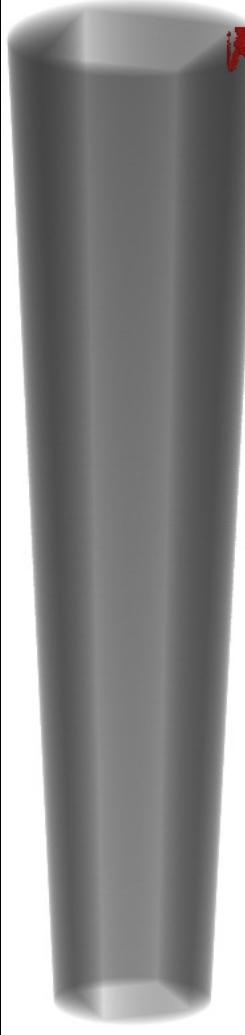
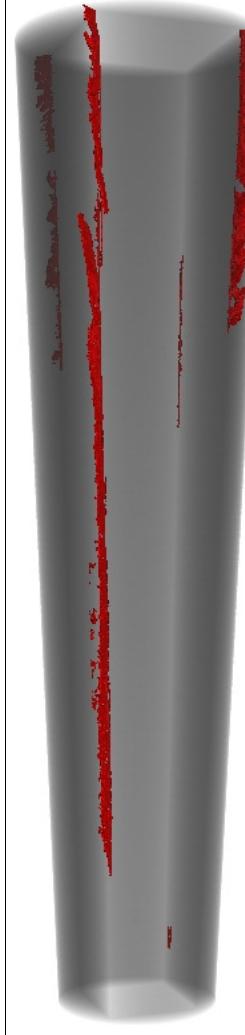
Felicity Test Load Induced Cracking			
Test 6	Test 7	Test 8	Test 9

Split volume = $4.52\text{mm}^3$ Split Surface Area = $131.98\text{mm}^2$	Split volume = $3.92\text{mm}^3$ Split Surface Area = $61.51\text{mm}^2$	Split volume = $1.45\text{mm}^3$ Split Surface Area = $19.48\text{mm}^2$	Split volume = $52.27\text{mm}^3$ Split Surface Area = $784.78\text{mm}^2$

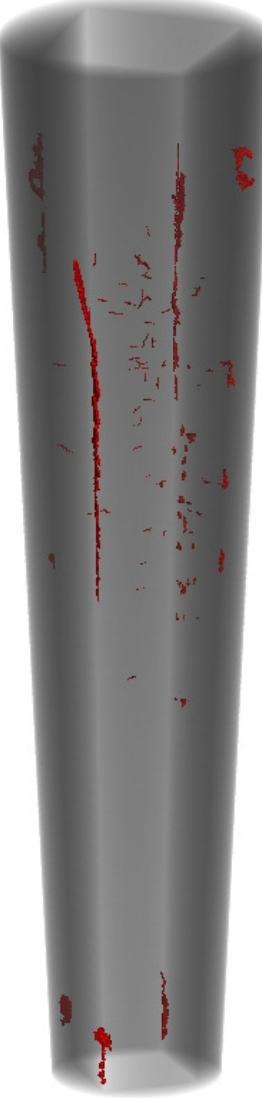
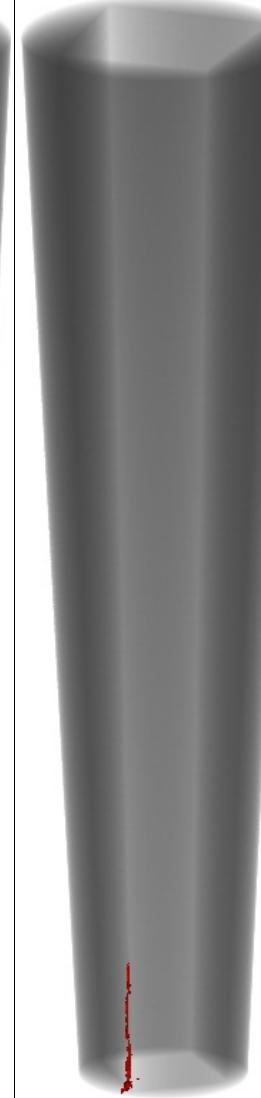
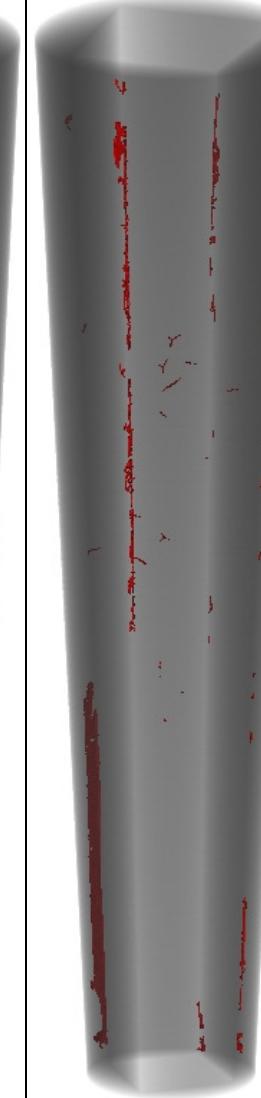
Fatigue Test Load Induced Cracking			
Test 1	Test 2	Test 3	Test 4

Split volume = 21.46mm <sup>3</sup> Split Surface Area = 361.35mm <sup>2</sup>	Split volume = 83.45mm <sup>3</sup> Split Surface Area = 720.98mm <sup>2</sup>	Split volume = 0.86mm <sup>3</sup> Split Surface Area = 21.47mm <sup>2</sup>	Split volume = 17.95mm <sup>3</sup> Split Surface Area = 302.05mm <sup>2</sup>

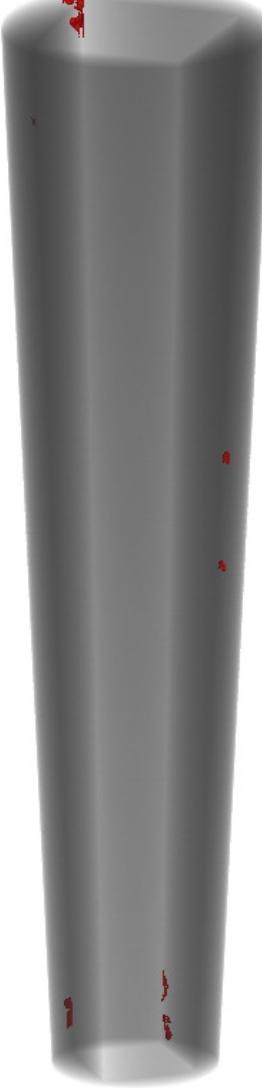
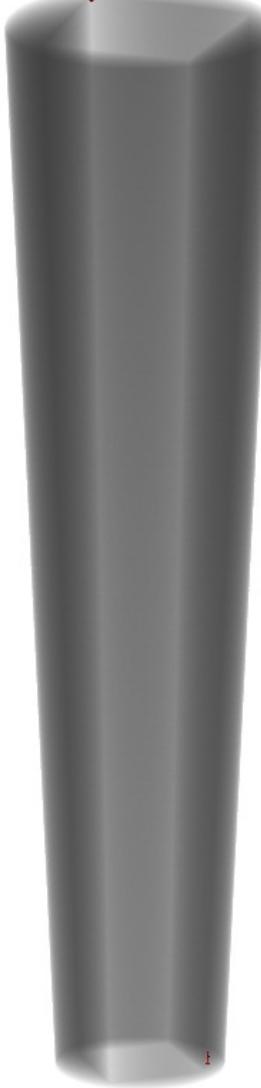
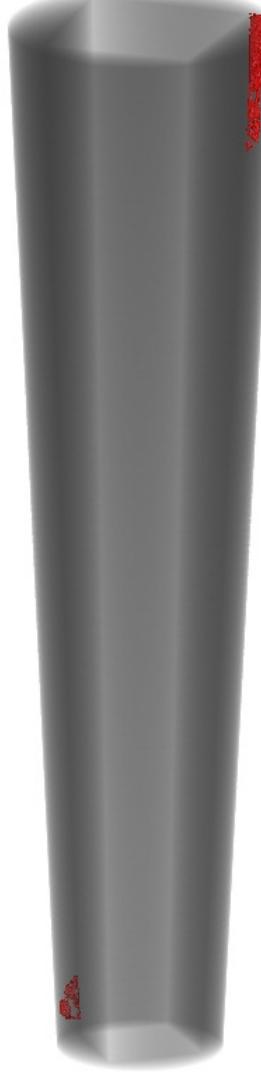
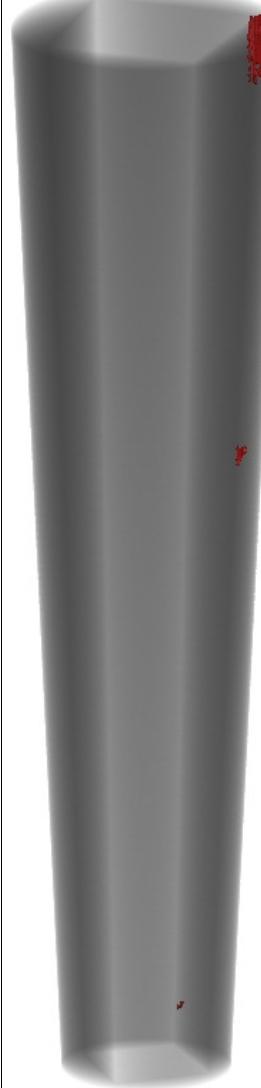
Fatigue Test Load Induced Cracking			
Test 5	Test 6	Test 7	Test 8

Split volume = $1.85\text{mm}^3$ Split Surface Area = $34.38\text{mm}^2$	Split volume = $0.14\text{mm}^3$ Split Surface Area = $3.24\text{mm}^2$	Split volume = $4.27\text{mm}^3$ Split Surface Area = $70.14\text{mm}^2$	Split volume = $3.55\text{mm}^3$ Split Surface Area = $42.28\text{mm}^2$
