Lubricated sliding wear behaviour of aluminium alloy composites

J.C.Walker*, W.M.Rainforth, H.Jones

Department of Engineering Materials, University of Sheffield, UK

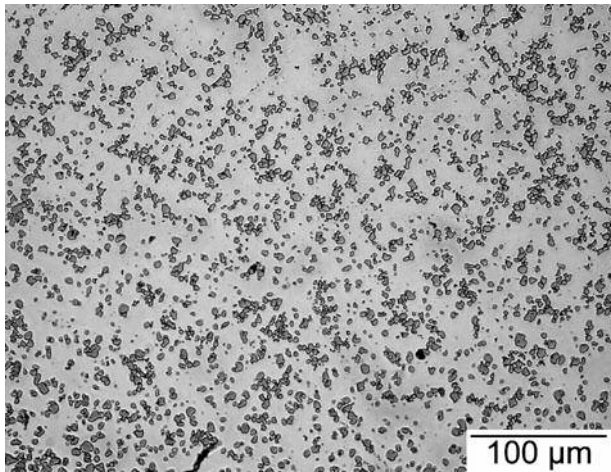
Figure 1. Optical micrograph of 5056 + 15vol.% MoSi₂ showing an even particle distribution after extrusion.

The microstructure of the as-extruded specimens was made up of a relatively even distribution of reinforcement throughout the matrix, as shown for 5056 + MoSi₂ in Figure 1, with a minimal amount of porosity (<2%). The shape of the silicide particulate reinforcements was relatively equiaxed, whereas higher aspect ratios were seen for both the angular SiC particles and the more rounded Ni₃Al particles, which had occasionally led to the incomplete flow of 5056 matrix around the Ni₃Al particles. Vickers microhardness values, represented in Figure 2, were generally higher for the naturally aged 2124 alloy and

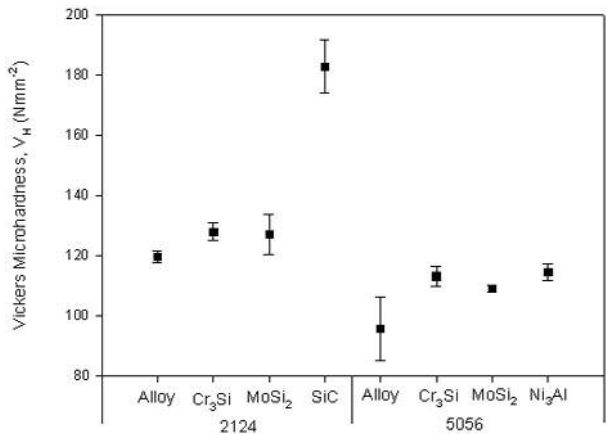
Figure 2. Vickers microhardness (200g, 15s) for 2124 and 5056 alloys and composites.

composites, compared to 5056 alloy and composites, with artificially aged (T351) 2124 + SiC showing the highest hardness.

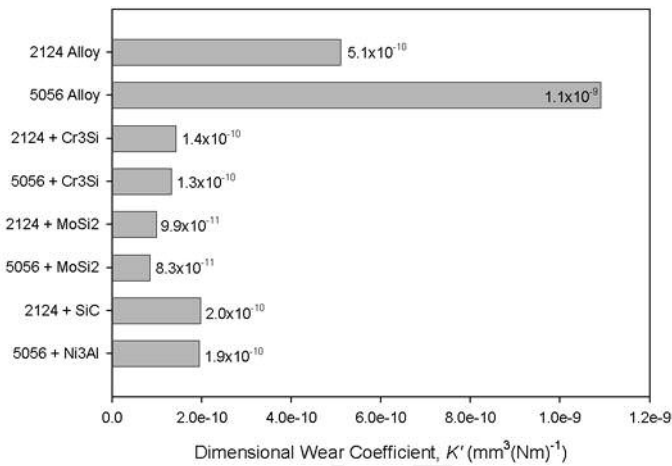
Figure 3. Dimensional Wear Coefficient, K' for lubricated sliding wear of 2124 and 5056 alloys and composites, at 630N normal load, based upon volume loss measurements calculated from wear scar geometry.

Figure 3 and Table 4 give the specific wear rate for all samples after lubricated sliding, with values ranging from approximately 8×10^{-11} to 1×10^{-9} mm³/Nm. The un-reinforced 2124 and 5056 alloys showed the highest wear rates at 5×10^{-10} and 11×10^{-10} mm³(Nm)⁻¹, respectively. The change of scar geometry with sliding distance for 5056 alloy was recorded in more detail and revealed that after an initial high volume loss (~ 0.4 mm³), additional losses for the remainder of the test were negligible, thus reducing the specific wear rate with sliding distance.

In accordance with previous studies [9,10,15], SiC reinforcement significantly improved the lubricated sliding wear resistance of the aluminium alloy, to approximately 2×10^{-10} mm³/Nm. The same matrix reinforced with silicide intermetallics Cr₃Si and MoSi₂ showed a similar wear resistance $\sim 1 \times 10^{-10}$ mm³/Nm, and even lower with a 5056 matrix, in particular 5056 + MoSi₂, which exhibited a wear rate of around 8×10^{-11} mm³/Nm after sliding for 467km. 5056 reinforced with Ni₃Al particles wore at a similar rate to 2124 reinforced with SiC.

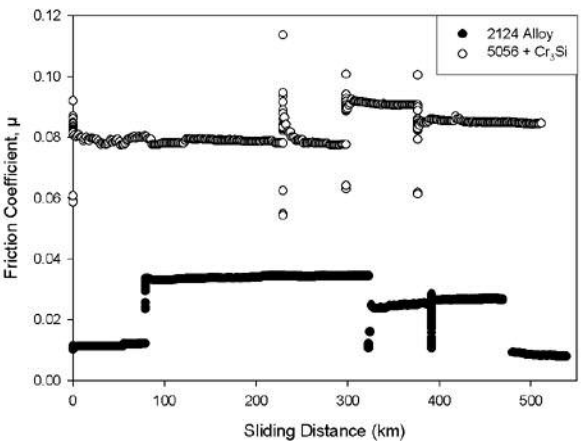
Figure 4. Friction Coefficient (μ) values for lubricated wear tests of 2124 alloy and 5056 + Cr₃Si at 630N load, as a function of sliding distance (km).

Average friction coefficients for all tests were within the range 0.01-0.11, as detailed in Table 4, the higher values all being for the silicide reinforced composites. Figure 4 shows the typical friction behaviour observed during the tests, where a large friction peak was associated with the initial rotation of the counterface from stationary. This high value of μ was not sustained for a significant sliding distance, and reduced to a lower, steady value for

the duration of the test interval. Although average friction values between tests intervals varied a little, this pattern of behaviour was universal for all tests, except for perhaps 2124 + SiC and the un-reinforced alloys, where fluctuations were occasionally seen for distances of 10-20km, before levelling out again.

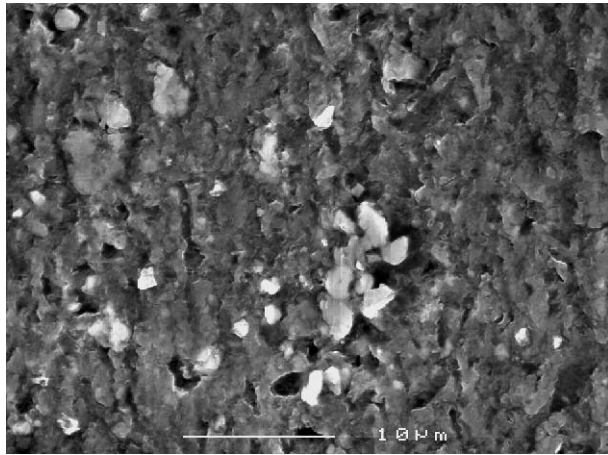
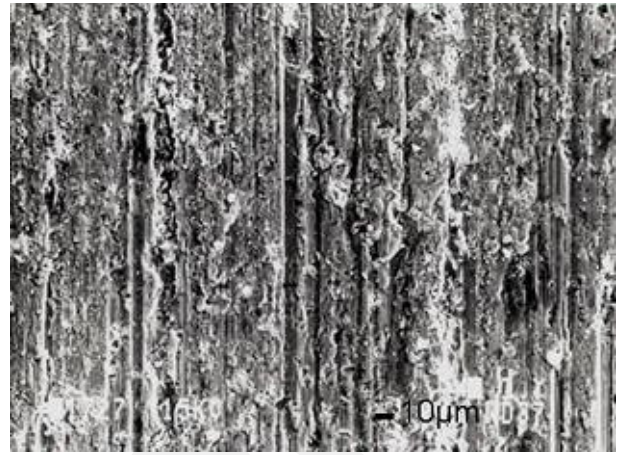
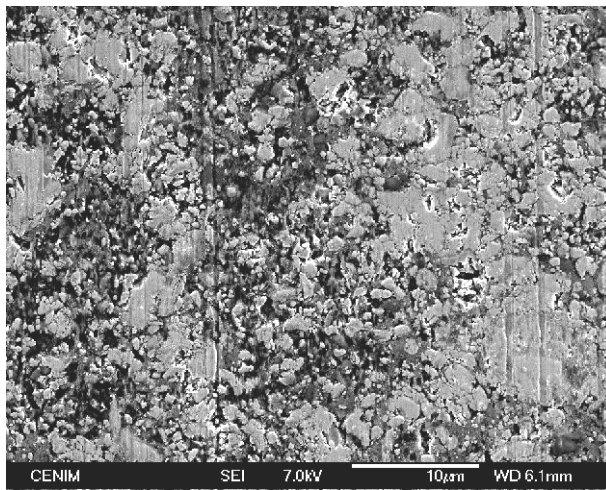
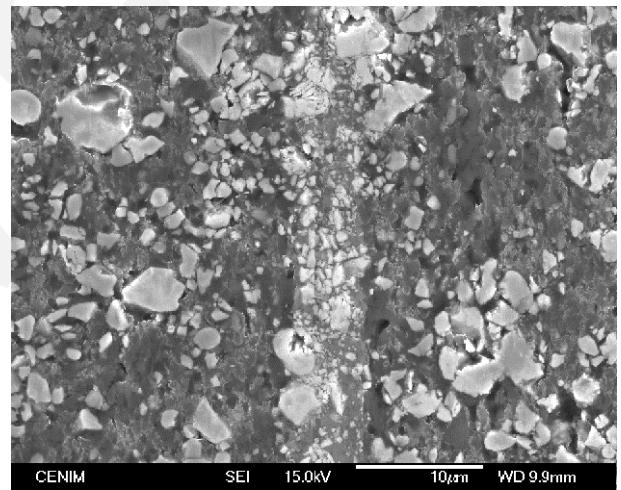
a) 2124 Alloy

b) 2124 + SiC

c) 2124 + Cr₃Si

d) 2124 + MoSi₂

Figure 5. Secondary electron SEM micrographs of 2124 alloy and composites after lubricated wear at 630N normal load for a) 496km, b) 548km c) 421km and d) 374km; sliding direction is in the vertical direction.

Secondary electron images of 2124 and 5056 un-reinforced alloys, in Figures 5a) and 6a) respectively, showed a surface containing voids and loose particles, some of which appear to be embedded in the matrix. The 5056 alloy also exhibited smooth, broad wear tracks, of the order $\sim 10\mu\text{m}$ wide, along with deeper grooves, $\sim 1\text{-}2\mu\text{m}$ wide. Severe ploughing was found on the surface of the 2124+ SiC, as shown in Figure 5b), as well as detachment of SiC particles at the particle/matrix interface. Wear grooves were seen to pass through both matrix and reinforcement in 5056 + Ni_3Al , as shown in Figure 6b). However, more significantly, within the central region of this scar, cracks ran through the matrix within the vicinity of large craters.

The composites reinforced with Cr_3Si and MoSi_2 exhibited extensive fracture of the silicides, Figures 5c)-d) and 6c)-d). Again, directional ploughing was observed, through both reinforcement and matrix. Importantly, there appeared to be an increase in reinforcement particle volume fraction at the worn surface, which was subsequently confirmed by point

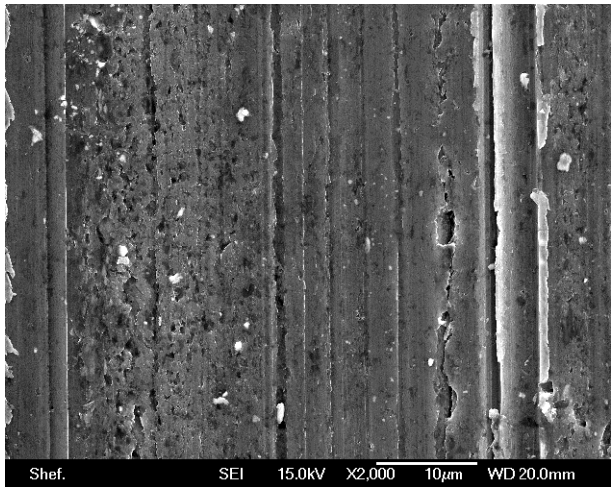
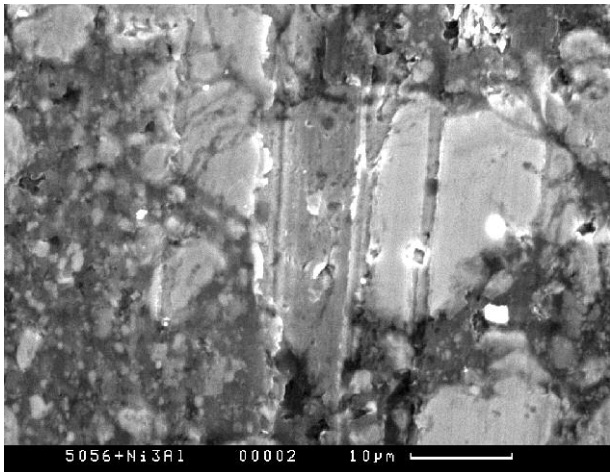
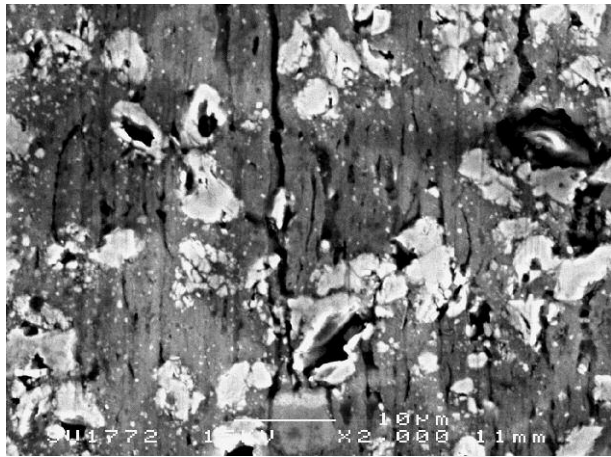
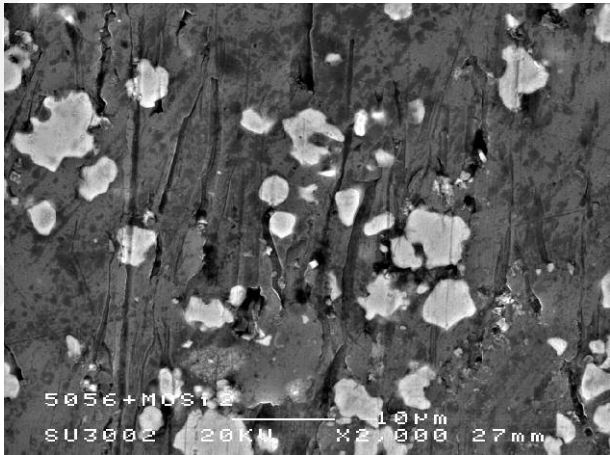
a) 5056 Alloy

b) 5056 + Ni₃Al

c) 5056 + Cr₃Si

d) 5056 + MoSi₂

Figure 6. Secondary electron SEM micrographs of 5056 alloy and composites after lubricated wear at 630N normal load for a) 617km, b) 543km, c) 511km, and d) 467km; sliding direction is in the vertical direction.

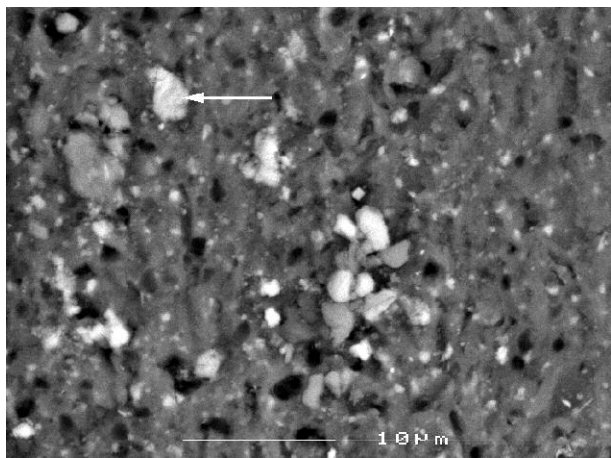
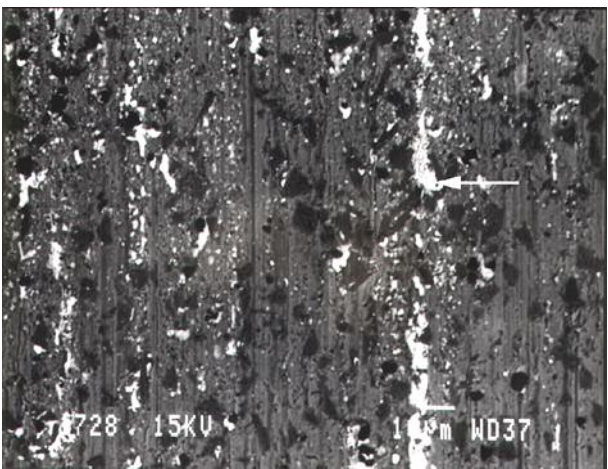
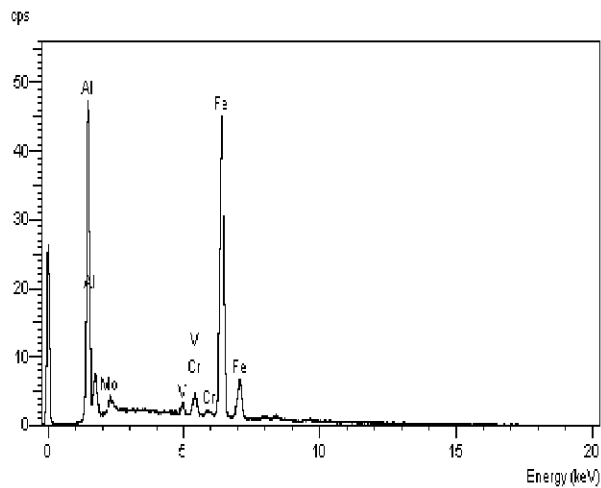
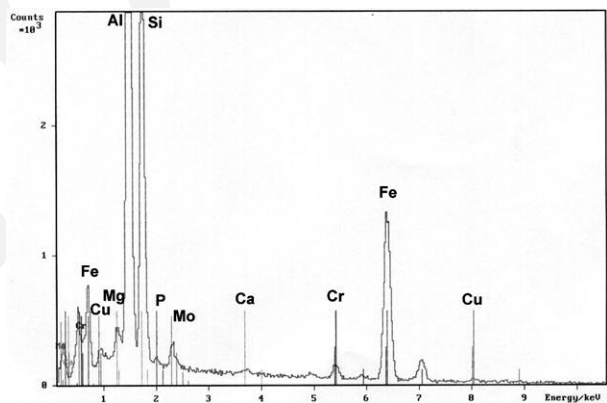
a) 2124 alloy

b) 2124 + SiC

c) EDX spectra of arrowed particle in a).

d) EDX spectra of arrowed particle in b).

Figure 7. Backscattered SEM images corresponding to Figures 5a) and b), showing evidence of Fe transfer from counterface. Arrows indicate sampling point of EDX spectra c) and d) for 2124 and 2124 + SiC, respectively.

Transfer of Fe from the counterface was observed for both un-reinforced 2124 and 5056 alloys, as shown by EDX and FIB cross sections, the distribution of which was demonstrated by 3D surface reconstructions. The abrasive action of these Fe-rich particles is unquestionable, Figure 14, since their presence was characterised by a groove in their wake. The pressure acting on the particles must have been significant, in excess of the flow stress of the Al-alloy, since the majority of the particle was below the worn surface. Moreover, the intimate contact of particle and matrix, with an absence of any significant voids at the interface, further indicates the pressure on the particles. However, it is interesting to note that, although severe plastic deformation was observed in the matrix around these Fe particles, the total depth of severe deformation in other areas of the matrix was not large ($\sim 1.5\mu\text{m}$). Voids within grains were present below the region of heaviest plastic deformation, indicating that the subsurface stress levels were sufficiently high to cause nucleation, but not high enough for void coalescence to form sub-surface cracks, the exception perhaps being 5056 + Ni_3Al .

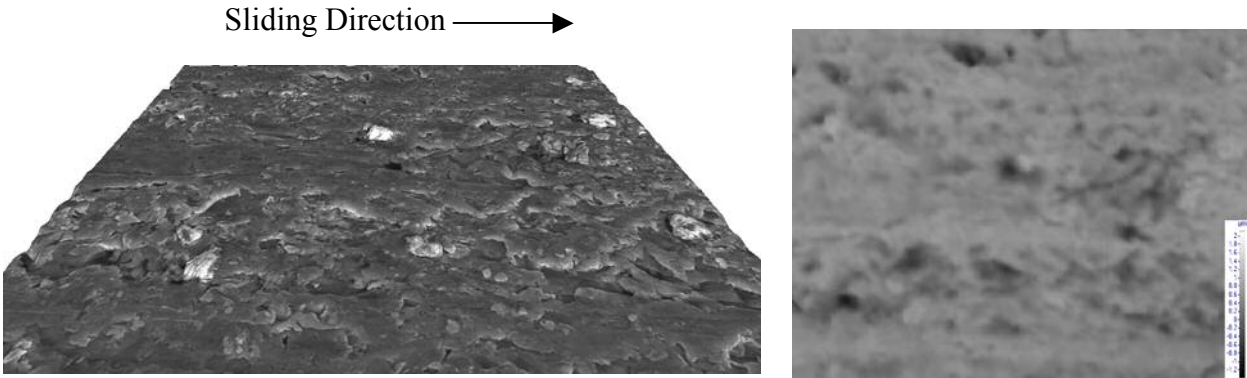
Figure 8. Tilted tomographic surface reconstruction of 5056 Alloy at $\times 1000$ magnification, left, and corresponding texture depth image, right.

Tomographic reconstruction of tilted SEM stereo pairs such as those in Figures 8-12 give information about specific height distributions over the worn surface. The overall height distribution for all samples investigated was small, 3-4µm, but rougher than the polished starting surfaces. A greater height difference was observed with 5056 + Ni₃Al, Figure 10, where although the wear surface was within the same roughness scale, craters extended as deep as 12µm. Interestingly, some Fe-rich particles were found implanted into the surface of the 5056 alloy, Figure 8. However, as shown by the corresponding texture depth image, the height difference between these particles and the surrounding matrix was negligible, although deep pits were often seen immediately behind. Figure 12 confirmed the severity of abrasion clearly visible at the worn surface of 2124+ SiC. Surface height changes were abrupt, perpendicular to the sliding direction, as the peaks and troughs of multiple wear tracks were traversed, in contrast to other samples where surface gradients were much shallower.

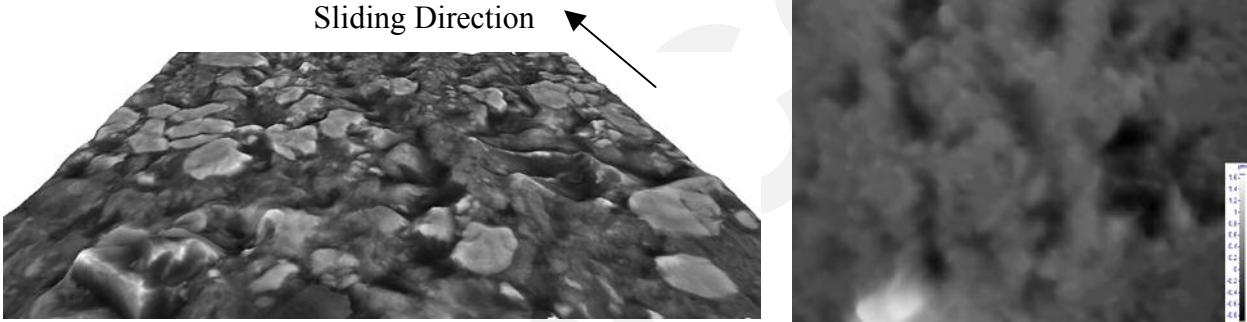
Figure 9. Tilted tomographic surface reconstruction of 5056 + MoSi_2 at $\times 3000$ magnification, left, and corresponding texture depth image, right.

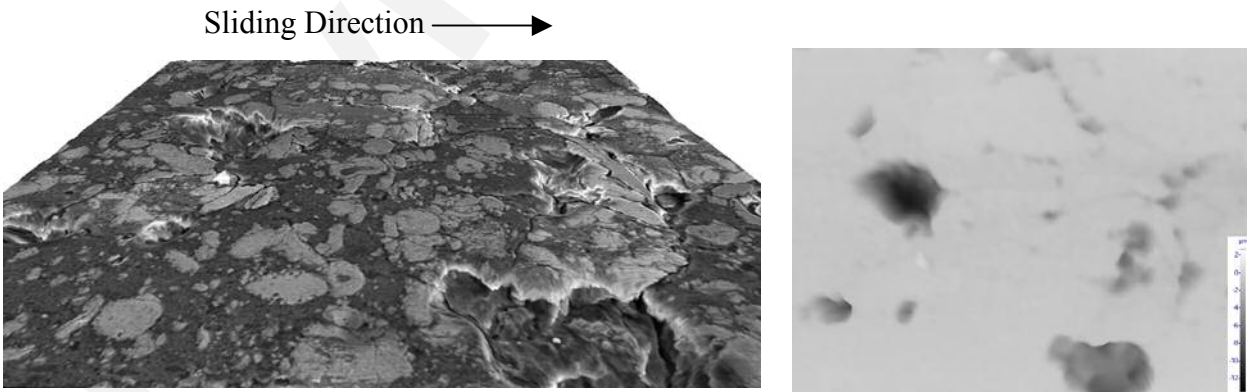
Figure 10. Tilted tomographic surface reconstruction of 5056 + Ni_3Al at $\times 500$ magnification, left, and corresponding texture depth image, right.

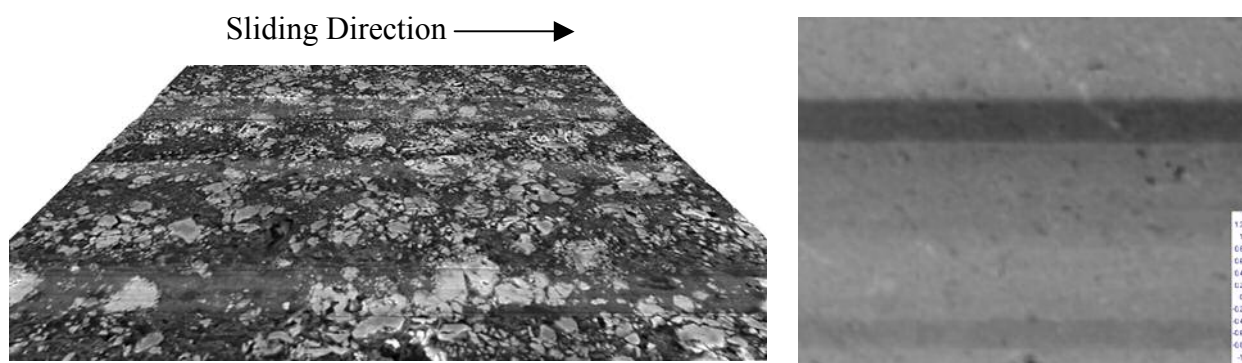
Figure 11. Tilted tomographic surface reconstruction of 2124 + MoSi₂ at $\times 1000$ magnification, left, and corresponding texture depth image, right.

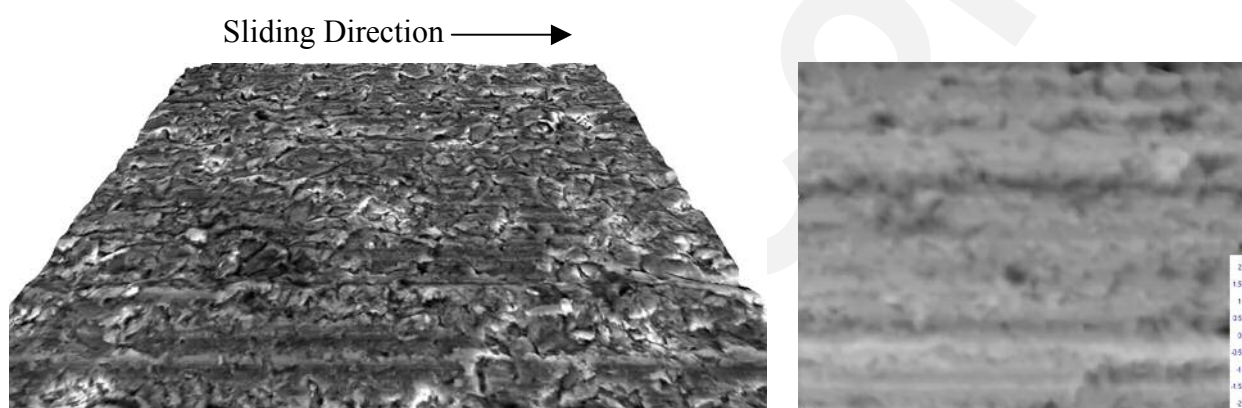
Figure 12. Tilted tomographic surface reconstruction of 2124 + SiC at $\times 1000$ magnification, left, and corresponding texture depth image, right.

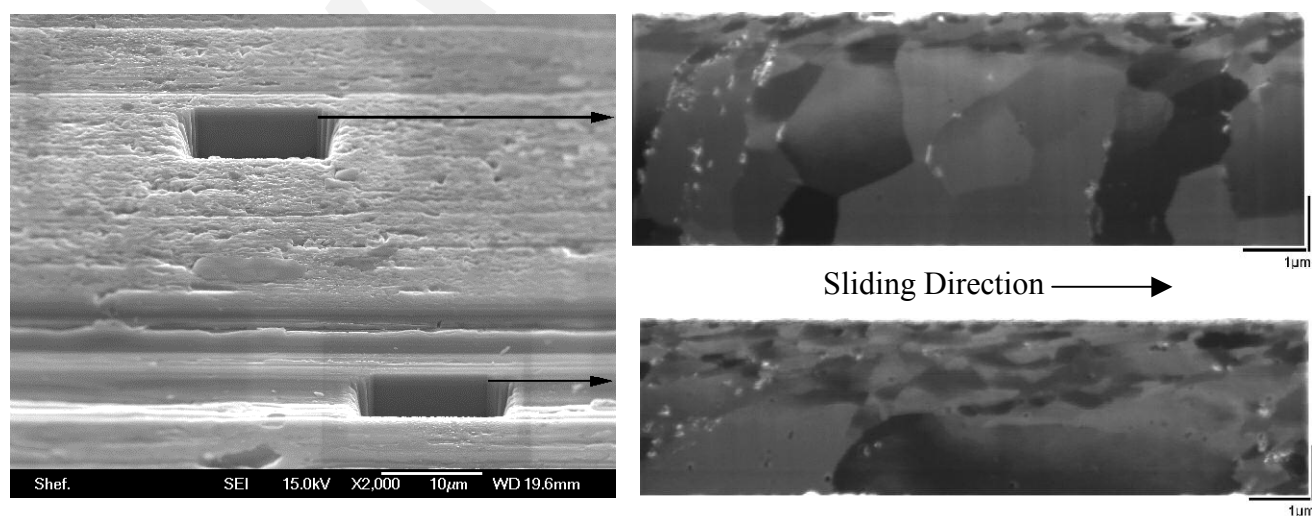
Figure 13. Secondary electron image (left-55° tilt) of trenches milled parallel to the sliding direction in 5056 alloy after lubricated sliding at 630N for 306km. Secondary ion images at 63° tilt of the sub-surface faces are shown to the right.

The versatility of FIB techniques to analyse site-specific sub-surface behaviour was demonstrated in Figures 13-19. Ion channelling contrast revealed the strain and depth of deformation of aluminium grains. The un-reinforced 5056 alloy, Figure 13 showed heavily deformed grains, strained parallel to the sliding direction, extended to a depth of 1-1.5 μm from the surface, with equiaxed grains of the order 2 μm at greater distances. A greater amount of plastic deformation appeared below the surface of the lower trench in Figure 13, compared to the upper trench, attributed to the broad wear track. In all samples, subsurface voids were also apparent further away from the region of greatest strain, along with the flow of smaller particles at the grain boundaries towards the sliding direction.

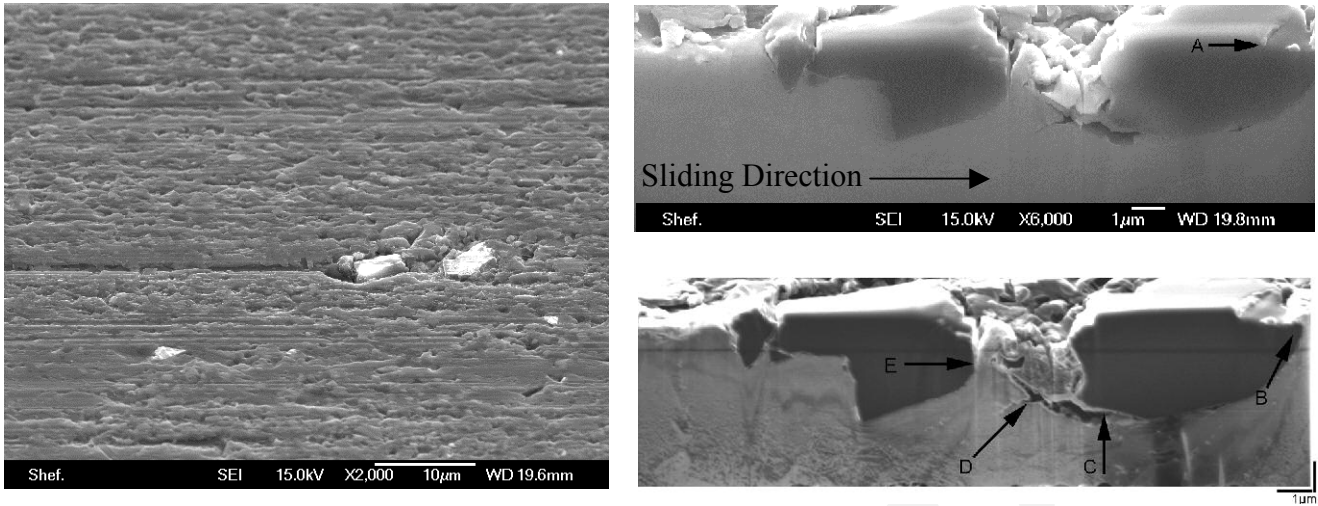
Figure 14. Secondary electron images (left and upper right-55° tilt) of Fe particles in 5056 after lubricated sliding for 306km. The secondary ion image of the same area is shown lower right at 63° tilt, with letters A-E corresponding to features described in the text.

Figure 14 shows a section through a large ($\sim 6\mu\text{m}$) Fe-rich particle on the surface of the 5056, believed to be from the counterface. It appears that these particles had been pushed along the surface, leaving a distinct wear groove in their wake. Ion beam sectioning through this vicinity revealed numerous interesting features, labelled A-E: A indicates local cracking within the debris; B shows flow of the matrix around the debris particle; C relates to intimate contact between the particle and the matrix; D shows cracking of the matrix and E refers to ploughing of the matrix by a second debris particle. Lines believed to reflect the flow of matrix around the bottom of the particles could just be resolved, although these were somewhat obscured by milling effects (vertical lines, re-sputtered material). Also apparent was the effect of atomic number contrast from the secondary ion emission, where heavier elements appear darker than the matrix, the opposite to backscattered electron contrast [25,26].

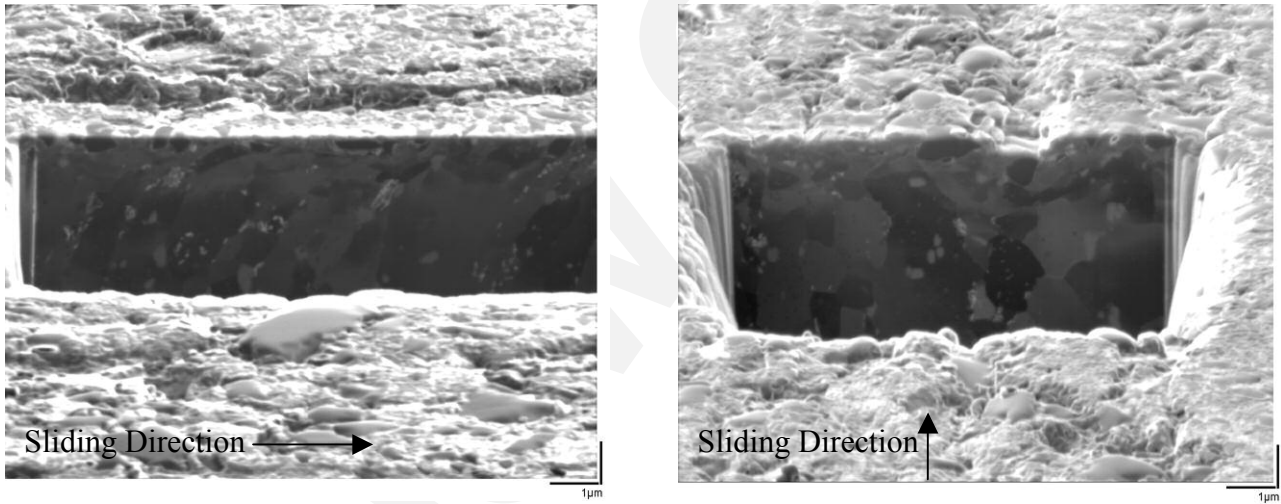
Figure 15. Secondary ion images (63° tilt), showing channelling contrast of the subsurface microstructure in 2124 alloy, after lubricated sliding for 469km.

The worn surface of the 2124 alloy showed a similar region of heavily deformed grains at approximately 1 μm depth, Figure 15, in trenches milled parallel and perpendicular to the sliding direction. In the trench perpendicular to the sliding direction, the depth of the

deformed near surface layer was extended at the base of a groove, an effect also seen in Figure 19, where a non-linear wear track passes through the surface of 5056 + MoSi₂. However measurements of plastic deformation from the surface indicated that the region of highest strain is in fact to the sides of the groove and not directly under it, suggesting ductile micro-ploughing instead of a direct load bearing effect.

Sections perpendicular to wear grooves in both un-reinforced and reinforced samples showed the extension of the depth of plastic deformation below the groove, Figures 15 and 19. During elasto-hydrodynamic lubrication, where mating surfaces are separated with a significantly thick fluid film, 3-body abrasive particles generated during earlier boundary lubrication conditions can often be larger than the thickness of the film itself, in which case, contact is inevitable [28] and wear proceeds by abrasion.

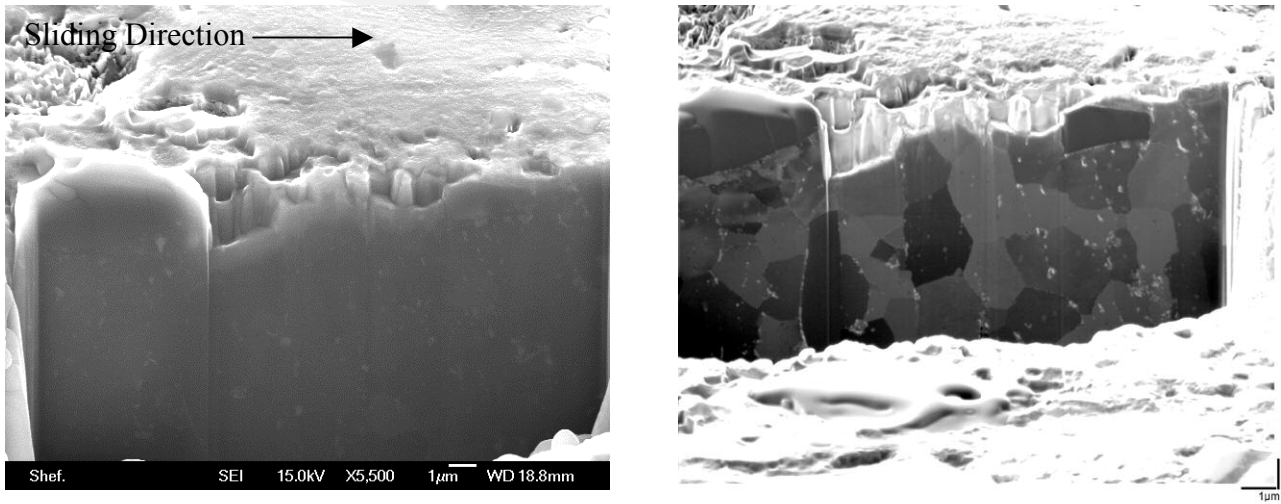
Figure 16. Secondary electron (left-55° tilt) and secondary ion (right-63° tilt) images of the subsurface region of 2124+SiC, after lubricated wear for 548km.

Figure 16 shows the subsurface microstructure of the 2124 + SiC composite, which was distinctly different to others, in that no evidence was found of surface deformation; rather relatively equiaxed grains were seen even at the surface. Indeed it appeared that load transfer has occurred only below the SiC particle standing above the surface, to the left of the image, with heavily deformed grains up to a depth of approximately 2µm below the particle. Angular pits within the surface also suggest that SiC particles have been removed from these areas.

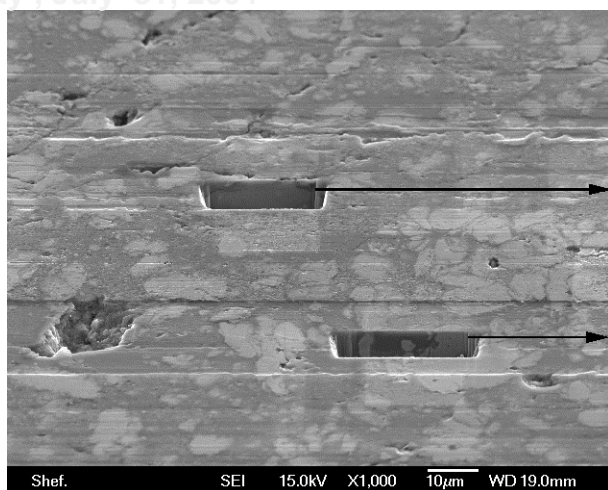
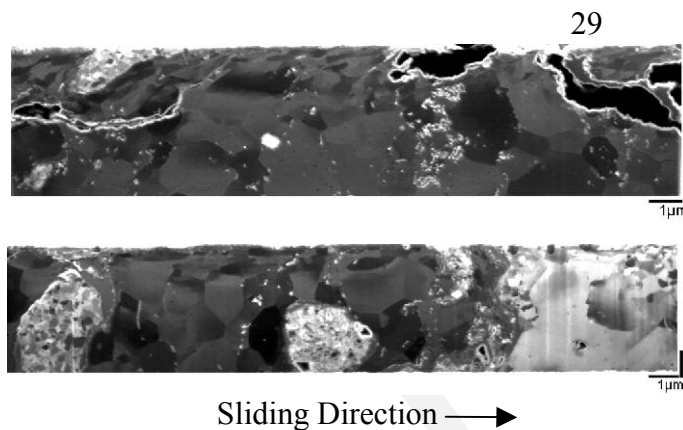
Figure 17. Secondary electron image (left-55°) of a trench in the worn surface of 5056 + Ni₃Al. Secondary ion images of the sub-surface areas are shown to the right (67° tilt).

Milling of the 5056 + Ni₃Al specimen, Figure 17, showed that cracks which were clearly visible on the surface of the specimen, also extended below the worn surface, and appeared to be deflected by the presence of a Ni₃Al particle, to the left of the upper trench. Also apparent in the top trench was the flow of matrix around the Ni₃Al particle to the left, whilst the total depth of deformation was still in the range 1-1.5µm.

with little evidence of direct particle pull-out. Instead, wear appeared to proceed by micro-ploughing and plastic deformation of both particles and matrix, with evidence of matrix flow around reinforcements, Figure 17, an effect also seen by Wang *et al* [17,18] for dry sliding of similar composites. Further to this was the appearance of deep ($\sim 12\mu\text{m}$) craters, around a cracked region of the wear scar, with reinforcements appearing to deflect the crack propagation. This behaviour was not seen in the un-reinforced 5056 alloy and therefore could be the result of the initiation of sub-surface cracks at voids between particles with high aspect ratios, where incomplete flow of the matrix around the reinforcement has led to increased porosity. The depth of the craters themselves may give an indication as to the total depth of deformation, not apparent from FIB sectioning of the surfaces.

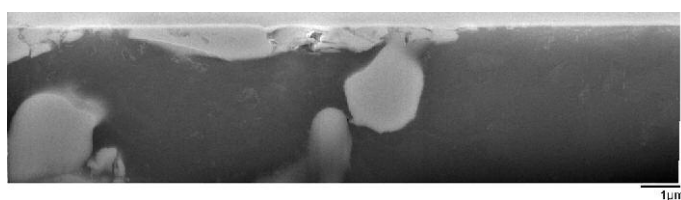
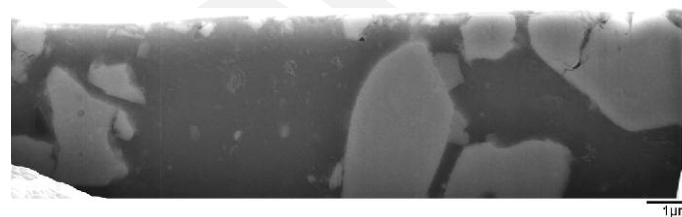
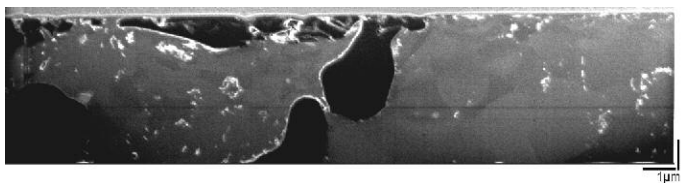
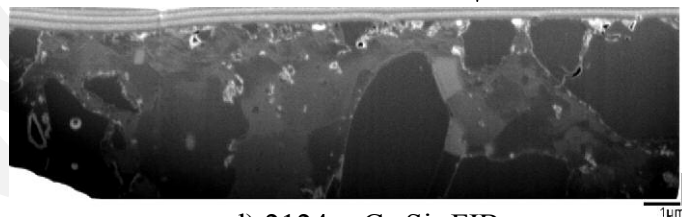
a) 5056 + MoSi₂ - SEM

b) 2124 + Cr₃Si -SEM

c) 5056 + MoSi₂ -FIB

d) 2124 + Cr₃Si -FIB

Figure 18. Secondary electron images (55° tilt) of trenches within the wear tracks of a) 5056 + MoSi₂ and b) 2124 + Cr₃Si, after lubricated sliding for 467km and 421km respectively. Secondary ion images c) and d), below, are of the same areas (63° tilt). Note the platinum deposit at the top of these trenches, to protect the worn surface.

Sections through the worn surface of the silicide reinforced alloys, Figure 18, showed fracture and re-embedding of the silicide phases in the matrix at the near surface region, while larger particles away from the worn surface exhibited no visible effect of the wear process. The depth of strain deformation appeared similar to that for the un-reinforced alloys.

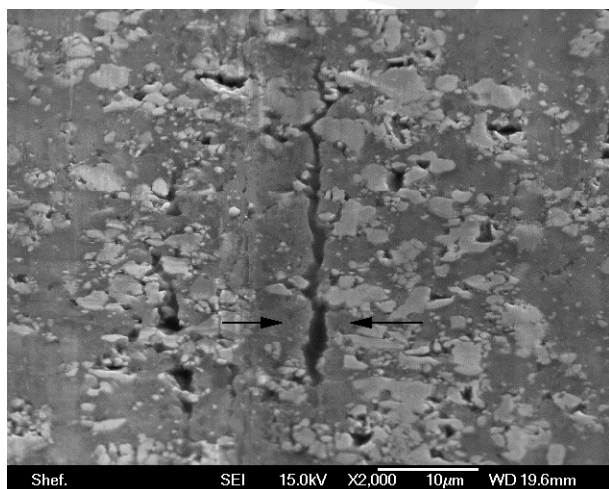
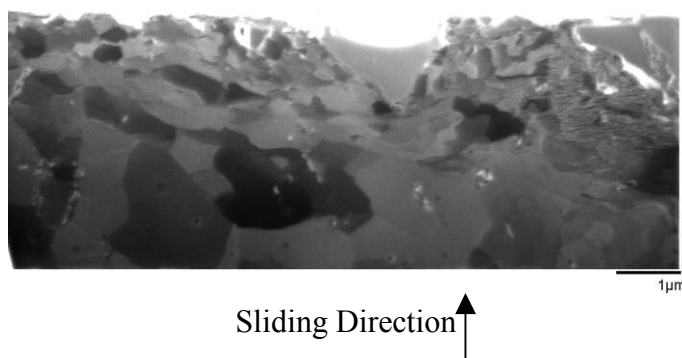
Figure 19. Secondary electron image (left – 55° tilt) of a non-linear wear track in 5056 + MoSi₂ and secondary ion image (right-63° tilt) of a trench milled between arrows; lubricated sliding for 467km.

The worn surface of these composites also exhibited what appeared to be surface cracks, parallel to the sliding direction. However, a FIB trench milled perpendicular one of these features, Figure 19, showed them to be non-linear abrasive grooves, with evidence of sub-surface plastic deformation and the ability of the reinforcements to deflect the linear propagation of the abrasive particle.
