Title: Assessing debris flows using LIDAR differencing: 18th May 2005 Matata event, New Zealand

Keywords: LIDAR differencing, slope failure, debris flow, sediment pathways, Matata, hazard assessment, LIDAR

1 **Assessing debris flows using LIDAR differencing: 18th May 2005 Matata event, New**
2 **Zealand.**

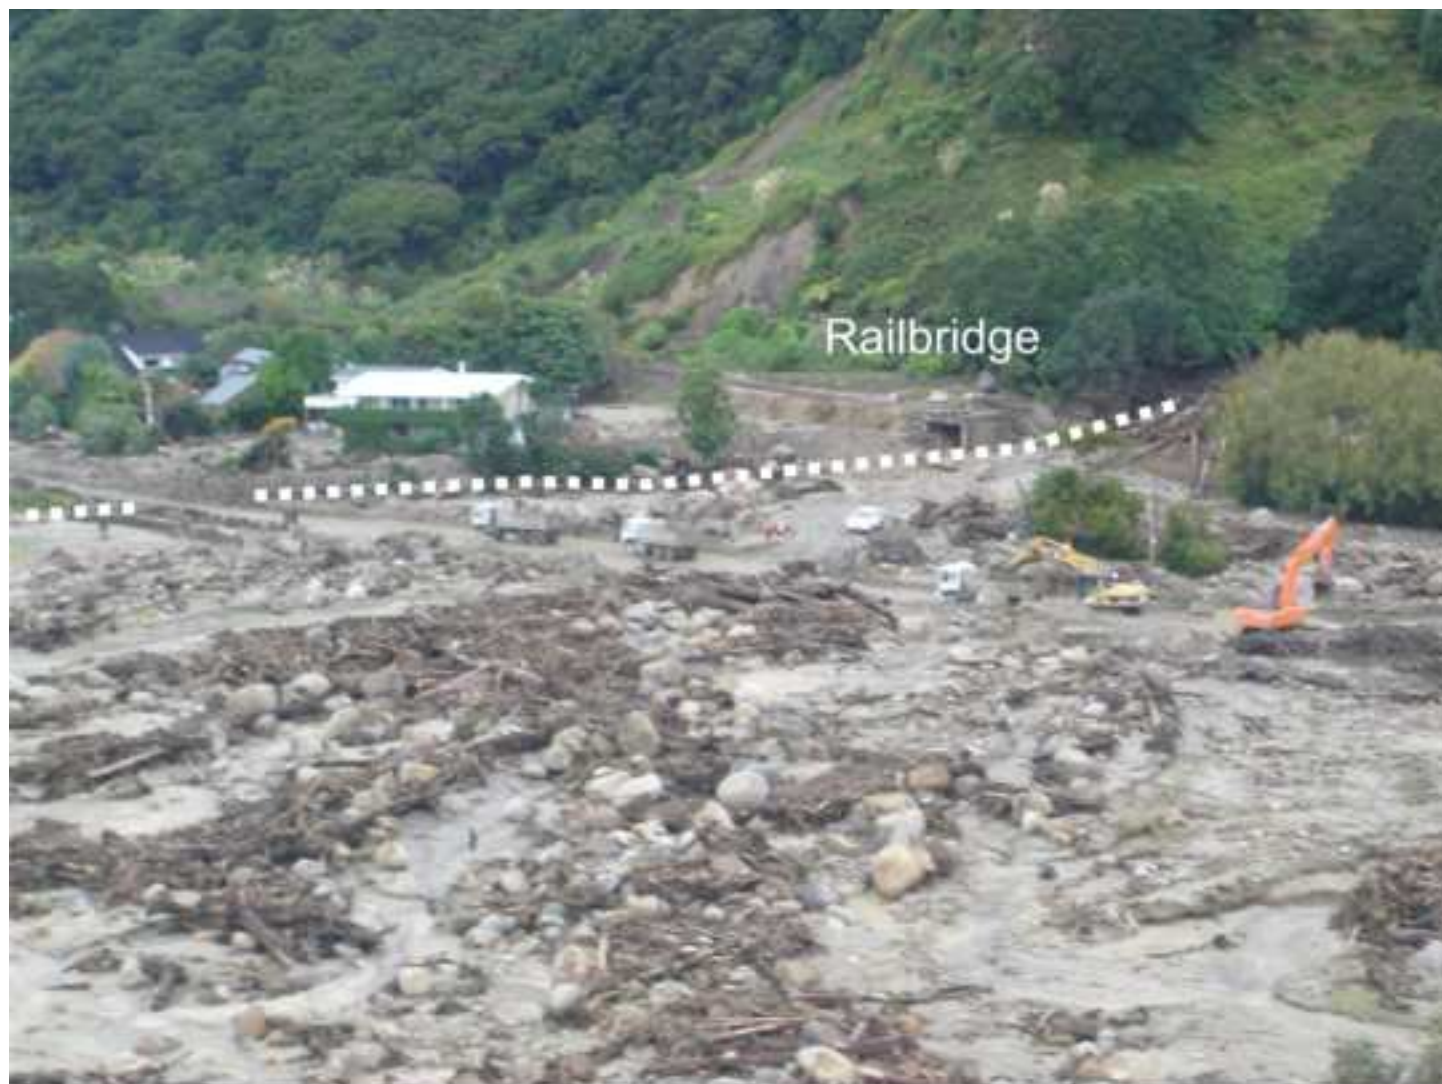
Fig. 4. Aerial Photograph (courtesy Terrain Consultants) showing in detail where the debris flow emerged from the confinement of the Awatarariki Stream. The first debris-laden currents passed beneath the railroad bridge and followed an existing stream channel (white dotted line). After debris build-up behind the bridge and its failure, the main debris flow bypassed the channel and spread out in an unconfined way across the pre-existing fan with large truck-sized boulders visible in the proximal fan. Remediation efforts had just commenced when this photograph was taken.

165 stream channel that delivered fresh sediment to the south-eastern lagoon (see Fig. 4). As
166 debris began to pile up behind the rail bridge, it became a sediment barrier that cut off flow
167 into the aforementioned channel and ultimately failed from the back pressure of the
168 subsequent debris flow pulses that were more voluminous and carried the large ignimbrite
169 boulders. Following the failure of the bridge, the debris flows became unconfined, spread out
170 across the pre-existing debris fan, and quickly decelerated which triggered rapid deposition of
171 the heavy boulders and logs (Fig. 5). The rapid loss of mass created a transition from debris
172 to hyperconcentrated flows that carried finer sediment 10's of metres further before it was
173 deposited as smaller lobate fan structures (Fig. 5) and debris floods developed as the currents
174 became even more dilute (Costello, 2007). The debris floods were topographically controlled

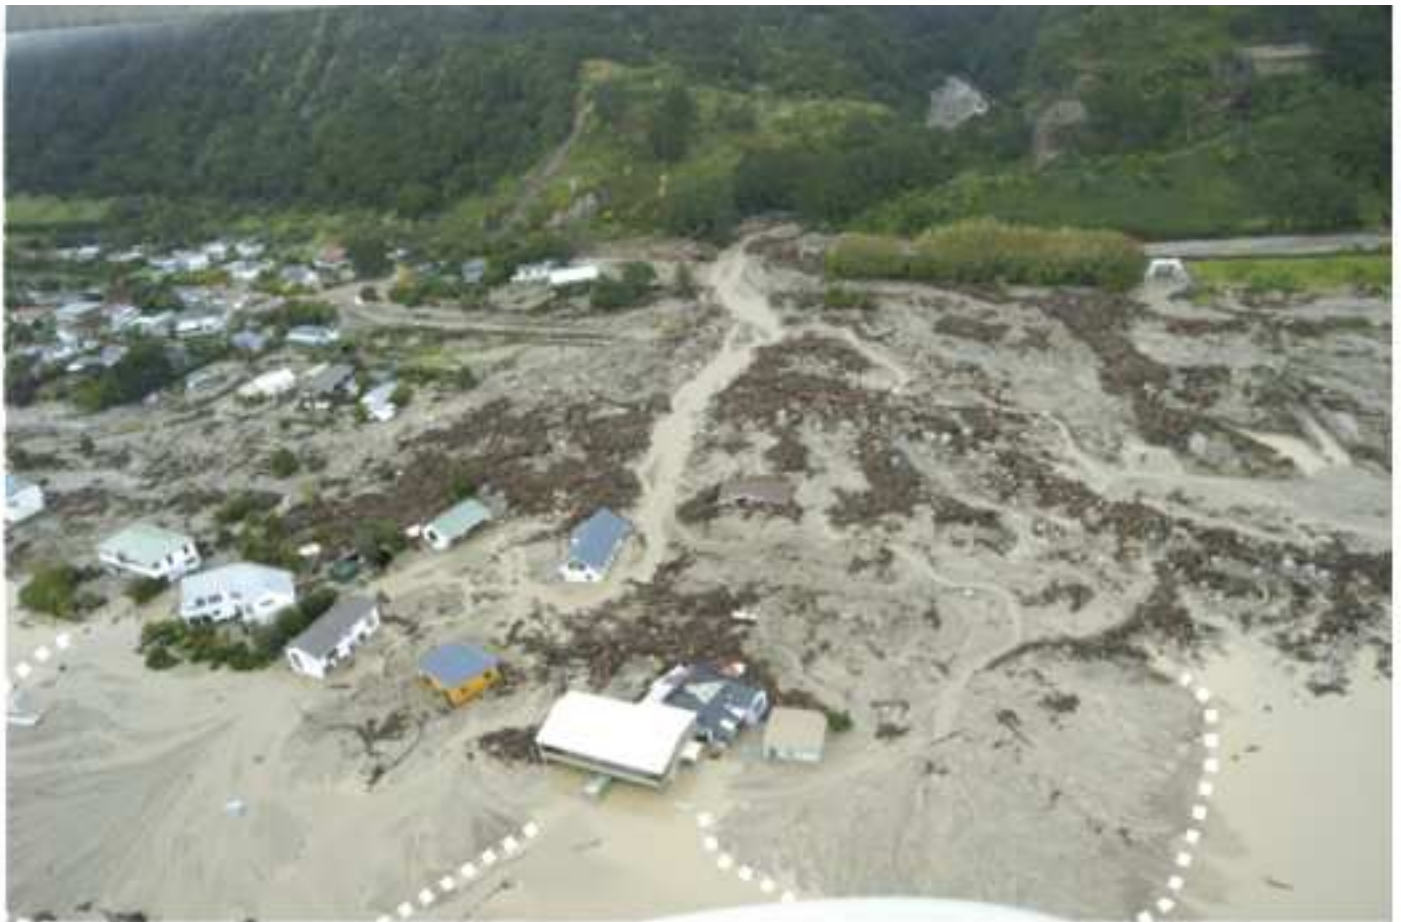
Fig. 5. Aerial photograph (courtesy Whakatane Beacon) showing the debris flow from the Awataraniki Stream. The emergence of the Awataraniki Stream onto the flat coastal plain is visible, as is the lobate boulder train. This photograph was taken before any remediation activity and is a good record of the immediate aftermath of the debris flow. Large boulders were limited to the area between the line of the buildings and the base of the hill. Fine debris was deposited as a debris flood in the foreground, while the dashed white lines show small lobate fan structures.

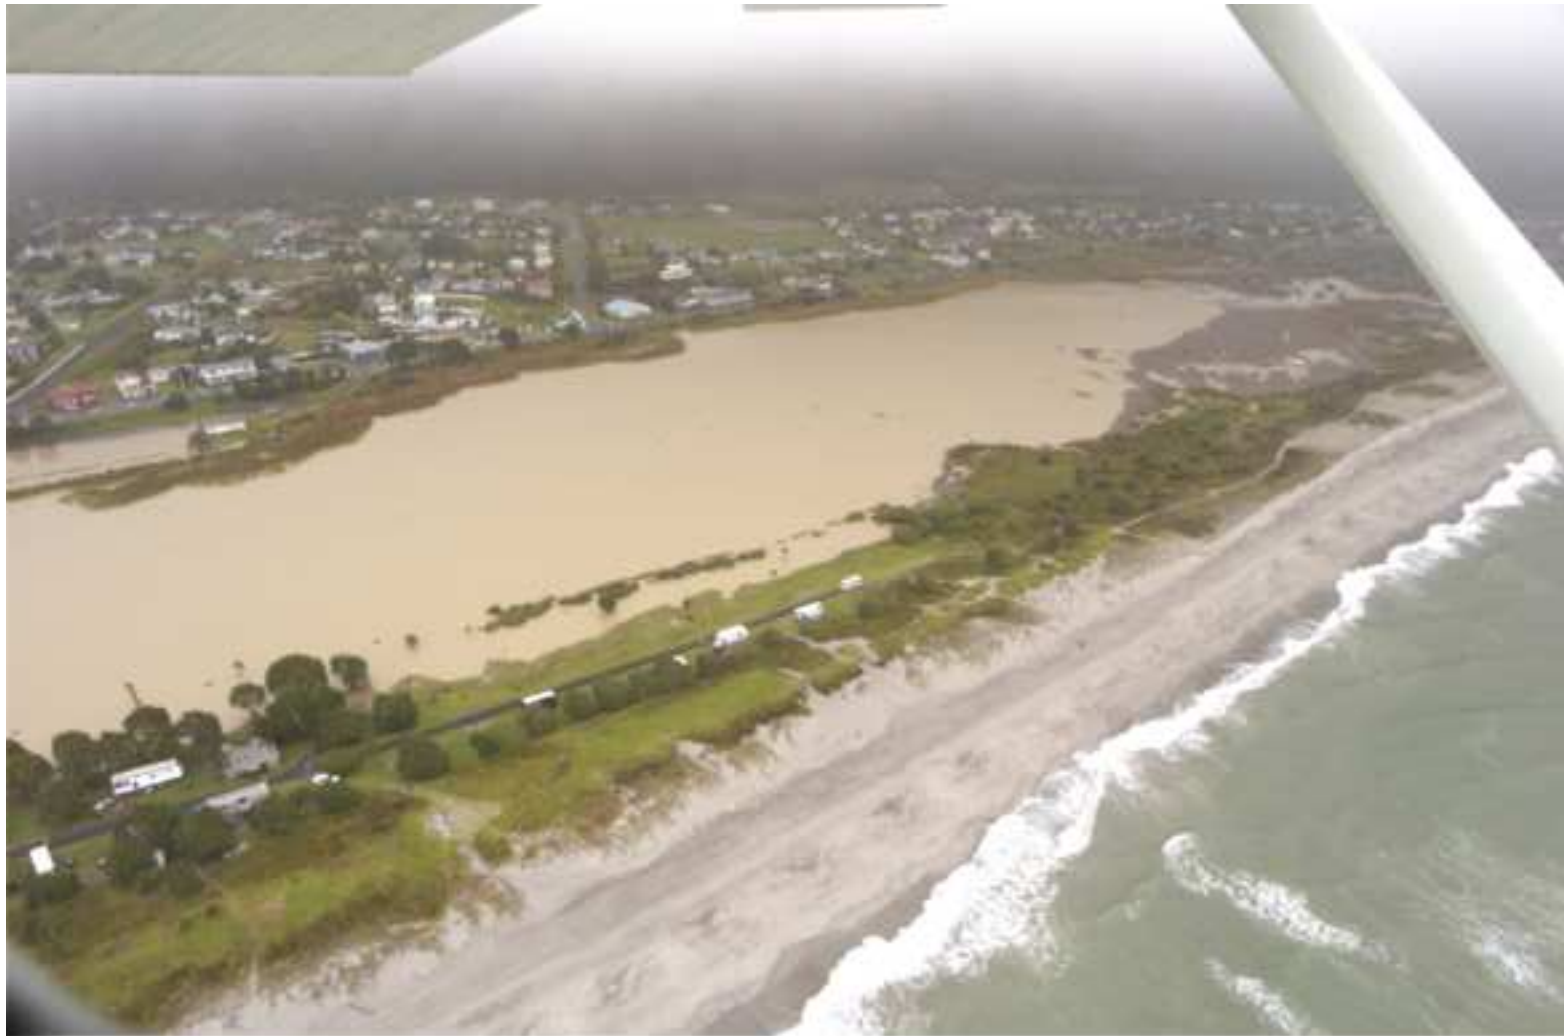
Figure6

Fig. 6. Oblique aerial photograph (courtesy Whakatane Beacon), looking southwest, showing debris entering the western portion of the Matata lagoon, and associated silt-laden waters. Much of the fine sediment was not confined to the fin from the Awatanuki Stream, but was carried in the lagoon.

175 by the coastal foredunes and followed pathways parallel to the coast, delivering sediment to
176 the lagoon systems (Fig. 6).

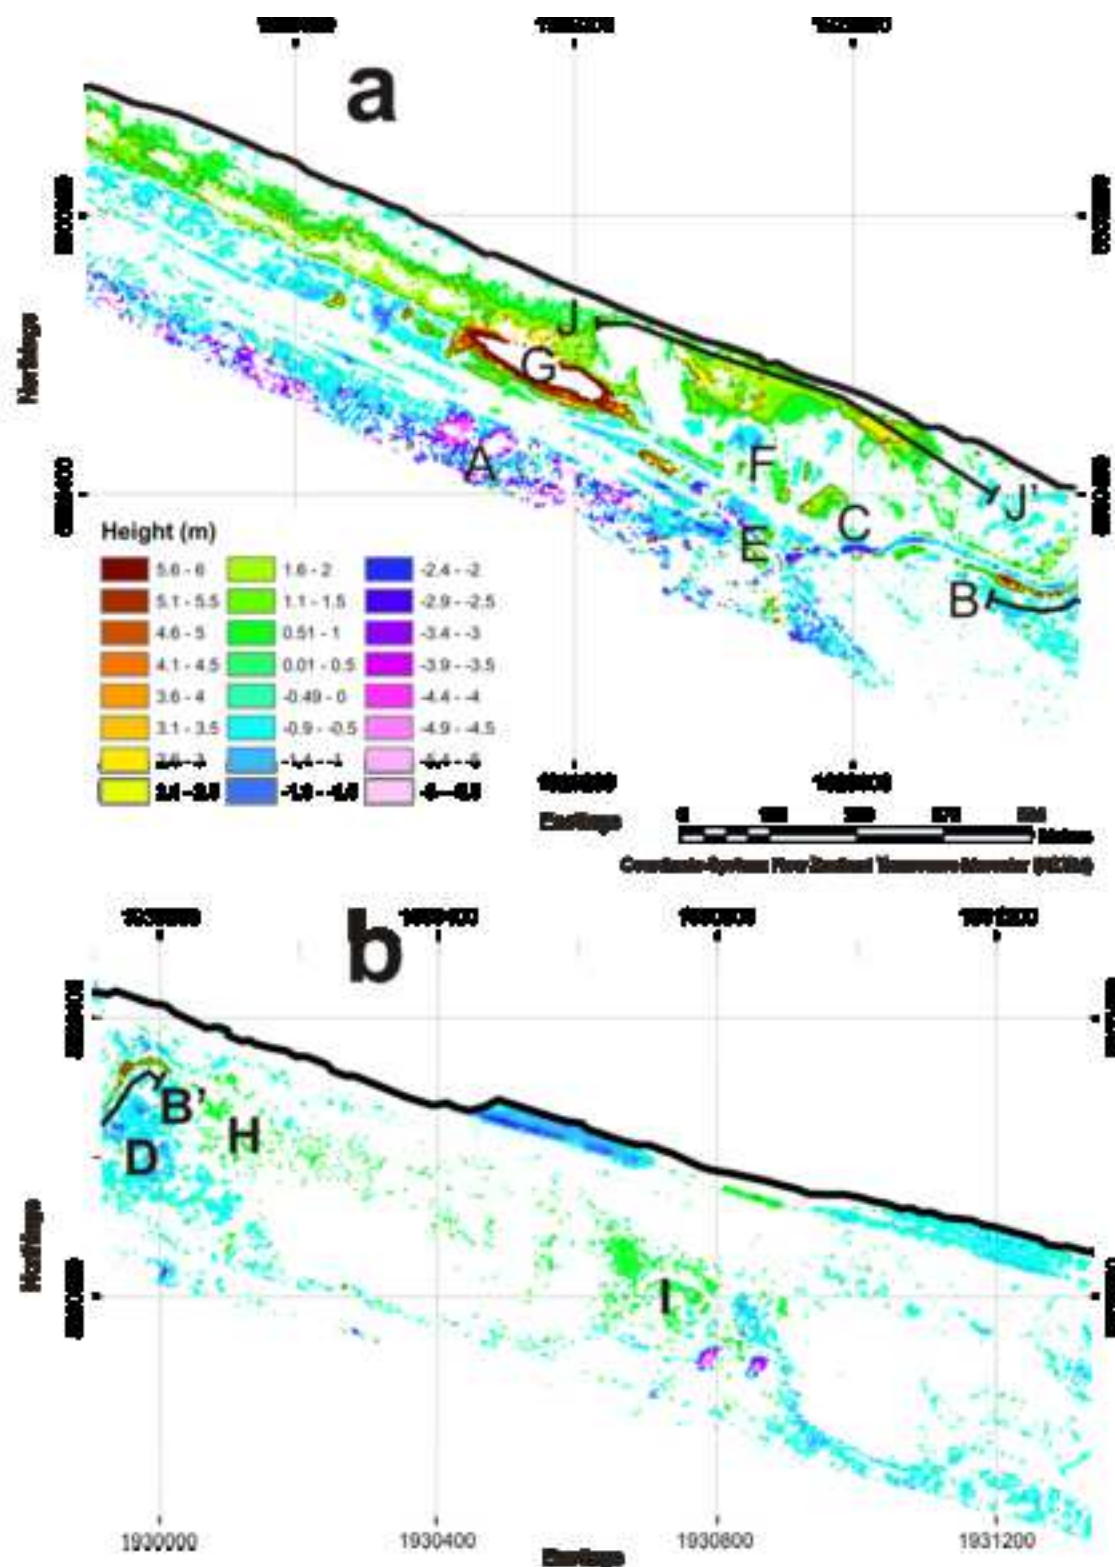
Figure9

Fig. 9. Difference in vertical height between the 2000 and 2006 LIDAR data (a) for an area including the Awatururiki stream and (b) for an area to the east including Mutata lagoon (location shown in Fig. 2). Contours are at 1 m intervals. Lettered points are referred to main text. Classification of heights around the mean has resulted in high values assigned no colour, as at Point G. In this location, the maximum height is 11 m.

259 The LIDAR data in the topographic plots is used primarily to examine the key region of
260 interest, and has demonstrated significant change in topography following the Matata debris
261 flows. This can be further assessed and built upon through comparison with the differenced
262 plots, which precisely map the distribution of morphological change following the debris
263 flow event in 2005. These plots illustrate quantifiable areas of erosion and deposition in the
264 form of sedimentary features and geomorphic landforms associated with the Awatarariki
265 Stream course. Erosion scarps and pockets of deposition are captured in the differenced
266 image along the coastal hill slopes west of Awatarariki catchment (Fig. 9a, area A).

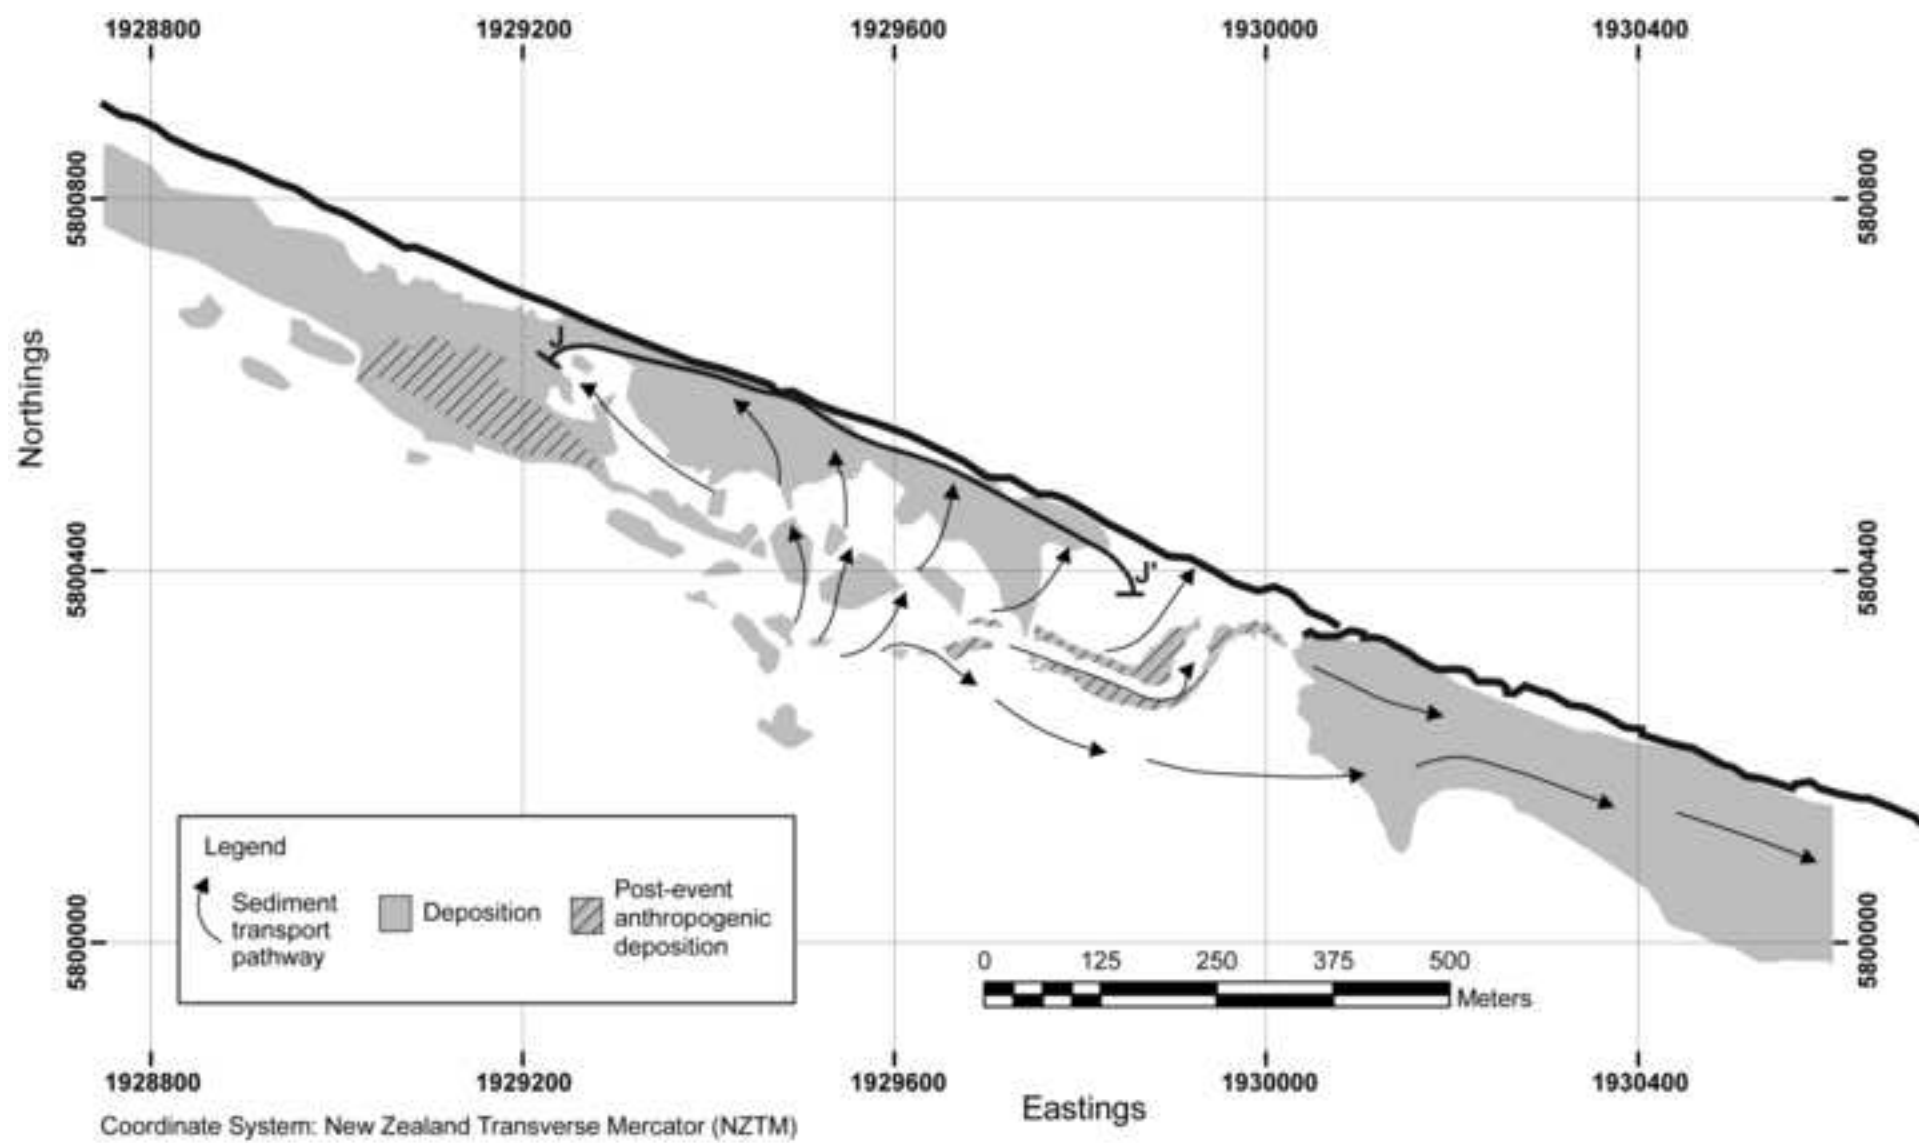
Figure10
[Click here to download high resolution image](#)

344 suggest that the channel was subsequently bypassed after the rail bridge initially trapped
345 material, and then failed allowing the debris fan to become unconfined (Fig. 10).
