**Performance of a propped retaining wall at the  
Channel Tunnel Rail Link, Ashford**

**Thesis for the degree of Doctor of Philosophy**

**June 2006**

This thesis is based on the field monitoring of a propped bored pile retaining wall installed in an overconsolidated clay. Pile bending moments, prop loads, pore water pressures and lateral earth pressures were logged automatically at intervals of up to 5 minutes throughout construction (and for 4 years afterwards) and wall deflections were measured during construction, making this the most comprehensive instrumentation project of its kind.

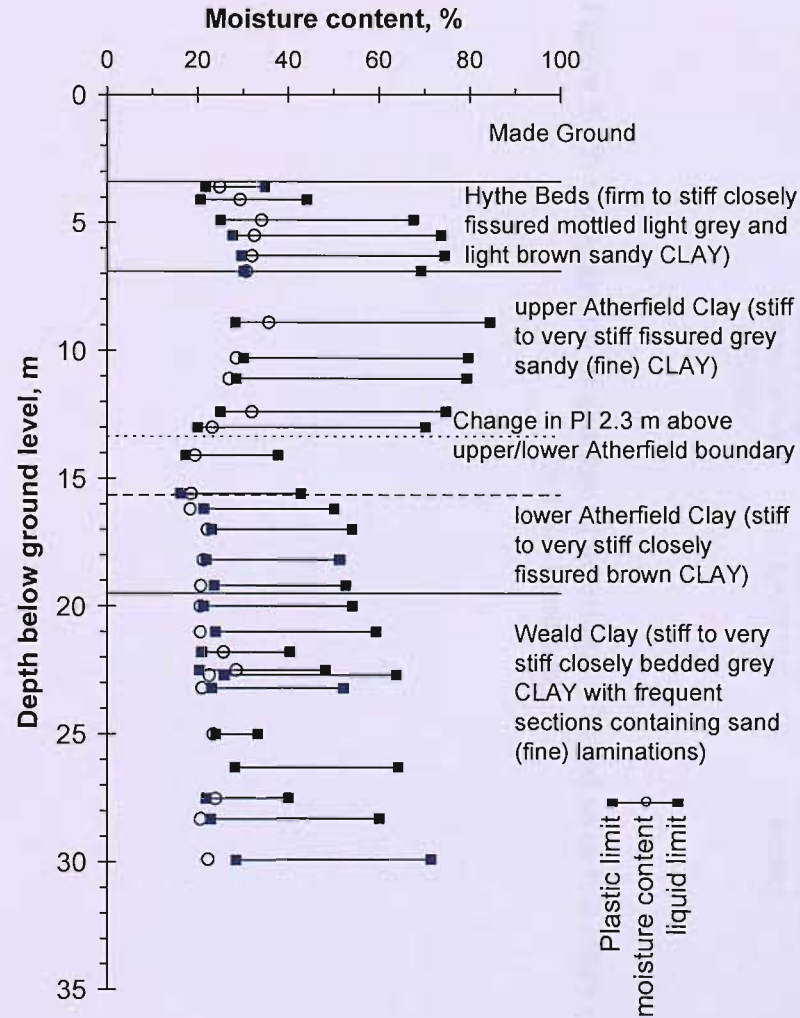
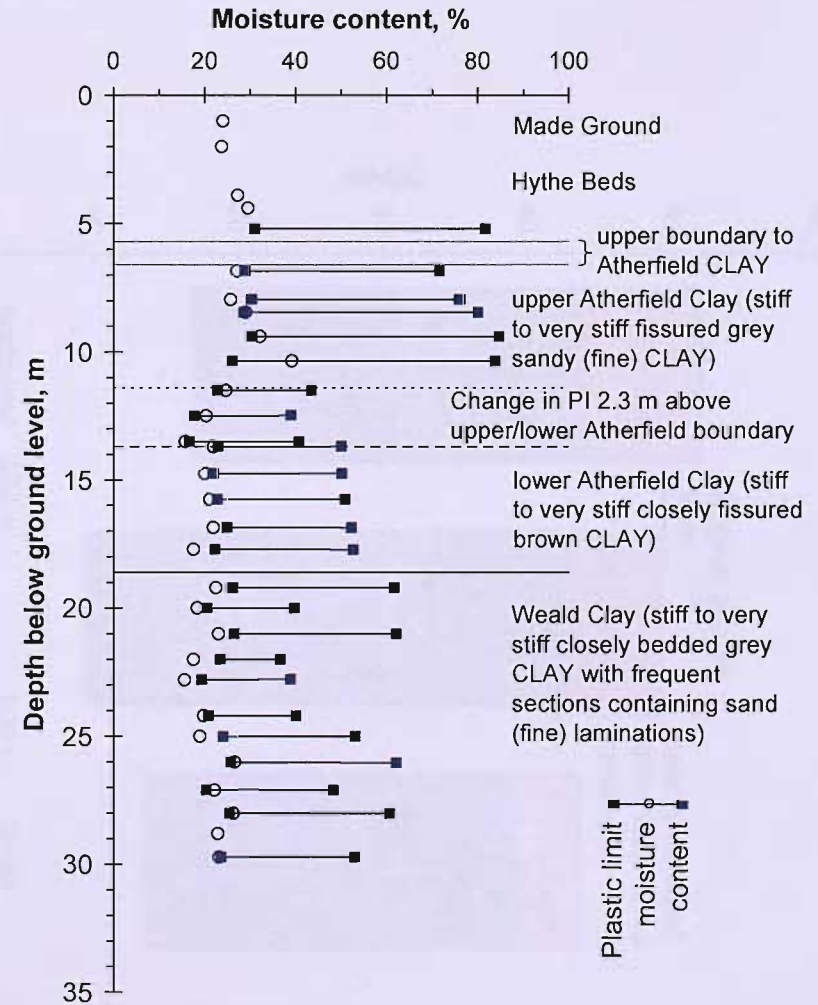
Figure 3-11: Geotechnical profiles including liquid and plastic limit data from wireline boreholes BH1 and BH2 (see Figure 3-1)

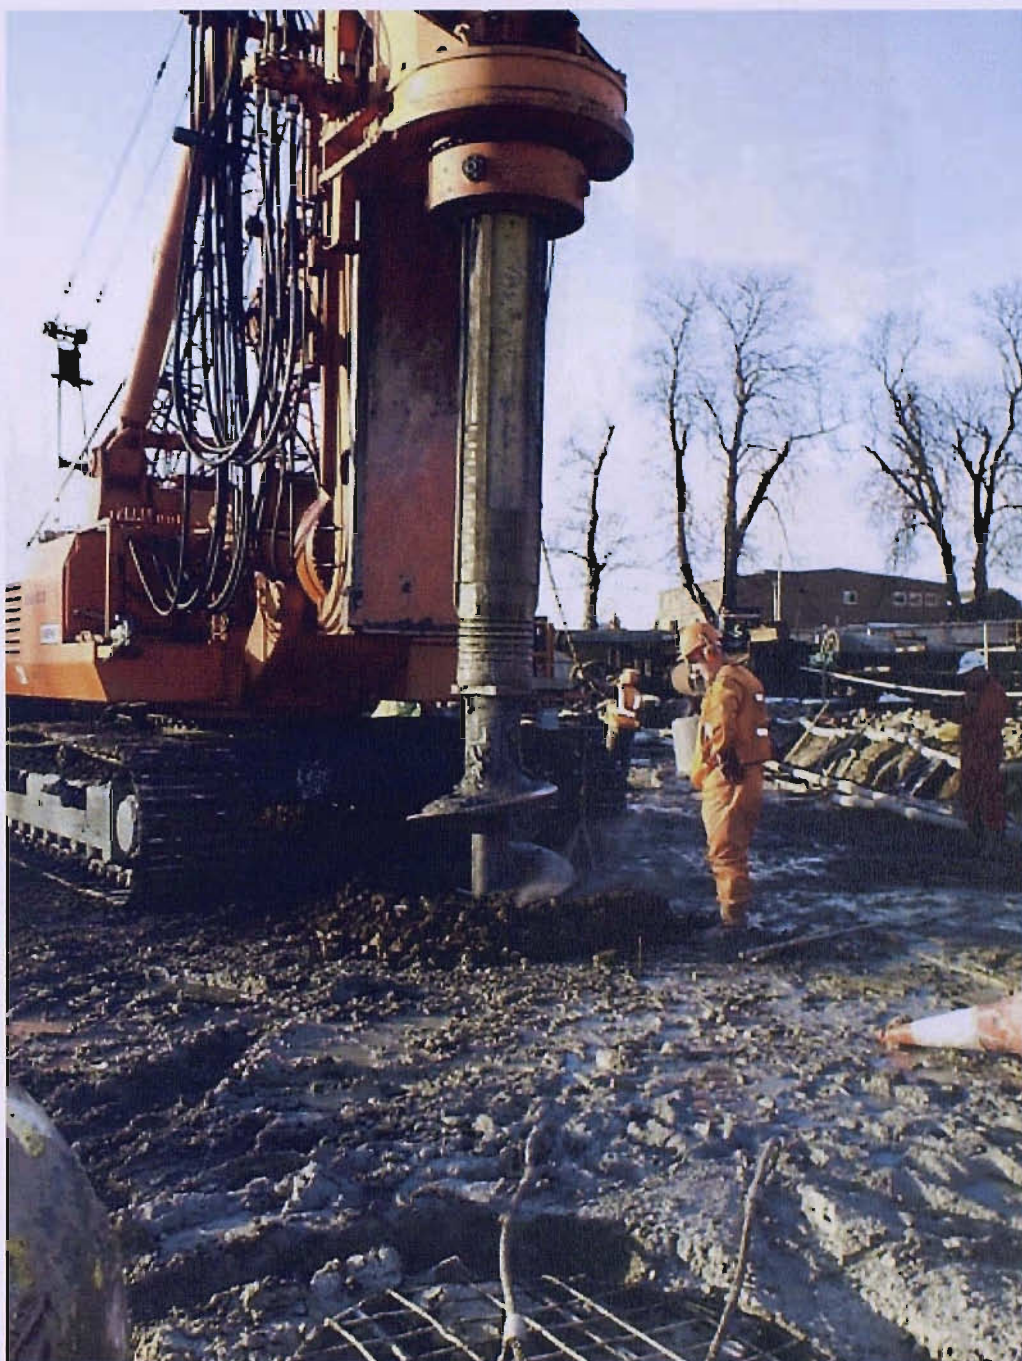
**Figure 3-26: Pile boring**

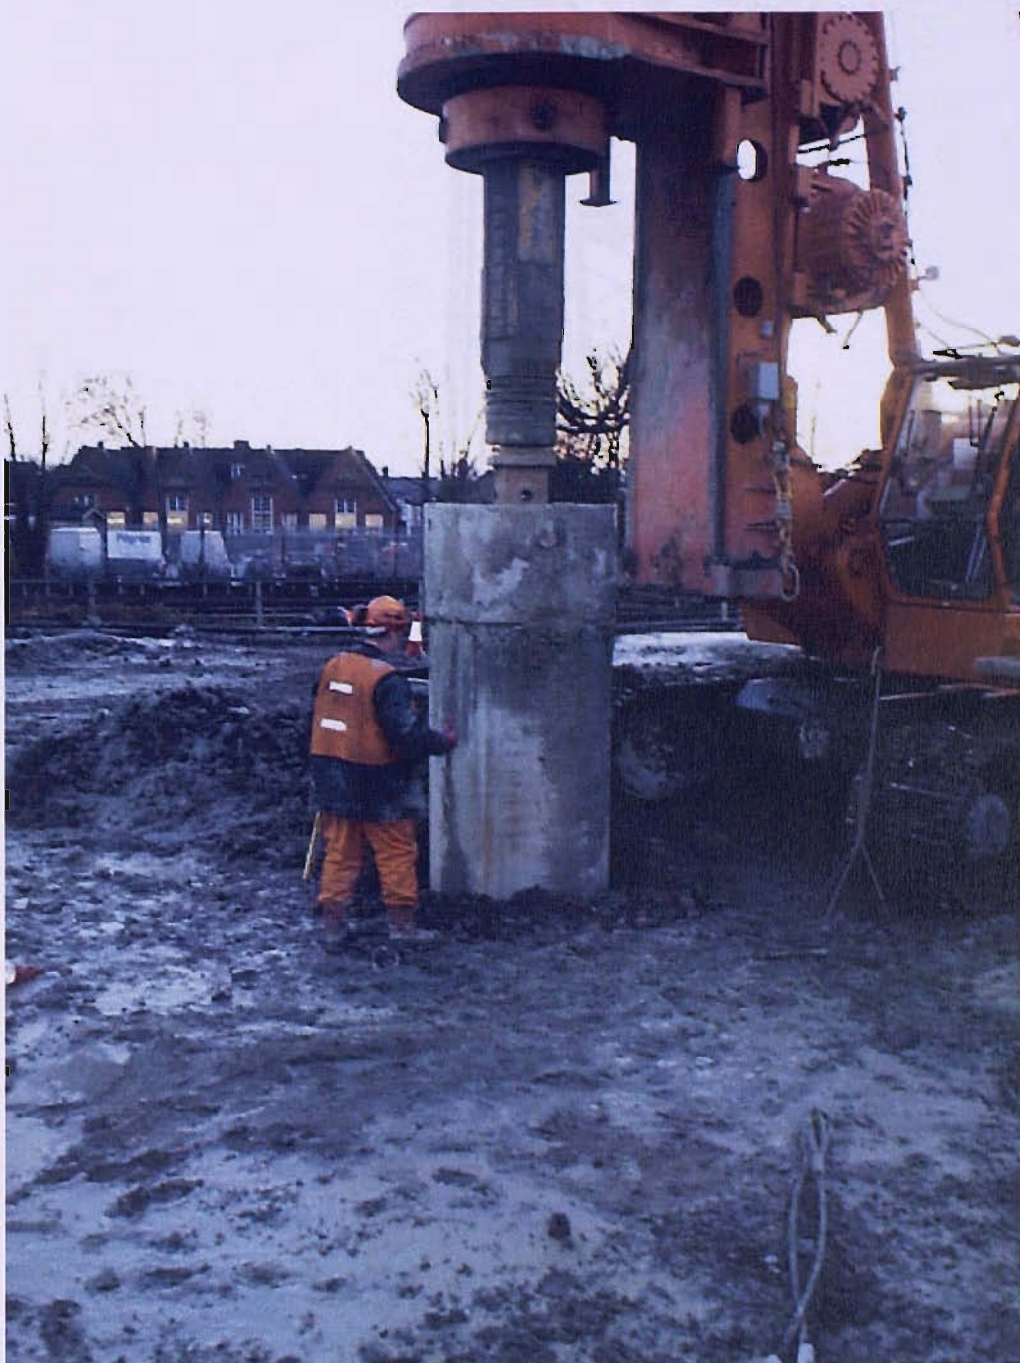
**Figure 3-27: Installation of casing**

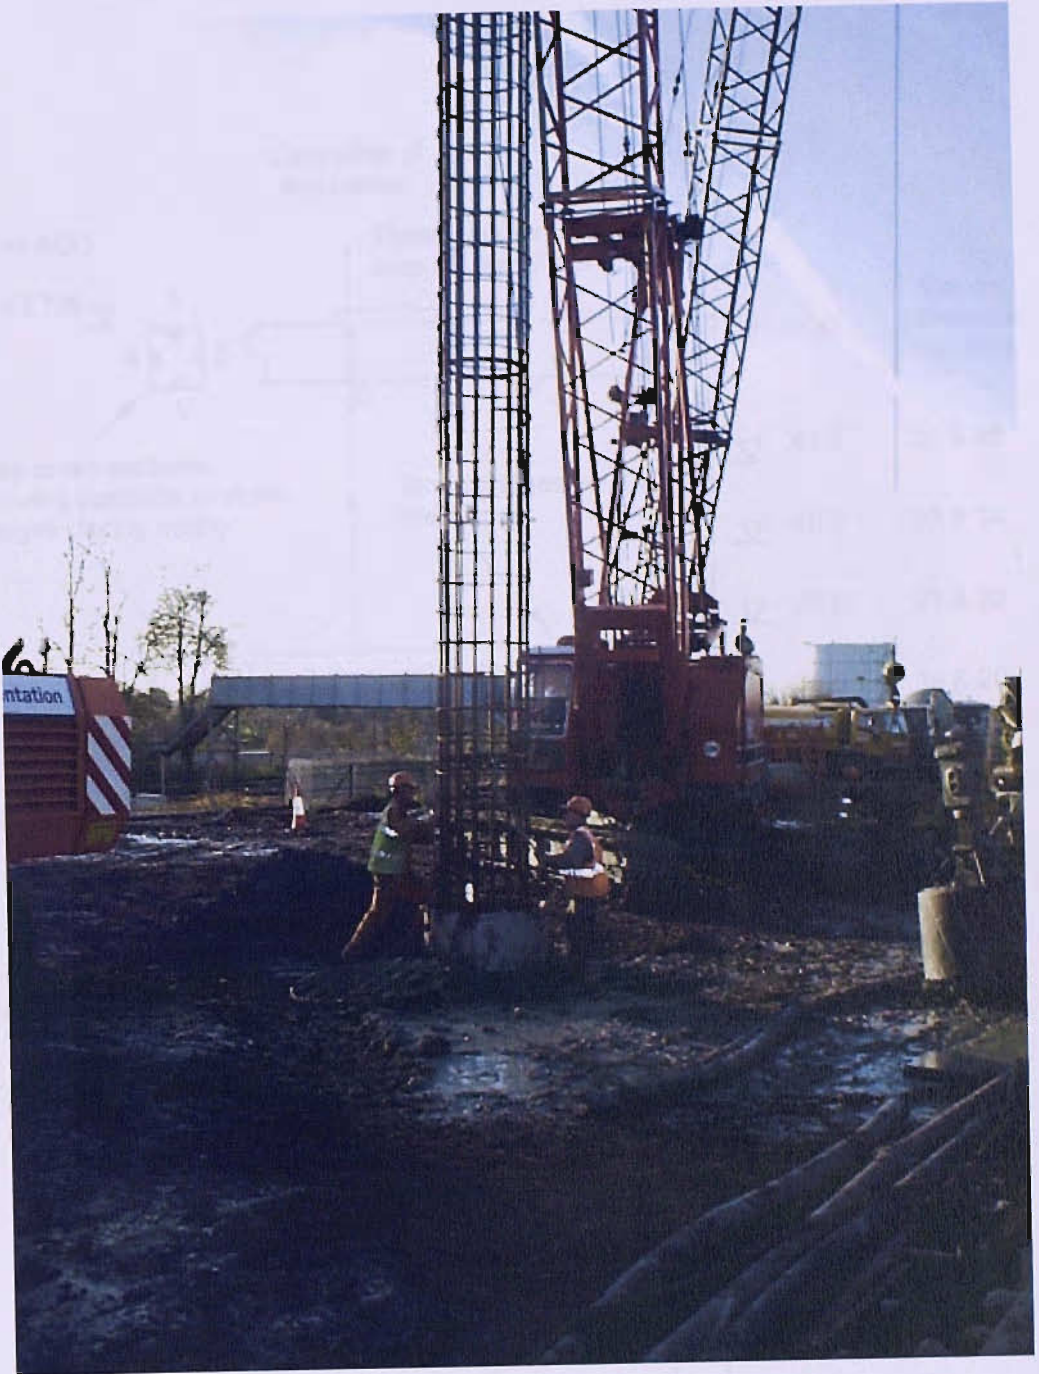
**Figure 3-28: Installation of reinforcement cage**

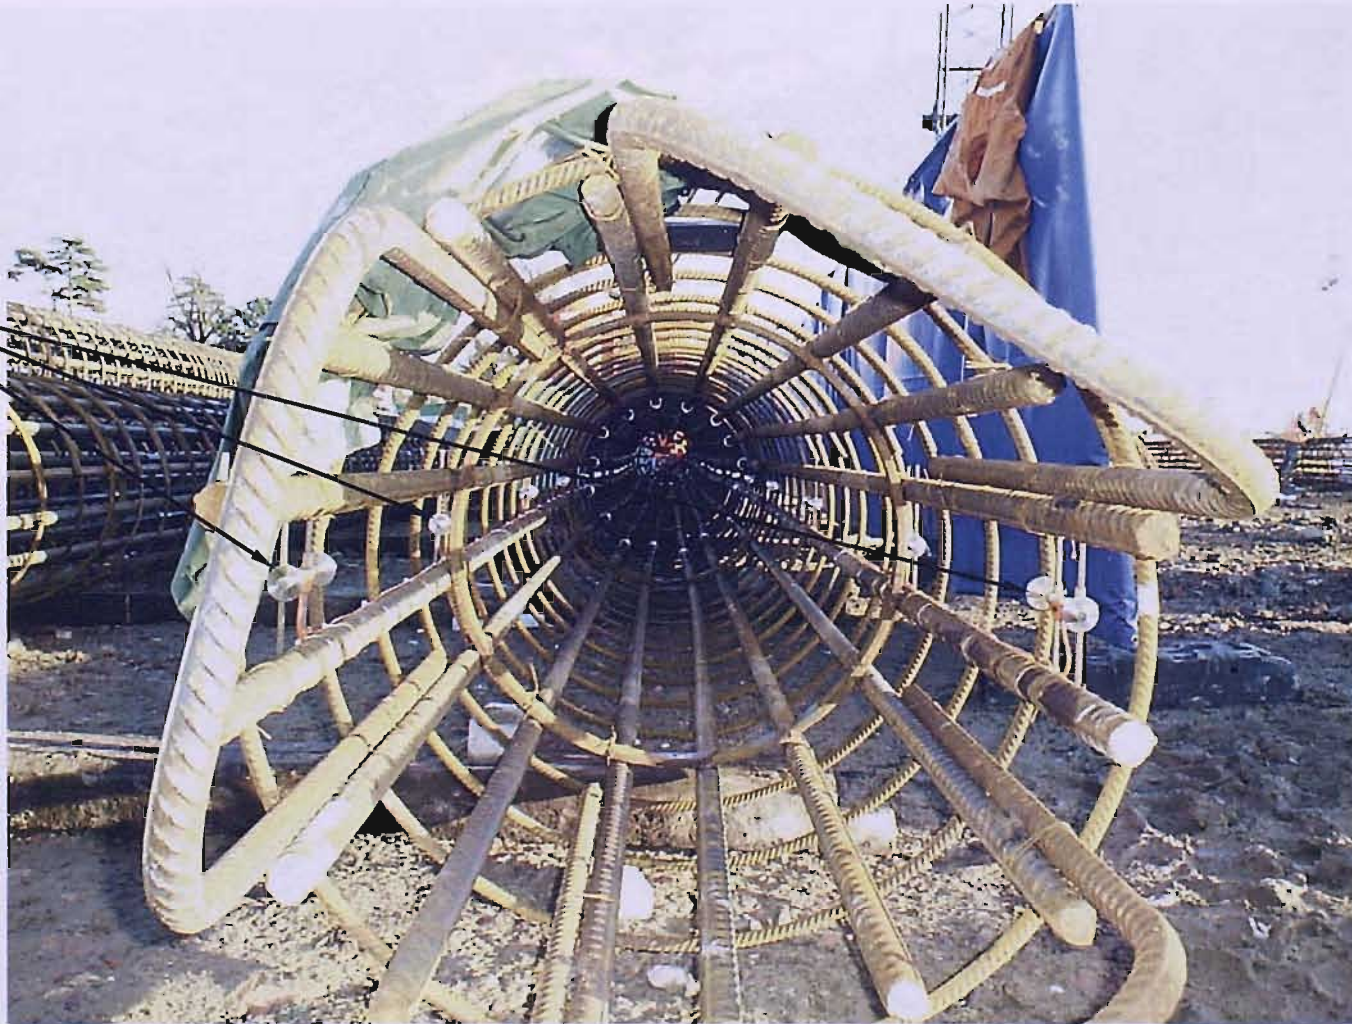
Figure 3-30: Strain gauges for measurement of pile bending moment

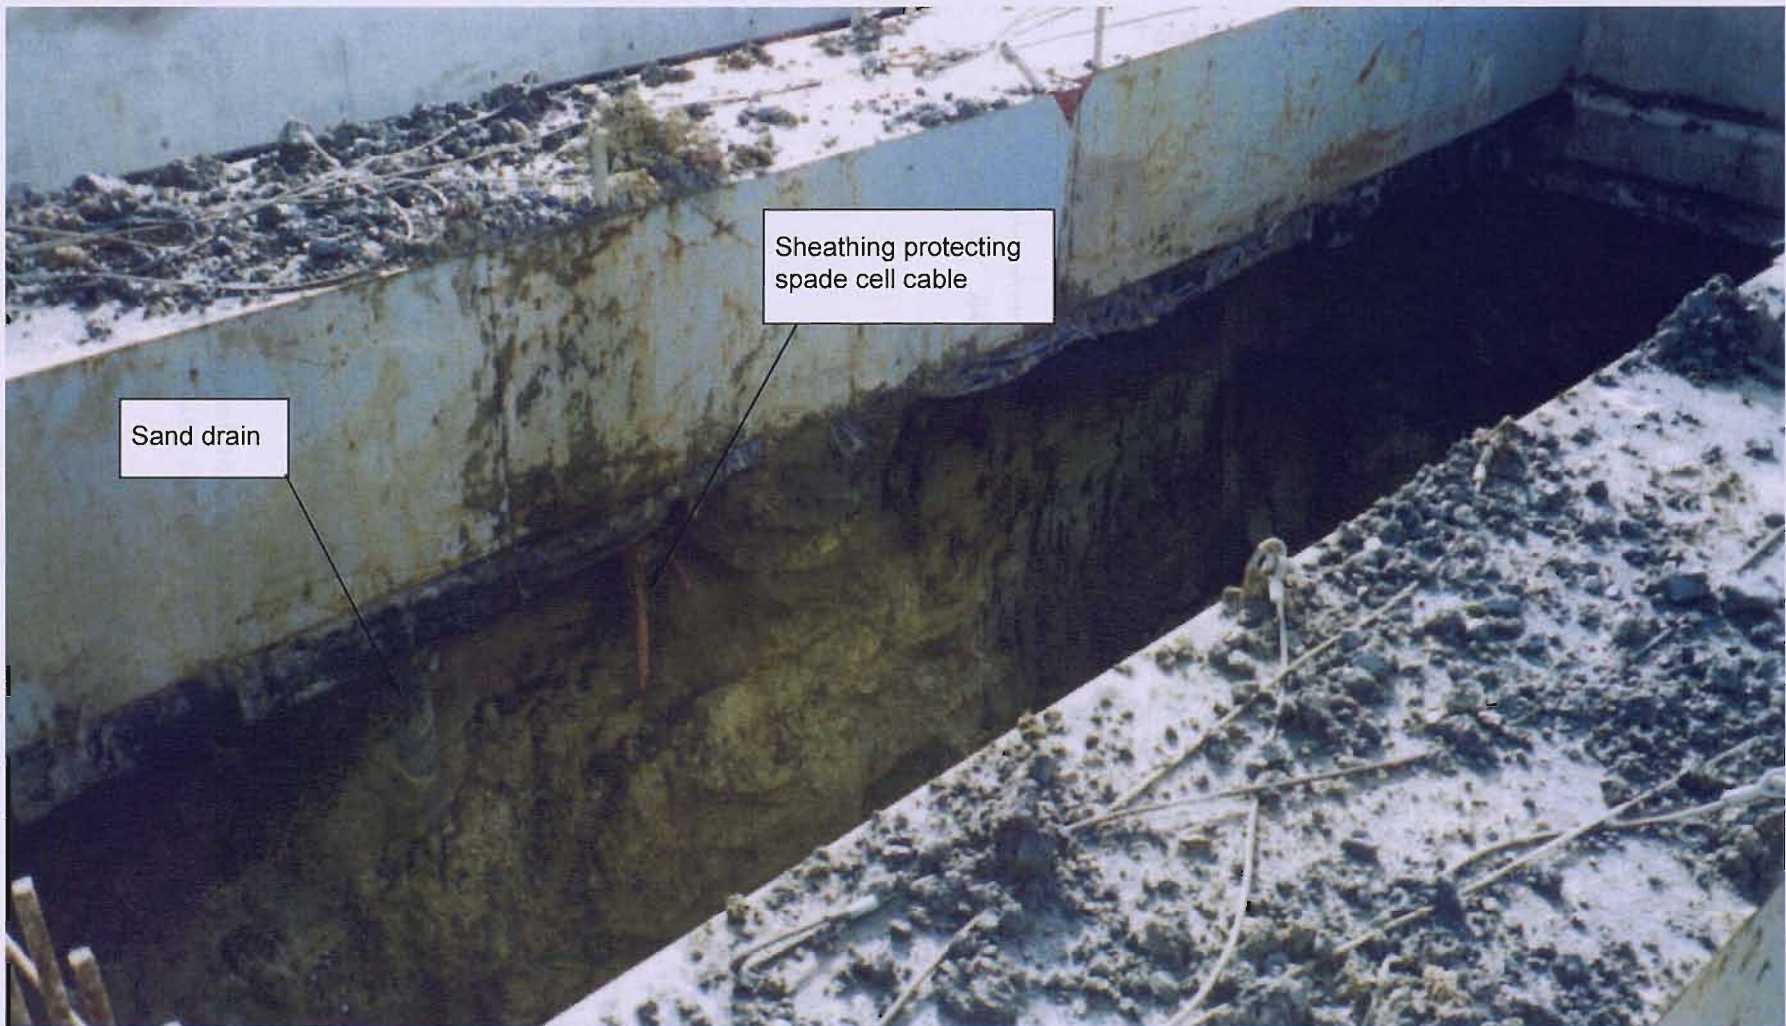
**Figure 3-31: Photo showing sand drain and cable for spade cell 11 (taken on 13<sup>th</sup> February 2001 – Day 495)**

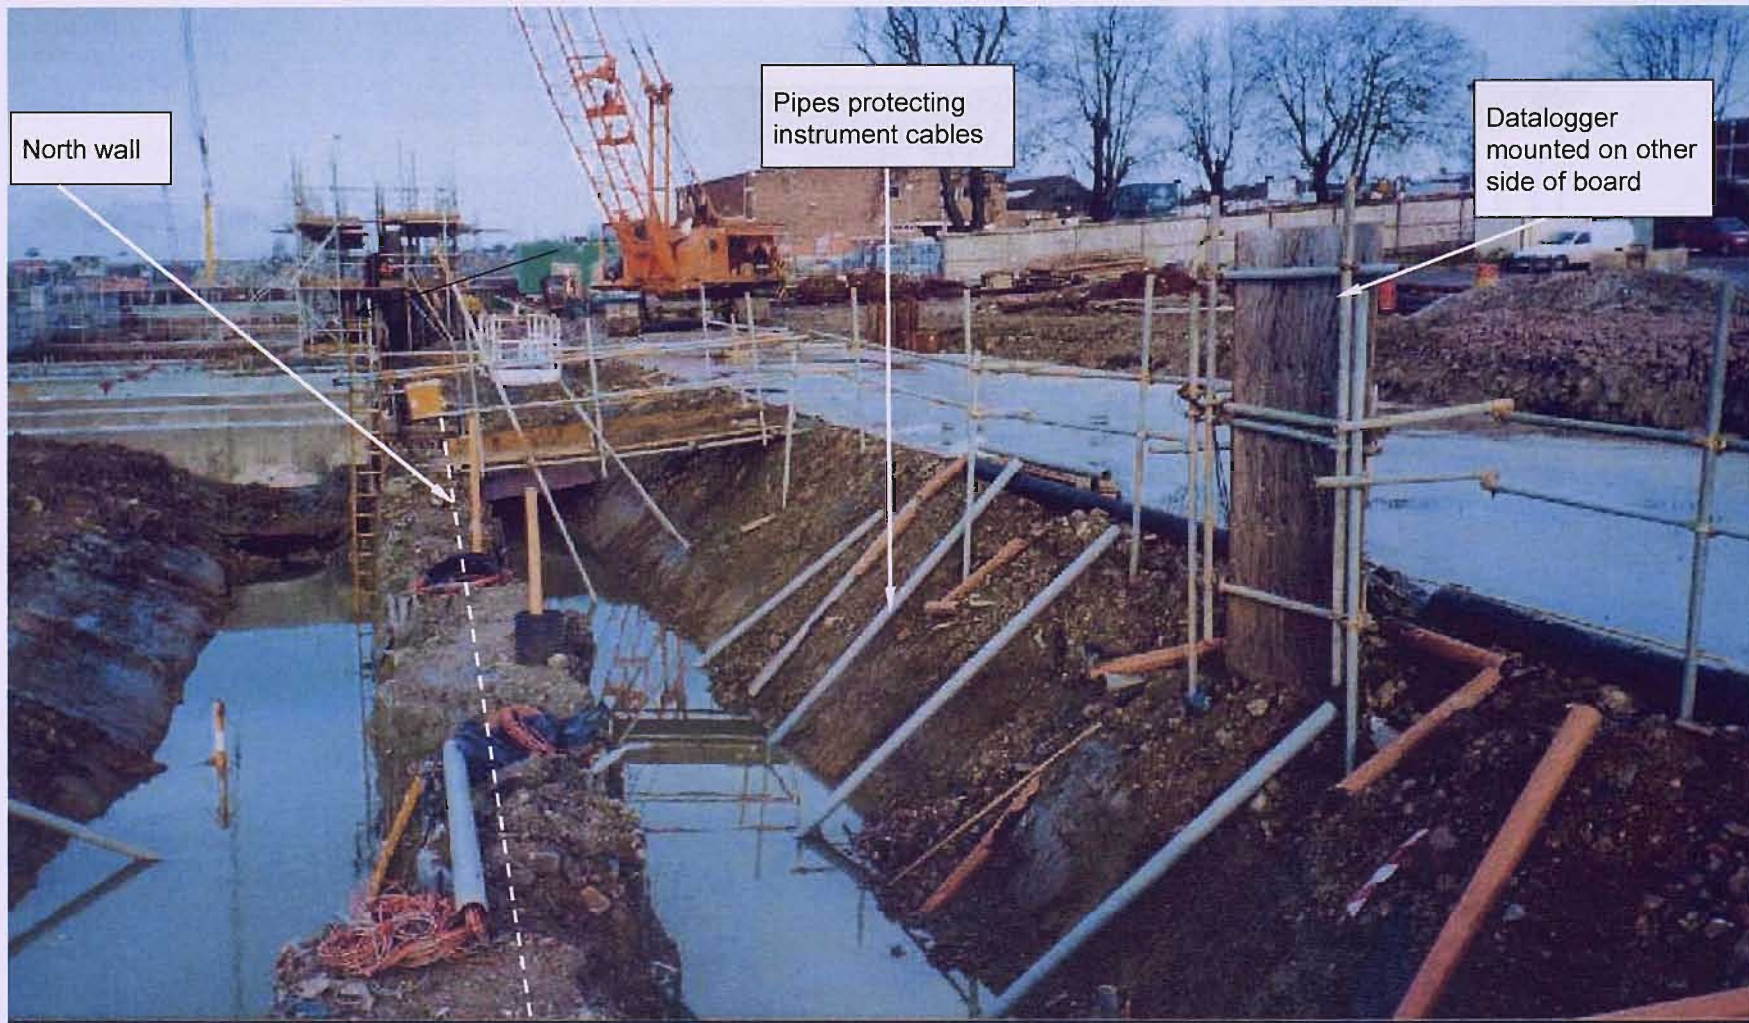
**Figure 3-33: Excavation either side of the north wall before break down to level of capping beam  
(taken on 1<sup>st</sup> November 2000 – Day 391)**

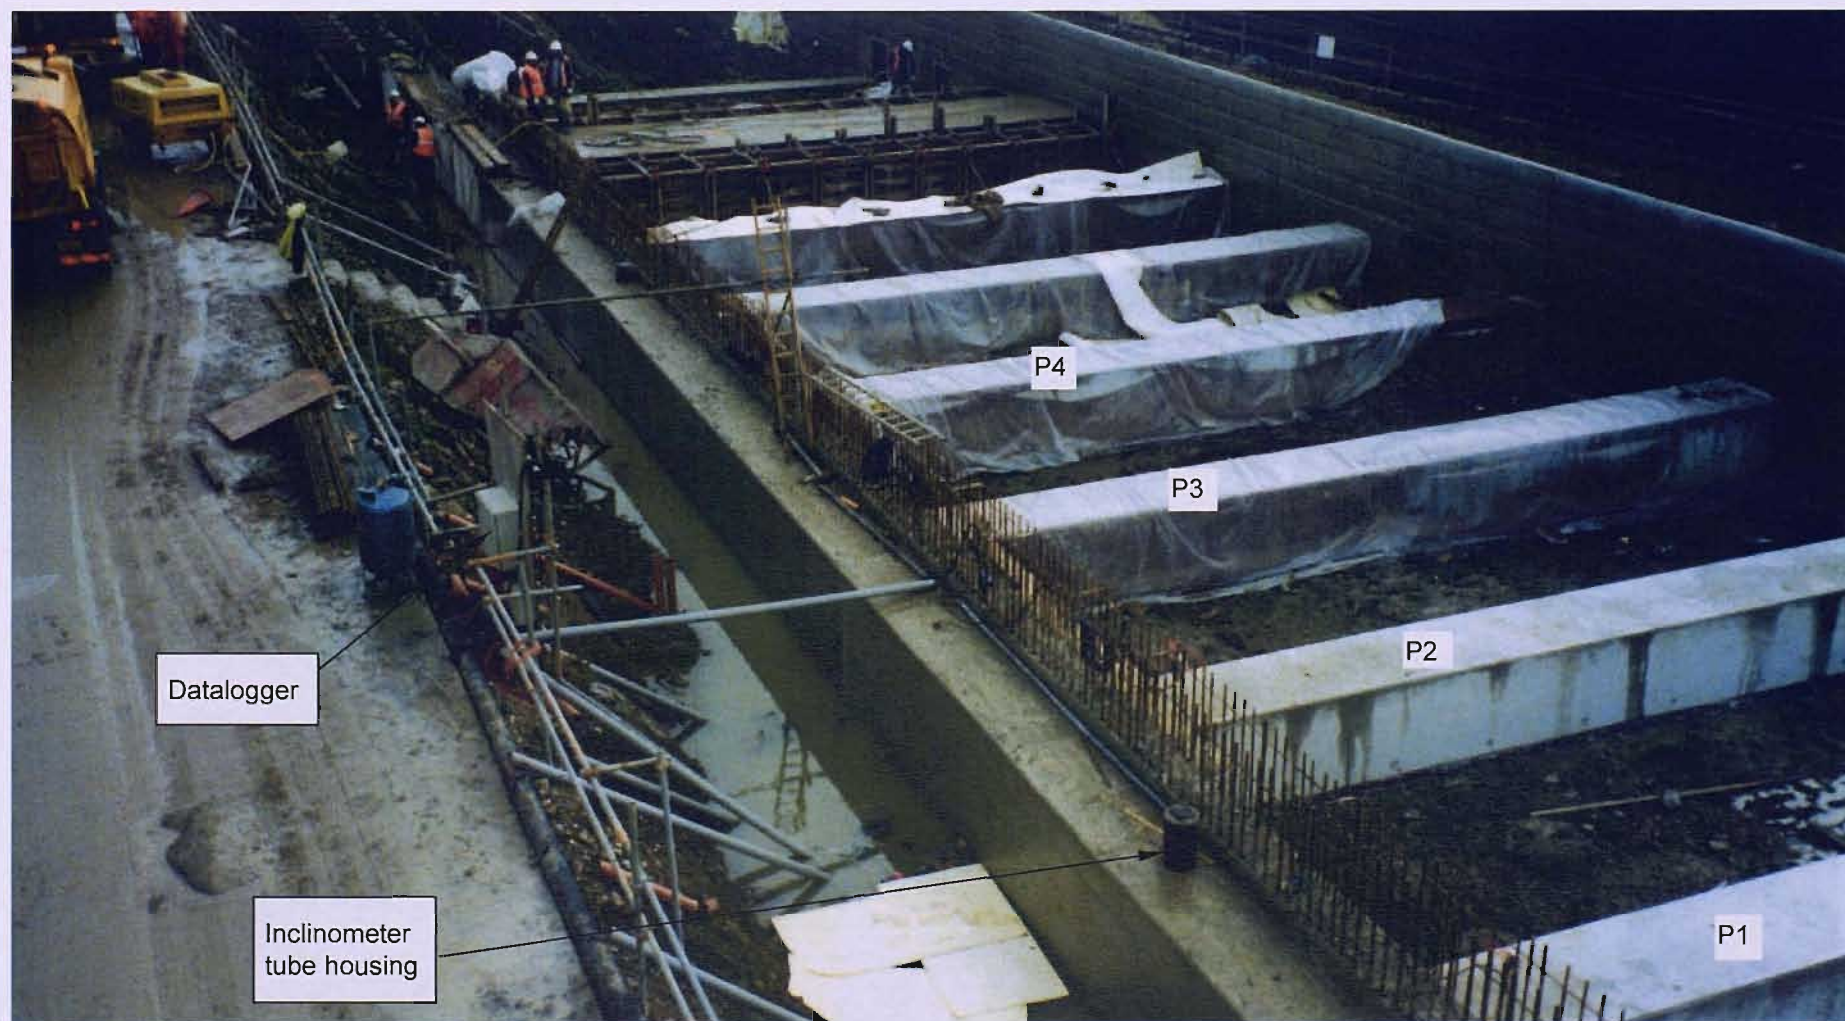
**Figure 3-40: Photo showing instrumented area before excavation (taken on 22<sup>nd</sup> January 2001 – Day 473)**

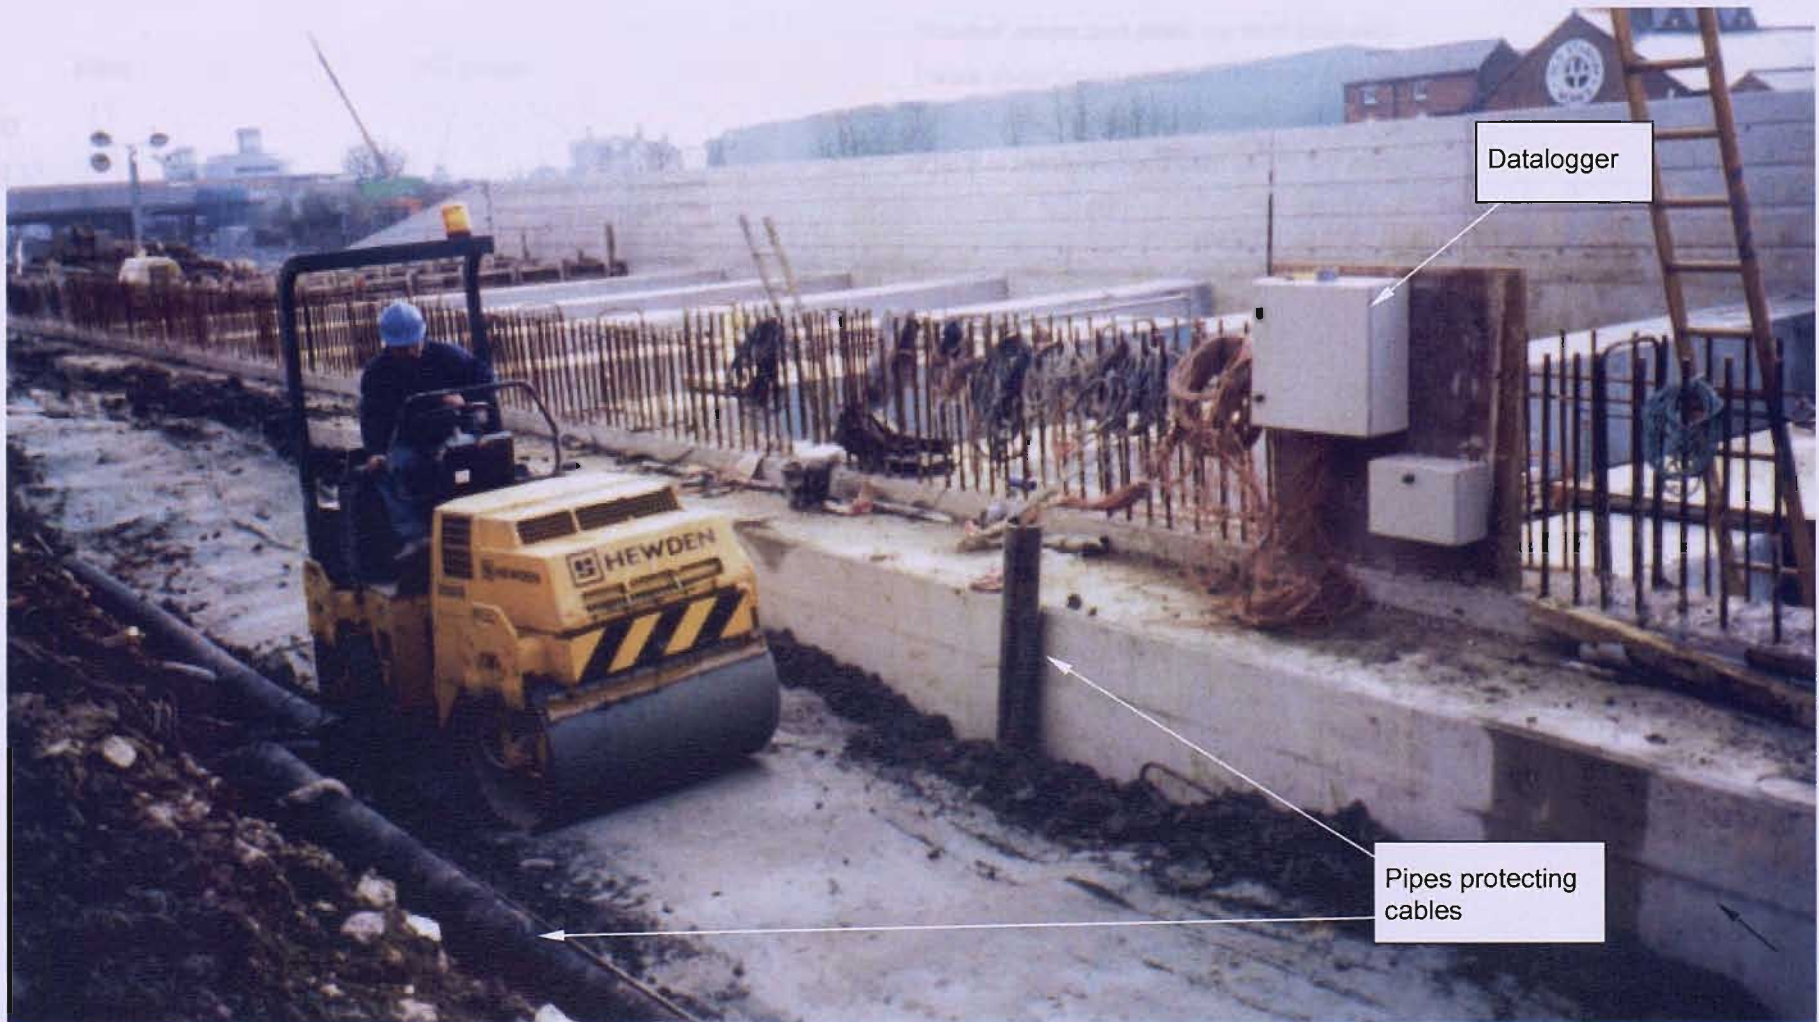
Figure 3-41: Compacting backfill in the instrumented section (taken on 29<sup>th</sup> January 2001 – Day 480)

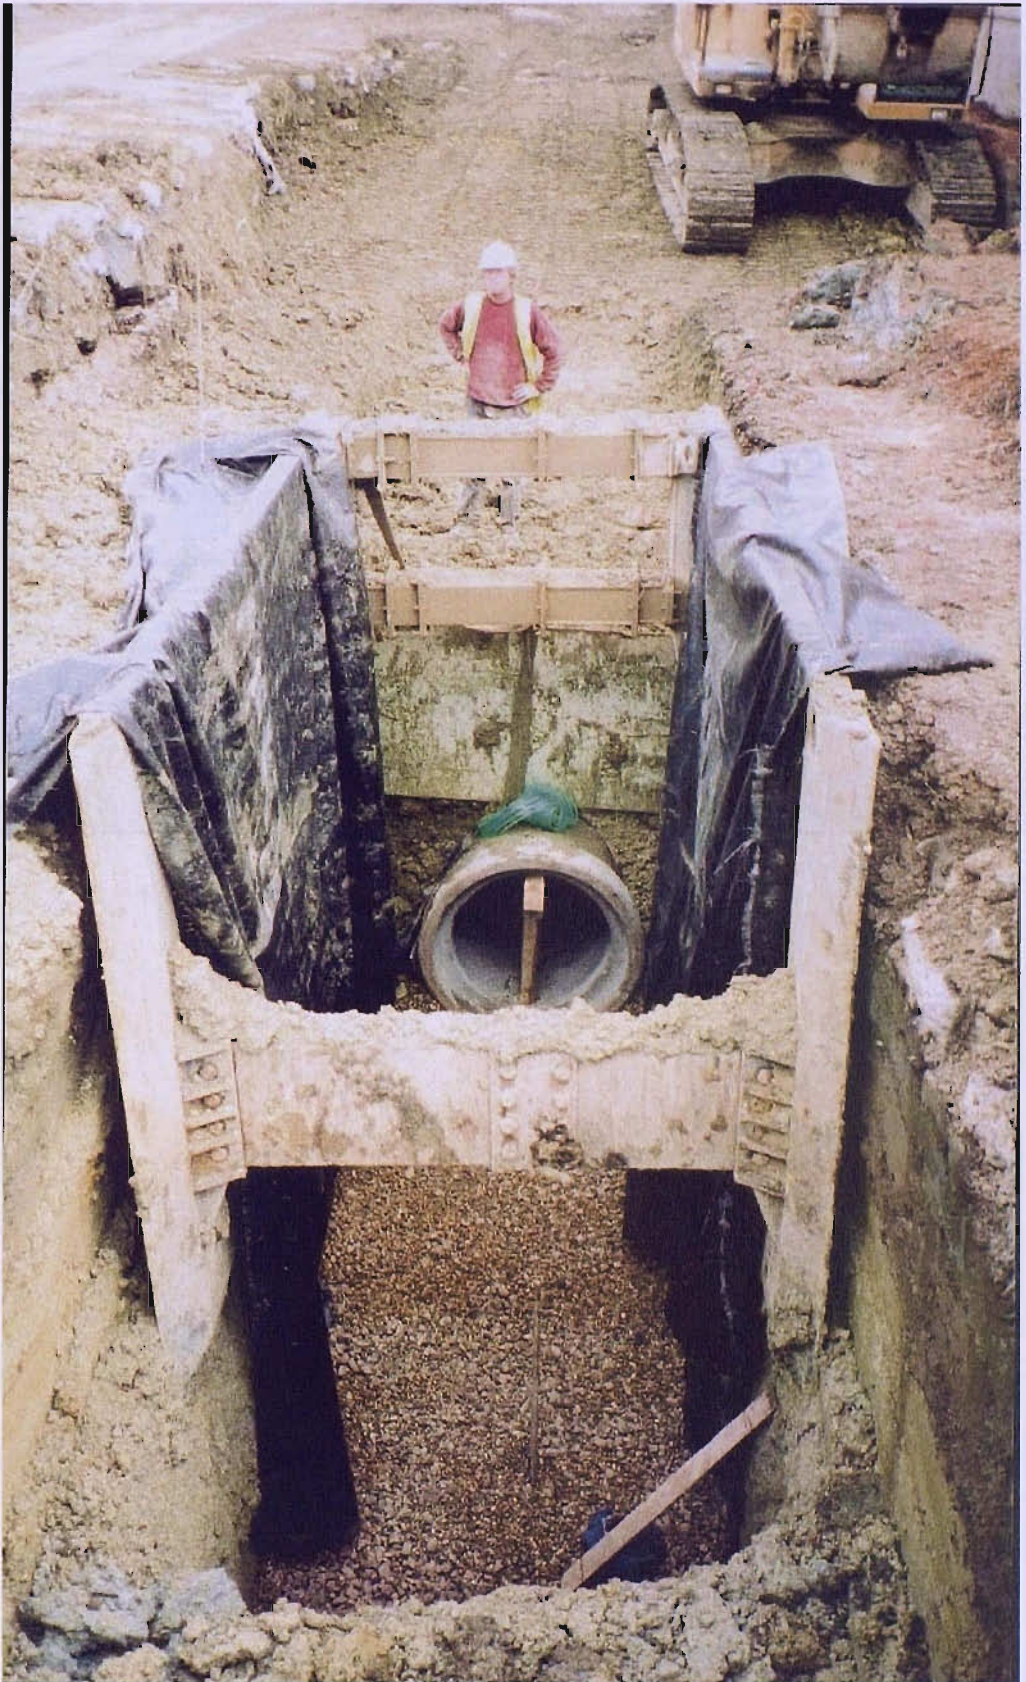
**Figure 3-48: Storm drain installed behind north wall in November 2001 (Day 864)**

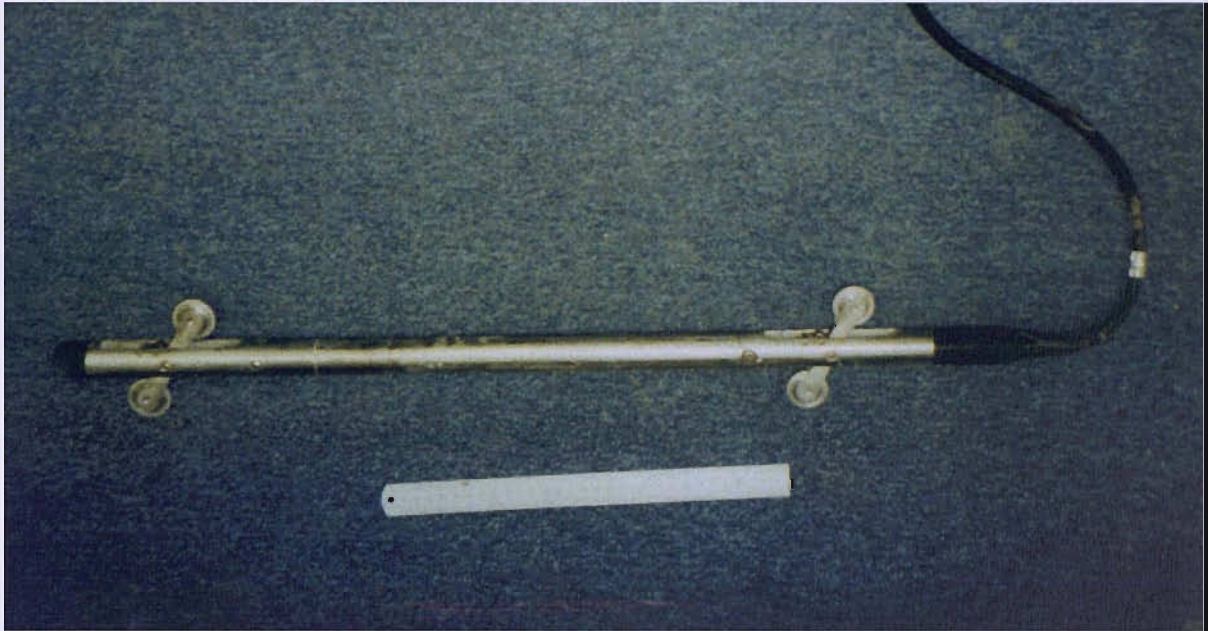
Figure 4-1: Inclinometer probe

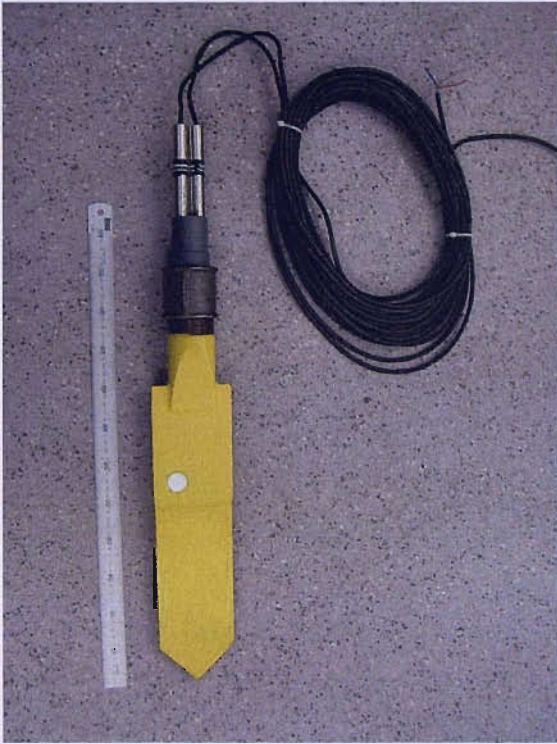
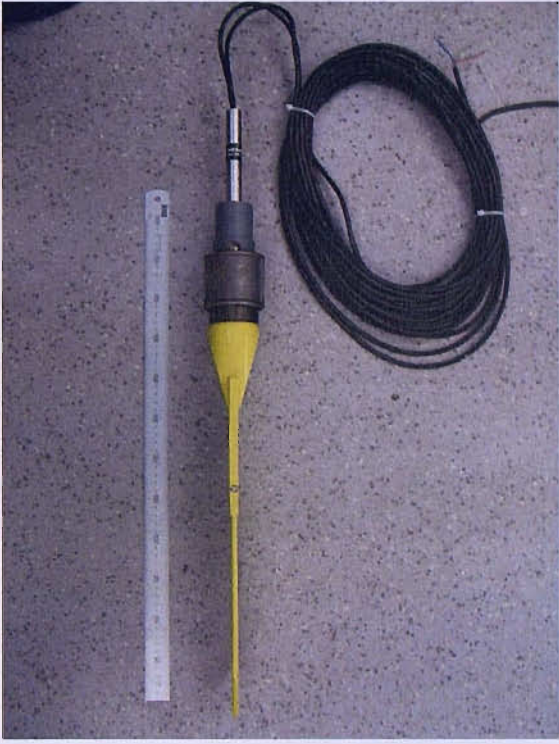
**Figure 5-1: Spade cell**

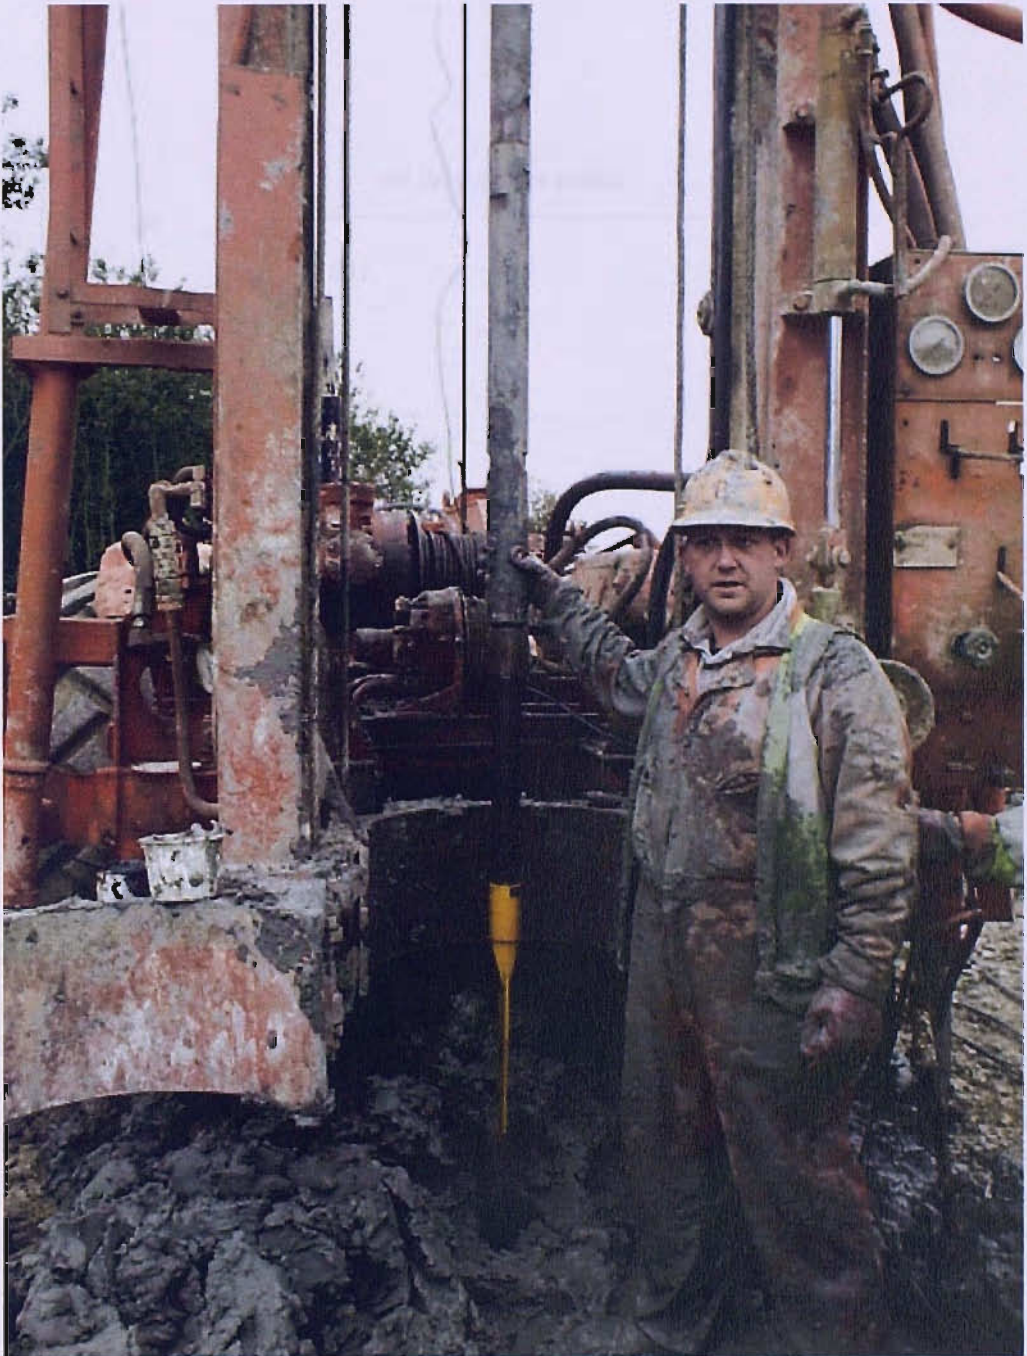
**Figure 5-14: Spade cell installation**
