AVT-109 The Control and Reduction of Wear in Military Platforms

Rolling Contact Fatigue - Review and Case Study

Aircraft Materials Evaluation Group
AD AIM

Case Study: Chinook Bearing Failure

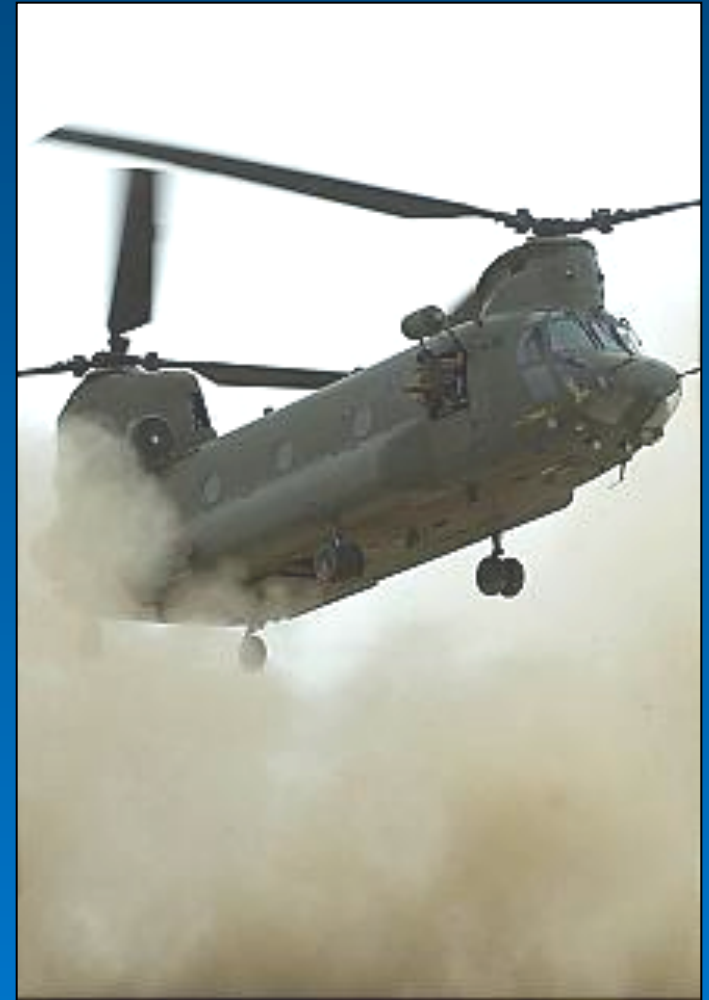
- Tribological failure investigation of a roller bearing
- Part of a rejected gearbox within a RAF Chinook
- Rejected due to an increasing vibration trend.
- Aims of investigation
 - Understand the cause, prevent re-occurrence
 - Interpret vibration data in terms of physical cause

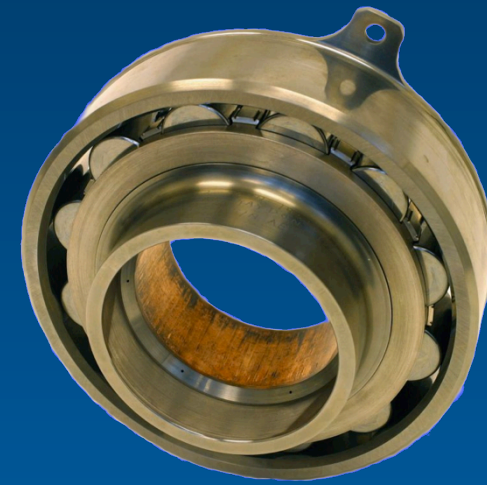
- Facts:
 - 12 rollers, 26 mm diameter (M50NiL)
 - Outer race fixed (M50)
 - Inner race (M50NiL) rotates at 12,263 rpm
- The most damage was found on inner race.
- Damage took the form of:
 - Subsurface macropitting
 - micropitting
 - GSC surface macropitting
 - Sliding wear (scuffing)
