# THE BEHAVIOUR OF RAILWAY LEVEL CROSSINGS: INSIGHTS THROUGH FIELD MONITORING.

**Key words:** level crossing, ballast, railway, railroad, geophones, digital image correlation, transition

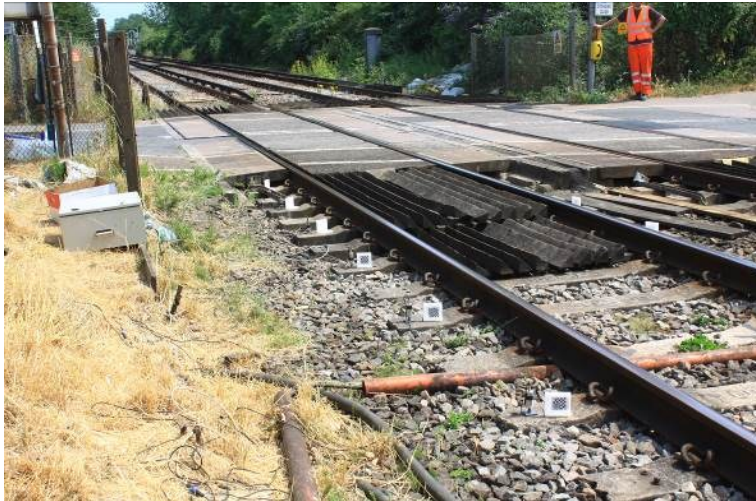
**Figure 1: Photo of level crossing looking towards the nearby station in the direction of the train movement on the near track**

The study site is shown in Figure 1. The site is underlain by soils of the London Clay formation (clay, silt and sand). Throughout this paper, distances are given from the edge of the level crossing on the side where measurements were carried out. At this location there are two tracks and the side of the track monitored is on the nearside of Figure 1 with trains moving from right to left. The start of a platform at a nearby station is about 200 m beyond the end of the level crossing, in the direction of train travel. A renewal took place through the station on 24 October 2012 but although this renewal was originally intended to include the crossing it was curtailed 35 m before the crossing, on the opposite side of the crossing to the monitoring location.

The level crossing is surfaced with Bowmac concrete panels, visible in Figure 1 (and also in Figure 5, see later). The Bowmac concrete panels rest on longitudinal concrete beams at the termination of the blacktop (tarmac), and on rubber wedges inserted into the rail webs to provide a roadway (Figure 1). Beneath the Bowmac panels, the track support structure is sleepers on ballast.

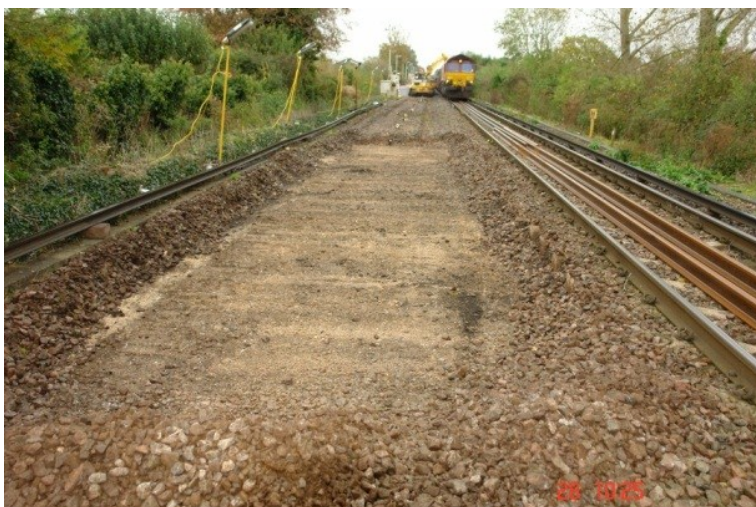
**Figure 2: Formation being prepared for track renewal looking towards the nearby station from the level crossing**

Figure 2 shows the track bed being excavated in preparation for the renewal. The renewal permitted an assessment of the likely trackform below the study site (where there was no renewal). Figure 2 shows that the ballast is partly fouled and a brown sandy / silty / clayey formation, probably intermixed with ballast fragments has started to be exposed. Neither a geotextile nor a sandblanket are present.

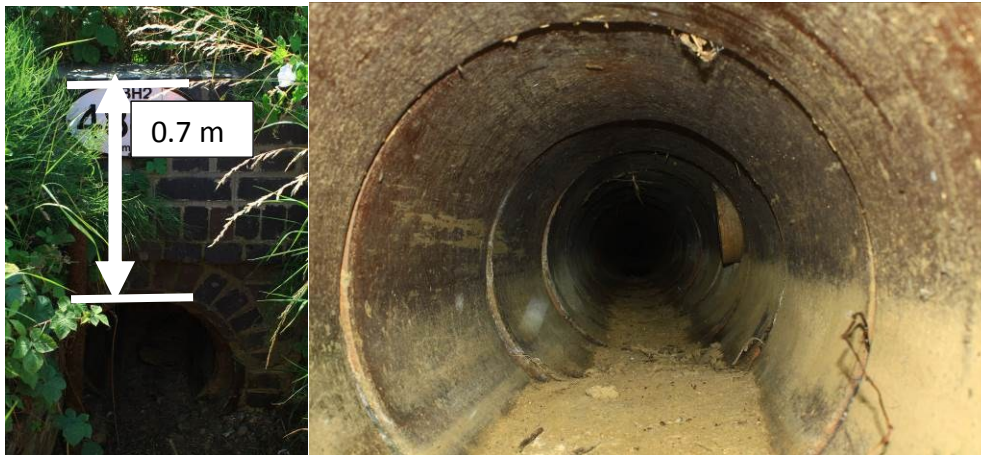
**Figure 4: Culvert below the level crossing**

A culvert passes below the track on the side of the level crossing studied; the inside of the top of the culvert was estimated to be at 0.7 m below sleeper level and is shown in Figure 4. The culvert represents a potential hard spot beneath some of the sleepers near to the crossing.

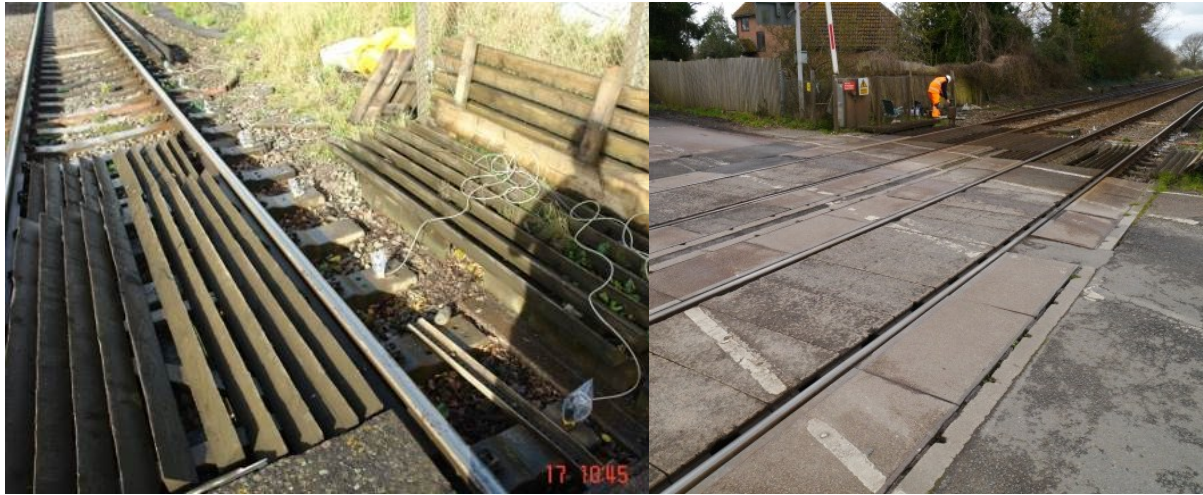
**Figure 5: (a) Arrangement of geophones and (b) level crossing viewed from the opposite side of the road from the instrumented section**

Geophones and digital image correlation (DIC) of video images following the principles described in Bowness et al (2007) were used to determine track movements during train passage along a run of 14 sleepers up to the crossing as shown in Figure 5. The geophones were placed on 7 alternate sleepers from the termination of the third rail on the approach to the crossing. The geophones are visible in Figure 5 as small cylinders covered in plastic bags with cables connecting them to a Campbell 9000 data logger (Campbell Scientific, 2014) situated beside the track and out of view. The geophones are attached to small metal brackets glued temporarily to the sleepers.

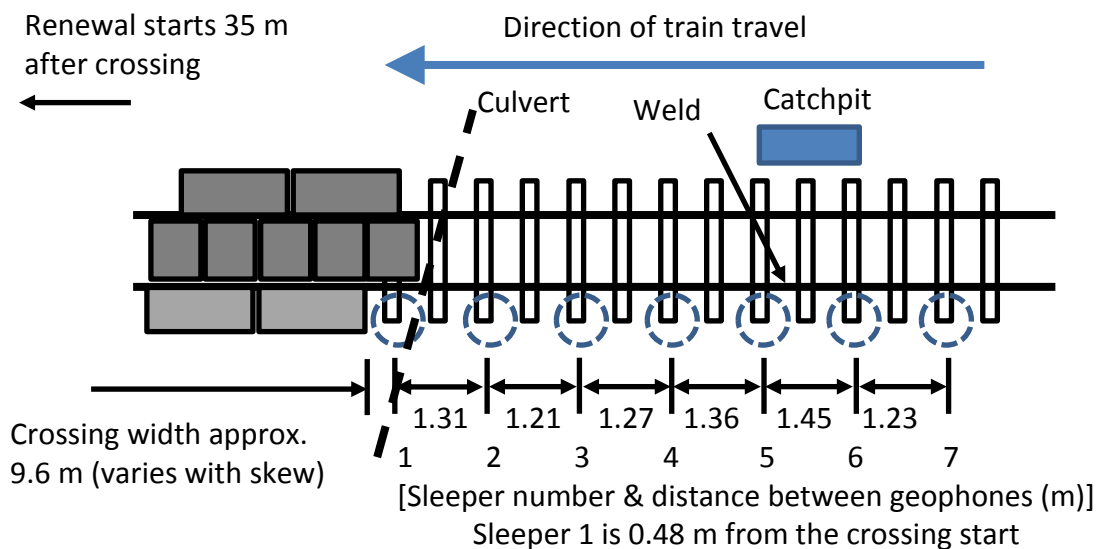
**Figure 6: Schematic plan of the area of interest**

Figure 6 shows a schematic plan of the instrumented area including various features, dimensions and the numbering of sleepers adopted when presenting the track measurement data. The crossing is skewed (i.e., it is not at  $90^\circ$ ) to the track with a width generally of 9.6 m (measured across the road in the direction of the track). Bowmac panels forming the road surface of the crossing are occasionally interspersed with tarmac fill (visible in Figure 5b), perhaps evidencing previous ad hoc repairs to the roadway.

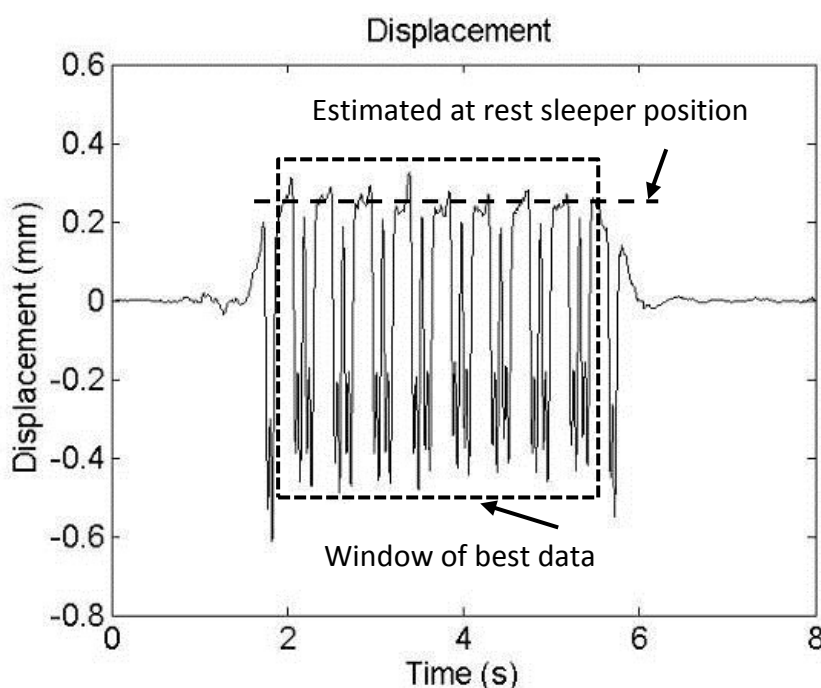
**Figure 7: Example geophone data, processed and filtered to give track displacements**

Figure 7 shows a sample of geophone data obtained during passage of a 9 car Pendolino (class 390) train on the West Coast Mainline, UK (WCML). This track is performing well and Figure 7 illustrates typical geophone data in the absence of track faults. The data have been processed to show the displacement against time, and the axles, bogies and cars can be identified in the trace. The displacement data are obtained from the measured raw velocities by integrating and applying signal processing techniques to filter out low frequency data below the threshold of linearity for the geophone used and high frequency data not significant to the major displacements following established mathematical practice (see, for example, Santamarina and Fratta, 2005 or Rao, 1986). Provided the lowest main frequency content measured by the geophones is above a minimum frequency related to the limit of linearity of the geophone used, the geophones are able to measure accurately the peak-to-peak movements of the track. In practice, for the 1 Hz natural frequency geophones used, the trains generally need to be travelling at more than 30 mph (45 km/h). In this example the displacement trace has been calculated following application of a 1 Hz high-pass and a 30 Hz low-pass Butterworth filter.

As a result of the (unavoidable) 1Hz high pass filter applied, the displacement trace always has a zero mean over any 1Hz equivalent (1 second) portion of the time trace and it is usual to ignore the first and last axle passes as their relative positions are more significantly affected. In this example, the dashed lines in the plot indicate an estimate of the at-rest sleeper position and the window of best data. Figure 7 shows that the track displaces approximately 0.8 mm; data obtained by the University of Southampton from a variety of sites indicate that displacements between 0.5 mm and 2 mm are typical in the UK for ballasted plain line track in serviceable condition. Further details of the first use and development of geophone methods for measuring track movements can be found in Bowness et al., (2007).

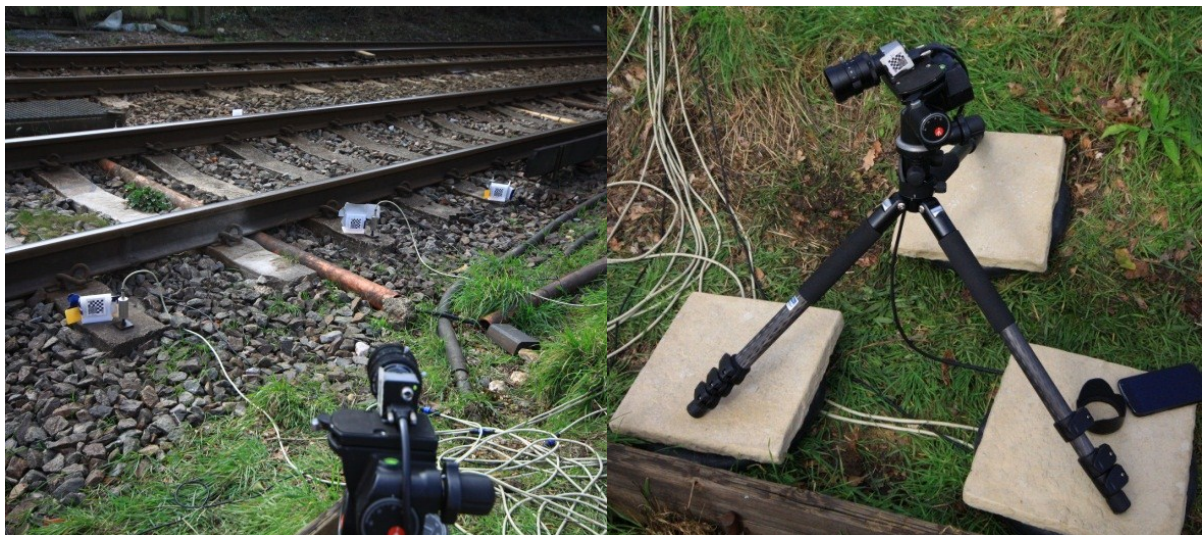
**Figure 8: (a) targets on sleepers and (b) camera set up**

To aid the analysis and provide a reference for scaling it is usual (although not a requirement of the system) to attach square textured targets to the sleeper ends (Figure 8a). Filming of these targets generates a video file which is then converted to a series of jpeg images for analysis. The analysis is carried out using a variant of the digital image correlation technique described by Bhandari *et al.* (2012). The technique involves defining measurement (tracking) points and identifying corresponding patterns at these points in the subsequent images using a normalized cross-correlation algorithm. The basic assumptions are that the pattern is approximately constant between successive images and that the local textural information is unique. To allow maximum flexibility a bespoke front end Matlab (Mathworks, 2012) script is used which permits a target (Figure 8a) of known dimensions to be selected. The movement is then determined for a subset of pixels of user defined number in each image in sequence, relative to the initial image.

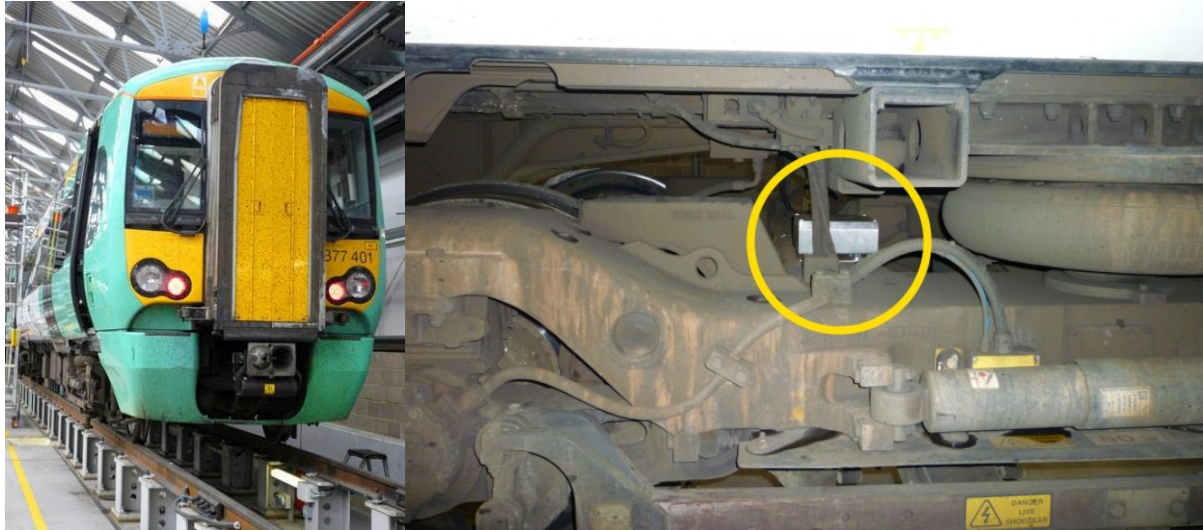
Figure 9: Class 377 train and location of inertial measurement box

In addition to the TRC data, an in-service Class 377 train has been instrumented by the University of Birmingham (UoB) to obtain more frequent, albeit less accurate, track geometry measurements. An inertial measurement system is attached to a bogie to determine the orientation and trajectory of the bogie. From this information the left and right rail vertical geometry can be inferred (Weston *et al.*, 2007). As the bogie is separated from the rails by the primary suspension and its movement driven by both the leading and trailing wheelsets on the bogie, the left and right rail geometry are estimated with some error. Despite this, the results are comparable to the NR TRC at wavelengths longer than 3 m, as will be demonstrated later. Figure 9 shows the class 377 train and the location of the Birmingham instruments.

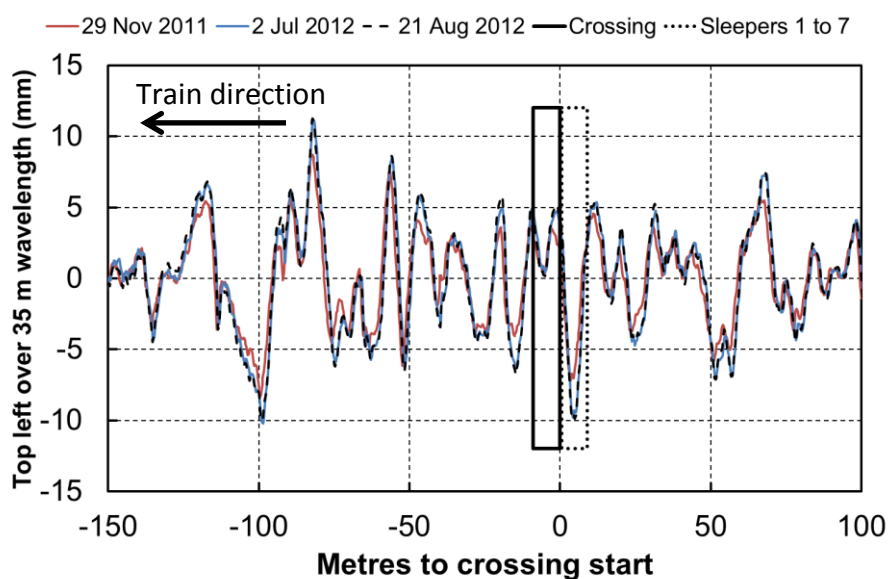
**Figure 10: TRC data, top left (vertical alignment of the left rail viewed from the train) prior to renewal**

In Figure 10, TRC vertical geometry data for the rail nearest the geophone locations are shown for three runs prior to the renewal: between November 2011 and August 2012. In Figure 10, trains are travelling from right to left corresponding to the movement of trains as observed from the near trackside (the side from which the photograph in Figure 1 was taken). The x-axis is shown in relation to the crossing edge on the side being monitored with the crossing being present between approximately 0 and -9 m. The monitored sleepers 1 to 7 are within approximately 0 to 9 m on the x-axis. As is usual with this type of data, the relative distance along the track for different runs can vary by some tens of metres. The data can be aligned by adjusting the relative distances, but finding the exact location in relation to track features remains subject to some uncertainty.

The data show little change in vertical alignment over the period, although there is some evidence of a tamping intervention between the November 2011 and July 2012 TRC runs. This had only a minor effect and the track has reached a state of poor quality characterised by a significant range in vertical alignment but more importantly by large changes in vertical geometry over short lengths. However, the vertical alignment is remaining reasonably constant over time so that the rate of track degradation is low and reducing with further cycles of load (Selig and Waters, 1994).

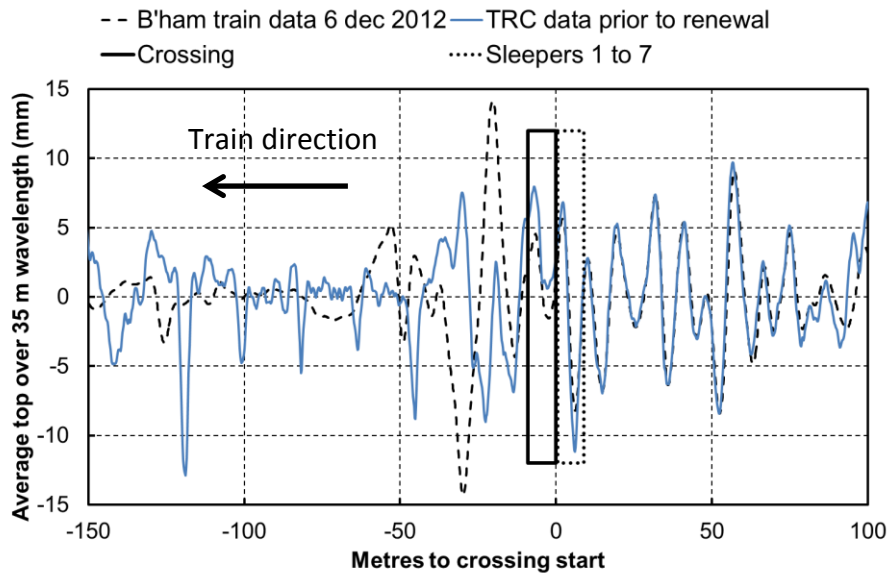
**Figure 11: TRC data and UoB instrumented train data, mean top left (vertical alignment)**

To compare the data from the TRC with those from the UoB instrumented train, a fourth order reverse filter was applied to the averaged top of the TRC data to correct the phase (it is thought the TRC data are only filtered in the forward direction). Figure 11 compares the TRC data from before the renewal with UoB train data from after the renewal. The renewal was observed (measured) to terminate at 35 m from the opposite side of the level crossing (approximately at  $x = -45$  m in Figures 10 to 12); this information enables the uncertainty in the precise location of the level crossing in relation to the train recorded data to be reduced. Between  $x = -45$  m and  $x = 0$  m the track geometry is influenced by the adjacent renewal and associated tamping works and the track geometry changes following renewal. At values of  $x$  less than  $-45$  m there is a dramatic reduction in the variation in track geometry as a result of the renewal. At values of  $x$  greater than  $0$  m the pre and post renewal data align very closely, with large variations in vertical level both before and after the renewal.

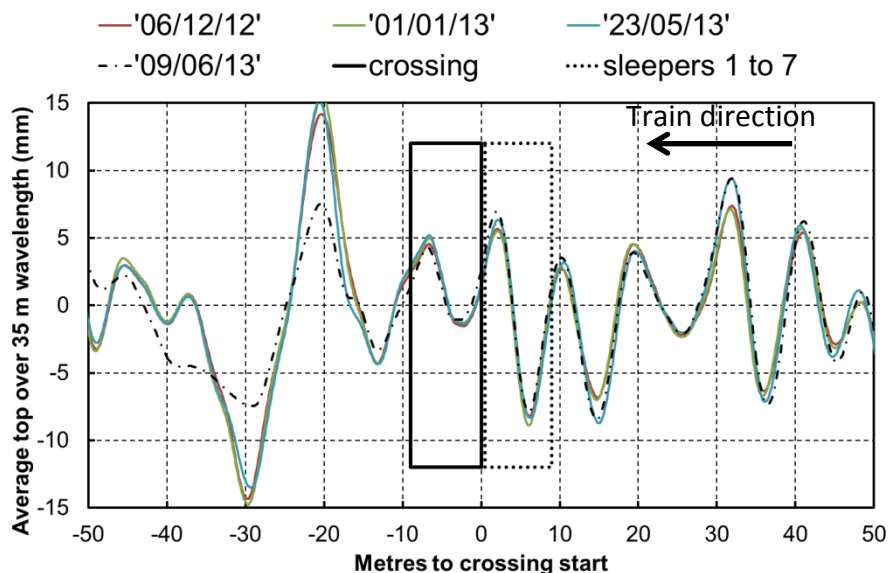
**Figure 12: UoB train data, June 2012 to September 2013**

Figure 12 shows a series of runs of the UoB instrumented class 377 train over the level crossing between December 2012 and June 2013. These data are generally very consistent between runs and little appears to happen at the site until the final run; it is therefore possible to conclude that a maintenance intervention took place between 23 May and 9 June 2013. Further investigation found that tamping took place over the full length of track shown in Figure 12 on 4 June 2013. This had some influence on the data, mainly between  $x = 0$  m and  $x = -50$  m, with relatively minor changes elsewhere.

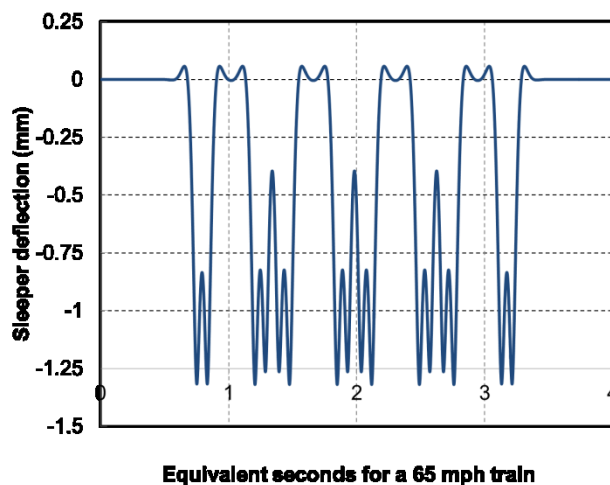
**Figure 13: Theoretical track deflection for 4 car class 377 train travelling at 65 mph**

Figure 13 shows interaction between adjacent axles and bogies with the track only returning to its initial position between cars, where there is also some uplift due to the bending stiffness of the rails.

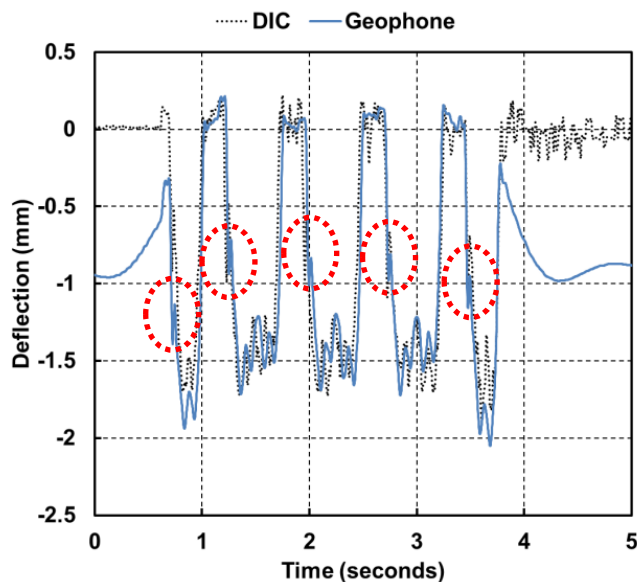
**Figure 14: Track measurements at sleeper 4 for a class 377 train travelling at approximately 65 mph (29 m/s)**

For comparison, the track deflections measured at sleeper 4 for a 4 car class 377 during the March 2014 visit are shown in Figure 14. This highlights some key features of the

- The track at this sleeper has a lower support stiffness than used in the the example calculation, as shown by the larger movement and the trace fluctuating more. In particular there is a repeating feature (circled), which is thought to be caused by the impact load at a previous hanging sleeper. This is discussed later.
- Due to the processing techniques applied it is necessary to ignore the first and last bogies in the geophone data. Also, the geophone data are normally averaged about zero but in Figure 14 the trace has been migrated so that zero is an estimate of the at rest sleeper position.
- The DIC data and geophone data are in close agreement for the middle 6 bogies
- The DIC data includes some low frequency groundborne or wind generated vibration, which can be seen on its own after the train has passed (oscillations between 4 and 5 seconds).

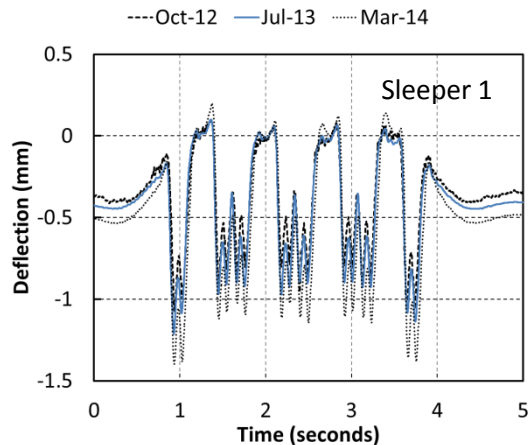
**Figure 15: Geophone data from the three visits for sleepers 7, 6, 4, 3, 2, 1 and DIC data from the two more recent visits for sleeper 5. The geophone data are filtered between 1 and 30 Hz and the DIC data have a low pass filter with a high cut off frequency of 18 Hz. Geophones for sleeper 5 were omitted because their movement was too fast for the sensors.**

Figure 15 shows data from 3 train passes, one from each visit, for all of the instrumented sleepers (7 to 1, in the order traversed by the train). The trains were travelling at approximately 65 mph (~29 m/s) and the data have been shifted fractionally so that each trace overlays. The vertical scales differ in between graphs, but note the large changes in movement from sleeper to sleeper.

Examination of the geophone measurements for sleeper 5 from all the visits and for sleeper 6 for the first visit revealed that on these occasions the geophones were reaching their maximum speed of movement and sleeper movements were probably in excess of 5 mm. DIC measurements for sleeper 5 were taken on the latter two visits and confirmed that the movement range was nearly 6 mm. The data for sleeper 5 match the shape of the data expected from theory; however, the data from all of the other sleepers have features that

should not be there as indicated by the dotted circles in Figure 14. It is thought that a large impact is occurring at sleeper 5, which is causing the unusual movements that are not in phase with the axle passage at the other sleepers.

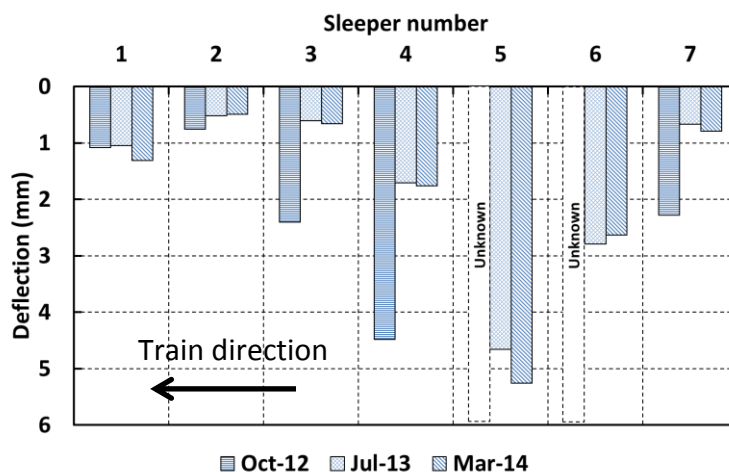
**Figure 16: Sleeper deflections for axle 7 of a class 377 train travelling at approximately 65 mph (~29 m/s); data from all visits for all sleepers**

Figure 16 summarises the sleeper movements for axle 7 as a bar graph. Both Figures 15 and 16 show that there is some improvement in performance of this section of track following the tamping (or Kango packing) of 4 June 2013 as evidenced by the reductions in some of the geophone movements. However, the track performs very poorly on all visits in terms of large variations in movement between nearby sleepers and the generally low support stiffness. In particular, sleepers 5 and 6 show large movements, indicating that they are almost certainly hanging (voided). Sleepers 1 and 2, nearest the crossing and possibly over the culvert, are performing the best in the sense that their movement is consistent between visits and generally small (<1.5 mm). Sleepers 7 and 4 show the greatest improvement in terms of a reduction in the movement as a result of the tamping intervention of 4 June 2013.

Figure 16 shows that prior to the tamping of 4 June 2013, the largest sleeper movements were centred around sleepers 5 and 6 (which were offscale for geophone measurements) and sleeper 4. These movements are consistent with a lack of support due to sub-sleeper

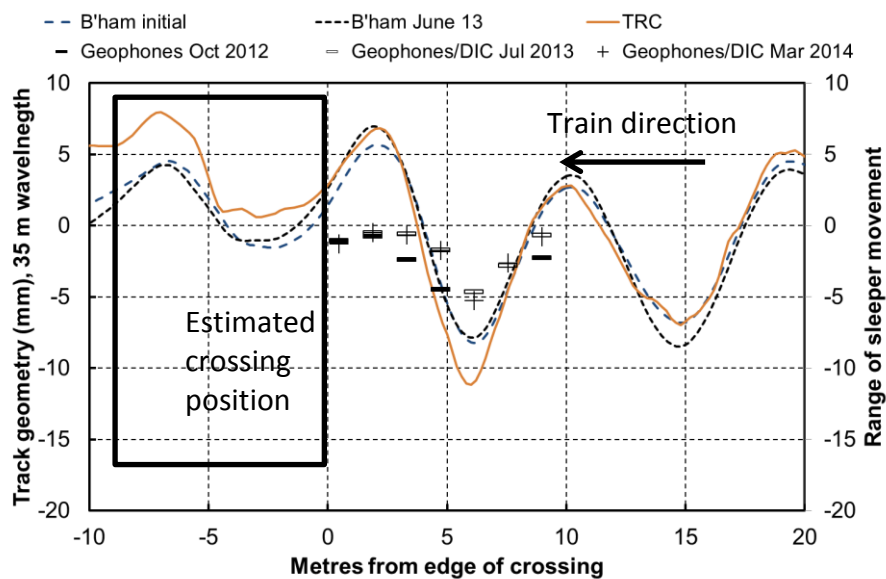
**Figure 17: Comparison of TRC data prior to renewal, UoB train data and geophone data before and after follow up tamping on 4 June 2013.**

Figure 17 compares the TRC data prior to the renewal in October 2012 and two UoB instrumented class 377 train runs from before and after the tamping of June 2013 with the magnitudes of sleeper movement from the geophone and DIC measurements. This comparison shows that the track measurements of deflection do indeed lie around a relative dip in the train recorded track geometry, which corresponds to the position of the worst hanging sleepers.
