**Observing early stage rail axle bearing damage**

*Dr N. Symonds <sup>1</sup>, Dr I. Corni <sup>1</sup>, Prof R.J.K. Wood <sup>1</sup>, Dr A. Wasenczuk <sup>2</sup>, Dr D. Vincent <sup>2</sup>*

*1. National Centre for Advanced Tribology at Southampton (nCATS),  
University of Southampton, SO17 1BJ*

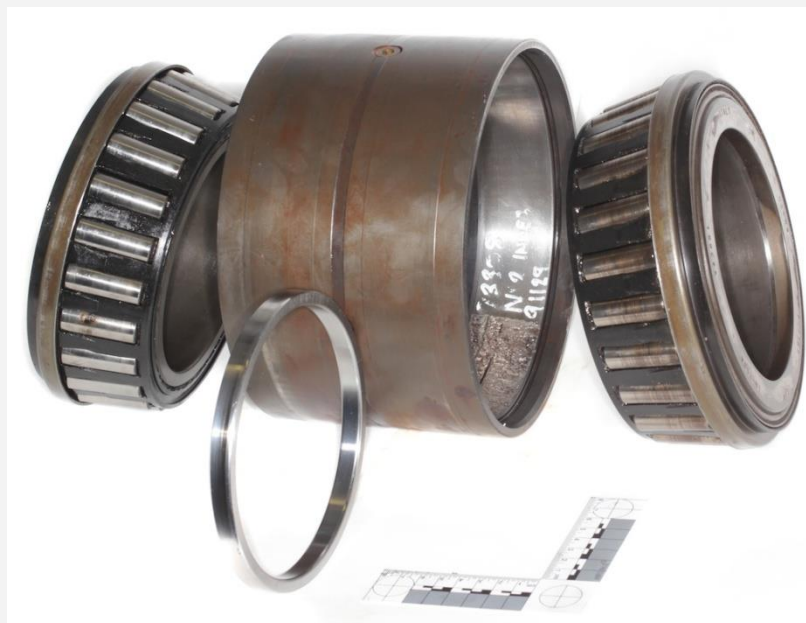
Figure 2: Damaged bearing

Figure 1 plots vibration against time as recorded by the on-board sensors. The failed bearing (Figures 2 and 3) displayed consistently higher readings than the other bearings from the same side of the same unit. Figure 4 shows subsurface damage visible on a CT slice.

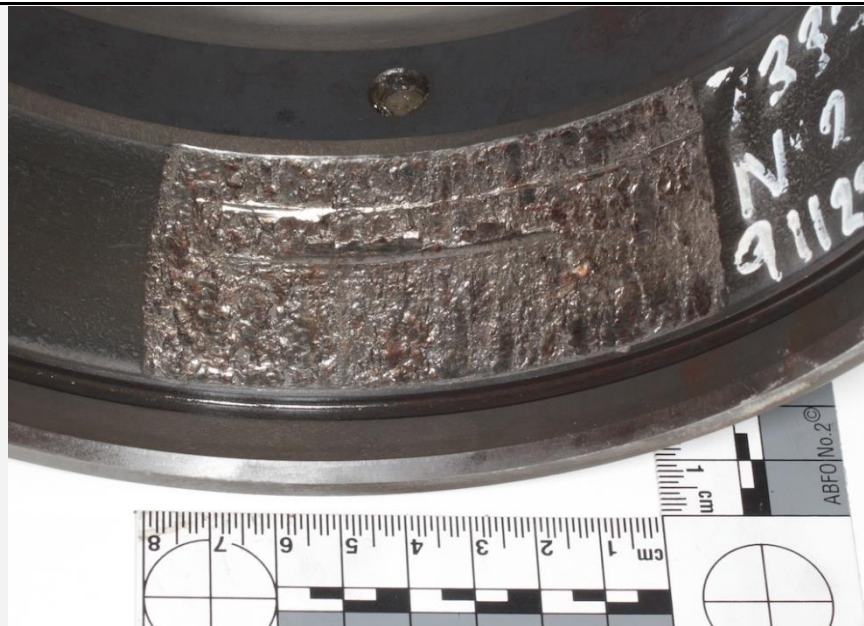
Figure 3: Damaged outer race
