1 **Title:** Tensile and hydraulic properties of geosynthetics after mechanical damage and abrasion
2 laboratory tests.

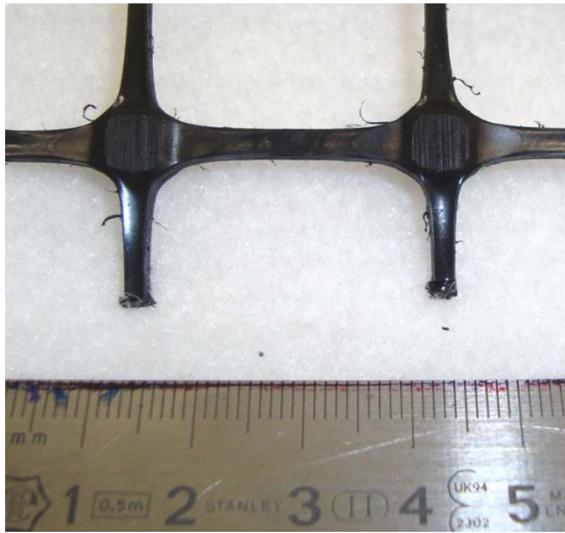
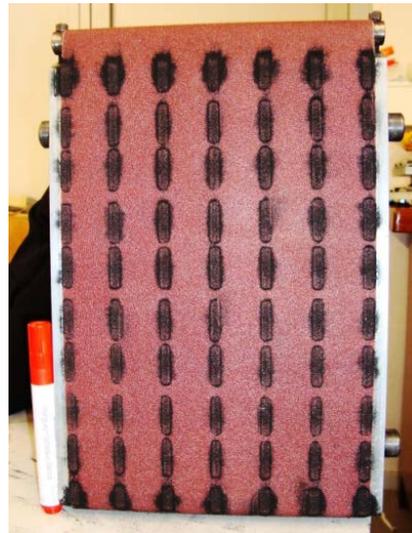
710 **Figure 1 – Visual effects of abrasion damage tests on GGRé (a) and on the abrasion film (b).**

236 Visually, the extruded geogrid (GGR_e) was the material least affected by mechanical
237 and abrasion damage induced in the laboratory tests, although abrasion (either in isolation or
238 combined with mechanical damage) induced reductions of about 13% of its junctions. In the
239 abrasion tests on GGR_e only its junctions were in contact with the abrasive (Figure 1) as its
240 junctions are thicker (5.8 mm) than its ribs (1.4 mm and 2.2 mm, respectively, for the
241 transversal and longitudinal ribs).

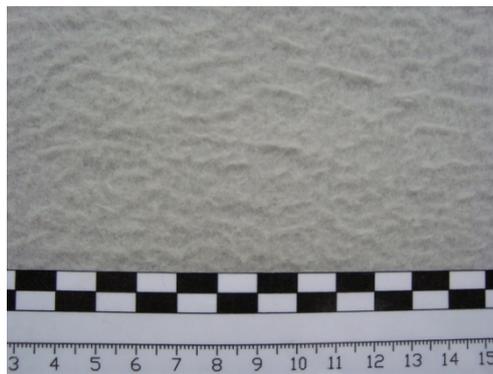
718 **Figure 3 – Visual effects on GTX2 after tests: a) mechanical damage with 900 kPa; b) abrasion; b)**
719 **mechanical damage with 900 kPa followed by abrasion.**

257 The visual appearance of the geotextile and geocomposite samples subjected to
258 mechanical damage followed by abrasion is quite similar (Figures 3-c and 4-c). It seems that
259 the effects of previously induced mechanical damage enabled the detachment and superficial
260 disaggregation of filaments, which gave rise to the perpendicular accumulation of fibres in the
261 machine direction of these geosynthetics.

353 abrasion damage (combined) are in agreement with the observed visual effects (Figure 3,
354 Table 4) since they were more severe. In terms of tensile strength, the most conditioning
355 damage mode for GTX1 seems to be mechanical damage, as the response of the specimens

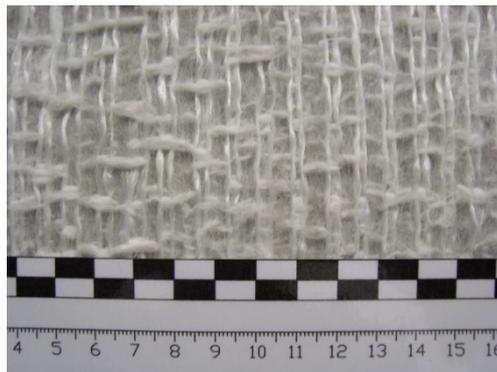
721 **Figure 4 – Visual effects on GCR2 after tests: a) mechanical damage with 900 kPa; b) abrasion; c)**
722 **mechanical damaged with 900 kPa followed by abrasion.**
723

248 The visually observed changes for the geotextiles (GTX1 and GTX2) and the
249 geocomposites (GCR1 and GCR2) were the incrustation of fines after mechanical damage and
250 detachment and cuts of some PET yarns (for the geocomposites). The changes observed on
251 these geosynthetics after abrasion and after mechanical damage followed by abrasion (Figures
252 3 and 4, Table 4) are in good agreement with those reported by Van Dine et al. (1982).

458 GCR1 (Figure 11) exhibits significant tensile strength, peak strain, and stiffness for
459 2% of strain reductions after the induced damage. This is in good agreement with the severe
460 damage observed in the PET yarns and geotextile backing (Table 4). Similar overall
461 behaviour was observed after mechanical damage (for both cyclic loadings considered) as for
462 mechanical damage followed by abrasion (for both cyclic loadings). The stiffness for 2% of
463 strain reductions after damage was important and ranged between 37% (mechanical damage
464 with 500 kPa) and 73% (mechanical damage with both 500 kPa and 900 kPa followed by
465 abrasion). The reductions observed for the peak strain were lower (varying between 20% and
466 52%); after mechanical damage with 900 kPa they were 5%. Abrasion largely affected the
467 yarns of this geocomposite and also its base geotextile (similar to Figure 4b, for GCR2). As
