# Synergy between mechanical damage and abrasion of a composite geosynthetic and its variability

M. Pinho-Lopes<sup>\*1,2</sup> and M.L. Lopes<sup>3</sup>

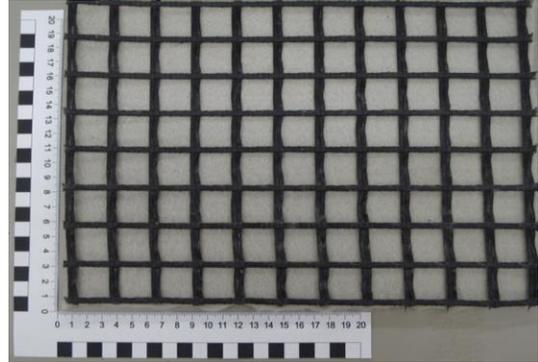
A composite geosynthetic consisting of two overlapping geosynthetics (Figure 1) was studied: a nonwoven geotextile consisting of continuous mechanically bonded polypropylene filaments (GTX) over a woven geogrid composed of high modulus polyester fibres knitted in a flat orientation and covered with a protective polymeric coating (GGR). The materials were tested overlapped and on the machine direction. Nominal values of some properties of the geosynthetics are included in Table 1: mass per unit area ( $\mu_{a_{nom}}$ ); peak tensile strength and elongation at peak at machine direction, respectively,  $T_{nom}$  and  $\epsilon_{nom}$ .

**Figure 1.** Composite tested (GTX+GGR).

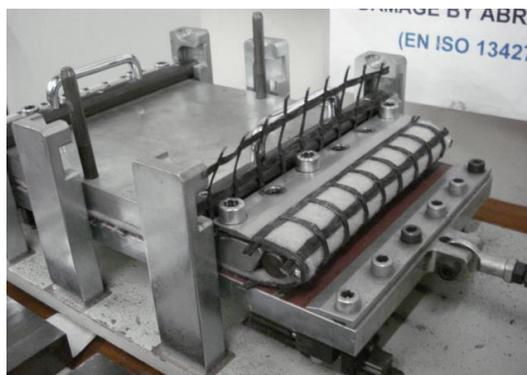
The equipment used is a prototype (Figure 2) which allows for specimens larger than those described on the test standard: area of geosynthetic in contact with the abrasive of 220 mm x 300 mm (instead of 50 mm x 200 mm imposed on EN ISO 13427:1998). The equipment consists of two plates: the upper plate, which is stationary and where the specimen is fixed; and the lower plate with the abrasive (P100), able to move along a horizontal axis under controlled pressure.

Figure 2. Equipment for the abrasion damage tests.

During the test a pressure of 6 kPa is applied to the specimen and the abrasive is rubbed against it for 750 cycles (1 cycle = 1 double pass). The specimen is then removed carefully and subjected to a characterisation test.

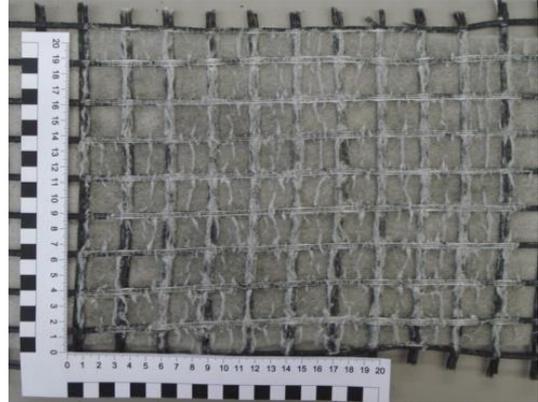
The structures of the geocomposite after abrasion damage and after mechanical damage followed by abrasion damage were similar (more severe for the later, Figure 3).

**Figure 3.** Specimen of the geocomposite after sequential mechanical and abrasion damage tests.

These were quite different from those described for a single exposure to mechanical damage. There was a significant and generalised detachment of the protective coating, and splitting of some ribs of geogrid GGR. The superficial layer of geotextile GTX became partially disintegrated and many filaments were grouped into clumps perpendicular to the direction of motion in the abrasion test. The constituent elements of geotextile GTX and geogrid GGR became physically connected. According to Pinho-

Lopes & Lopes (2014), the mechanical damage allowed for additional detachment of filaments and superficial disaggregation during the sequential abrasion damage tests.

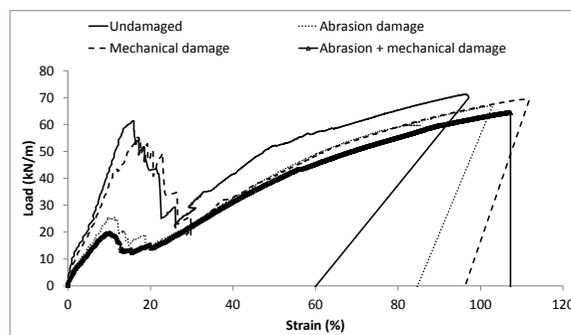
Figure 4 summarises representative load-strain curves for the four types of samples studied. These curves represent the complete response of the geocomposite measured in the tensile tests (until rupture). It is likely that such high strains are never achieved in real applications.

**Figure 4.** Representative load–strain curves of samples of the geocomposite (undamaged and after laboratory damage tests).

The tensile response of the geocomposite studied exhibits two peaks. The first peak (strains between 10% and 17%, depending on the sample) corresponds to the rupture of geogrid GGR (nominal peak strain of 10.5%), while the second peak (strains between 94% and 105%, depending on the sample) refers to geotextile GTX (nominal peak strain of 105%).

For most applications the strains on the geosynthetics will be very low. Thus, only the initial part of the load-strain curves, up to the first peak, is discussed. The load-strain curves clearly show the effect of the damage induced, by the reduction of the peak parameters and of the stiffness of the samples. After abrasion (in a single exposure or combined with mechanical damage) the reduction of parameters is obvious. The changes observed visually help understanding the differences found for the mechanical response of the geocomposite.
