Flaw and damage assessment in torsionally loaded CFRP cylinders using experimental and numerical methods

Erwin Hack, Richard K. Fruehmann, René Roos, Mara Feligiotti, Philipp Schuetz, John P. Tyler, Janice M. Dulieu-Barton

To appear in: *Composite Structures*

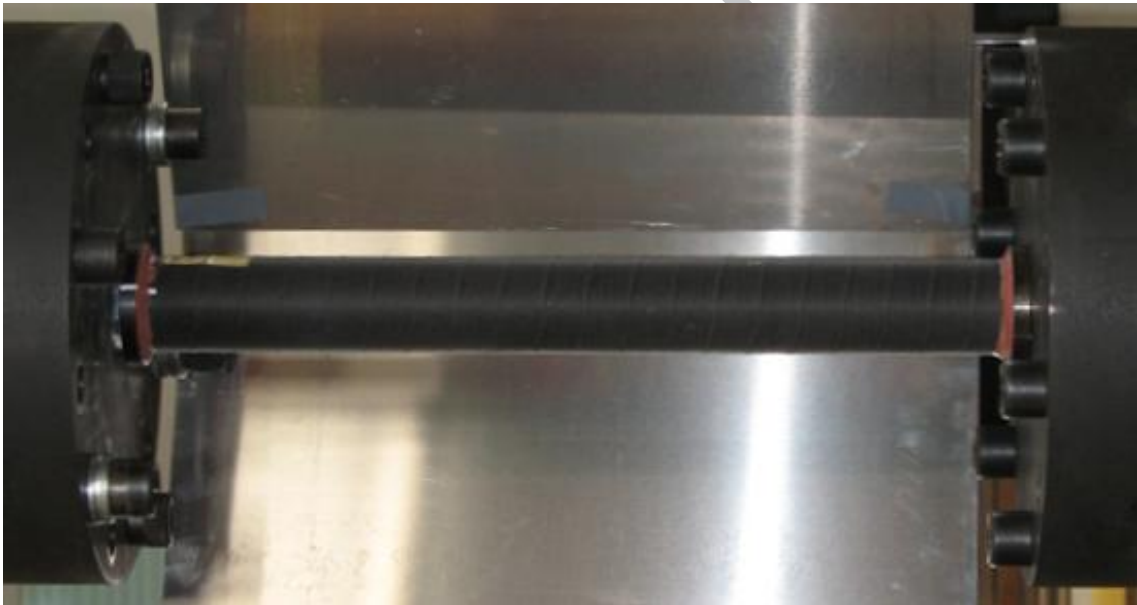
Figure 5: Test specimen mounted on the test machine with the two metal mirrors. Rotated view.

identified in the pristine specimen and to estimate the extent of damage in the damaged specimen. In addition, IRT was applied to monitor the surface temperature during quasi-static tests to failure with a view to identifying the actual failure initiation site by observing the temperature rise associated with the formation of a crack. A FLIR SC7000 series camera (FLIR Systems ATS, Croissy-Beaubourg, France) was used, with a 320 x 256 pixel Indium Antimonide detector array and a 50 mm lens. To enable the full specimen surface to be viewed simultaneously, two metallic mirrors were placed behind the specimen under an angle, see Figure 5. To obtain data with higher spatial resolution, the camera was moved closer to the specimen. To access the full specimen surface in this case, the specimen was rotated four times about 90° in the grips, and the camera was positioned at different heights to collect data along the full length of the specimen. The TSA data were then stitched together.

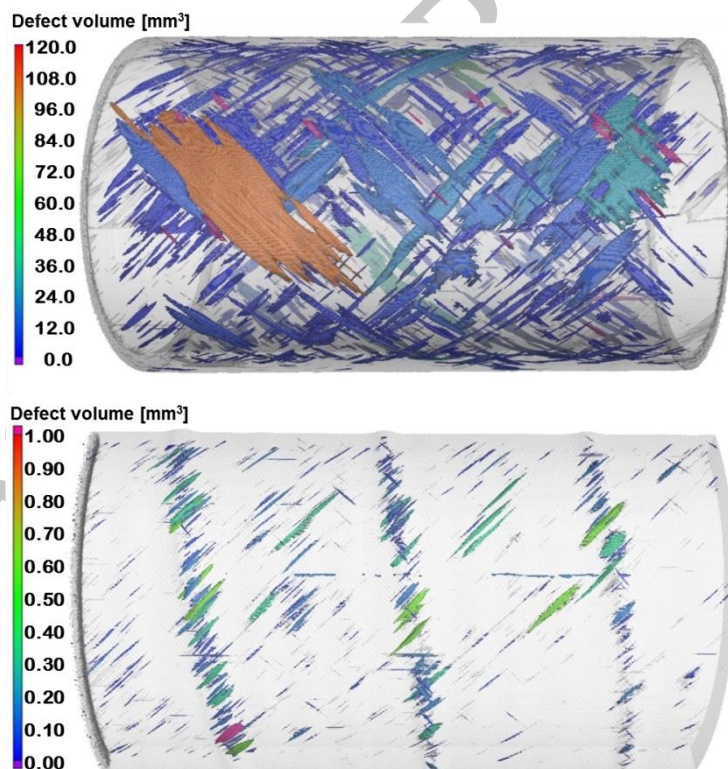
Figure 6: CT scans of a 110 mm section of cylinder B1 (top) and B6 (bottom) with colour coded defect volume. Note that the colour scale is different by a factor of 120 for the two specimens.

X-Ray CT scans were performed on specimen B1 (smooth surface) and B6 (peel ply surface) in their pristine state. The void content and distribution differ drastically between the two types of finishing as shown in Figure 6. It can be seen that voids, up to 100 mm^3 , are distributed throughout specimen B1. By contrast, the much smaller voids in B6 are concentrated in a spiral pattern coincident with the edges of the peel ply tape wrapped around the laminate during manufacturing. This indicates that the peel ply has served to ‘squeeze out’ a fair portion of the voids, leaving void concentrations at the peel ply overlaps. In the following, the void distribution found in specimens with smooth surface finishing is referred to as VD1, while the distribution found in specimens with peel-ply finishing is named VD2.

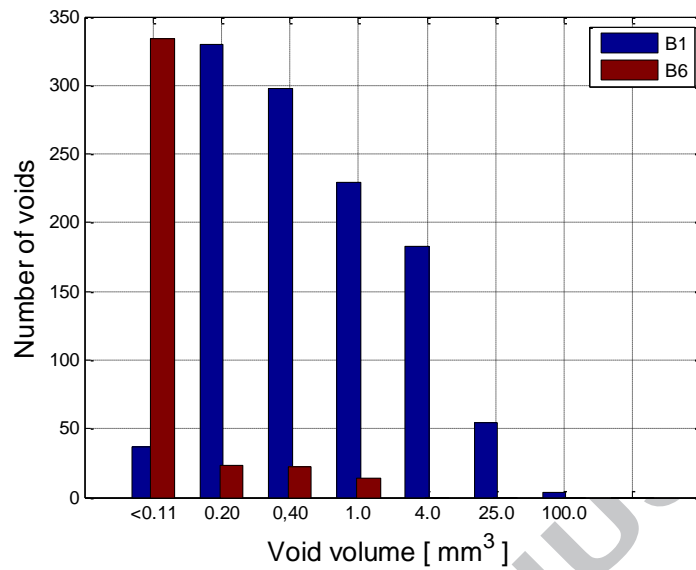
Figure 7: Void volume distribution of cylinder B1 (VD1, blue) and B6 (VD2, red).

The histogram of the void content by size is shown in Figure 7. VD1 has fewer of the very small voids ($< 0.11 \text{ mm}^3$) but many more in total (approximately 3 times as many) and much larger void than VD2s. This significant difference in void content would suggest a likely very large difference in ultimate strength of the component.

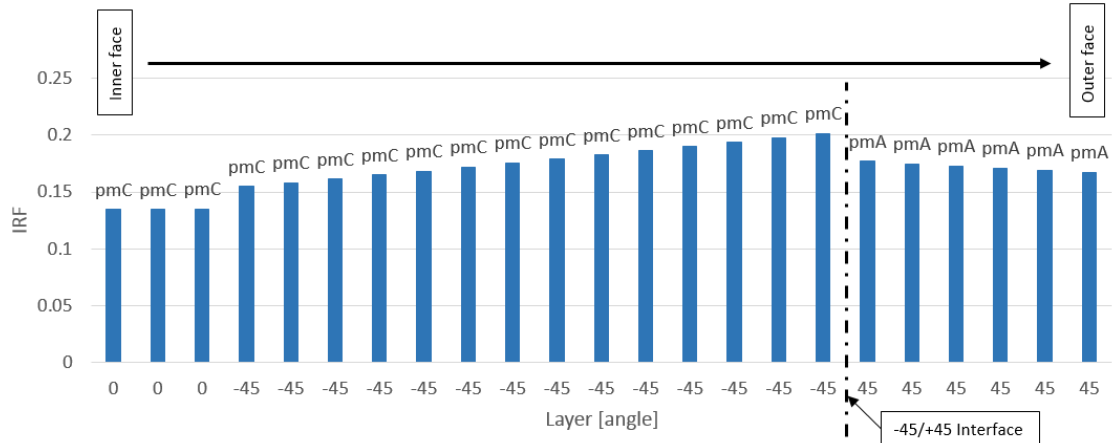
Figure 11: Inverse reserve factors for each layer of a laminate without voids calculated for a torsional moment of 1200 Nm.

The expected failure mode was calculated from the stress values reached in each laminate layer for a torsionally loaded cylinder without voids. Figure 11 shows a plot of the resulting inverse reserve factor (IRF) for each ply through the thickness of the cylinder wall, from the inner ply (left) to the outer ply (right). The IRF is the ratio of the actual load and the failure load such that a value of $IRF < 1$ indicates a 'safe' load, while an $IRF > 1$ indicates that the local stress combinations exceed the respective Puck failure criterion. For the defect free cylinder, the strength distribution is roughly homogeneous and an exemplary through-the-thickness plot shows that the maximum IRF occurs just below the $-45^\circ/45^\circ$ interface highlighted with a dash-dotted line. With the external load applied such that the surface fibres are in compression, the failure mode in this and the adjacent -45° plies is shear compression (pmC). In a cylinder without voids, it would be expected that the failure initiates in the -45° ply, just below this interface.

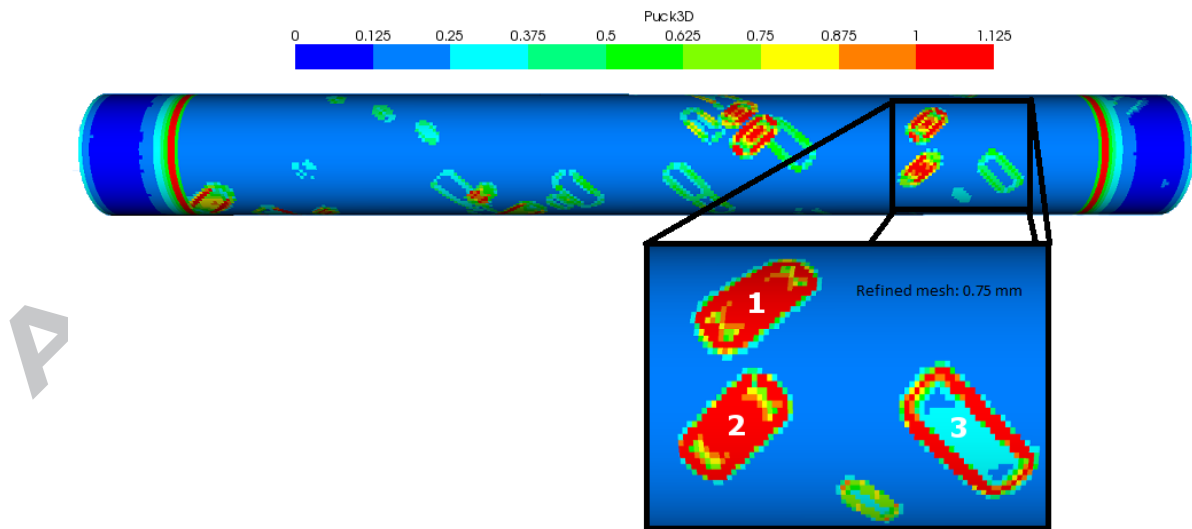
Figure 12: Element-wise maximum IRF of the Puck 3D failure criterion for a load of 1200 Nm. Three voids are highlighted in the box.

The effect of the voids on the failure mode was investigated by considering 50 randomly generated defect configurations based on the void distribution VD1, with the cylinder strength evaluated for each; all of the configurations gave similar results. The failure torque of the cylinders was reduced from 5900 Nm for a void-free cylinder, to 1200 Nm for a typical defect rich cylinder. A representative example of the overall failure distribution is visualized in Figure 12 in terms of the IRF. The difference between the defect free regions and those with voids is clearly identified. Furthermore the illustration shows that the orientation

of the voids has a relevant effect regarding the strength. Because orientation is given by fibre direction of the ply above the void, the voids oriented from bottom-left to top-right are found in the outer +45° layers and are prone to failure while those with a void rotated by 90° are found in the inner -45° layers and are more stable. Note that the calculated IRF at the edges of the voids are strongly influenced by edge effects resulting from the mesh. Results are therefore only to be trusted from the middle of the voids.

This effect was investigated further by consulting the through-the-thickness results of three individual, isolated voids highlighted within the box in Figure 12. *Void 1* is located in the $-45^\circ/+45^\circ$ interface, *Void 2* is above the interface; *Void 3* is below the interface. The corresponding through thickness distribution of the IRF in the centre of each void is shown in Figure 13. The *void locations* are indicated by labelled rectangles and the $-45^\circ/+45^\circ$ interface is marked with a dash-dotted line. *Void 3*, near the inner side of the laminate, has a much lower impact on the IRF when compared with *Void 1* and *2*. The IRF only increases moderately close to the void and more at the adjacent plies inward from the void location. The failure mode however, does not change and the maximum IRF is still located in the ply just below the $-45^\circ/+45^\circ$ interface. In contrast, for both voids 1 and 2 the IRF increases significantly away from the void toward a maximum at the surface of 1.6. Also noteworthy is the change in the dominant failure mode from pmC at the interface, Figure 11, to pmA near the surface. The failure modes pmB (combined shear and compressive matrix failure) and pd (ply delamination) also occur but do not dominate the failure mechanism. The X-ray CT scan of cylinder B1 indicates that a void of relevant size is always found in the outer critical layer bundle. This explains the reduction of the limit load from 5900 to 1200 Nm when failure starts, and the change in failure mode to a tensile matrix failure explains the explosive growth of a matrix crack on the specimen surface.

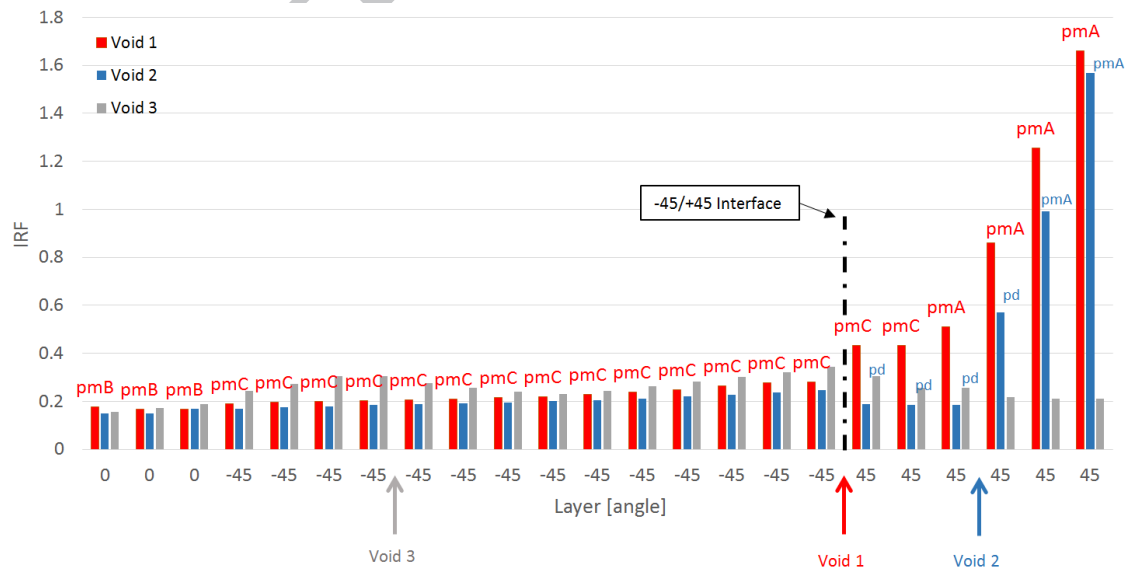
Figure 13: Through-the-thickness IRF distribution of Void 1 (red), Void 2 (blue) and Void 3 (grey) for VD1 and a torsional moment of 1200 Nm.

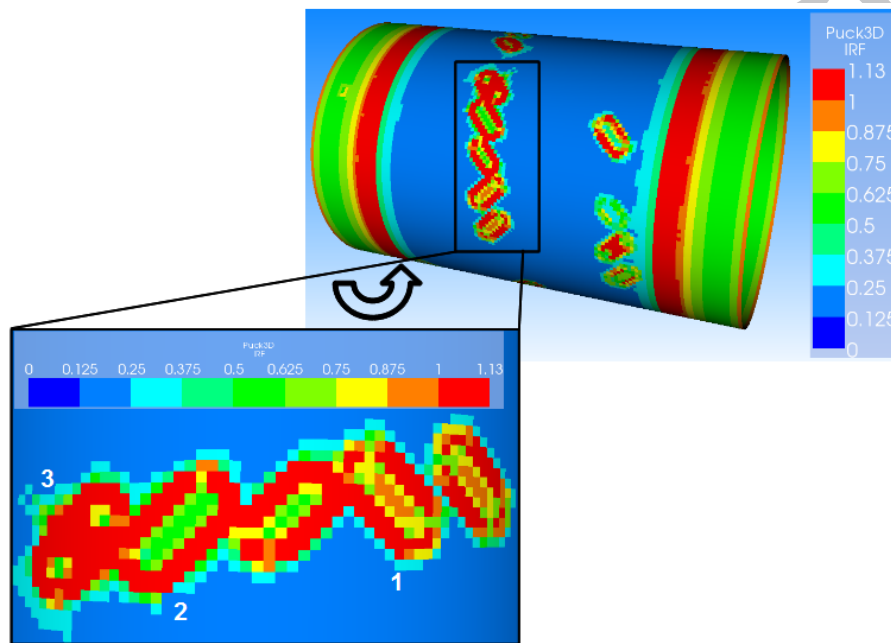
Figure 14: Global IRF distribution for a load of 1400 Nm and detail view of simulated void distribution VD2. Three Voids are high-lighted in the box.

The same evaluations were repeated for VD2. Due to the smaller void size, a finer mesh was needed to obtain reliable results. The simulated external load was taken to be 1400 Nm in accordance with the measured limit loads of cylinders with peel ply finish B2, B4 and B5 of 1400, 1400 and 1500 Nm, respectively. A typical IRF distribution is shown in Figure 14. In this case, it is less obvious how the through-the-thickness distribution of the voids affects the strength. Due to the smaller size of the voids in VD2, the edge effects due to meshing are more prominent than in VD1.

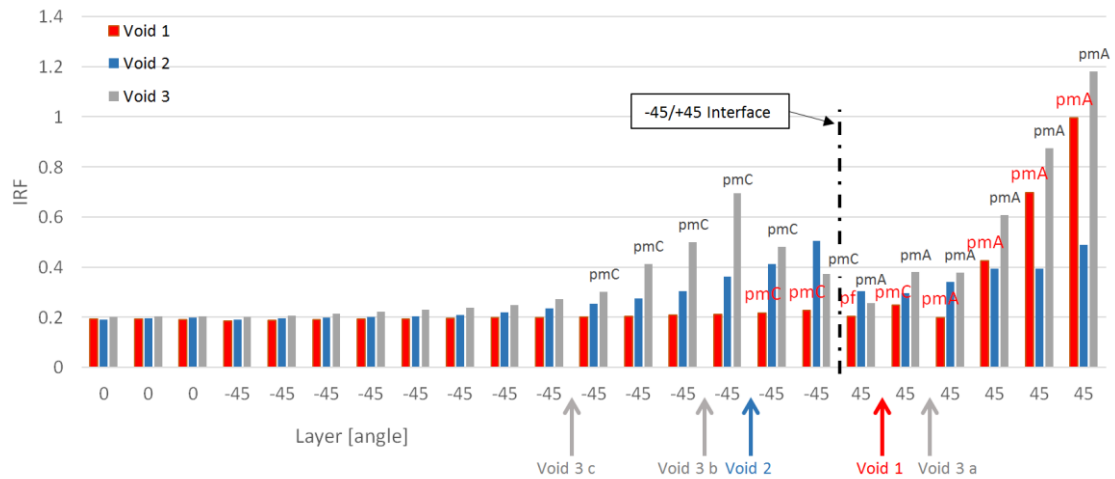
Figure 15: Through-the-thickness IRF distribution of Void 1 (red), Void 2 (blue) and stacked Voids 3a, b, c (grey) for void distribution VD2.

The through-the-thickness distribution of the IRF (Figure 15) corresponding to *Voids 1* and *2* highlight again, that the IRF is critical if the void is above the $-45^{\circ}/+45^{\circ}$ interface, similar to what is observed in VD1. In this case, the maximum IRF is 1.0 and 0.5 for *Void 1* and *2*, respectively, and the failure mode distribution is similar to VD1, Figure 13, i.e. if the void is at or above the $-45^{\circ}/+45^{\circ}$ interface, the critical failure mode is pmA, with IRF increasing towards the surface ply. *Void 3* in the distribution VD2 investigates the effect of stacking voids, one above (3a) and two below (3b and 3c) the critical interface, a typical situation that is also found in the CT data of specimen B6.

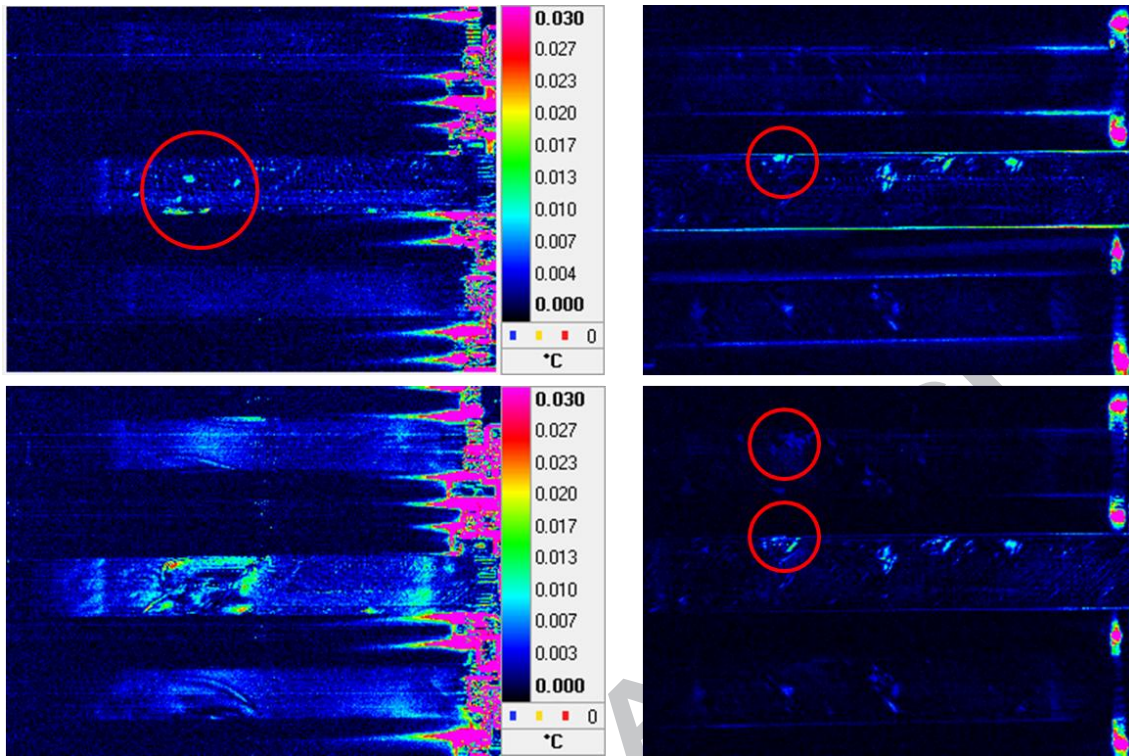
Figure 18: Left: TSA amplitude data, ΔT , from specimen B0 cyclically loaded at (-500 ± 100) Nm and frequency 2 Hz, before (top left) and after failure (bottom left). Right: Specimen B1 before (top right) and after growth of debonding (bottom right), measured at (-250 ± 100) Nm and frequency 2 Hz.

An initial test was conducted using specimen B0 to verify that the inspection using TSA under torsional loading as described in section 3.3 could reveal defects. Figure 18 shows TSA amplitude images, each containing three views: the central direct view to the cylinder and two reflected views from the mirrors (above and below in these rotated views) showing the specimen from behind and to either side. The data obtained (Figure 18, top left) show that the majority of the specimen has a fairly low response (typical for CFRP) of the order of $0.004\text{ }^{\circ}\text{C}$. In a number of areas, the thermoelastic response is significantly greater ($0.01 - 0.025\text{ }^{\circ}\text{C}$) which confirms that defects have a clearly visible effect on the thermoelastic response under torsion. The large difference in the thermoelastic response between a defect free and void containing region provided confidence in using TSA to inspect the specimens prior to the static tests to failure. Two potential failure initiation sites were thus identified in specimen B0, circled in red in Figure 18, top left. The torsional load was increased in steps of 250 Nm and cycled at each level with amplitude of 100 Nm for TSA measurements. Failure occurred at 1000 Nm, slightly lower than the FEA predictions for model void distribution VD1. A comparison between the images before and after failure suggests that the failure initiated indeed from the region of increased thermoelastic response highlighted in Figure 18, top left. Furthermore, the failure manifested the explosive growth of a matrix crack in the surface ply and a corresponding delamination at the $-45^{\circ}/+45^{\circ}$ interface.

The experiment was repeated with cylinder B1. The ΔT image in Figure 18, top right, shows the thermoelastic response of the pristine specimen again with signatures of near surface flaws which had been corroborated with CT and DSPI pre-test (see Figure 8). A *quasi*-static load ramp was then applied until a crack was initiated on the surface of the specimen at 1200 Nm. The crack initiated from the defect circled in red in Figure 18, top right. After crack initiation, the load was reduced again to 250 Nm and a delamination was grown by further cyclic loading with amplitude of 100 Nm. The grown defect is highlighted by red circles in Figure 18, bottom right. The TSA images were taken at a mean load of -250 Nm with amplitude of 100 Nm. Thus, the specimen was still able to support load, i.e. it was not completely failed. The extent of the damage in specimens B0 and B1 was assessed post-failure with close-up TSA in-situ and with DSPI in the laboratory, see section 4.7.
