Assessing the impact of coastal erosion on archaeological sites: a case study from Northern Ireland

Kieran Westley & Rory McNeary (Centre for Maritime Archaeology, University of Ulster, Coleraine)

Abstract

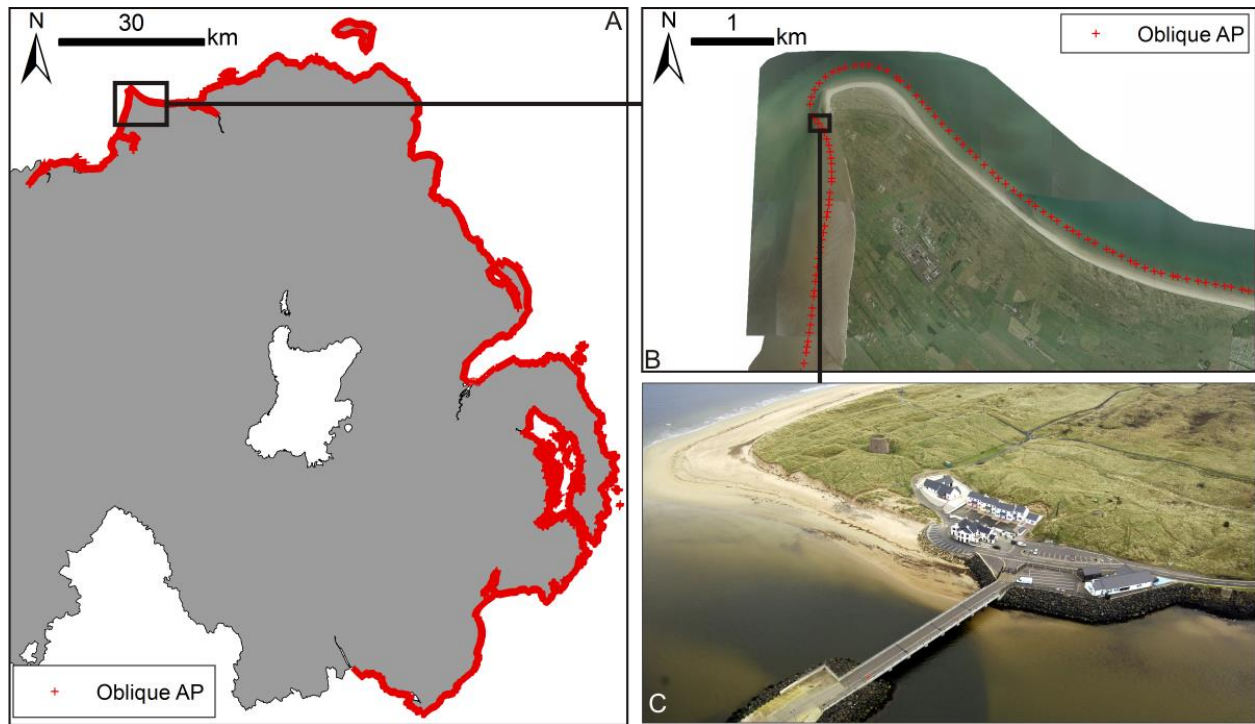
Figure 2. a) Province-wide distribution of oblique APs. Separation between individual APs is invisible at this scale, but the continuous coastal coverage is clear. b) Zoomed view of Magilligan Point showing separation of 100-200m between each AP. b) Oblique AP showing sandy beach and pier at Magilligan.

Stage 1 used an extant series of oblique APs flown in 2006 by the Department of Environment Northern Ireland (DoENI). This comprises a continuous overlapping sequence of oblique APs spaced approximately 100-200m apart along the entire coast and focussing directly on the coastline (Figure 2). All photographs are high resolution (4288 x 2848 pixels); however, clarity varies between individual frames depending on the distance from the camera to the shore and the ambient light on the day.

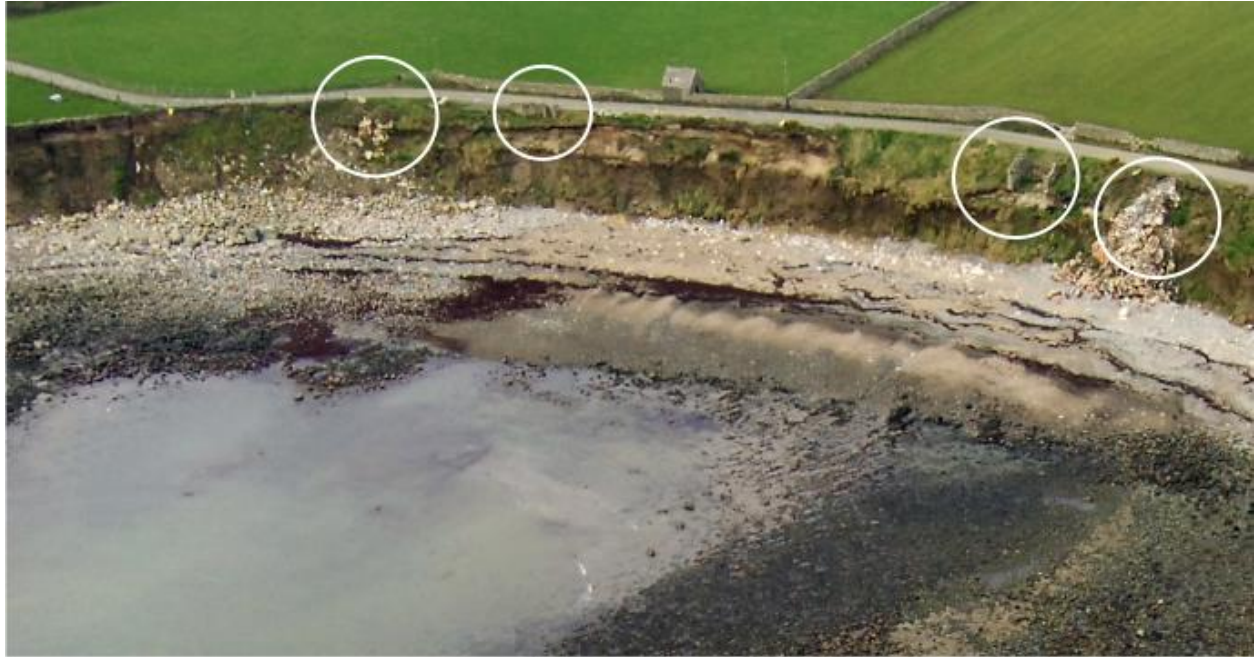
Figure 6. Collapse of historic buildings (circled) at Derryoge due to cliff erosion.

There are also unrecorded sites at risk. Firstly, a visit to Derryoge in 2011 confirmed that several stone buildings are perched on, or just below, the eroding cliff edge and have collapsed as the underlying cliff has retreated. These buildings are visible on the oblique APs (Figure 6) and also mapped on the First and Second Edition County Series (6 Inch) maps, making them at least 19th century in age. Secondly, an extensive set of kelp grids can be seen on the intertidal flats of Mill Bay. Although noted in the published literature (McErlean, 2007), they are not recorded in the HERs. Whether or not they will suffer erosion in the future is uncertain. Their surrounding environment - a low energy intertidal flat - would suggest that erosion is unlikely, or perhaps that silting up could be a greater possibility. However, without further research, it is not possible to say for certain.

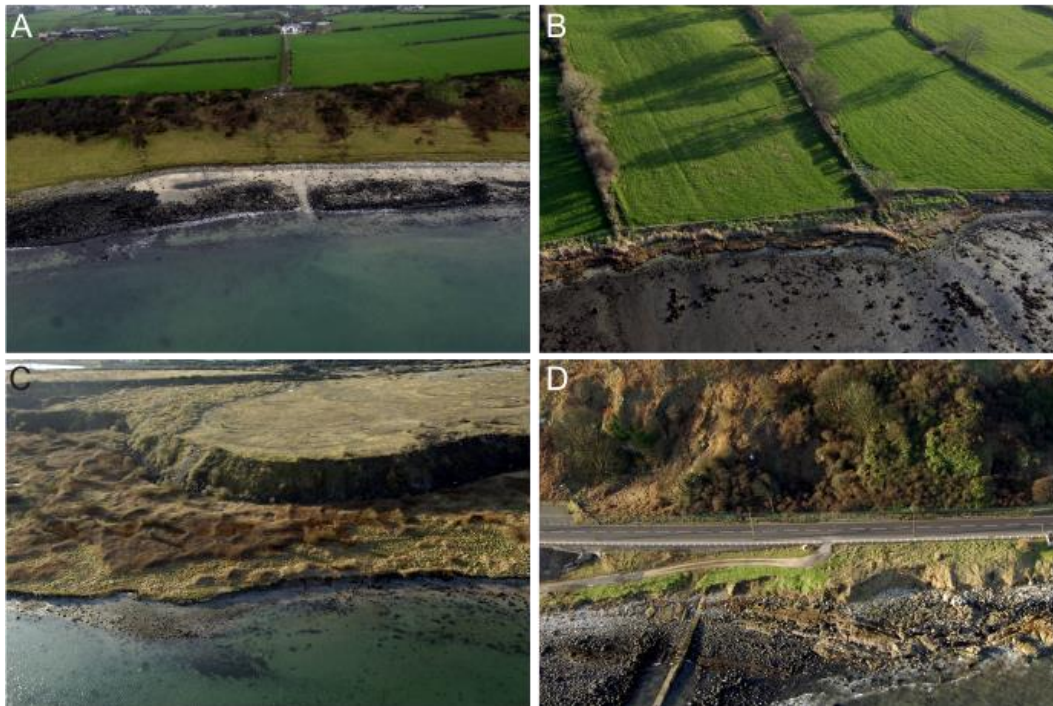
Figure 7. Simplified erosion summary for Larne. Place names are in italics. Black dots show locations of representative coastal erosion visible on the APs. A) Eroding scarp behind beach. B) Possible marsh retreat. C) and D) Eroding scarp behind beach. The simpler erosion by photo layer is used as a proxy of erosion location because the digitized geomorphological/erosion polygons are difficult to see at this scale.

This area is located in County Antrim between Blackhead and Drains Bay, is approximately 61km long and encompasses the Irish Sea coast of Islandmagee and the sheltered water of Larne Lough (Figure 7). South of Blackhead, the coastline consists of an unconsolidated, coarse-grained beach (primarily gravel/boulder but with some sand). Erosion is present in the form of exposed vertical scarps, sometimes several metres high, cut into the unconsolidated slopes behind the beach (Figure 7A). Topography then rises sharply to form basalt cliffs >25m high at Blackhead. These run north for a short distance before sloping down to allow coarse-grained (sand, gravel or boulder) beaches to form. These continue for c. 3km whereupon, at Gransha, sheer 25m high bedrock cliffs return. These run largely unbroken for the majority of Islandmagee's eastern coastline and have no visible erosion.

South of the Isle of Muck, topography becomes gentler and coarse-grained beaches and bedrock platforms appear. The Isle of Muck is a good example of how coastal geomorphology is dependent on exposure: its outer-east facing coast is a bedrock cliff, while its inner, more sheltered shoreline has coarse grained beaches. North of Portmuck, the coast exhibits a mix of high energy features including bedrock cliffs, platforms and boulder and gravel beaches. The exceptions are the two bays on the tip of Islandmagee where greater shelter and low-lying topography allow the formation of sand beaches. Around the top of the peninsula, a few isolated exposures are visible behind boulder beaches and low platforms.

At the eastern side of Larne Lough's entrance, the coast consists initially of bedrock platforms which give way to partly defended sand/gravel beaches, often with boulders. These beaches form a continuous fringe down the Lough's north-eastern shore until an intertidal flat at Mill Bay. Visible erosion is minimal, presumably resulting from the shallow bathymetry and sheltered conditions. Small isolated exposures occur as far down as Kilcoan Beg. Around Mill Bay these breaks occur in walls or structures along the shore. The headland south of Mill Bay then consists of an unconsolidated beach which in turn gives way to an intertidal flat. From here to the southern end of the Lough, the shoreline consists almost entirely of intertidal flat, with marsh concentrated at the southernmost margin. Two longer sections of possible erosion were identified between Kilcoan Beg and the southern end of the Lough. These were picked out on the basis of distinct vertical edges visible along the fringe of marsh vegetation (Figure 7B). Note however, that there are uncertainties associated with this attribution, for instance whether this is the natural appearance of the marsh or indicative of active retreat.

The southwestern Lough shore also consists of intertidal flat, although some sections are cut by railway embankments. Potential eroding areas consist again of vertical edges to marsh vegetation. Some of these are fronted by an apparently bouldery substrate which could indicate an erosion surface. The flats are replaced by sand/gravel beaches around the Magheramorne Quarry. Thereafter; erosion is characterized by low vertical scarps, occasionally with collapses, backing the beach (Figure 7C). These are interspersed with long sections of defended embankments. From here until Larne, the shoreline is heavily modified with extensive seawalls and

railway embankments. Natural features are restricted to short stretches of intertidal flat and unconsolidated beach. The southern and eastern margins of Larne itself are entirely defended by seawalls and harbour facilities and hence erosion-free, the exception being the Curran Point, where sand/gravel beaches are still present together with some isolated unvegetated exposures.

North of Larne, the coastline becomes more open, initially with sand/gravel beaches and short stretches of platforms and boulders which gradually become more prevalent. This section is undefended with the exception of structures south of Blackhead and immediately north of Larne where they protect the coastal road and housing. Consequently, erosion is visible between Larne and Drains Bay in the form of low scarps apparently retreating back from beaches or platforms (Figure 7D).

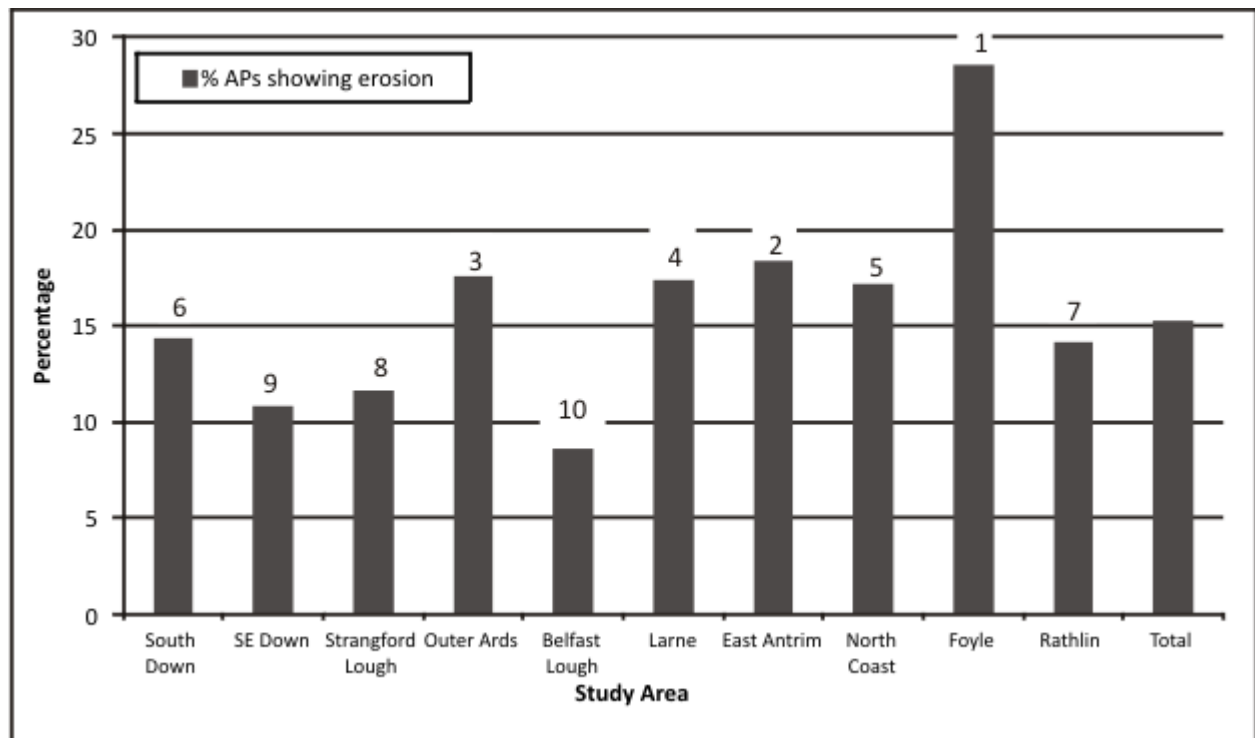
Figure 10. Bar chart showing percentage of APs for each study area with visible erosion. Numbers above each bar represent the ranking of each study area.

Therefore, if AP erosion percentage is used as a crude proxy, it can be applied to each of the study areas to compare their relative risk levels (Figure 10 and Table 3). This implies that the Foyle area is most at risk with almost 29% of its APs showing erosion. The next highest percentages cluster between 17-18% and include the Outer Ards, Larne, East Antrim and the North Coast. The majority of shorelines in these areas, excepting small semi-enclosed embayments (Bann Estuary, Larne Lough), are highly exposed and would be expected to have relatively high erosion rates. The remaining areas - South Down, Southeast Down, Strangford Lough, Belfast Lough and Rathlin all have percentages between 8-15%. Of these, only Belfast has a percentage below 10%. The results for Belfast, Strangford and Rathlin are the least surprising and most explicable. Belfast's low value stems from extensive shore defences lining the Lough. Strangford Lough is the most sheltered of all the study areas, with no exposure to the open sea and limited fetch. Rathlin, despite its highly exposed situation, is dominated by resistant bedrock cliffs and platforms. The values for South and Southeast Down however, are more surprising because it might be expected that, given their exposed situation, frequency of unconsolidated sediments close to the shoreline and visibly eroding sections, they would have higher levels of erosion. In reality, this study suggests that while there are distinct high risk localities within each area (e.g. Derryoge), the majority of the shoreline is not visibly eroding.
