Experimental analysis of debris distribution of masonry panels subjected to long duration blast loading

Richard A. Keys^{a,*}, Simon K. Clubley^a

Keywords: long duration blast, masonry, debris distribution, breakage

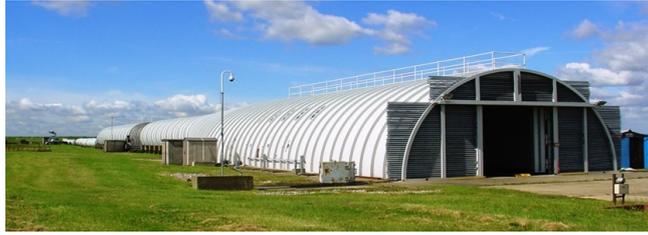
Figure 2: The Air Blast Tunnel (ABT)

60 Three experimental trials, accommodating a total of ten test items, were conducted at the Air Blast
61 Tunnel (ABT), shown in Figure 2, which is located at MoD Shoeburyness on Foulness Island in the UK. The
62 ABT is a large shock tube designed to replicate large explosive events, with two sections for instrumentation
63 which are 4.9m and 10.2m in diameter [15]. The ABT is also fitted with a rarefaction wave eliminator
64 (RWE) at its exhaust to reduce unwanted reflections and complex airflow interfering with the test items.
65 Previous trials conducted at the ABT show the maximum achievable peak static overpressure in the 4.9m
66 and 10.2m sections to be 100-120kPa and 50-60kPa respectively with corresponding positive phase durations
67 of approximately 200ms and 150ms [16]. Using the Kingery and Bulmash polynomials for hemispherical
68 surface charges [17], the TNT equivalence of the blast wave was approximately 450 Tonnes at a stand-off

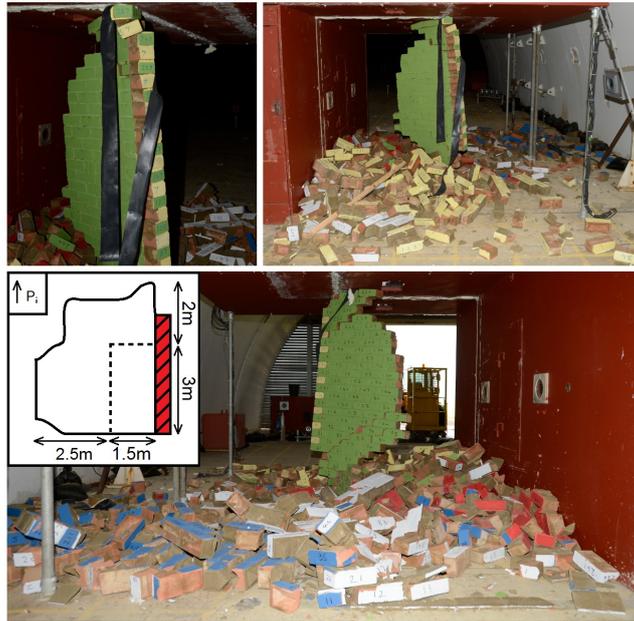
Figure 23: Debris distribution of structure BWL3C

333 The smallest of the three enclosed structures, BWL3C, produced the largest debris pile covering an
 334 approximate area of 16m^2 , shown in Figure 23. Unlike the other two enclosed structures, the rear wall
 335 was not restricted by the roof of the steel enclosure. This followed as a result of the front panel impacting
 336 the rear, significantly weakening the lower half of the rear wall and causing it to collapse. The increased
 337 rotational force on the rear corner joint, resulting from the collapse of the rear panel, caused the rear, green
 338 side panel to become delicately wedged against the roof of the steel enclosure. The white bricks, originating
 339 from the front panel, were evenly spread across the interior at the bottom of the debris pile. Towards the
 340 rear, the yellow bricks from the rear wall cover the white bricks, forming the top layer of the debris pile with
 341 a peak height of approximately 0.6m . The red bricks from the centre panel of the side wall cover the white

342 bricks in the middle section of the interior, with the blue bricks from the front of the side wall forming the
 343 entire lateral distribution at the front of the structure.
