Fibre failure assessment in carbon fibre reinforced polymers under fatigue loading by synchrotron X-ray computed tomography

S.C. Garcea, I. Sinclair, S.M. Spearing

To appear in: *Composites Science and Technology*

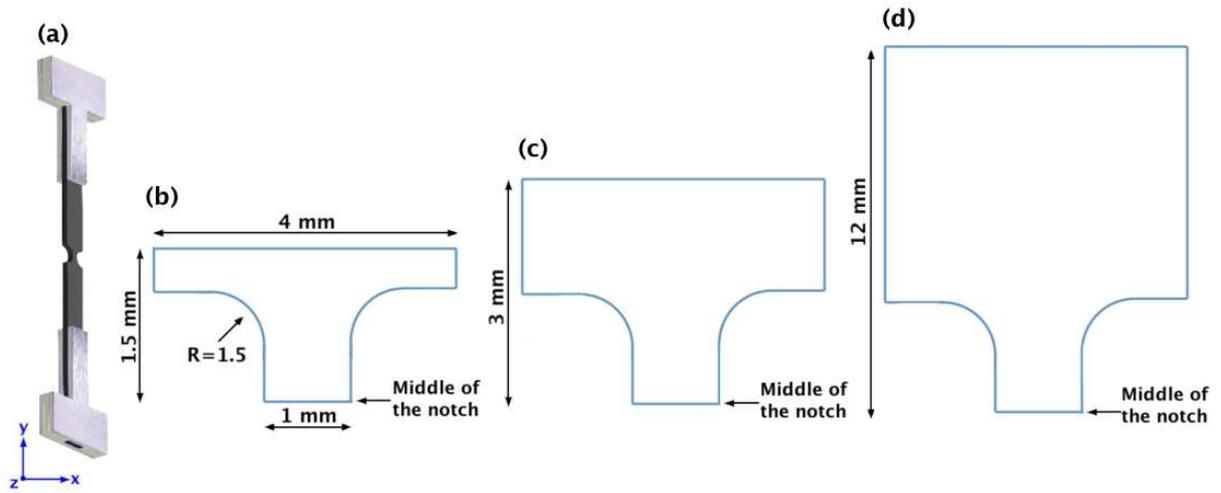
Fig. 1 Coupon geometry (a) and schematic of the reference volume used for: (b) *in situ* tests; (c) notch region considered in the *ex situ* experiments; (d) example of the extended volume (multiple concatenation) to include the full 0° ply split length.

Double-edge notched specimens (Figure 1(a)), with a nominal central ligament between the notches of 1 mm, a width of 4 mm, lengths of 34 mm (*in situ* tests) and 66 mm (*ex situ* tests); were shaped by waterjet cutting. Further details on the geometry, coupon dimensions, and experimental setup are described in [23] for the *in situ* fatigue tests, and in [24] for the *ex situ* tests. The average ultimate tensile failure stress (UTS) was measured as 960 MPa across the notched cross-section [25] with a coefficient of variation of 0.03 [26]. *In situ* fatigue tests (R ratio = 0.1), performed at 0.05 Hz using a compact load frame, were used to assess the micromechanisms of fibre failure. A peak load of 50% UTS was used to cycle specimens, CT images were obtained at 700 and 800 cycles. The increment of 100 cycles allowed the damage to remain within the restricted field of view available (~1.5x1.5 mm) at the high imaging resolution. *Ex situ* fatigue tests were used to monitor the accumulation and the distribution of fibre breaks

for a wider range of loading conditions, varying the peak load (30%-50%-70% UTS), and the number of cycles (10^3 , 10^5 , 10^6). *Ex situ* E-experiments were performed using a standard servo-hydraulic load frame, with a load ratio of $R=0.1$ and a frequency of 10 Hz. *In situ* and *ex situ*-loaded coupons were scanned at the Swiss Light Source (on the TOMCAT-X02DA Beamline, Paul Scherrer Institut, Switzerland). The beam energy was 19 keV and the distance between the specimen and detector was 30 mm; providing a degree of phase contrast. Specimens were placed in the load frame and scanned under load, applying 90% of the peak load used during the fatigue tests. The voxel resolution was chosen accordingly with the objective of the study: $0.69\ \mu\text{m}$ was used for the *in situ* tests to facilitate the identification of the micromechanisms of fibre failure, while $1.6\ \mu\text{m}$ was used for the *ex situ* experiments, allowing a larger field of view, but still reasonable resolution for fibre break detection [19]. Three-dimensional reconstruction was obtained from radiographs using an in-house code based on the GRIDREC/FFT approach [27]. The scanned volume of the *in situ* coupons located at the middle of the notch-center and up to 1.5 mm on one side of the notch (as shown in Figure 1(a) (b)), was maintained the same between the two cycling conditions (700 and 800 cycles) to facilitate registration. The reference volume used for the *ex situ* tests was larger, corresponding to the lower voxel resolution, starting from the middle of the notch and extending for a length of 3 mm, Figure 1(c) (b). The reason for assessing fibre breaks over a wider region than the ‘geometrical notch region’ was dictated by the fact that matrix-dominated damage and fibre fracture is not limited to the notch region, but occurs over a larger volume [28]. Therefore, in this study the term ‘notch region’, does not strictly correspond to the geometrical notch, but to an extended region (~ 3 mm in length) as shown in Figure 1(c) (b). The distribution of fibre breaks along the 0° ply

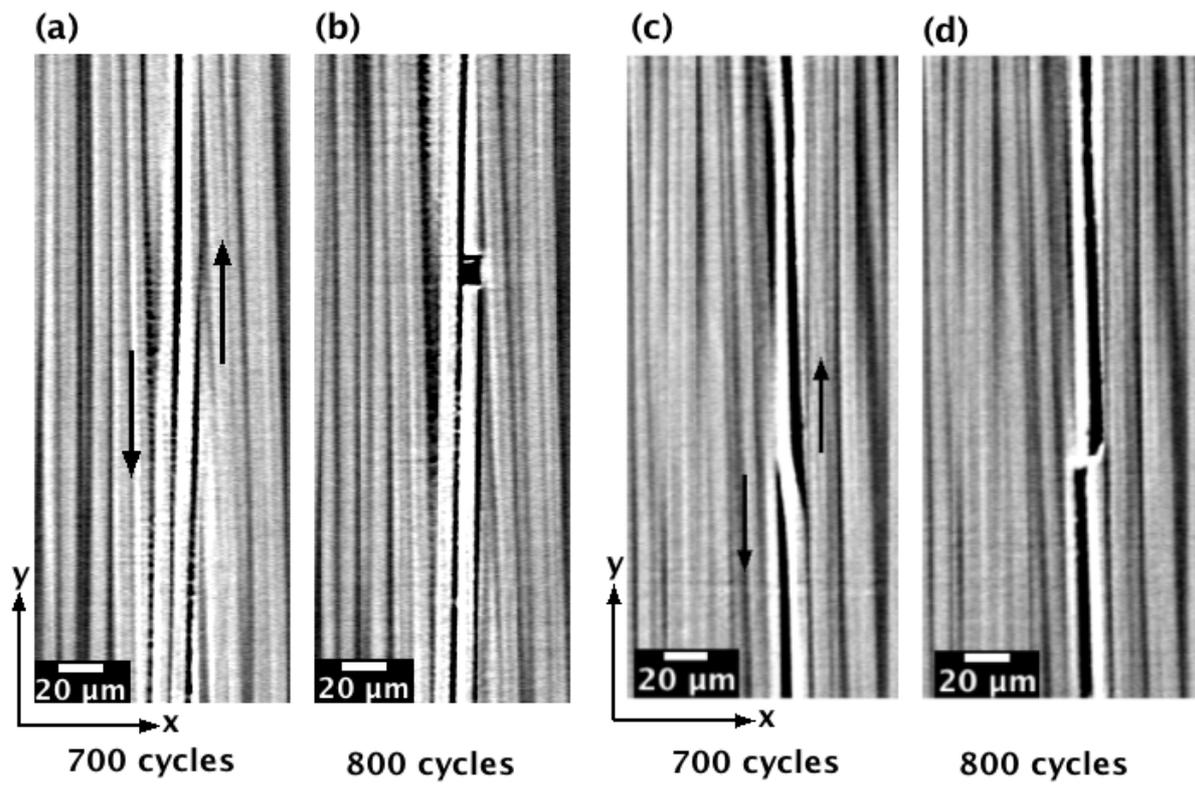
Fig. 2 0° ply split propagation along the fibre interfaces at 50% UTS and 700 cycles (a, c), and fibre failure at 800 cycles (b, d).

A previous study conducted under fatigue loading using the same material system has shown that 0° ply split propagation in fibre-packed regions occurs principally at the fibre matrix interface [24]. The current work investigates the micromechanisms of fibre fracture observed along the 0° ply split paths using *in situ* fatigue tests. The comparison of the two cyclic conditions (700 and 800 cycles at 50% UTS) has shown twelve additional fibres breaks in this small region ($\sim 1 \times 1.5 \times 1$ mm) occurring during the increment of 100 cycles, in addition to the 74 fibres that had already failed at 700 cycles. The fragmented fibres observed are all located along the planes of the 0° ply splits, and most of the additional breaks appear as single breaks (10), with one doublet (two adjacent fibre breaks). Depending on the direction of the fibre bridging (with respect to the damage propagation), and on the direction of the shear, two fibre failure modes have been identified, shown in Figure 2. In these two cases crack cross-sections parallel to the loading direction have been considered, and the image at 800 cycles is registered to the same position in the coupon as at 700 cycles. The 0° ply split propagates at the fibre/matrix interface at 700 cycles (Figure 2(a) and 2(c)) creating a partial debonding of the fibre, which is connected to the adjacent matrix in an asymmetric way with respect to the split propagation. The traction associated with the crack opening (perpendicular to the load direction) acts on the fibre causing local bending, visible in Figure 2(c). The next cyclic increment (800) shows the failure of the fibre in Figure 2(b) and 2(d). The fibre does not fail when it interacts with the damage propagation in the first instance, but as consequence of the increasing shear and bending, acting on the debonding fibre. This mechanism represents a wake process rather than a near-tip process. The direction of the shear, Figure 2(a), indicates that the failure of the fibre is due to tensile stress in this particular case. However, in the same

coupon fibre failure due to local compression resulting in a highly localised buckling process has also been detected (Figure 2(d), consistent with the opposite shear direction shown in Figure 2(c). Again, in these two images, the same position in the specimen is viewed for 700 and 800 cycles. The comparison between Figure 2(b) and Figure 2(d) clearly displays fracture planes perpendicular to the load for the tensile failure (Figure 2(b)), whereas the fibre break due to local buckling is orientated at 45° with respect to the loading direction (Figure 2(d)). In addition, differences in terms of the opening between the fracture surfaces of the fibre have been observed for the two cases: the buckling failure shows fracture surfaces close to each other, Figure 2(d); while those associated with the tensile failure are separated by a greater distance, Figure 2(b). Considering that 0° ply split propagation is mode II dominated, this difference is consistent with the stress acting on the fibre, which is in compression in the buckling failure and in tension in the tensile failure. The analysis conducted has shown that the additional fibre breaks detected at 800 cycles along the 0° ply split do not occur adjacent to pre-existing fibre breaks, but in new locations. The number of fibres failed in buckling and in tension detected along the 0° ply splits is the same (exactly 37 of each) at 700 cycles, while the additional fibre breaks observed at 800 cycles are predominantly due to buckling (11) rather than tension (1). Given the small numbers of broken fibres involved, further work would be needed to assess the significance of this observation. However, the balance between the number of fibre breaks due to buckling and tension is of interest, and provides insight regarding the micro-mechanisms of failure and has the potential to inform the development of models for failure.

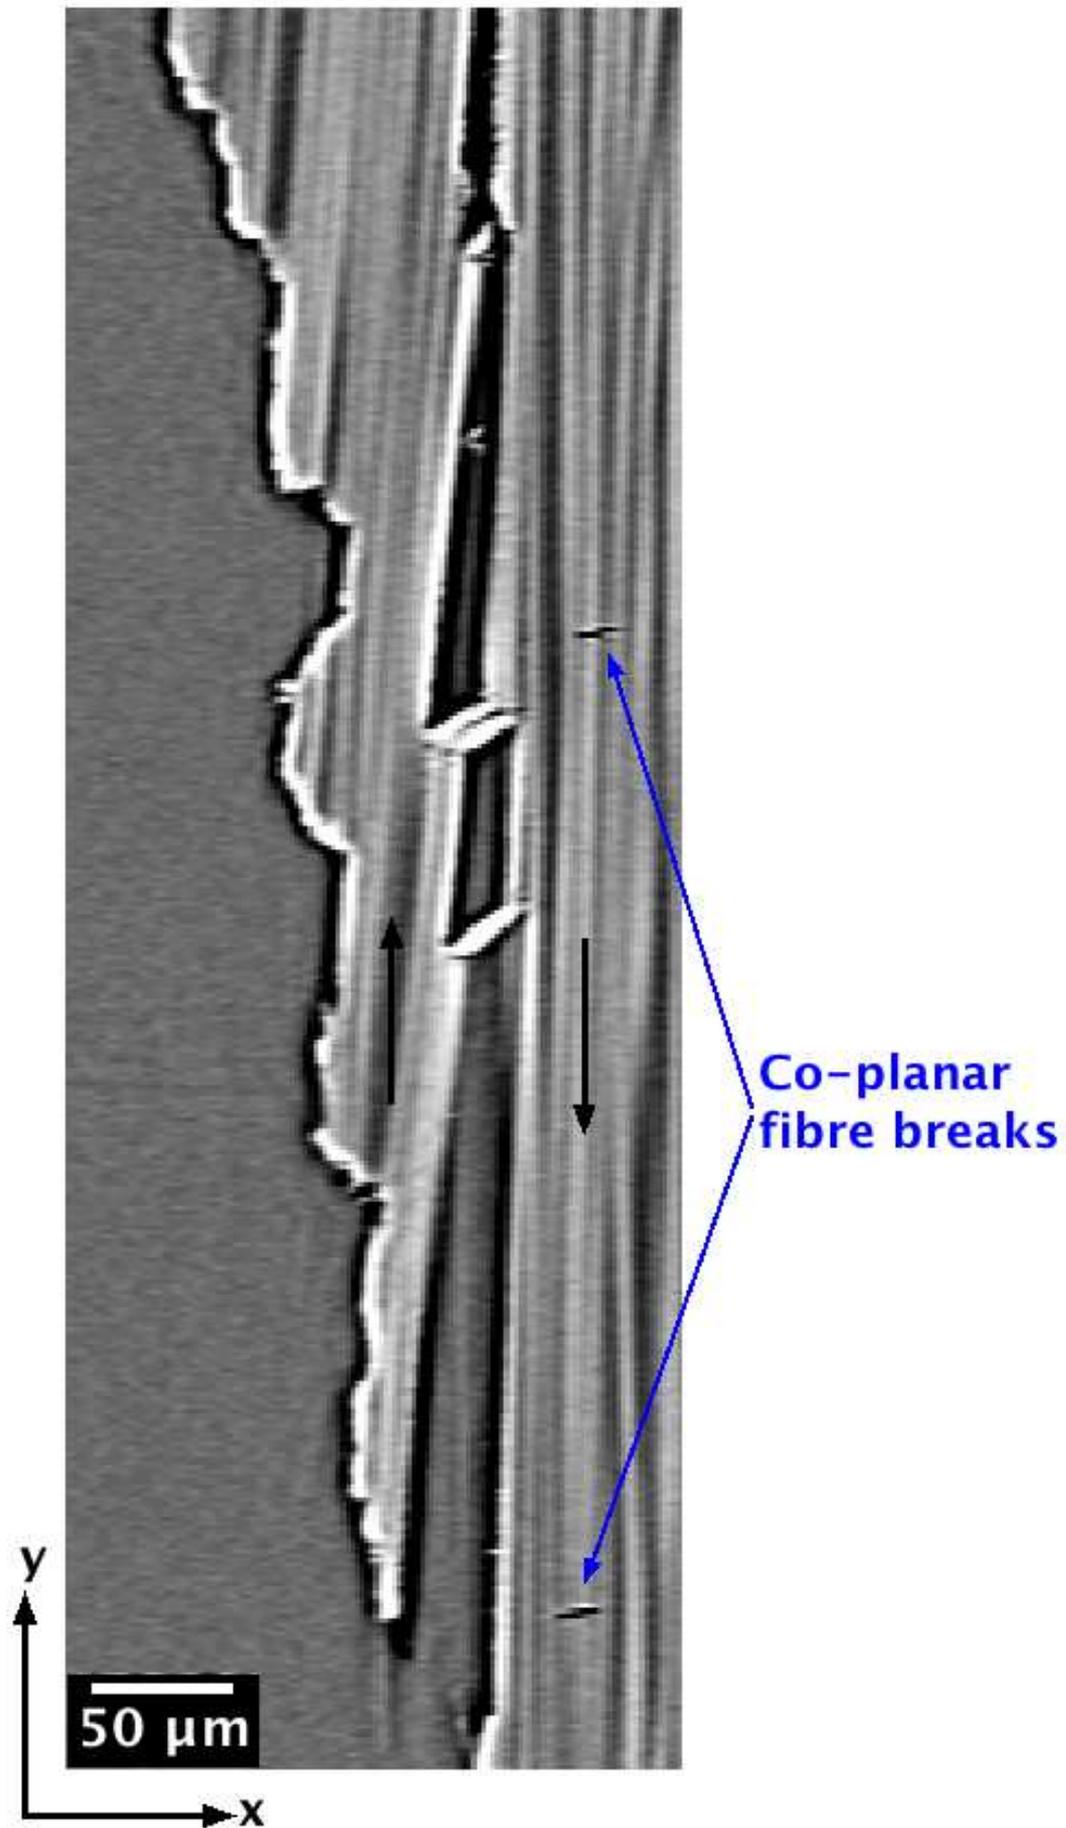
Fig. 3 Fibre breaks along the 0° ply split and as co-planar breaks in the bulk composite for a peak load of 50% UTS and 10^3 cycles.

Observations conducted on the *ex situ* fatigue tests for different loading conditions have confirmed the micromechanisms detected for the *in situ* experiments. Figure 3 shows an

example from an *ex situ* test of fibre buckling that involves two adjacent fibres and a single fibre located a few fibre diameters apart along the split path, which resulted in local fibre kinks. Two co-planar fibre break doublets, located within the composite, close to the 0° ply split path have also been detected, and may be a result of stress transfer from the compressive failures.

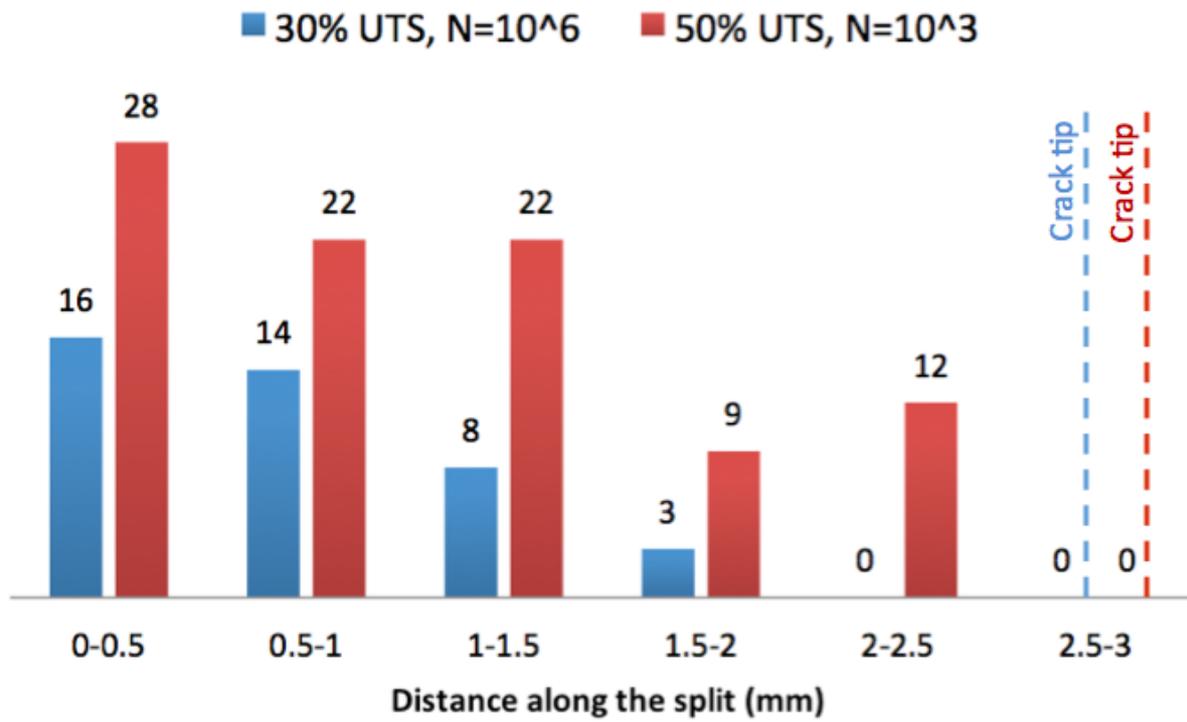
Fig. 4 Fibre break density along the 0° ply split for the cases of: 30% UTS and 10^6 cycles, and 50% UTS with 10^3 cycles, both specimens have splits of similar length.

observed from a direct comparison between these two loading conditions, as shown in Figure 4:

- The fibre break density increases with the distance away from the crack tip. As such, the root of the cracks exhibit the highest number of fibre breaks, consistent with fibre failure being primarily linked to fibre bridging in the wake.
- No fibre breaks were observed within 0.5 mm of the crack tip, again indicative of fibre fracture being a wake phenomenon, and not being driven by local crack tip stresses.
- No fibre breaks have been detected ahead of the crack tip.

Figure 4 shows that for a given total crack length the fibre failure density distribution along the split path is strongly influenced by the peak load, resulting in higher values of fibre break density at equivalent locations relative to the crack tip for the higher load case. Further increases in the peak load and/or the number of cycles (for loads equal or higher than 50% UTS) result in an increase of fibre breaks along the 0° ply split. Figure 5 shows the results obtained for an intermediate peak load (50% UTS) at 10^5 cycles compared with a higher peak load (70% UTS) at a lower number of cycles (10^3). The two data sets show similar overall trends from the crack tip back to the root of the crack. For both load cases, the fibre break densities along a given crack wake appears to ‘saturate’ with increasing distance from the crack tip (at a value of ~25 breaks/0.5mm), particularly in the 50% UTS case. In the 70% case this also occurs but is complicated by a number of local peaks in break density (>30 breaks/0.5mm). These peaks were found to be associated with clusters of fibre breaks in the 70% UTS case, which is discussed in the following section. In the first instance, this suggests that the maximum number of fibres available for fracture across the crack width is limited, presumably

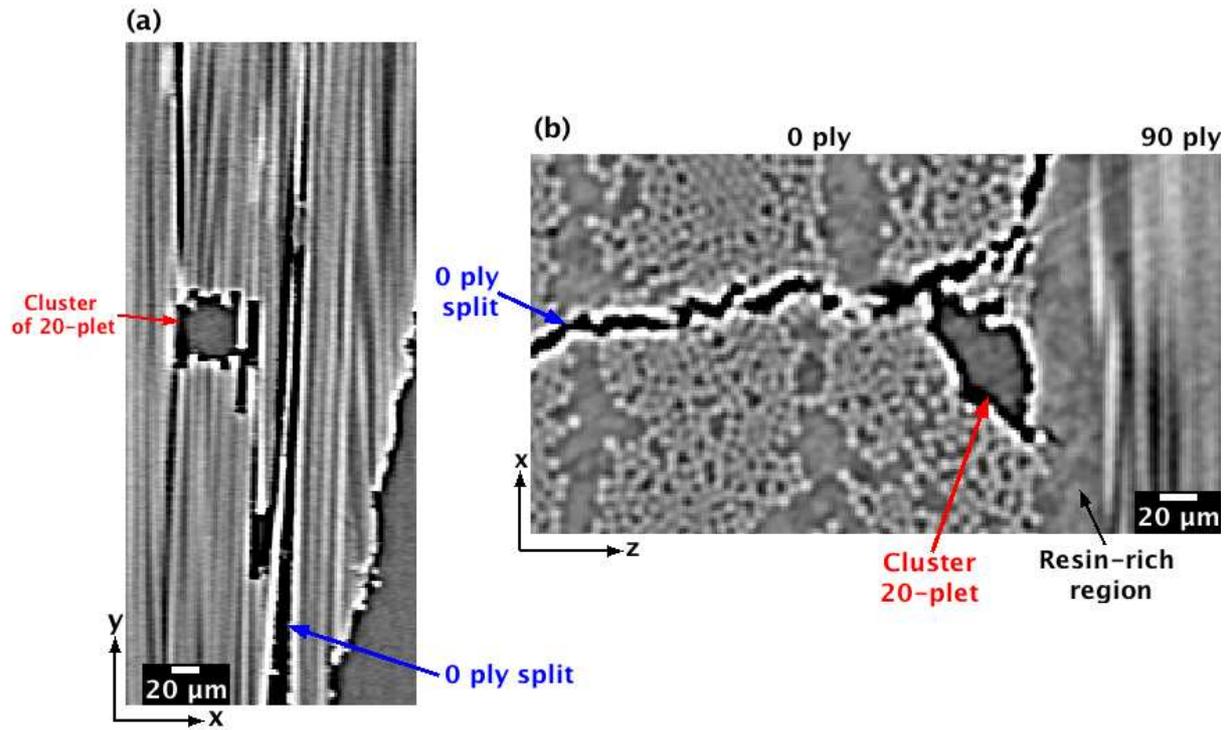
Fig. 6 Cluster of 20 fibre breaks near the 0° ply split detected at 50% UTS and 10^5 cycles: cross-section parallel (a) and perpendicular (b) to the loading direction.

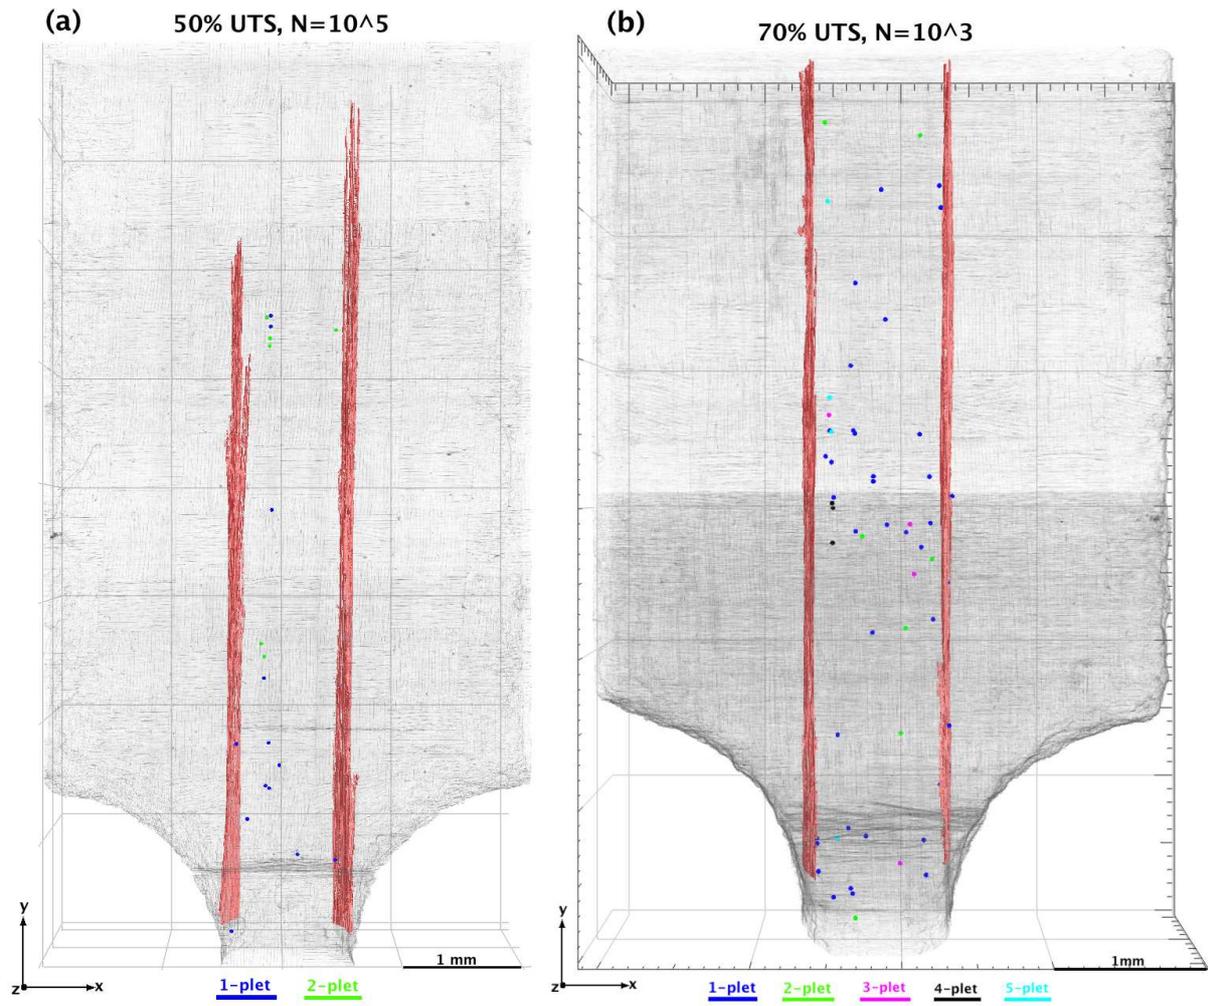
Fig. 7 3D Distribution of fibre breaks in the bulk composite for: (a) peak load of 50% UTS and 10^5 cycles, (b) peak load of 70% UTS and 10^3 cycles.

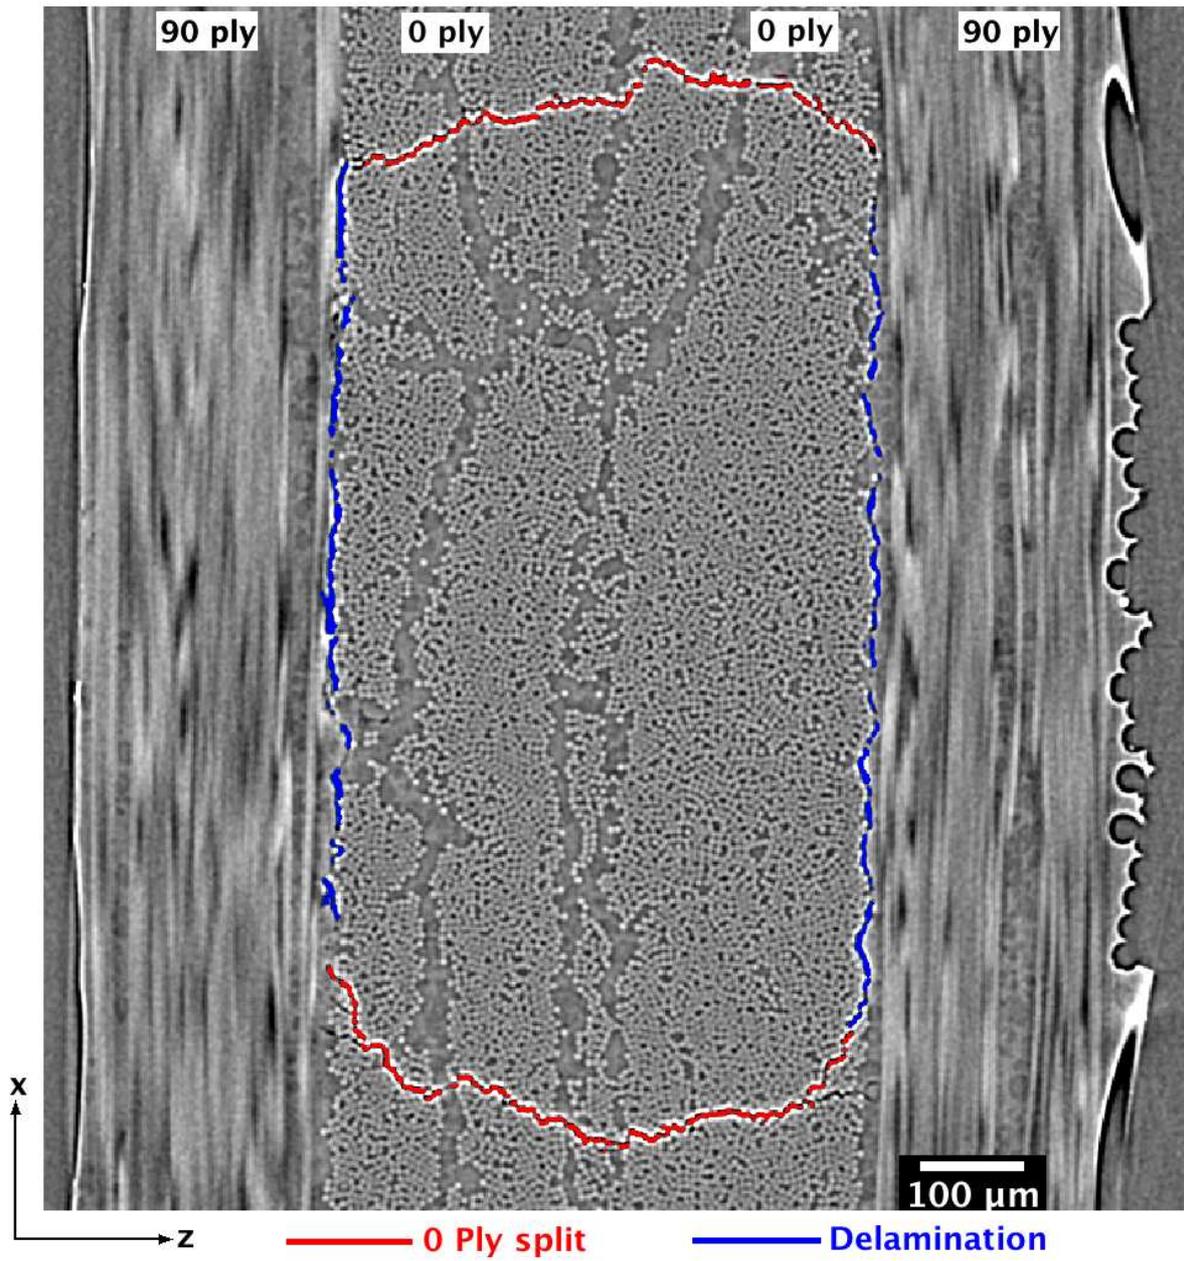
Fig. 8 Cross-section of the coupon loaded at 50% UTS 10^5 cycles in the direction perpendicular to the load.

The application of an intermediate load, (e.g. 50% UTS) coupled with more than 10^3 cycles equal or higher peak loads (e.g. 70% UTS), resulted in fibre failure in the bulk composite, away from splits and delamination, see Table 1. The comparison of the number of fibre breaks detected within the 0° plies is referred to here as the ‘notch region’, which is defined by a nominal gauge length of 3 mm, measured from the middle cross-section of the notch, see Figure 1(b). The case of 50% UTS and 10^3 cycles exhibits a low number of fibre breaks in the bulk: seven were identified, where three appear as singlets (single fibre breaks), and two as doublets. The doublets consisted of co-planar fibre breaks, as shown in Figure 3. The increase in the number of cycles (10^5) for the same peak load (50% UTS) corresponds to a slight increase in the total number of fibre breaks in the bulk (18), the majority occurring as singlets (14), and a few co-planar doublets (2). The distribution of fibre breaks in the bulk with respect to the position of the 0° ply splits for this latter loading case is shown in Figure 7(a), where the volume defined by the 0° ply split lengths has been considered, concatenating three scans. Fibres failed in the bulk are located within the region bounded by the 0° ply splits and the delamination, where the local stress is expected to be raised due to the load-bearing cross section being reduced by the presence of splits and delamination. While split growth reduces the load bearing cross-section along the 0° ply width, the delamination separates the 0° from the 90° plies, as shown in a typical cross-section perpendicular to the loading direction in Figure 8. This is consistent with the observation that no fibre breaks have been detected ahead of the crack tips (Figure 7(a)) and outside of the region of interest delimited by the 0° ply splits and by the delamination (Figure 8). The majority of fibres failed as singlets (in blue), consistent

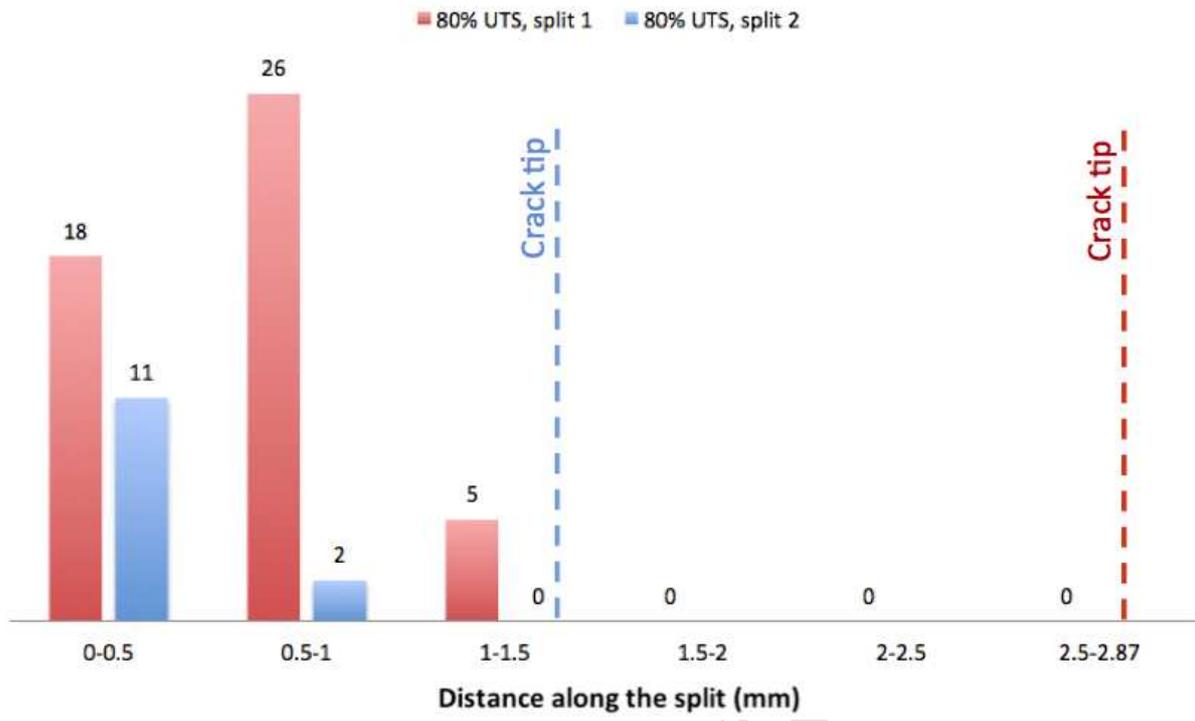
Fig. 9 Fibre breaks density along the 0° ply split for a quasi-static load of 80% UTS.

In order to provide a comparison, fibre breaks for an equivalent quasi-static load of 80% UTS have been counted. The same measurement volume was used as in the fatigue cases, in terms of dimensions and location. In this measurement a total of 124 fibres were observed to have failed, with 14 breaks in the bulk composite, see Table 1. The fibre break density along the 0° ply split was calculated following the same procedure used for the fatigue cases, and the results are shown in Figure 9. Fibre break density increases from the tip towards the root of the split, showing a higher value at the root for the longer split. In addition, this latter case does not exhibit any fibre breaks over the 1.5 mm nearest the crack tip, which represents half of the crack length. The comparison between the quasi-static case (Figure 9) and the fatigue case at an intermediate peak load with low number of cycles (Figure 4) shows a similar trend. However, when higher peak loads and/or number of cycles were considered the fatigue cases exhibit a different trend, with a saturation of fibre breaks along the split (Figure 5). Both loading conditions (quasi-static and fatigue) do not result in fibre breaks in the immediate region behind the crack tip, suggesting that fibre failure along the 0° ply split is a wake-process for both cases. The level of fibre breaks in the wake (~20-25 breaks/0.5mm) is of the same order for both the quasi-static (Figure 9) and fatigue cases (Figure 4-5), consistent with the limiting number of fibre bridges formed being a function of the fibre distribution. Even though the maximum quasi-static peak load (80% UTS) was higher

than the corresponding fatigue case (70% UTS), the number of fibre breaks is lower along the static 0° ply split and in the bulk, see Table 1. This is consistent with the observation that most fibre breaks occurring in the fatigue cases are associated with the cycling process and not with the initial quasi-static load. The clustering of fibre breaks in quasi-static loading are restricted to singlets (4) and doublets (5), in approximately equal proportion; and they are all located close to the 0° ply splits or to the ply interface. No delamination was detected for the quasi-static loading case.
