# Remediation of Mud Pumping on a Ballasted Railway Track

## Abstract

This paper describes measurements at a mud pumping site before and after a complete track renewal where previous, localised gravel packing interventions had been shown to be ineffective.

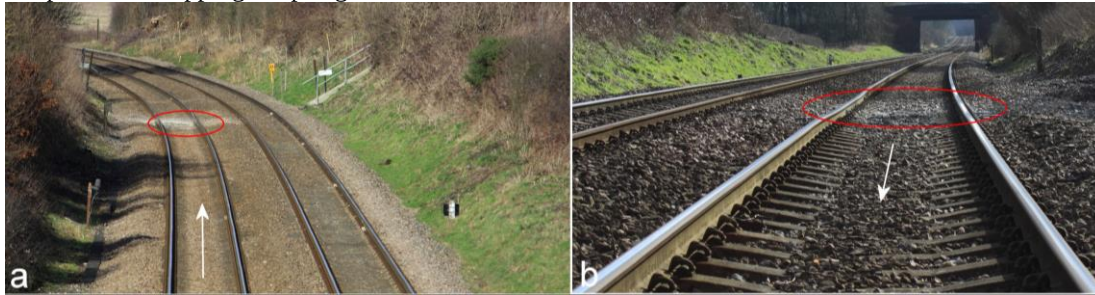
**Figure 1:** (a) View from bridge in the direction of travel (left line). (b) View from beyond the wet bed area looking back towards the bridge. The wet bed area is circled. Arrows indicate the direction of travel on the affected line.

The track at the study site is on a 1:100 upward gradient and a transition curve (Figure 1a) between a curve (2510 m radius, 40 mm cant) and a preceding straight section. Service trains are class 171 diesel multiple units typically in 2, 4 or 6-car formations travelling at up to the line speed of 113 km/h (70 mph). During the weekday visits the off-peak service frequency was one train an hour.

Figure 1a shows the localised wet bed area on the left hand track as a lighter region caused by the drying of clay pumped to the surface. Figure 1b, shows the localised dip within the wet bed area.

The TRC data pre-renewal indicates a substantial localized dip of some tens of millimetres compared with the adjacent track (as was apparent visually in Figure 1b). The TRC data represents

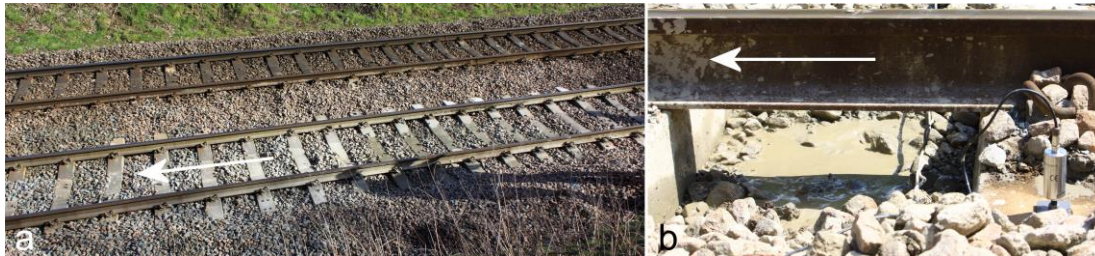
**Figure 2:** (a) Wet bed prior to track renewal. (b) Close-up of worst region – slurry and pea gravel also visible. Arrows show direction of travel on affected line.

The wet bed lies roughly in the middle of a cutting with the local terrain rising to a high of 4 m above the track at the wet bed location. It is possible that a contributing factor for the development of the wet bed is water runoff from the surrounding higher ground ponding on top of the underlying clay, along this section of track. The underlying geology is alluvial clay, silt, sand and gravel overlying mudstone of the Weald Clay formation. In Figure 2a, the nearer line crosses the wet bed, while the adjacent line is unaffected. The severity of the mud pumping is apparent in Figure 2b, where ponded water can be seen within the crib. Several previous attempts to remediate the problem were evident when the site was first visited from the condition of the wet bed and heaps of fouled ballast piled adjacent to the track. These had consisted of local ballast removal and repacking beneath the voided sleepers with chippings or pea gravel.

Prior to renewal, Network Rail described the stretch of track which includes the wet bed, as “very poor” with a mean standard deviation over a 35 m wavelength vertical top of 4.9 mm. The rate of deterioration of 1 mm/year was noted as ‘high - indicative of potential formation problems’. In the renewal, the track (rail and sleepers) was replaced over a length of 820 m and the ballast was dug out to a depth of 200 mm below sleeper base level. The full depth of the ballast was not known. Over a stretch of about 135 m which spanned the wet bed area, a micro-porous filter (TRACKTEX) sandwiched between geotextile (Tensar SSLA30) layers was used to separate the subgrade and fouled sub-ballast from the ballast. This is a type of renewal that, while relatively extensive falls short of a

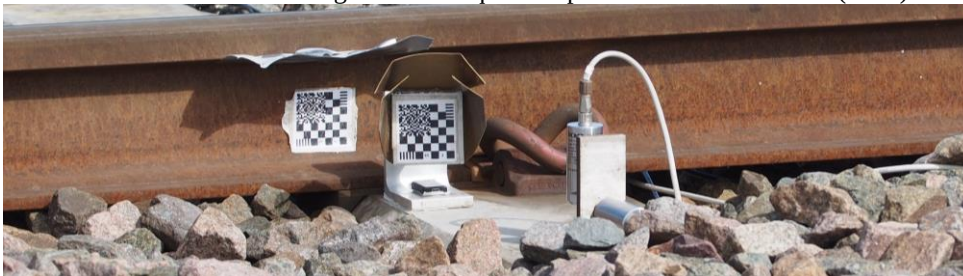
**Figure 3:** Sleeper end with DIC targets on sleeper and rail and a pair of horizontal and vertical geophones.

The use of geophones for determining of sleeper movements as trains pass is well established (e.g. Bowness *et al.*, 2007; Coelho *et al.*, 2011; and Priest *et al.*, 2013). Each geophone is contained within a small cylinder (80 mm height and 30 mm diameter) and is wired to a data logger beside the track (Figures 2b & 3). The geophones are attached to sleepers using glued brackets. Geophones provide a voltage proportional to velocity; the recorded data are converted to displacement by applying the appropriate calibration and integrating. A summary of the data they provide and their interpretation can be found in Le Pen *et al.* (2014).

High speed video and digital image correlation (DIC) can be used to obtain track movements (e.g. Bowness *et al.*, 2005, Le Pen *et al.*, 2014 and Murray *et al.*, 2014) as a measurement system complementary to geophones. A target is usually attached to the sleeper end (Figure 3) and videoed. Analysis is carried out using a variant of the DIC technique described by Bhandari *et al.* (2012). The technique involves identifying corresponding patterns in the subsequent images using a normalized cross-correlation algorithm.

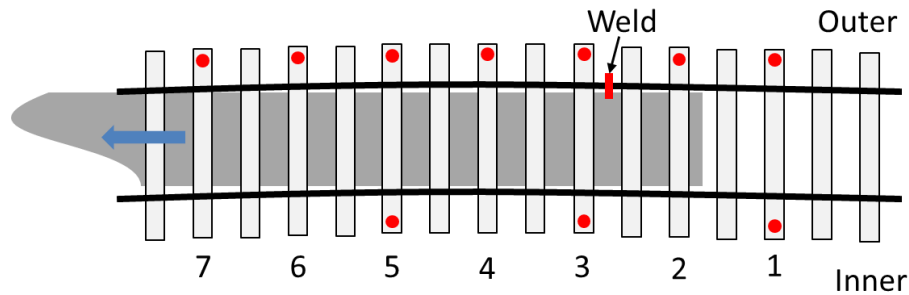
**Figure 4:** Site layout prior to renewal showing the approximate extent of the wet bed (in grey) and the vertical geophones (red circles). The arrow indicates the direction of travel.

10 vertical and 4 horizontal geophones were placed on 7 alternating sleepers spanning a run of 13 sleepers labelled as shown in Figure 4. The instrumented section of track spans the apparently unaffected track ahead of the wet bed and the major portion of the wet bed prior to renewal.

Figure 4 shows a weld next to sleeper 3. This could have been a potential trigger for the development of the wet bed. However, it was noted that welds were present on the adjacent track where no wet bed was present. Thus although the weld could have been partly responsible for the development of the wet bed, there is no proof of this.

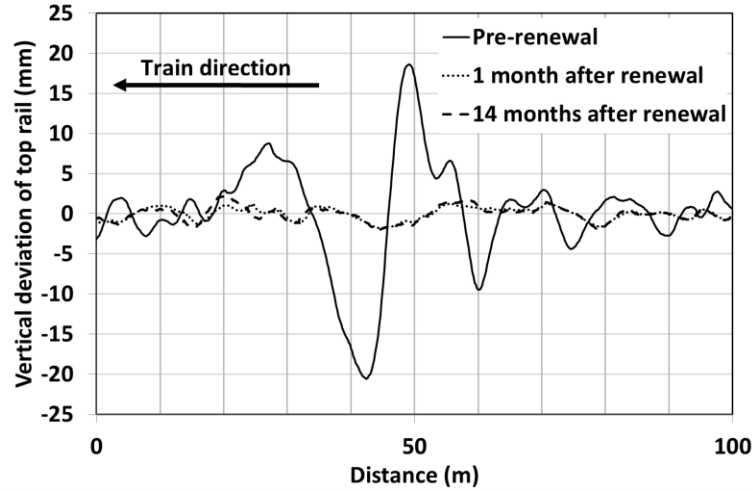
**Figure 5:** TRC data, for the top right rail (from the train) over a 35 m wavelength, pre- and post-renewal.

Figure 5 shows TRC vertical loaded geometry data for the outside rail (adjacent to the area between the tracks – known as the ‘six foot’ on UK railways) for a run, prior to and two runs after renewal. As is usual with this type of data, the relative distance along the track for different runs can vary by some tens of metres. The data can be manually aligned, although finding the exact location in relation to track features remains subject to some uncertainty. The pre-renewal data showed the track was performing very poorly and it is clear that the wet bed location lies between 35 and 50 metres. The post-renewal runs show substantial improvement.

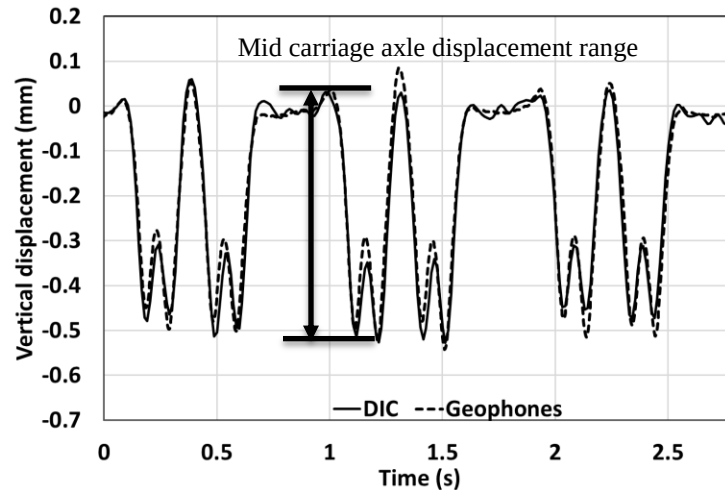
**Figure 6:** Post-renewal comparison of DIC and geophone movements for a 6 car 171 on sleeper 1 inside.

Figure 6 compares the movements of sleeper 1 on the cess side for some middle axles (6 bogies can be identified) of a 6 car Class 171 train, measured using a geophone and DIC after renewal. The geophone data have been migrated to adjust for the relative movement introduced in processing, so that zero is an estimate of the unloaded sleeper level. The DIC data give the correct level directly, provided vibration has not influenced the data. DIC and geophone traces show close agreement. Figure 6 is annotated to show the range of movement from a single axle (used to produce Figure 7).

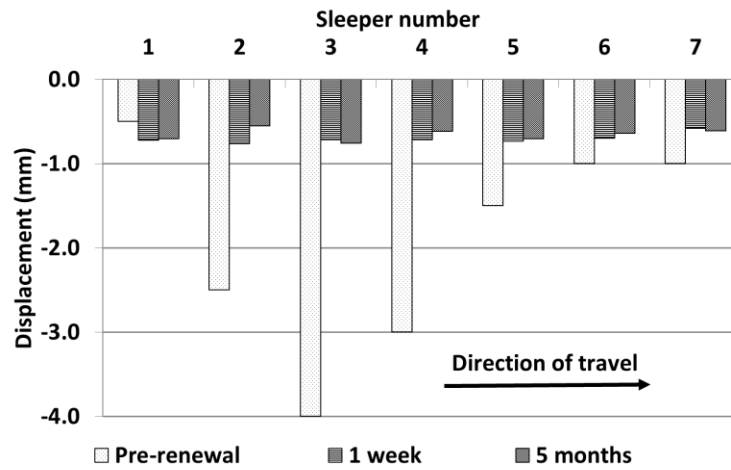
**Figure 7:** Average sleeper vertical deflections for each sleeper across several visits (Class 171)

Figure 7 compares the averaged mid-carriage axle displacement ranges obtained from the geophones installed adjacent to the six foot (on the outside of the transition curve). Each bar is the average from at least three train passes. Prior to renewal, sleepers 2, 3, and 4 were performing exceedingly badly and were voided. Sleeper 5 also showed larger displacements than the remaining sleepers. The inner geophones showed similar behaviour. It is apparent that the problem was at its most severe over a localised zone covering just 3 or 4 sleepers with the adjacent sleepers (1, 6 and 7) performing much better. The post-renewal data show that there are no longer any voided sleepers and that the sleeper deflection is much more uniform across the monitored zone. There was little change in displacement between the two post-renewal visits.
