# Remediation of Mud Pumping on a Ballasted Railway Track

Andrew Hudson<sup>1</sup>, Geoff Watson<sup>1</sup>, Louis Le Pen<sup>1</sup> and William Powrie<sup>1</sup>

<sup>1</sup> Faculty of Engineering & the Environment, University of Southampton, Southampton, U.K.

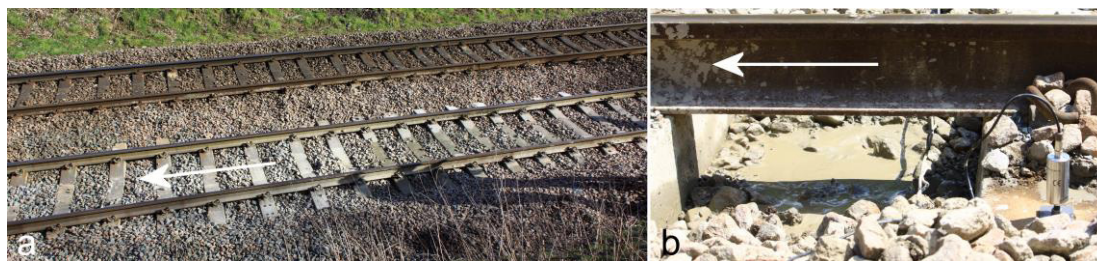
**Figure 2:** (a) Wet bed prior to track renewal. (b) Close-up of worst region – slurry and pea gravel also visible. Arrows show direction of travel on affected line.

Prior to renewal, Network Rail described the stretch of track which includes the wet bed, as “very poor” with a mean standard deviation over a 35 m wavelength vertical top of 4.9 mm. The rate of deterioration of 1 mm/year was noted as ‘high - indicative of potential formation problems’. In the renewal, the track (rail and sleepers) was replaced over a length of 820 m and the ballast was dug out to a depth of 200 mm below sleeper base level. The full depth of the ballast was not known. Over a stretch of about 135 m which spanned the wet bed area, a micro-porous filter (TRACKTEX) sandwiched between geotextile (Tensar SSLA30) layers was used to separate the subgrade and fouled sub-ballast from the ballast. This is a type of renewal that, while relatively extensive falls short of a

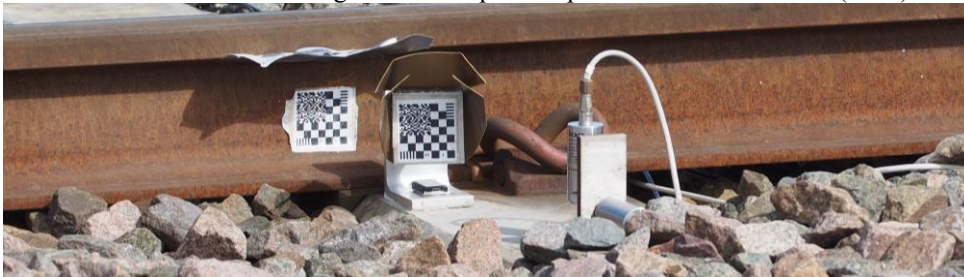
**Figure 3:** Sleeper end with DIC targets on sleeper and rail and a pair of horizontal and vertical geophones.

High speed video and digital image correlation (DIC) can be used to obtain track movements (e.g. Bowness *et al.*, 2005, Le Pen *et al.*, 2014 and Murray *et al.*, 2014) as a measurement system complementary to geophones. A target is usually attached to the sleeper end (Figure 3) and videoed. Analysis is carried out using a variant of the DIC technique described by Bhandari *et al.* (2012). The technique involves identifying corresponding patterns in the subsequent images using a normalized cross-correlation algorithm.
