Microstructural changes in White Etching Cracks (WECs) and their relationship with those in Dark Etching Region (DER) and White Etching Bands (WEBs) due to Rolling Contact Fatigue (RCF)

Viktorija Šmeļova, Alexander Schwedt, Ling Wang, Walter Holweger, Joachim Mayer

To appear in: *International Journal of Fatigue*

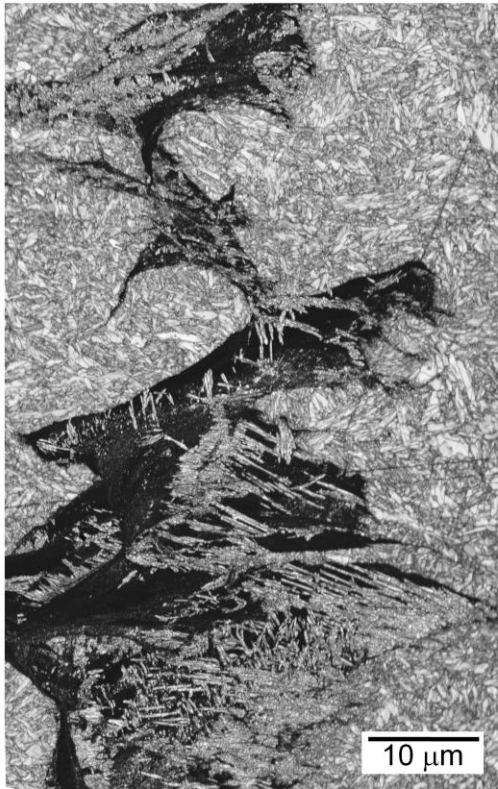
For comparison, the chromium and carbon distributions measured by EDX during the EBSD scan in the energy ranges of Cr-K α and C-K α are shown in Figures 3(c) and 3(d). In the unaltered matrix, primary carbides are clearly shown as higher x-ray intensities in both Cr-K α and C-K α energy ranges. In comparison, in the microstructurally altered region, no similar high intensity spots are seen. In the chromium map, the altered area shows more or less homogeneous intensities. In the carbon map some high-intensity areas within the altered region are detected and the average intensity in the altered area is slightly lower than that in the unaltered matrix. Since the detection of low energy x-rays is challenging at the scanning speed of an EBSD scan, the maps appear to be noisy and the count rates can only be evaluated statistically. A 13% drop for carbon and a 3% drop

for chromium have been found by comparing the accumulated x-ray intensities over areas of 10 μm by 10 μm around positions 1 and 2 marked in Figure 3(d). In order to understand the causes of the inhomogeneous carbon intensities within the altered region, TEM analysis has been conducted on lamellae cut along the red lines shown in Figure 3(d).

Figure 3: EBSD/EDX maps of the WEA: (a) IQ map; (b) non martensite-martensite HAGBs map; (c) chromium map; (d) carbon map with marked carbon-rich areas, positions of the TEM lamellae, and positions '1' and '2' discussed in the text.

As for the carbon redistribution, even though the measurement of carbon is generally challenging using EDX, the corresponding x-ray map obtained shows an inhomogeneous carbon redistribution within the microstructurally altered regions in both the WEC and WEBs [1]. The high carbon intensities found for the primary spherical $(\text{Fe, Cr})_3\text{C}$ carbides in the unaffected matrix of the WEC and WEBs specimens are not seen within the altered region, suggesting that not only the decomposition of the crystal structure has occurred but also a movement of the elements enriched in the former primary spheroidised $(\text{Fe, Cr})_3\text{C}$ carbides. It is interesting that elevated carbon intensity is only seen at particular locations of the altered region in the WEC specimen, often at the boundaries of the altered region. Similar high carbon intensity areas, that are strongly resistant to etchant and result in EBSD unindexable regions, have also been observed in the WEBs specimen

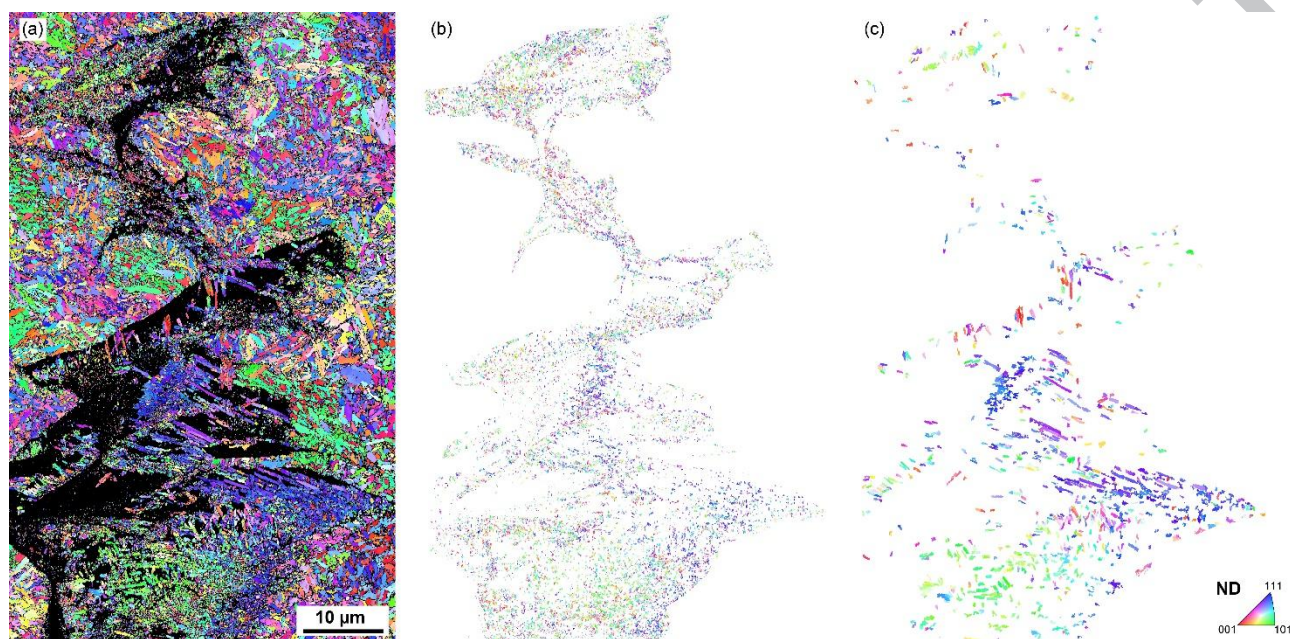
Inverse Pole Figure (IPF) maps of the area of interest with respect to the rolling normal direction are plotted in Figure 5 for: all points indexed with CI more than 0.1 (Figure 5(a)); bcc grains in altered region with grain size less than 250 nm (Figure 5(b)); and bcc grains in altered region with grain size more than 300 nm and aspect ratio less than 0.5 (Figure 5(c)). The indexable crystallites within the altered region appear to be present in clusters of preferred orientations, which, however, do not show any correlation with the prior austenite grains of the martensitic matrix, see Figure 5(a). The altered microstructure is separated into small rather globular grains and larger elongated

grains as seen in Figure 5(b) and 5(c), respectively. Both components show similarities in the preferred crystal orientation within each cluster but crystal and shape orientation of the elongated grains change from one cluster to another.

Figure 5: IPF maps with respect to the rolling normal direction: (a) all points indexed with $CI > 0.1$; (b) bcc grains in altered region with grain size < 250 nm; (c) bcc grains in altered region with grain size > 300 nm and aspect ratio < 0.5 .

network do not show any uniform local orientation that can be directly related to the external rolling conditions. The prevailing texture of the newly formed ferritic grains in the WEC varies from cluster to cluster in the WEC network. The elongated grains in the WEC show a similar crystal orientation (Figure 5(b)) as those of the smaller globular grains (Figure 5(c)), suggesting that they have similar formation mechanism.
