ALTERNATIVE METHODS OF DATA CAPTURE FOR GLASS SUBJECTED TO LONG-DURATION BLAST LOADING

S. Monk, *University of Southampton, UK*
S. K. Clubley, *University of Southampton, UK*

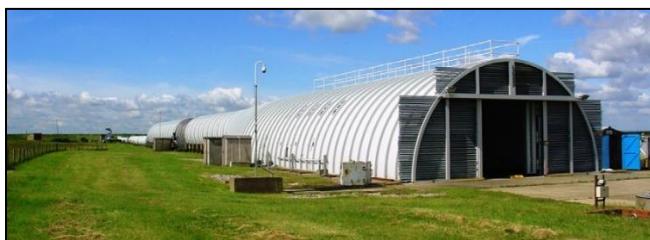
Figure 1. The air blast tunnel (ABT) at MoD Shoeburyness, UK [1].

The air blast tunnel (ABT) at MOD Shoeburyness, UK, was constructed in 1964 and is one of a small number of facilities in the world which are capable of testing full-scale structural response to long-duration blast waves (Figure 1)[1]. Long-duration blasts are typically defined by a positive phase duration greater than 100ms, observed in the far field of large explosions. The 200m long explosively driven shock tube has been used for a number of glass related trials in the past[2]–[4], however the harsh environment makes collecting precise data very challenging. Currently, data capture relies on high-speed photography, however this is susceptible to camera shake, reducing accuracy of the results.

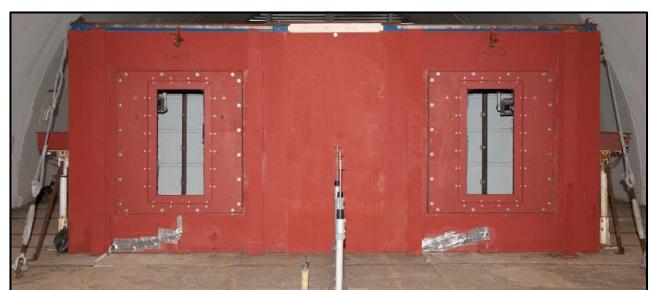
Figure 7. Front elevation of test cubicles in ABT.

Four glass samples with piezo transducers attached were subjected to a blast wave in the ABT with peak overpressure of 14kPa and positive phase duration of 100ms. Two steel test cubicles, designed and constructed by Foulness Trials Group of Spurpark Ltd[2], were fitted in the 10.2m diameter section of the ABT normal to the blast wave (see Figures 6 and 7). 667mm x 1334mm x 4mm annealed glass was supported by a steel frame with an aperture of 1207mm x 537mm. The frame provided rigid support conditions and was fixed by bolts tightened against spacers (Figure 8).

A full free-field pressure history was recorded for each trial using a series of Endevco 8510-50 gauges (shown in Figures 6 and 7). Phantom 2512 cameras, with a frame rate of 75kHz, recorded crack location and break time of the glass. Five 20mm diameter piezo transducers, with a sample rate of 1MHz, were adhered to the rear side of each window (see Figure 9). All instrumentation was triggered at the time of driver detonation to ensure a common time scale.

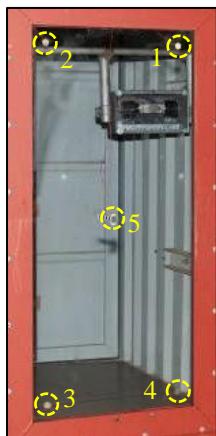
Figure 9. Piezo transducer numbering.
