Maritime Flight Trials of the Southampton University Laser Sintered Aircraft – Project Albatross

Abstract

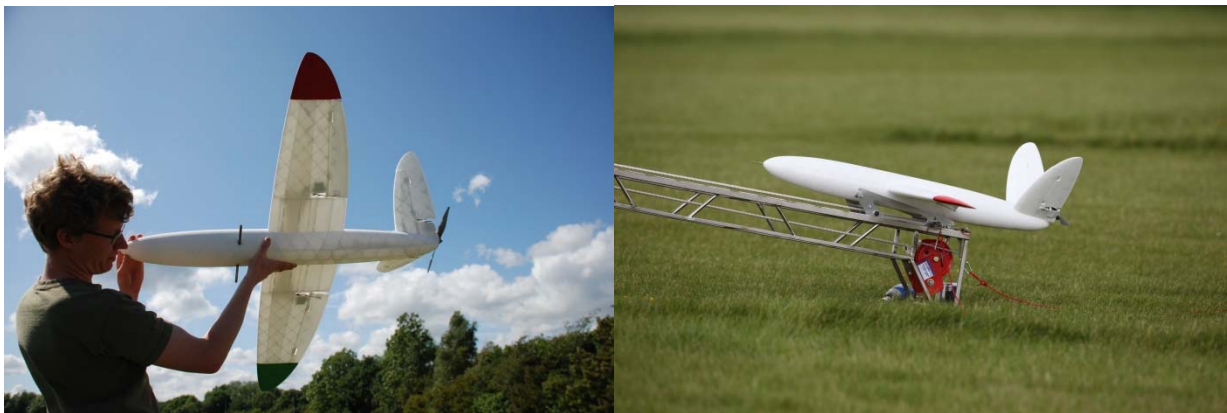
Figure 1: SULSA airframe illustrating SLS structure and catapult mounting.

The Southampton University Laser Sintered Aircraft (SULSA) is an all laser sintered, battery powered sub 4kg unmanned air vehicle (UAV) with on-board GPS enabled autopilot, see Figure 1. Basic details of the system are set out in Table 1. SULSA was originally designed, built and flown to demonstrate the possibilities of using as much 3D printing in a UAV airframe as possible. This method of manufacture enabled the creation of complex geometry, including elliptical wings and geodesic structural reinforcement throughout. SULSA was not initially designed to carry a payload or to be operated other than from its catapult to landing on grass strip runways.

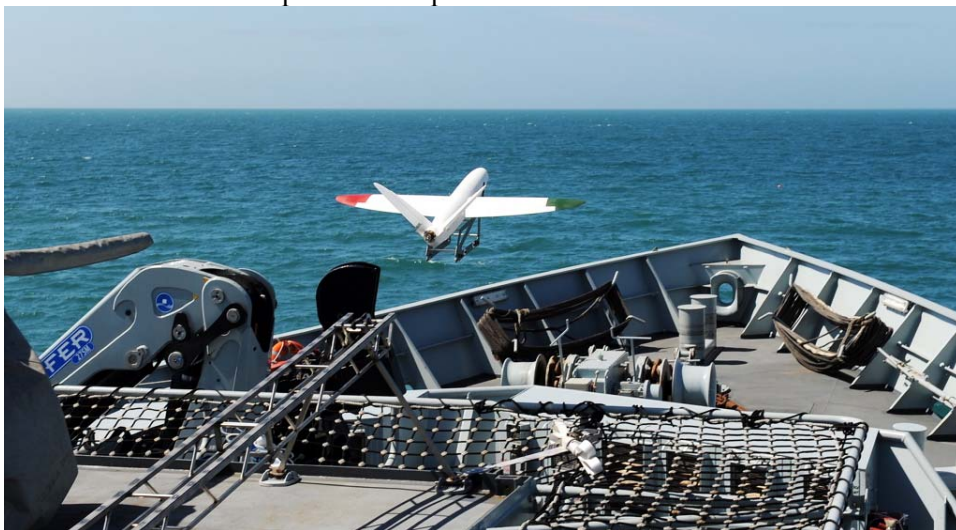
Figure 2: SULSA launching from HMS Mersey – 21st July 2015

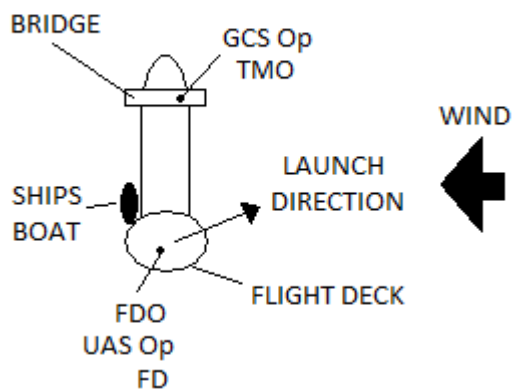
Figure 3 – SULSA Launch Template

Figure 3 illustrates the typical template for a SULSA launch and shows the relative launch direction of the aircraft, a figurative position of the ships boat and the anticipated positions of all trial personnel. It also shows an initial estimated position of the launcher. Once launched the UAV would

be set to attain a nominal altitude of at least 300 ft. above sea level at its first waypoint at which point it would commence following its pre-planned route.

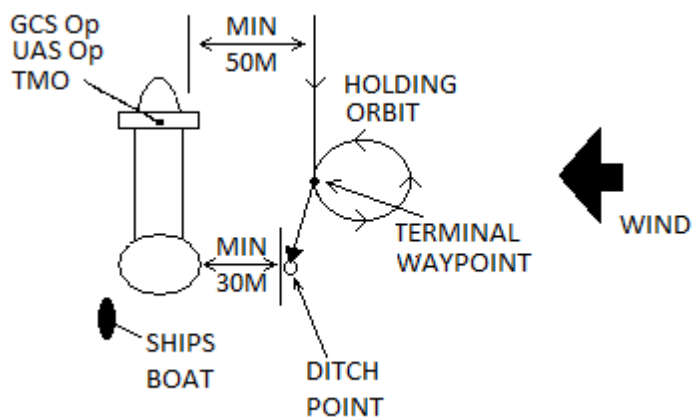
Figure 4 – SULSA Recovery Template

Figure 4 illustrates the typical template for SULSA recoveries with the anticipated positions of project personnel: the UAV to approach its terminal waypoint on a track parallel to the ships course. The terminal waypoint (TWP) would be at least 50m from the ships side and at an altitude of at least 150 ft.; in order to ensure the UAV approaches TWP parallel to the ship, a waypoint (TWP-1) would be established. Once the UAV overflies the terminal waypoint it would then immediately enter a holding orbit away from the direction of the ship. It would stay in this orbit until the UAS Operator (located on the bridge wing) had visually acquired it – once it is parallel to the ship again (at its closest point) the UAS operator would take control of it in MANUAL mode and fly the aircraft to a soft ditch in the sea beside the Ship ensuring that it did not get closer than 30m. The Ships boat would then be tasked to recover the UAV using directions from the Bridge.

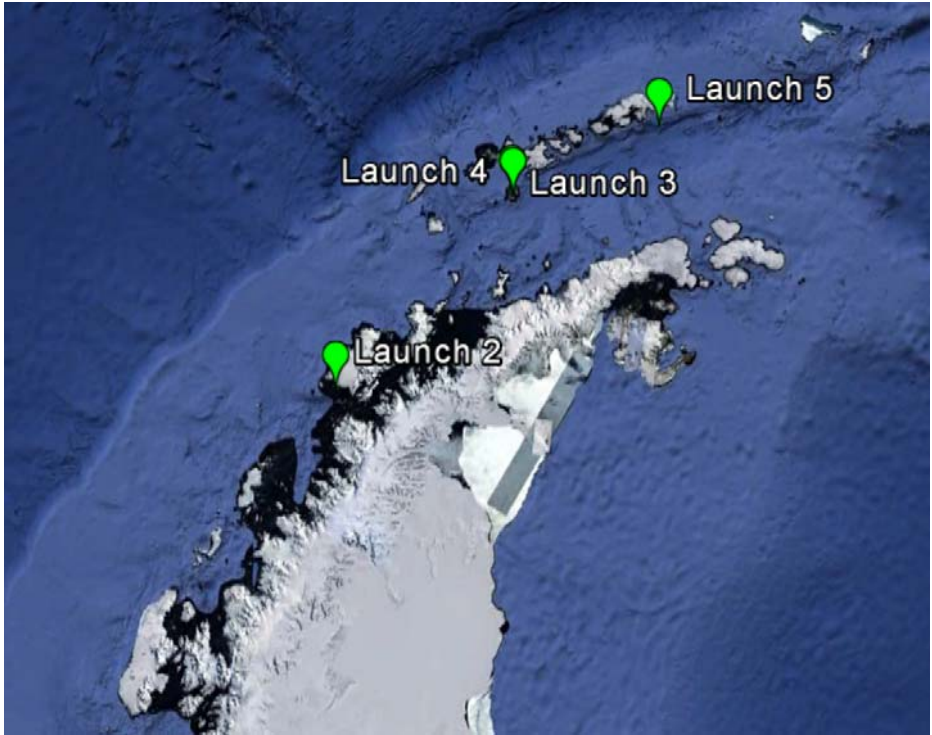
Figure 5 – Launch Locations

Five launches were attempted during the flight trials series which are summarised next. Figures 5-8 show the locations of the successful launches, the launch arrangements, aircraft landing and airframe recovery by sea boat. Table 2 lists the locations of the ship at the start of each of the successful launches.

Launch no.	Latitude	Longitude
2	-64.80748	-64.06076
3	-62.96096	-60.63770
4	-62.97870	-60.61325
5	-62.21362	-57.87393

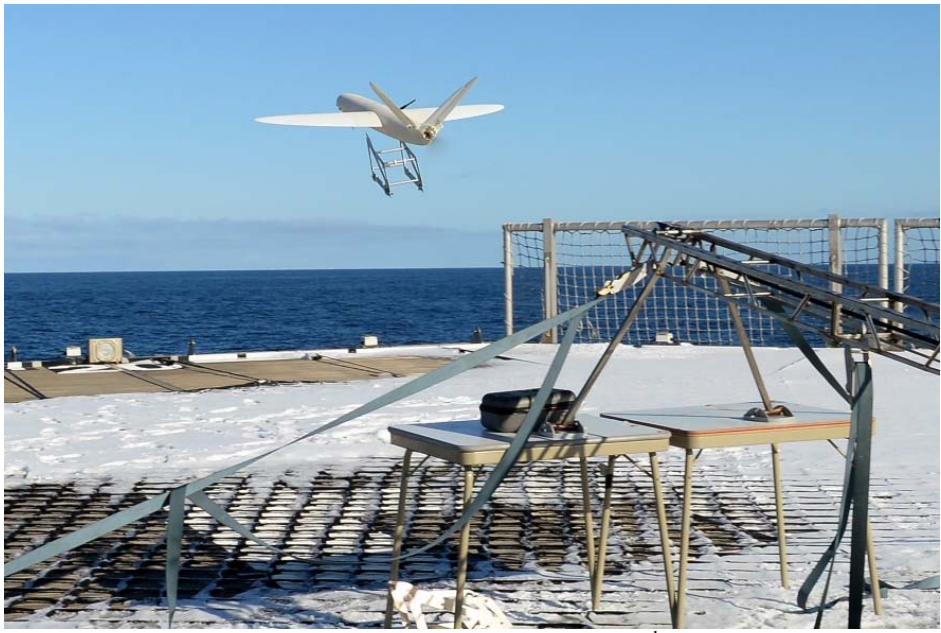
Figure 6 – SULSA launching from HMS Protector – 3rd April 2016

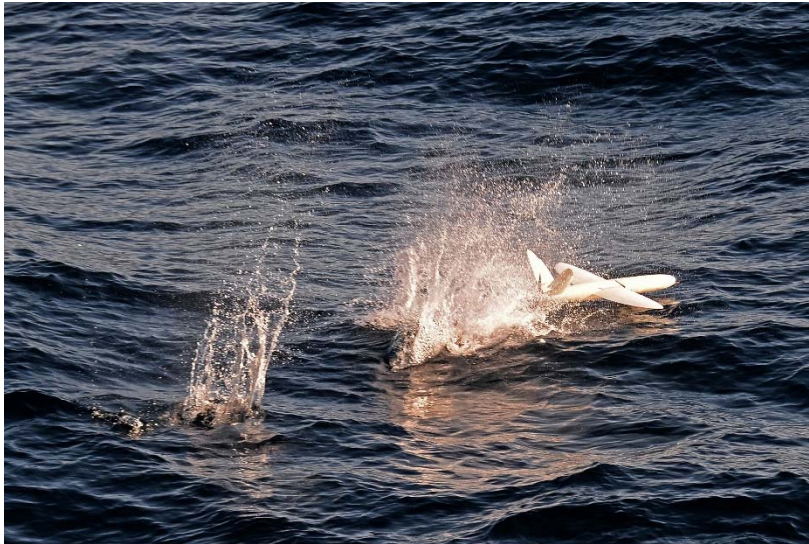
Figure 7 – SULSA landing alongside HMS Protector – 3rd April 2016

During the trials SULSA was launched from HMS Protector to conduct visual surveys as directed by the commanding officer in the vicinity and ahead of the ship prior to being recovered by ditching in the sea alongside. It was then recovered by sea boat. The choice of sea boat recovery was dictated by the health and safety requirements of the ship rather than by any limitations of the airframe or difficulty in landing the aircraft directly on the ship into a net or other compliant structure. By landing in the sea well clear of the ship and sea boat, risks to personnel were reduced to their lowest possible extent, albeit at the cost of some inconvenience and possible damage to the airframe. Clearly, an on board recovery would be more practicable and for such a small airframe landing on such a large flight-deck area, easily accomplished. A series of SULSA airframes were made available for use during the trial with the intention that, where possible, they would be re-used following recovery. The low cost of the system allowed multiple airframes to be supplied for the flight trials. To achieve the trial objectives a minimum of three flights were required with the survivability of the UAVs following recovery determining if further flights would be possible.

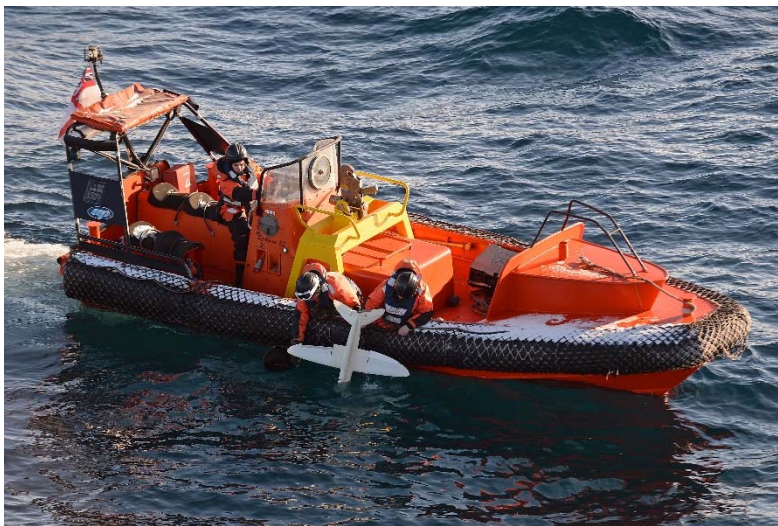
Figure 8 – SULSA being recovered by HMS Protector's ship's boat – 3rd April 2016

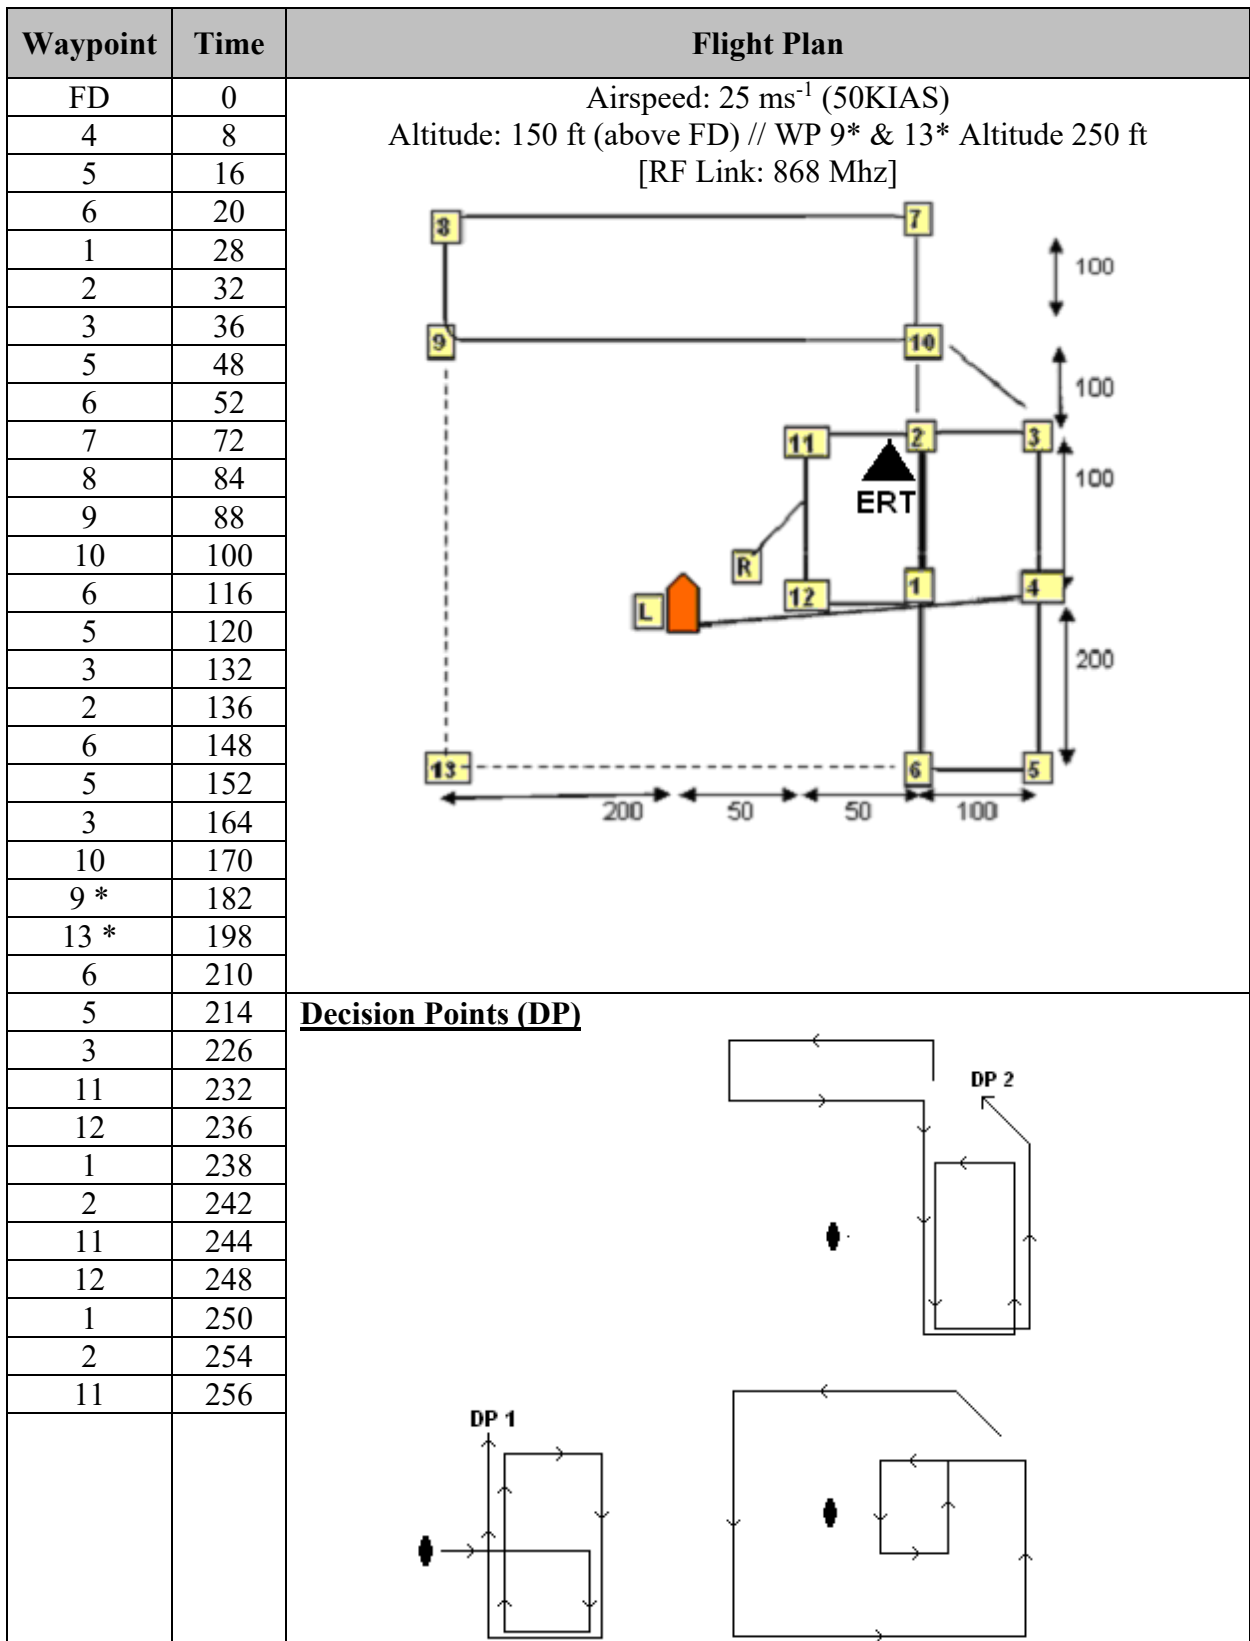
Figure 9 – Launch Two Flight Profile

The flight was conducted using the template shown in Figure 9. The waypoints were planned using a relative position to the ship's location and aligned to the ship's head bearing. However, it became evident on launch that the autopilot was not quite aligned to this heading and although it attempted to follow the pre-determined flight plan its accuracy slowly decreased. At decision point 2 it was determined not to allow the flight plan to proceed on the 3rd phase (an orbit of the ship) as the flight path took the aircraft to approximately 50m of the Ship rather than the planned minimum of approximately 200 m at this point. The UAV was transferred to MANUAL control and landed safely on the water. The aircraft was recovered safely and efficiently by the Ships boat.

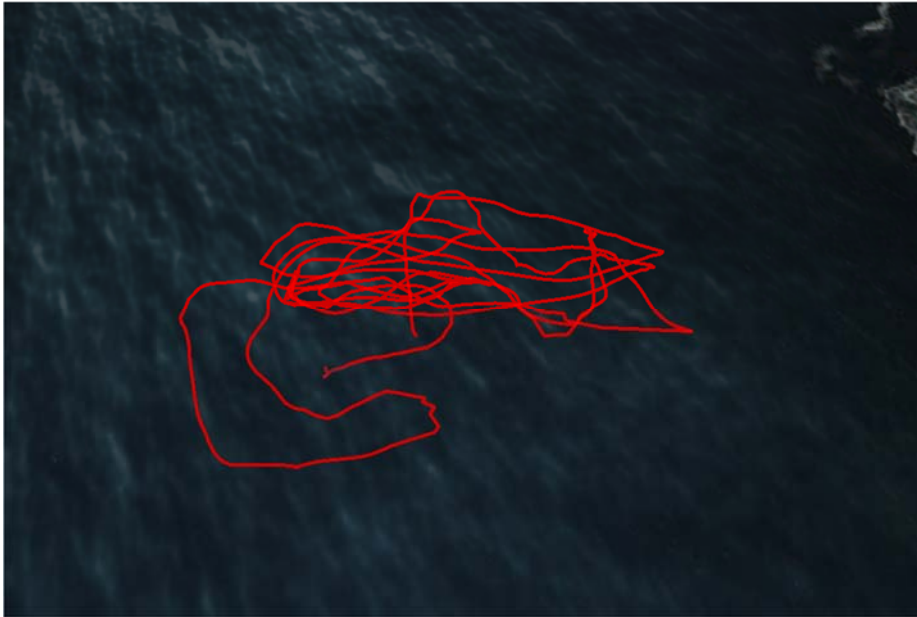
Figure 10 – Launch Two Flight Track. Note that this is based on the GPS positions logged by the autopilot and is not representative of the flight path followed by the aircraft in this case.

Flight time was approximately 5 minutes.20 seconds. The media was recovered from the UAV and provided good quality footage of the flight. The flight track recorded by the aircraft GPS is shown in Figure 10 but this track was corrupted by intermittent GPS location failures in the logging process.

It is assessed that the deviation from the planned flight path was caused by a combination of two things: (1) Incorrect interpretation of reference heading by the UAV following transfer of the route i.e. the orientation of the route did not accurately reflect the actual heading of the ship at the time of launch and (2) The relative tightness of the planned route caused the aircraft to continually overfly its intended waypoint due to inaccuracy in track maintenance thought to be caused by the low feedback rate autopilot steering commands. The restricted accuracy of route maintenance compounded the initial heading orientation errors. Note that the tightness of the route was required to maintain the aircraft within VLOS – it is not assessed that this would be an issue for Extended Visual Line Of Sight (EVLOS) flight when minimal waypoints would be planned.

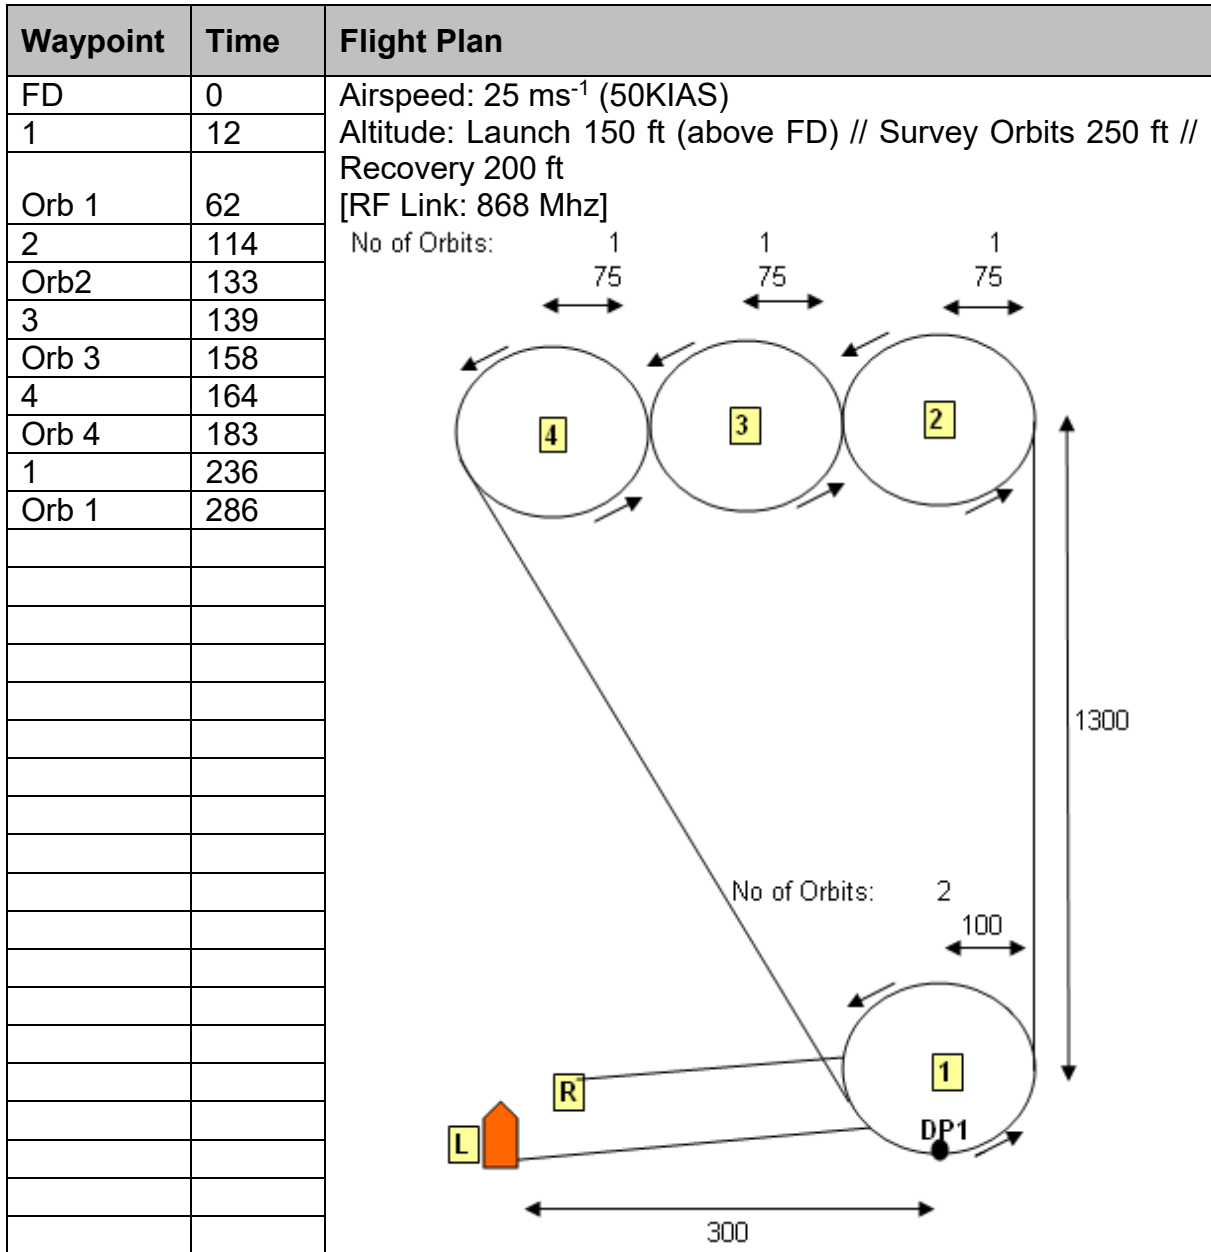
Figure 11 – Launch Three Flight Profile.

A survey area was identified within Deception Island with the ship in Dynamic Positioning approximately 1.2nm from nearest point of land. The flight was conducted using the template shown in Figure 11. The lat/long of the survey area and the Ships location was provided and input to the GCS Skycircuits PLAN tool. It was noticed that the range and bearing given between the survey area and the Ship were significantly different on PLAN and the ship's own systems. (GCS gave 1,325 yards at 223°. whereas the ship systems gave 1,600 yds. at 216°). Waypoint 3 was specified as the survey area and flanked by waypoints 2 and 4 with similar search orbits. To mitigate the potential variation in the survey area direction it was decided to add an additional search orbit after waypoint 4 to ensure that the survey area was covered – noting the limitation of maximum range of 1500m. Prior to launch the Ship was manoeuvred to give the correct WOD and the orientation of the initial and terminal waypoints adjusted accordingly (300m at GREEN 45). Note that due to the max range limitation, the aircraft did not actually overfly the survey area – the intention was to try and gain video footage of it.

The multiple orbit of waypoint 5 was found to be an error in planning. It is required that the number of orbits be input in a dialog box during the planning process, if the number input is left as 0, then an infinite number of orbits will be conducted – this was found to be the case. This was an oversight in planning and not due to autopilot error. On the positive side, the GCS comms. to the UAV proved the ability to update UAV route geometry commands during flight.

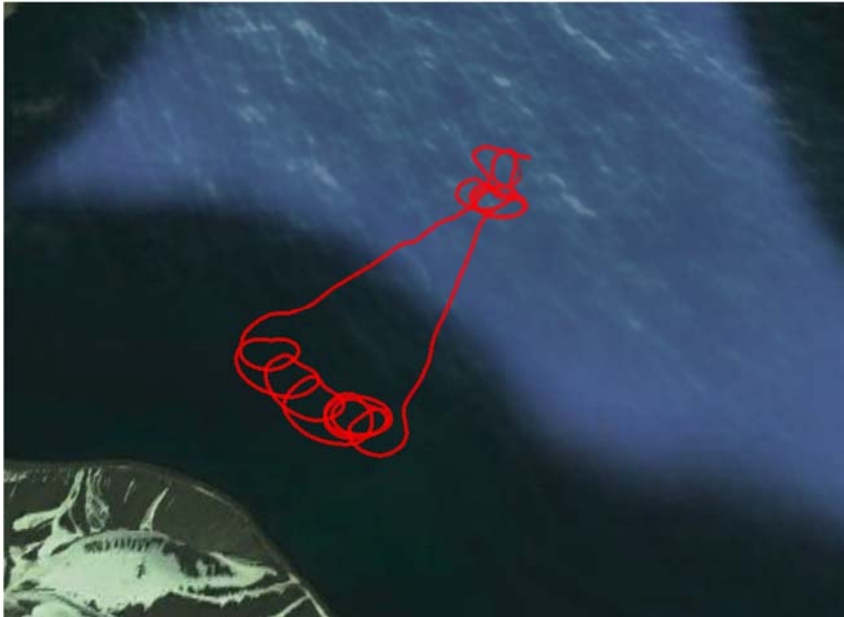
Figure 12 – Launch Three Flight Track.

Flight time was approximately 4 minutes.50 seconds. Unfortunately, the media recovered from the UAV was found not to have recorded the actual flight. The flight track recorded by the aircraft GPS is shown in Figure 12.

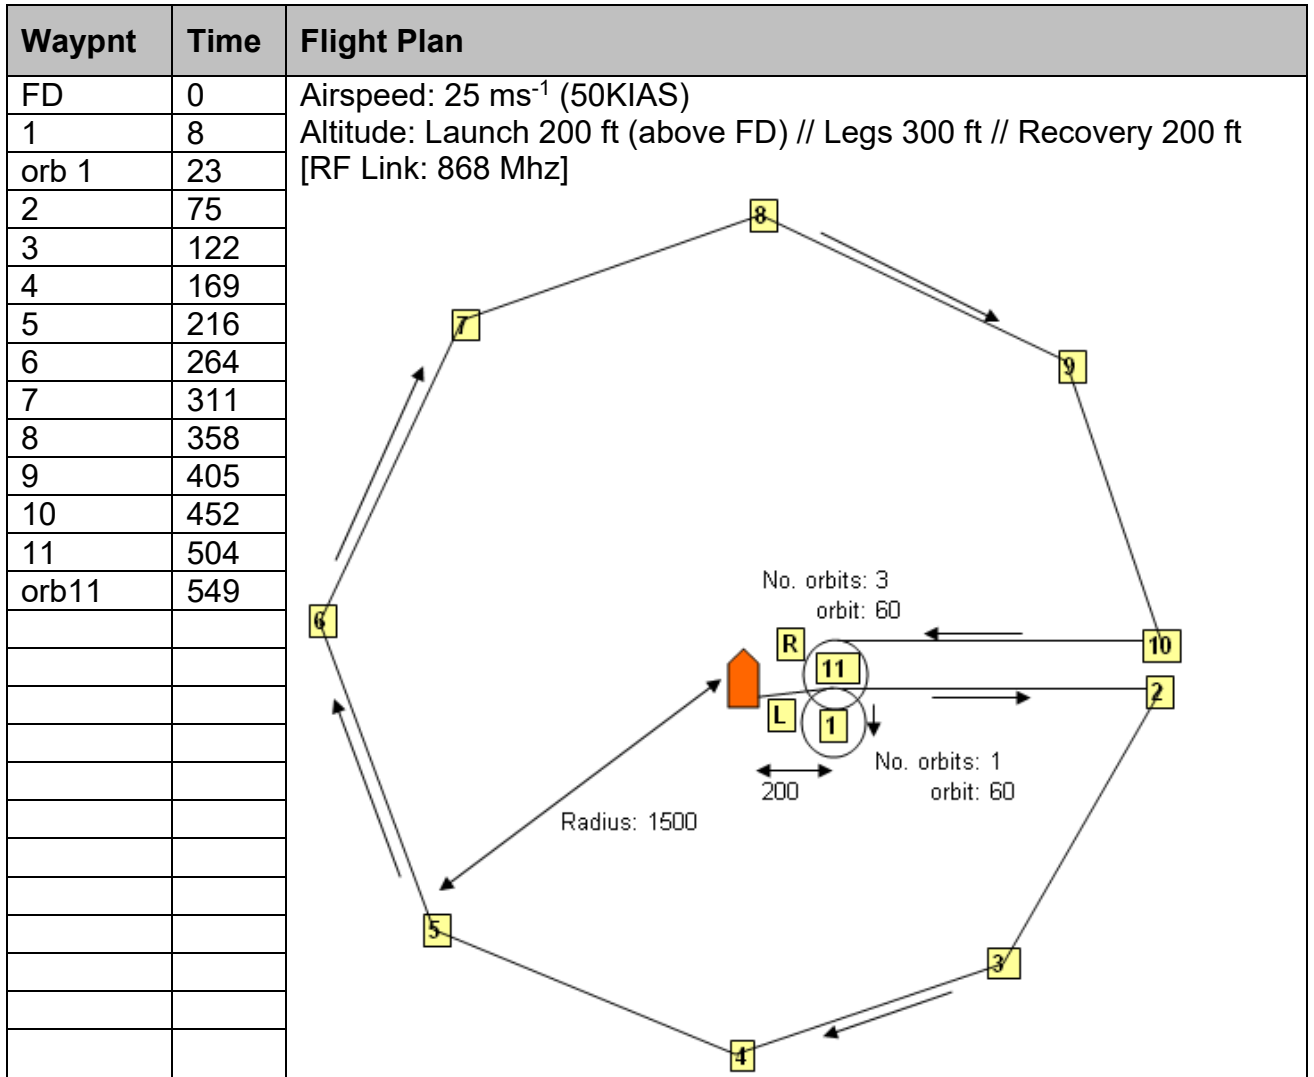
Figure 13 – Launch Four Flight Profile.

The route was planned using the reference method of plotting waypoints with particular effort to ensure correct orientation with the Ships head. The outbound transit to 1500 m was designed to be as near to 90° from the ships head as possible to assess if the orientation was correct. The autopilot safety perimeter was set at 1500 m (if route maintenance failure occurred and the UAV reached this range, the aircraft would automatically return to its Emergency Return Point (ERP) at G45 300 m where it would orbit until ditched).

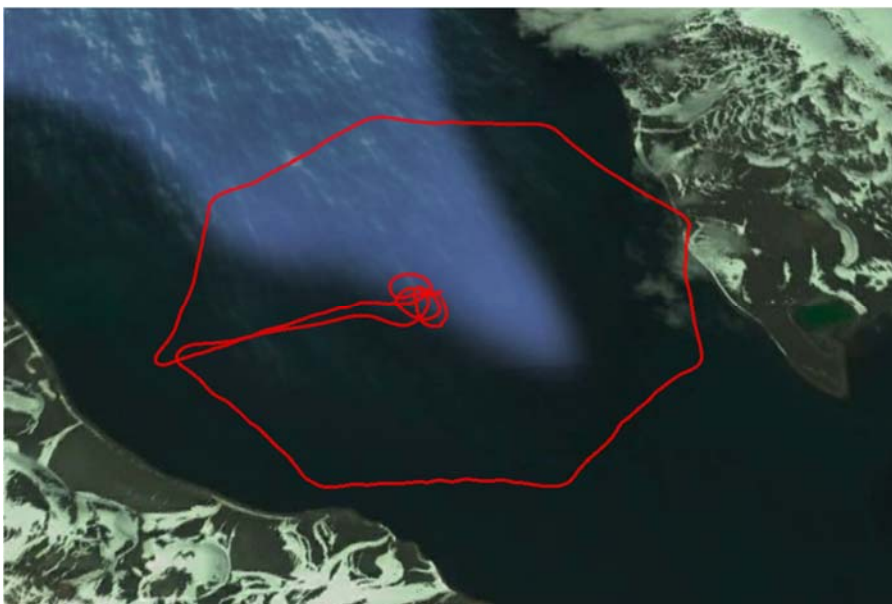
Figure 14 – Launch Four Flight Track.

Flight time was approximately 10 minutes 20 seconds with a route length of approximately 12km. The media recovered from the UAV provided approximately 8 minutes of flight footage, however failed to record the last 2 minutes of the flight. The flight track recorded by the aircraft GPS is shown in Figure 14.

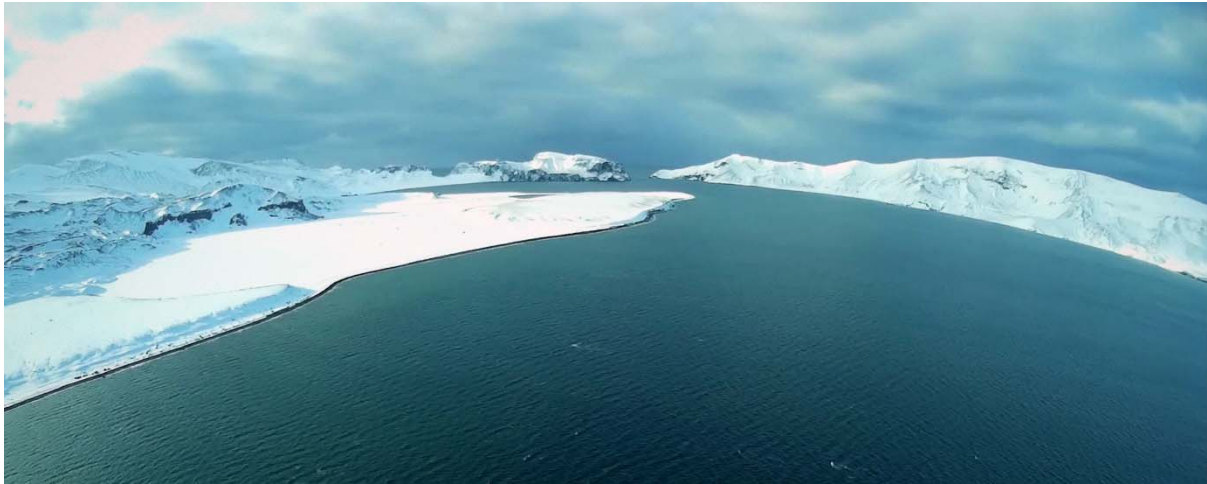
Figure 15 – A frame from the video captured during the third flight.

The test flight intended to prove the reusability of the avionics package following a previous ditching. The Autopilot module was the only part of the avionics that required to be reused with the Engine, Camera, speed control unit and battery all replaced with new items. It was also intended that the flight would be used to gain footage of the Ship in the Antarctic environment as the last opportunity in the Antarctic region – this was a requirement requested for university publicity reasons. As this was considered to be the ‘spare’ airframe, it was the only not painted with highlighted colours (i.e. it was plain white), hence another reason to maintain a closer range. The flight was conducted using the template shown in Figure 15.

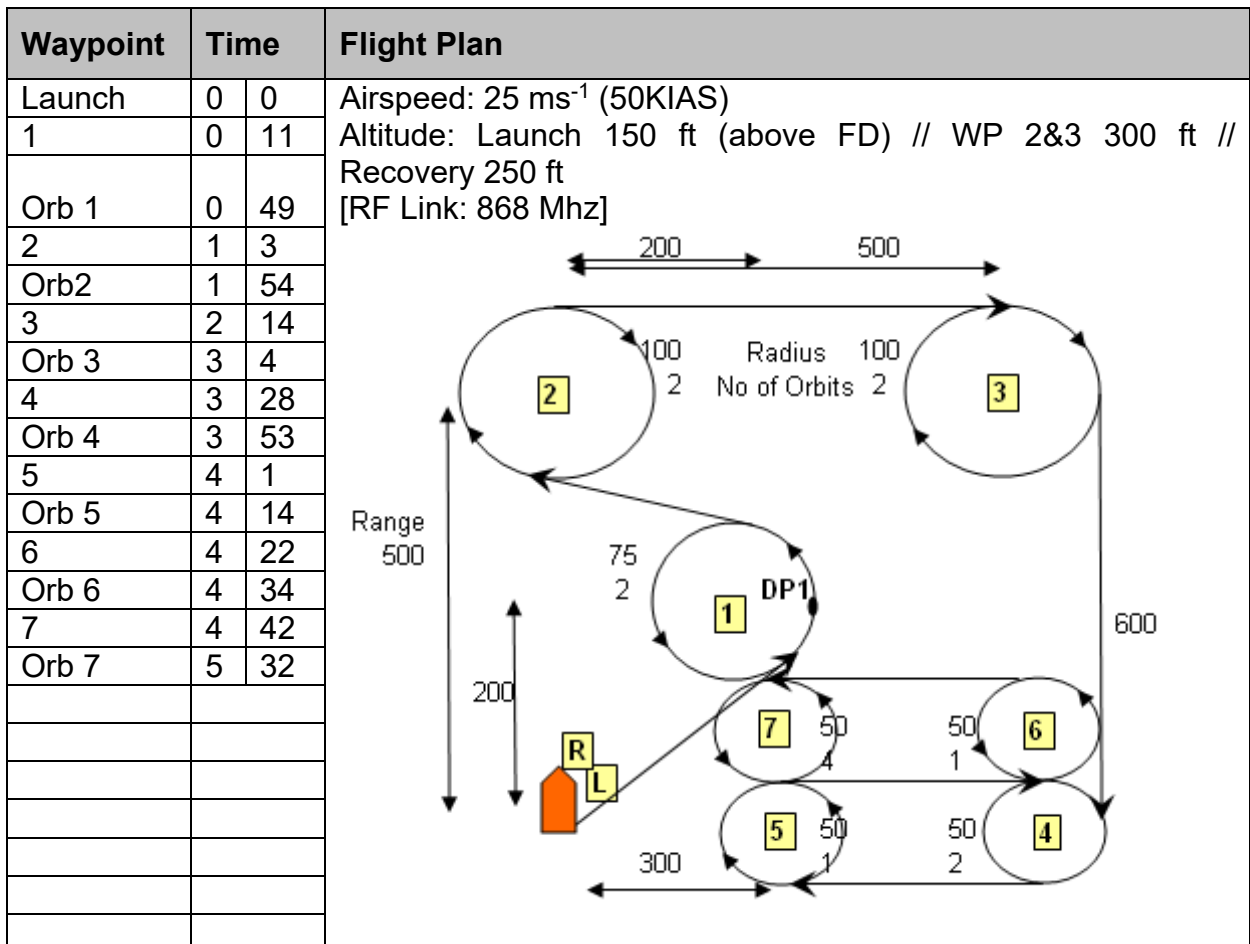
Figure 16 – Launch Five Flight Profile.

The route was planned using the reference method of plotting waypoints with particular effort to ensure correct orientation with the Ships head. The autopilot safety perimeter was set at 900 m (if route maintenance failure occurred and the UAV reached this range, the aircraft would automatically return to its Emergency Return Point (ERP) at G45 300 m where it would orbit until ditched).

The aircraft was launched into wind GREEN 90 in 2-3 kts negligible gusts. The launch was fault free and efficient. After attaining the initial cruise altitude of 200 ft (above FD), the UAV turned towards its first waypoint and conducted its planned two orbits before departing to WP 2. At some point during this transit the GCS operator reported that the UAV had registered a GPS failure with zero satellites. Approximately 30 seconds later, the GCS Operator reported that the UAV was diverging from the flight path by over 100m with no attempt to correct. The UAV still [visually] appeared to be following its planned flight path in that it was orbiting at approximately the correct time scheduled. Around this time the Ship reported that the GPS position in DP had also momentarily failed. Approximately 30 seconds later, the GCS Operator then reported that the UAV had crossed the safety radius at 900 m from HMS PROTECTOR (flight time approximately 4 minutes). The GCS Operator also reported that the aircraft flight path (as displayed on the GCS laptop) appeared highly erratic. As the aircraft was still visual (with aided visual support from the bridge), the UAS Operator took MANUAL control and flew the UAV directly back to the ship. As this was one of the last remaining flights, it was decided to get some camera footage of the Ship before conducting a safe ditch in the sea approximately 30m of the STBD quarter. The UAV was recovered safely to the Ship.

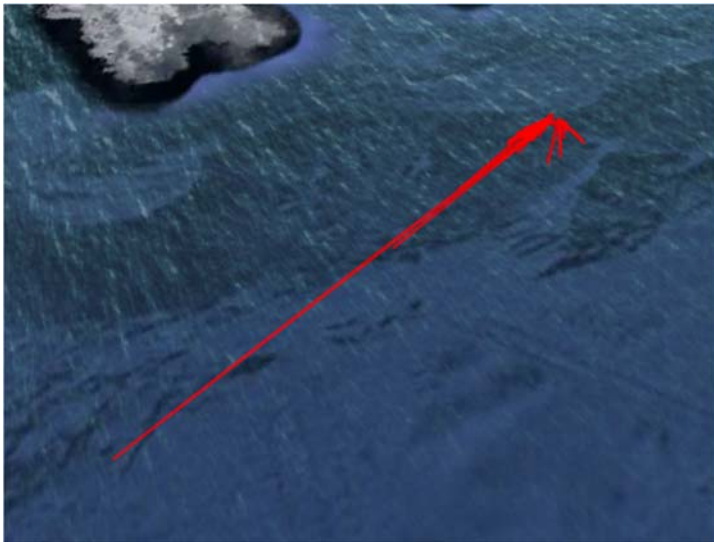
Figure 17 – Launch Five Flight Track. Note that this is based on the GPS positions logged by the autopilot and is not representative of the flight path followed by the aircraft in this case.

Flight time was 14 mins 30 seconds. Approximately 13 minutes of footage was obtained from the camera. The flight track recorded by the aircraft GPS is shown in Figure 16.

The exact cause of GPS failure is unknown but is not thought to be a technical issue with the AV/GCS (i.e. functioning as designed), however at this latitude lack of GPS could simply be due to Ship's position and time of day where the coverage is not a great as previously encountered, this is corroborated by HMS PROTECTOR losing its GPS position at approximately the same time. The UAV GPS failure may also be due to incorrect almanac data or atmospheric model however lack of detailed technical knowledge of SULSAs GPS means that this cannot be checked.

This flight highlights the SULSAs reliance on GPS – once the GPS failed, [theoretically] the navigation of the UAV should have reverted to the on-board Inertial Reference System (IRS) with its compass at least providing a directional reference for the UAV to turn and head in the general direction of the Ship. It is unknown why this didn't occur; the IRS system itself did not fail as the UAV was correctly orientated throughout the flight and therefore it may be concluded that the AV's compass did not function correctly – due to lack of knowledge of the SULSA avionics systems, it cannot be definitively determined at this stage. There is also the possibility that any errors in the compass system (or any module of the avionics packages) may have been suspect due to previous damage incurred by salt water immersion.

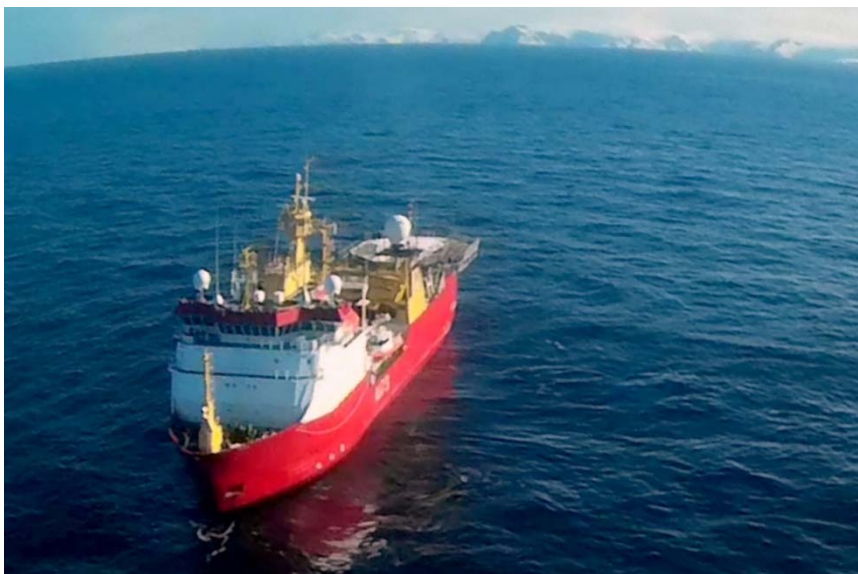
Figure 18- A frame from the video captured during the last flight

Footage was not obtained for the full duration of all flights. It was found that the camera would not consistently survive the ditching in the sea and occasionally failed to record. Modifications were made to the method of operation which enabled periodic 'clips' to record to the on-board SD card, this allowed the majority of the flight to record with only the clip recording at the time of ditching lost due to camera failure.

The footage obtained was a direct recording which could only be relayed to the Ship's Command following recovery. The largest inadequacy of the system was that it did not provide a live Full Motion Video (FMV) downlink. Subsequent versions of SULSA will provide a suitable link.
