# **Cavitation erosion-corrosion in marine propeller materials**

Lloyd's Register

Thesis for the degree of Doctor of Philosophy

June 2017

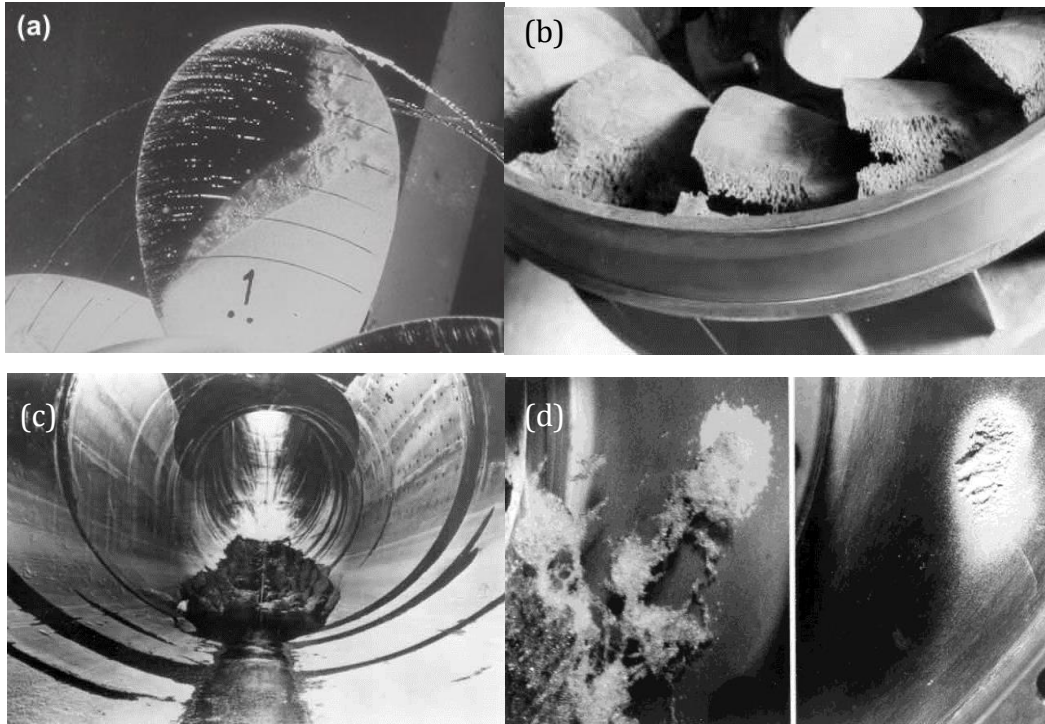
**Fig. 1.1:** (a) Sheet and cloud cavitation damage together with a tip vortex on a propeller blade [9]; (b) Cavitation damage on the blades at the discharge from a Francis turbine; (c) Cavitation damage to the concrete wall of the 15.2m diameter Arizona spillway at the Hoover Dam; (d) Axial views from the inlet of the cavitation and cavitation damage on the hub or base plate of a centrifugal pump impeller [8].

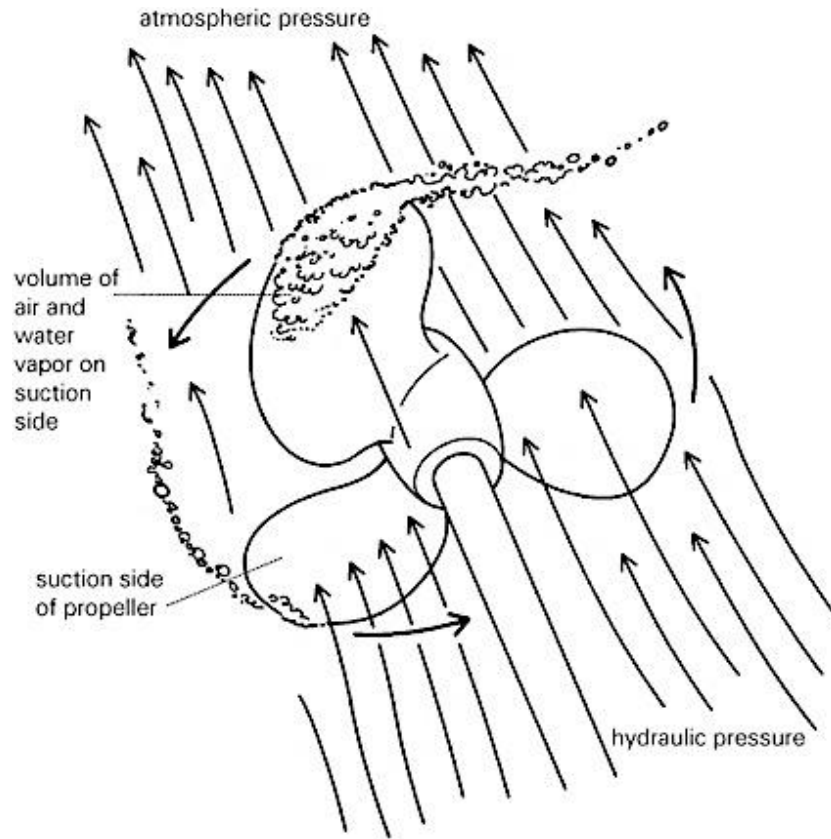
**Fig. 1.3:** Cavitation formation on the suction side of the propeller [14].

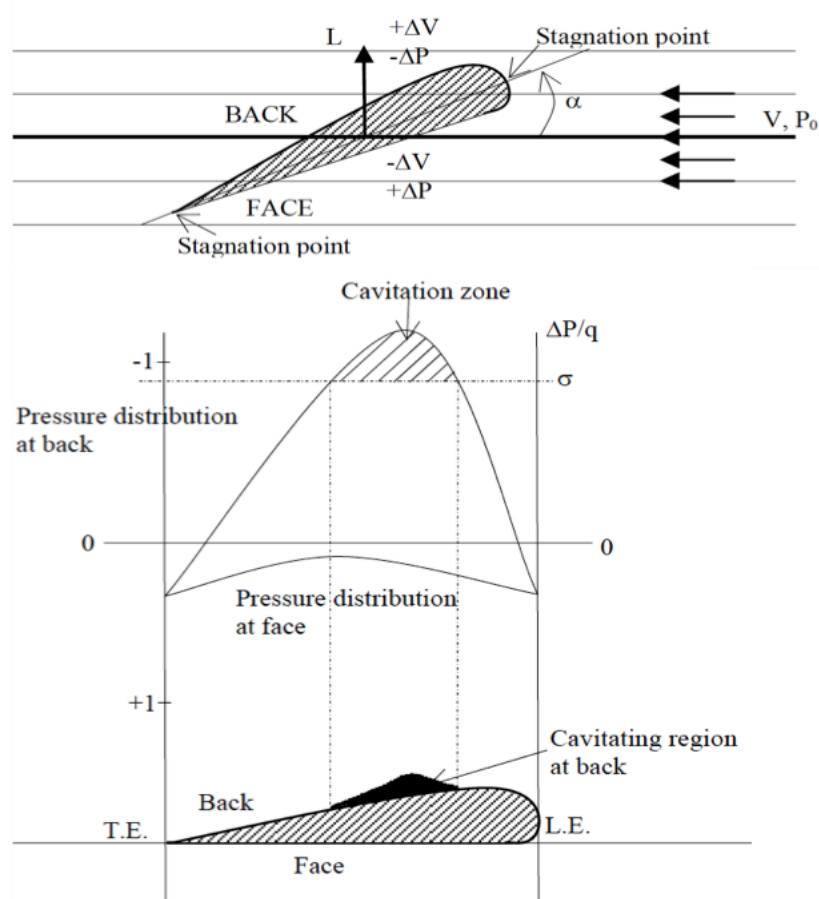
**Fig. 2.8:** Positive angle of attack on the propeller blade with pressure distribution at different areas of the propeller blade [83].

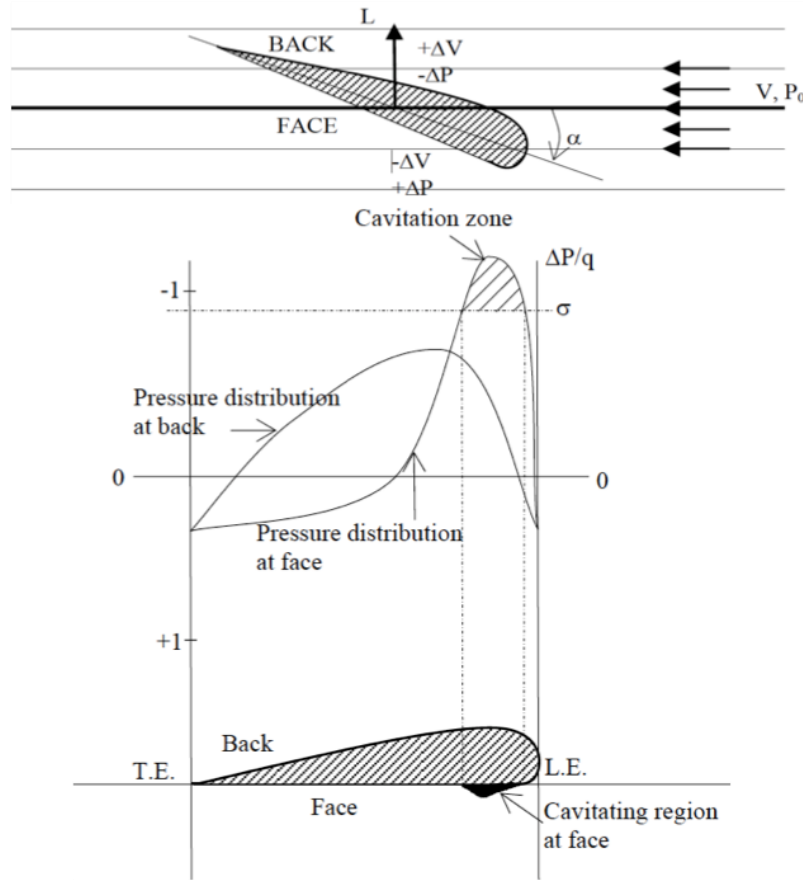
**Fig. 2.9:** Negative angle of attack on the propeller blade with the pressure distribution depicting the cavitation zone on the propeller blade [83].

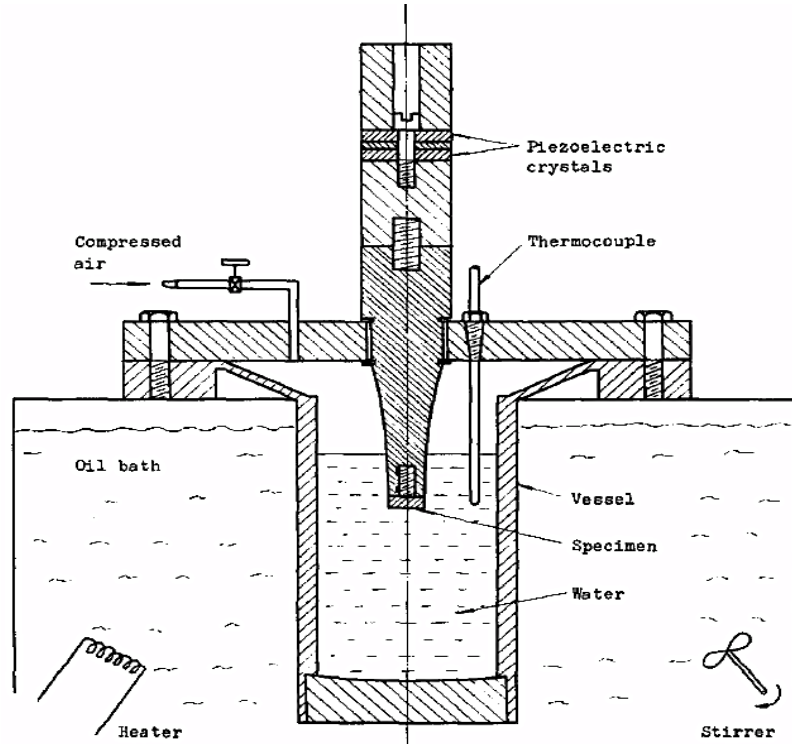
**Fig. 3.2:** Vibratory system in the University of Michigan used by Hammit and He [105].

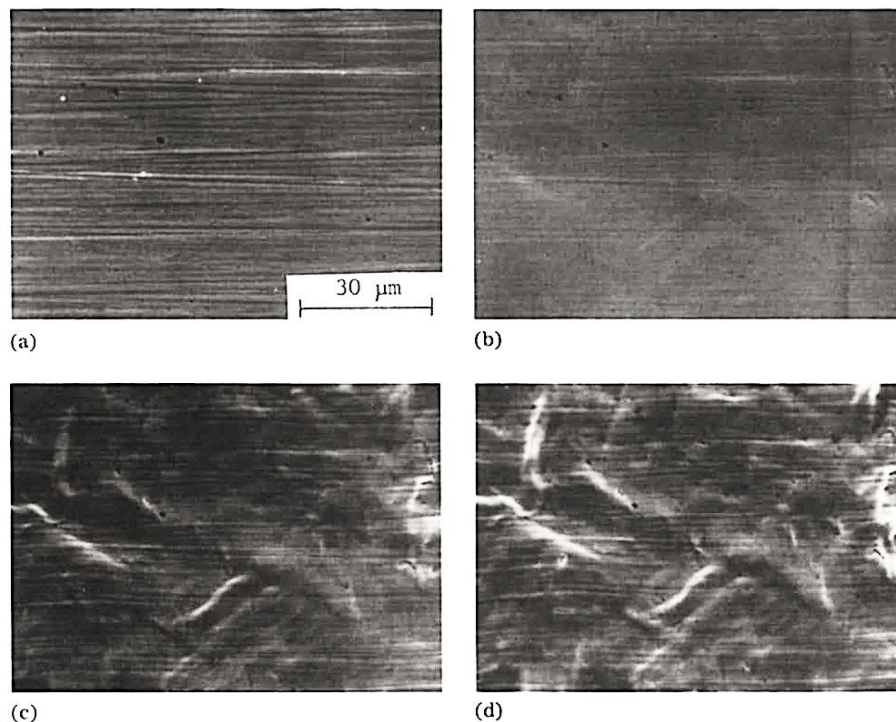
**Fig. 3.6:** Development of plastic deformation near the centre for various  $t$ :  
 (a) 0 min; (b) 5 min; (c) 15 min; (d) 20 min [137].

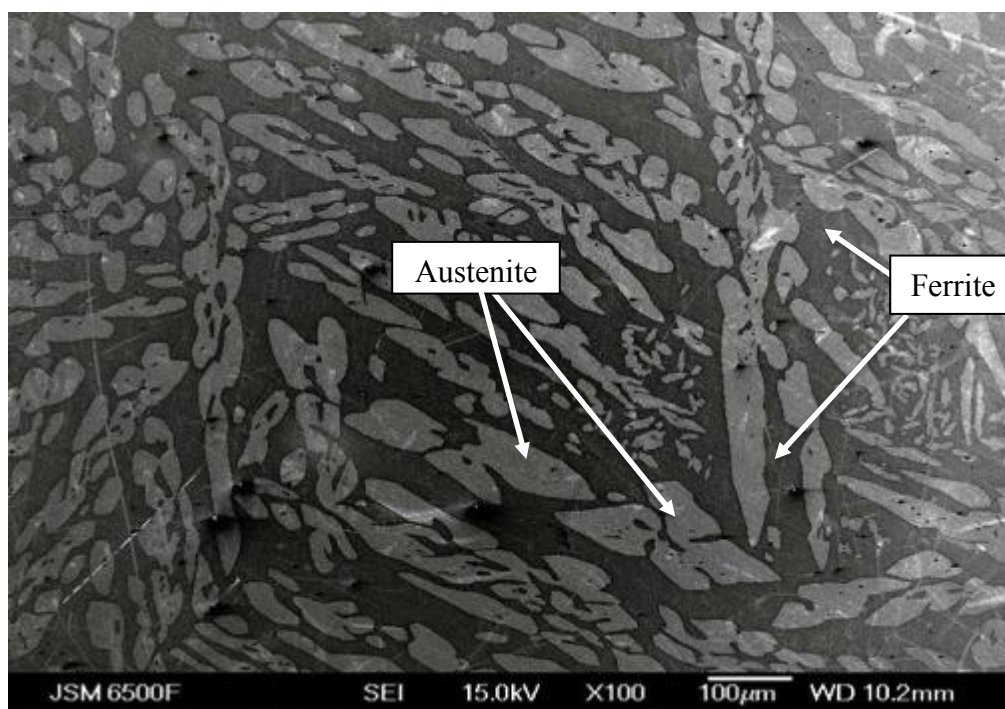
**Fig. 4.5:** Two-phase (duplex) microstructure of austenite and ferrite grains of 2205 duplex stainless steel, as obtained under SEM at a magnification of 100x.

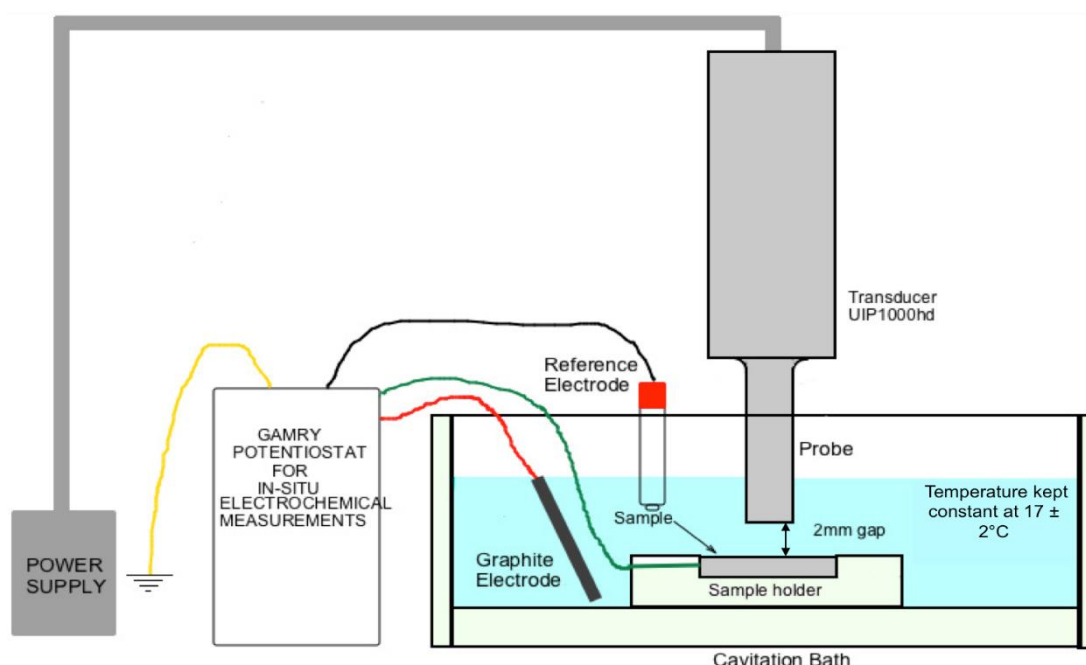
**Fig. 4.13:** Schematics of the cavitation rig with specimen connected to the potentiostat for cavitation erosion-corrosion measurements [18], [202]–[204].

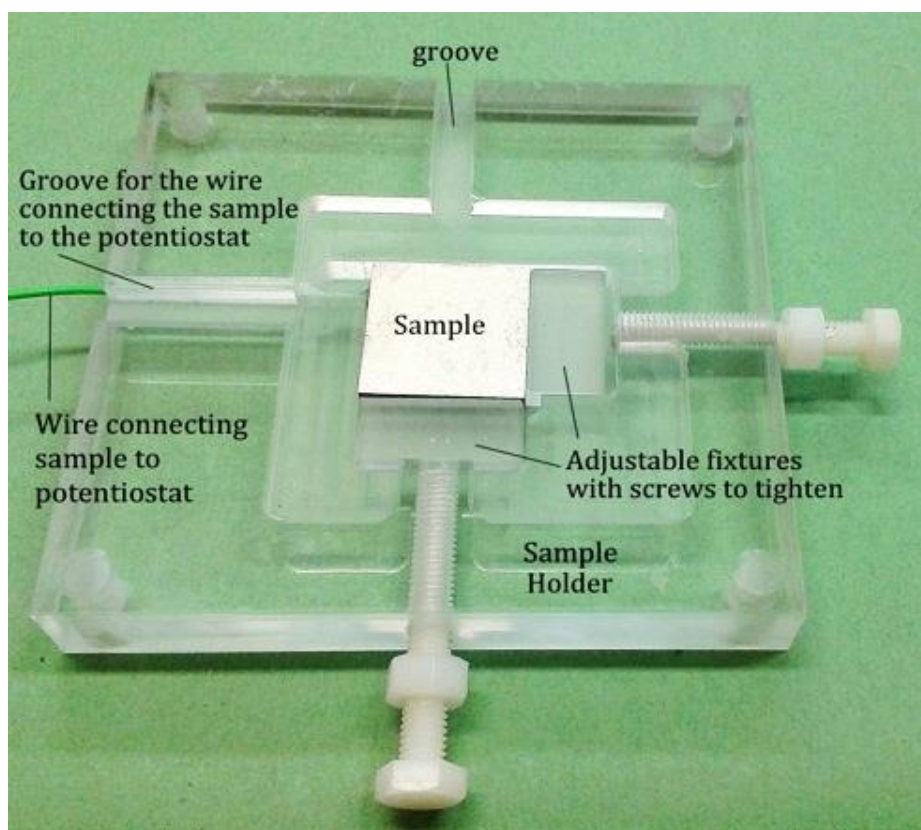
**Fig. 4.14:** Perspex sample holder with adjustable fixtures securing the sample of size 25 mm x 25 mm x 5 mm with perspex screws.

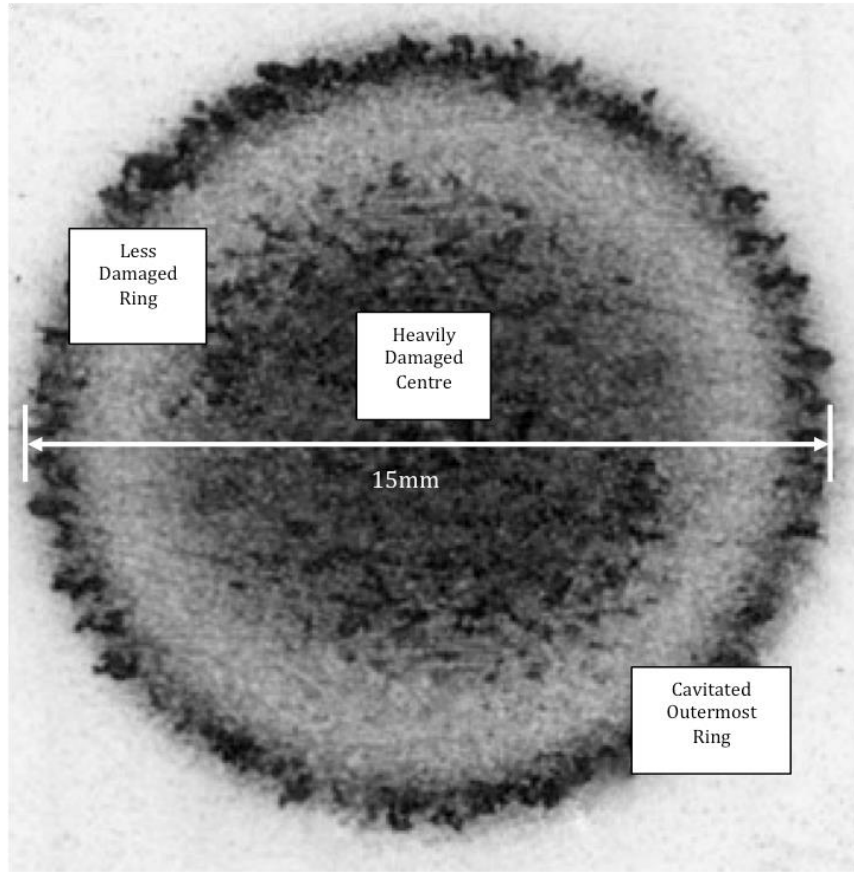
**Fig. 5.2:** *Cavitated surface of DSS in 3.5% NaCl solution after 1 h of test.*

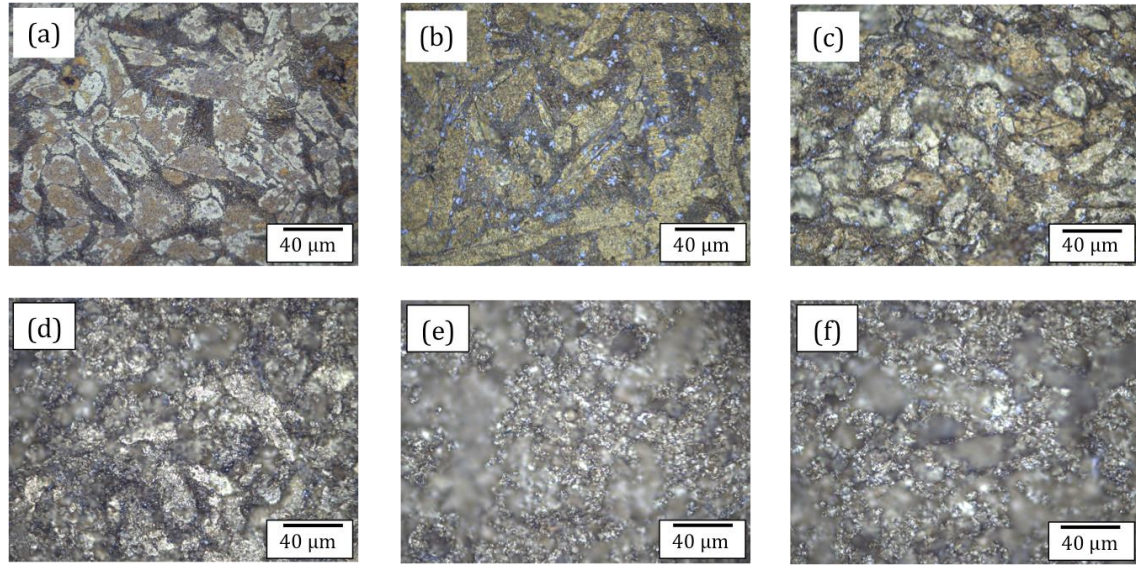
**Fig 5.8:** Optical images of the progression of cavities on the central region of the air-formed oxide filmed NAB after cavitation erosion for (a) 30 min, (b) 1 h, (c) 2 h, (d) 3 h, (e) 4 h, and (f) 5 h in 3.5% NaCl solution, showing the increasing roughness of the surface, and growth in cavity sizes with time.

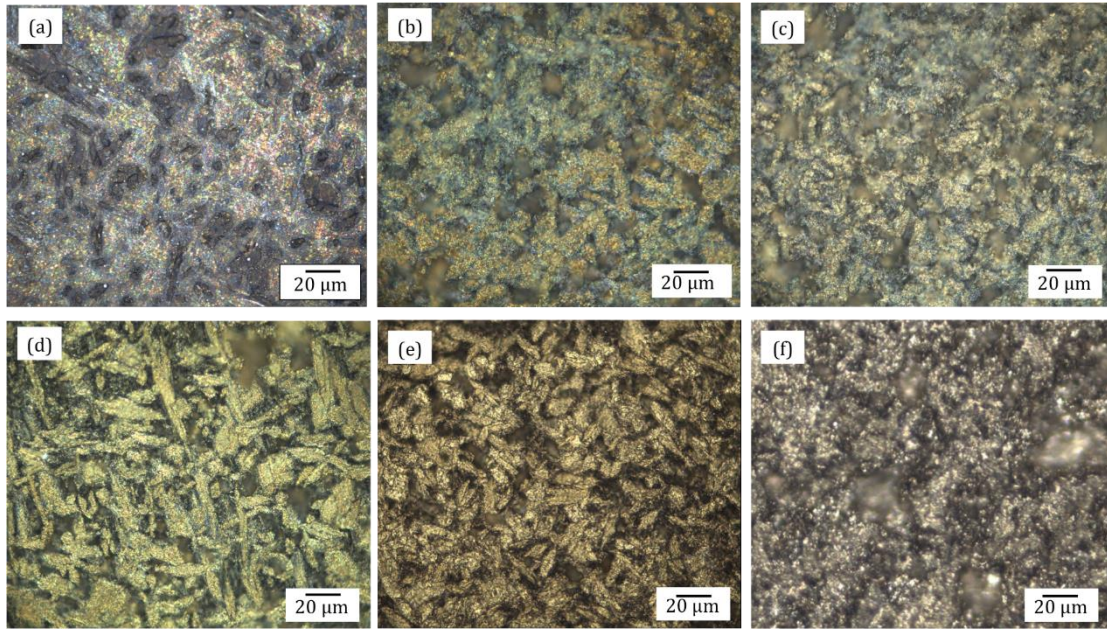
**Fig 5.9:** Optical images of the central region of NAB with water-formed oxide layer subjected to cavitation erosion for (a) 30 min, (b) 1 h, (c) 2 h, (d) 3 h, (e) 4 h, and (f) 5 h in 3.5% NaCl solution, showing the periodic removal of oxide film, increasing roughness of the surface, and growth in cavity sizes with time.

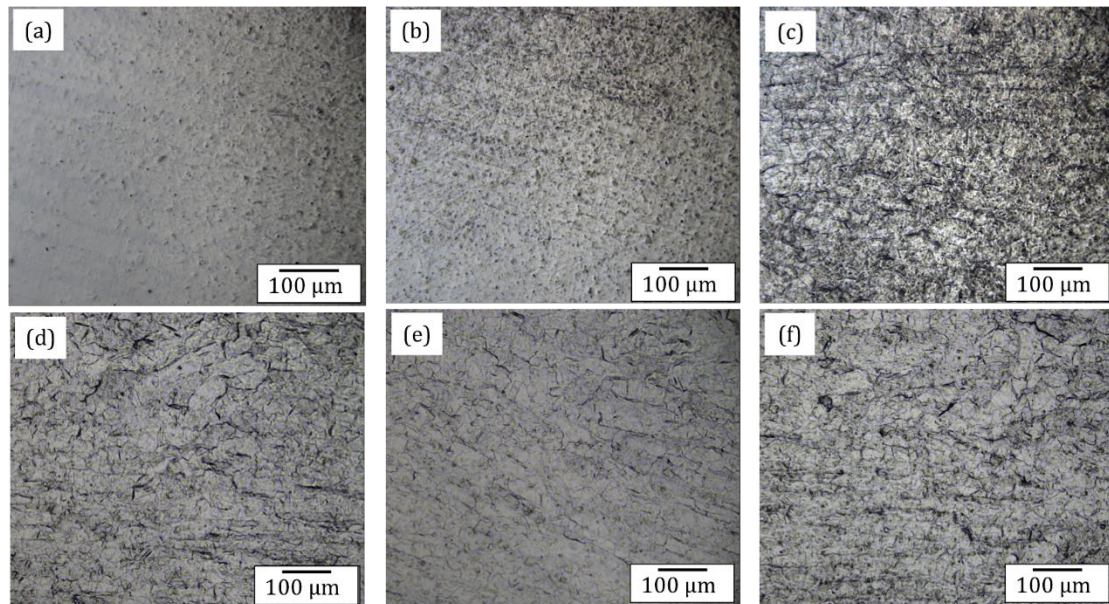
**Fig 5.11:** Optical images of the central region of a DSS sample subjected to cavitation erosion for (a) 30 min, (b) 1 h, (c) 2 h, (d) 3 h, (e) 4 h, and (f) 5 h in 3.5% NaCl solution, showing the increasing roughness of the surface, and growth in cavity sizes over time.

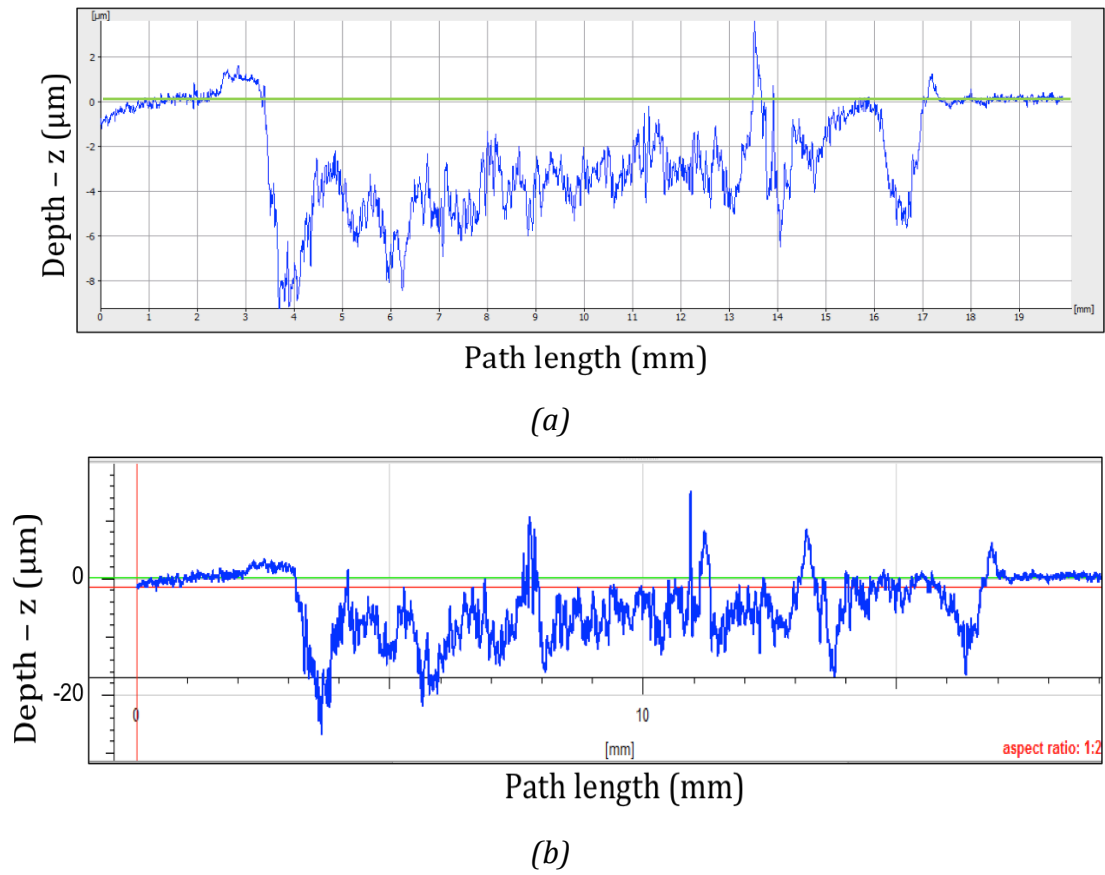
**Fig. 5.14:** Wear scar profile of air-formed oxide filmed NAB after cavitation in (a) distilled water, and (b) in 3.5% NaCl solution for 1 h obtained using Alicona 3D profilometer.

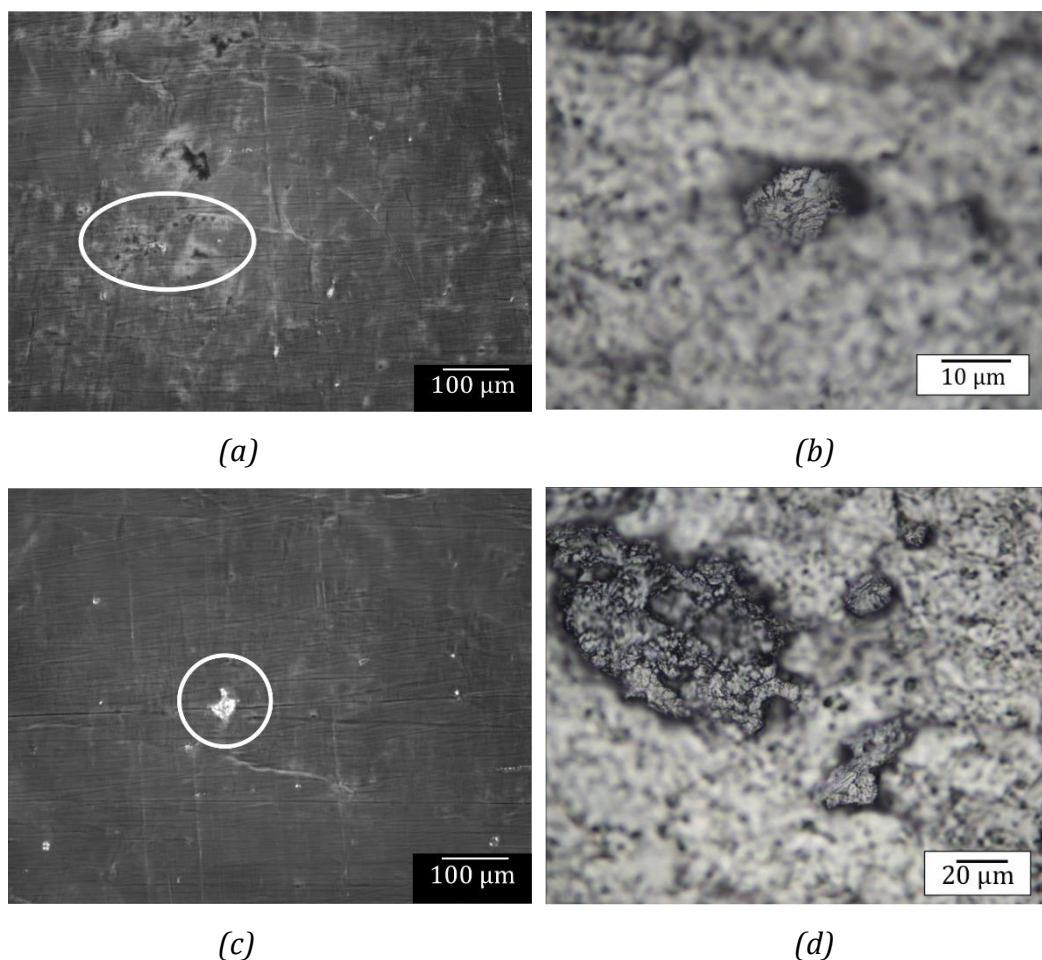
**Fig. 5.15:** Cavitated region of DSS obtained under an optical microscope (a) in distilled water; (b) cavity of 10- $\mu\text{m}$  size under distilled water after 1 h; (c) in 3.5% NaCl solution; and (d) 20  $\mu\text{m}$  – 50  $\mu\text{m}$  cavities obtained in 3.5% NaCl solution after 1 h.

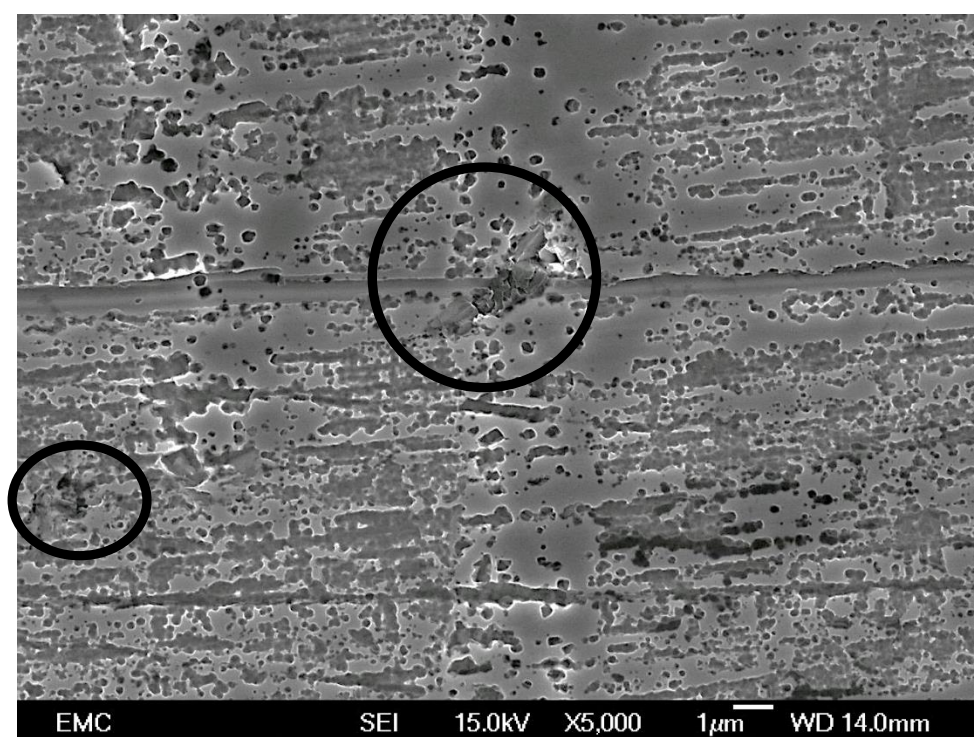
**Fig. 5.16:** The SEM image of DSS surface after 1 h of cavitation in 3.5% NaCl solution with pitting and cavities of sizes  $5\ \mu\text{m}$  –  $10\ \mu\text{m}$ .

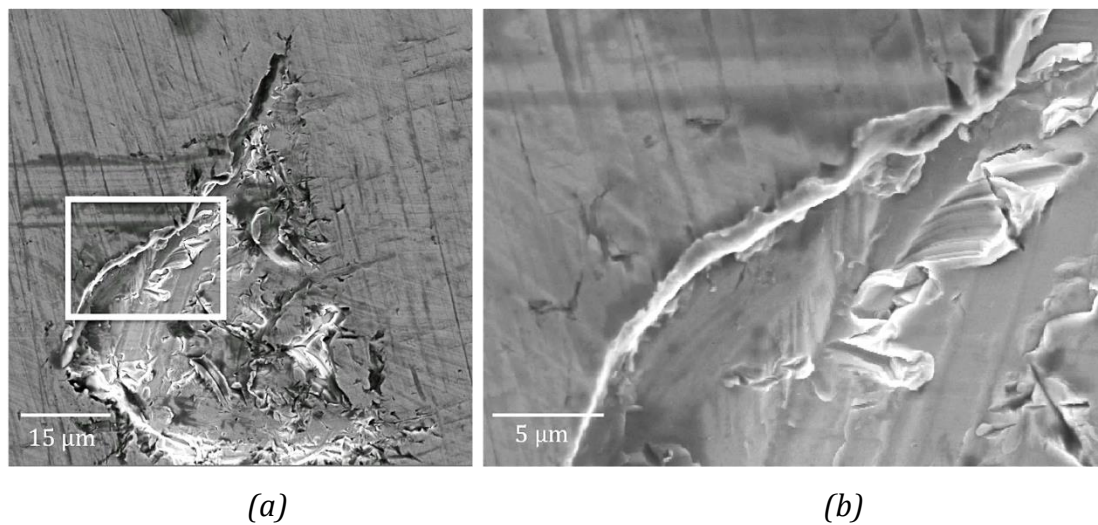
**Fig. 5.18:** SEM image of (a) plastic deformation at cavitation damaged edge for DSS in 3.5% NaCl solution, (b) detailed magnified image of plastic deformation at the cavity edges in (a) [18].

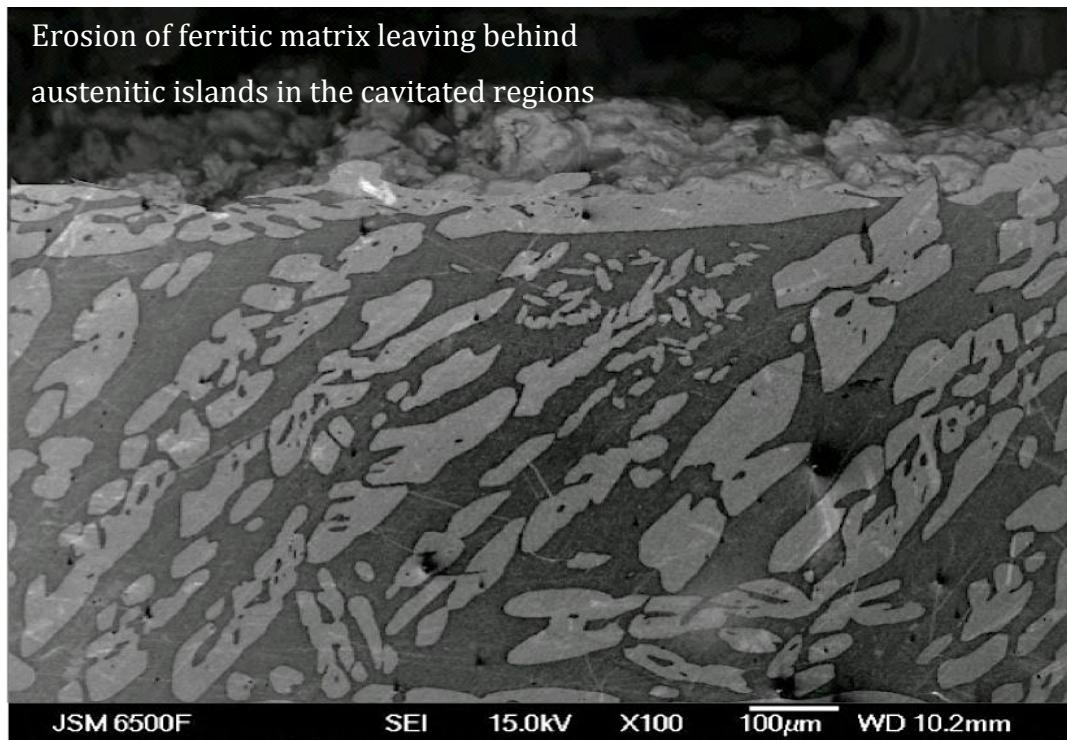
**Fig. 5.19:** Transverse of the DSS cavitated in 3.5% NaCl solution for 1 h.

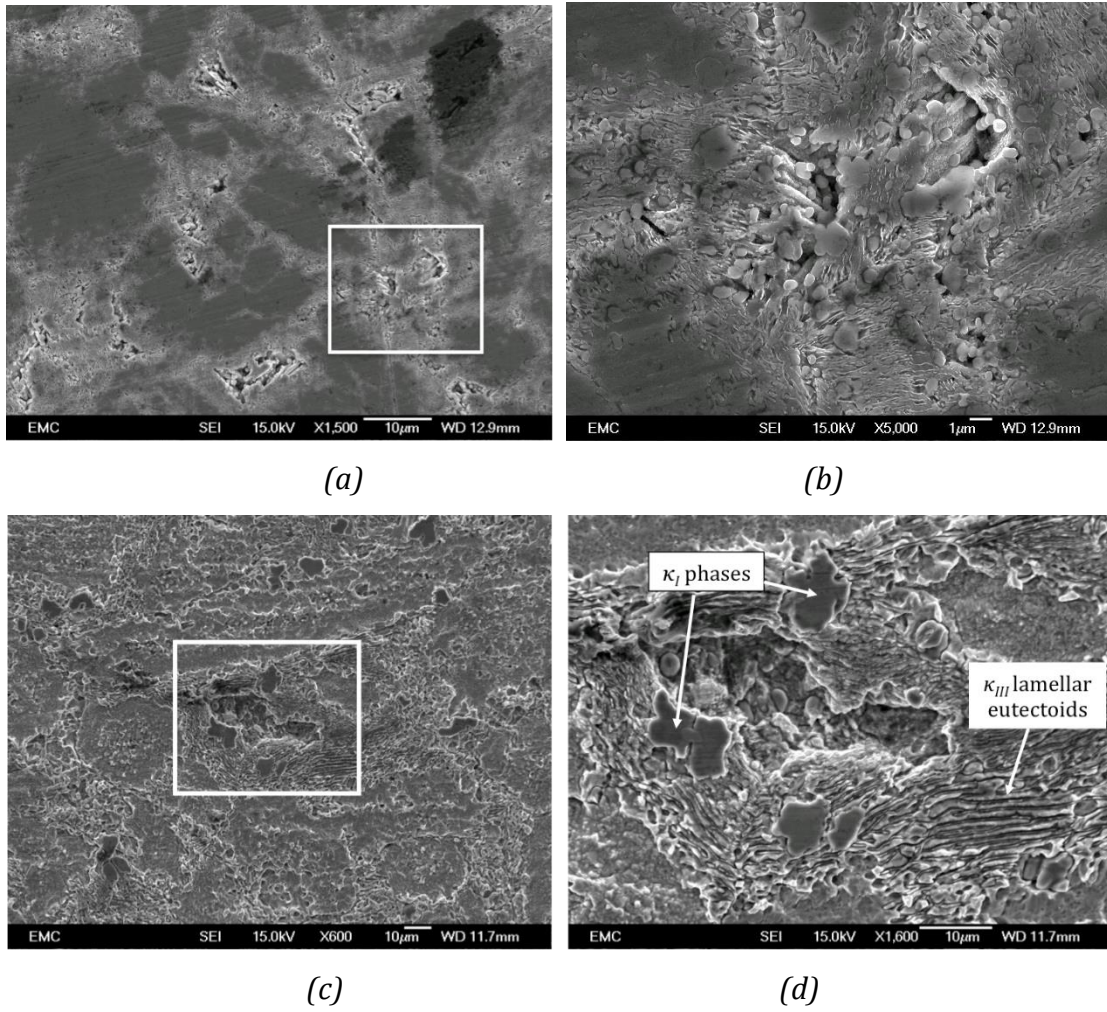
**Fig. 5.20:** SEM images of (a) small boundary erosion on air-formed filmed NAB at a magnification of 1500x in distilled water; (b) shows the magnified image of the cavities of size 10-μm at the selected area in (a); (c) SEM image of a 50-μm large cavity on the sample surface undergone cavitation erosion-corrosion in 3.5% NaCl solution; and (d) the magnified image of a cavity in (c) showing selective phase attack at the  $\alpha$ - $\kappa$  phase boundaries leaving  $\kappa_I$  globules and  $\kappa_{III}$  lamellar phases exposed [202], [203].

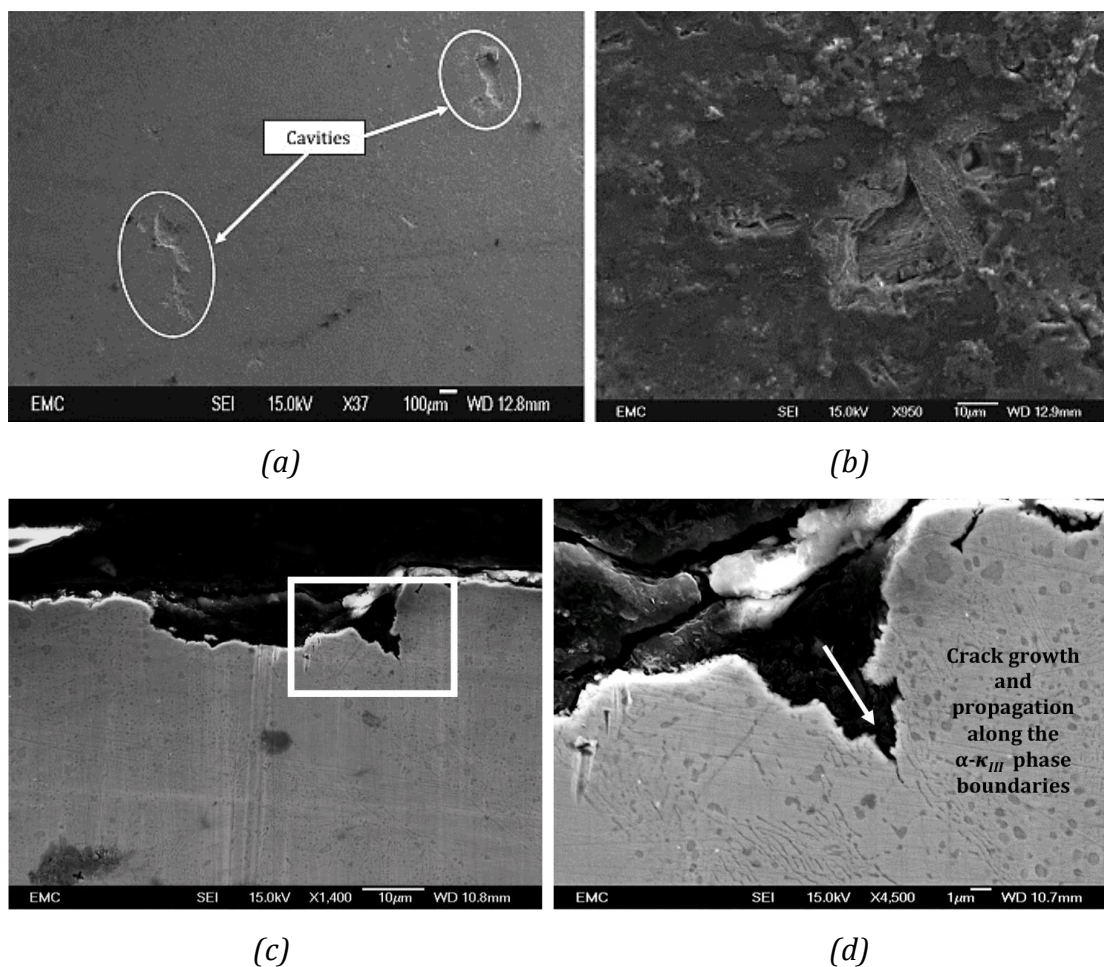
**Fig. 5.25:** SEM images of water-formed oxide filmed NAB sample under pure cavitation erosion conditions: (a) showing cavities formed on the sample surface; (b) magnified image of a cavity on the surface; (c) transverse-sections of a cavity; (d) detailed magnified image of a cavity in (c) exhibiting crack growth and propagation along the  $\alpha$ - $\kappa_{III}$  phase boundaries [203].

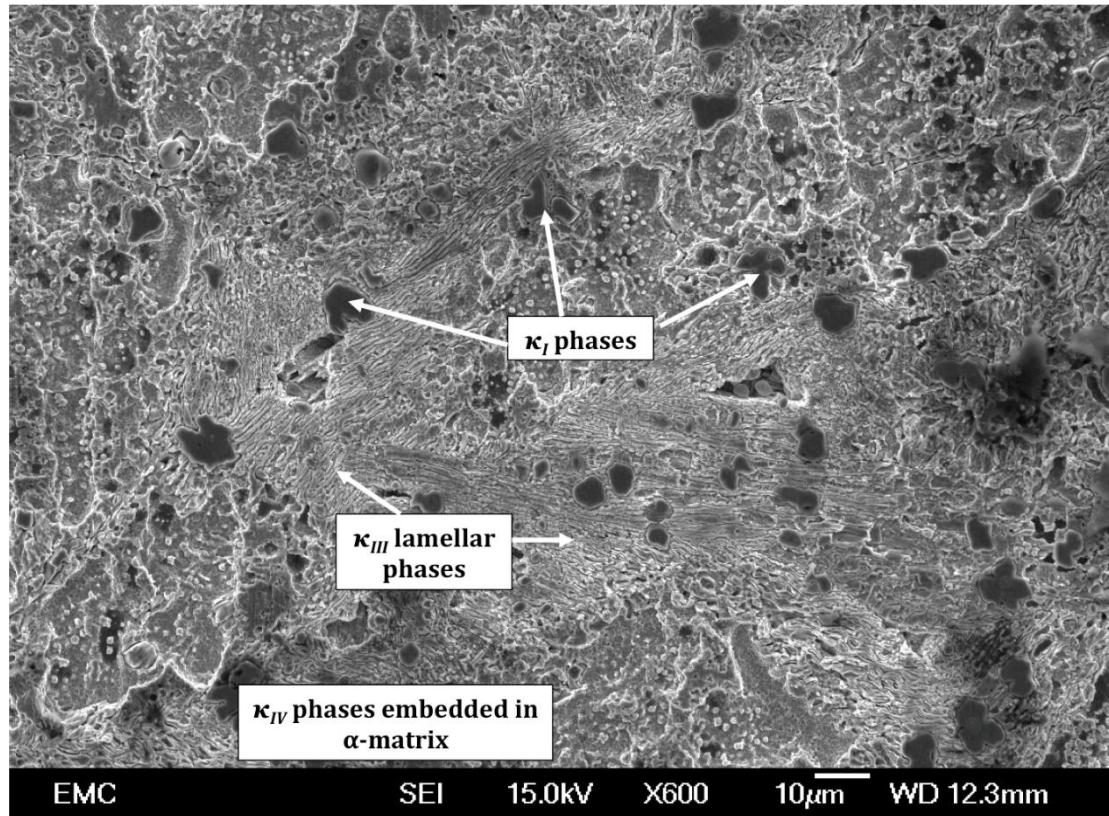
**Fig. 5.27:** SEM image of the eroded surface of NAB sample with water-formed oxide film after combined cavitation erosion-corrosion test conducted in 3.5% NaCl solution for 1 h [203].

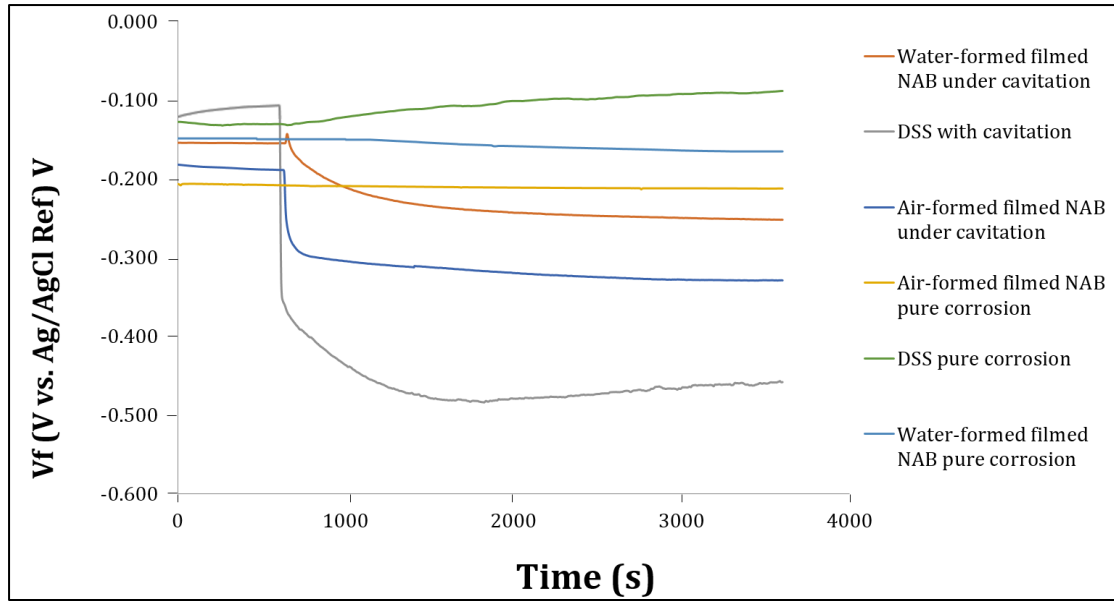
**Fig. 6.1:** OCP for DSS, air-formed filmed NAB and water-formed filmed NAB in 3.5% NaCl solution for 1 h with and without cavitation as adapted from references [18], [202], [203].

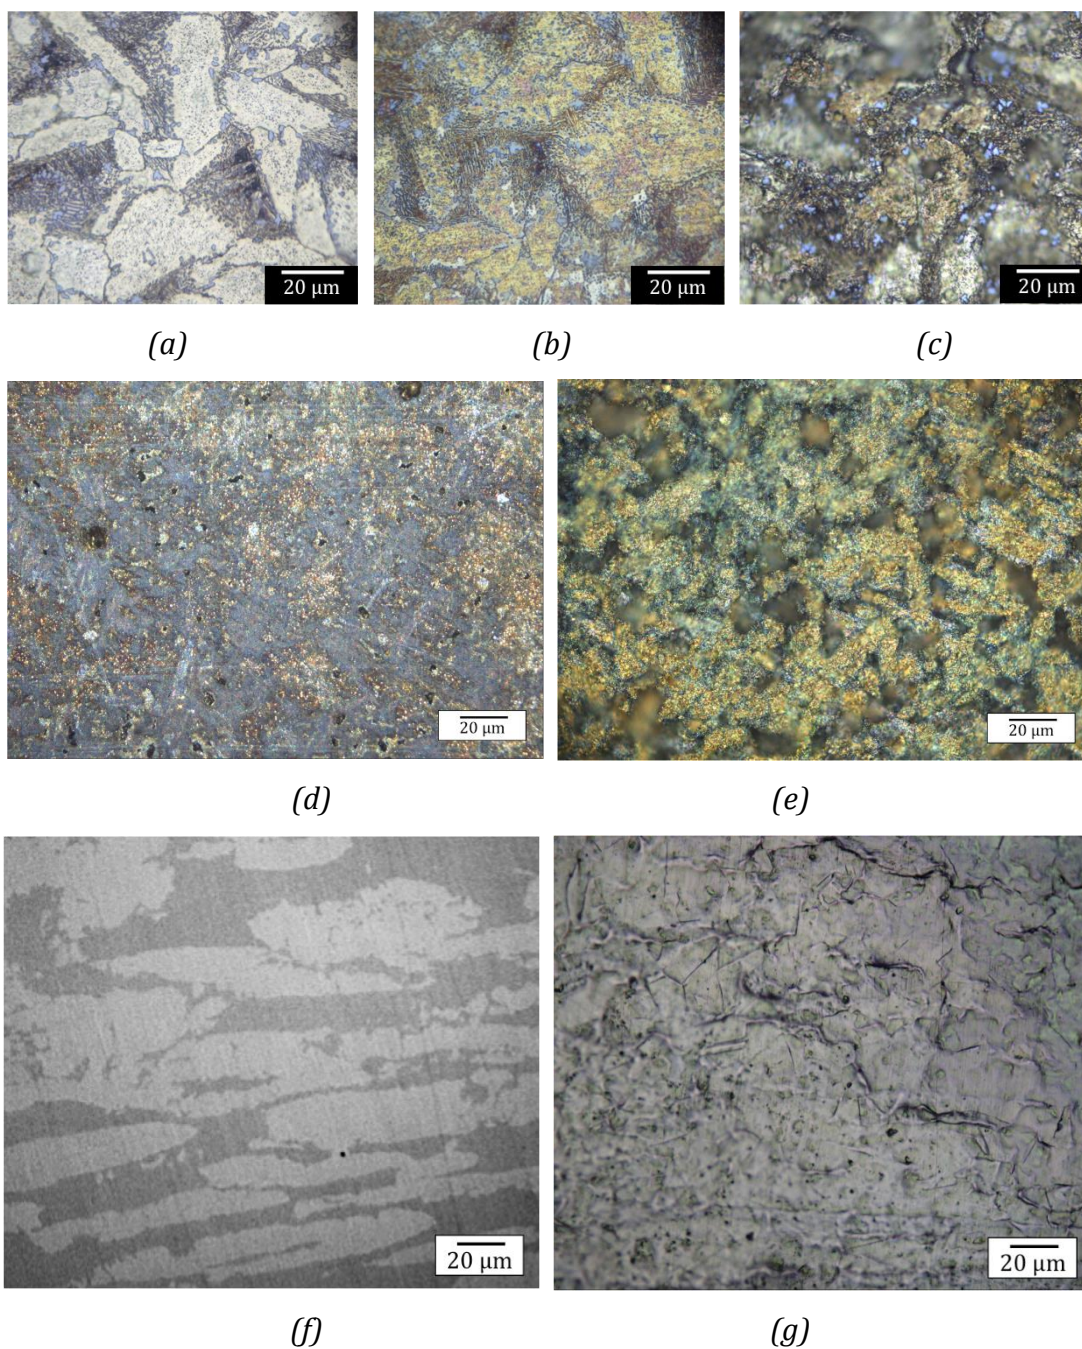
**Fig. 6.2:** Optical images of the cavitated region from the central region of the air-formed oxide filmed NAB samples (a) before OCP and cavitation; (b) after 1 h of OCP; and (c) after 1 h of cavitation while kept at OCP in 3.5% NaCl solution. Water-formed oxide filmed NAB (d) before OCP and cavitation, and (e) after 1 h of cavitation while kept at OCP in 3.5% NaCl solution. And DSS (f) before OCP and cavitation, and (g) after 1 h of cavitation while kept at OCP in 3.5% NaCl solution.

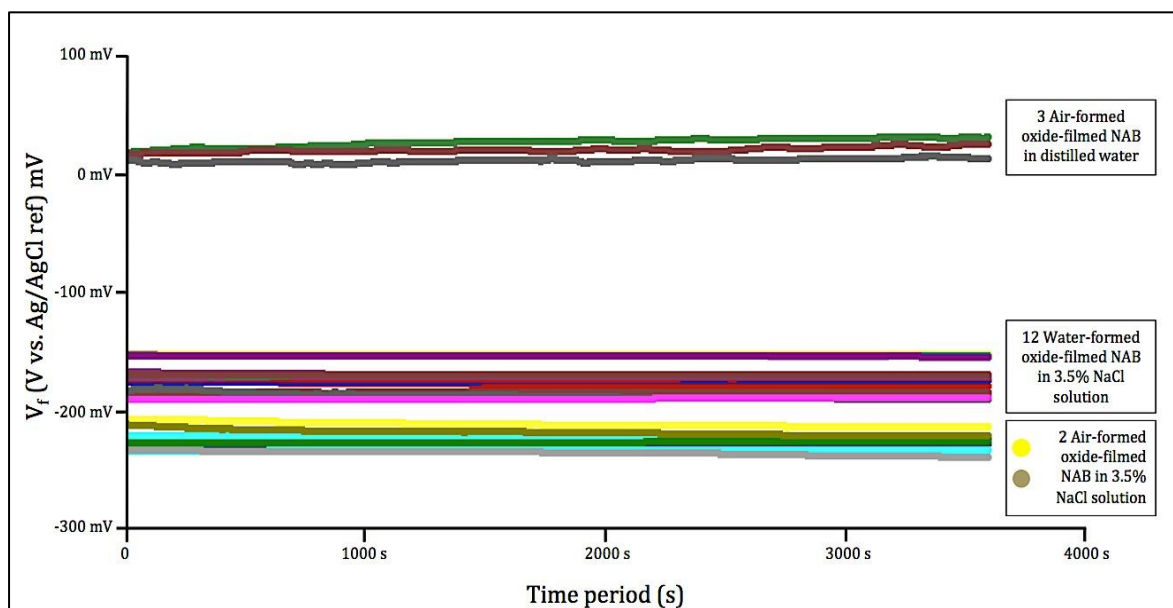
**Fig. 6.3:** OCP for NAB with air- and water-formed film in distilled water and 3.5% NaCl solution for 1 h each.

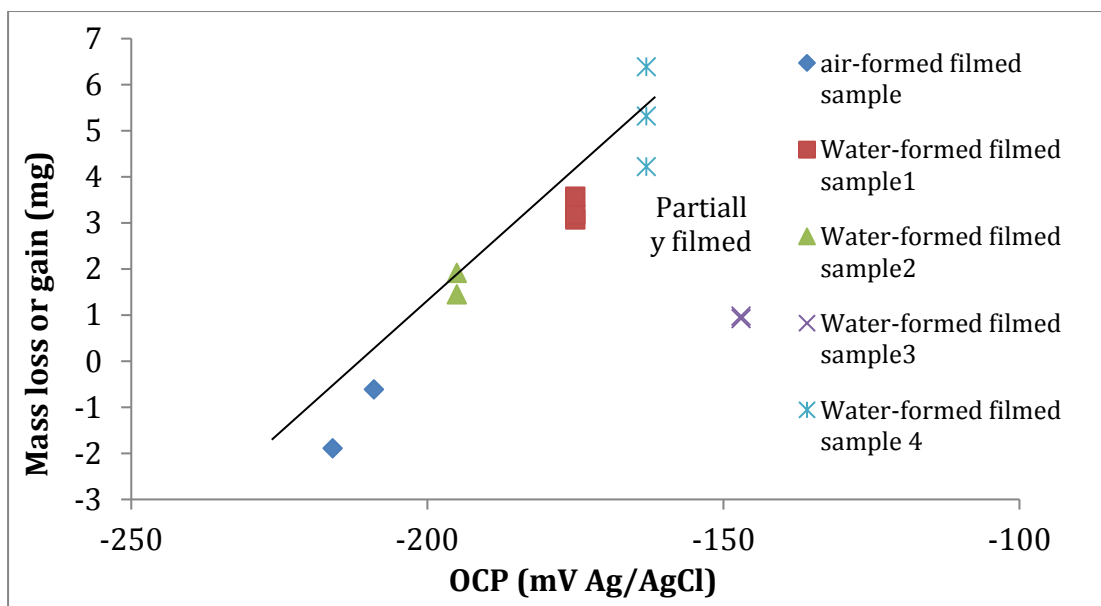
**Fig. 6.4:** Mass change data plotted against the OCP for air- and water-formed oxides on NAB after pure static corrosion tests in 3.5% NaCl solution tested for 1 h each [204].

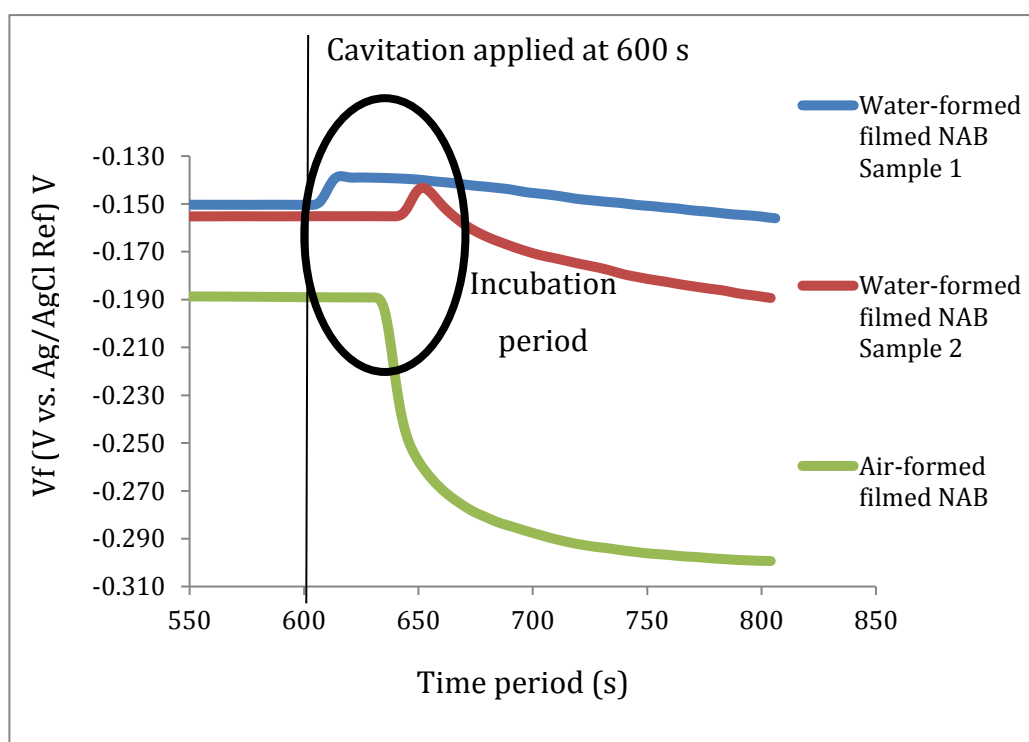
**Fig. 6.6:** The OCP trend for NAB with air and water-formed oxide film in 3.5% NaCl solution at the incubation period.

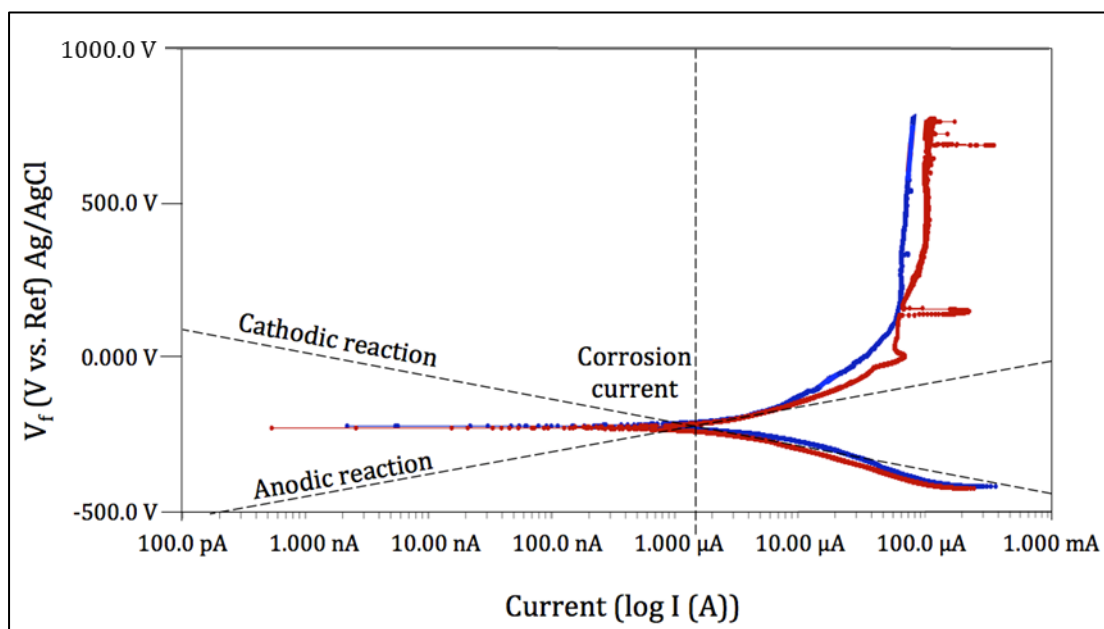
**Fig. 6.14:** Polarization curves for DSS in 3.5% NaCl solution, showing the location of the current density derived from Tafel extrapolation.
