# **Cavitation erosion-corrosion in marine propeller materials**

Lloyd's Register

Thesis for the degree of Doctor of Philosophy

June 2017

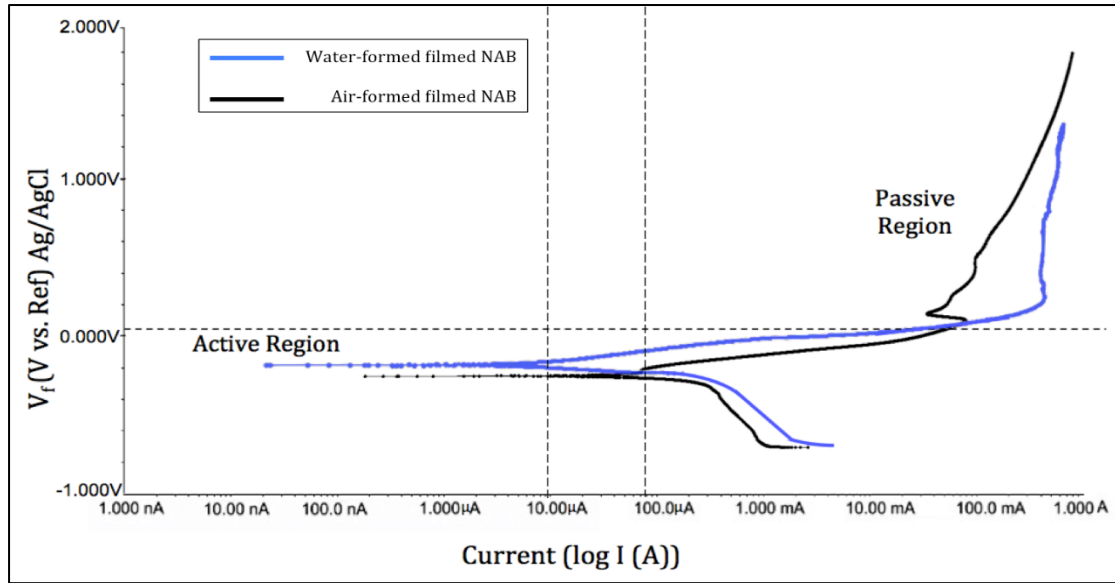
**Fig. 6.15:** Polarization curves for NAB samples with air-formed and water-formed oxide films in 3.5% NaCl solution [203].

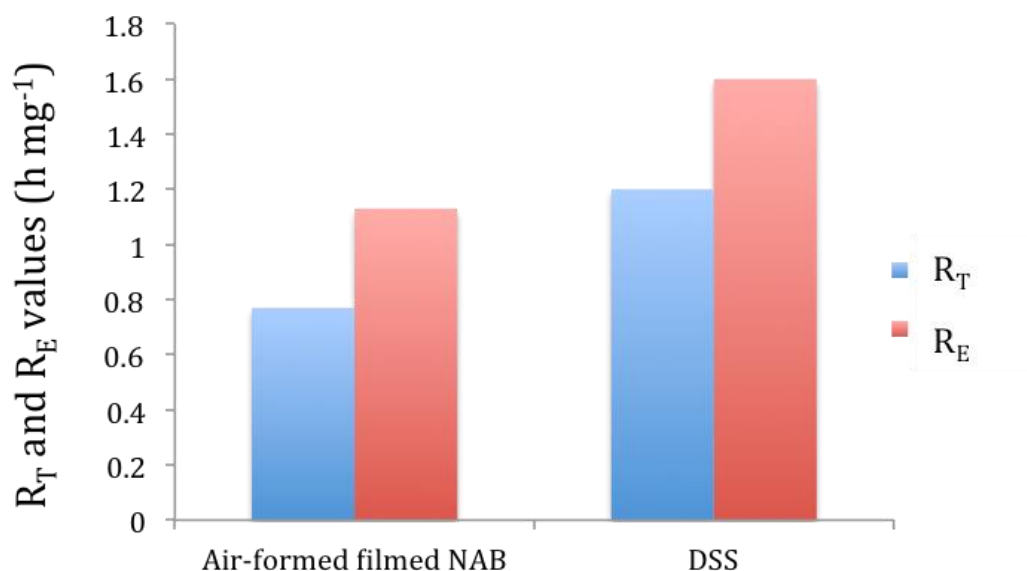
**Fig 7.2:**  $R_T$  and  $R_E$  graph for DSS, and NAB with air-formed oxide films obtained from the volumetric mass loss analysis for T and E.

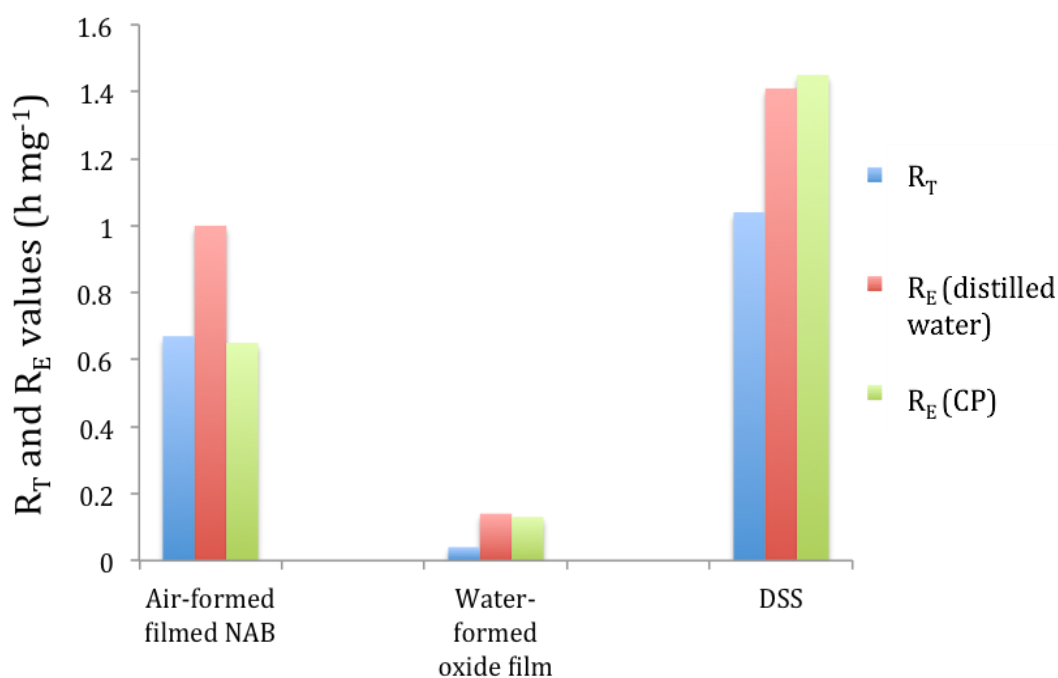
**Fig. 7.3:**  $R_T$  and  $R_E$  graph for DSS, and NAB with air- and water-formed oxide films obtained from Table 7.3 and 7.5.

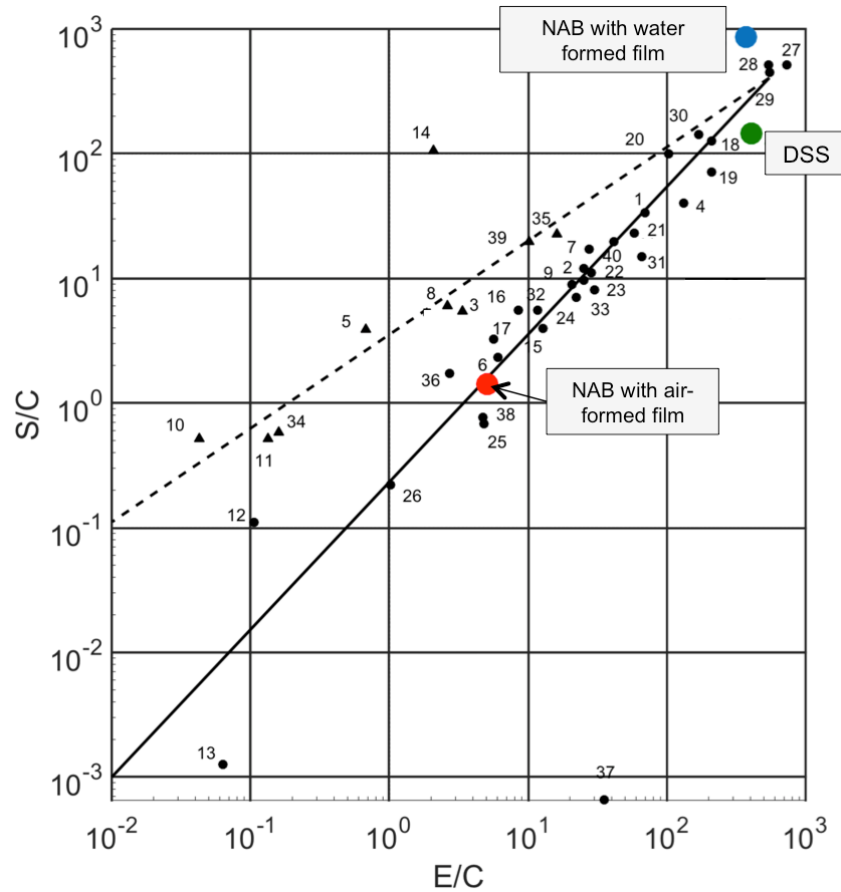
**Fig. 7.5:** Extended  $S/C$  vs.  $E/C$  plot showing the locations of DSS, air-formed filmed and water-formed filmed NAB on the graph plotted using data from Table 7.8, adapted from Ref. [203], [204].

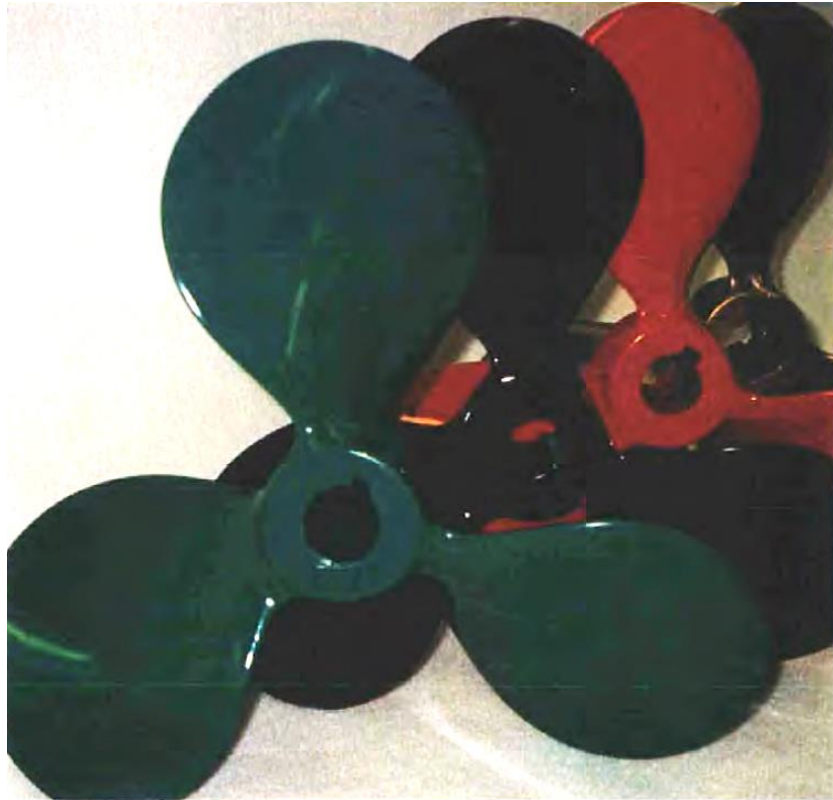
**Fig 8.1:** FRP propeller of diameter 305 mm painted in preparation for open water testing [248].

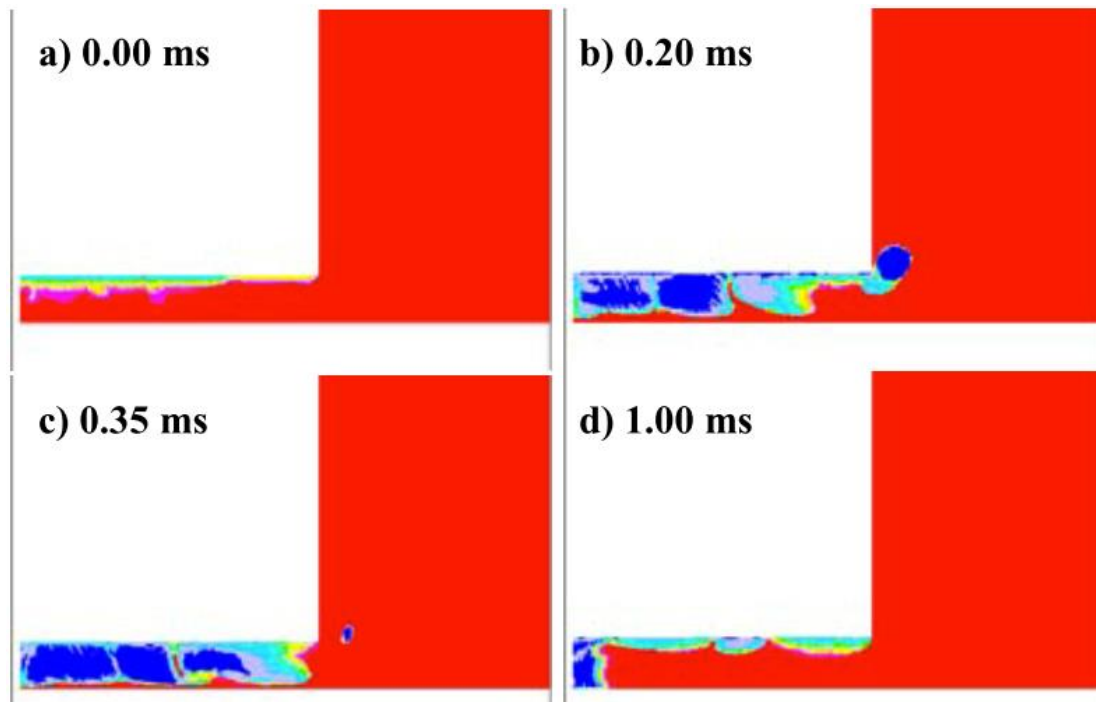
**Fig. 8.4:** Contour plots showing cavitation phenomena beneath the probe occurring within 1ms (where, blue signifies vapour, and red signifies liquid).

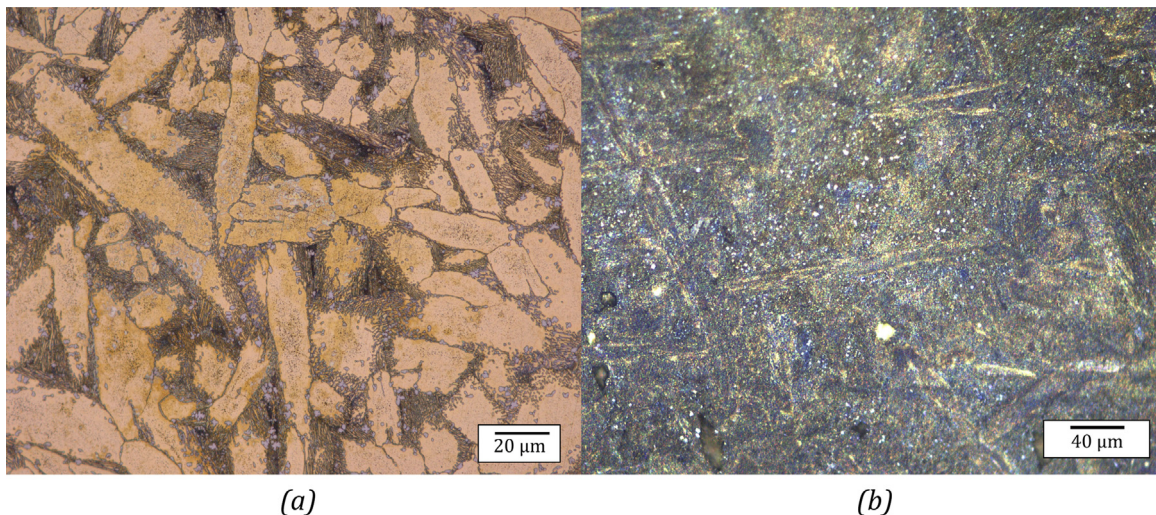
Fig. 3. 600x optical image of general oxide film (a) after 1 week in air; (b) after 3 months of immersion in 3.5%  $\text{NaCl}$  solution.

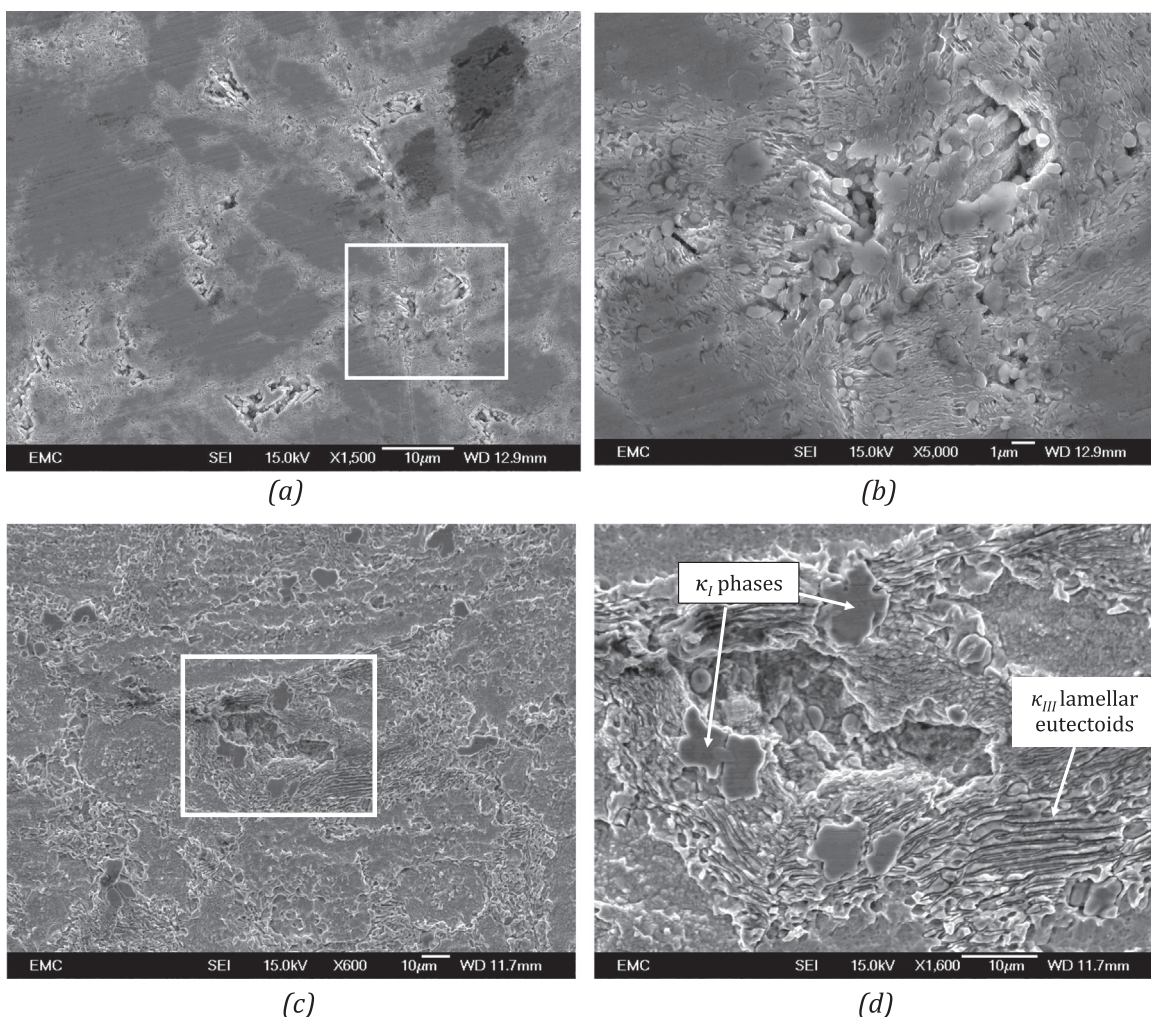
**Fig. 8.** SEM images of (a) small selective phase attack on air-formed film at a magnification of x1500 in distilled water; and (b) magnification of the selected area at x5000; (c) SEM image of a 50 μm large cavity on the sample surface undergone cavitation erosion-corrosion in 3.5% NaCl solution; (d) the magnified image of a cavity in (c) showing selective phase attack at the α-κ phase boundaries leaving κ<sub>I</sub> globules and κ<sub>III</sub> lamellar phases exposed [34].

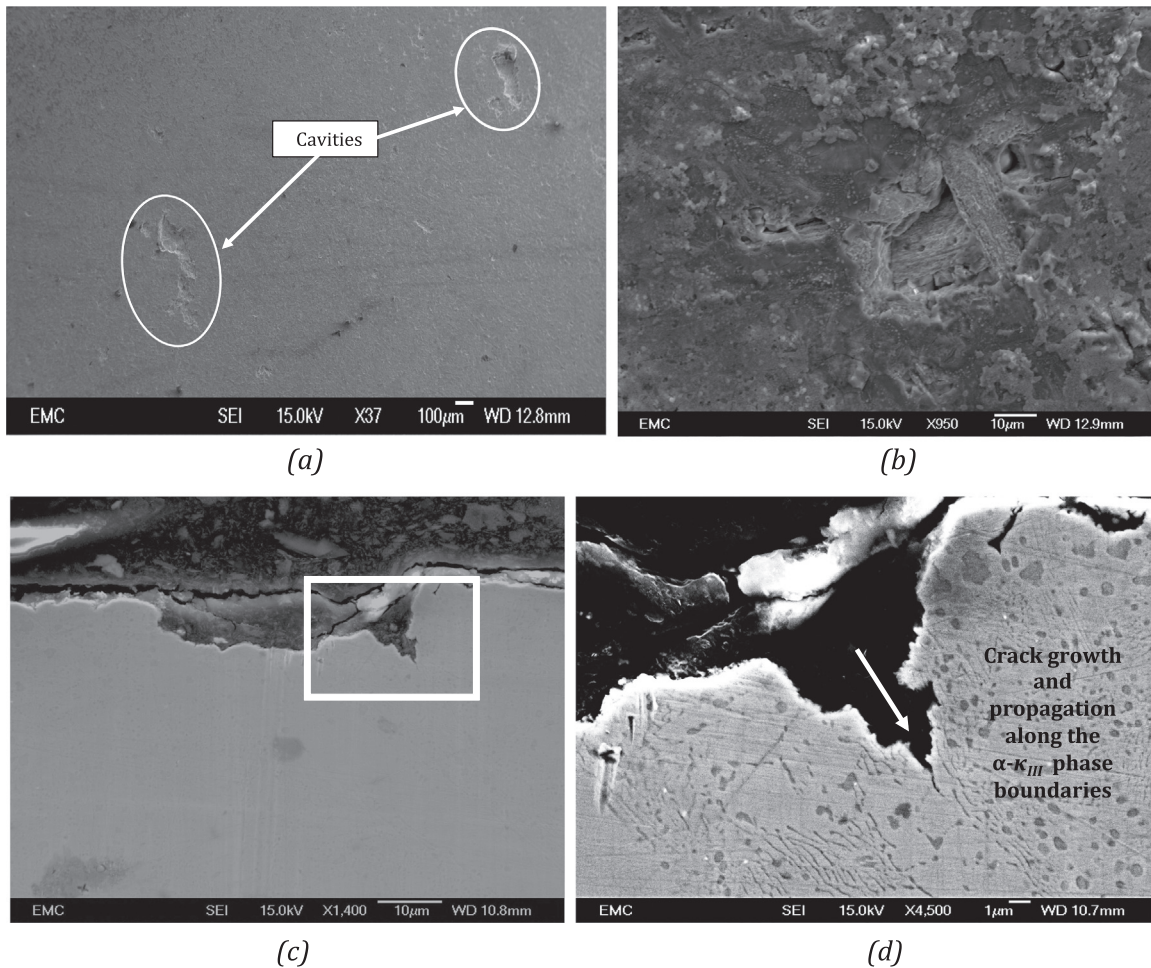
**Fig. 12.** SEM images of water-formed oxide film on NAB sample under pure E conditions: (a) cavities formed on the sample surface after 1 h of cavitation erosion-corrosion; (b) magnified image of the cavities on the surface; (c) transverse-sections of a cavity at x1400; (d) detailed magnified image of a cavity in (d) exhibiting crack growth and propagation along the  $\alpha$ - $\kappa_{III}$  phase boundaries.

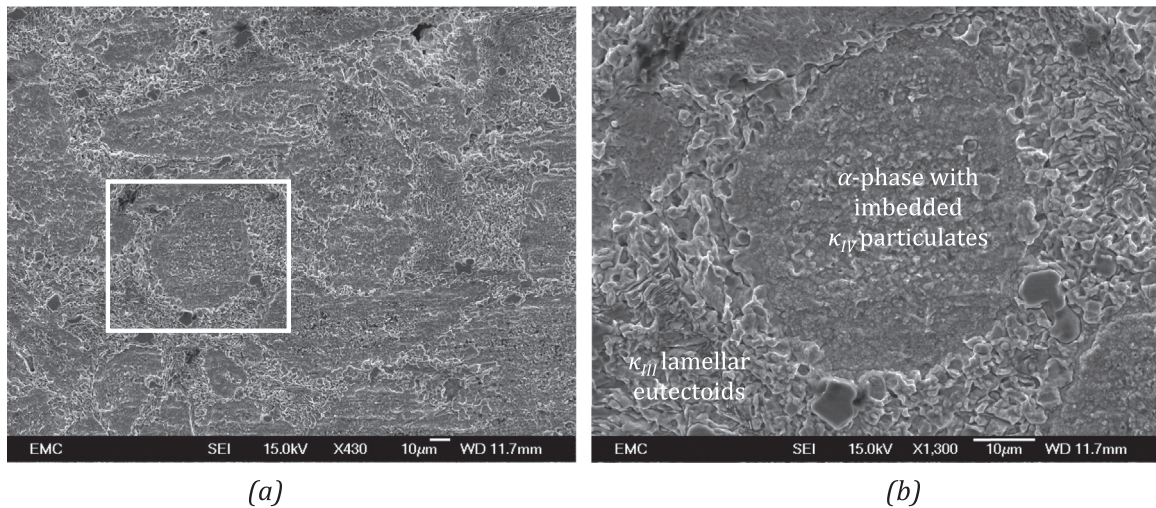
Fig. 14. SEM images of the distinguished phase erosion of the oxide filmed sample in 3.5% NaCl solution after 1 h of cavitation.

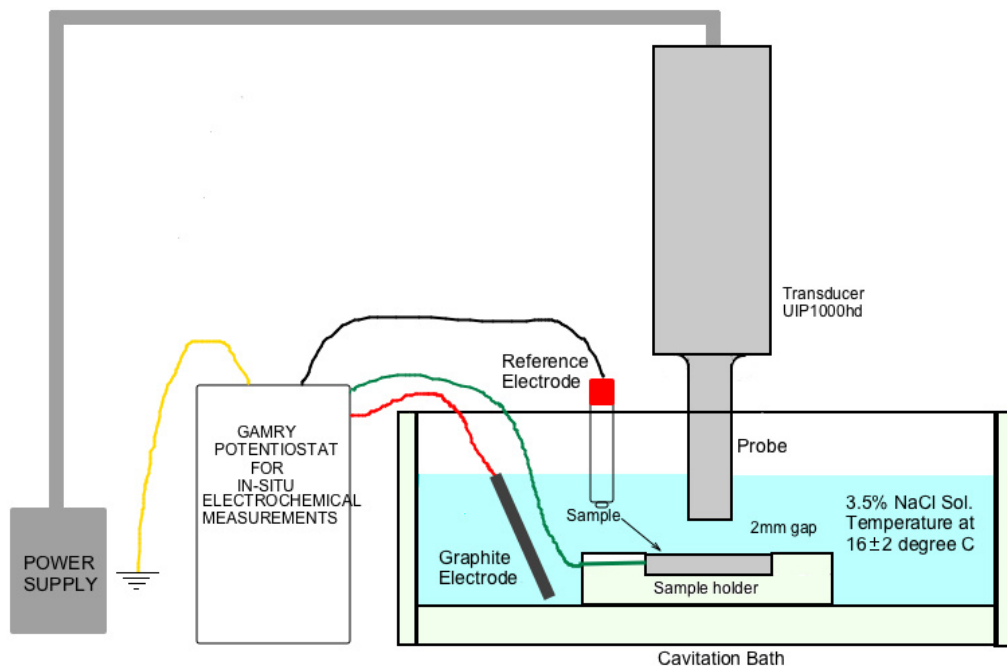
**Fig. 1:** Schematics of the cavitation rig with specimen connected to the potentiostat for cavitation erosion-corrosion measurements [44].

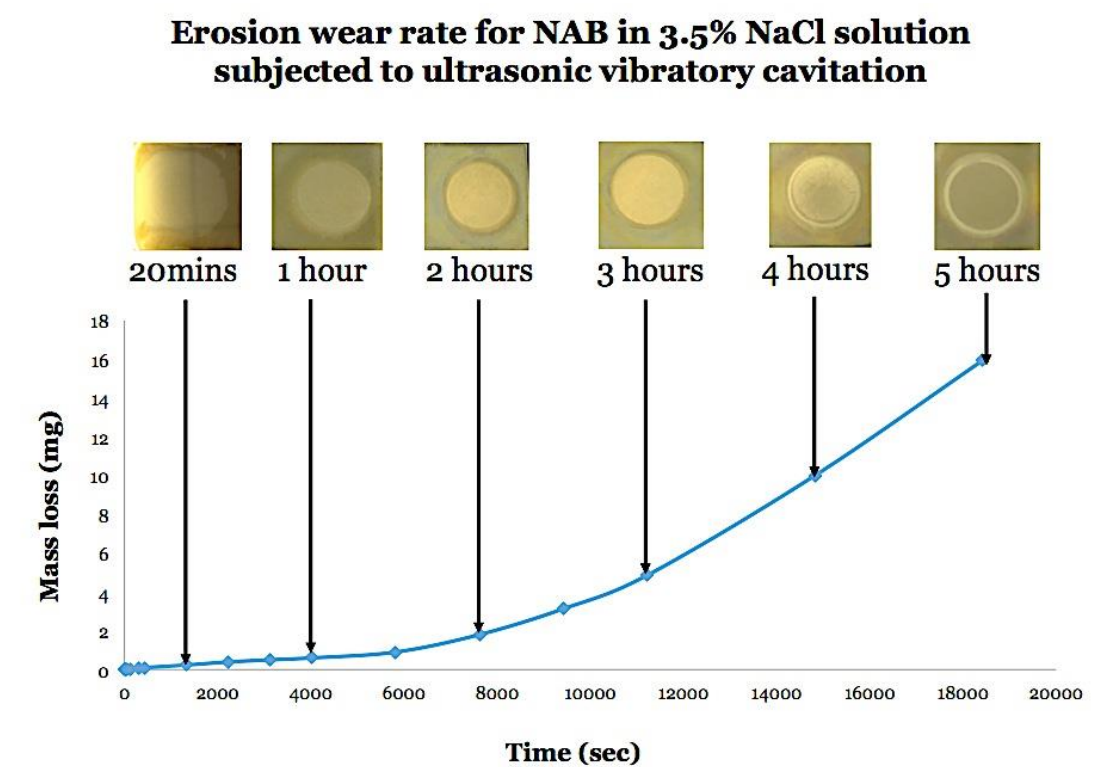
**Fig. 2:** Cumulative cavitation erosion rate curve for NAB tested in 3.5% NaCl solution for a time period of 5 h and 14 min.

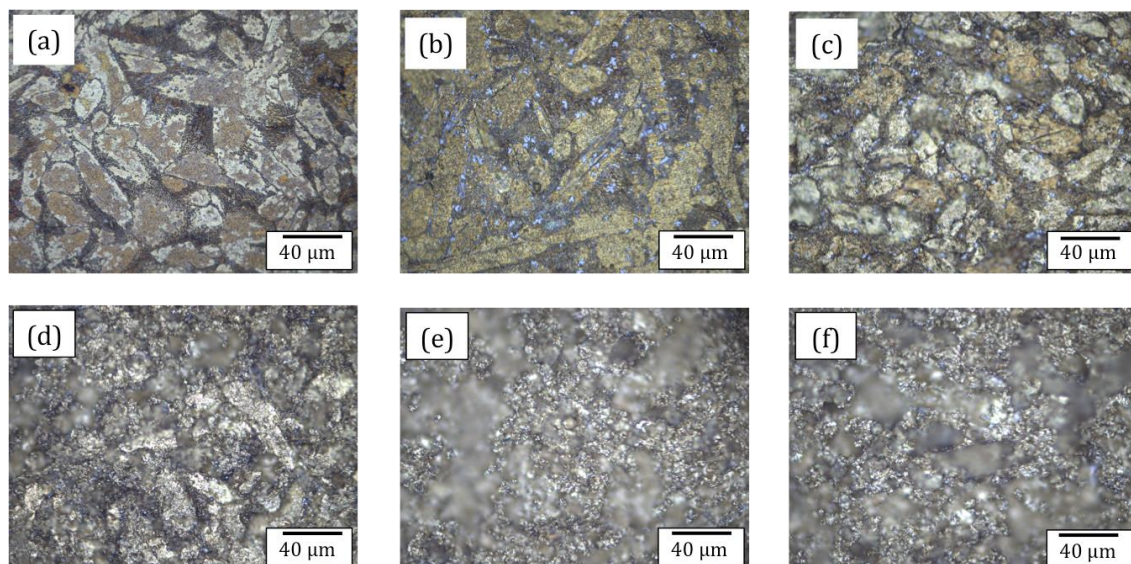
**Fig 5:** Optical images of the progression of cavities on air-formed oxide filmed NAB after cavitation erosion for (a) 30-min, (b) 1 h, (c) 2 h, (d) 3 h, (e) 4 h, and (f) 5 h in 3.5% NaCl solution, showing the increasing roughness of the surface, and growth in cavity sizes with time.

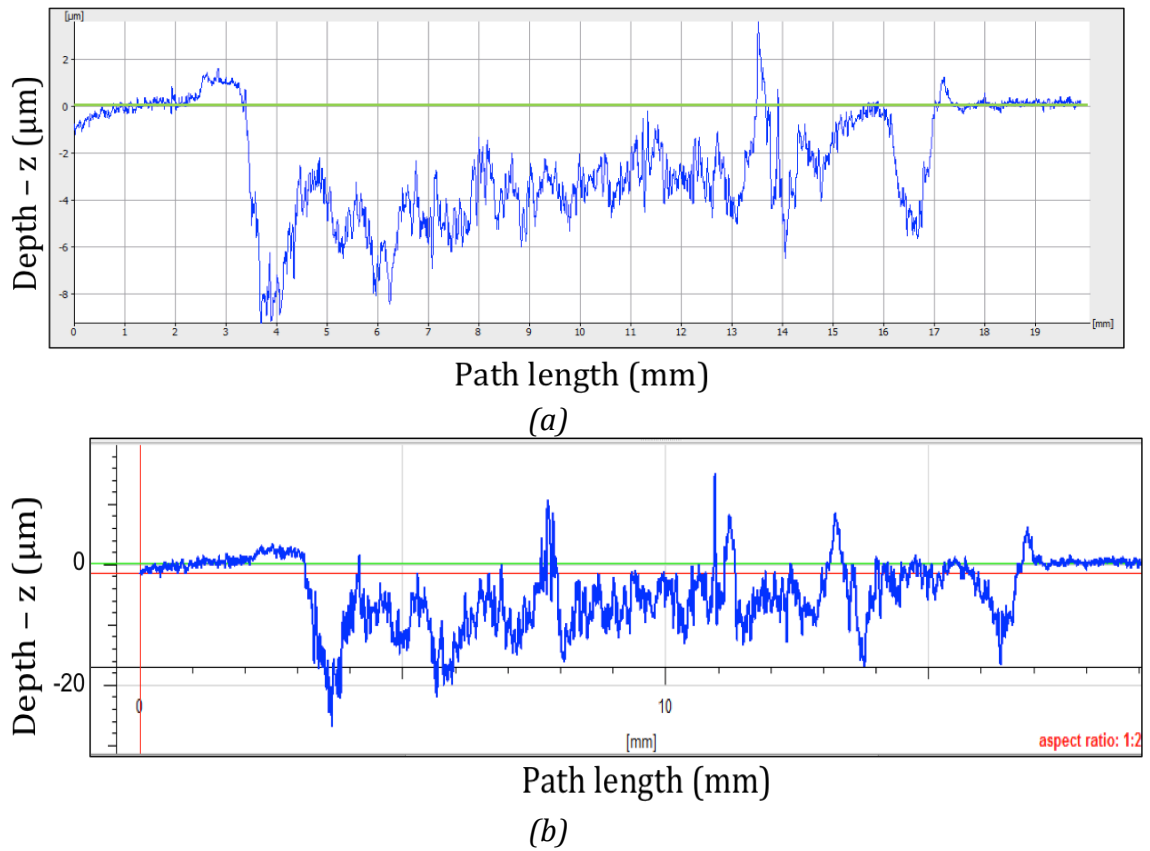
**Fig. 6:** Wear scar profile of air-formed oxide filmed NAB after cavitation in (a) distilled water, and (b) in 3.5% NaCl solution for 1 h, obtained using Alicona 3D profilometer.

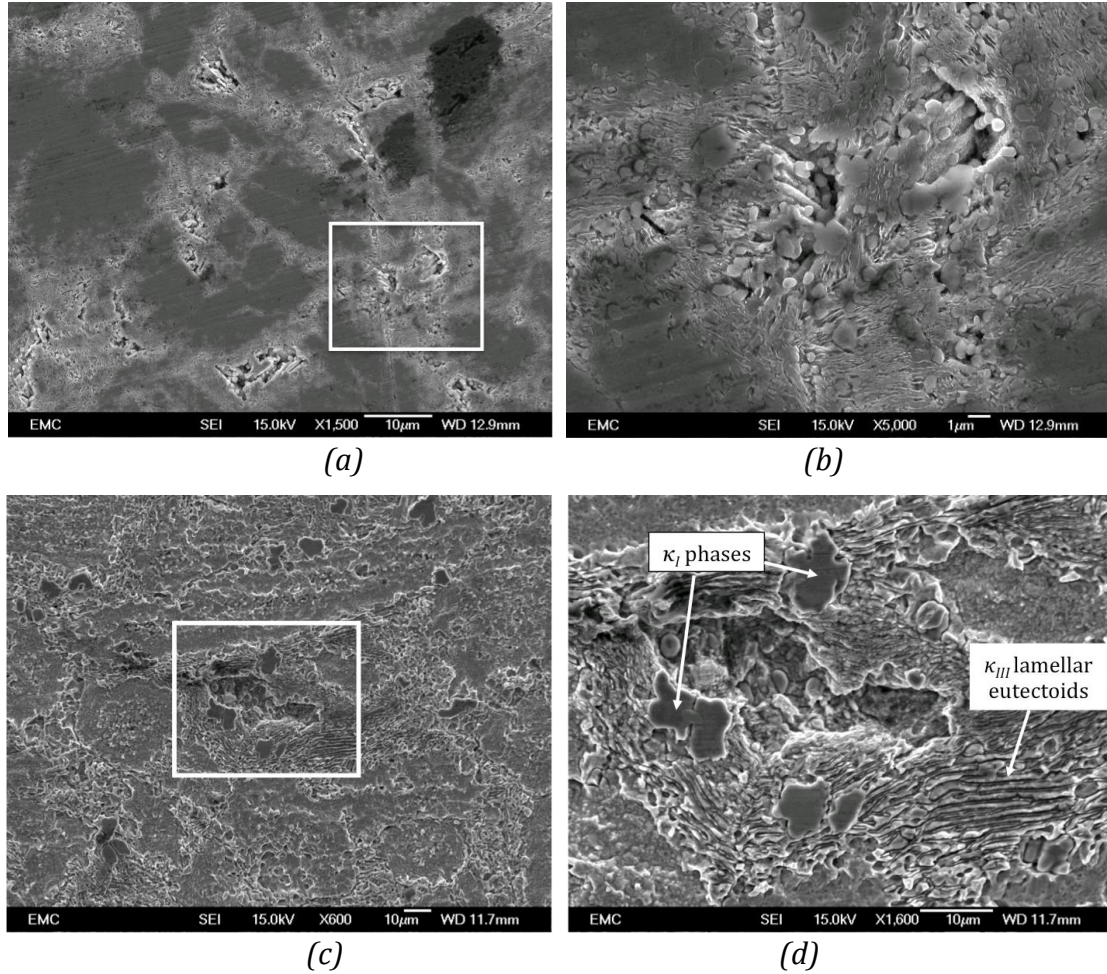
**Fig. 8:** SEM compo/backscattered images of (a) small boundary erosion on air-formed filmed NAB in distilled water; (b) shows the magnified image of the cavities of size 10-μm at the selected area in (a); (c) SEM image of a 50-μm large cavity on the sample surface undergone cavitation erosion-corrosion in 3.5% NaCl solution; and (d) the magnified image of a cavity in (c) showing selective phase attack at the  $\alpha$ - $\kappa$  phase boundaries leaving  $\kappa_I$  globules and  $\kappa_{III}$  lamellar phases exposed.

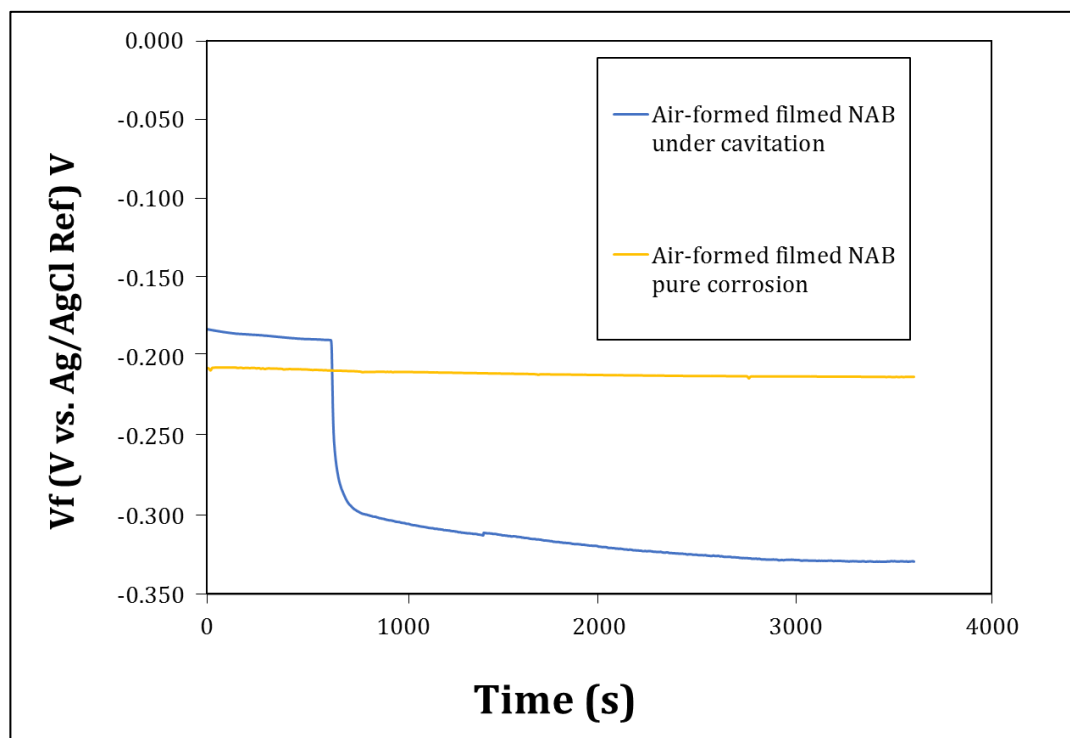
**Fig. 10:** OCP for NAB in 3.5% NaCl solution for 1 h with and without cavitation [44].

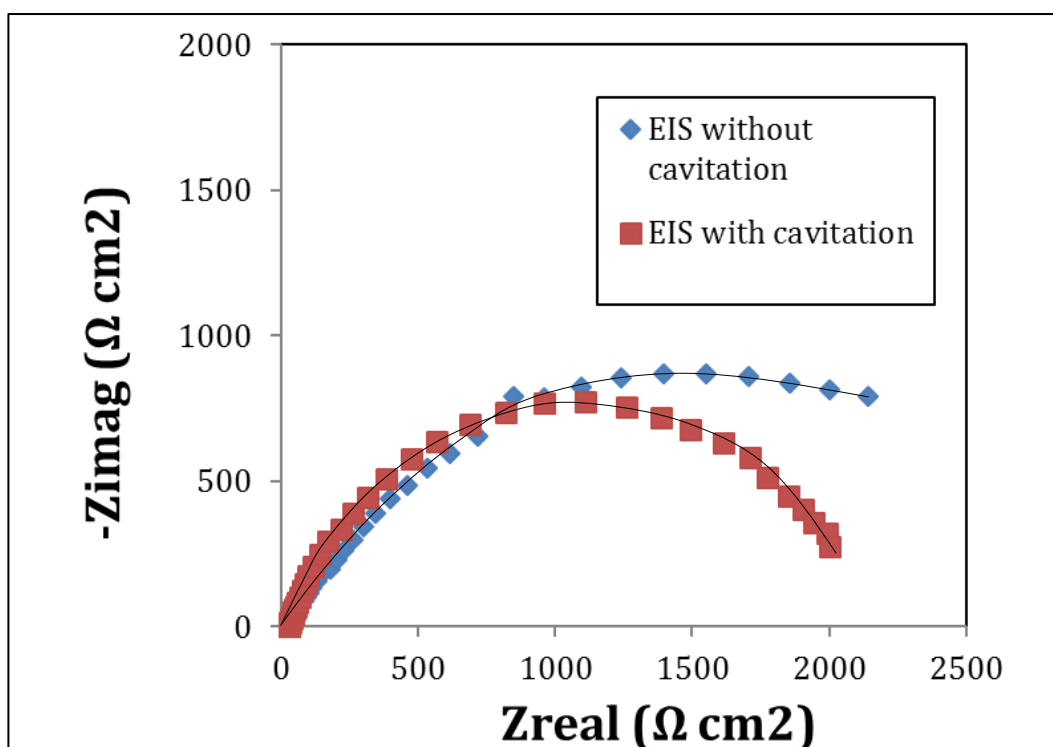
**Fig. 11:** Nyquist plots for NAB samples in 3.5% NaCl solution with and without cavitation.

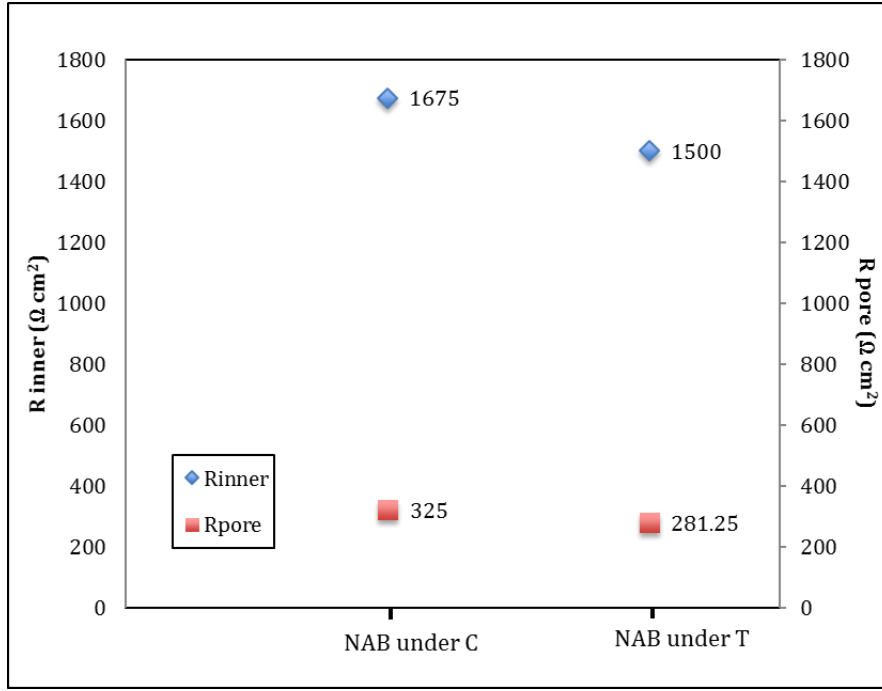
**Fig. 14:** EIS fit plot for NAB under C and T conditions.

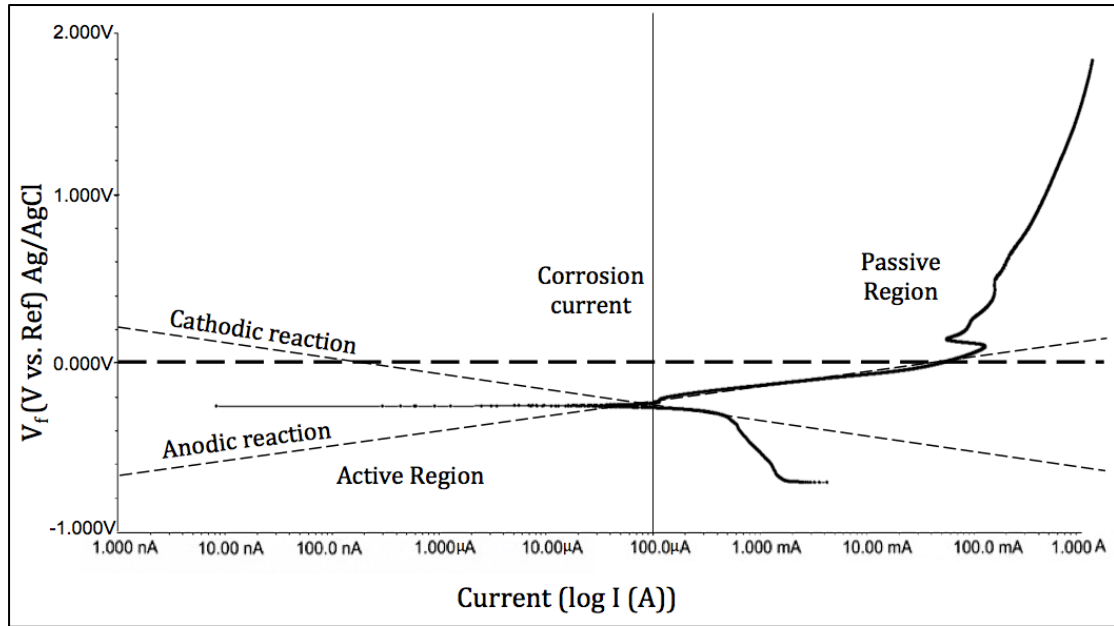
**Fig. 15:** Polarization curve for the NAB in 3.5% NaCl solution showing Tafel extrapolation of corrosion current.

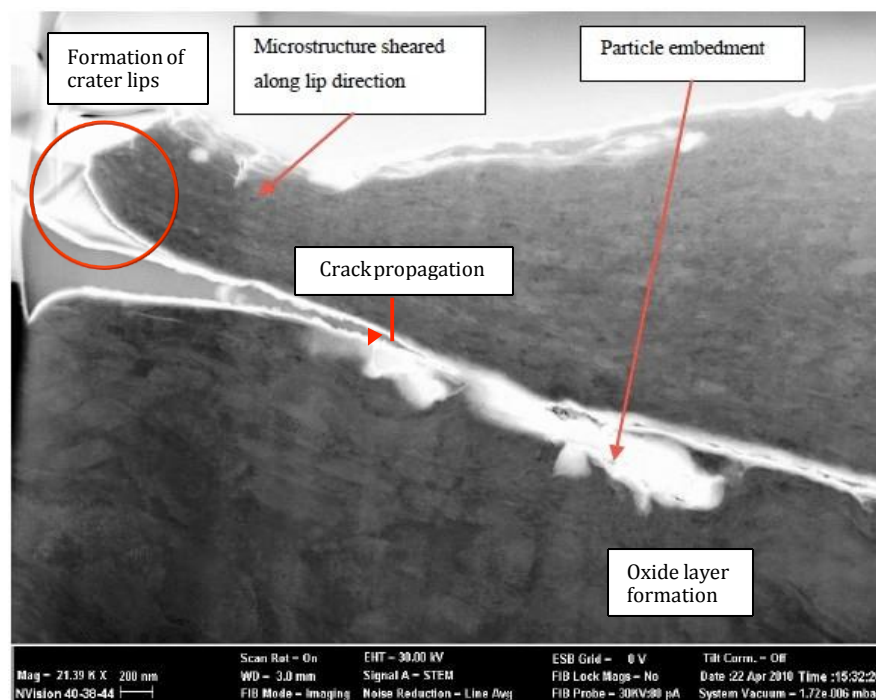
Figure 4 – TEM (dark-field) image showing extruded lip region, and the crack extending underneath it [42]

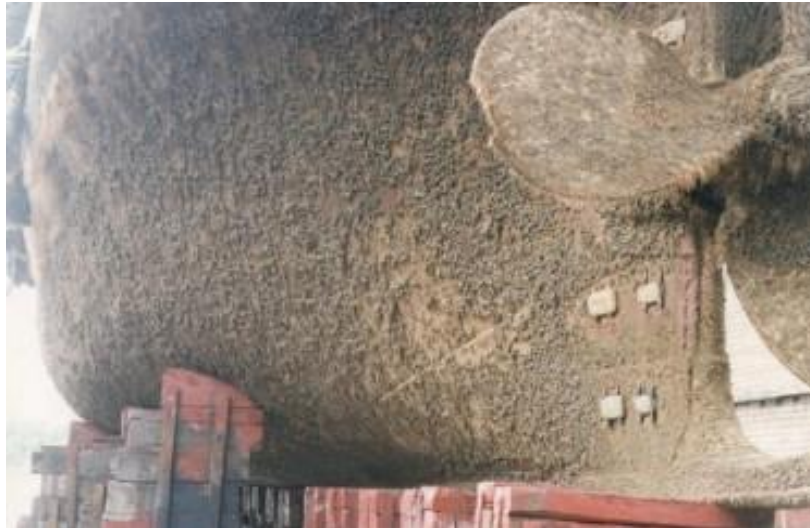
Figure 9 – Microbial surface interaction on marine vessels, propeller fans, etc. [67]

Microbiologically Influenced Corrosion (MIC), also known as microbial corrosion or biological corrosion, is the deterioration of metals as a result of the metabolic activity of microorganisms on the metal [66]. About dozens of bacteria known cause the microbiologically influenced corrosion of metals, such as carbon steels, stainless steels, aluminium alloys and copper alloys, in water and soil, especially with pH of 4-9, and at a low temperature range of 10-50°C. For example, the Sulphate reducing bacteria (SRB) is often responsible for the accelerated corrosion damages to ships and offshore steel structures, figure 9 shows a microbial layer causing corrosion damage to a ship [66,67].

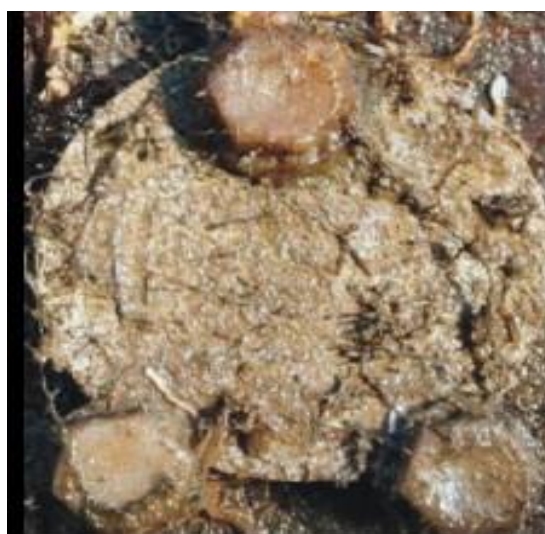
Figure 12 – Biofouling of a NAB coupled Ti disc sample immersed in seawater for 12 months at National Oceanography Center at Southampton [67].

Biofouling growth will affect wave machines perhaps more than submerged tidal systems. Surface and sub-marine structures have to withstand the aggressive marine environment with its corrosive salt water, fouling growth and abrasive suspended particles. Even at a depth of 5m, the tidal systems and the rotor hubs (low velocity parts) get covered with fouling [89]. Penetration of coatings/paints on tidal systems could lead to an accelerated coating paint loss due to substrate corrosion and interfacial de-bonding [90]. Figure 12 illustrates the biofouling of a nickle aluminium bronze [NAB] coupled titanium alloy disc immersed in seawater, for 12 months from January '03 till January '04, at National Oceanography Center, Southampton [NOCS]. [67].

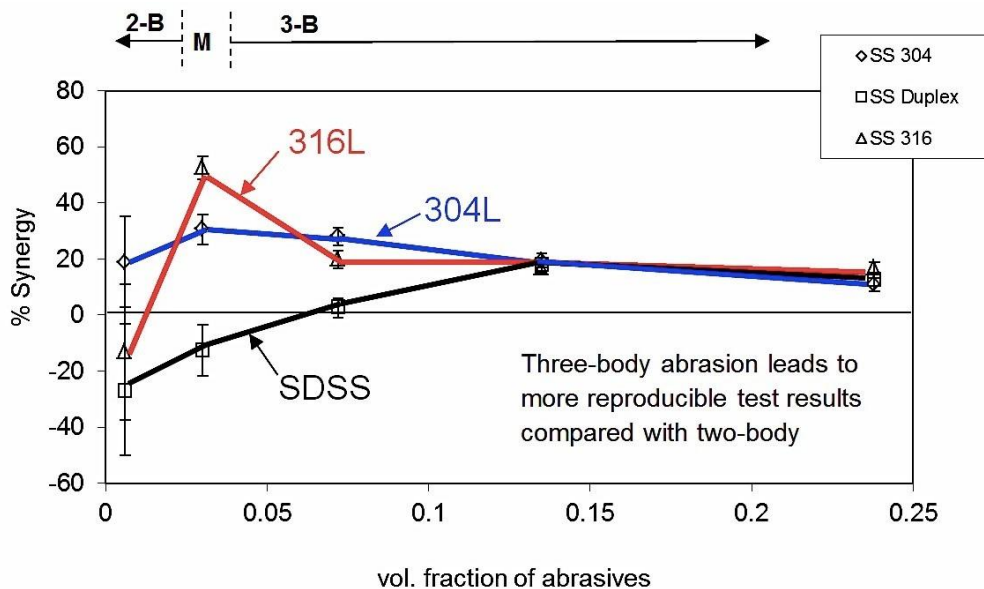
Figure 14 – Synergy % (S) vs. volume fraction of the abrasives for UNS S30403, S31603 and S32760. Low volume fraction of abrasive gives 2 body grooving abrasion while higher concentration generate 3-body rolling abrasion. Intermediate concentrations caused a mixed 2 and 3-body mode (M on figure) [91].

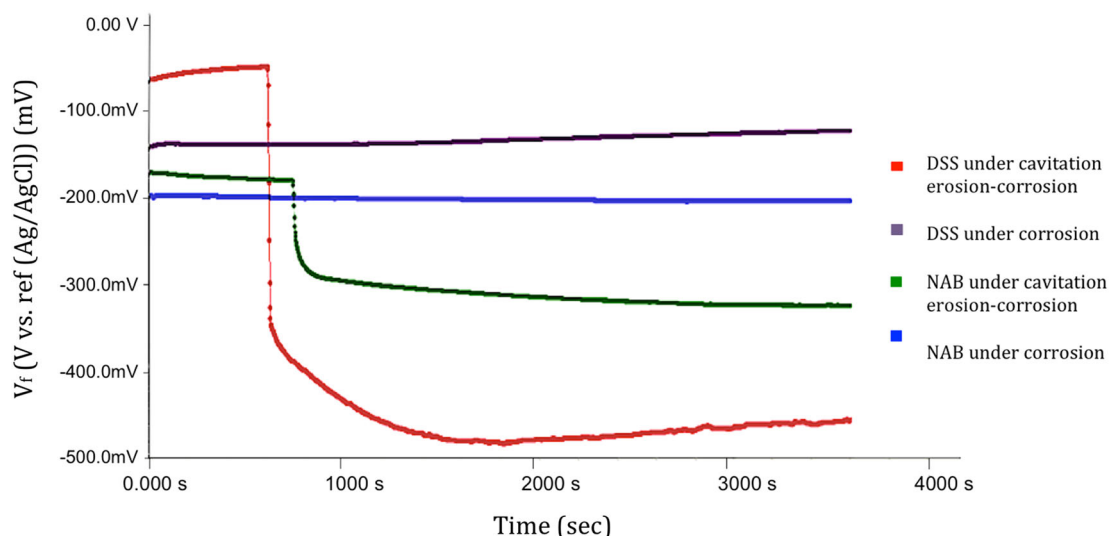
**Fig. 8** OCP for DSS and NAB in 3.5 % NaCl solution for 1 h with and without cavitation

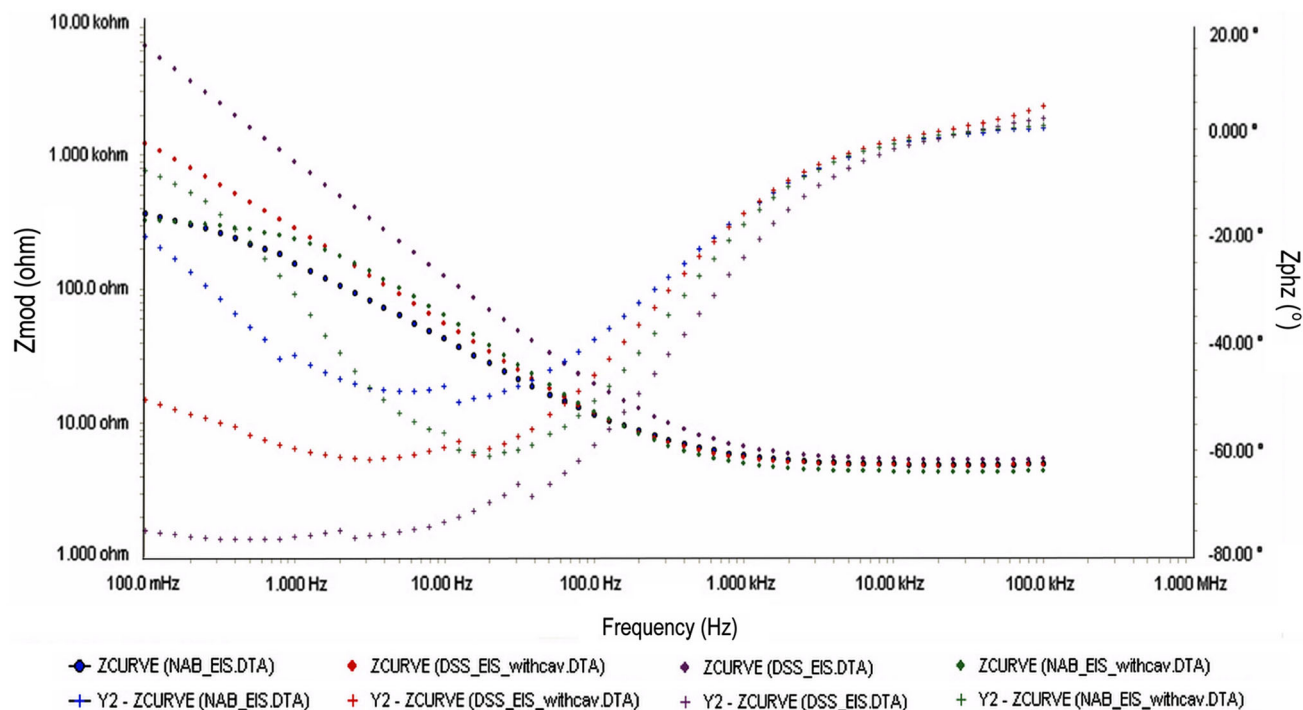
**Fig. 9** EIS for DSS and NAB in 3.5 % NaCl solution with and without cavitation
