Thermal Desorption Analysis of Hydrogen in Non-hydrogen-Charged Rolling Contact Fatigue-Tested 100Cr6 steel

A.D. Richardson^{a*}, M.-H. Evans^a, L. Wang^a, R.J.K. Wood^a, M. Ingram^b

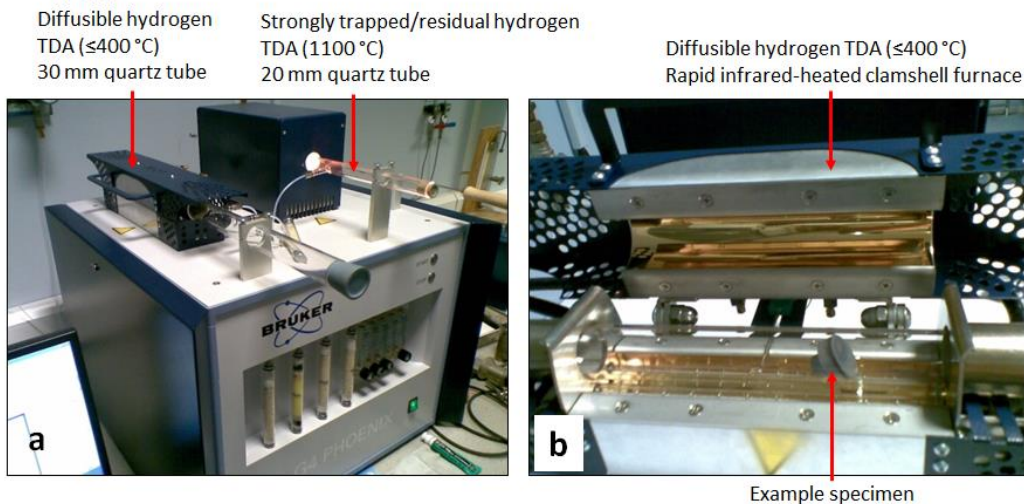
Set-up (1)

Fig. 1. TDA equipment set-up (1). (a) Diffusible and strongly trapped/residual hydrogen analysis tubes and (b) infrared-heated clamshell furnace. Adapted from [55].

(2) Ramped TDA was conducted using GC method at a rate of 25 °C/hour up from room temperature to a final temperature of 300 °C (diffusible hydrogen) using an in-house TDA system. TDA using this set-up was only conducted on the 0 hour control, 6 hour and 18 hour RCF tested bearings. The sample is heated at a linear rate using a resistance tube furnace, a thermocouple being used in close proximity to the sample to measure the temperature. The GC is calibrated with a helium gas containing 60.7 ppmv (part per million per volume) hydrogen before measurement. Helium is used as the carrier gas and flows at a constant rate of 10 ml/min. The carrier gas transports the desorbed gases from the sample through the GC system. The mix of gases is injected into the GC column every 3 minutes, where the mix of gases is separated and detected by a pulsed discharge ionization detector. The hydrogen desorption rate (ppm/min) is then measured. Analysis time was conducted over 1250 minutes, the final temperature of 300 °C being reached after 615 minutes.

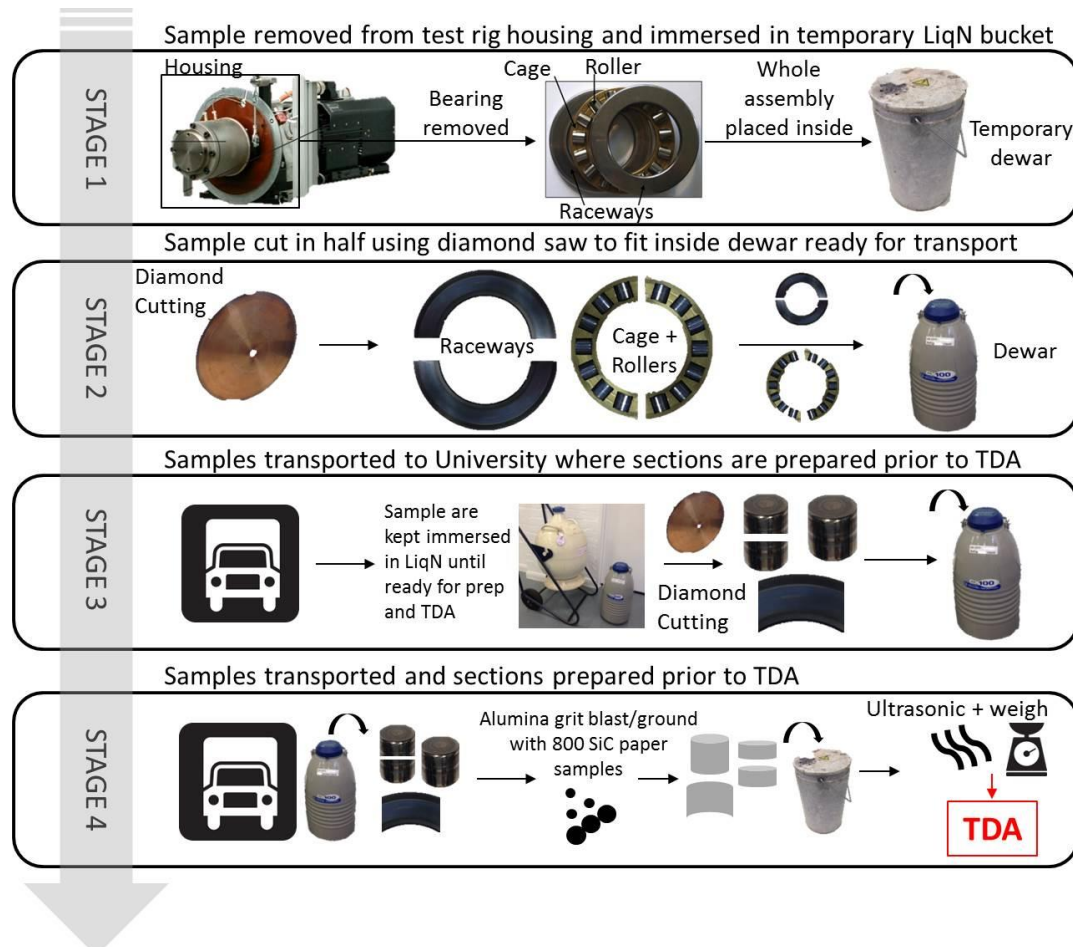
Fig. 2. Flow diagram demonstrating the stages of sample preparation post RCF testing and before conducting TDA.

Prior to TDA the bearing was prepared into the relevant samples to be analysed. The raceway washers were cut into ~20 x 20 mm square sections, the rollers kept whole or cut into halves to investigate the influence of outer and inner roller zones. Cutting time was kept to a minimum to limit the desorption of hydrogen (< 1 minute). In set-up 1 single and multiple rollers and raceway washer sections were analysed, only single roller and raceway sections being analysed in set-up 2. The rollers analysed were either non-spalled or spalled to investigate the influence of spall sites as exposed surfaces/cracks for additional hydrogen entry into the bearing steel during operation. The samples were kept continuously immersed in LiqN for a period of 2 – 15 days under BS ISO 3690 standards [32] until TDA was conducted. Before TDA samples were lightly blasted with Alumina grit for <60 seconds to remove contaminants, residues and the oxide layer this is with the exception of the 0 hour (control) roller and raceway analysed by set-up 2 which were lightly ground using 800 grit SiC paper. The samples were then ultrasonically cleaned in acetone for 60 seconds to remove surface contaminants; air dried and then weighed on a mass balance before being placed in the TDA analyser tube. A flow diagram of the sample preparation process prior to TDA analysis is illustrated in Fig. 2.

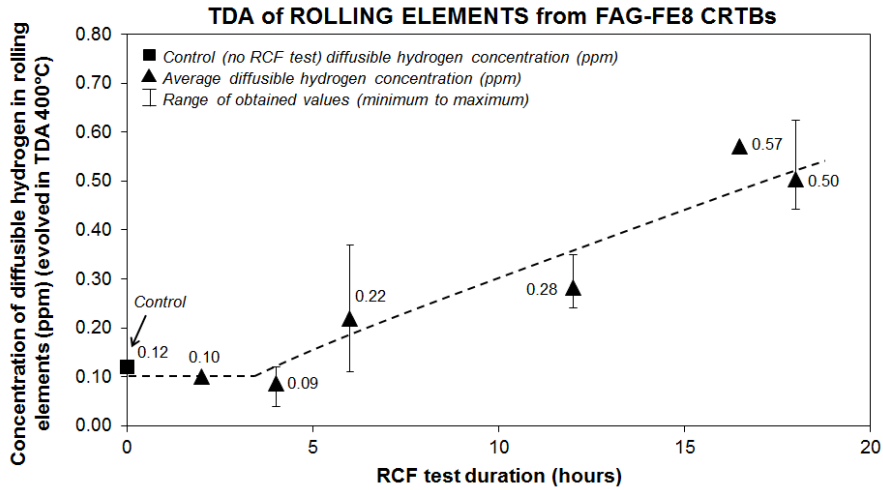
Fig. 3. Average concentrations of diffusible hydrogen measured by TDA at ≤ 400 °C using set-up #1 in the rolling elements post RCF testing. See **Table 2** for individual hydrogen TDA measurements.

For the rolling elements at 2-4 hours, hydrogen concentrations were similar to the 0 hour sample with no significant increases. This is logical, as 2-4 hours is short test duration, thus there is only a short time frame in which hydrogen can be generated and diffuse into the steel. Through contact surface inspection of rollers from the same test bearing, very little surface damage and no evidence of surface micro-cracking was also found at these early stages of RCF operation (see [ref paper 1] for further details), where surface micro-cracks and spall sites can act as sumps and zones for lubricant penetration and subsequent hydrogen generation.

At 6 hours elevated concentrations were measured when compared to 0-4 hours. It is proposed that at 6 hours, a significant time had been reached for sufficient tribo-chemical reactions at wear induced nascent surfaces or areas of heterogeneous tribofilm to occur generating hydrogen.

TDA at 12 hours showed comparable hydrogen concentrations to the 6 hour test. It could be thought that at 12 hours hydrogen concentrations would be higher than at 6 hours, however this may partly be driven by variability in rollers and RCF tests (see **Fig. 3**). It could be argued that the increased concentrations are due to lubricant penetration into surface micro-cracks. However again through contact surface analysis of rollers from the same test bearing conducted in [ref paper 1], SEM showed no evidence of surface micro-cracks, a more comprehensive analysis however should be conducted. In addition, serial sectioning analysis from the same study showed a minimal amount of cracks connecting to the contact surface, all rollers analysed between 0-12 hours were also non-spalled. Therefore, lubricant penetration into surface micro-cracks is infeasible, elevated hydrogen concentrations are proposed to be the result of wear induced nascent surfaces and heterogeneous tribofilm forming.

TDA was also conducted on non-spalled and spalled rollers at 16.5 and 18 hours with no significant differences being found between them. Serial sectioning analysis of rollers from the same test bearing at 18 hours revealed a number of very small crack connections relative to the extent of the WEC network, see [ref paper 1] for further details. It is proposed that these surface connections would be insufficient to allow adequate lubricant penetration for hydrogen generation to occur. To investigate the nature of nascent surface and heterogeneous tribofilm formation during operation and to further develop the mechanism hypothesis, analysis is being conducted by the authors and will be presented in a future paper.

to the 0 hour and 2 hour tests (see Fig. 3). This however may have been due to the lack of a sufficient volume of hydrogen being effused for the detection limit of the TDA analyser. Considering the case if there was indeed no increase in hydrogen concentration at the 4 hour roller. Since evidence for WEC initiation was consequently found at 4 hours, either; i) the local concentration of hydrogen was relatively high at the inclusion or crack to aid in crack initiation as opposed to the bulk average of the steel, or ii) hydrogen has not aided in the initiation stage of this WEC, rather hydrogen accelerated crack propagation, this only occurring once additional hydrogen has diffused into the steel above some threshold. This is supported as for longer RCF test durations (6-18 hours) an increase in WEC formation and size accompanies an increase in diffusible hydrogen concentration. It may be that a sufficient threshold concentration of diffusible hydrogen is reached accelerating WEC formations where hydrogen acts to decrease the Mode I/II stress limits for crack growth and propagation [40, 63]. Hydrogen acceleration of WECs is also supported by the fact that under the test conditions used in this study (P_{max} 1.5 – 1.9 GPa (depending on contact length used between 7-9 mm) and low RCF test times) flaking is not known to normally occur with other lubricants.

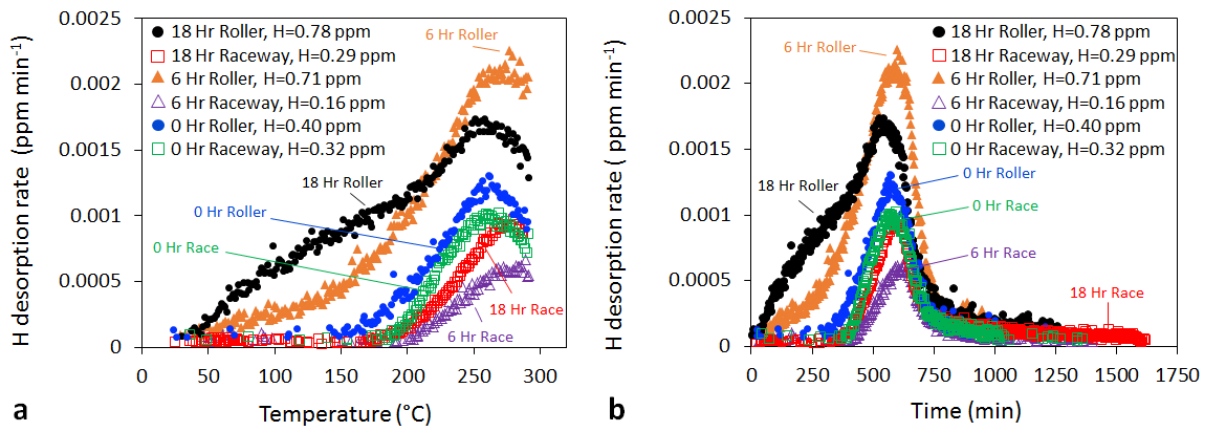
Fig. 4. Hydrogen desorption curves for 0, 6 and 18 hour RCF tested roller and raceway washer section analysed by ramped TDA to 300 °C using set-up 2 including the total diffusible hydrogen concentration measured. (a) Hydrogen desorption rate (ppm/minute) vs. desorption temperature (°C). (b) Hydrogen desorption rate (ppm/minute) vs. analysis time (minutes). See **Table 2** for individual TDA measurements.

From the TDA curve in **Fig. 4 (a)** it can be seen that the 18 hour roller shows a shallow desorption hump between 0 °C and ~50-75 °C, with steady desorption between ~50-200 °C. Another more pronounced desorption peak is observed just beyond at ~200-300 °C. For the 18, 6 and 0 hour raceway sections a single desorption peak is observed just beyond 175 °C. A single desorption peak is observed just beyond ~150 °C for the 0 hour (control) roller. The 6 hour roller shows a steady desorption between ~0-150 °C, beyond this a desorption peak is observed at ~200-300 °C. The desorption curves presented in **Fig. 4** show that hydrogen started to desorb out right away for the 18 and 6 hour rollers and at just after ~250-375 minutes for the 18, 6, and 0 hour raceway sections and the 0 hour roller after TDA had started. TDA indicates that all diffusible hydrogen was fully desorbed by the time the analysis had finished at 1750 minutes.

Fig. 5 discusses the key features found from the results obtained by TDA set-up 2 and detailed in **Fig. 4**.

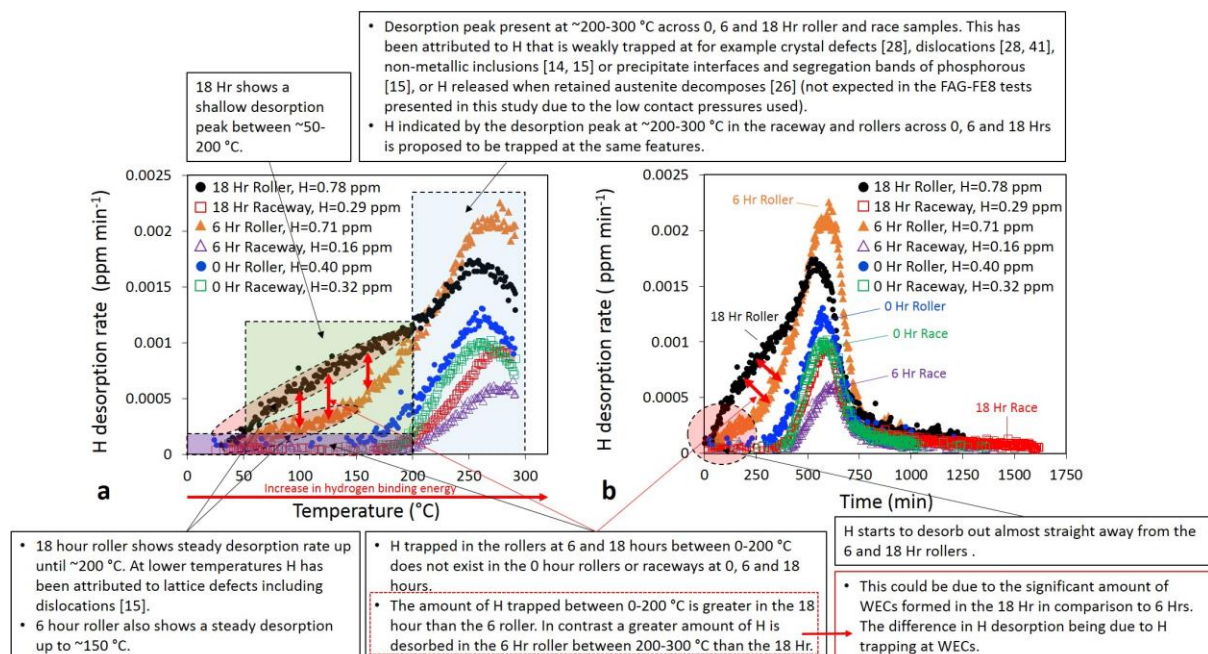
Fig. 5. Annotated discussion points of key features from TDA set-up 2 results shown in **Fig. 4**.

During RCF, hydrogen generated at the time of operation was at that point in its diffusible state. This hydrogen can then diffuse and become attracted to the various trapping sites within the steel matrix, some of this hydrogen becoming strongly trapped. Therefore if it is to be contested as to what is considered ‘diffusible’ or ‘non-diffusible’ hydrogen at temperatures ≤ 400 °C, then one could consider that hydrogen that has become strongly trapped or ‘non-diffusible’ (that was once ‘diffusible’ during RCF operation) is still a measure of the hydrogen that has ‘diffused’ into the steel at some point during operation. It is also important to note that at higher TDA temperatures (1100 °C) conducted post 1st round TDA at ≤ 400 °C on the 16.5 hour rollers (see **Table 2**), additional hydrogen was measured (0.30 ppm). This is classed as ‘non-diffusible’ strongly/residually trapped hydrogen (sourced during operation or from manufacturing processes). Therefore not all (or any) of the ‘non-diffusible’ strongly trapped/residual hydrogen was released when conducting TDA at ≤ 400 °C and so the hydrogen measured is considered to be weakly trapped ‘diffusible’ hydrogen.

It can be seen in one case (6hr rollers) that an increased concentration of diffusible hydrogen was measured when analysing 2x rollers simultaneously as opposed to a single rolling element (0.18 – 0.37 ppm). This could be due to a lack of total hydrogen evolved by the single roller to be detectable by the TDA, variability between different rolling elements, an increase in the surface area analysed, increased chance of surface contaminants, residue and oxide layer, though strict measures were taken to reduce the possibility of this effect.

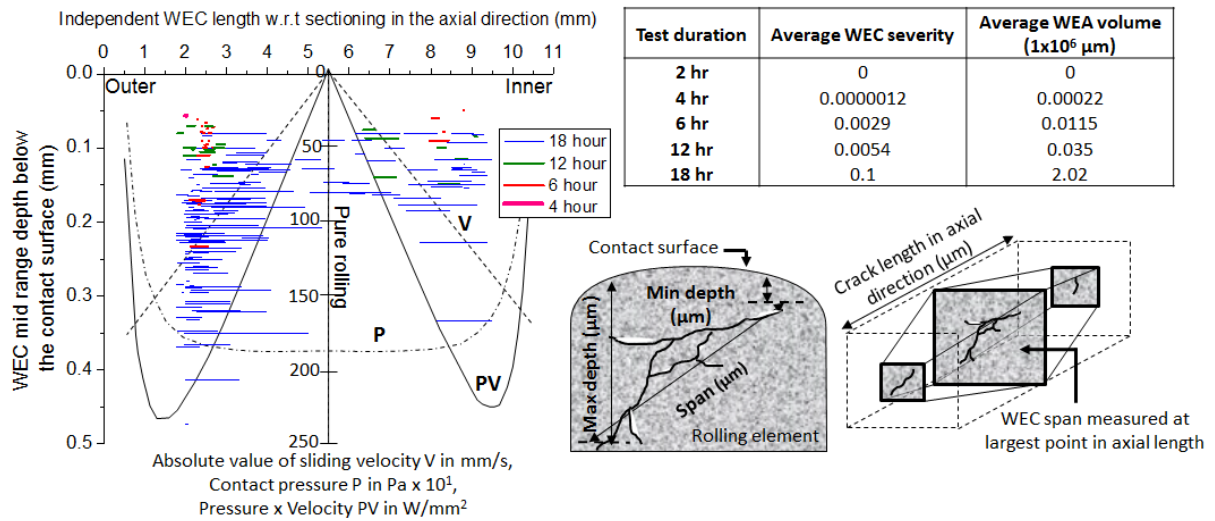
Fig. 6. Distribution of the individual WECs recorded in 4-18 hour rollers through metallographic analysis conducted in. The table shows the average WEC severity and WEA volume recorded for each test duration. Schematic illustrates relevant dimensions recorded for individual WECs. Adapted from [ref paper 1].

Evidence for WECs recorded at short RCF test times have been found through serial sectioning analysis of 4 hour rollers [ref paper 1] (see **Fig. 6**). TDA for the 4 hour rollers measured negligible concentrations of diffusible hydrogen, comparable

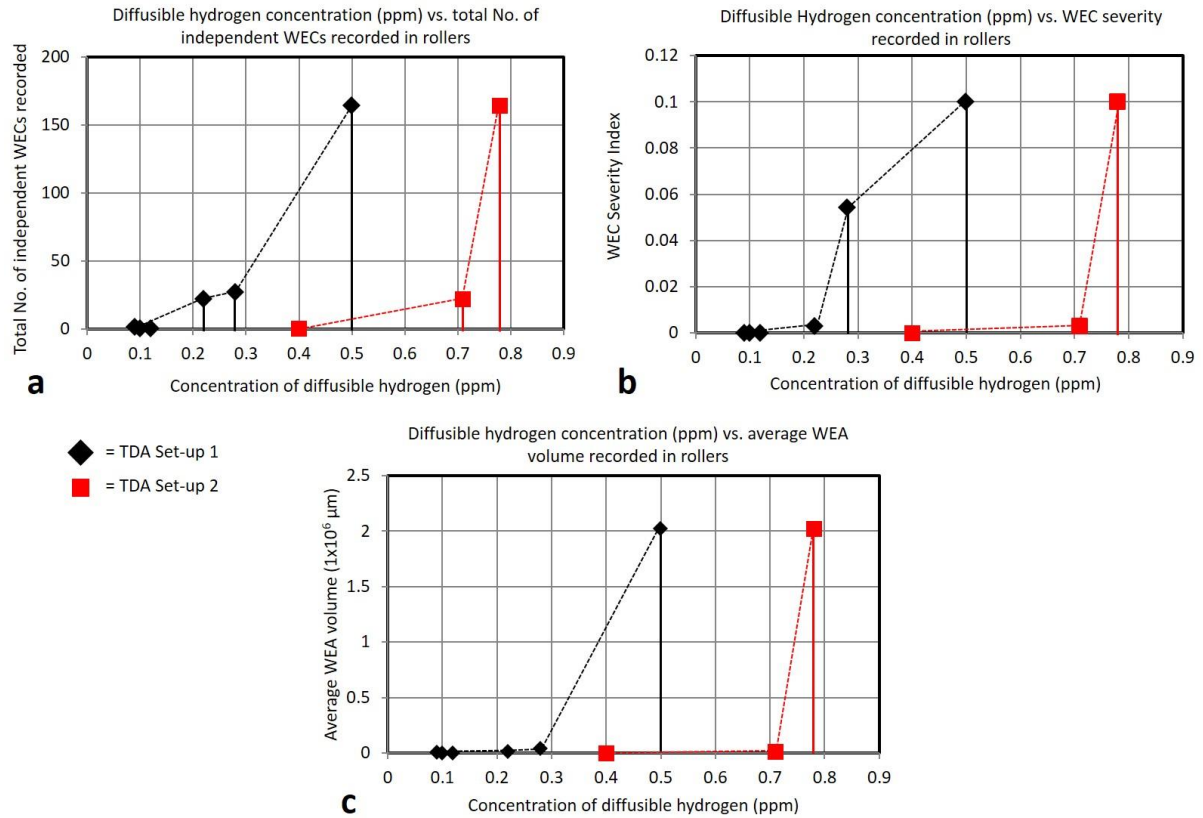
Fig. 7. Relationship between the concentration of diffusable hydrogen measured for set-up 1 and 2 and WEC formations recorded through metallographic analysis in [ref paper 1]. (a) Diffusible hydrogen concentration vs. the total number of independent WECs recorded in the rolling elements. (b) Diffusible hydrogen concentration vs. average severity for WEC formations in the rolling elements. (c) Diffusible hydrogen concentration vs. average WEA volume recorded in the rolling elements.

It has been shown through serial sectioning [ref paper 1] that the total WEA volume found associated with the crack increases with RCF test duration with a step increase in the total WEA volume being recorded at the later stages of RCF operation between 12-18 hours (see Fig. 6). From Fig. 7 (c) it can be seen that the average WEA volume increases for an increase in hydrogen concentration, a significant step increase occurring for hydrogen concentrations beyond ~0.3 ppm. Therefore, it is hypothesised that the diffusion of hydrogen can aid in the formation of WEAs. This appears to be at a greater extent at the later stages of RCF duration, the diffusion of hydrogen promoting WEC growth. Supporting evidence for the crack being a prerequisite to the WEA is shown in [ref paper 1], a possible mechanism for this being crack face rubbing/beating [28, 29], it is thus proposed that the addition of hydrogen aids in crack growth thus enhancing the ability for crack face rubbing/beating to occur in the formation of WEAs.
