**Development of Detection Techniques for Investigating Scuffing Mechanisms of
Automotive Diesel Cast Irons**

Thesis for the degree of Doctor of Philosophy

July 2017

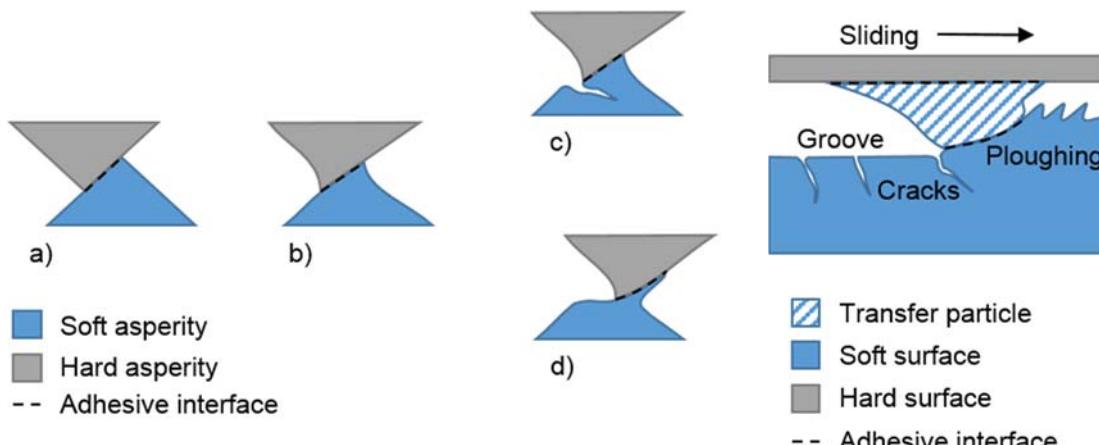
Figure 2.11: a) Asperities adhere together, b) asperities plastically deform due to shear stress, c) asperity fracture, d) ductile yield of asperity, adapted from [25].

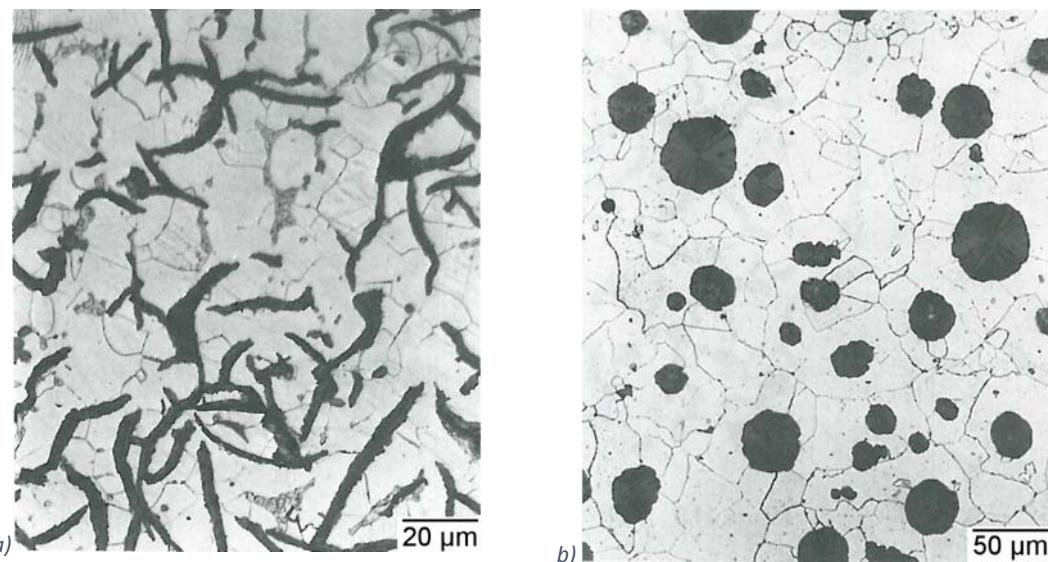
Figure 2.13: Optical images of a) Grey cast iron and b) Nodular cast iron reprinted from [48] with permission from Wiley & Sons Ltd ¹.

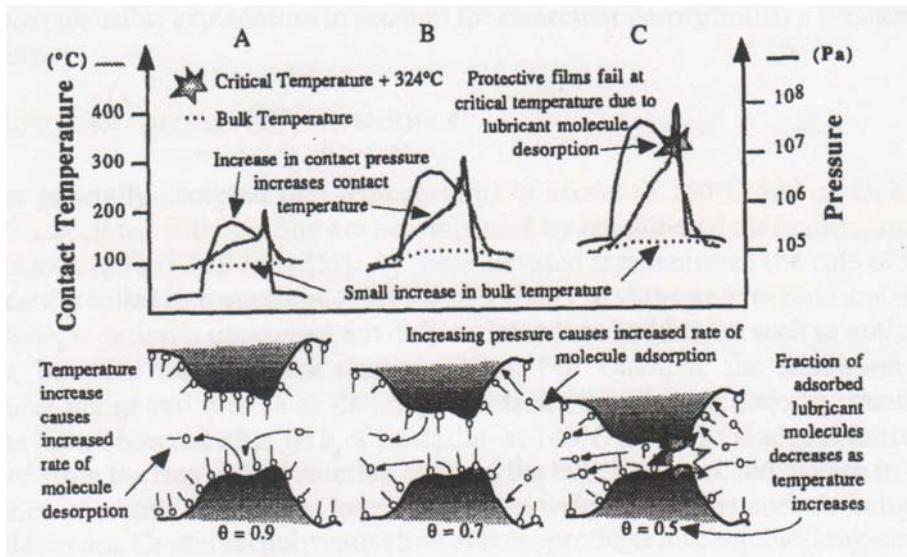
Figure 2.14: The chemical desorption model of Lee and Chen, reprinted from [80] with permission of Springer².

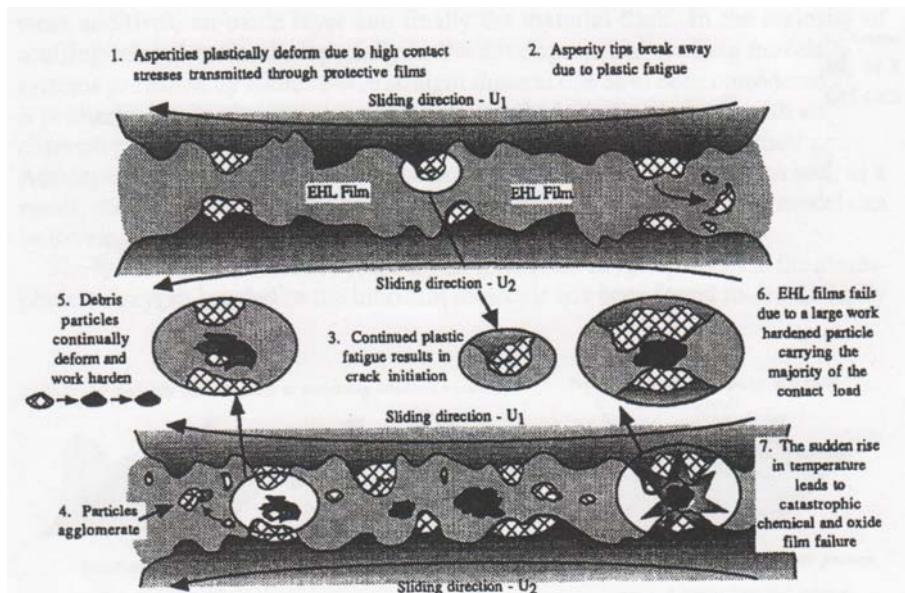
Figure 2.15: A visual interpretation of the scuffing model Ludema proposed, reprinted from [80] with permission of Springer³.

transfer through the lubricating film causing plastic fatigue [75]. A visual interpretation of the scuffing model proposed by Ludema is shown in Figure 2.15. It can be seen how plastic fatigue causes the formation of debris which compromise the EHL film leading to scuffing [80]. Staph et al [84] also noted that wear can take place without the lubricating film collapsing. They explained that cyclic stresses are still transmitted through a full EHL film and can cause pitting. These two reports are important in explaining scuffing which occurs towards the end of a components life under standard operating conditions. While this may offer a deeper understanding which can be used to improve the design of such a concentrated contact, it does not help explain unexpected scuffing events during the contact's working life.

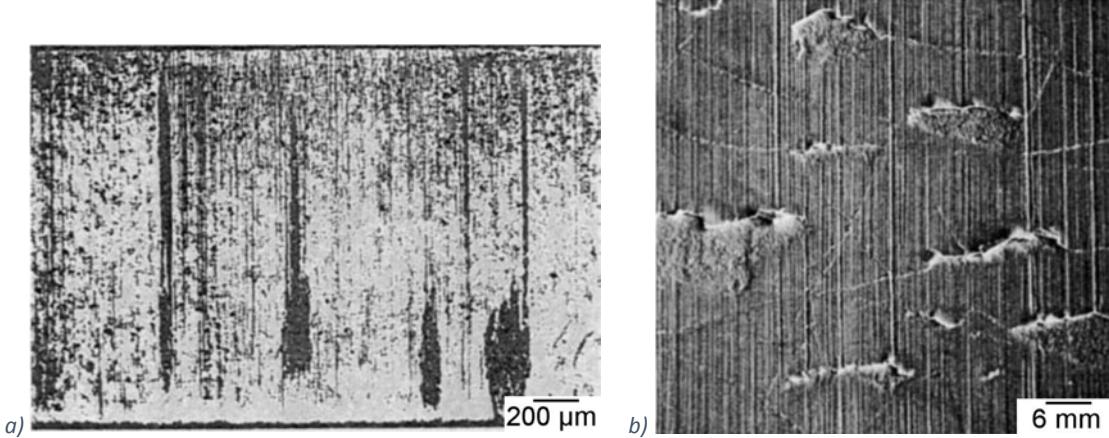
Figure 2.16: Scuffed and scored components from the piston ring liner contact: a) Major scuffing of cast iron ring, b) Scuffed chrome liner, republished from Neale [42] with permission from Elsevier ⁴.

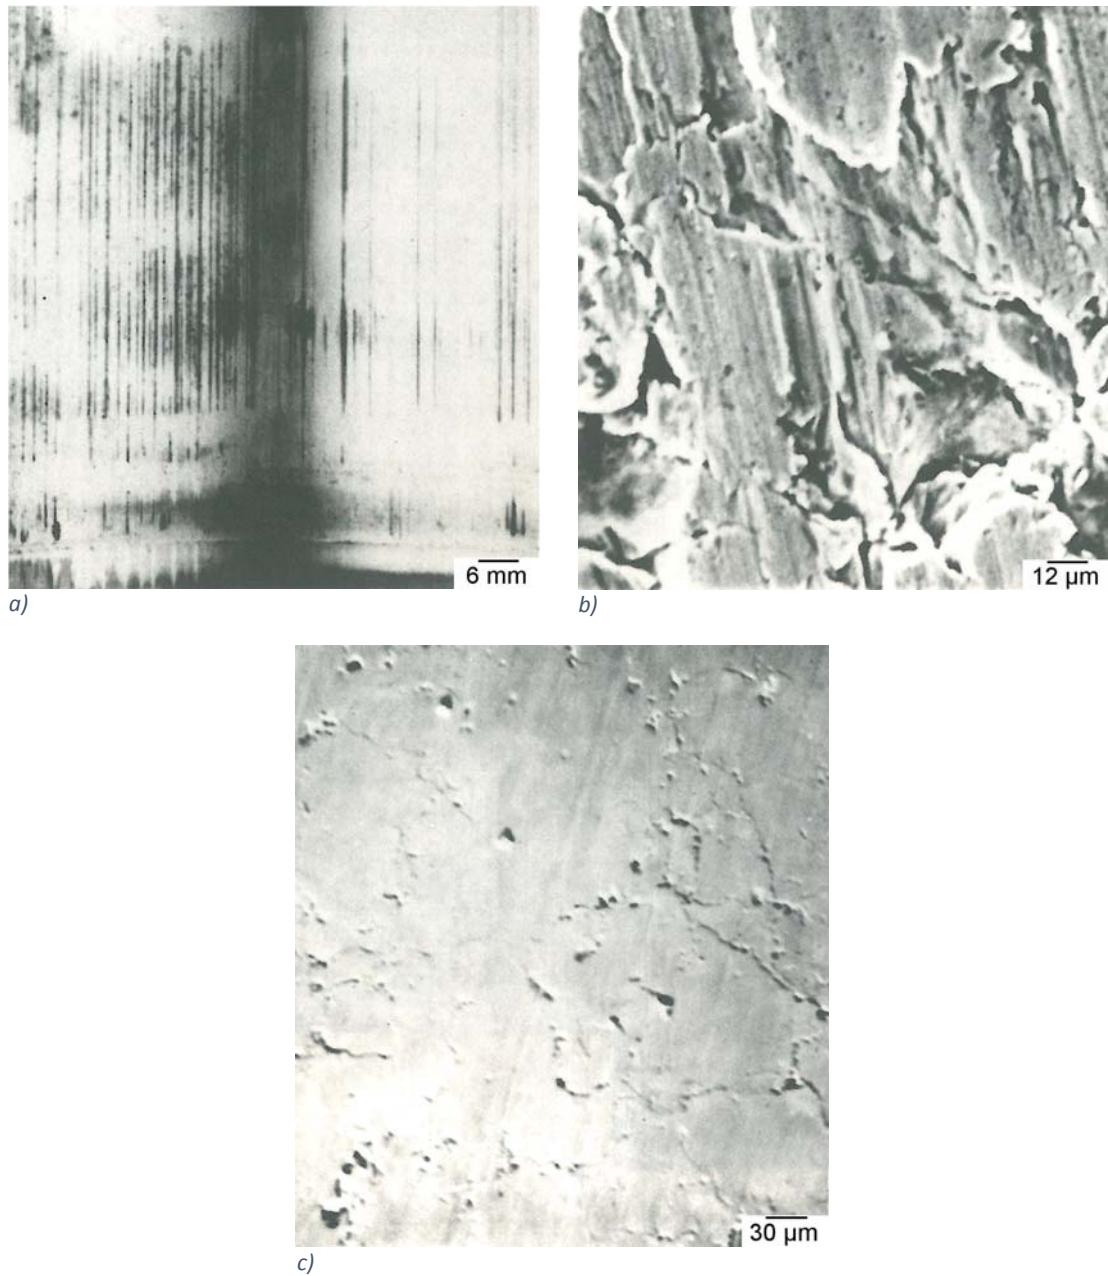
Figure 2.17: Scanning electron microscope images of a scuffed bore from a fired dynamometer test reprinted from [99] with permission of IMechE, a) Scuffed cast iron liner, b) Severe adhesive damage inside scoring marks, c) Mild adhesive smearing outside scoring marks.

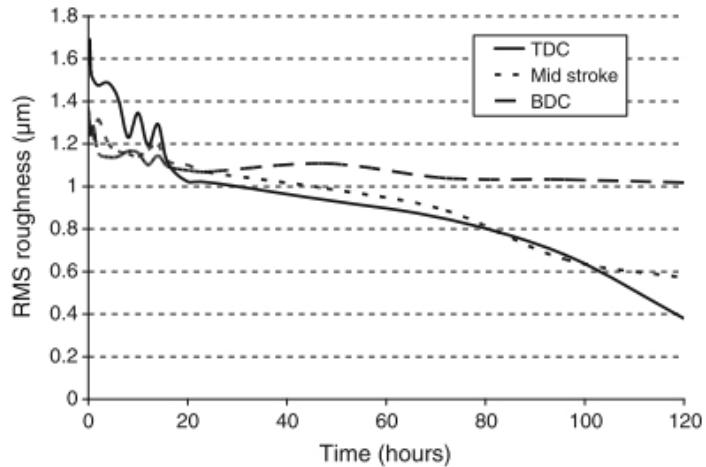
Figure 2.18: A graph of cylinder liner RMS roughness against engine operating time [117], reprinted from [116] with permission of Springer⁵.

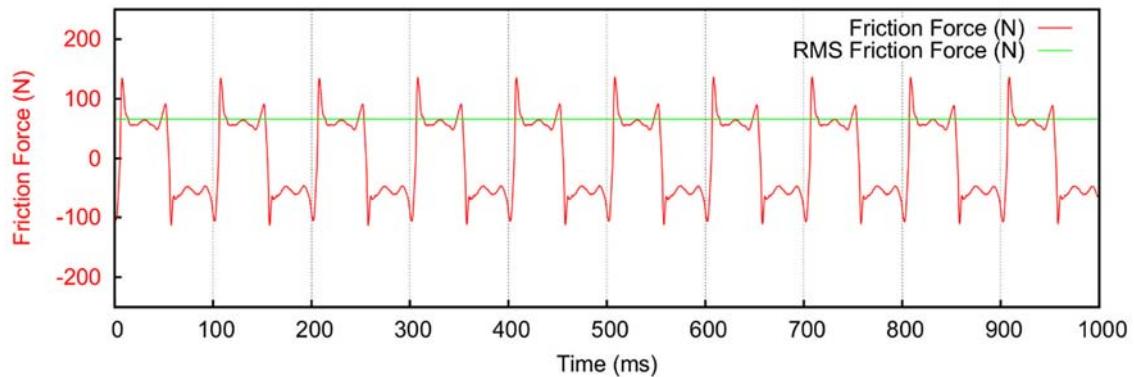
Figure 2.20: Comparison of instantaneous and RMS friction force measurements adapted from [132].

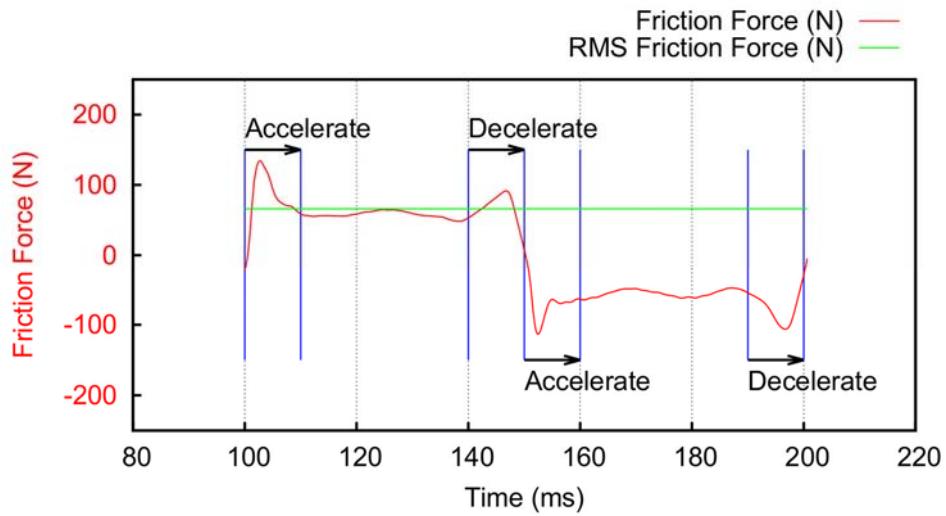
Figure 3.5: Local increases in friction force in both the accelerating and decelerating directions during mild scuffing.

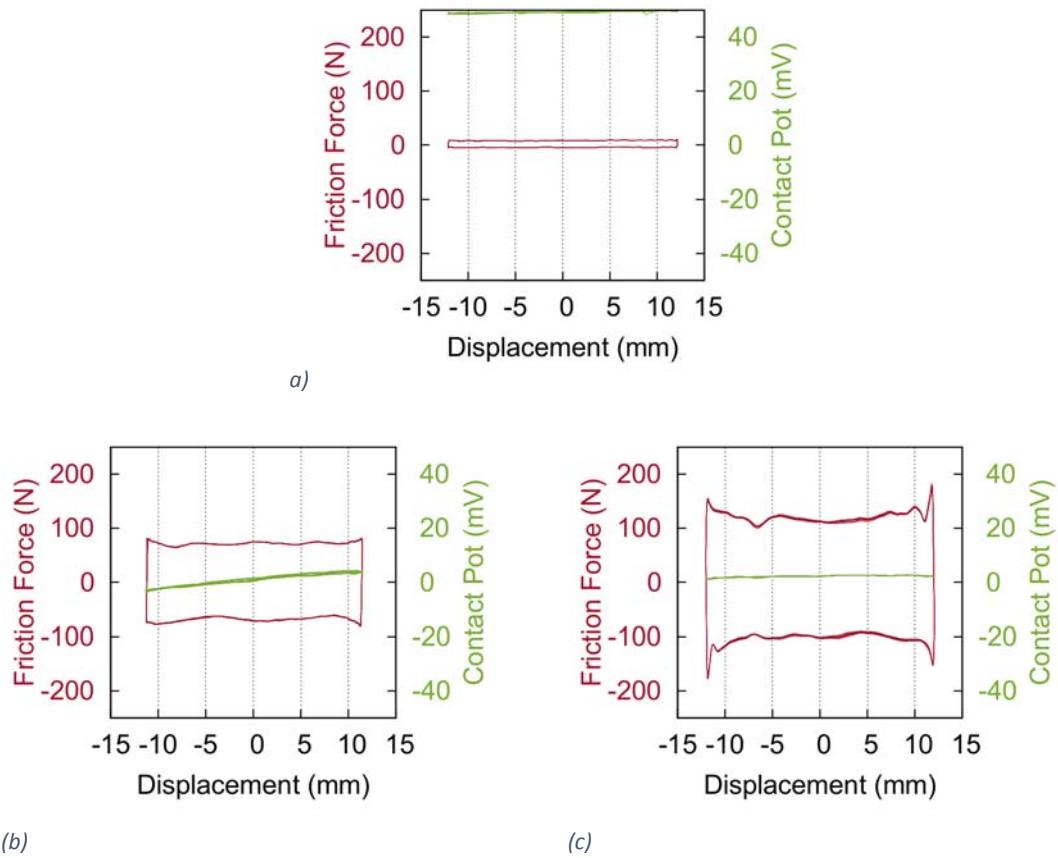
Figure 4.4: High speed friction and contact potential data for flake cast iron tests: (a) continuous load running in (b) Continuous load mild scuff, (c) Continuous load severe scuff.

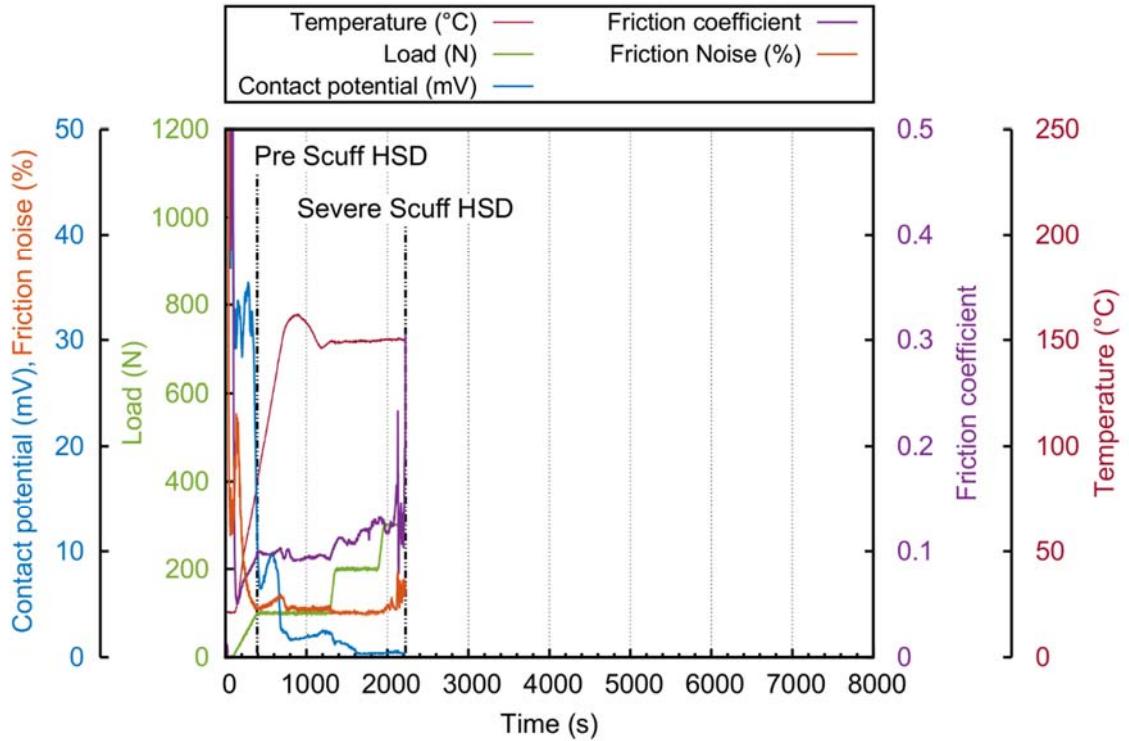
Figure 4.5: Discrete load flake cast iron severe scuffing test data graph.

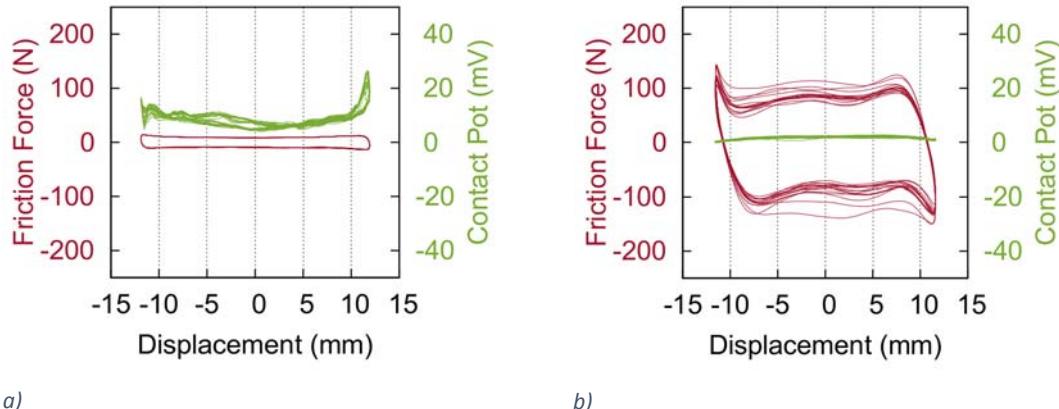
Figure 4.6: High speed friction and contact potential data for discrete load flake cast iron test: (a) pre scuff, (b) severe scuff.

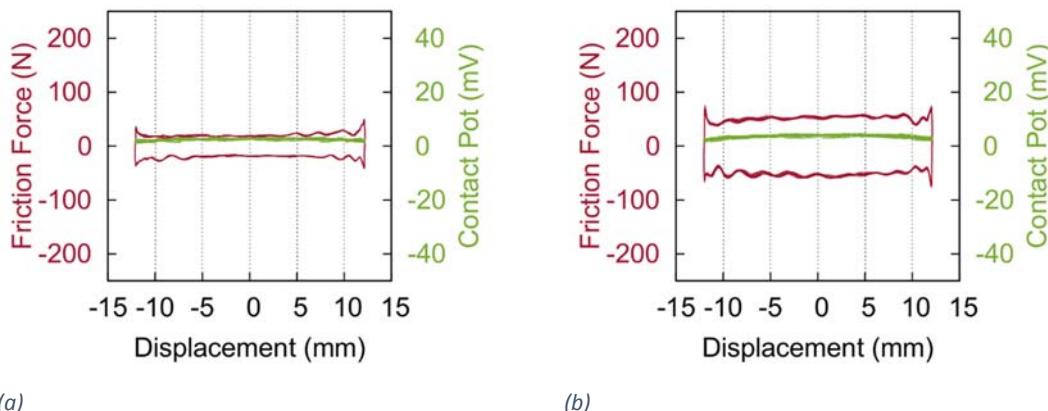
Figure 4.8: High speed friction and contact potential data from (a) mild and (b) severe scuffing of scuffed flake test S1.

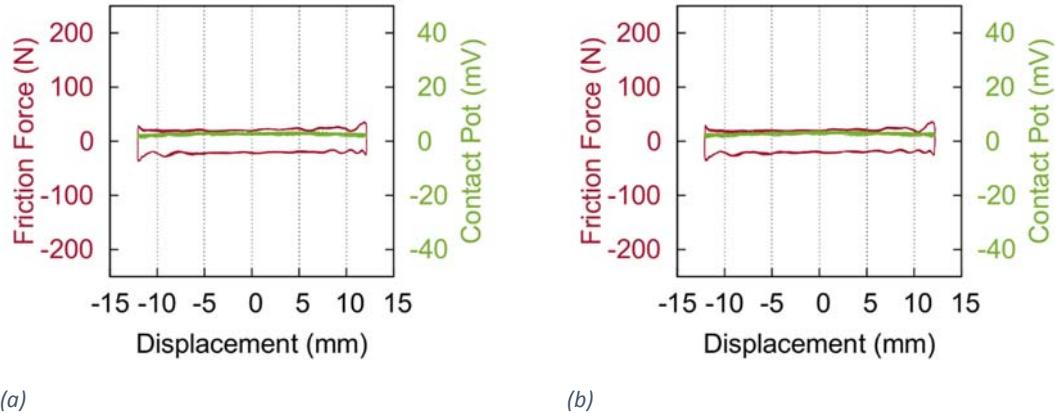
Figure 4.10: High speed friction and contact potential data (a) MS1 and (b) MS2.

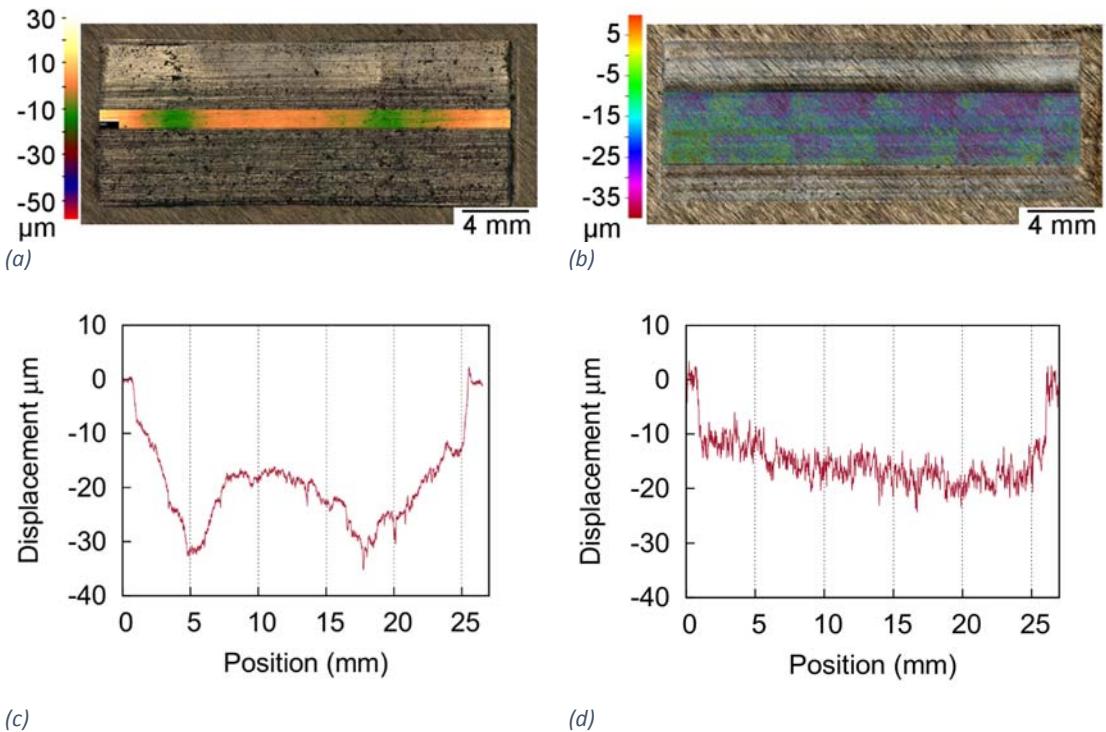
Figure 4.11: Optical images, 3D colour maps and surface profiles of the (a & c) severe CLMS and (b & d) mild CLMS scuffed flake cast iron wear scars.

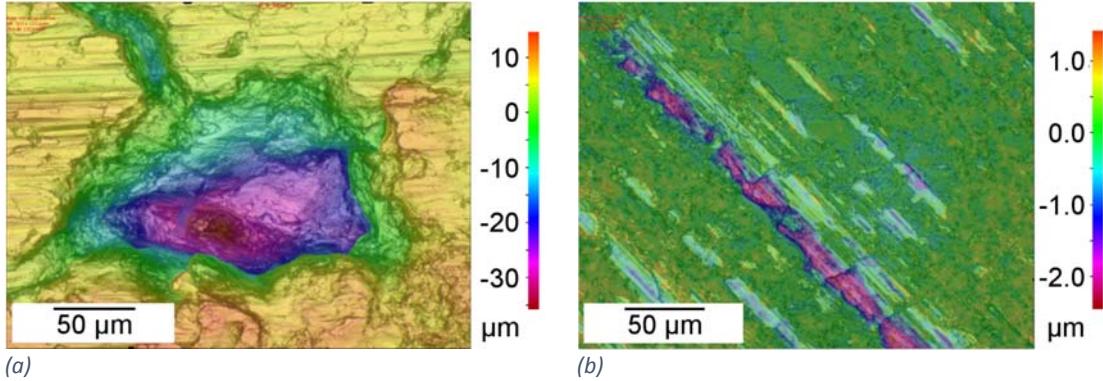
Figure 4.12: Optical images blended with 3D colour maps of the (a) severe CLS and (b) mild CLMS scuffed continuous load flake cast iron surfaces.

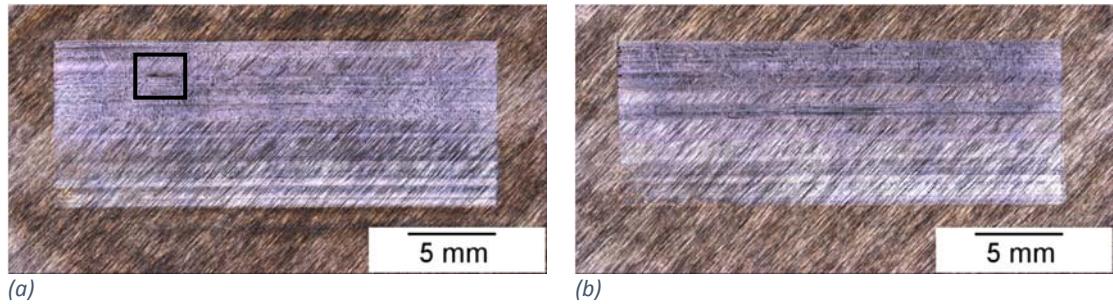
Figure 4.14: Optical images of mildly scuffed flake cast iron surfaces (a) MS1 and (b) MS2.

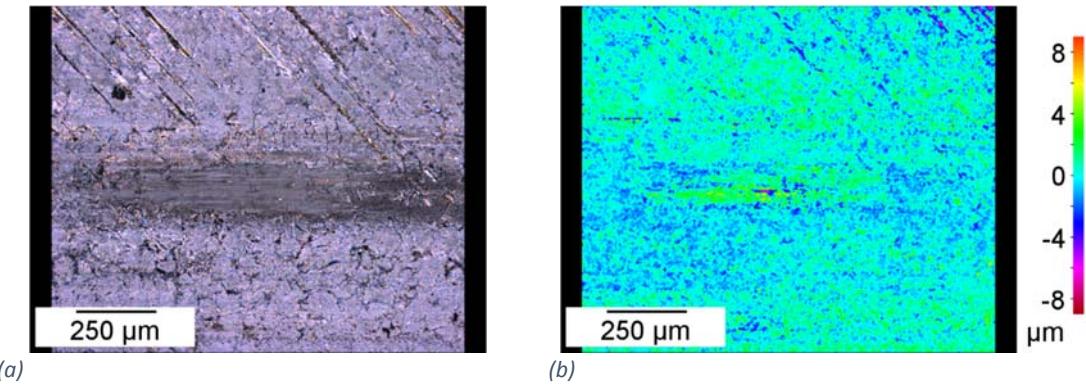
Figure 4.15: (a) Optical image and (b) colour map of scuffing initiation site on MS1.

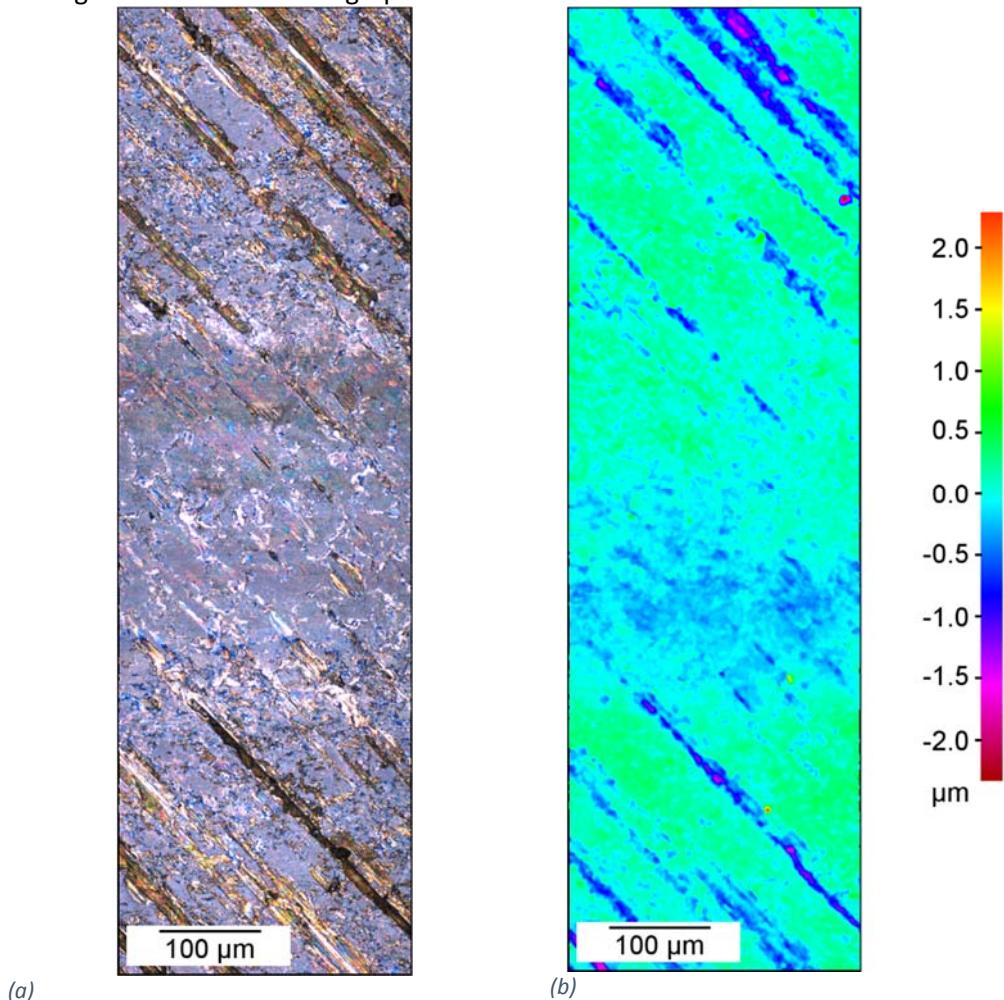
Figure 4.16: Optical images and colour maps of mildly scuffed flake cast iron surfaces MS2.

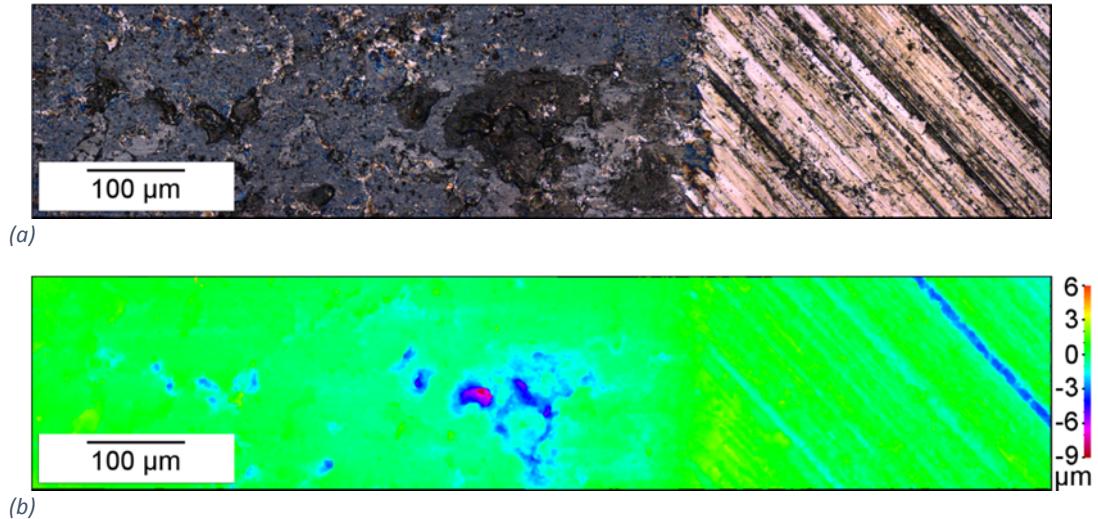
Figure 4.17: (a) Optical images and (b) colour maps of the onset of adhesive wear at the stroke reversal positions MS2.

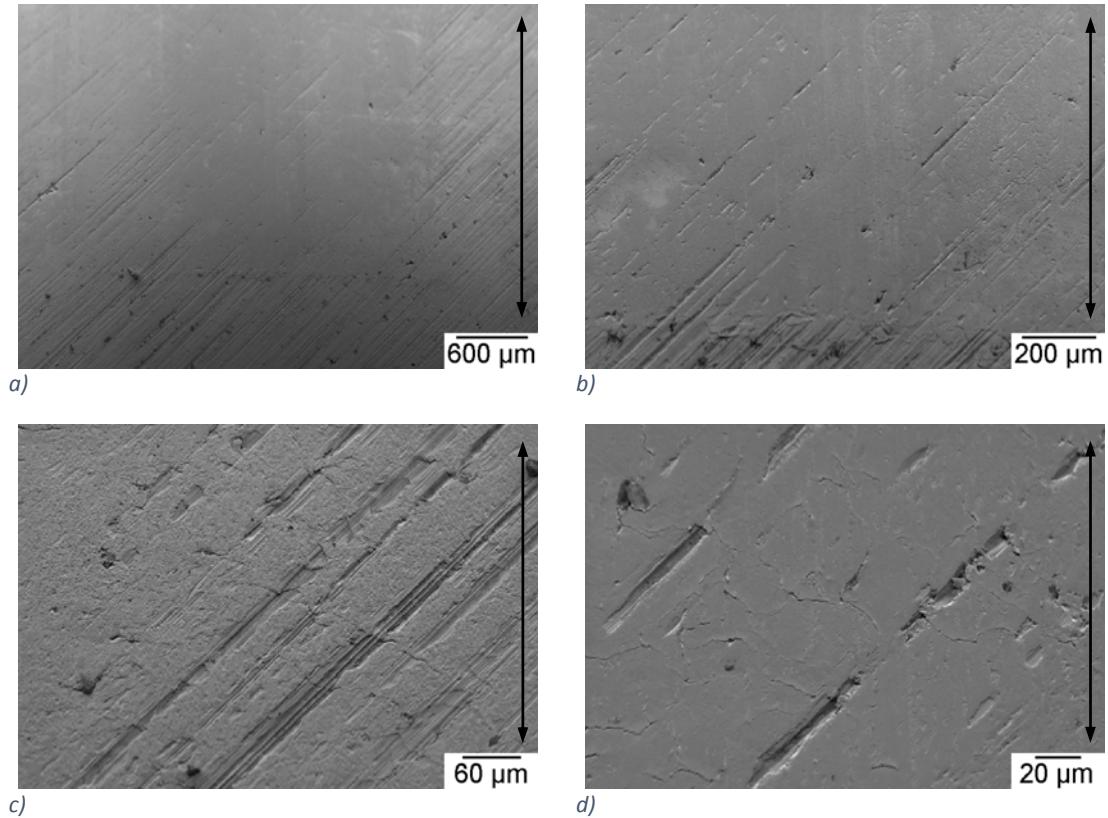
Figure 4.18: Secondary electron images from surface of the mild scuffed continuous load ramp test CLMS: a) Corner of the wear scar; b) Stroke reversal position; c) & d) Magnified regions near stroke reversal position.

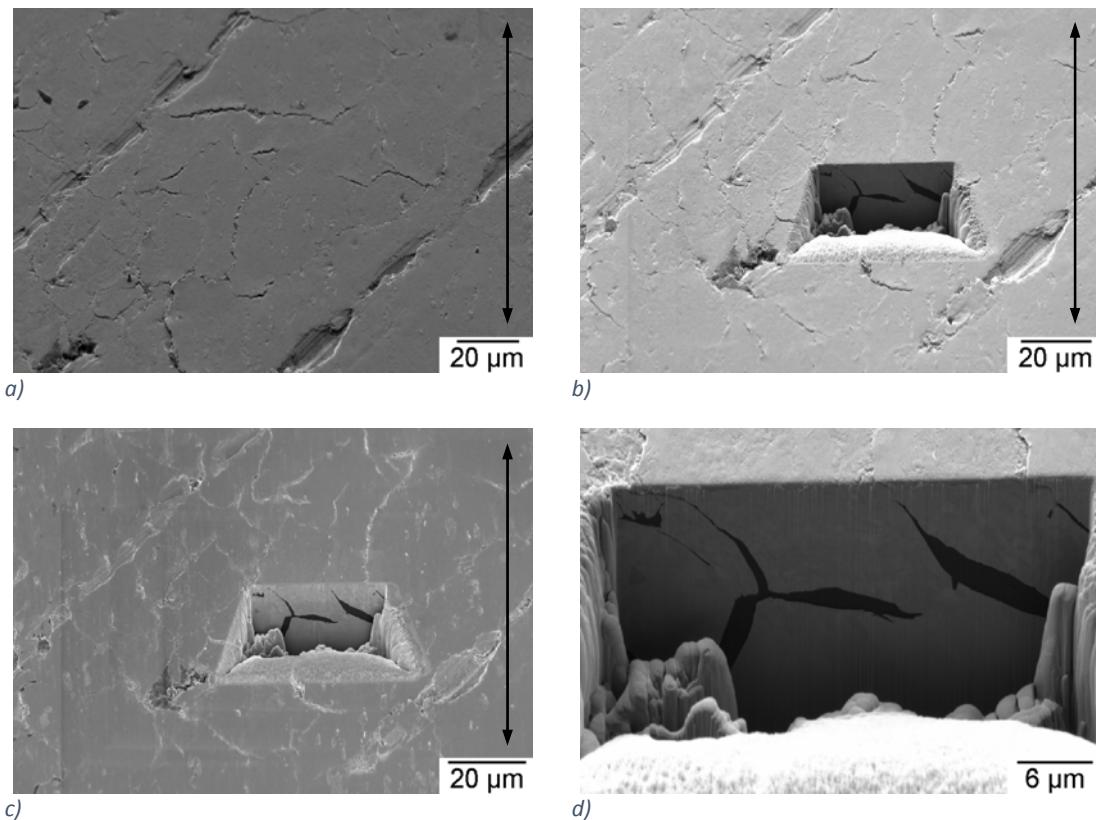
Figure 4.19: SEM images from test CLMS of a) FIB area of interest; b) Secondary and c) Backscattered images of cross-section; d) Higher magnification secondary image of cross-section.

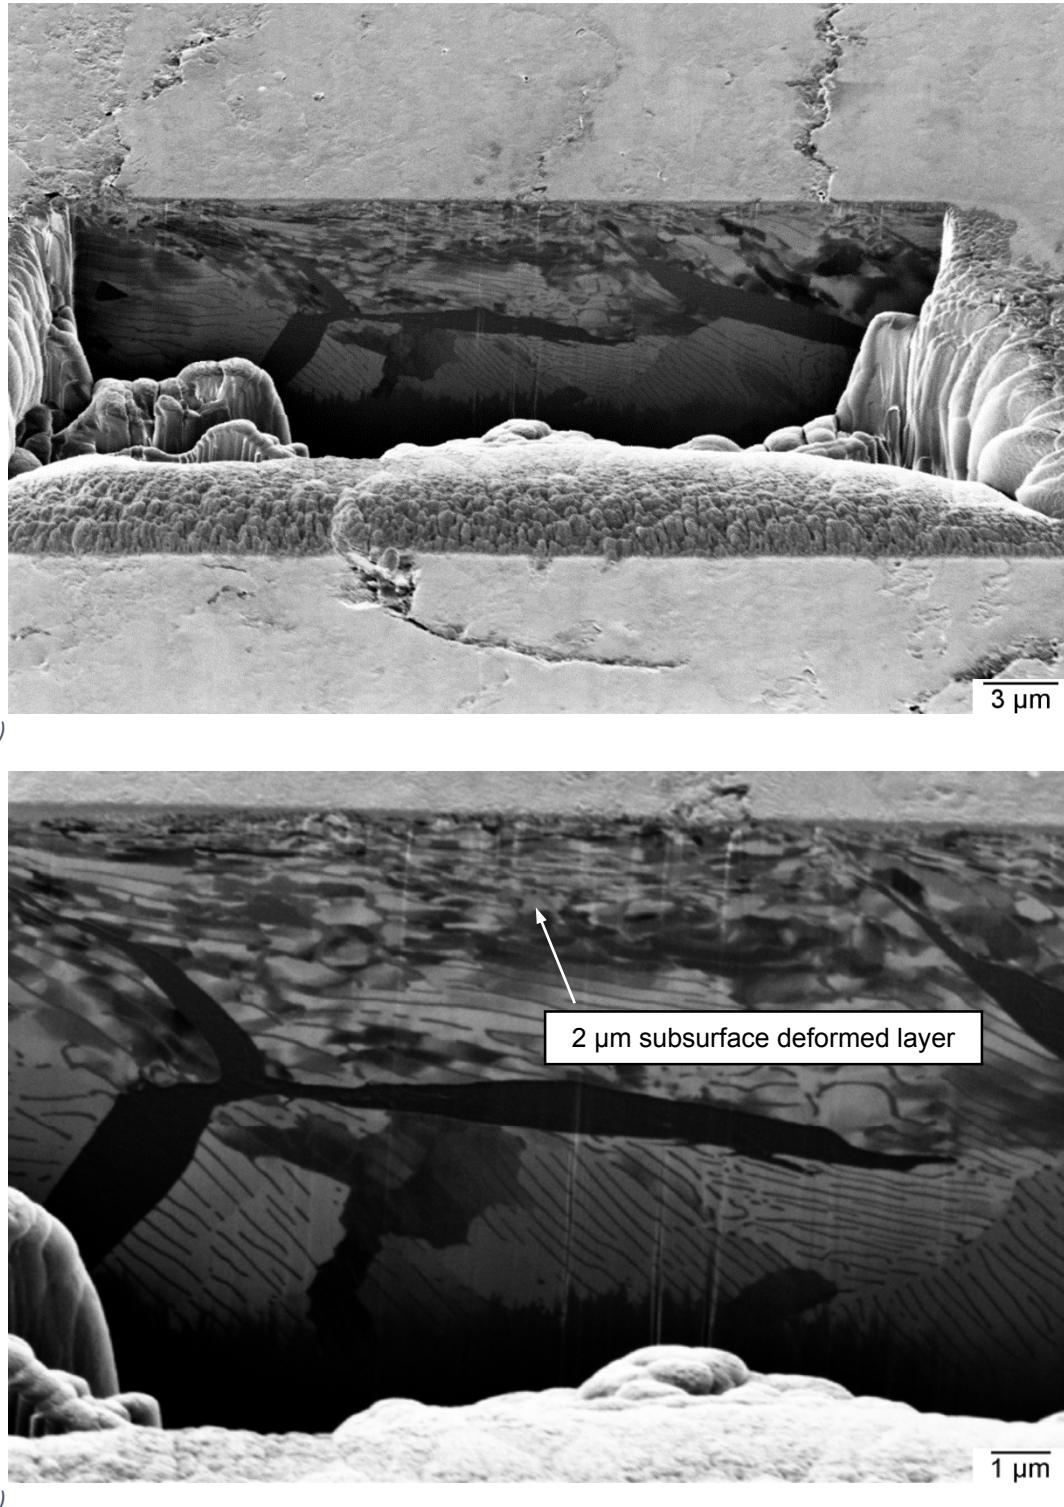
Figure 4.20: Secondary ion images of the mild scuffed flake graphite cast iron surface from the continuous load test CLMS, a) cracks at the interface between the lamellar graphite flakes and the free surface, b) strain induced subsurface microstructurally deformed layer and pearlitic matrix.

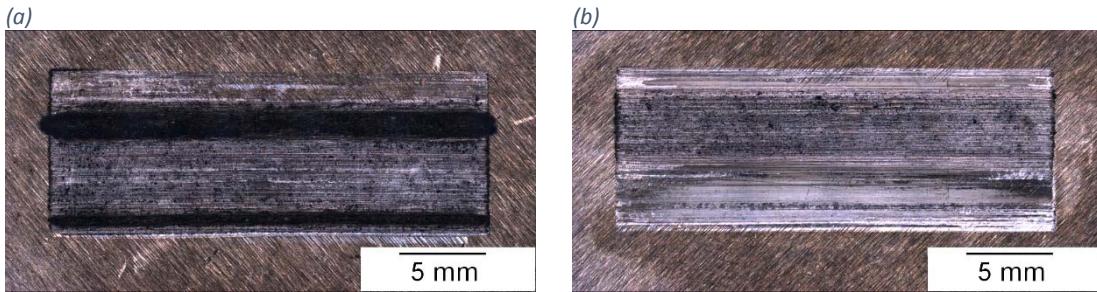
Figure 4.21: Optical images of severely scuffed flake cast iron surfaces (a) S1 and (b) S2.

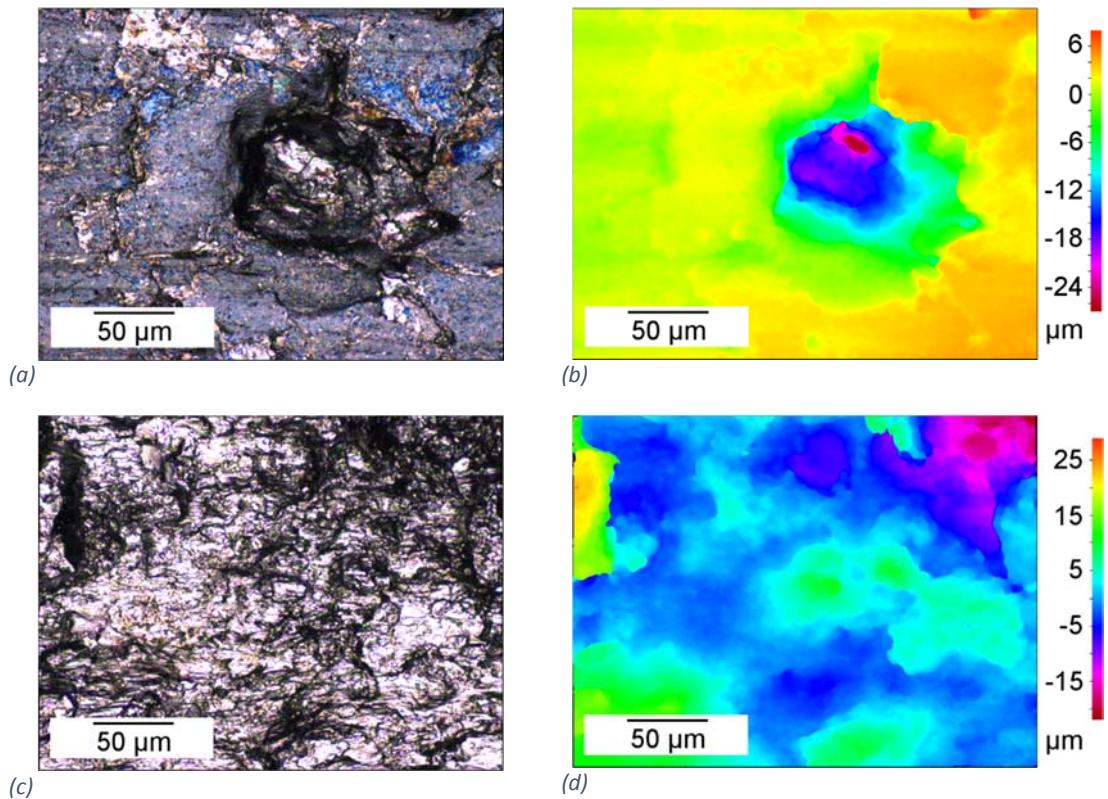
Figure 4.22: Optical images and colour maps of severe adhesive wear and gross material removal during severe scuffing S1.

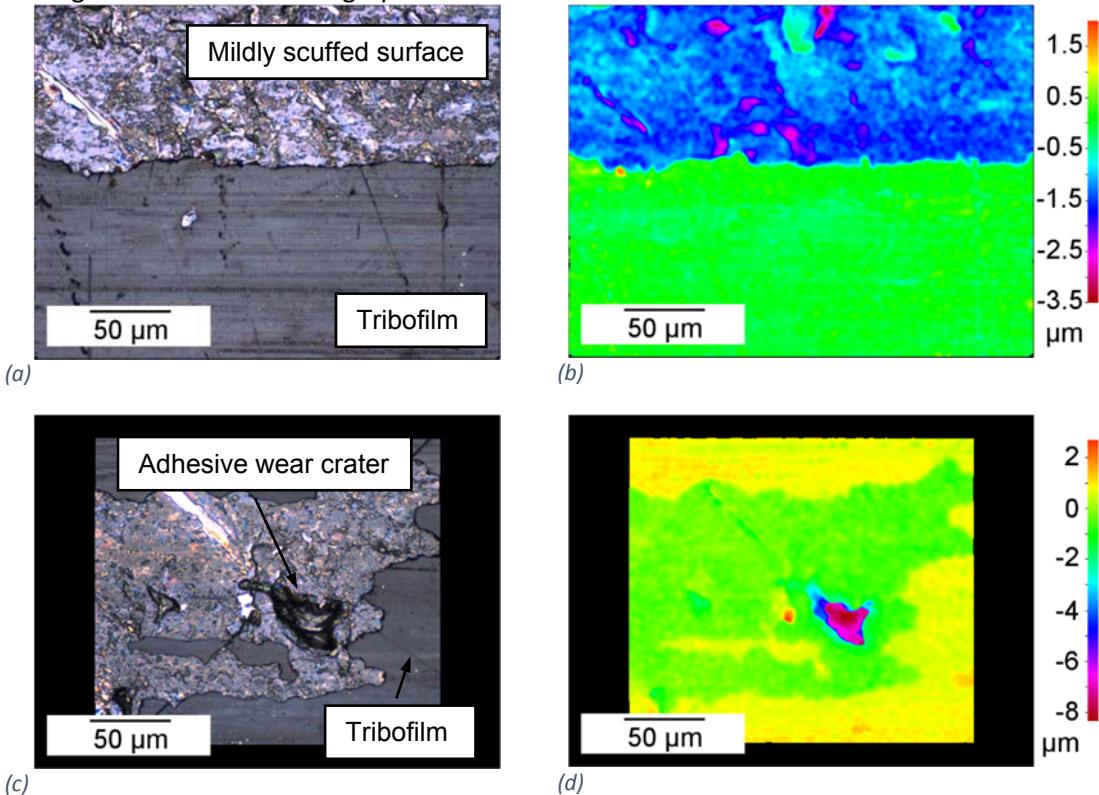
Figure 4.23: Optical images and colour maps after adhesive wear had spread across the stroke S2.

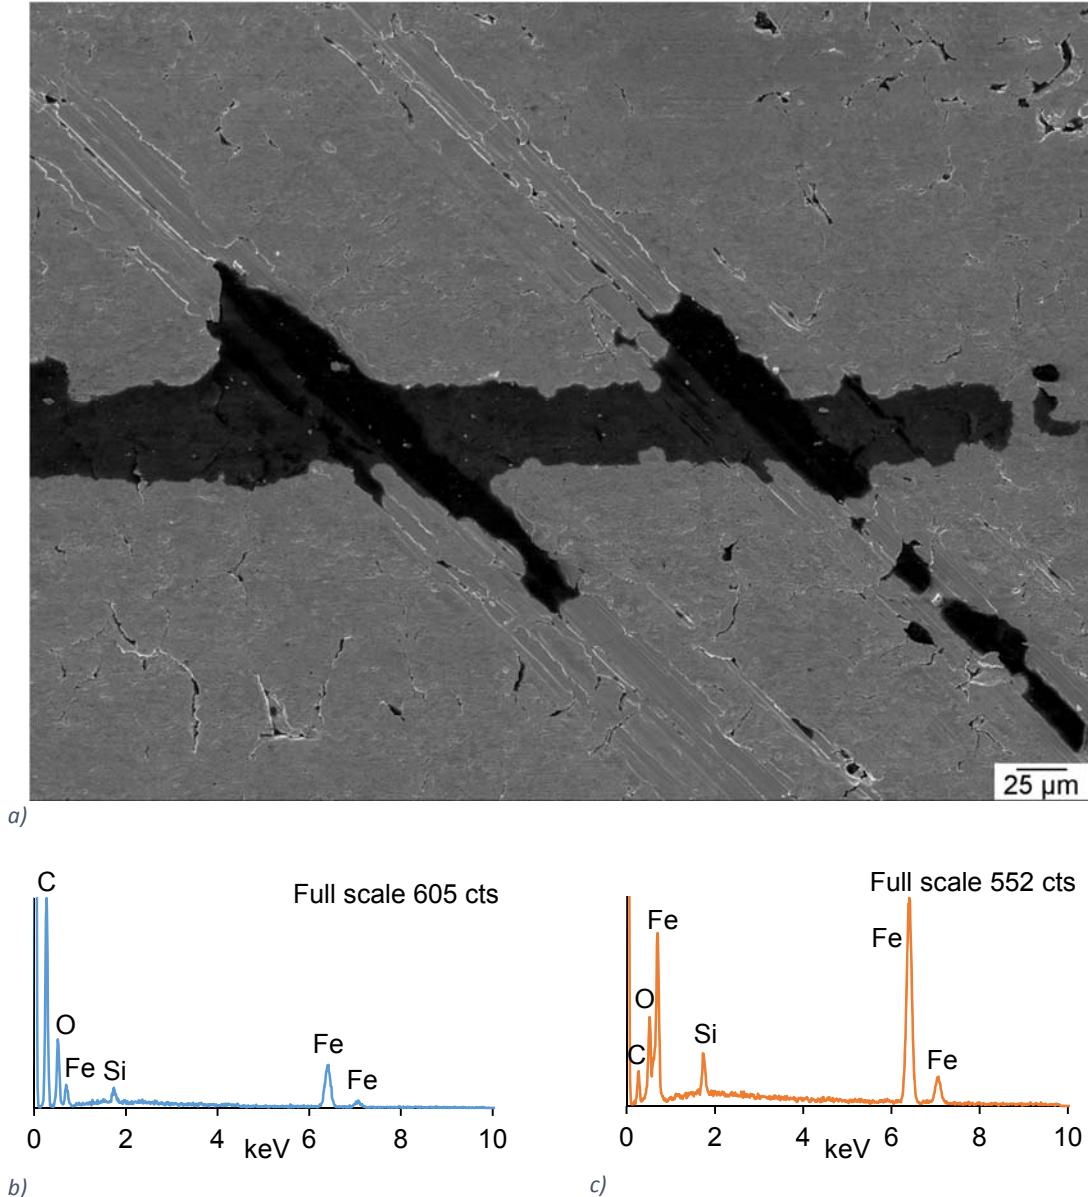
Figure 4.25: Secondary electron image (a) of surface film from severe scuffed Flake S2. EDX spectra of dark film (b) and mild scuffed area (c).

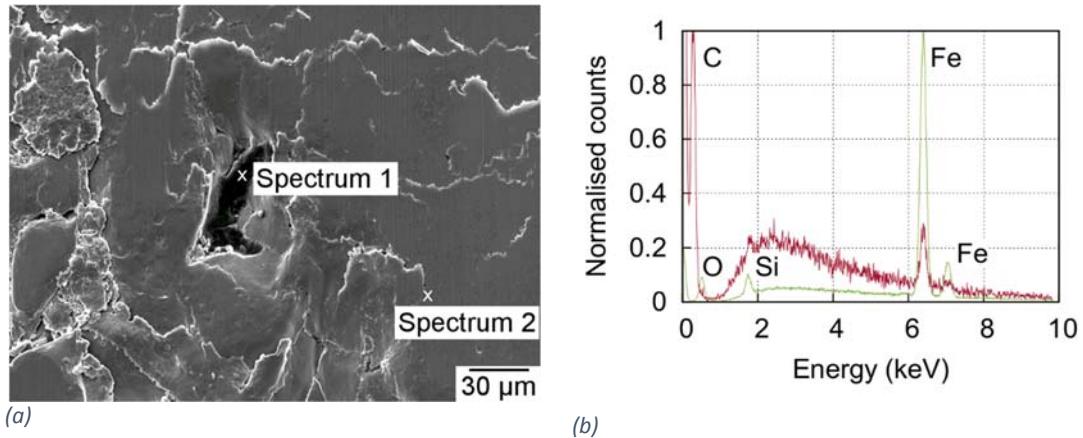
Figure 4.26: (a) Secondary electron image and (b) EDX spectra of a surface crater present on the severely scuffed flake cast iron surface from test CLS.

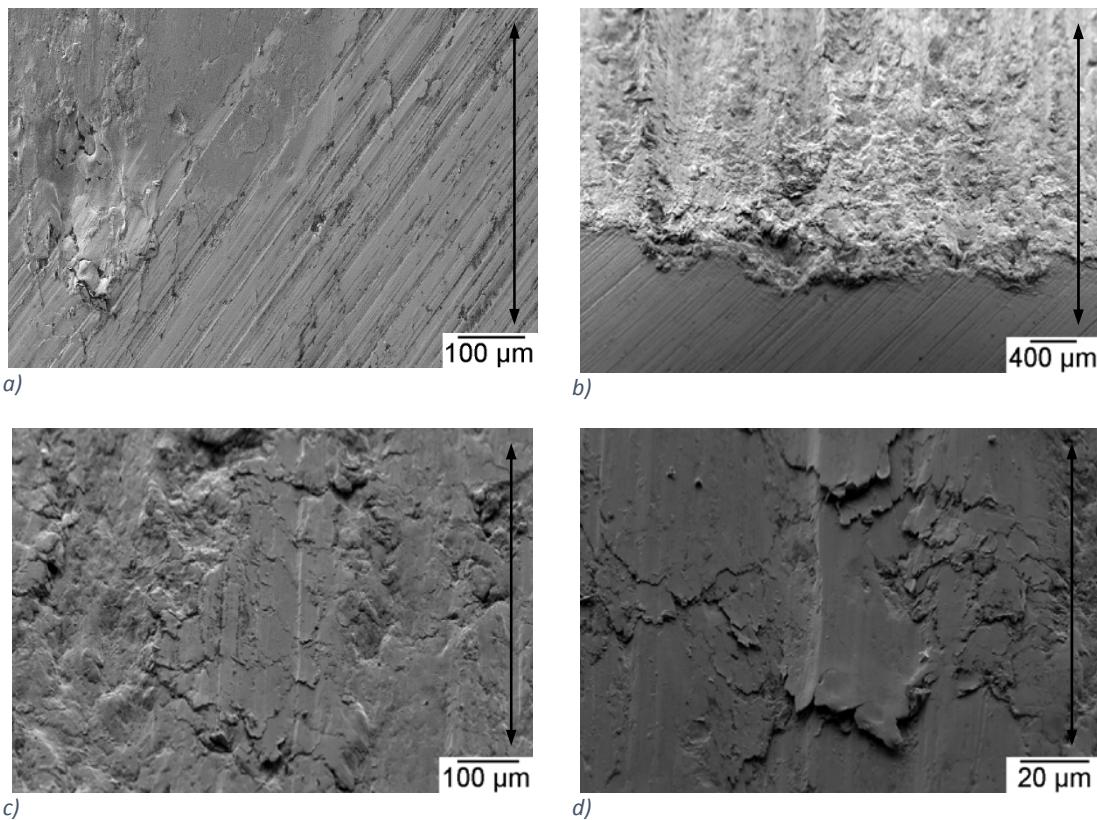
Figure 4.27: Scanning electron microscope images of the discrete load ramp severe scuffed flake cast iron surfaces from test DLS (a) Interface between wear scar and ground surface; (b) Tilted image of stroke reversal position; (c) & (d) Magnified tilted images of wear scar near stroke reversal position.

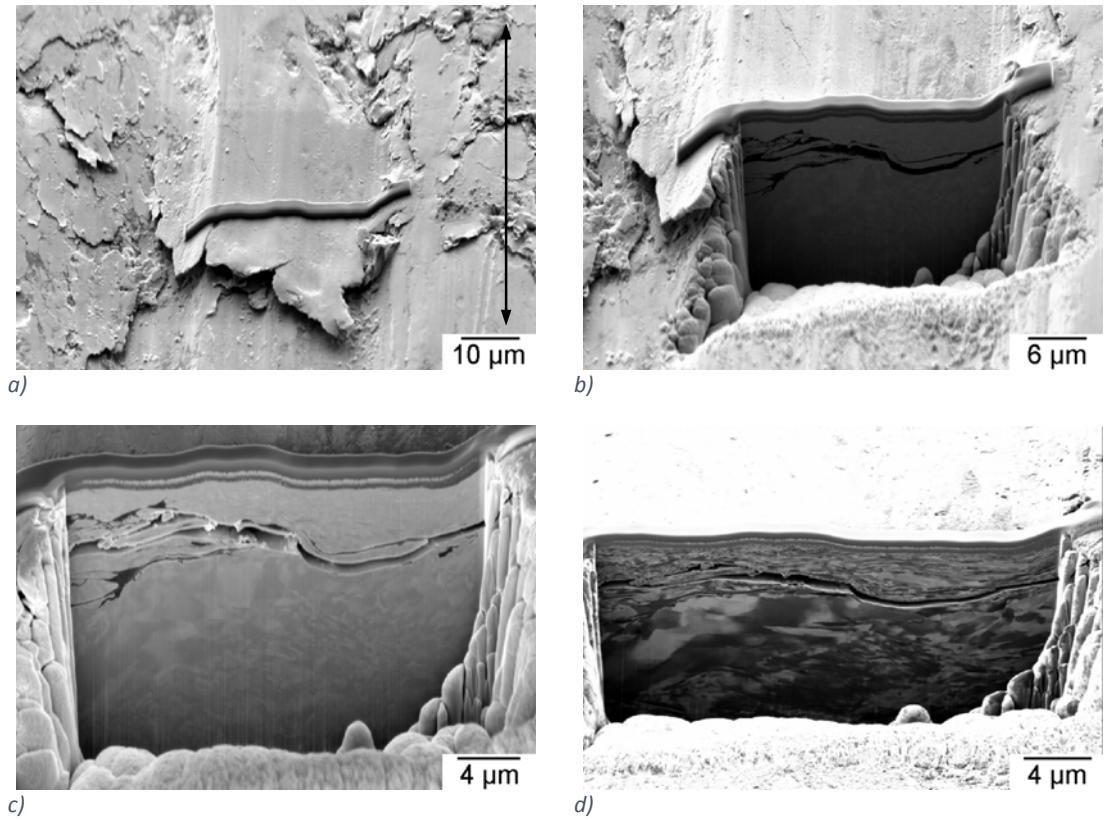
Figure 4.28: Secondary electron (a & b) of the FIB area of interest and cross section from the severely scuffed surface subject to discrete load ramp from test DLS. c) Backscattered electron image and d) Secondary ion image of the cross section.

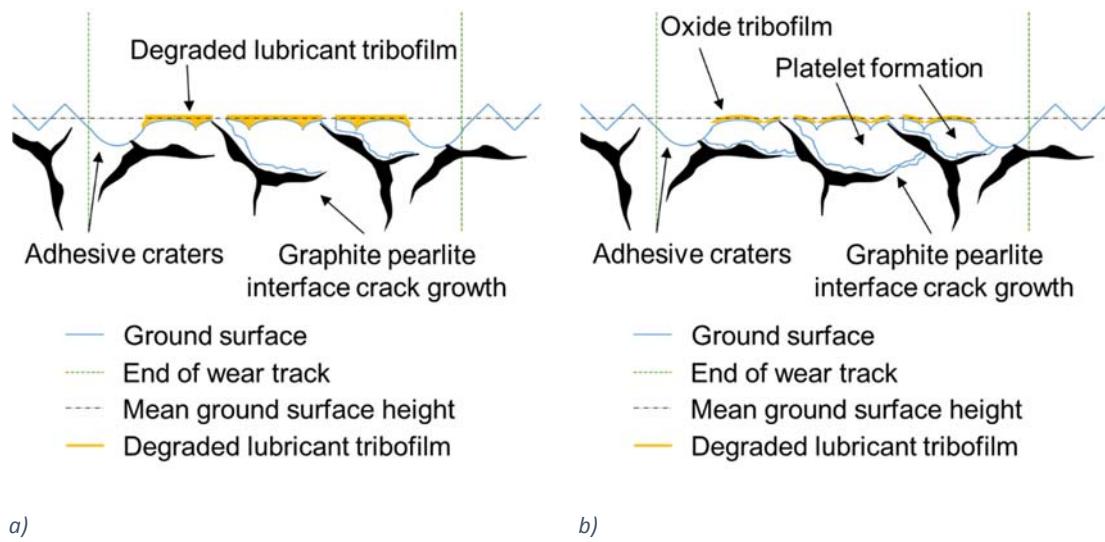
Figure 4.32: Flake cast iron mild to severe scuffing transition schematics, a) lubricant degradation and b) oxide tribofilm formation.
