**Development of Detection Techniques for Investigating Scuffing Mechanisms of
Automotive Diesel Cast Irons**

Thesis for the degree of Doctor of Philosophy

July 2017

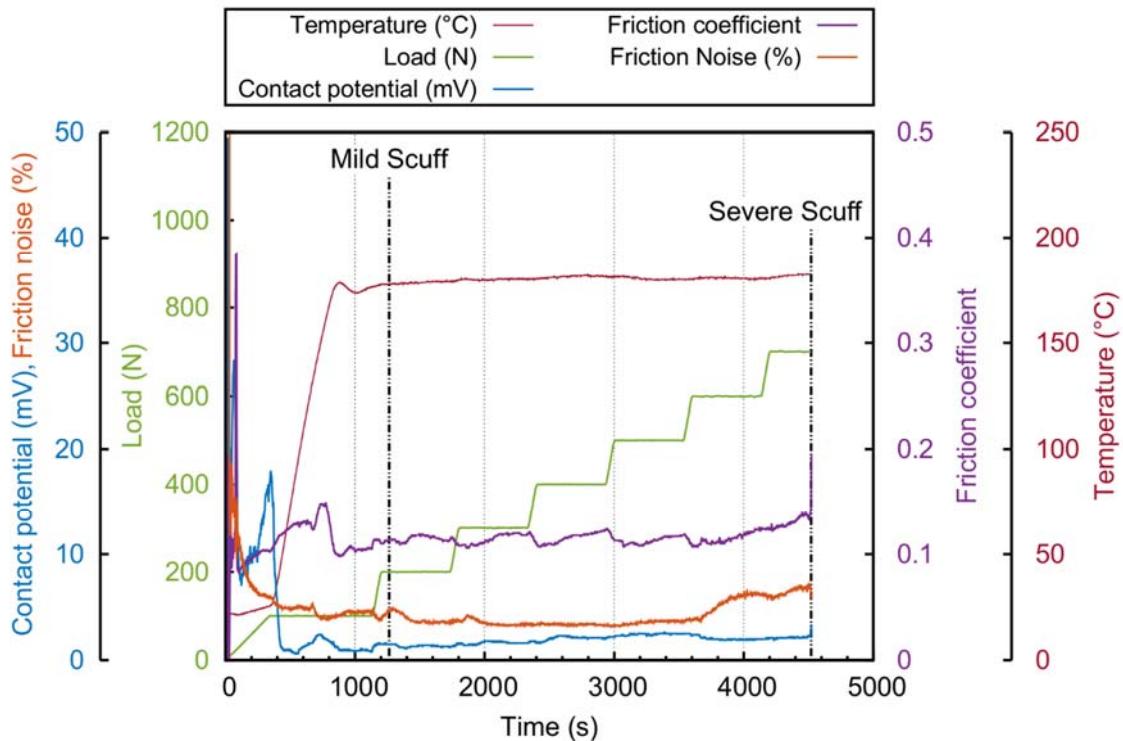
Figure 5.8: Average friction, normal load, temperature and contact potential plotted against time NS3.

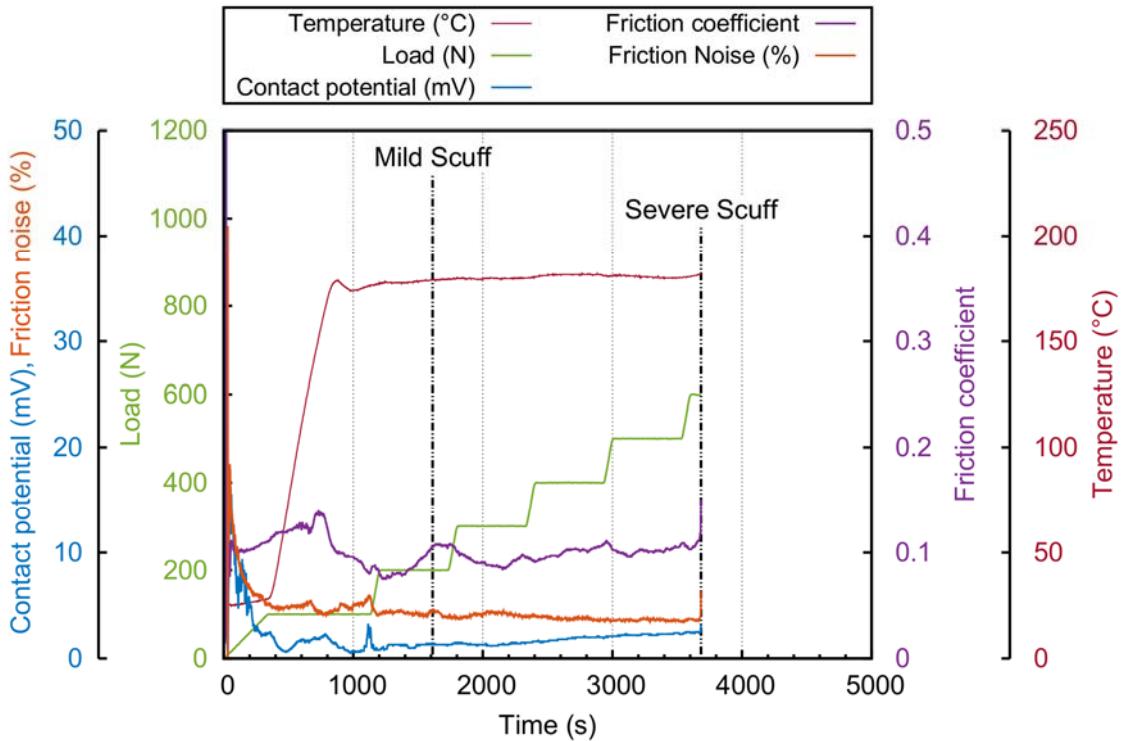
Figure 5.9: Average friction, normal load, temperature and contact potential plotted against time NS4.

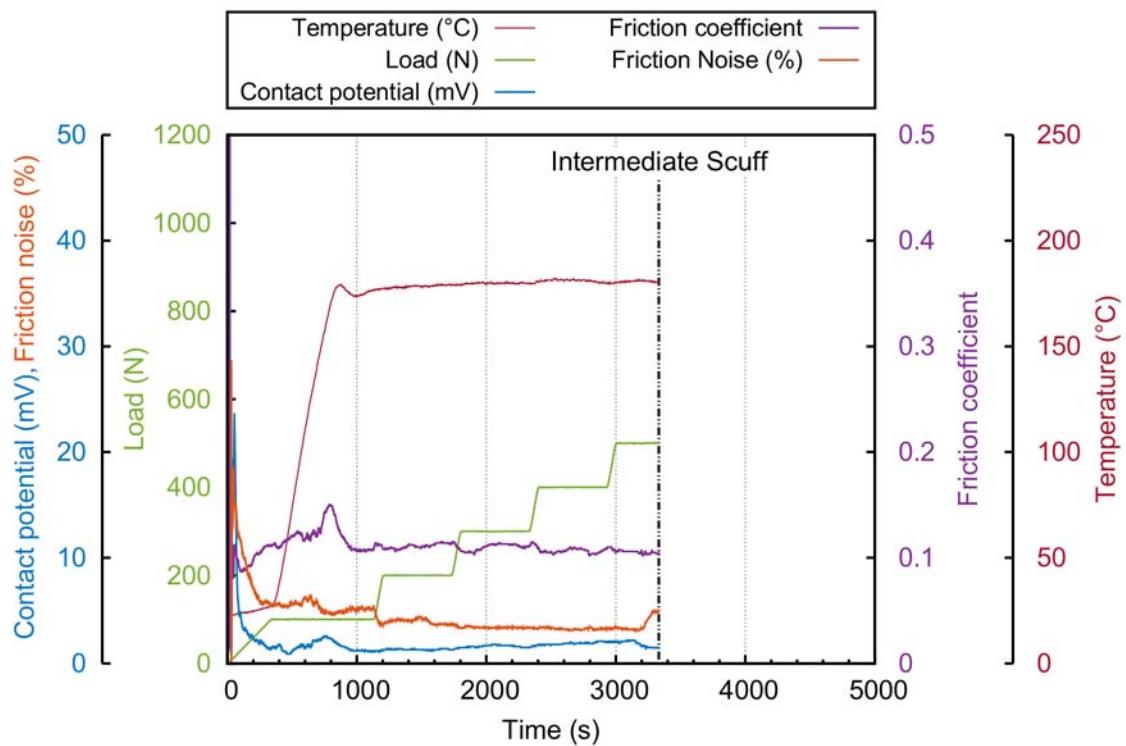
Figure 5.12: Average friction, normal load, temperature and contact potential plotted against time NIS1.

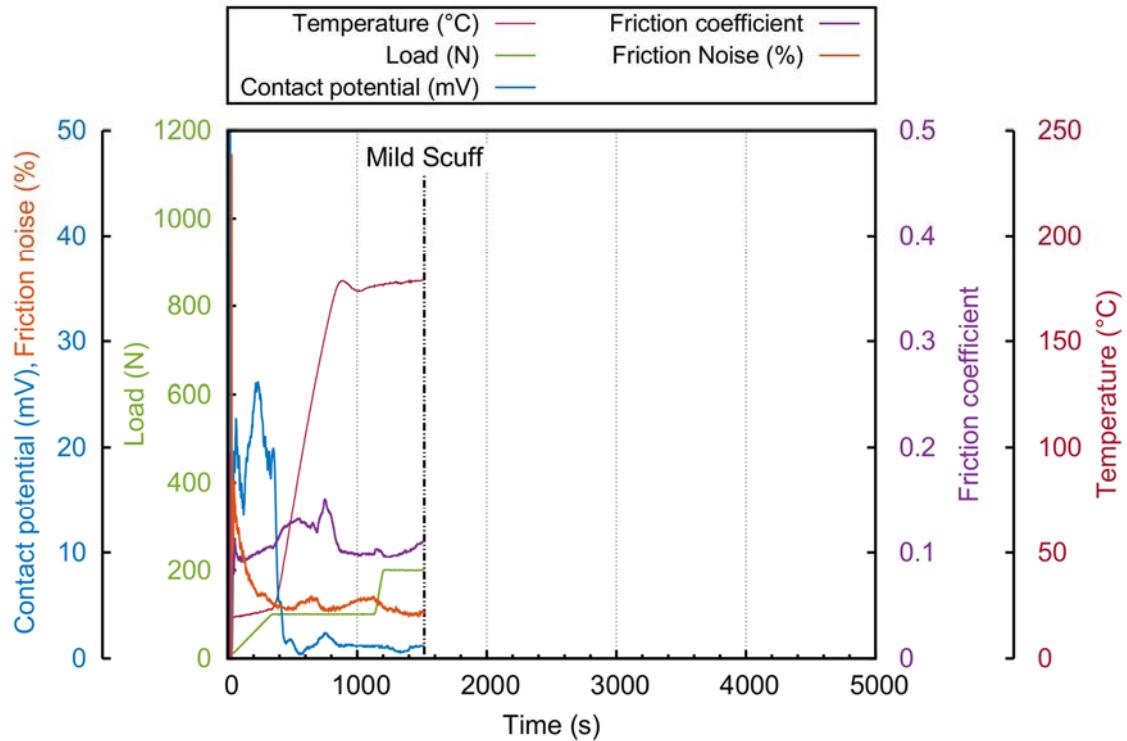
Figure 5.15: Average friction, normal load, temperature and contact potential plotted against time NMS2.

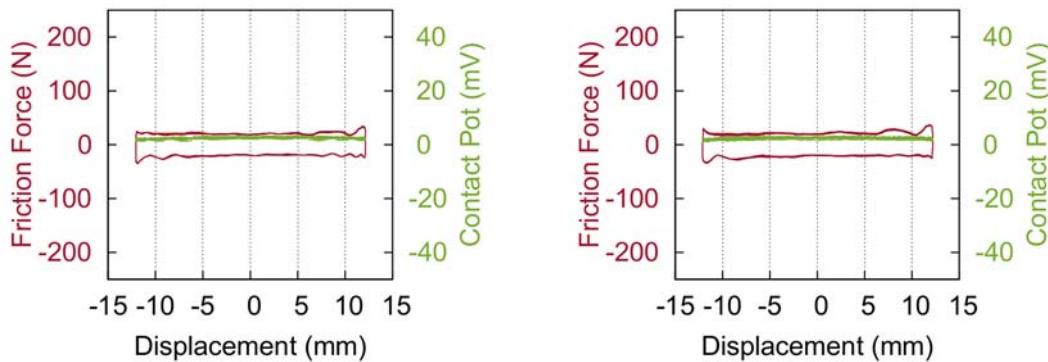
Figure 5.16: Friction force and contact potential data during mild scuffing NMS1.

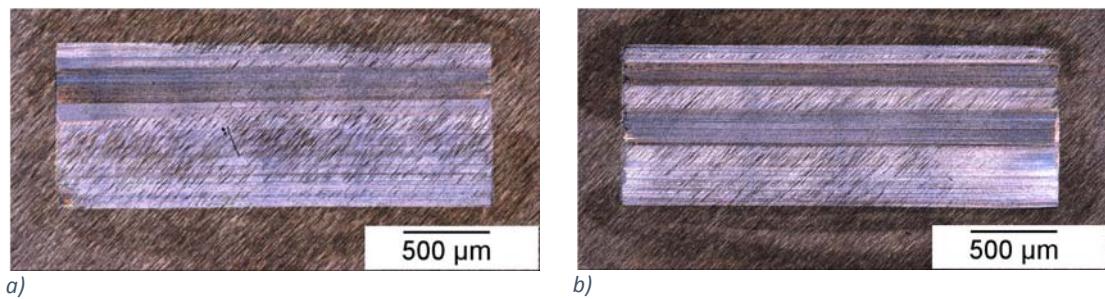
Figure 5.18 Optical images of mildly scuffed nodular cast iron surfaces (a) NMS1 and (b) NMS2.

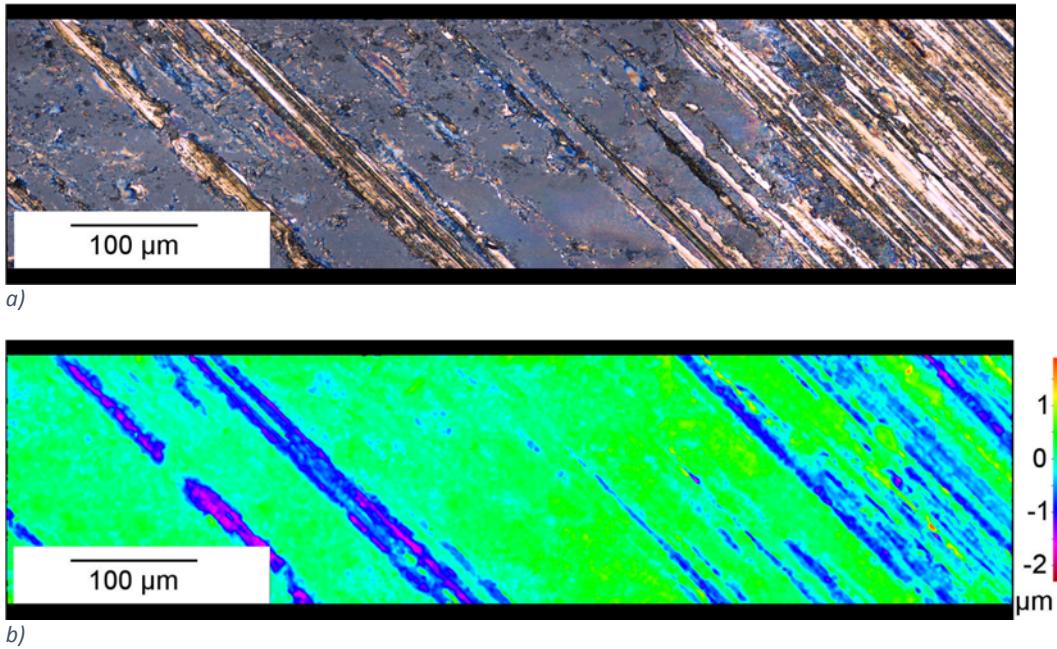
Figure 5.19: Optical image of the mildly scuffed nodular cast iron from test NMS2, showing first category plastic deformation of the surface a) and 3D colour map b).

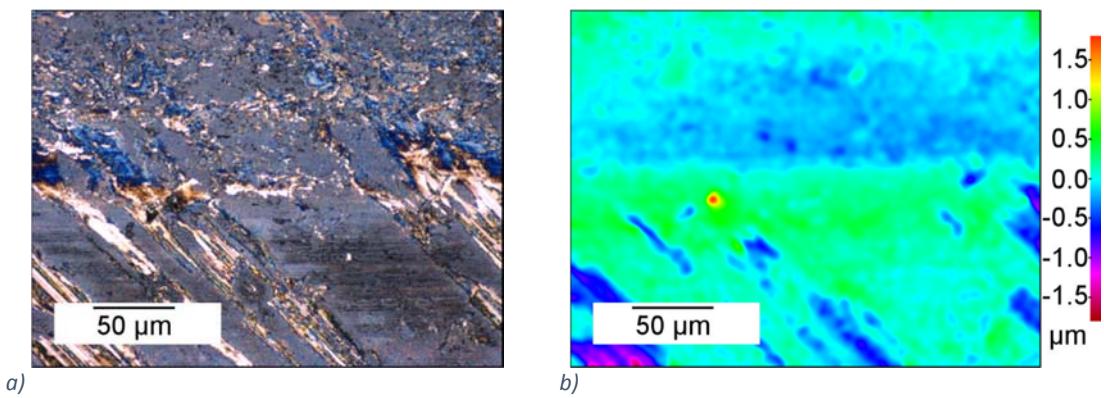
Figure 5.20: Optical image of the mildly scuffed nodular cast iron from test NMS2, showing the transition between first and second category wear a) and 3D colour map b).

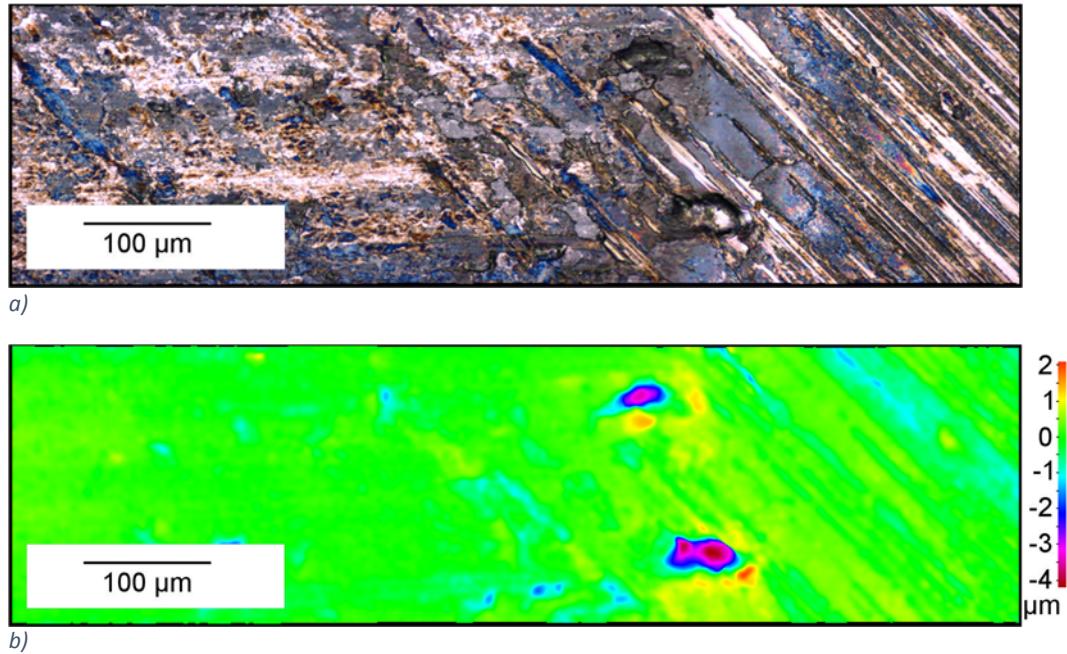
Figure 5.21: Optical image of the mildly scuffed nodular cast iron from test NMS2, surface showing adhesive wear craters and plastically deformed ferrite a) and 3D wear map b).

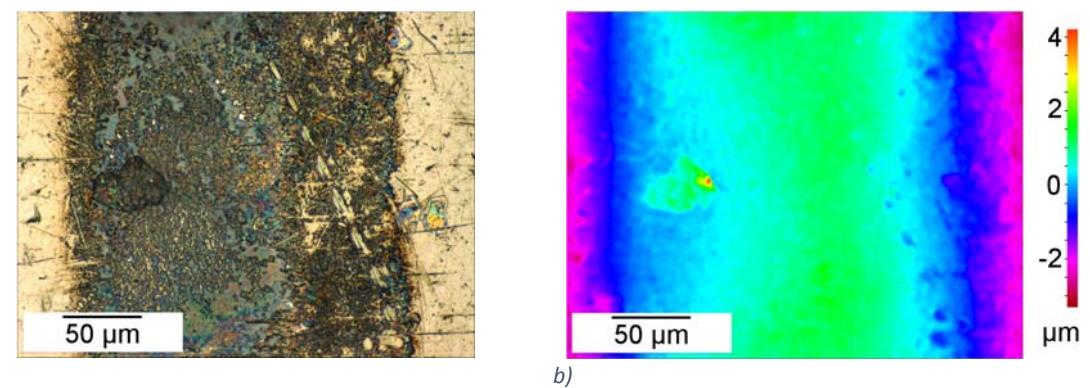
Figure 5.22: Optical image of the 52100 roller bearing element from test NMS1, showing a cast iron transfer film and an adhesive wear particle a) and 3D colour map b).

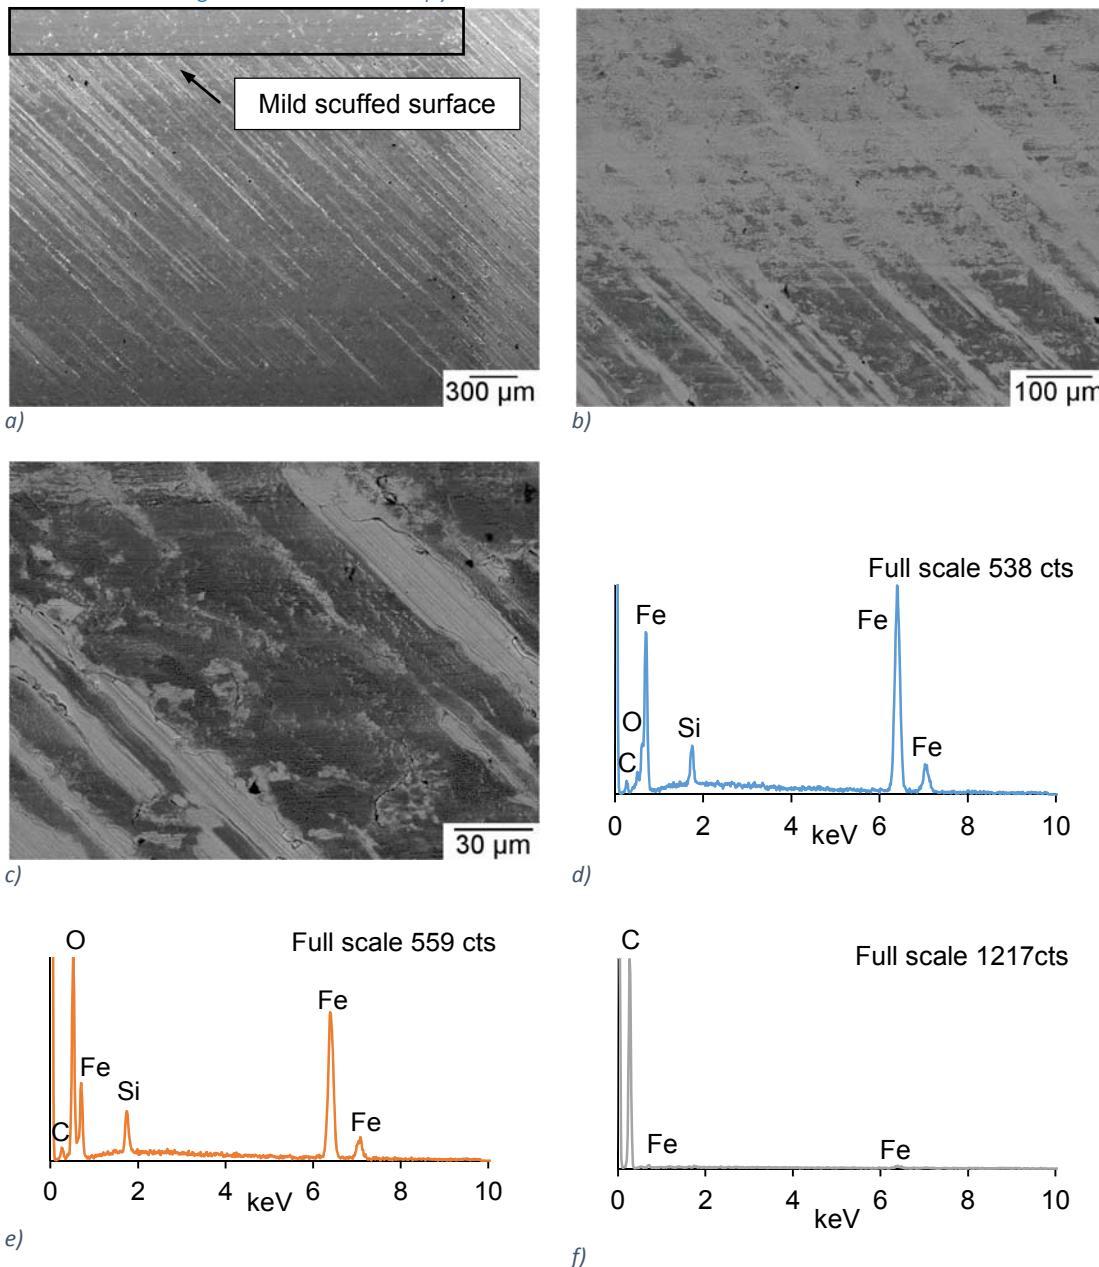
Figure 5.23. Secondary electron (a) and backscattered (b & c) of the wear scar from mild nodular test NMS2. EDX spectra from (c) of light grey grinding mark (d), the dark grey surface film (e) and the lower middle black particle (f).

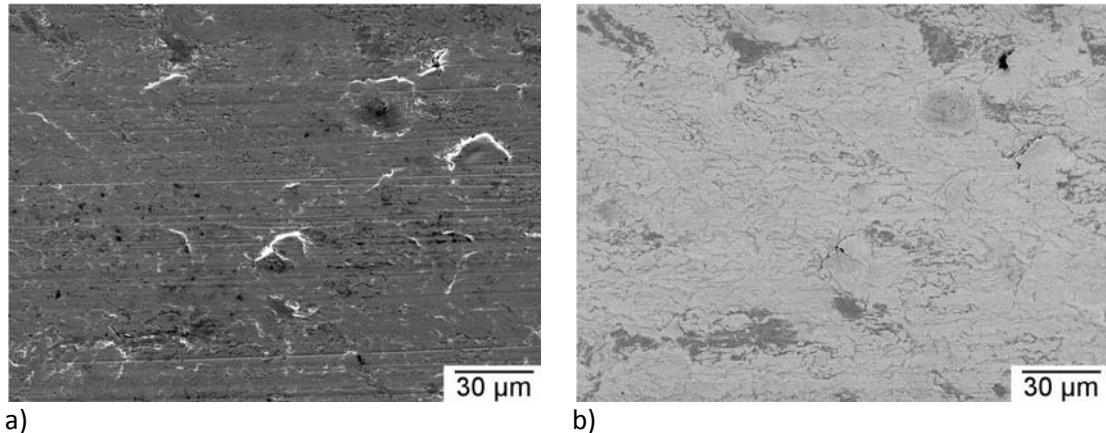
Figure 5.24. Secondary (a) and backscattered (b) electron images from the mild scuffed region of the nodular test NMS2.

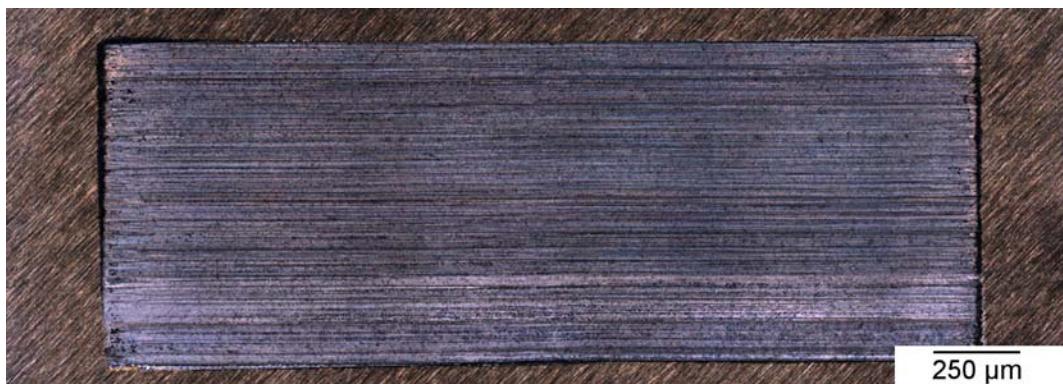
Figure 5.25: Optical image of intermediate scuffed nodular cast iron surfaces NIS1.

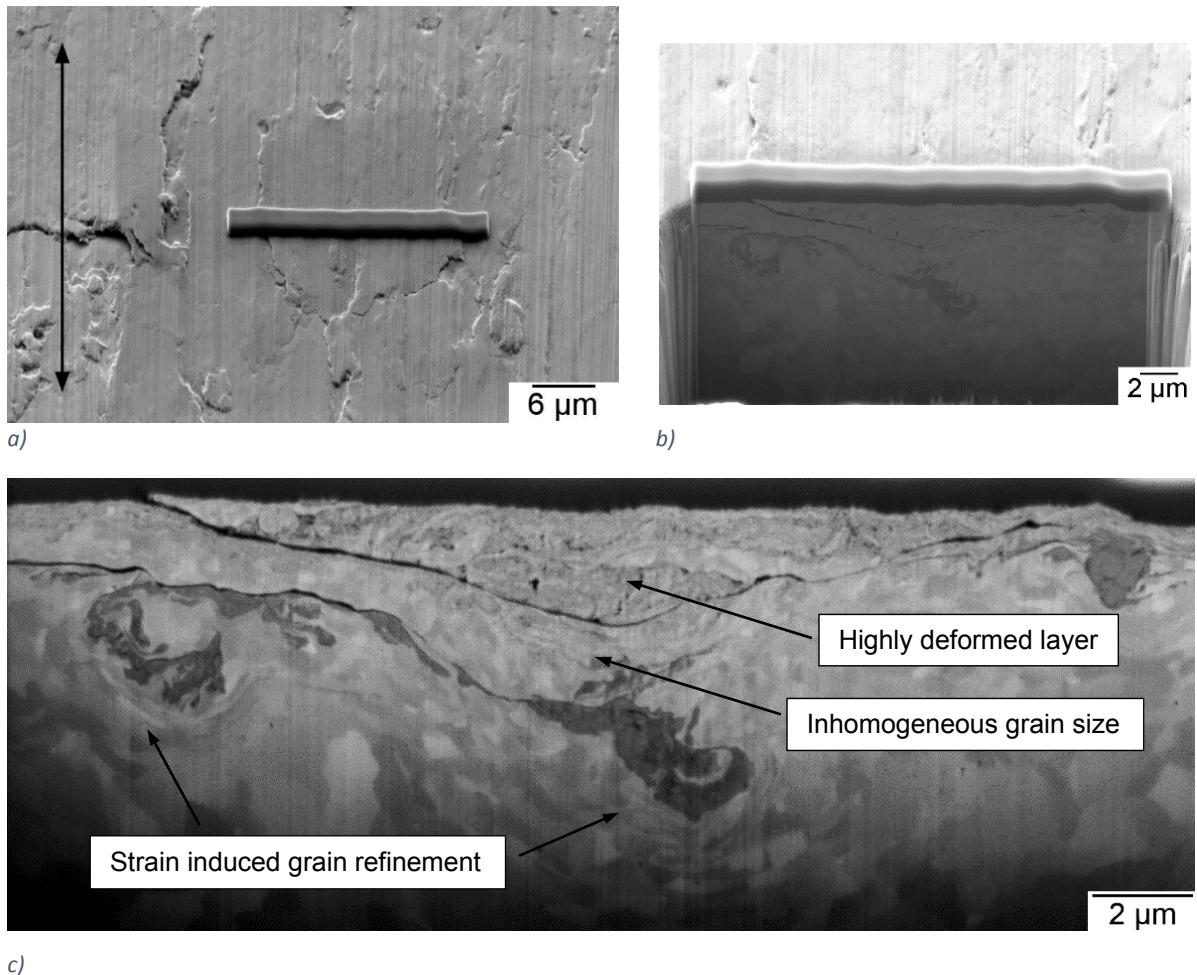
Figure 5.32: Secondary electron image of (a) the area of interest for transverse cross-section on transition-scuffed surface from test NTS1. Secondary electron (b) and ion (c) images of the sub-surface microstructure.

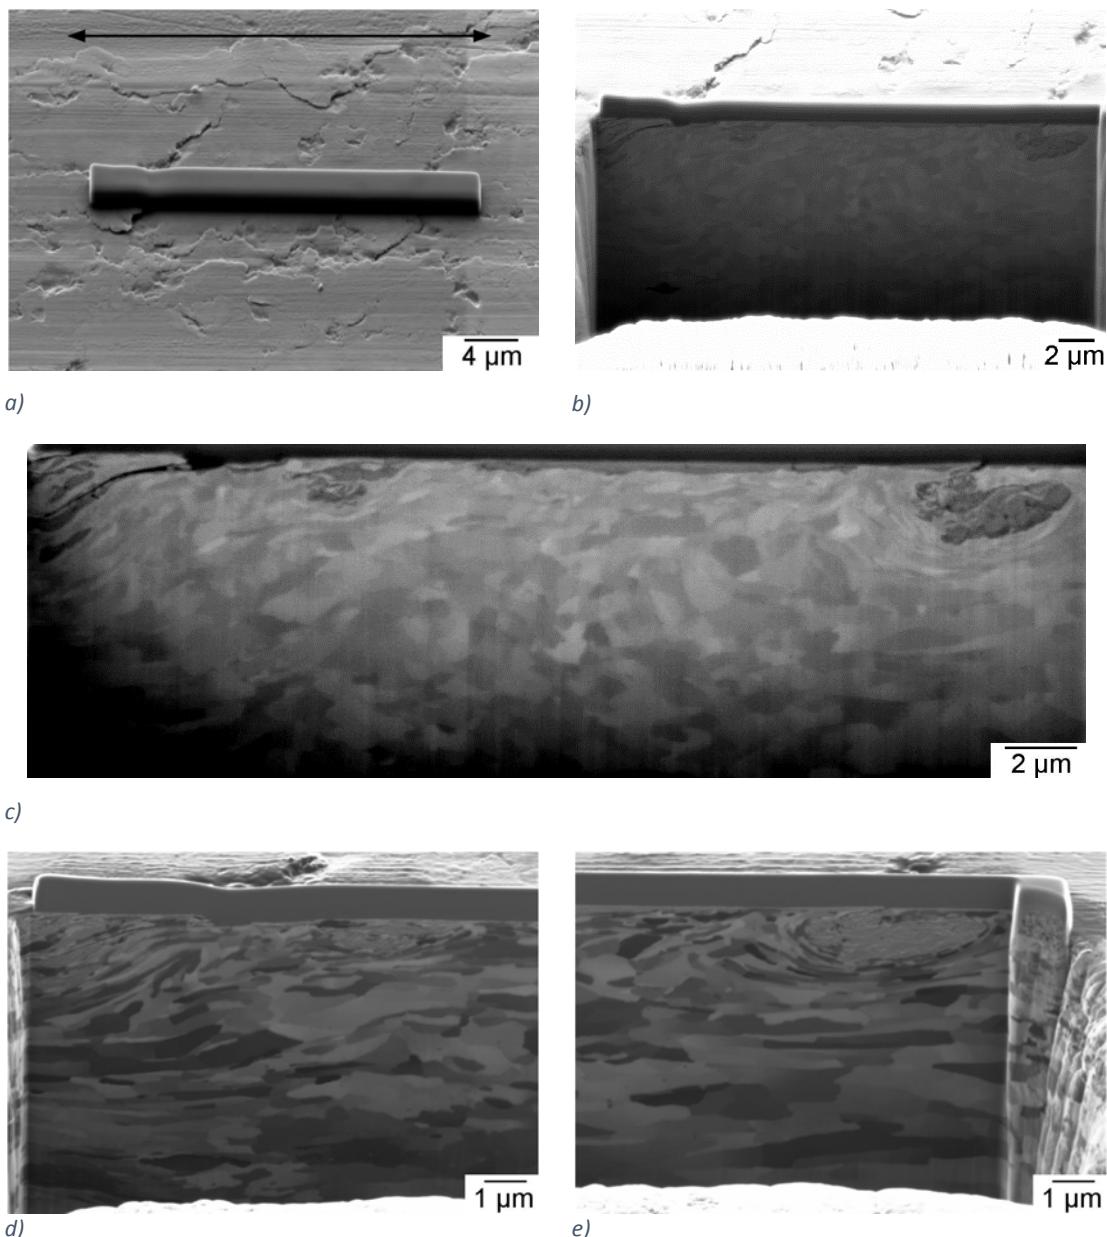
Figure 5.33: Secondary electron image of (a) the area of interest on transition-scuffed surface for longitudinal cross-section from NIS1. Secondary electron (b) and ion (c) images of the sub-surface microstructure. Higher magnification secondary ion images of the left and right cross-section boundaries are shown in d) and e), respectively.

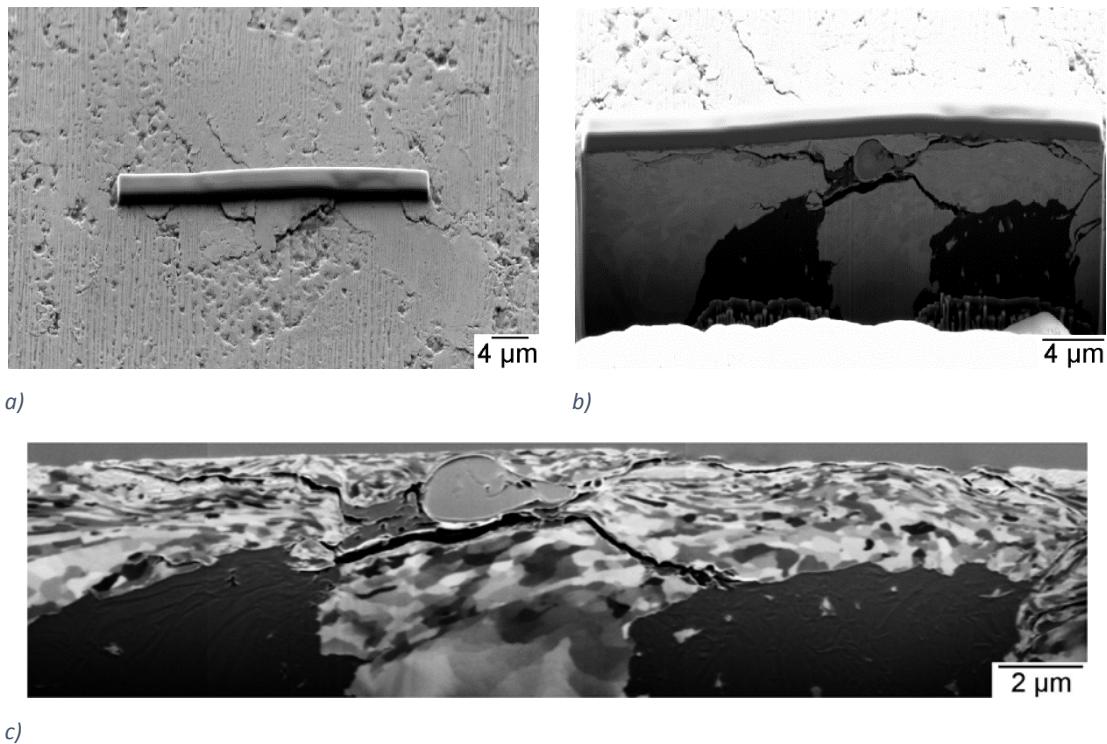
Figure 5.34: Secondary electron images of the FIB cross section area of interest (a) from the surface of NIS2 and the sub-surface cross section (b). Secondary ion image (c) shows deformed microstructure.

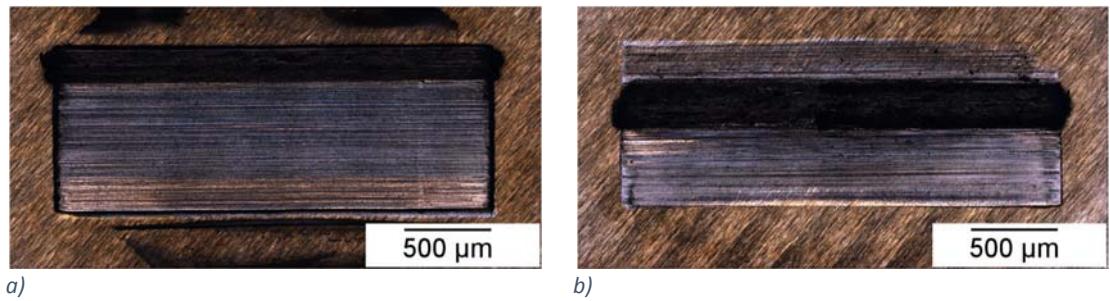
Figure 5.37: Optical images of severely scuffed nodular cast iron surfaces (a) NS3 and (b) NS4

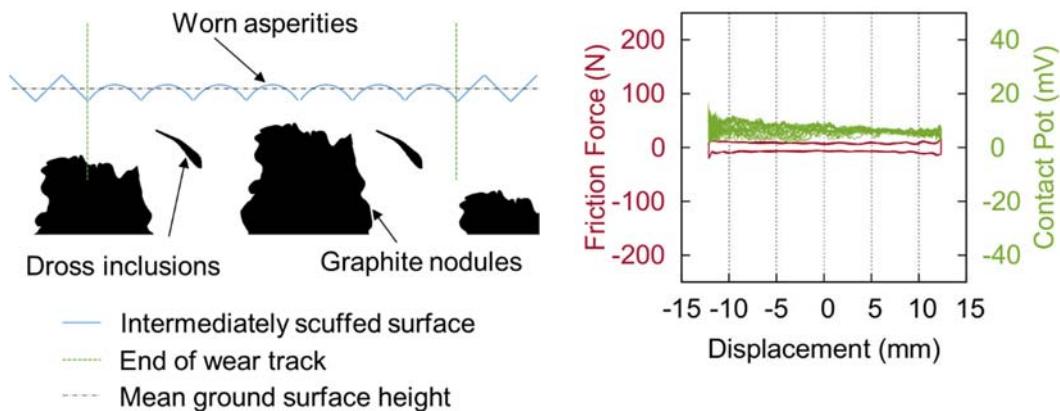
Figure 5.45: Nodular cast iron run-in surface schematic and associated high speed data.

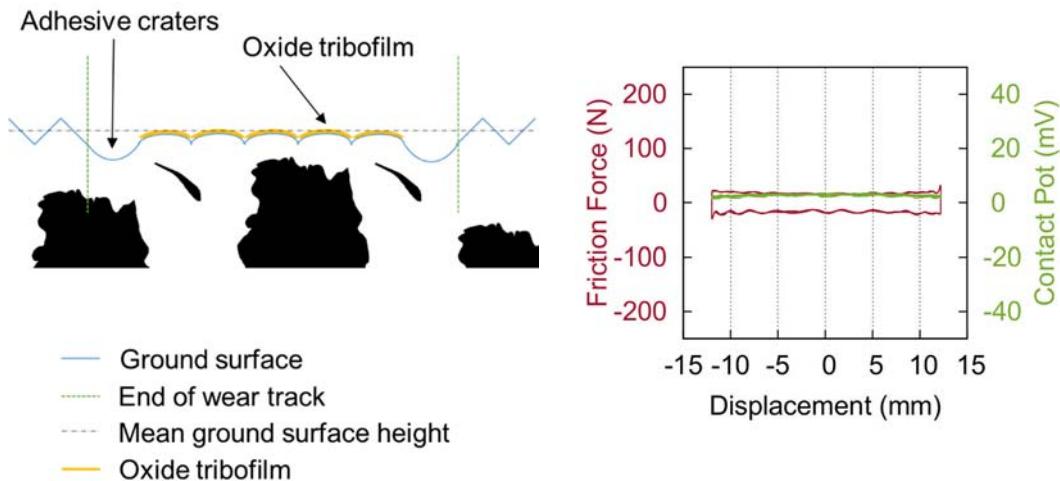
Figure 5.46: Nodular cast iron mildly scuffed surface schematic and associated high speed data.

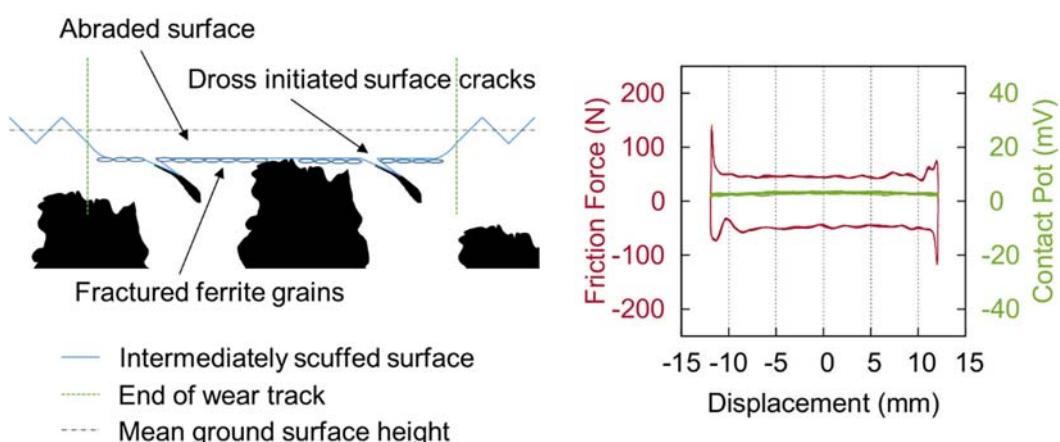
Figure 5.47: Nodular cast iron intermediately scuffed surface schematic and associated high speed data.

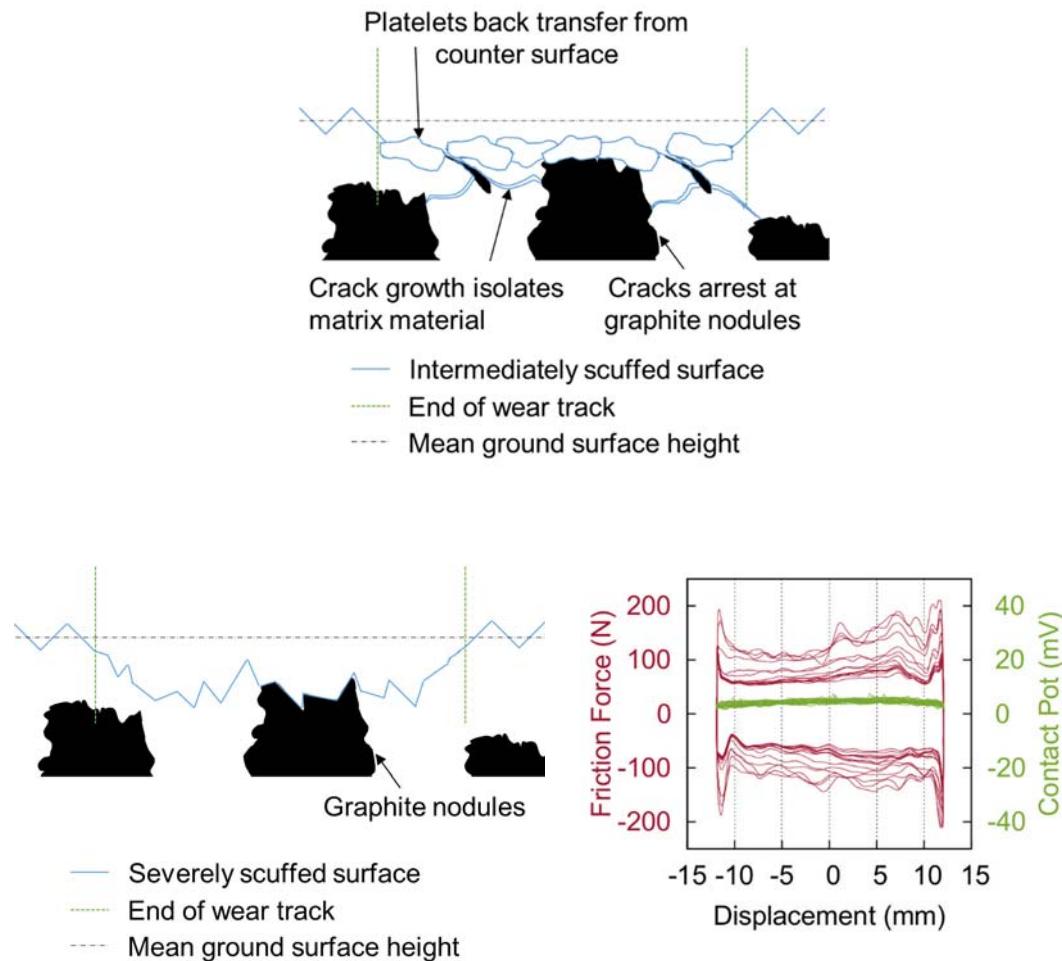
Figure 5.48: Nodular cast iron severely scuffed surface schematic and associated high speed data.

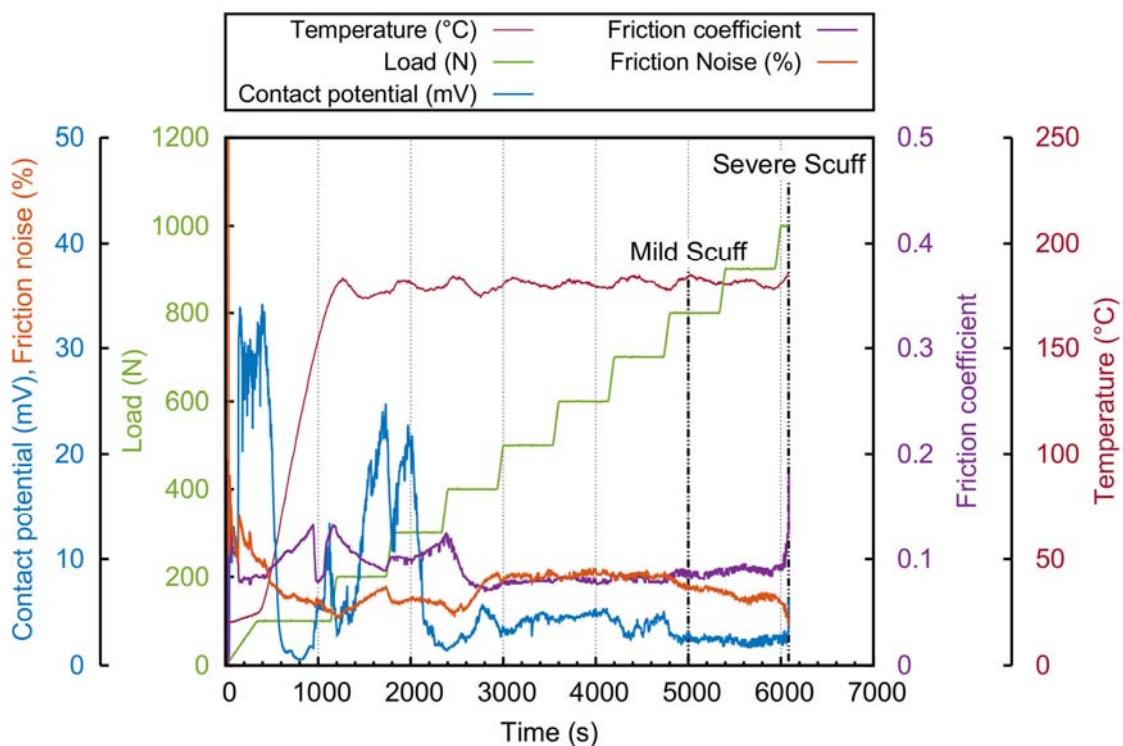
Figure 6.2: Average friction, normal load, temperature and contact potential plotted against time RLS1.

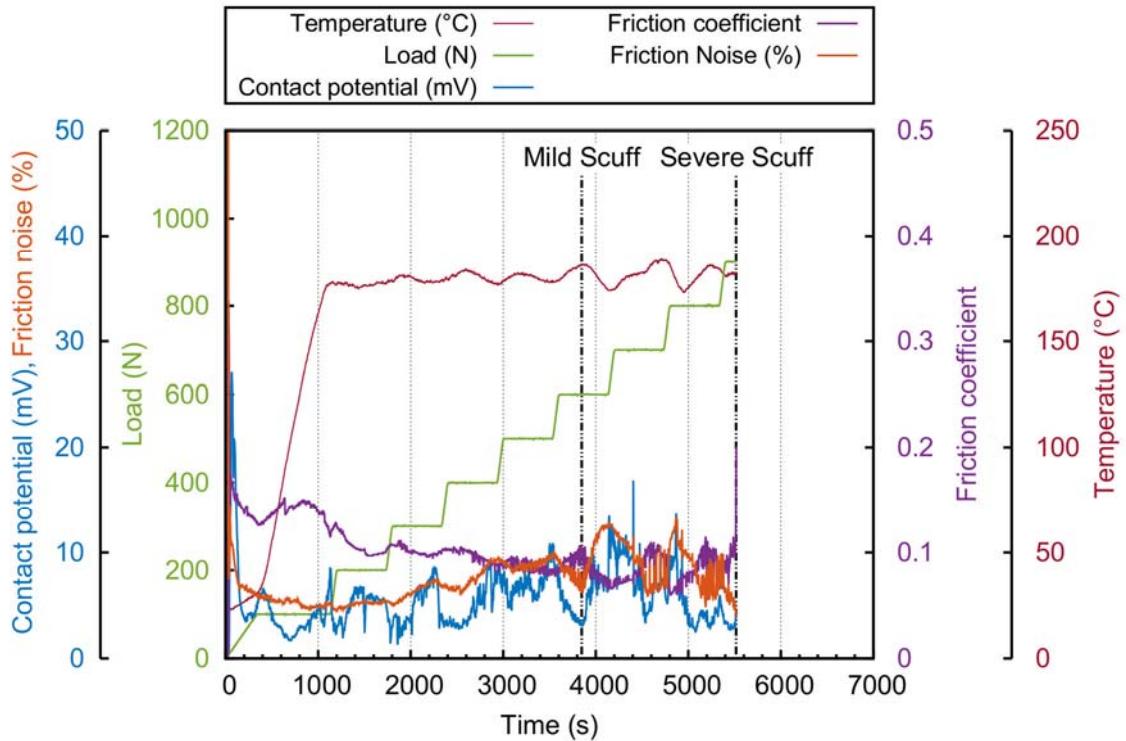
Figure 6.5: Average friction, normal load, temperature and contact potential plotted against time RLS2.

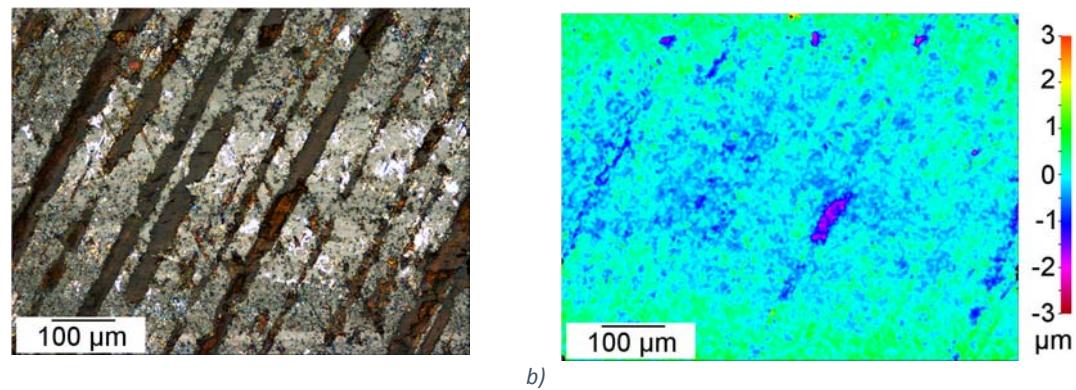
Figure 6.9: Optical image of mild scuff RLSM1 cast iron showing plastic deformation of asperities into grinding marks (a) and 3D colour map (b).

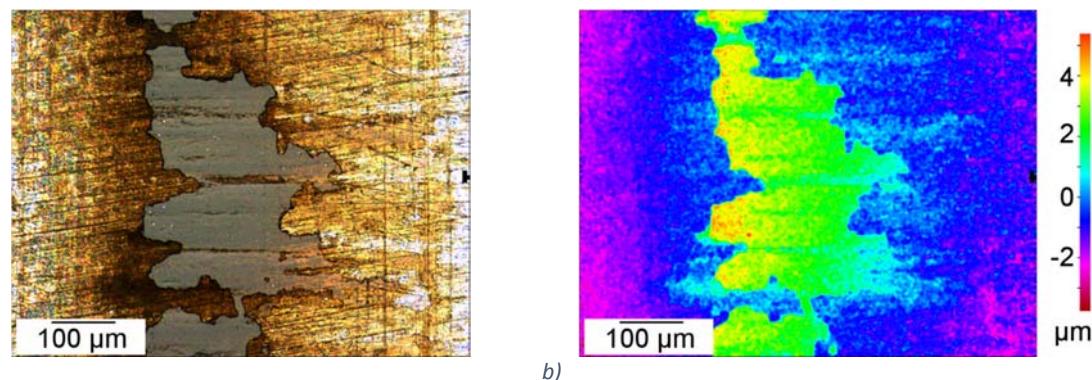
Figure 6.10: Optical image of the RLSM1 52100 roller element showing cast iron transfer (a) and 3D colour map (b).

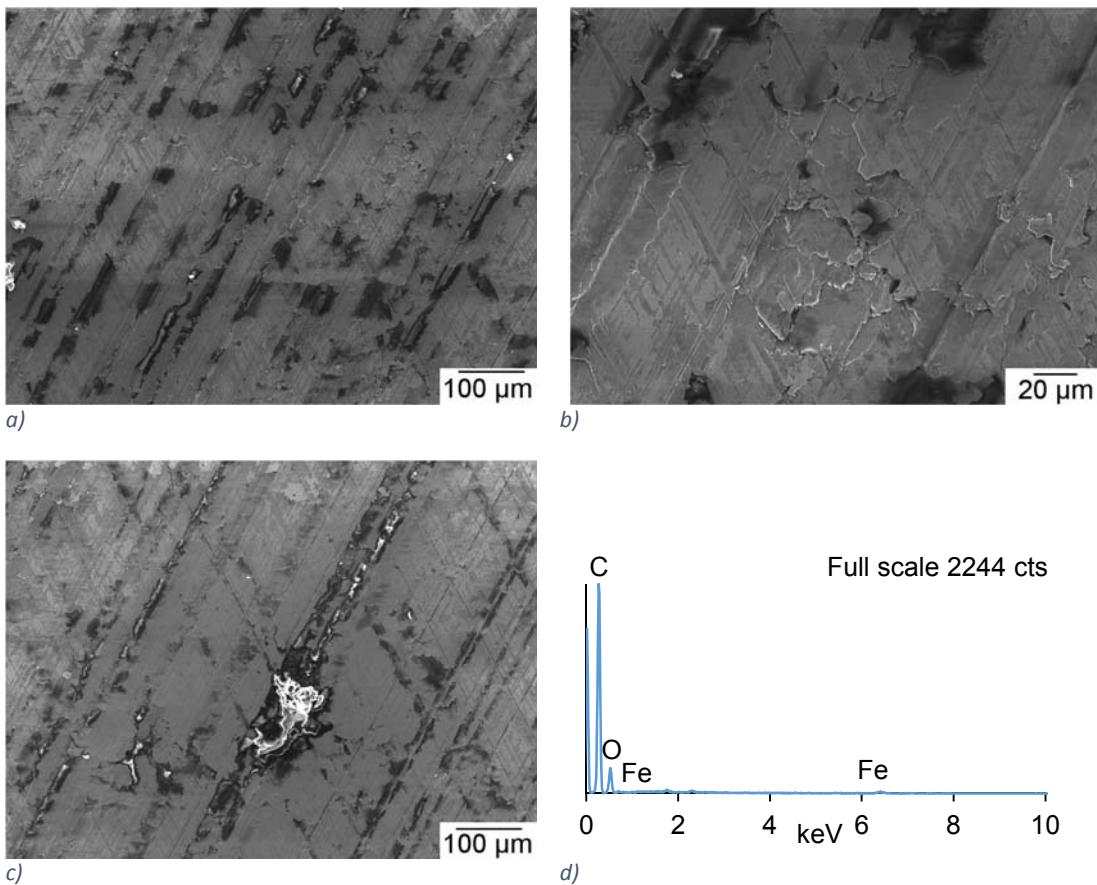
Figure 6.11: Secondary electron images (a-c) of mild scuffed region from ring on liner test RLMS1. EDX spectrum (d) from the central particle in c).

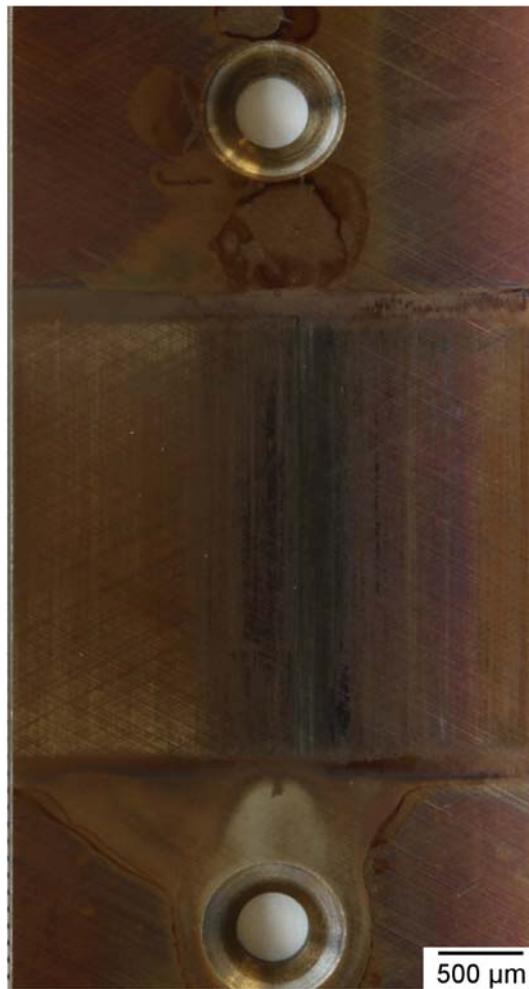
Figure 6.12: Optical images of the RLS2 cast iron wear scar.

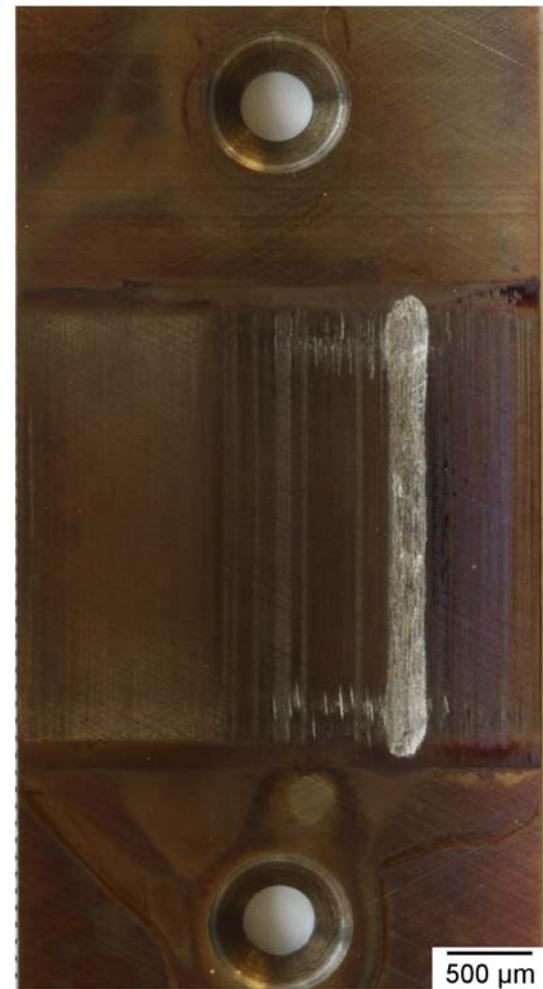
Figure 6.13: Optical images of the RLS1 cast iron wear scar.

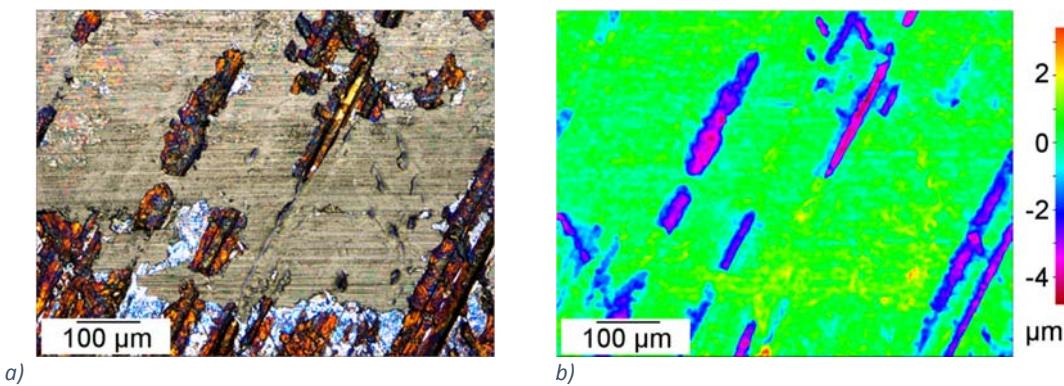
Figure 6.16: Optical image of severe scuff on RLS2 cast iron wear scar showing the initial formation of platelets and plastic deformation of asperities (a) and 3D colour map (b).

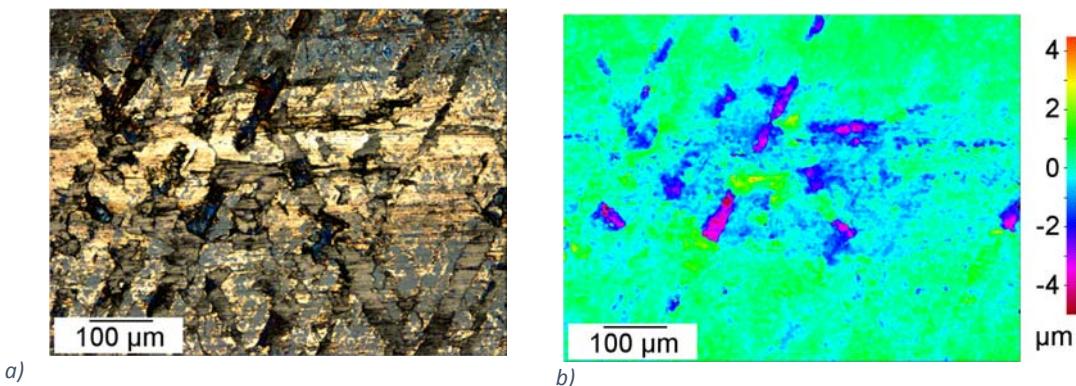
Figure 6.17: Optical image of severe scuff on RLS2 cast iron showing well defined platelets and scoring (a) and 3D colour map (b).

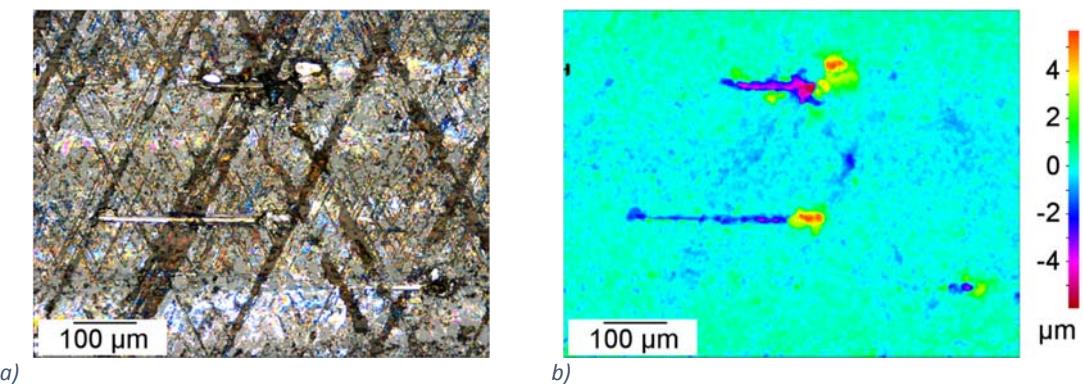
Figure 6.18: Optical image of adhesive wear particles leaving scoring marks on the RLS1 cast iron wear track (a) and 3D colour map (b).

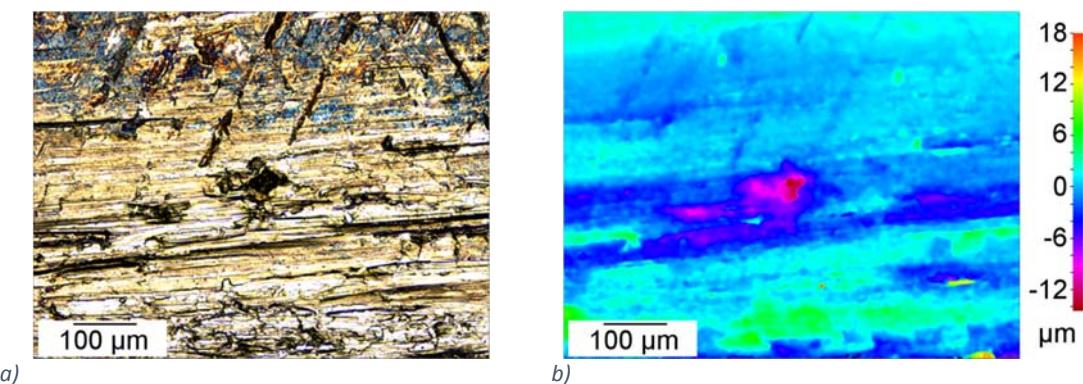
Figure 6.19: Optical image of adhesive wear crater on surface for the RLS1 cast iron wear track (a) and 3D colour map (b).

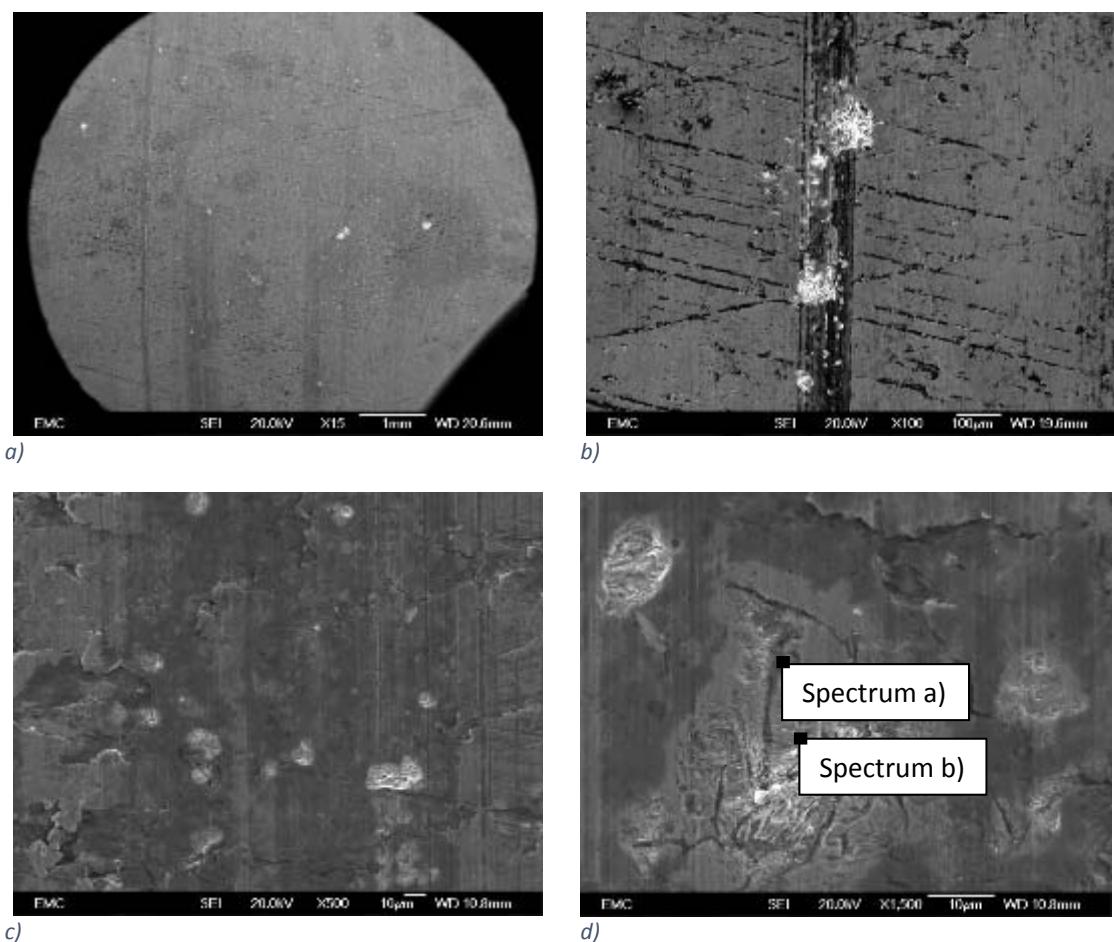
Figure 2.20: Secondary electron images of flake cast iron cylinder liner showing a region exhibiting mild and severe scuffing at a) low magnification, b) high magnification, c) high magnification of the mild scuffed, d) high magnification of the severe scuffing.
