**Development of Detection Techniques for Investigating Scuffing Mechanisms of
Automotive Diesel Cast Irons**

Thesis for the degree of Doctor of Philosophy

July 2017

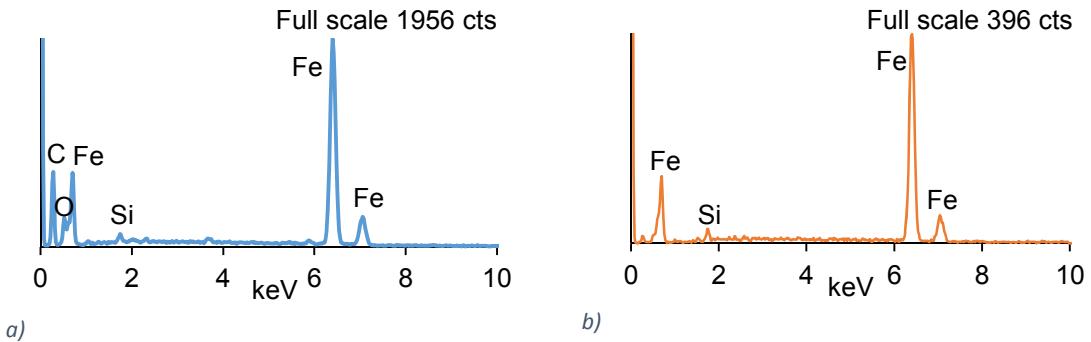
Figure 2.21: EDX spectra of the a) flake graphite and b) iron matrix in Figure 2.18b.

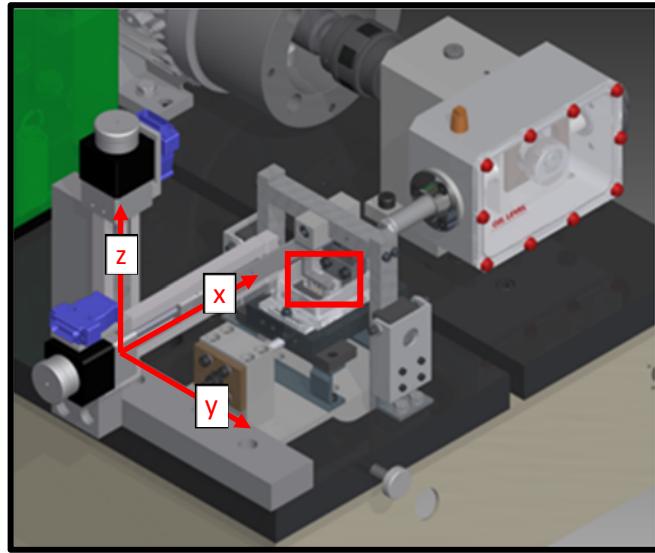
Figure 8.1: In situ profilometer attached to a TE-77 high frequency reciprocating tribometer.

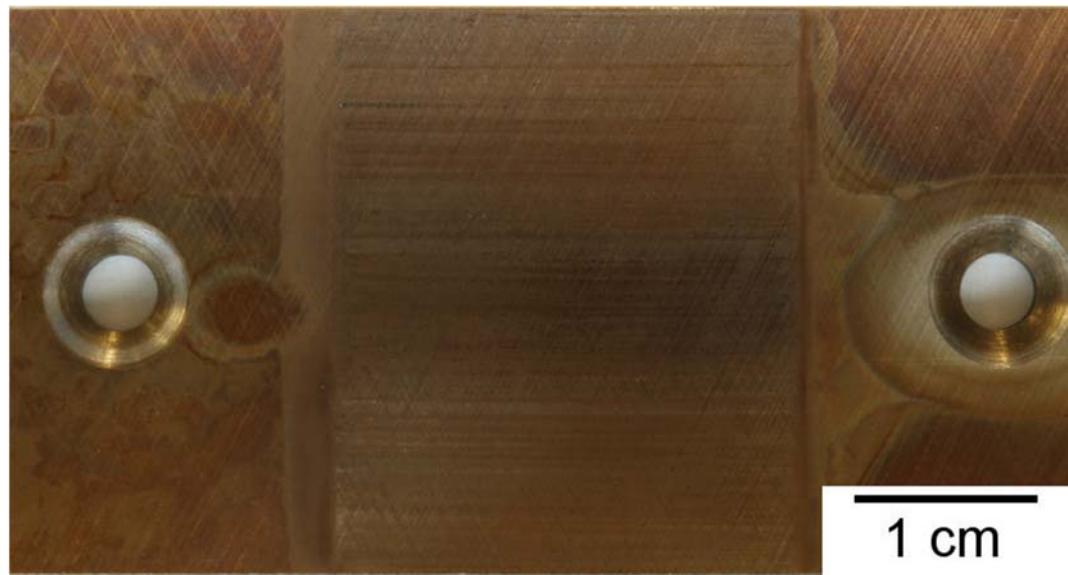
Figure 12.1: Optical images of the RLMS1 cast iron wear scar.
