## Coastal Landfill and Shoreline Management: Implications for Coastal Adaptation Infrastructure

### Case Study: Lyme Regis

Prepared by: R.P. Beaven, A.S. Kebede, R.J. Nicholls, I.D. Haigh, J. Watts, A. Stringfellow

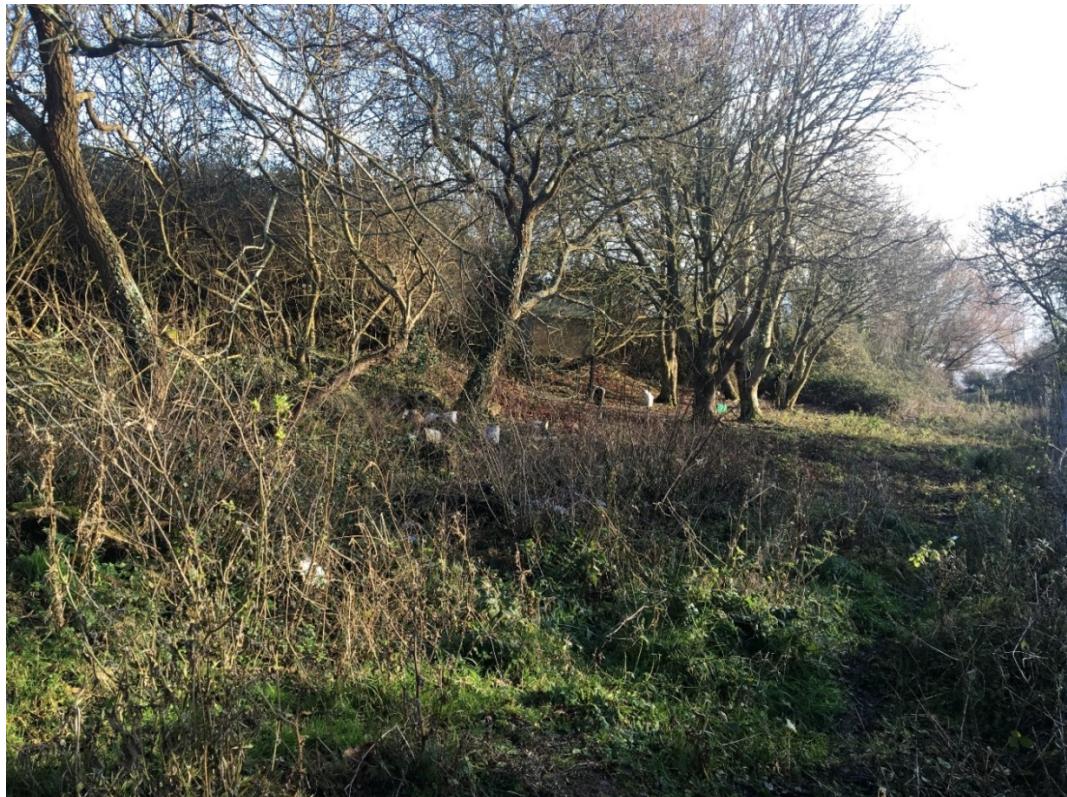
**Figure 6: View southwards from Spittles Lane track, from eastern boundary of allotments (January 2018 site visit).**

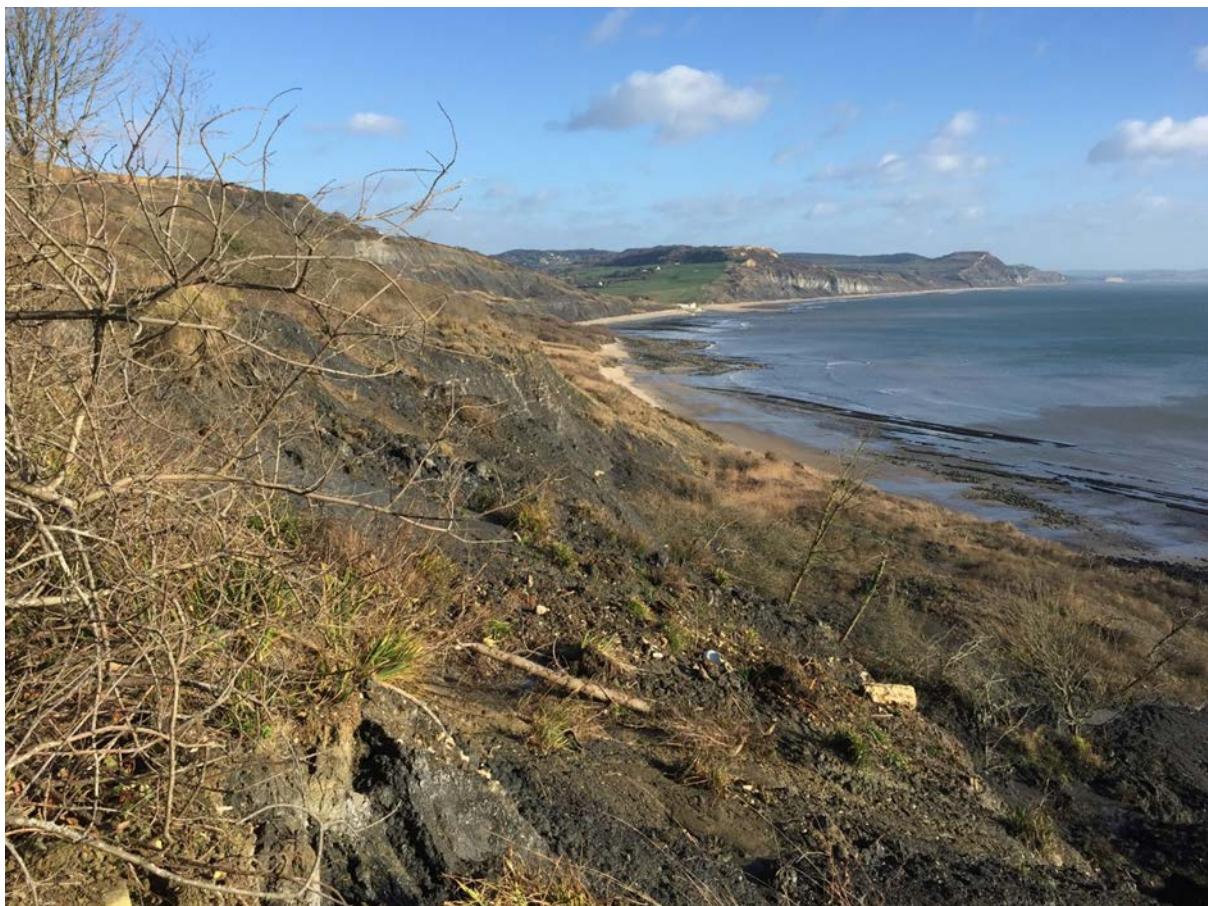
Waste was observed both at the top and bottom of the cliff. Sections of the top edge of the cliff showed evidence of waste at depths of up to 1.5 m. In areas where the slip occurred and ground had been unearthed from below, there was no evidence of landfill. It is clear that there was significant waste in the active section of the landfill, however due to landslip mechanisms, such as rotation, this is distributed throughout the landslide both horizontally and vertically. This made estimating the volume of waste in this section difficult. Figure 8 shows a view from the foreshore looking towards the waste tip; it is not possible to identify the exact position or extent of the original site from this location. Waste can be seen distributed on the benches formed during the landslip and in the landslip toe area.

**Figure 7:** View from the landfill site at Spittles lane, showing waste on the cliff face (January 2017 site visit).

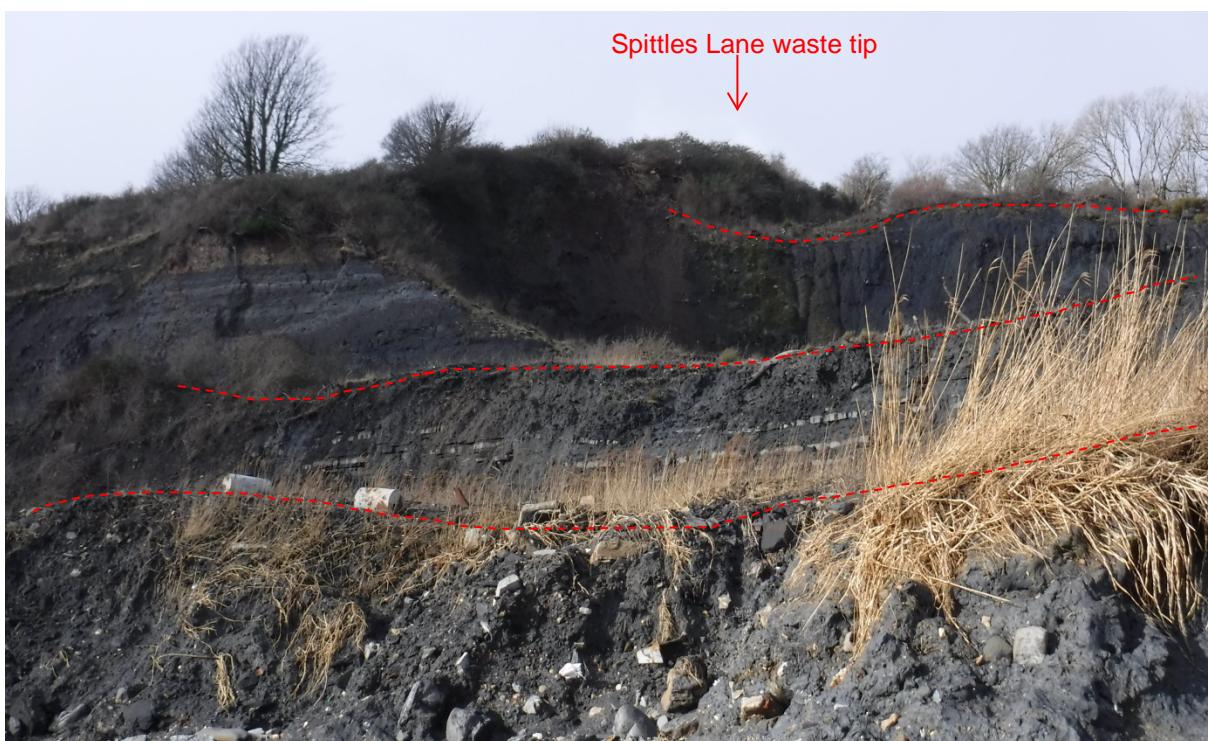
In May 2008, the landslip exposed old waste materials from the SL landfill site, spreading them over the cliff face and the beaches below. A number of tiered steps/benches were present in the landslip zone below the landfill containing loose soil and waste materials. WPA consultants observed the evolution of these benches in a series of reports between 2009 and 2013. In WPA's 2012 report it was noted that the original footprint of the lower tier at the back of the beach was considerably reduced due to erosion. Soft soil-like material had been eroded leaving behind larger boulders of sandstone, mudstone and the heavier fraction of waste materials, such as storage tanks and hard core. The beach area to the west of the landslide toe was reported to contain frequent fragments of glass, hard core and suspected asbestos containing material. In 2012, the steepness of an upper tier of land-slipped material had lessened to the extent that pedestrian access was possible for the first time.

**Figure 8:** View from the beach below Spittle Lane waste tip, showing benches (dashed red lines) formed during the landslip and some waste material on the benches (January 2018 site visit). Arrow shows the approximate position of waste tip.

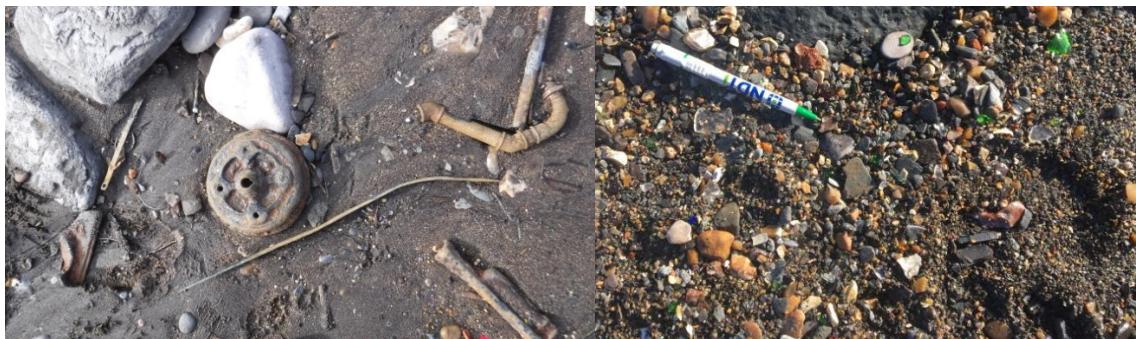
**Figure 10: Metal and glass on the beach from Spittles Lane waste tip (January 2018 site visit; pen for scale in right hand picture).**

A notice is displayed at the steps leading from the new sea wall down to foreshore below the landslip. The notice warns beach users that there is hazardous material on the beach (metals and glass) resulting from coastal erosion of an old rubbish tip and advises care should be taken.

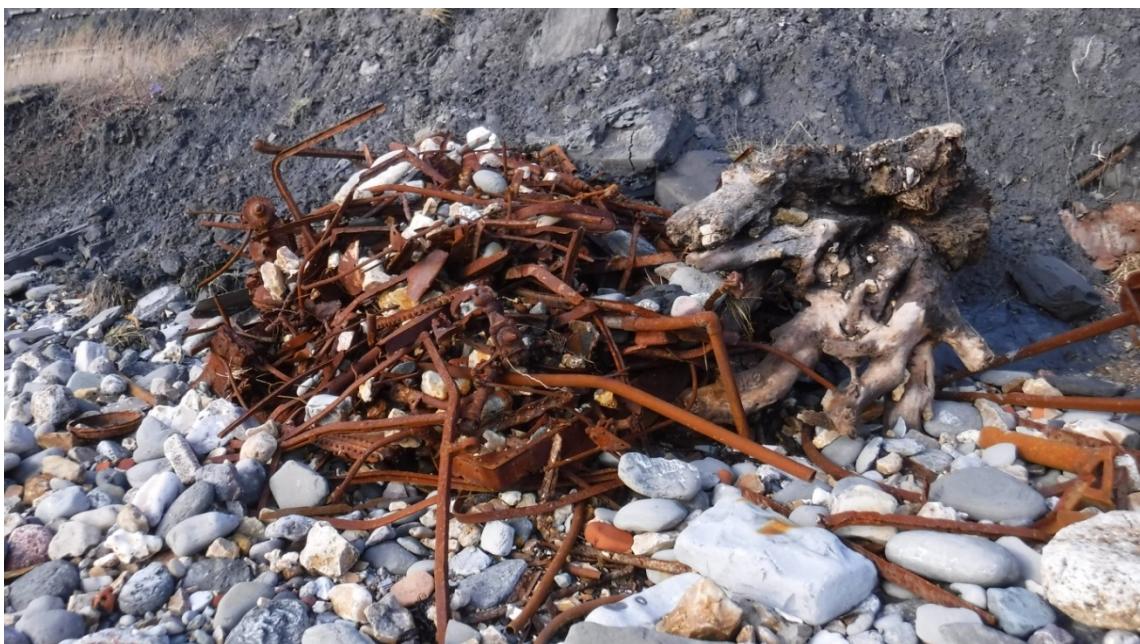
**Figure 11: Collection of metal waste on the beach below Spittle Lane waste tip (January 2018 site visit).**

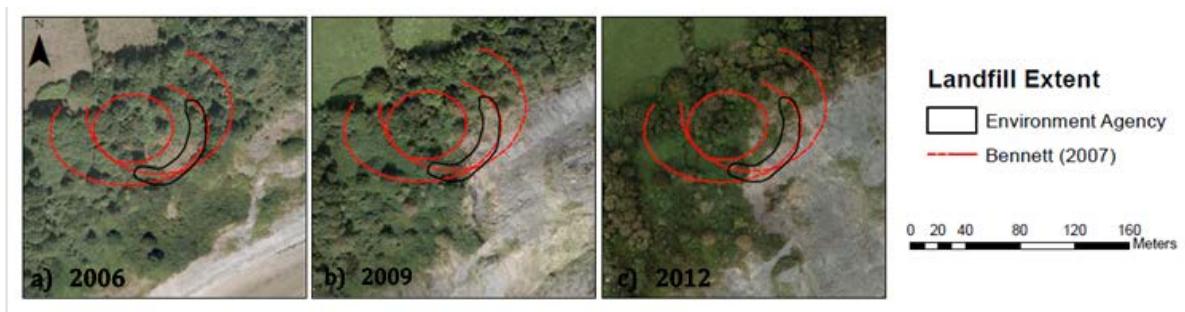
Figure 12 shows aerial imagery of the study site in a) 2006 (pre-landslide), b) 2009, and c) 2012. Assuming a waste depth of 1 m in the landfill, it can be estimated that 500 - 1100 m<sup>3</sup> of waste material was released from the cliff-top site between 2006 and 2009 (depending on the chosen landfill extent). Since 2009, a further 160 - 200 m<sup>3</sup> waste is estimated to have been released and is either still present in the landslide zone or in the wider environment.

Figure 12: Aerial imagery showing the landfill site and progression of the Spittles landslip complex in (a) 2006, (b) 2009 and (c) 2012. (source: Plymouth Coastal Observatory).
