## **Behaviour of discrete piles used to stabilise a tree-covered railway embankment**

Smethurst J A, Bicocchi N, Powrie W, O'Brien A S

## **Abstract**

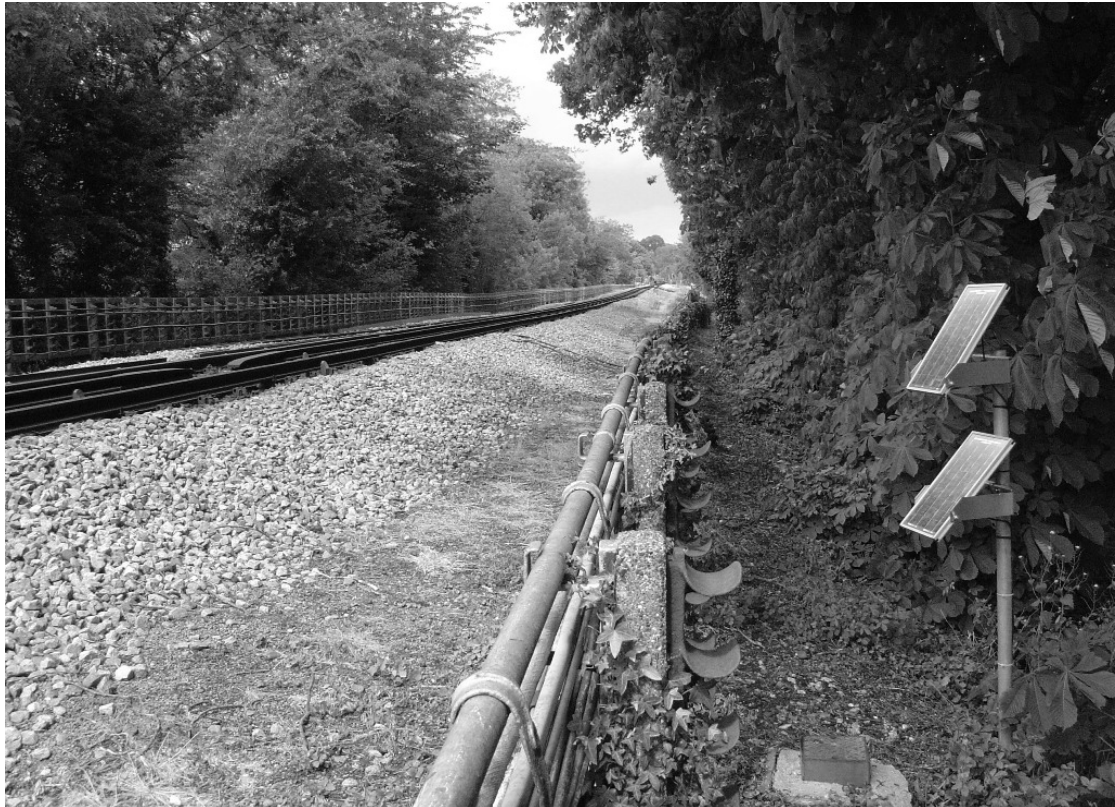
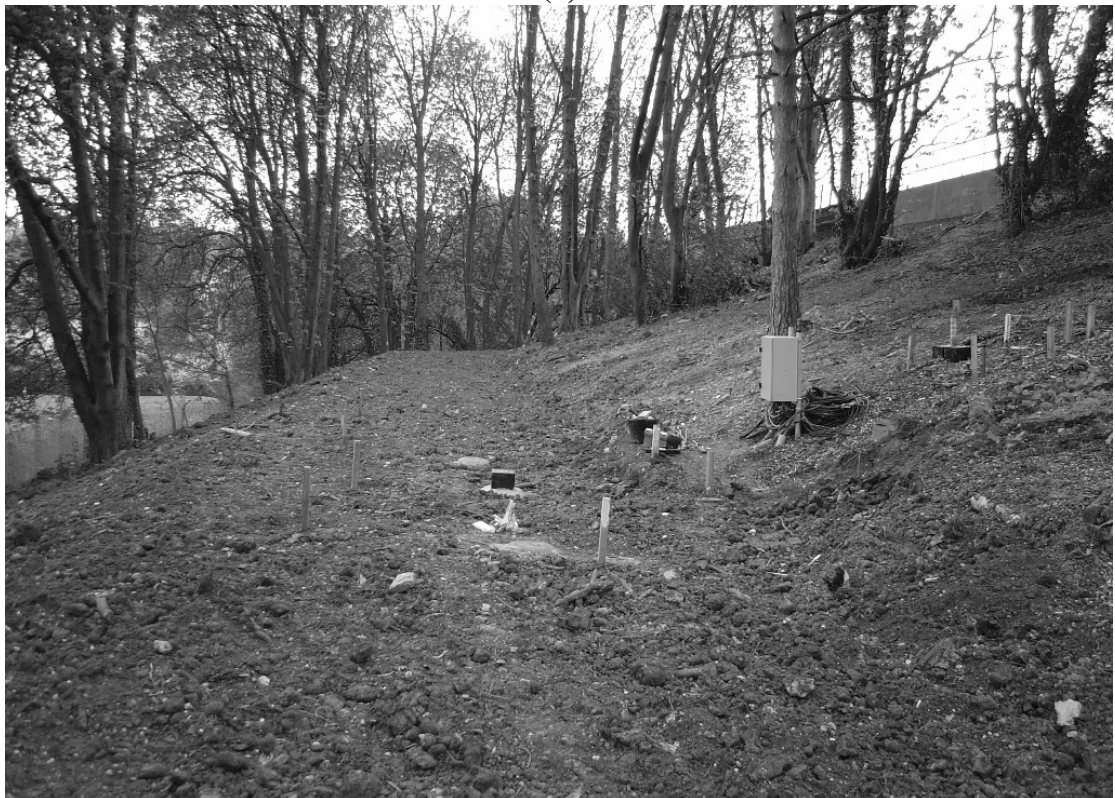
**Fig. 2: Photographs of the site showing (a) the top of the embankment (19 May 2009); and (b) the toe berm and instrumented section at the end of construction works (12 April 2005). Note the extensive mature vegetation retained on the slope post-construction.**

The Lowestoft Formation embankment fill is a sandy silty clay with occasional fine to medium gravel, including fine gravel of chalk, and is of low to intermediate plasticity. It was likely obtained from an area of cut for the railway adjacent to Finchley Central station, where *in situ* deposits of the till are present. The embankment overlies *in situ* weathered London Clay. A layer of ash is present at the top of the embankment, below the track ballast. The embankment is covered with mature trees, predominantly oak and horse chestnut (Fig. 2).

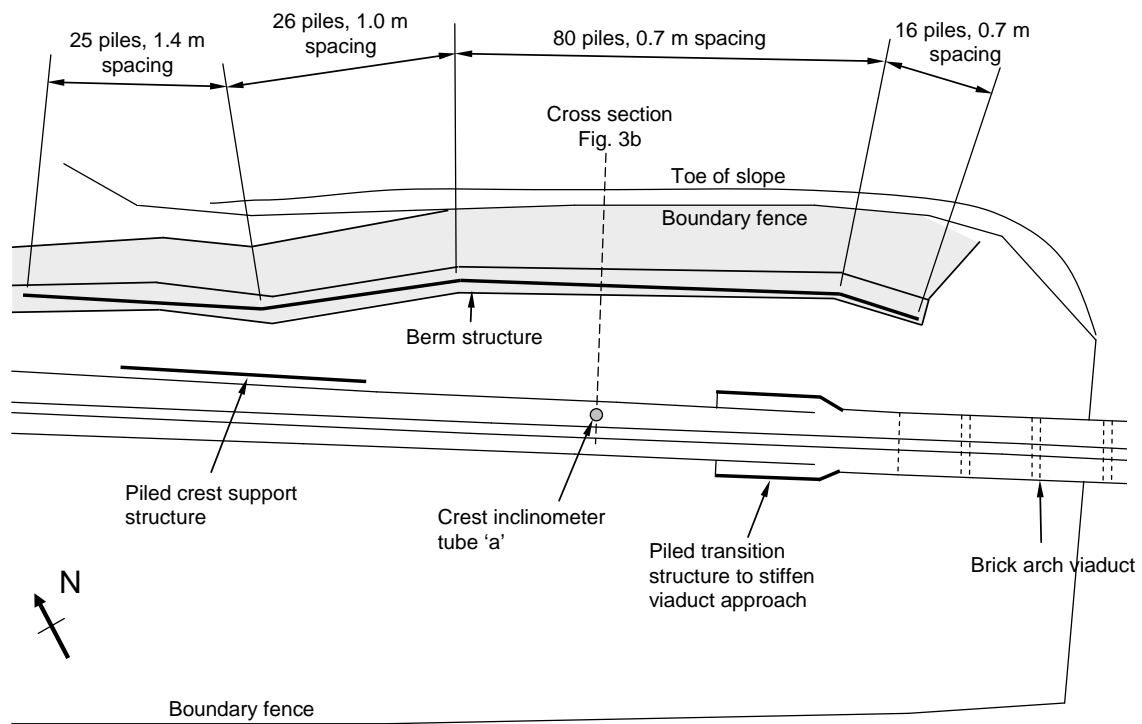
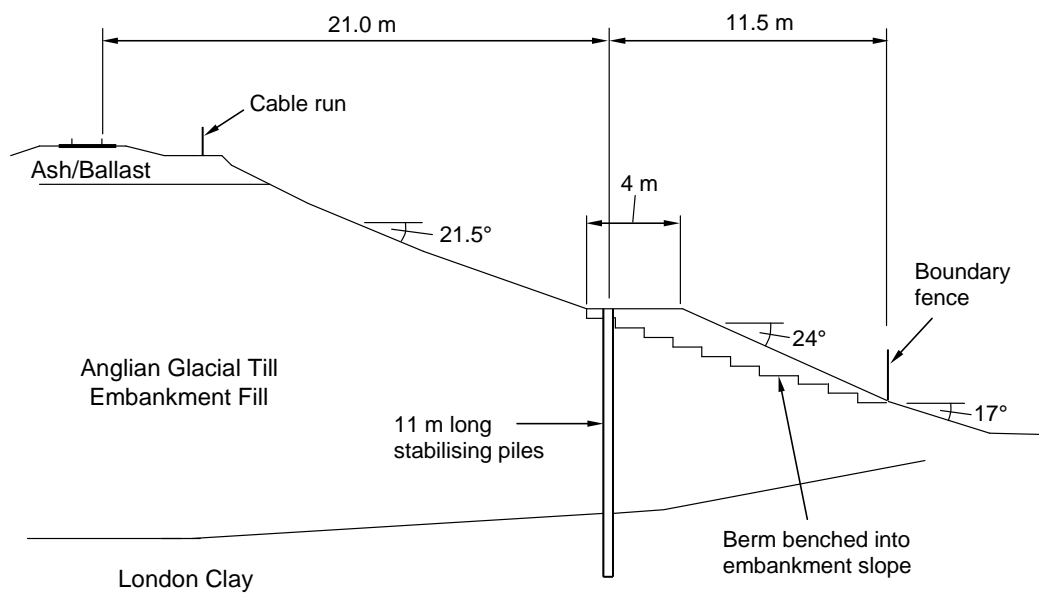
**Fig. 3: (a) plan, and (b) cross section through the stabilised embankment**

The clay embankment has slope angles in the range 17-21° (Fig. 3), including in places a steep (up to 30°) crest of granular ash and ballast. Inspections of the embankment condition in 1998 noted lateral and rotational movements of trees, lineside services and boundary fence posts. A ground investigation was carried out in 1999 comprising a mix of cable-percussion and window sample holes, and shallow trial pits at the toe of the embankment. Index, consolidated undrained triaxial and shear box tests were carried out on specimens of embankment fill material and the intact *in situ* London Clay. Table 1 gives plasticity, density and strength properties of the embankment materials. Trial pits revealed some evidence of relict shear surfaces within the toe

Crest stabilisation works were also carried out along short sections where the line side cables were being undermined by crest instability, and a transition structure was built to stiffen the embankment immediately adjacent to the viaduct (Fig. 3a).

A cross-section through the scheme was instrumented, as shown in plan in Figs. 3(a) and 4. The section comprises two piles instrumented with 10 no. pairs of vibrating wire strain gauges to determine bending strain and an inclinometer tube to measure pile displacement, and two

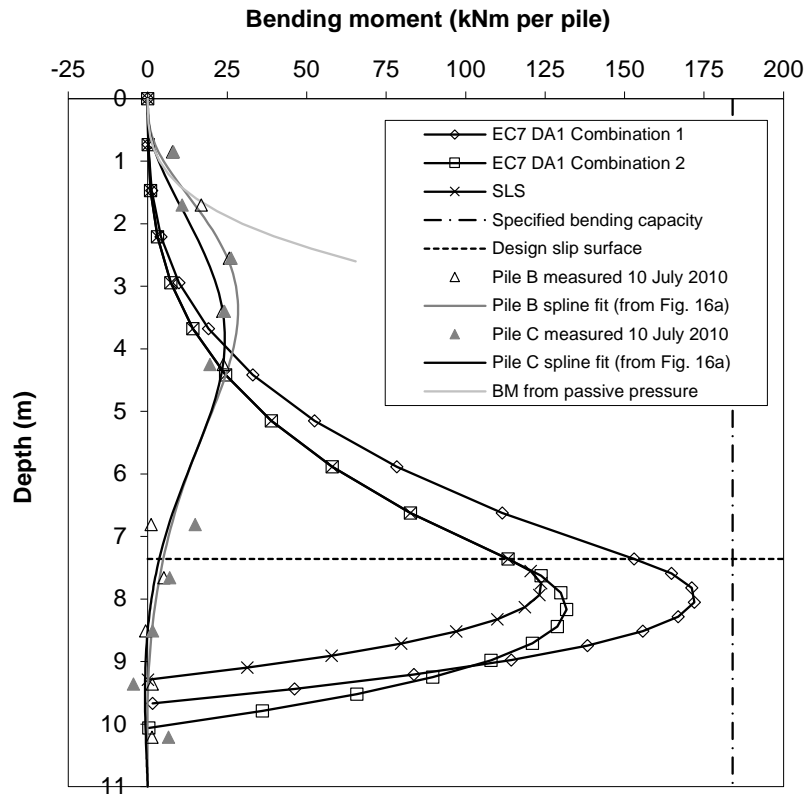
**Fig. 5: Bending moment profiles obtained from limiting equilibrium pile design, plotted with the pile bending moment measured using pairs of strain gauges and splines fitted to the measured moments. A technical problem meant that the strain gauges on Pile C below 8.0 m depth did not record after May 2010, and thus the plotted bending moment points for these gauges are for May 2010 rather than July 2010.**

While there are seasonal variations in pile bending after mid-2007, the general bending behaviour of the piles after this point (small bending moments at the base, and larger downslope bending moments over the top part of the pile) is consistent with the predominantly downslope shallow movements measured at inclinometer tubes c and d. This pile bending behaviour is very similar to that measured at Grange Hill by Bicocchi (2011), where the piles were also resisting fairly shallow (circa 2-3 m depth) downslope ground movements. The last measured bending moments are less than 20% of the design bending capacity of the piles (Fig. 5).

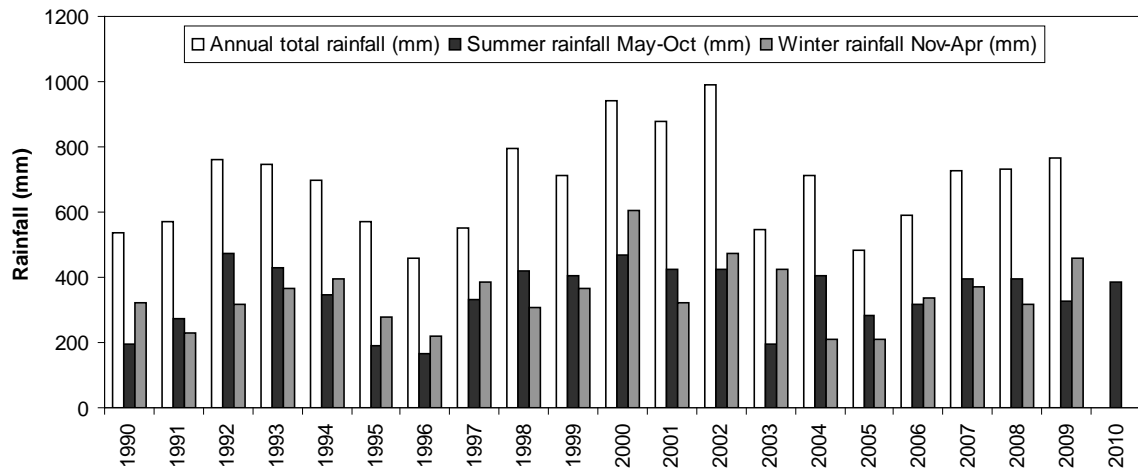
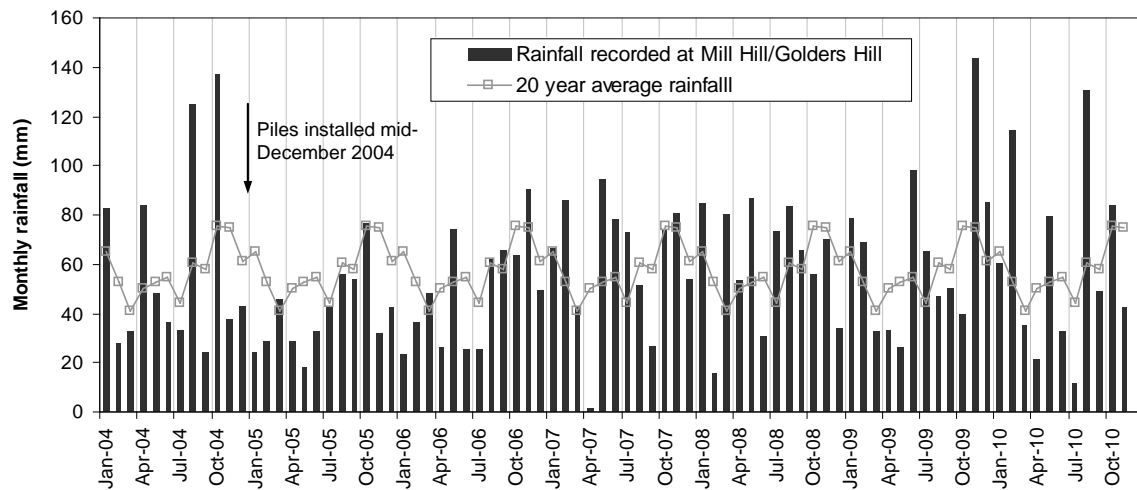
**Fig. 7: Rainfall recorded at the Mill Hill site from December 2004 to March 2007, and at Golders Hill, 4.5 km from the site, for the remainder of the periods shown: (a) annual and 6-month totals 1990-2010; and (b) monthly totals 2004-2010.**

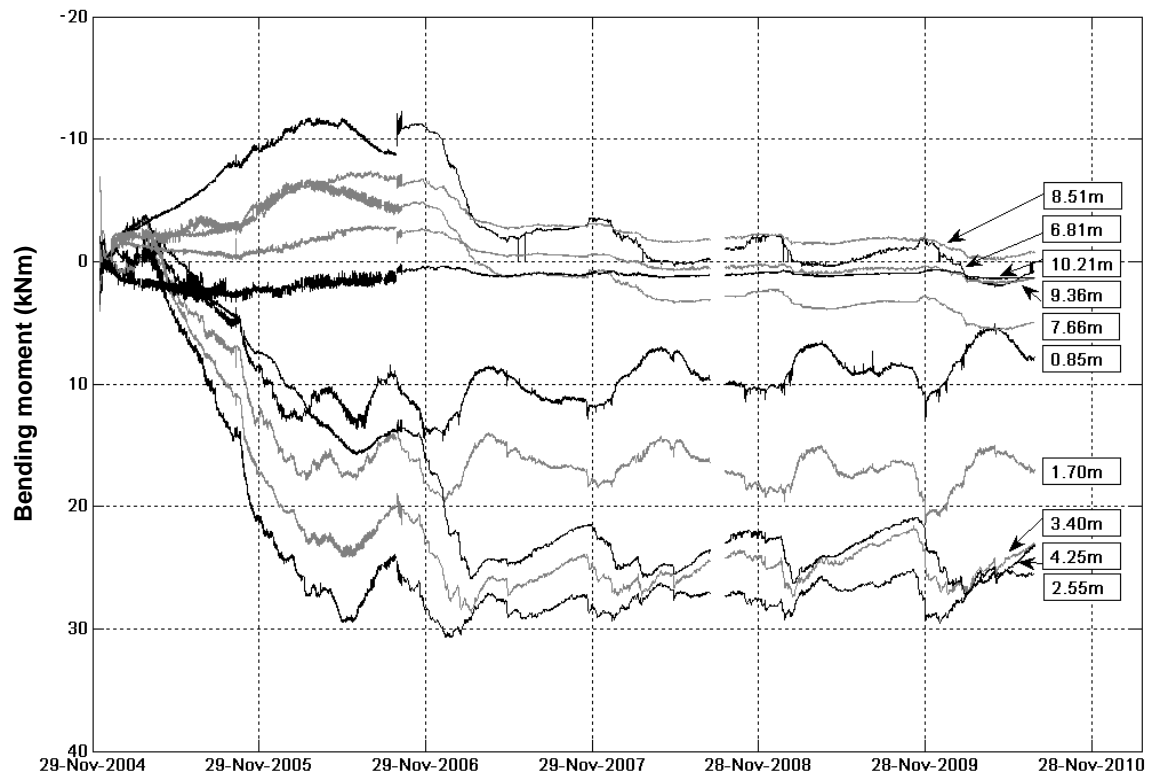
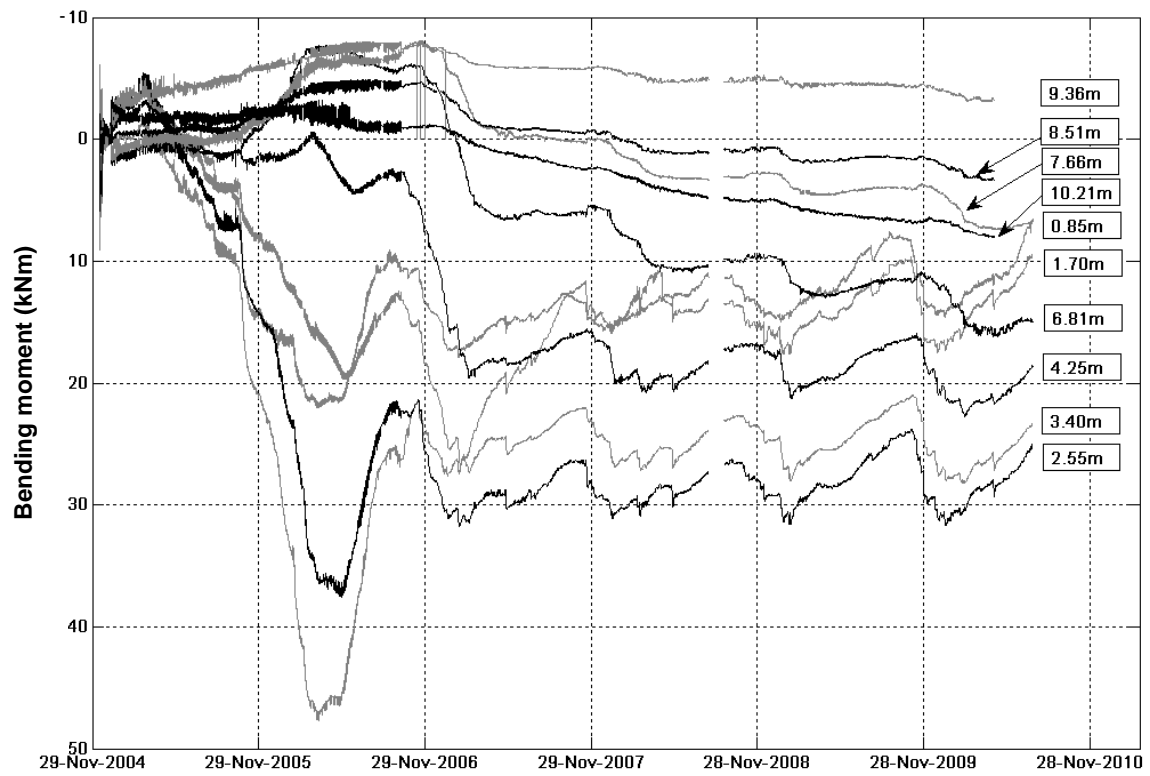
**Fig. 10: Bending moment plotted against time (a) Pile B; and (b) Pile C.**

The bending moments measured by pairs of strain gauges within each pile are plotted against time in Fig. 10. In both Piles B and C, bending moments steadily increased from installation to reach a maximum in mid-summer 2005. These peak bending moments were associated with the upslope movement of the upper parts of the piles as the embankment shrank inward due to tree water uptake. Negative moments (associated with compression on the upslope side) were generated over the bottom half of each pile as the piles bent upslope, and positive moments (tension on the upslope side) over the top half (particularly in Pile C) where the piles bent back in the downslope direction. This is consistent with the deflected shapes of the piles measured by the inclinometers (Fig. 6). Profiles of bending moment with depth are shown in Fig. 11.

During late 2006 and early 2007, wetter weather caused a clear net movement of the piles downslope, driven partly by the shallow displacements measured at the inclinometer tubes c and d, installed into the soil downslope of the pile row (Fig. 8b and c). The bending moments over the lower half of Pile B moved from negative to slightly positive; while in Pile C the large positive moments at 1.70 and 2.55 m depth fell substantially (Figs. 10 and 11). From mid-2007 onwards, bending moments remained largely unchanged, except for a clear seasonal fluctuation in the readings. The bending moments increased fairly rapidly in early winter, only to reduce gradually again over much of the mid- and late summer. These cycles of bending moment are consistent with the seasonal forward and backward movements of the piles measured by the inclinometers. Moments over the upper parts of the piles cycle back to the starting point, but there is a gentle ratcheting upward of moments over the lower parts of the piles (Fig. 10).

For Mill Hill, a quantitative calculation was not carried out, because: (i) there was insufficient information about soil suction changes above 4.0 m depth, where some measured suctions exceeded the maximum that the piezometers were able to read; (ii) there were no laboratory shrinkage data for the Lowestoft clay fill; and (iii) it was not clear how (probably 1D) laboratory shrinkage behaviour relates to (likely 3D) movements at slope scale, owing to uncertainty about soil cracking and the exact direction of inward shrinkage of the embankment. However, it is almost certain that the observed substantial soil drying at Mill Hill is the cause of the measured upslope movements of the piles into the embankment, and the maximum pile bending moment of 50 kNm obtained during the monitoring period (Fig. 10b).

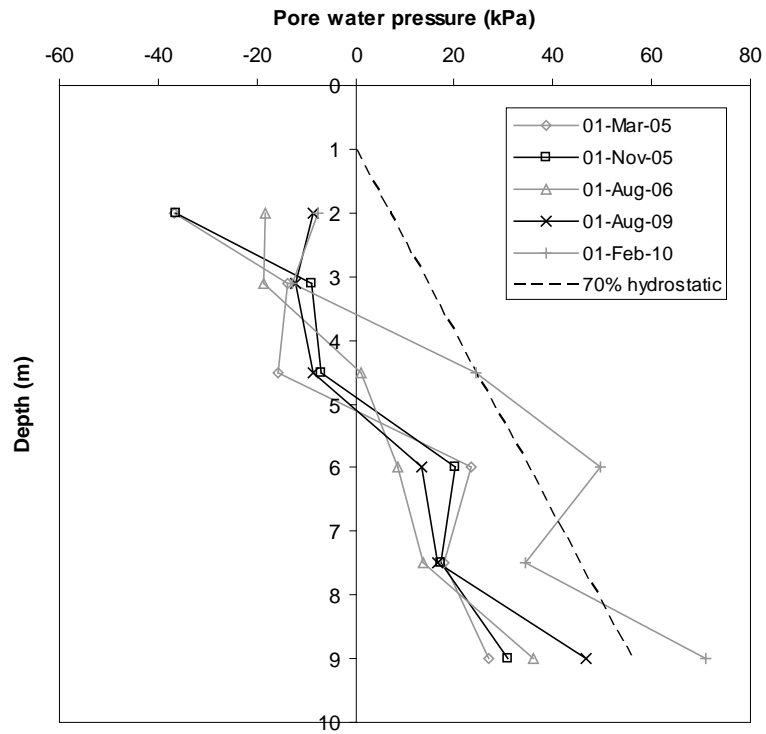
**Fig. 12: Profiles of pore water pressure measured by piezometers installed from the front edge of the berm.**

Profiles of pore water pressure measured by piezometers installed adjacent to the piles are shown in Fig. 12 for a number of dates over the monitoring period. The initial (March and November 2005) profiles show negative pore water pressures to about 4.0 m depth, below which pore pressures were positive but sub hydrostatic. The positive pore pressures measured through a large part of the embankment and in the top of the London Clay foundation are consistent with the founding material being low permeability London Clay (Briggs *et al.*, 2013a).

The mature trees growing on the earthwork are clearly able to cause substantial summer soil drying to at least 4.0 m depth. This helps to maintain a profile of pore water pressures close to zero, even during winter, within the uppermost 4 m or so of the mid-slope; as well as generally less-than-hydrostatic pore water pressures below this. Apart from the winter of 2010, the measured pore water pressures remained below the design pore water pressure profile (of 70% hydrostatic, as given in Fig. 12) throughout the monitoring period.

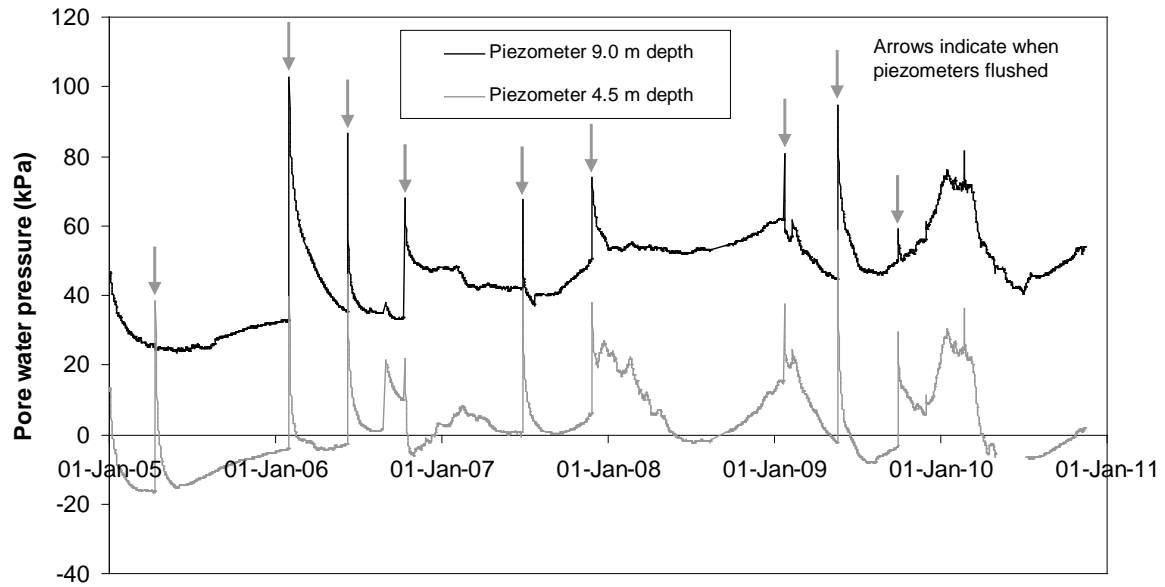
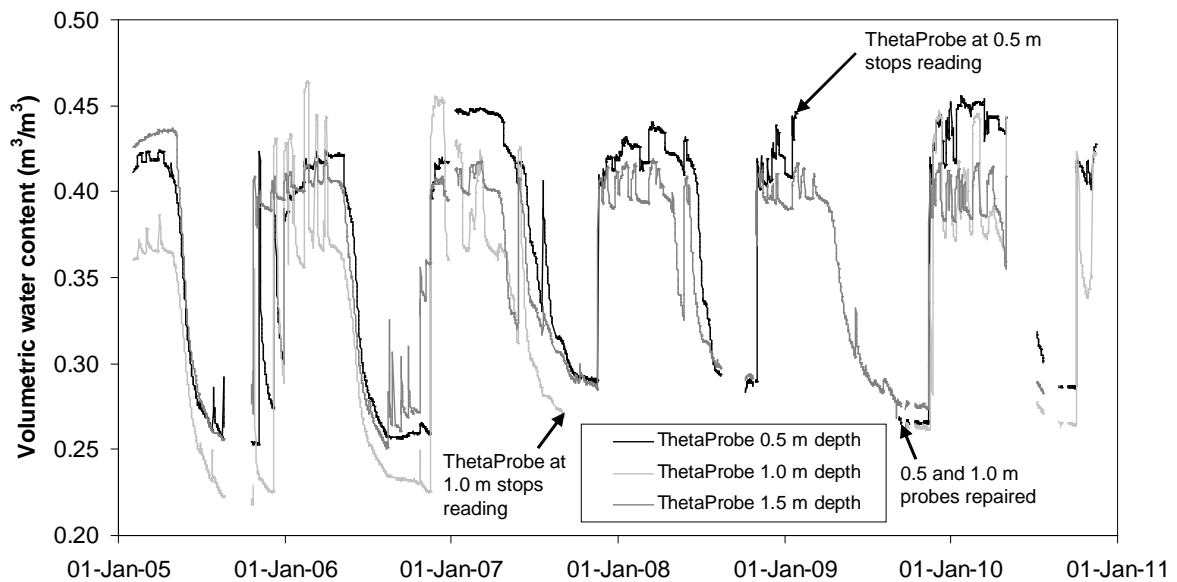
**Fig. 13: (a) pore water pressures plotted with time for select piezometers installed in the clay slope from the front edge of the berm structure; and (b) water content plotted with time measured using TDR ThetaProbes installed in the clay slope just upslope of the berm. The spikes in the readings in (a) indicate when the piezometers were flushed (i.e. had water circulated through them to remove any presence of air). It then takes a few days for the device to come back into equilibrium with the water pressures in the soil.**

Pore water pressures gradually increased over the monitoring period with some seasonal fluctuations, reaching a peak around February 2010 (Fig. 13a). Pore water pressures above 4.0 m depth varied from low suctions ( $< 10$  kPa) during winter, to moderate suctions ( $\sim 40$  kPa) in the summer. The shallow piezometers installed above the berm, which were about 4.5 m horizontally from a mature horse chestnut tree, routinely measured the maximum suction the device could read during the summer ( $\sim 70$  kPa) and fell close to zero during the winter (not shown). This strong seasonal variation is also seen in the measured water contents in Fig. 13(b), which show substantial summer drying throughout the measured profile (to 1.5 m depth). The extent and depth of drying is consistent with observations from other tree-covered embankments (Briggs 2010; Smethurst *et al.*, 2015), and is much greater than measured for rough grass vegetation (e.g. Greenwood *et al.*, 2001; Smethurst *et al.*, 2012).

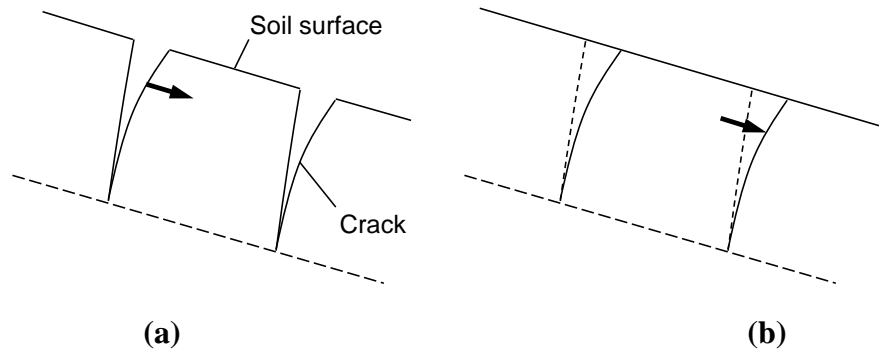
**Fig. 14: Postulated mechanism of surface downslope movement in which deep desiccation cracks: (a) open during summer in the downslope direction, and (b) close during winter, also in the downslope direction. (Note that movements of the individual crack faces on opening and closing may not both be in the downward direction as idealised here, but the net movement after crack opening and closing would be downslope).**

Later movements and bending of the piles are governed predominantly by the gradual shallow movement of the slope surface and berm in front of the pile row. Shallow movements of this type are commonly observed in clay earthwork slopes (e.g. Parsons & Perry, 1985; Greenwood, 1998), and occur as a result of the seasonal cycles of wetting and drying within the surface zone. Even if the higher winter/spring surface pore water pressures do not cause the surface of the slope to become unstable, seasonal shrinkage and swelling of the clay may cause gradual net downslope movements. Ridley (2017) used data from adjacent extensometer and inclinometer installations within a London Clay cutting to show that inward drying/shrinkage displacements occurred perpendicular to the slope surface, while the outward horizontal component of movement on swelling was much larger, so that over a drying and wetting cycle a net downslope displacement occurred. Hudacsek *et al.*, (2009) and Take & Bolton (2011) show similar net downslope displacements under cycles of drying and wetting in centrifuge model tests on clay slopes. Furthermore, high plasticity clay soils will crack on drying (e.g. Anderson *et al.*, 1982); a mechanism may be postulated in which desiccation cracks both open and close mainly in the downslope direction under the influence of gravity, also causing a net downslope displacement over a wetting and drying cycle (Fig. 14).

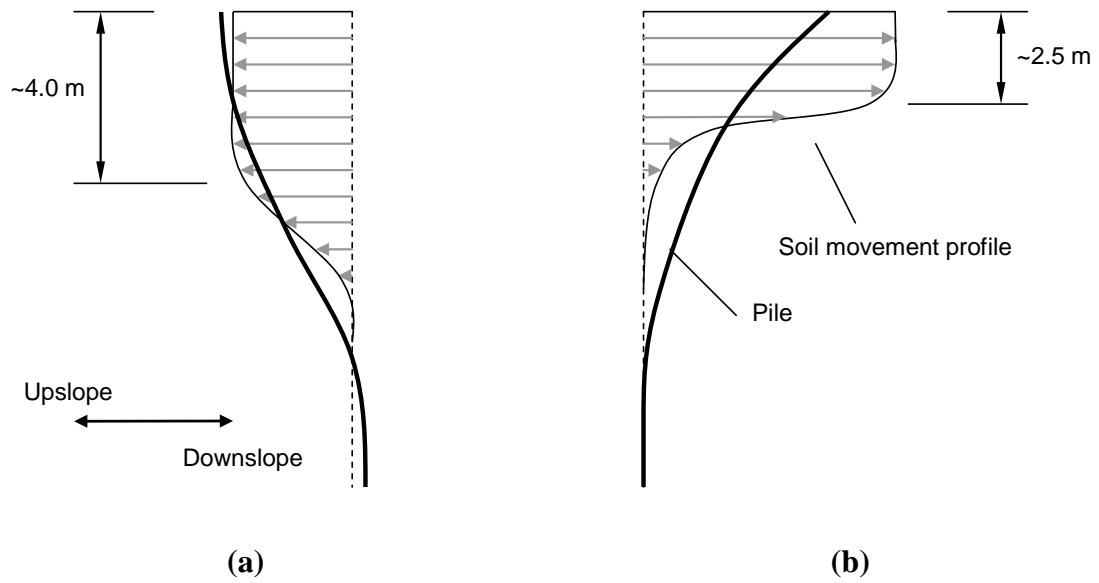
**Fig. 16: Idealised pile-soil interaction mechanisms: (a) upslope displacements of piles due to embankment shrinkage within the tree rooting zone; and (b) downslope displacements of piles due to surface instability.**

The relative pile/soil movements, based on the measured pile movements and the expected lateral soil shrinkage are shown schematically in Fig. 16(a). These are consistent with the net pile pressures (line loads) shown in Fig. 15(d).

Relative pile/soil movements, based on the pile and soil movements measured by the inclinometers, are indicated schematically in Fig. 16(b). These are again consistent with the net pile pressures (line loads) in Fig. 17(d).
