*An Integrated Methodology to Study Site Formation
Processes on Submerged Shipwrecks in the 21st c.*

By
Rodrigo Ortiz Vázquez

Thesis for the degree of Doctor in Archaeology

September 2018

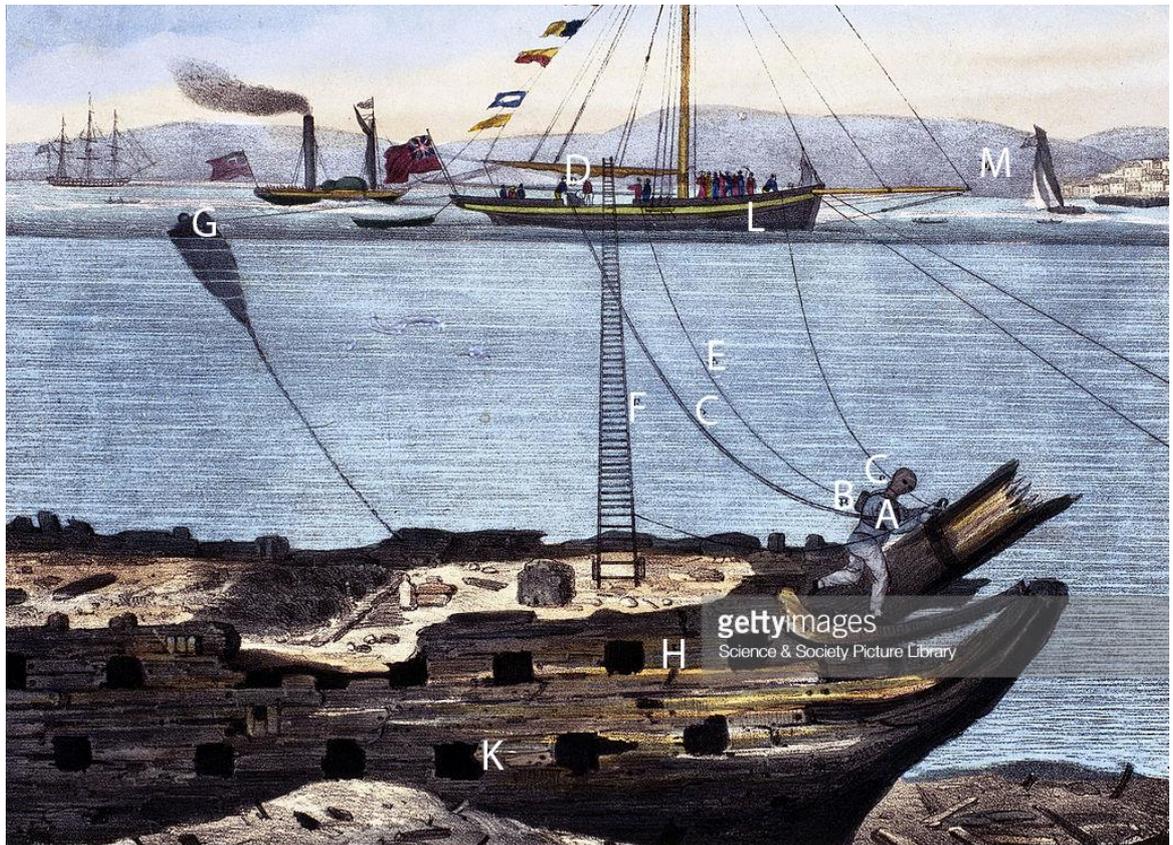
A REPRESENTATION OF H.M.S. ROYAL GEORGE OF 108 GUNS
now lying sunk at a depth of sixty fathoms at Spithead, having been under water fifty one years. W. Deane equipped in his newly invented Diving Apparatus engaged in taking off one of the hoops of the bowsprit in August 1832. A The Diver B Two leaden weights suspended from the neck of the helmet C Air tube passing from the Pump under the arm and entering at the helmet D Air Pump E Signal line F Ladder for ascending & descending with weights at its feet G Floating buoy H The Ship's middle deck I Main Hatchway K Lower Deck L Sloop with the Apparatus M Isle of Wight.

Figure 5. This engraving represents Charles Deane during salvage operations on the Royal George in 1883. (Wallis 1883). The image was taken from Getty images and the letter labels were enhanced by the author. A) The Diver B) Led weight suspended from the helmet C) Air tube passing from the pump under the arm into the helmet D) Air Pump E) Signal Line F) Ladder for ascending and descending G) Floating buoy H) The middle deck of Royal George I) Main hatchway K) Lower deck L) Sloop M) the Isle of Wight.

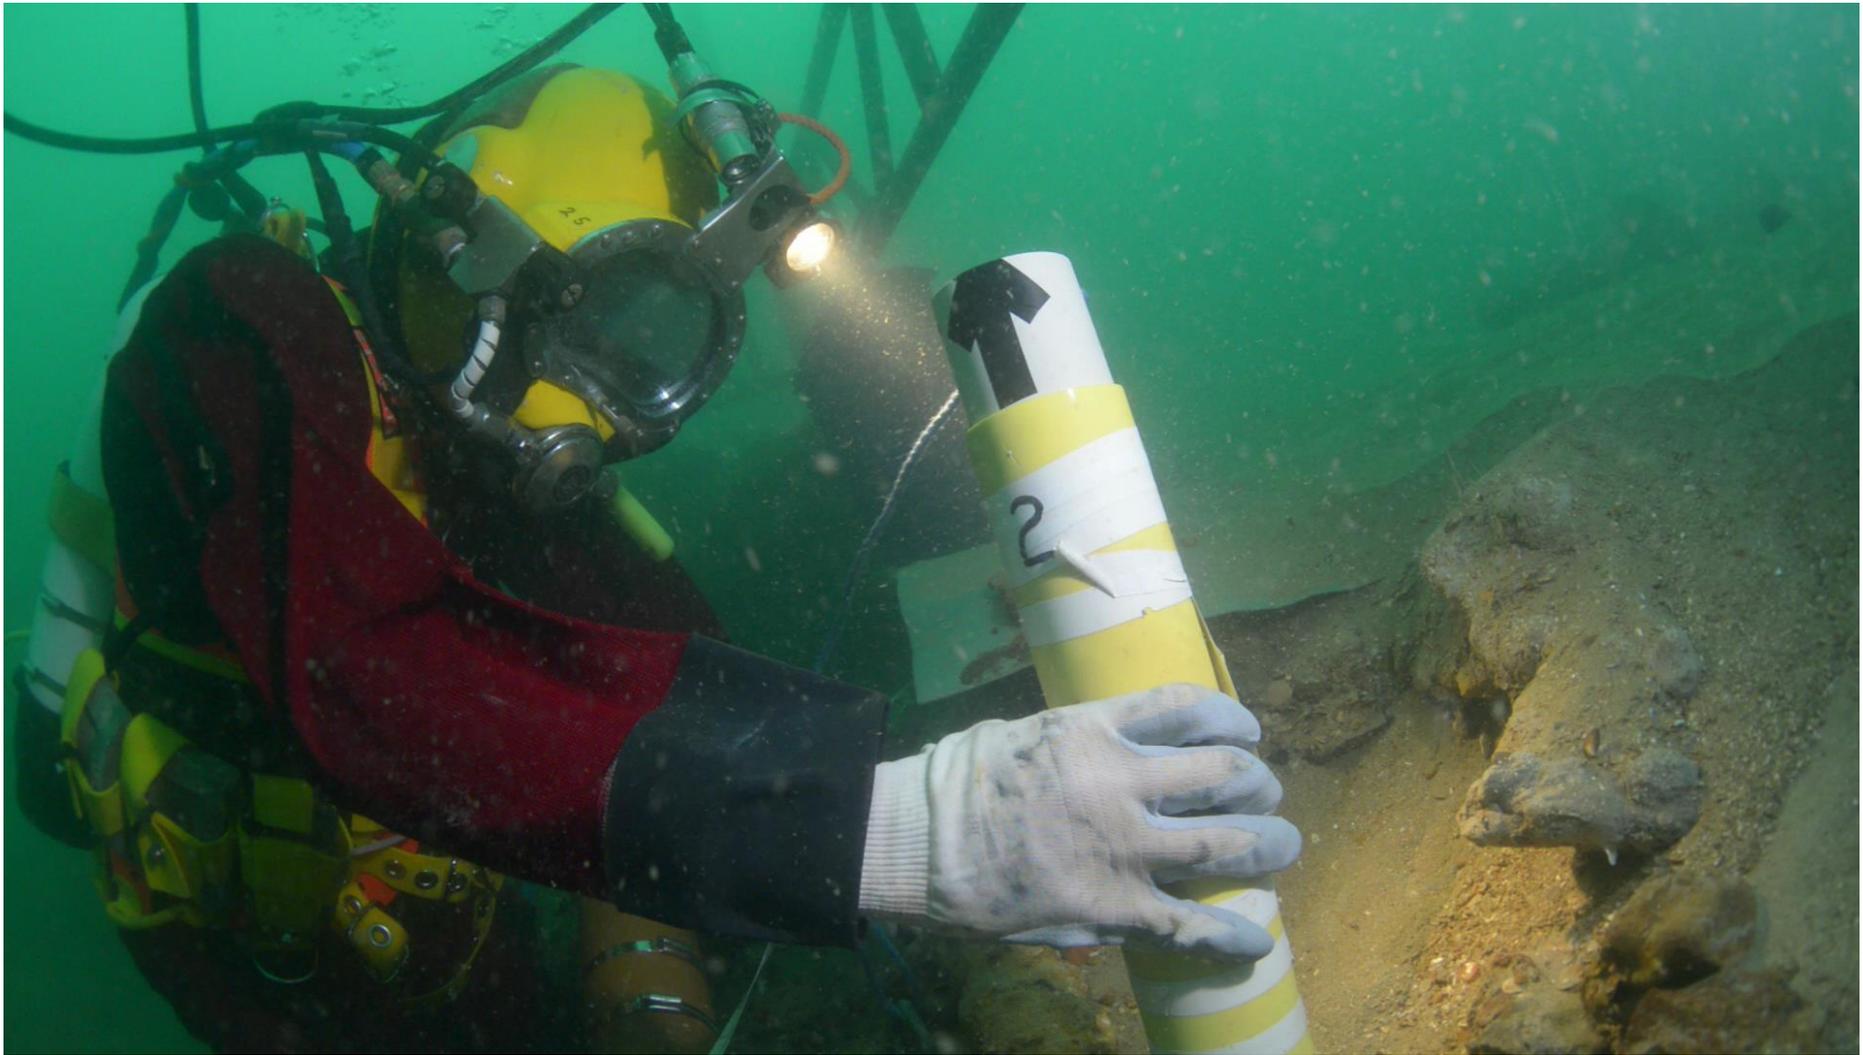
Figure 20. Diver deploying a mobile transponder to record an archaeological artefact position. The image is a frame by the author of this thesis taken from underwater footage filmed by Mike Pitts. The image is courtesy of RC

declination to determine the relative x, y, z position from the vessel (SONARDYNE 2012:1). The positioning of each transponder is then georeferenced by integrating a GNSS signal allowing tracking and positioning of multiple subsea targets simultaneously. The USBL was fundamental during the Rooswijk excavation. This system enabled the project to position the excavation grid, the artefacts, track divers, wet bell, and lifting crane. It was an essential tool regarding speed for recording and having an underwater reference to position the vessel for deploying the wet bell and lifting crane for operations on site. Diver's safety was also improved by adding the USBL tracking system, enabling the diving supervisor to monitor their positions at all times (Figure 20. Diver deploying a mobile transponder to record an archaeological artefact position. The image is a frame by the author of this thesis taken from underwater footage filmed by Mike Pitts. The image is courtesy of RC). Regarding the archaeological recording of artefacts, features and general site description, this was very important, especially with limited visibility and strong currents that restrict divers' time.

During the 2017 fieldwork season of *Rooswijk* the USBL positioning, and tracking was plotted with Site Recorder 4® (3H 2006), and then exported into ESRI ArcMap 10.5® (Figure 20).

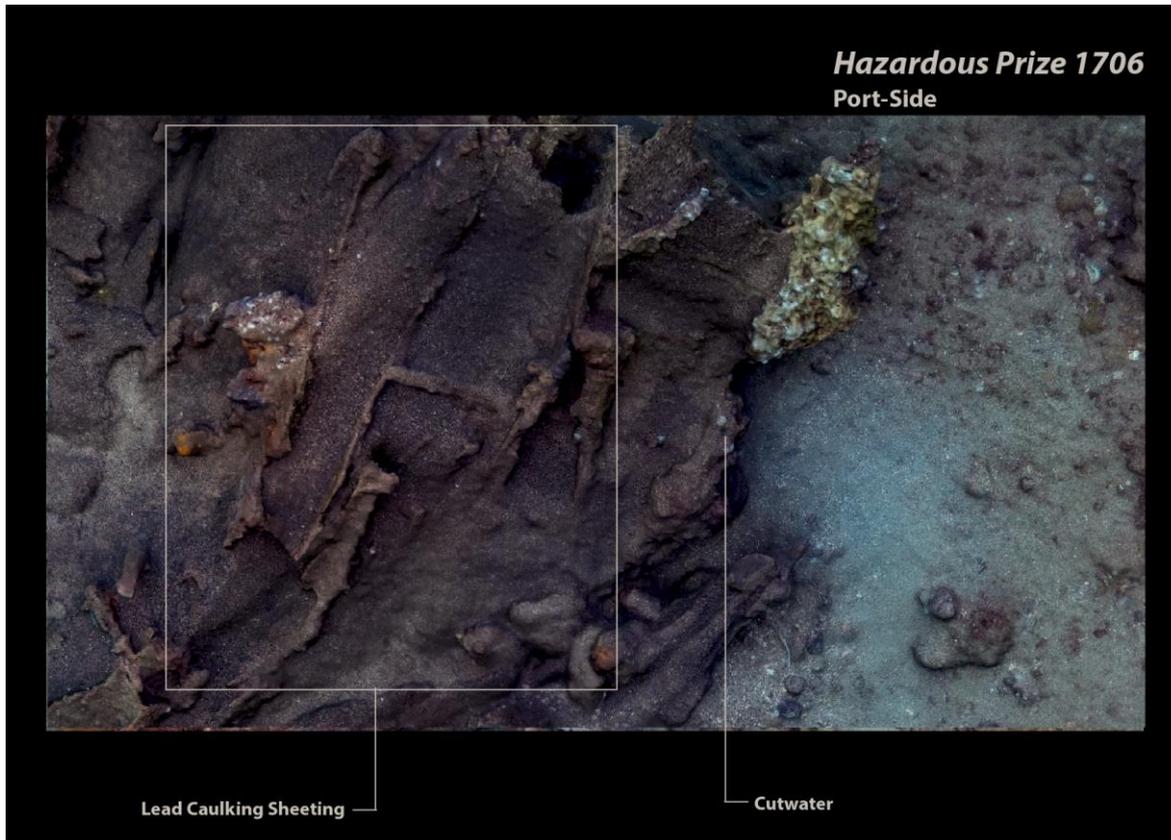
Figure 40. The image shows lead caulking sheeting at the bow section of the wreck. The image was generated with photogrammetry in Photoscan Agisoft Pro® and rendered in 3DsMax®. The pictures were previously colour corrected with Adobe Lightroom® the image was edited in Adobe Photoshop® and Adobe Illustrator ® by the author of this thesis.

The use of lead caulking was abandoned shortly after *Hazardous* wrecked, as these lead strips are not commonly found on other wreck sites of the 18th century. Another particularity of the *Hazardous* is the lead plates found between the inner and outer planking on the bow breast hook and other sections around the wreck (Figure 40 and Figure 41).

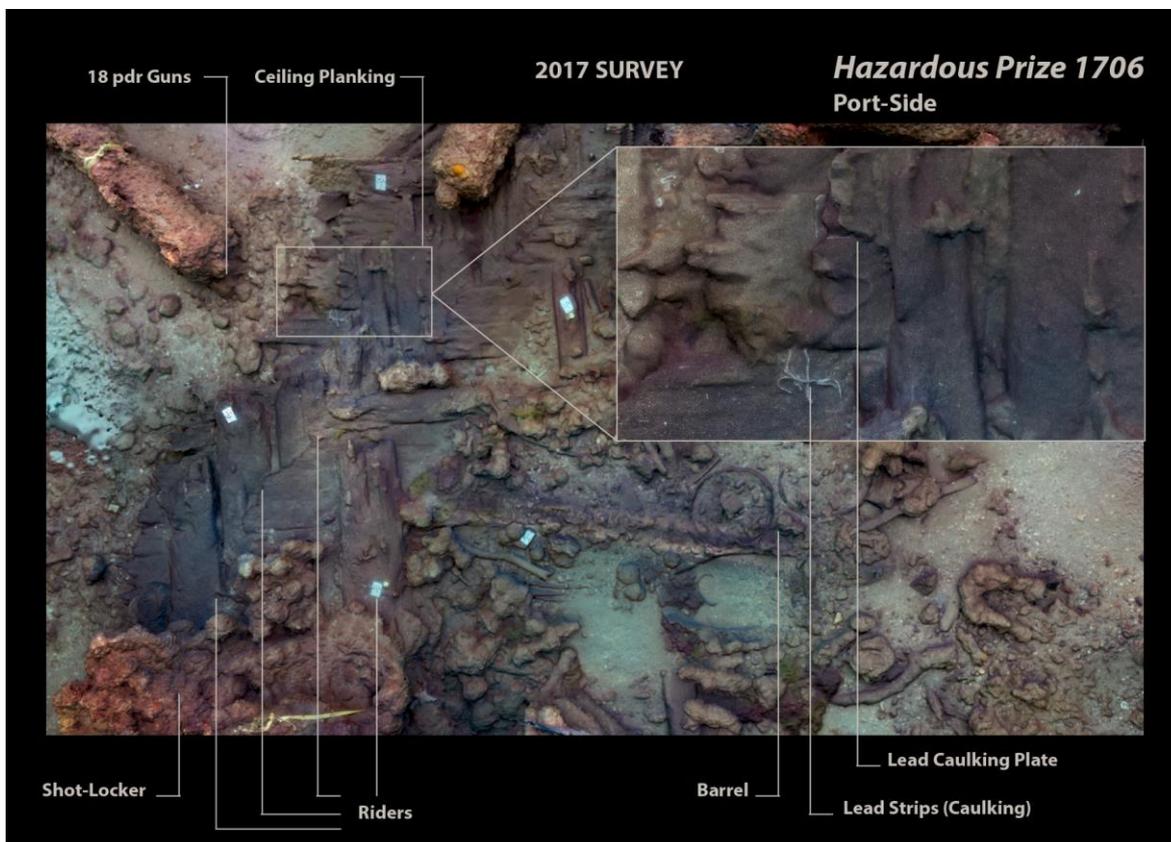
Figure 41. The image was generated with photogrammetry in Photoscan Agisoft Pro® and rendered in 3DsMax®. The pictures were previously colour corrected with Adobe Lightroom® and the image was edited in Adobe Photoshop® and Adobe Illustrator ® by the author of this thesis.

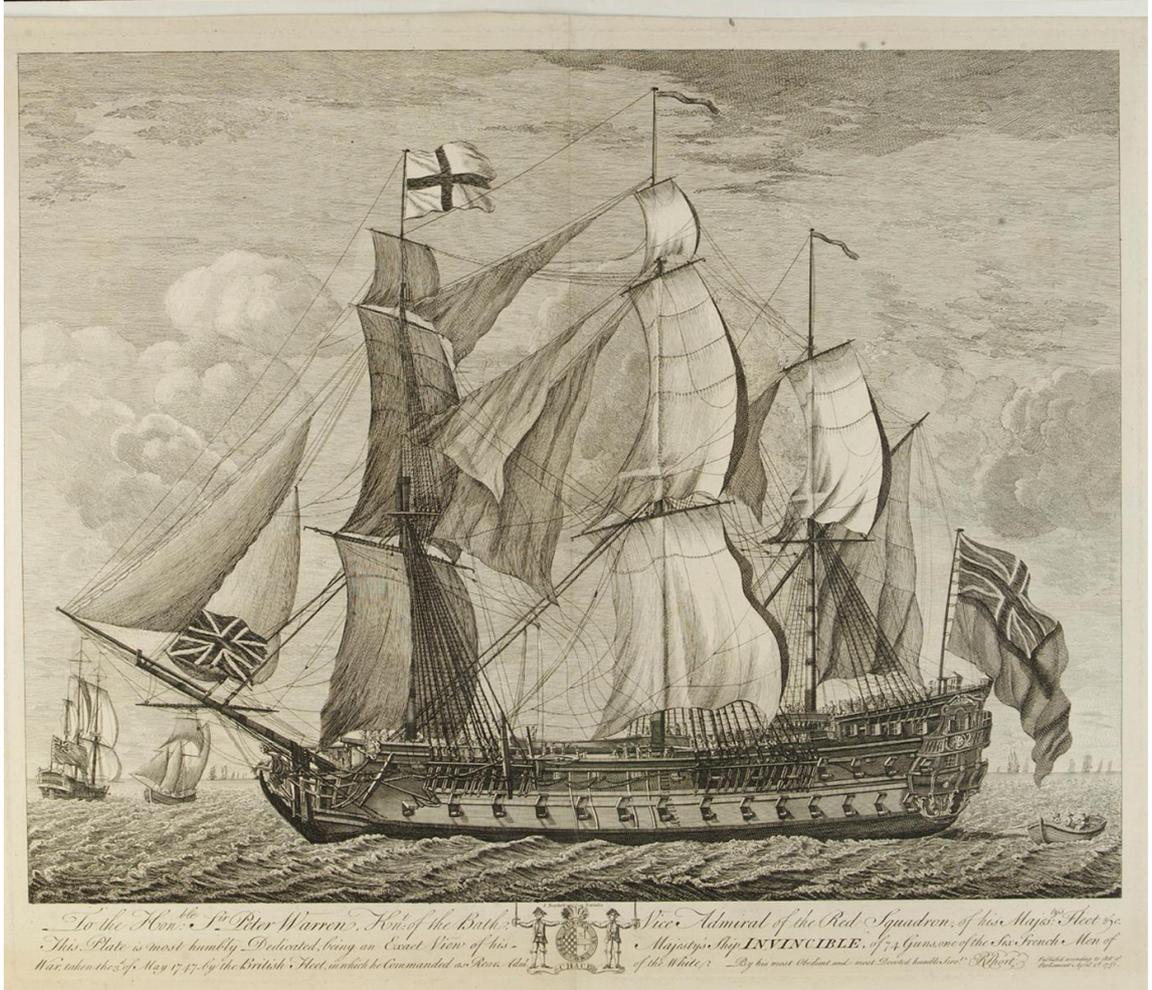
Figure 102. NMM. Top illustrations show details and decorations on bow and stern (Fincham 1851:84–85). While the illustration on the bottom shows HMS *Invincible* with full rigging (Mynd, Boydell, and Short 1747). The author of this thesis created the figure.

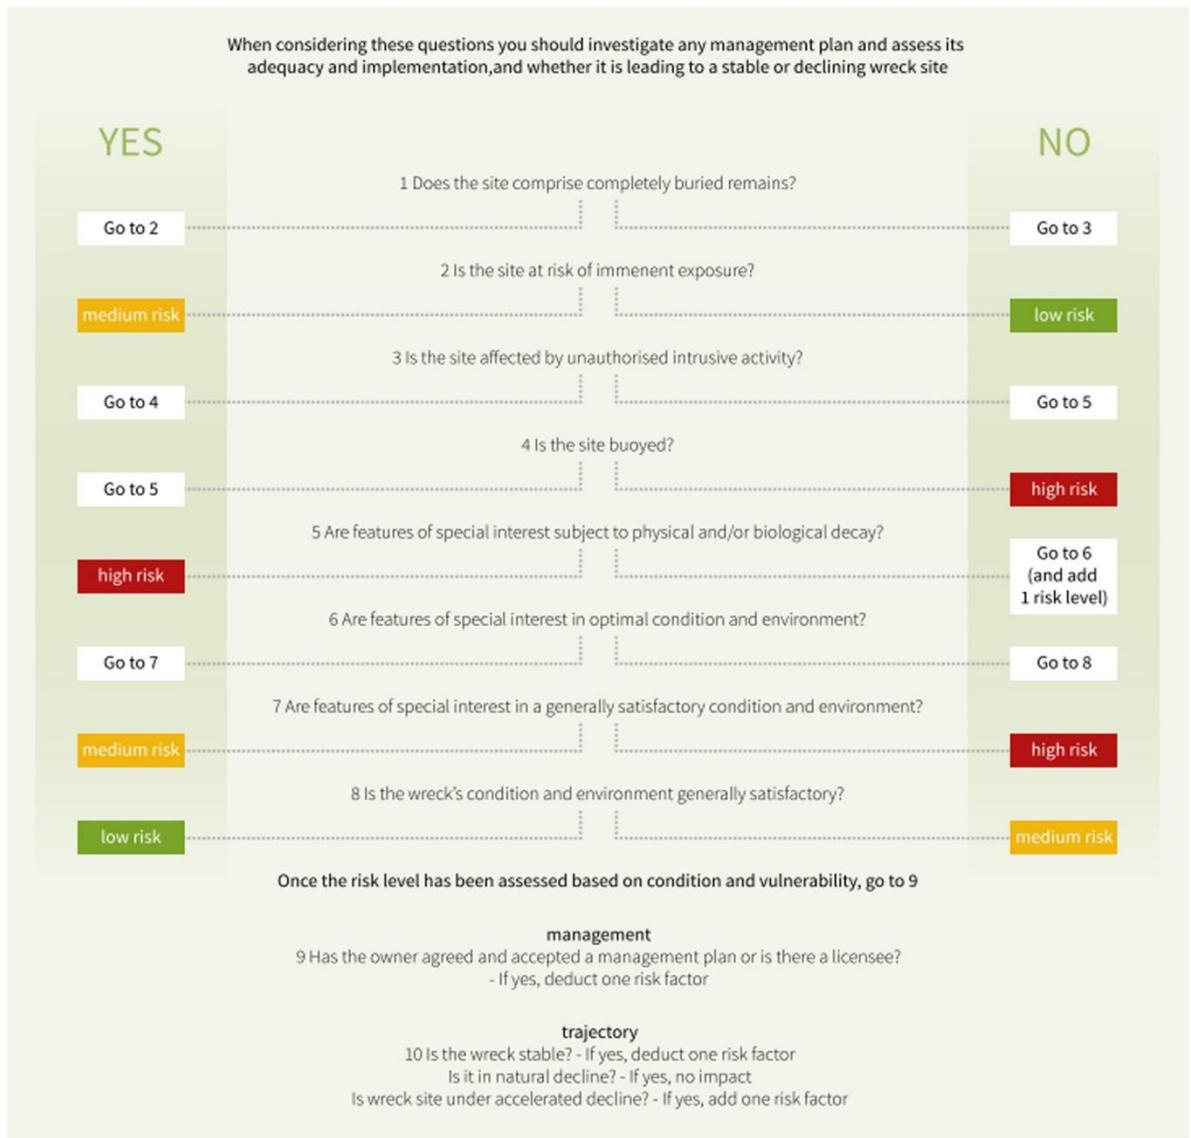
Figure 1. HE Risk Assessment decision-tree (HE 2017:14)

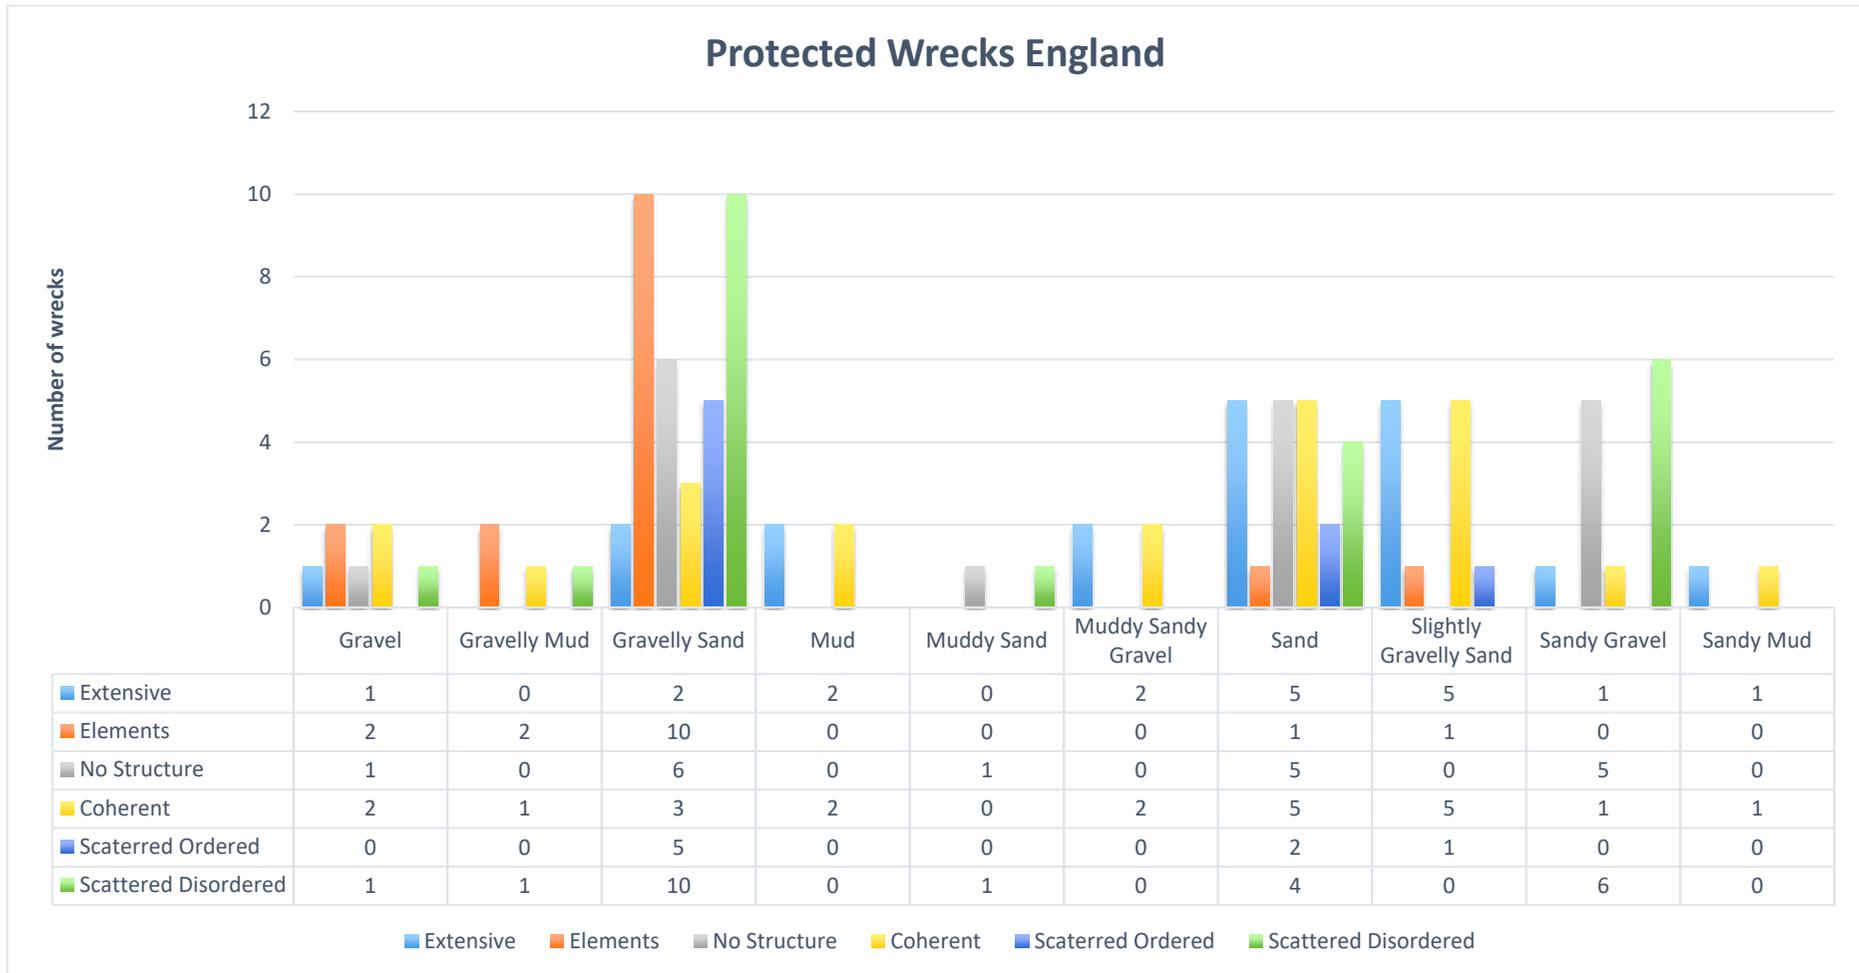
Figure 5. The graphic shows the number of Protected Wrecks in co-relating the seabed substratum in relation to structural integrity and distribution on the seabed.

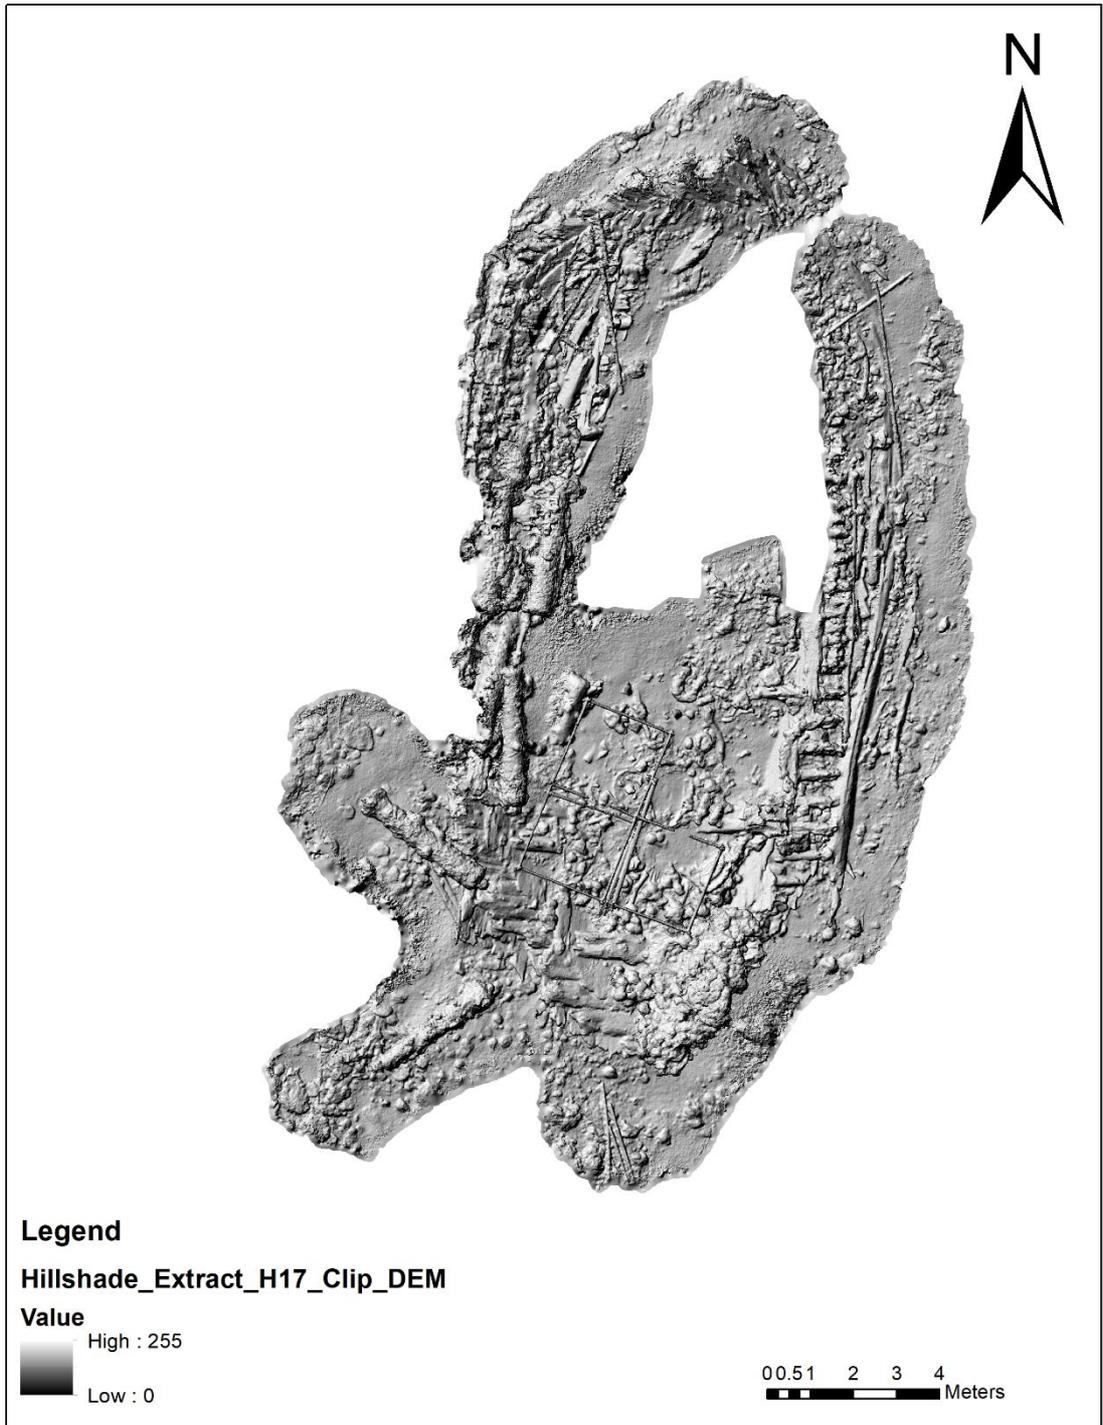
Figure 46. The figure presents a Hillshade of DEM from the 2017 survey, showing changes in the main area of the wreck site. The author of this thesis created the map in ArcMap10.5 ®

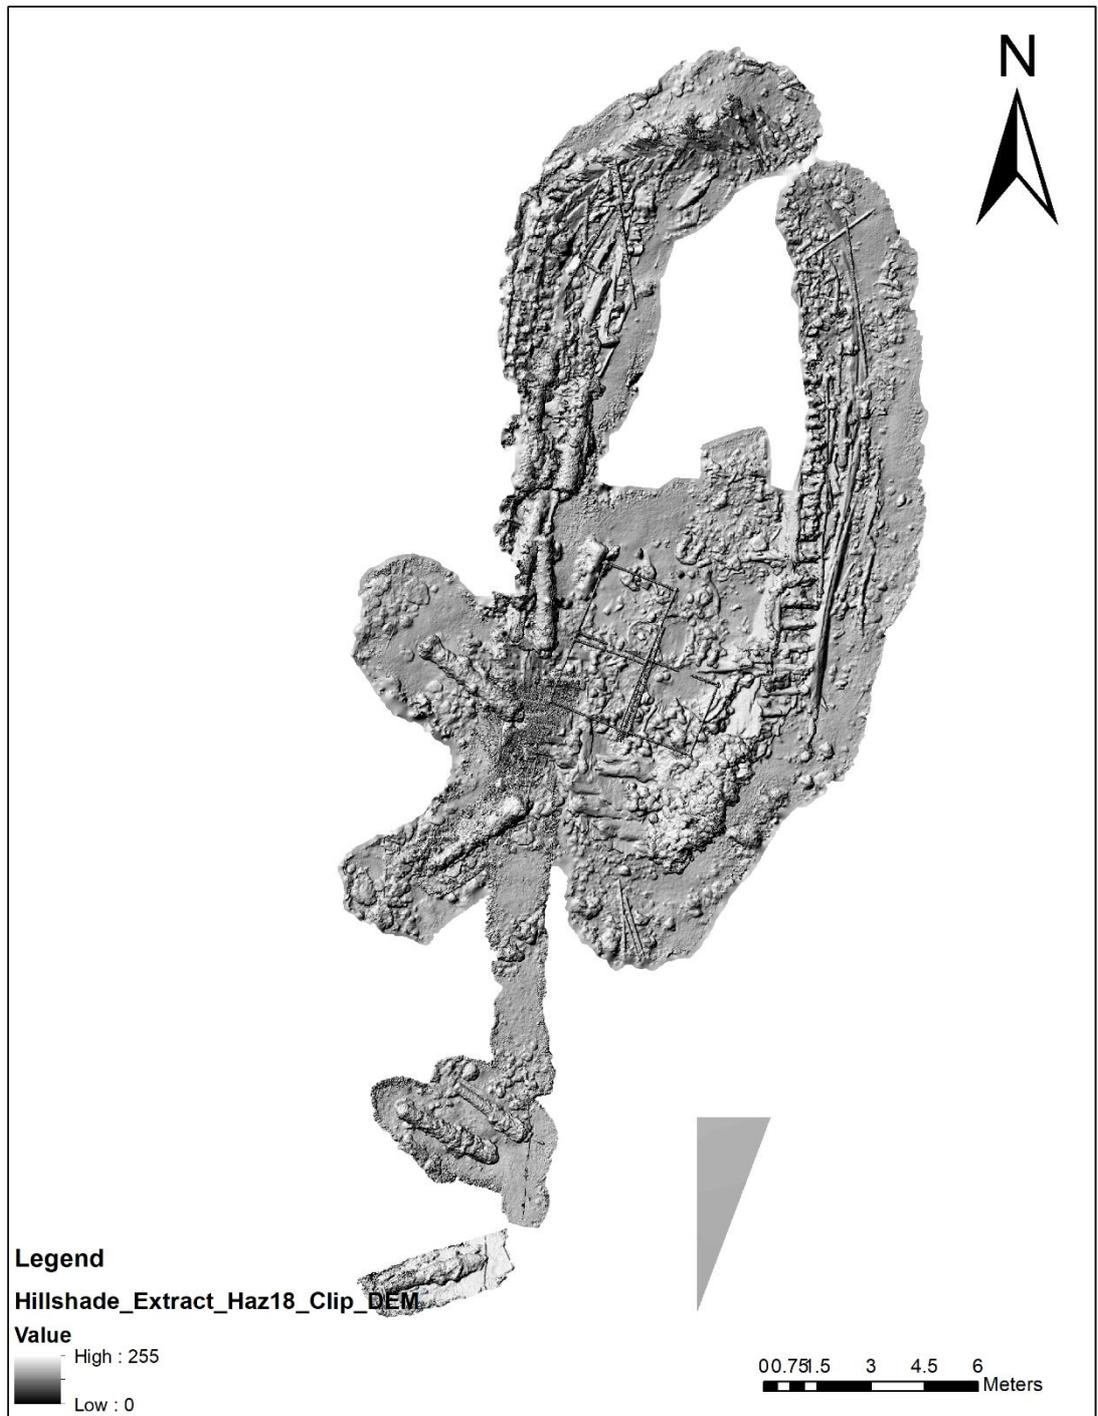
Figure 48. The figure presents a Hillshade DEM from the combined 2017 and 2018 surveys, showing changes in the main area of the wreck site. The author of this thesis created the map in ArcMap10.5®

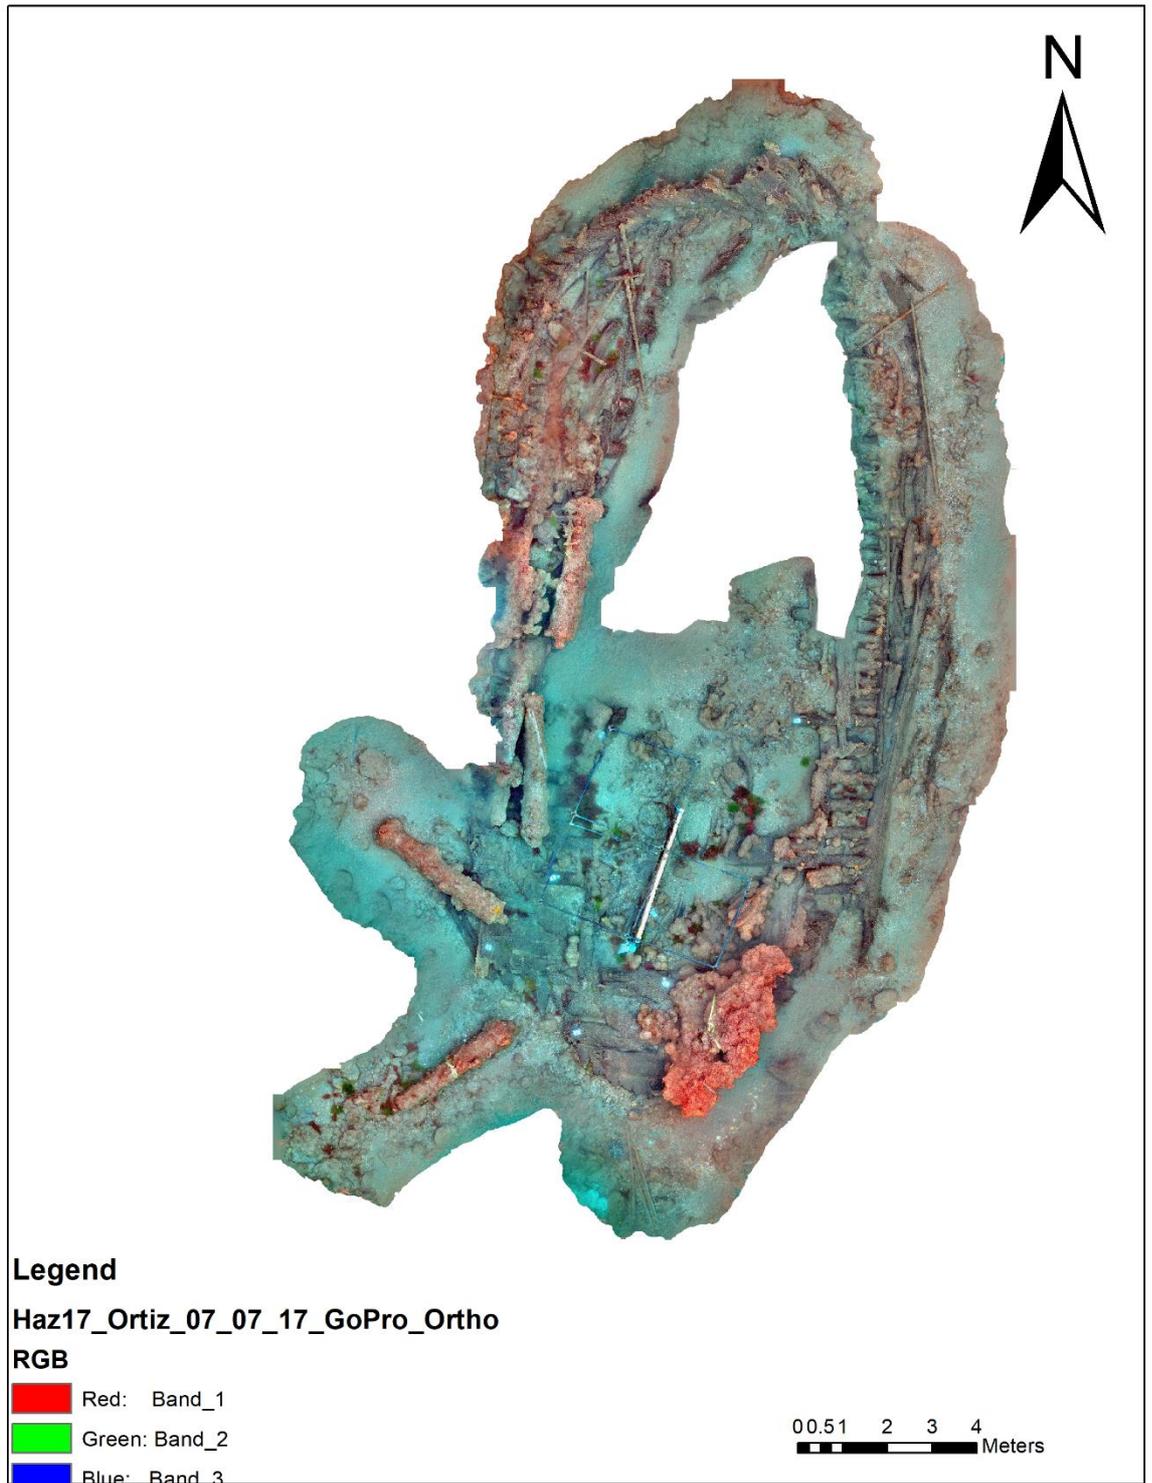
Figure 49. The figure presents an orthophoto from the 2017 survey, showing changes in the main area of the wreck site. The author of this thesis created the map in ArcMap10.5 ®

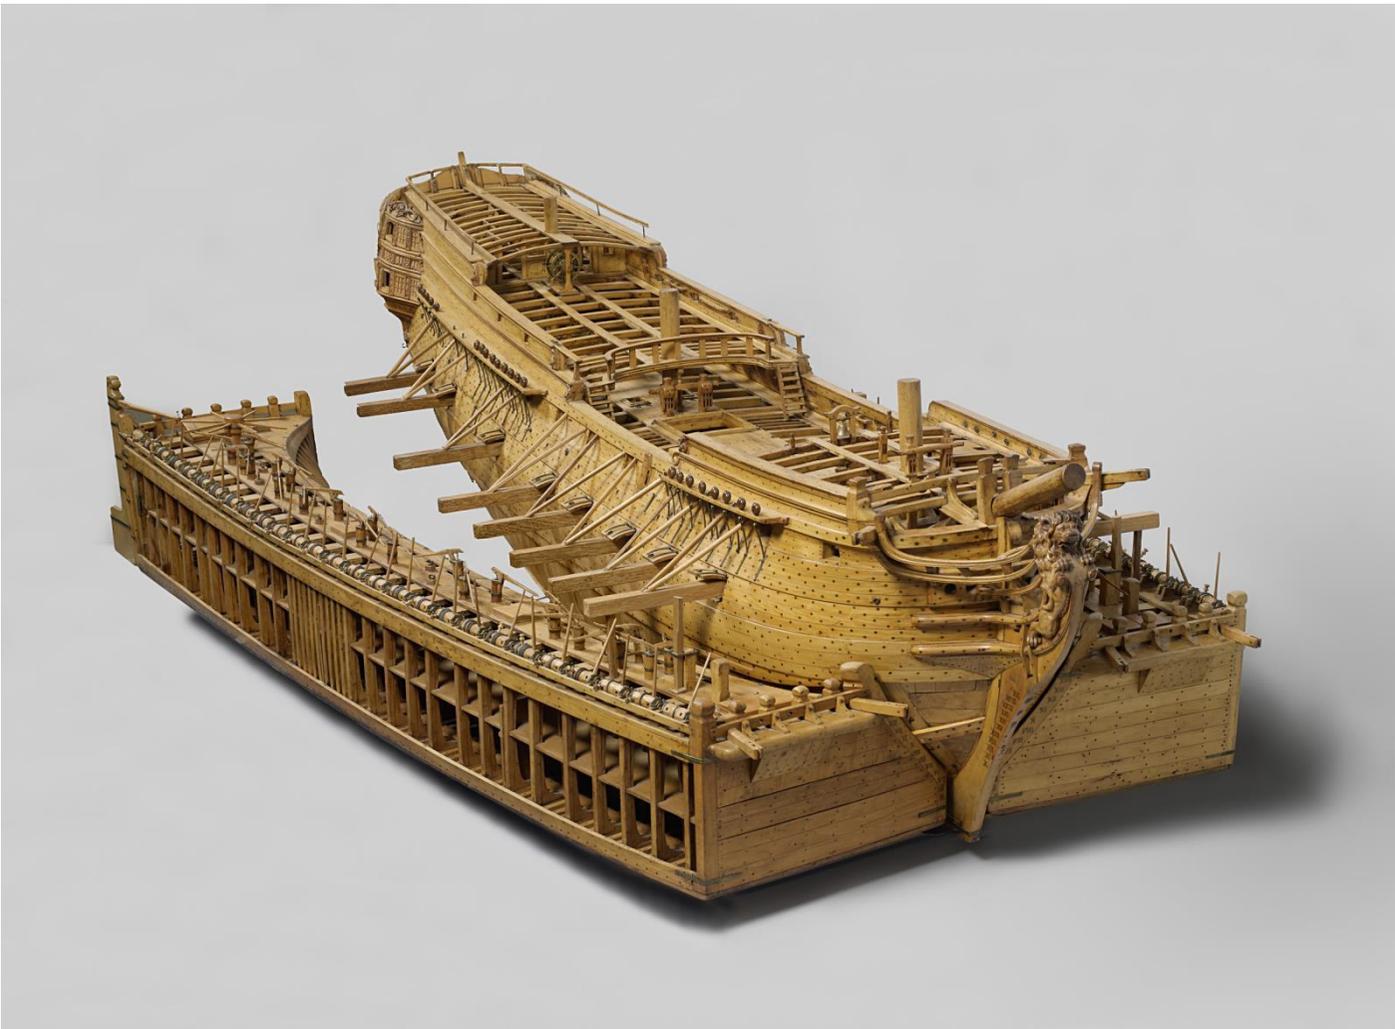
Figure 56. Boat model based on Charles Bentam 151 ft VOC *retourschip* (Bentam 1742a, 1742b). The original boat model is held at the Rijksmuseum, Amsterdam.

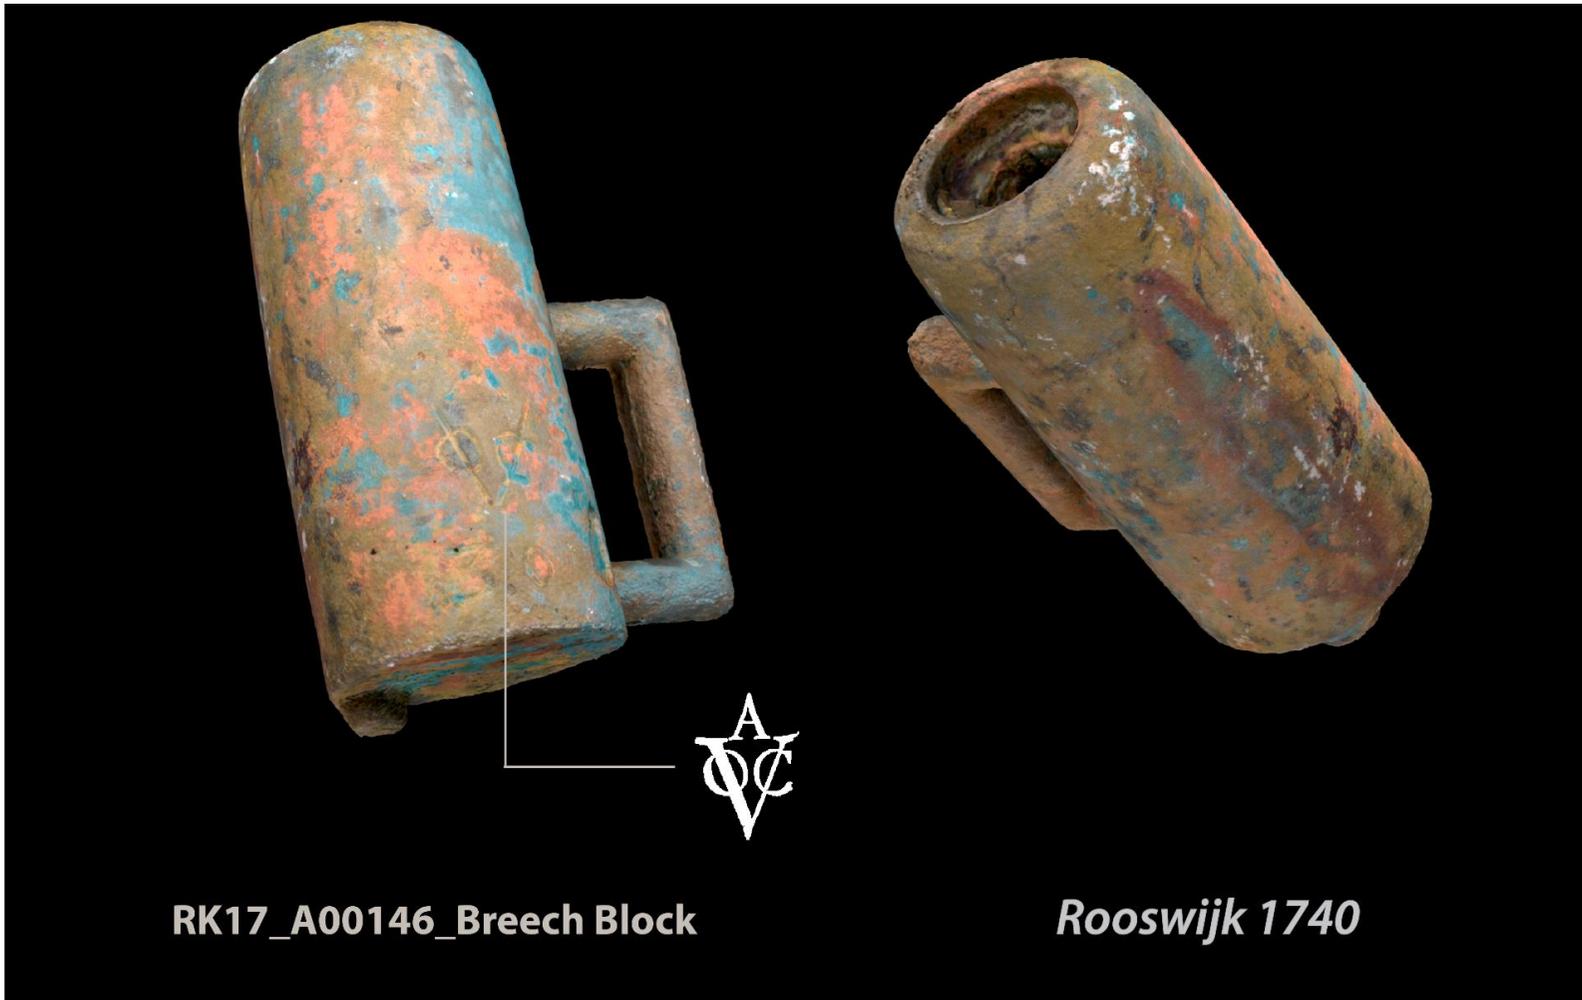
Figure 80. The figure a breech block used to load a bronze gun. The author of this thesis recorded the artefact and rendered the images in 3dsMax®. The images are used with the kind permission of the *Rooswijk 1740* project.

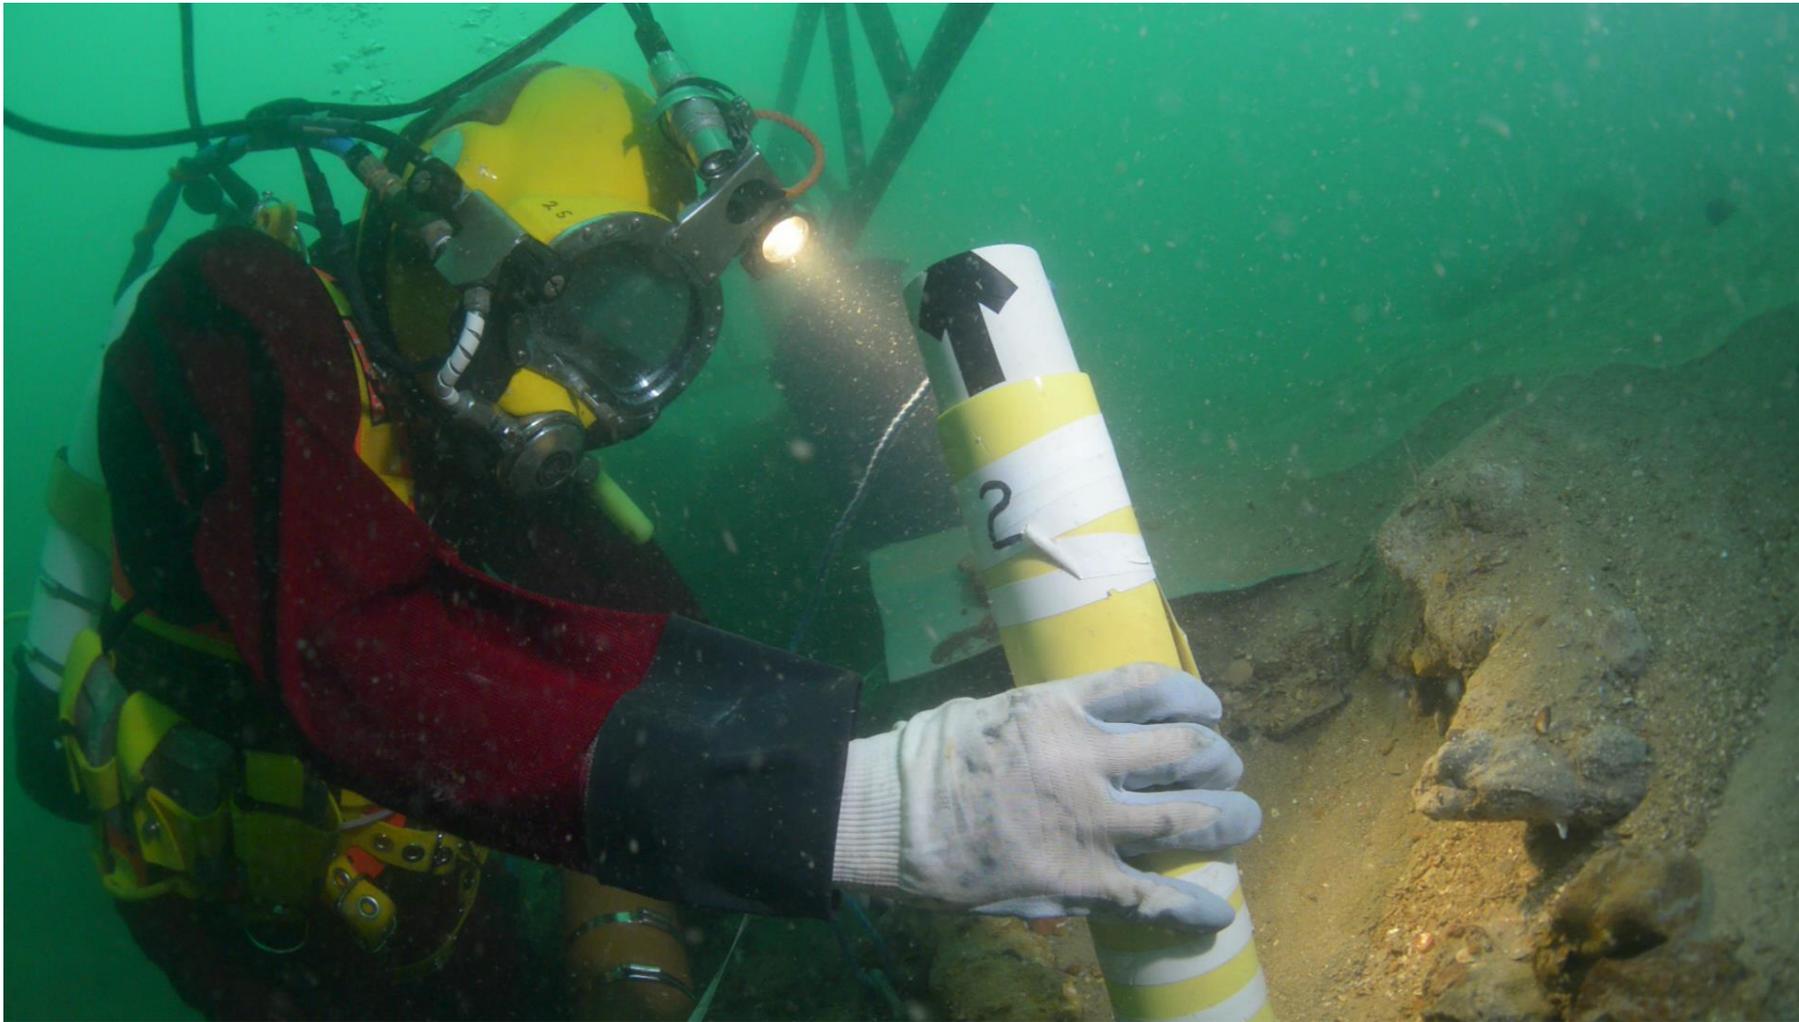
Figure 107. The image shows a diver positioning the oil lamp with a USBL system. The image is courtesy of Michael Pitts, kindly provided the *Rooswijk* Project 1740. The author of this thesis processed the picture.

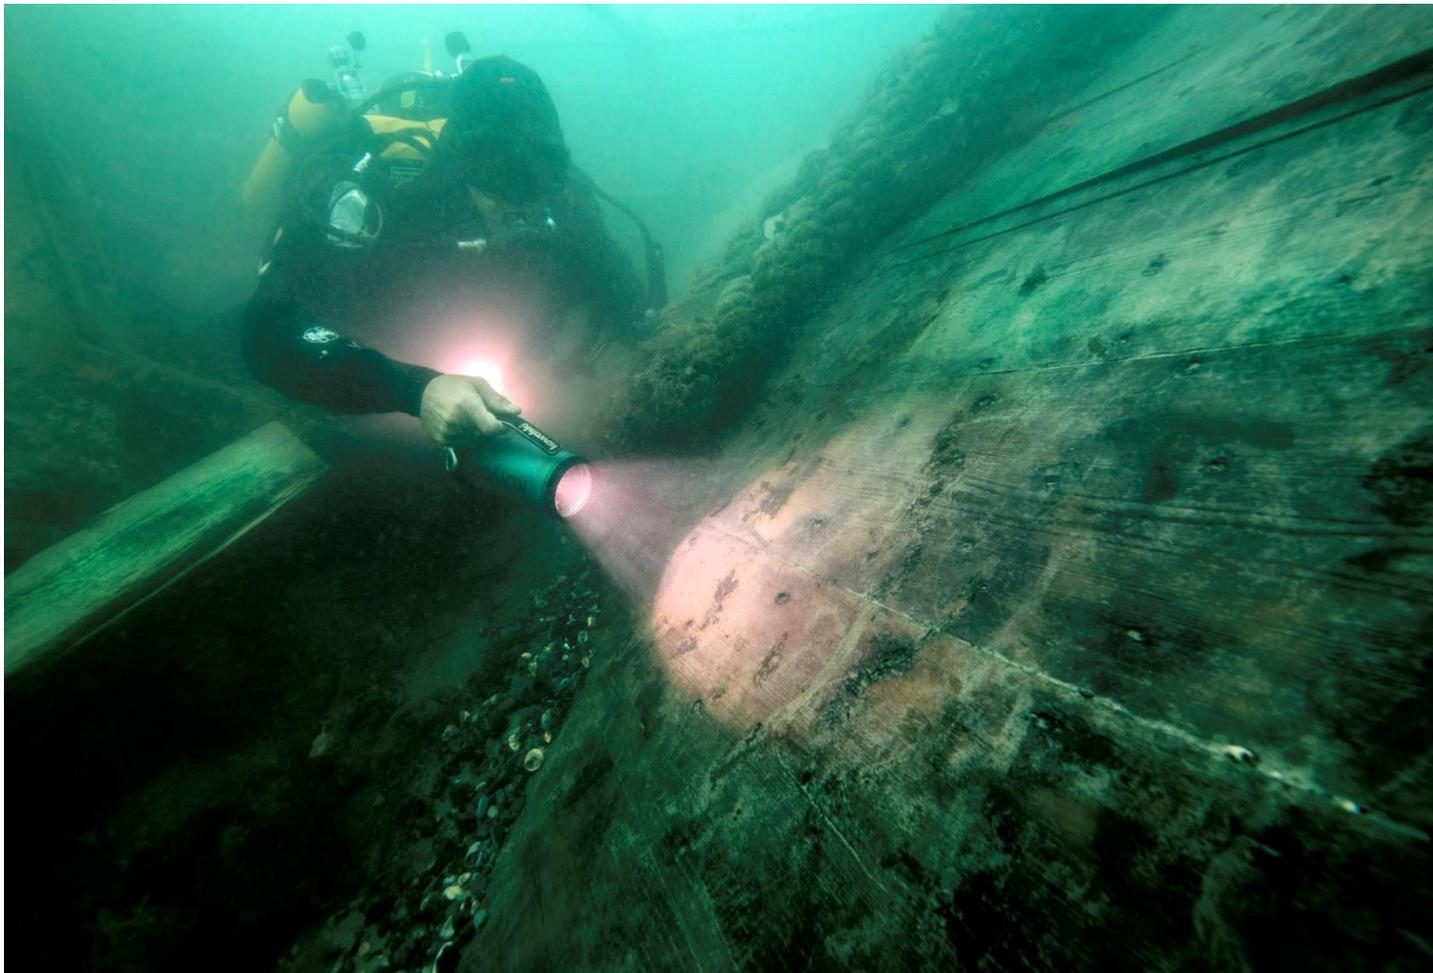
Figure 124. The image shows part of the Gun Stores in Area 1 close to the bow, in the stores exposed in 2017. The image is courtesy of Michael Pitts, kindly provided by BU and the Invincible 1744 Project.
