*An Integrated Methodology to Study Site Formation
Processes on Submerged Shipwrecks in the 21st c.*

By
Rodrigo Ortiz Vázquez

Thesis for the degree of Doctor in Archaeology

September 2018

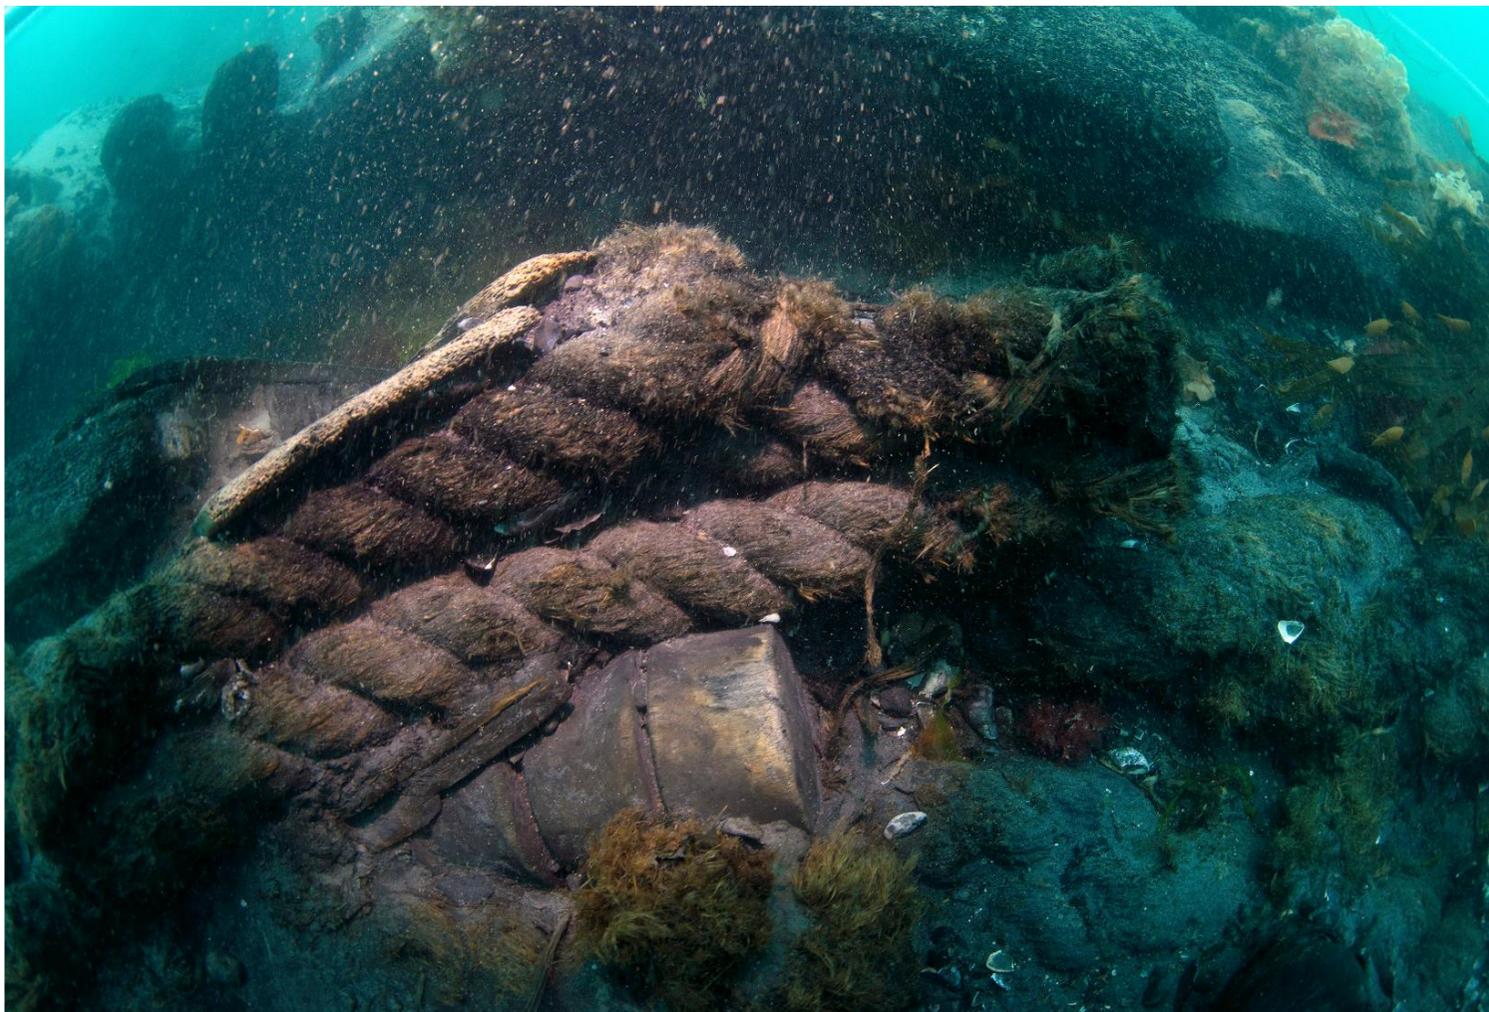
Figure 125. The image shows part of the Orlop deck in Area 1 close to the bow, exposed in 2017. Michael Pitts took the picture. The image is courtesy of Michael Pitts, kindly provided by BU and the Invincible 1744 Project.

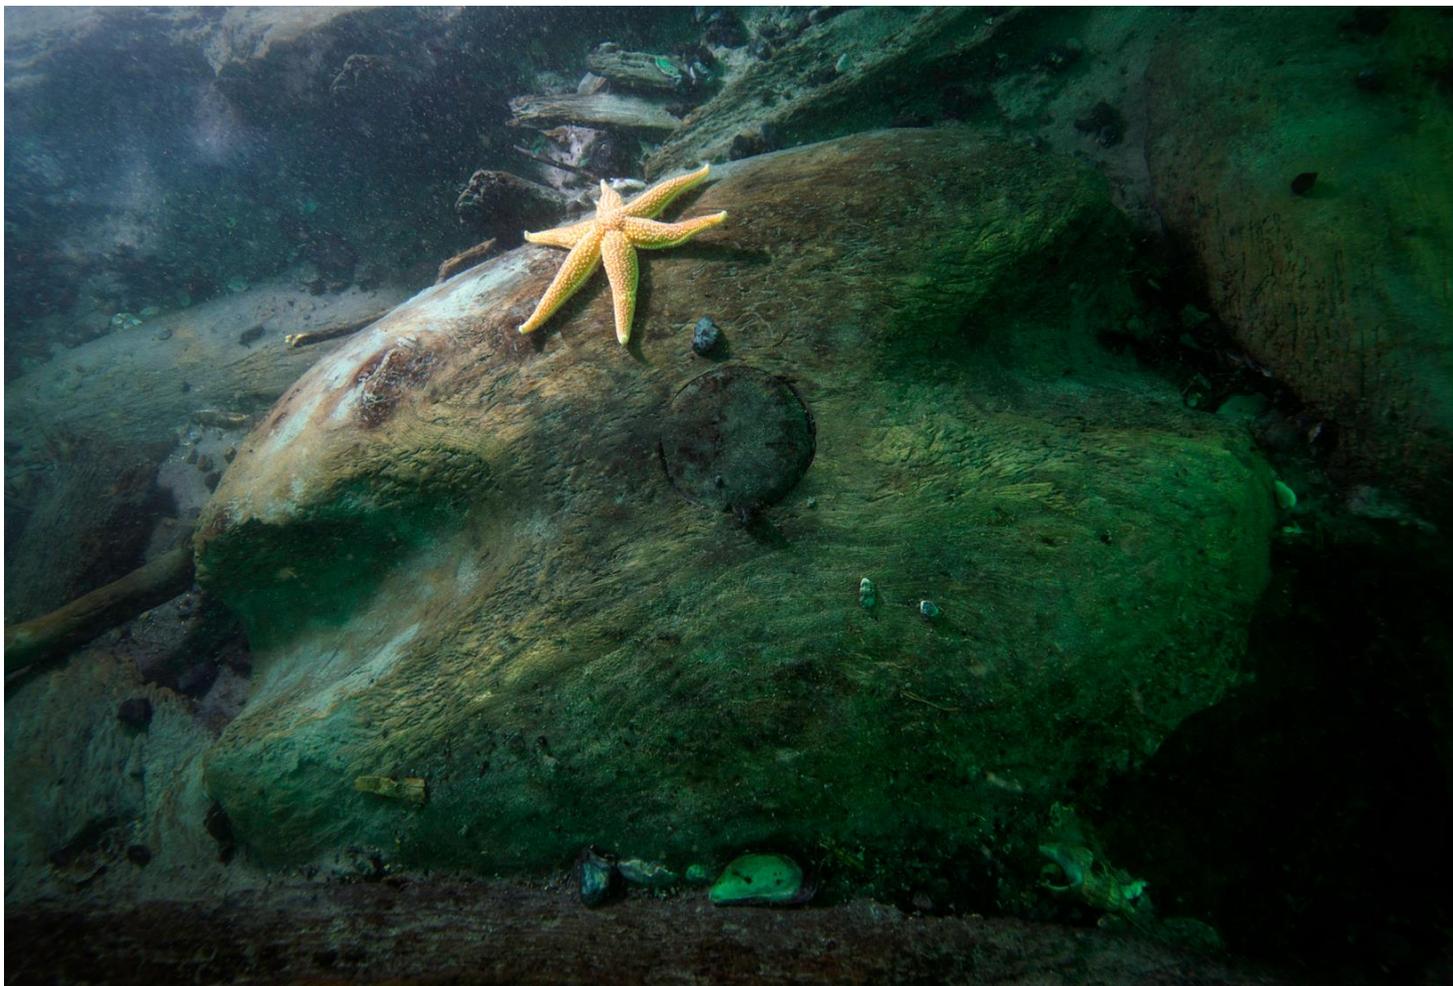
Figure 126. The image shows part of the pulley block found in the hold, close to the keel and stem, in the stores exposed in 2017. The image is courtesy of Michael Pitts, kindly provided by BU and the Invincible 1744 Project.

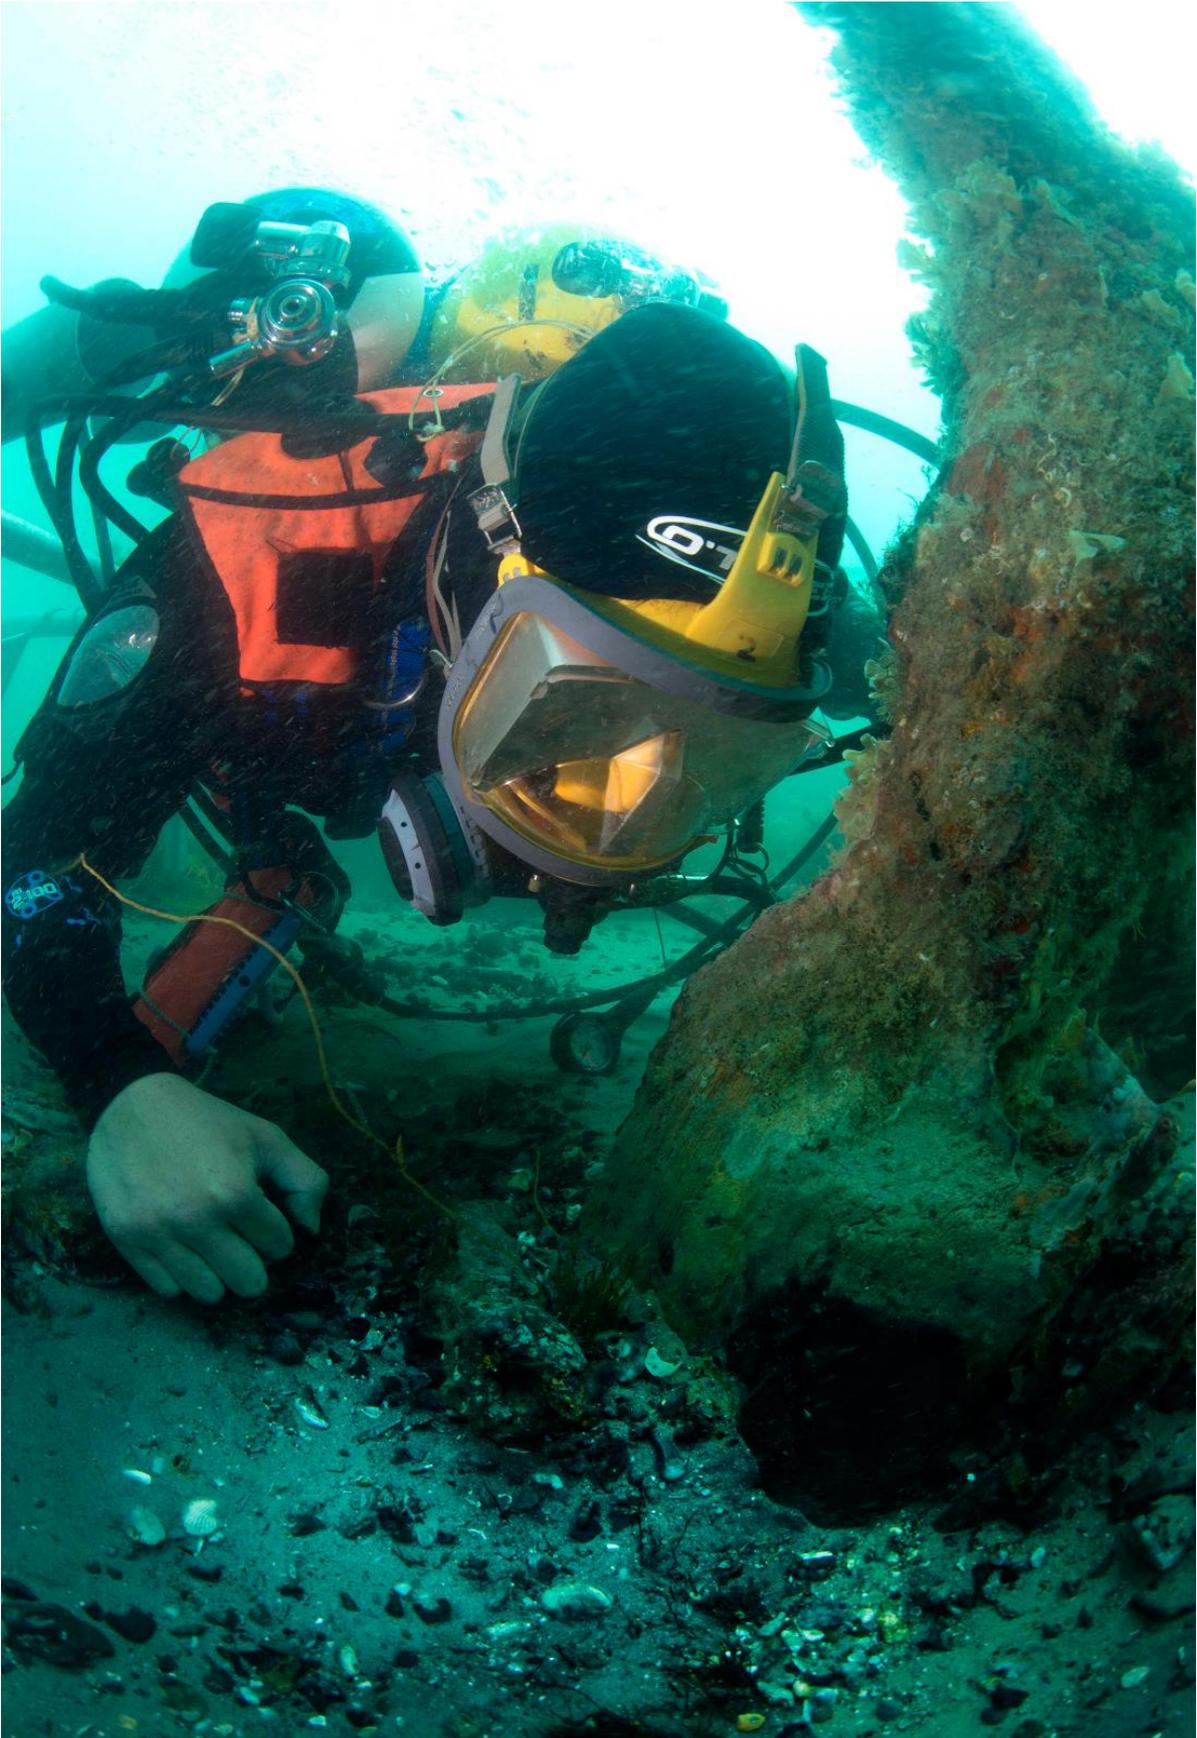
Figure 127. The image shows an iron knee supporting the gun deck, exposed in 2017. The image is courtesy of Michael Pitts, kindly provided by BU and the Invincible 1744 Project.

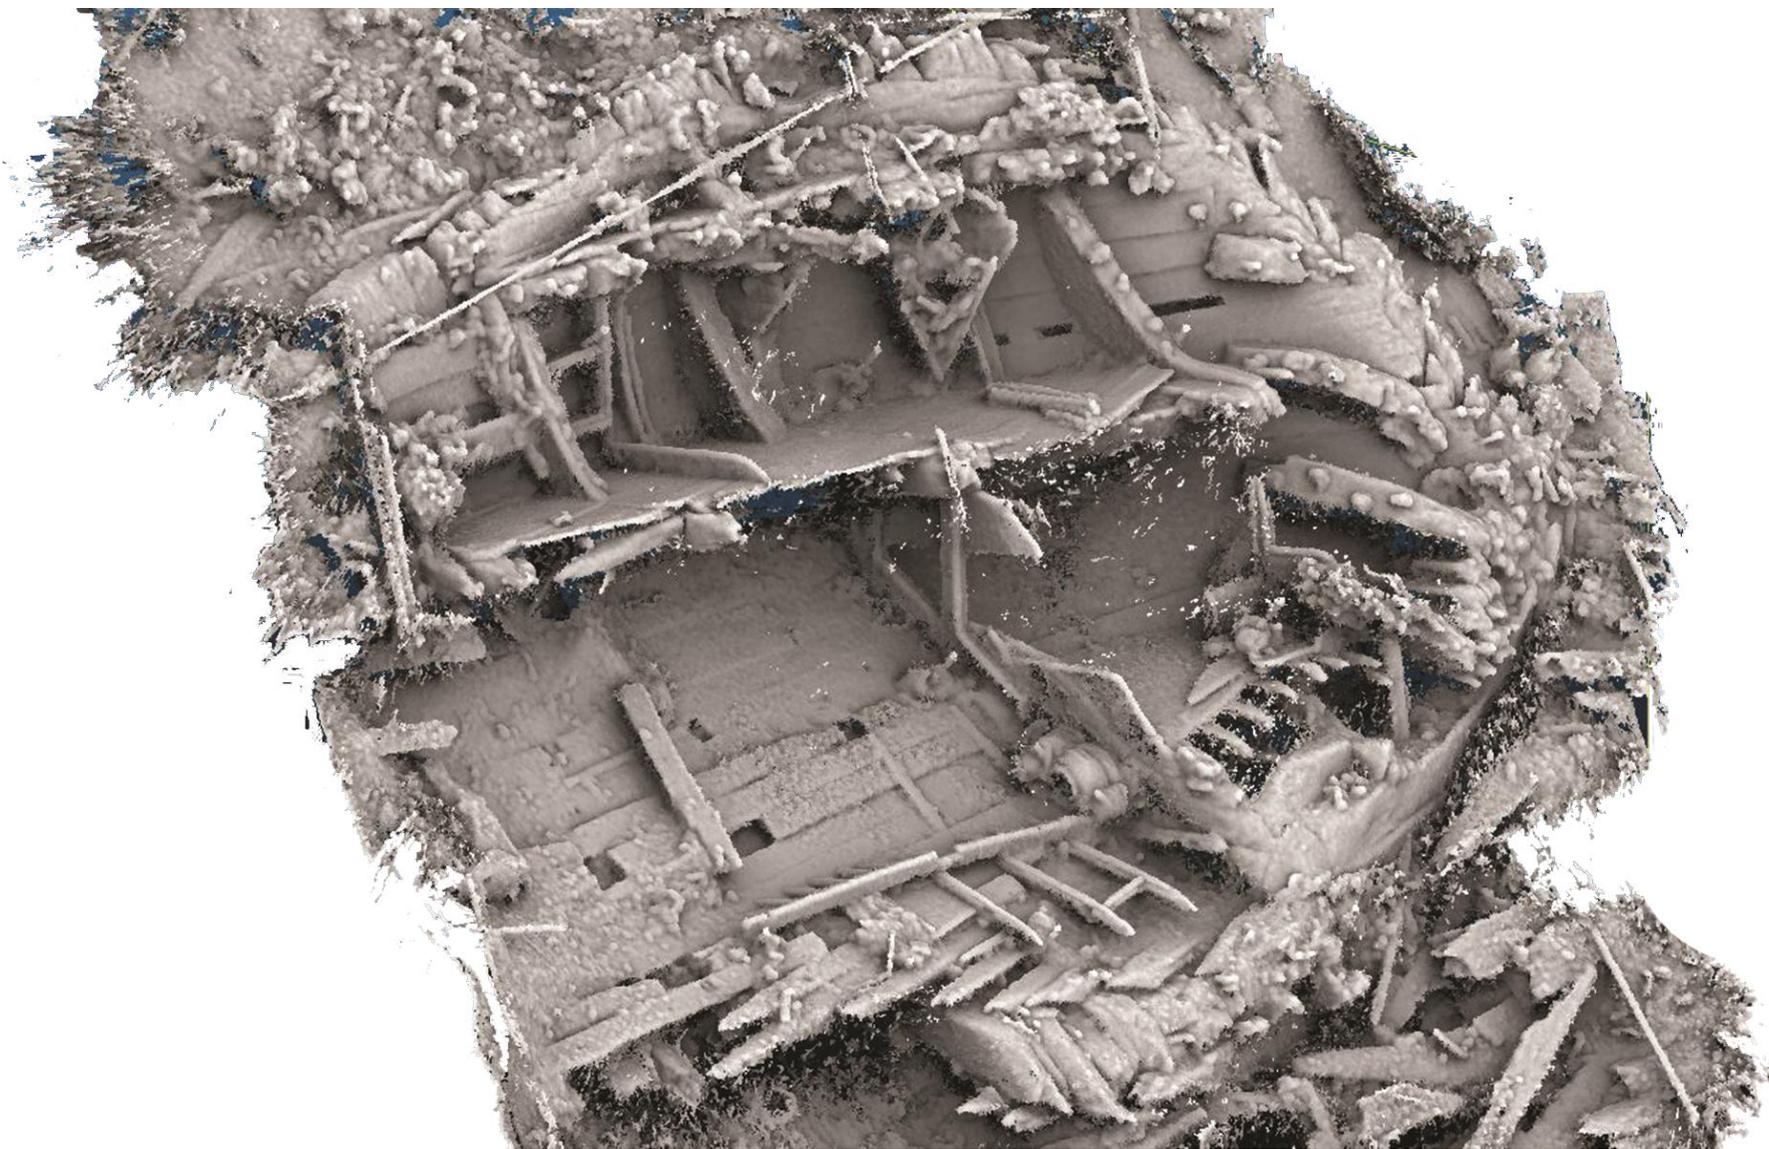
Figure 129. The figure shows a dense cloud of Trench 1, processed with PCV plug-in in Cloud Compare®. Set to the correct orientation, tilted on even keel.

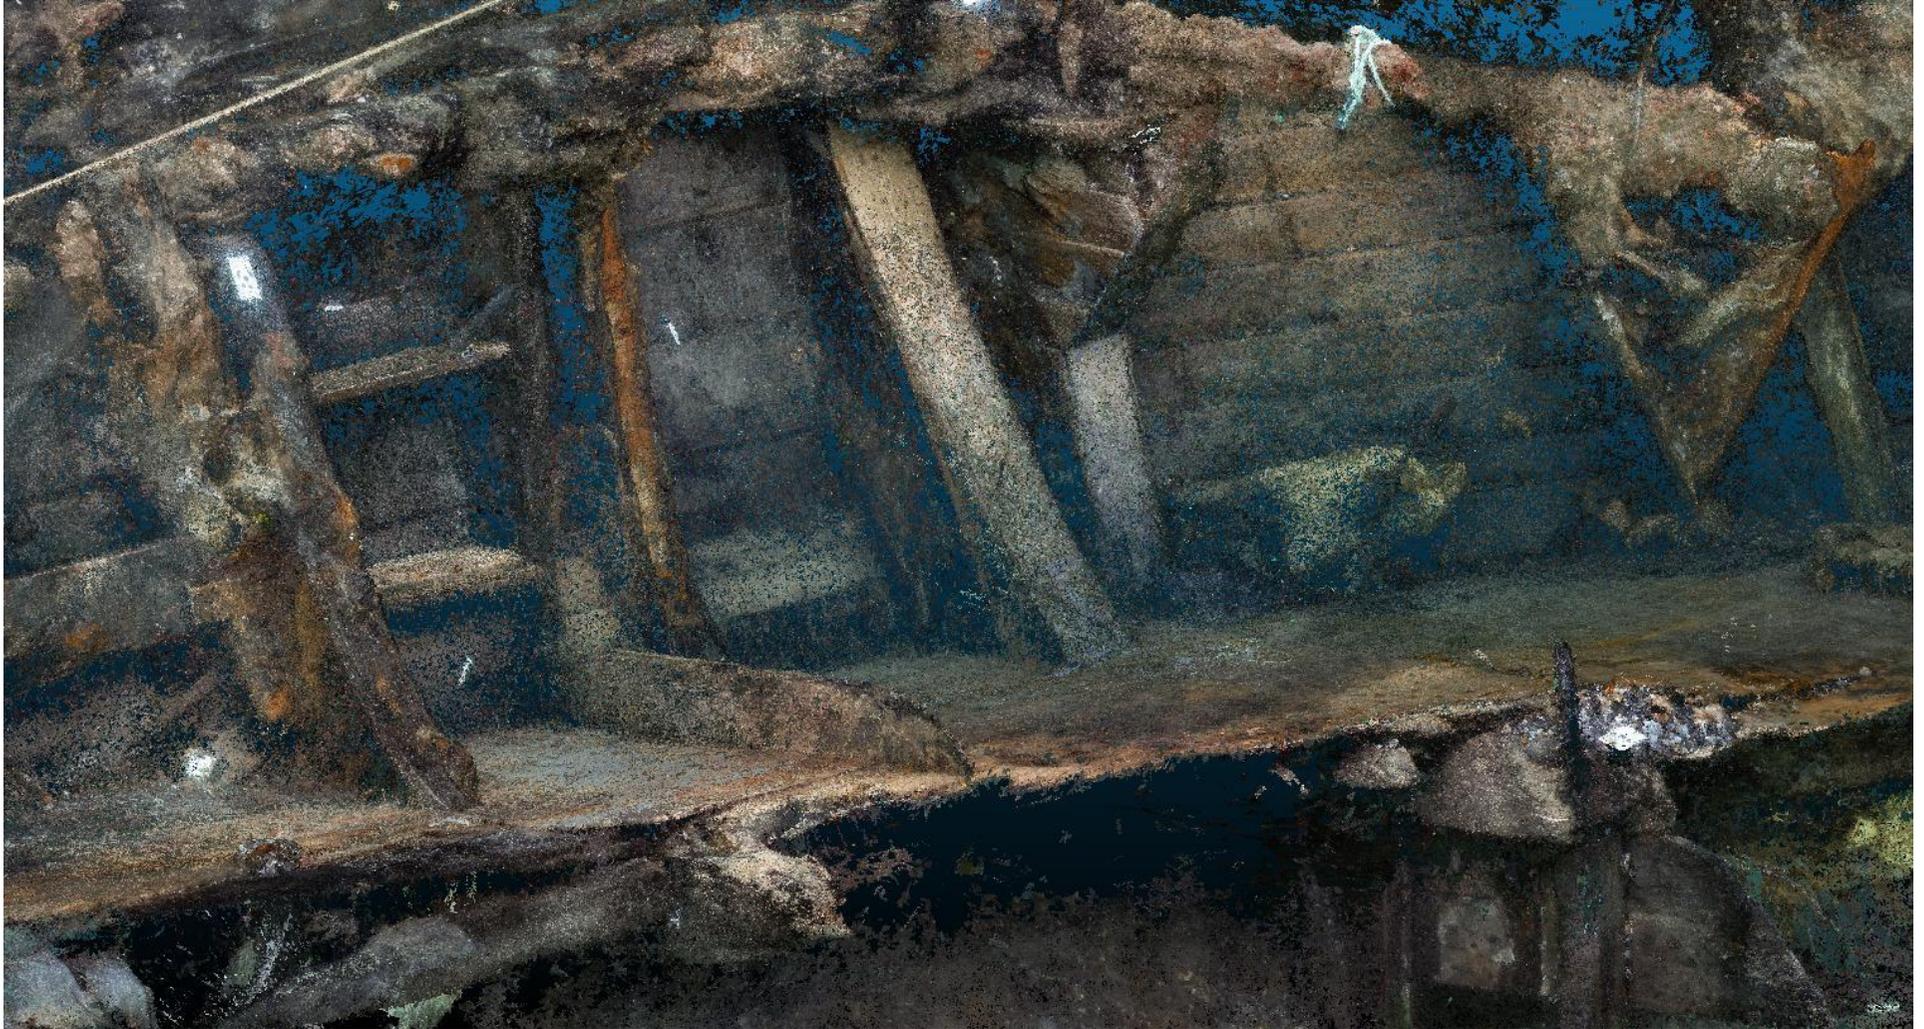
Figure 131. The figure shows close-up detail of a dense cloud of Trench 1, processed with RGB in Cloud Compare®. Set to the correct orientation, tilted on even keel.

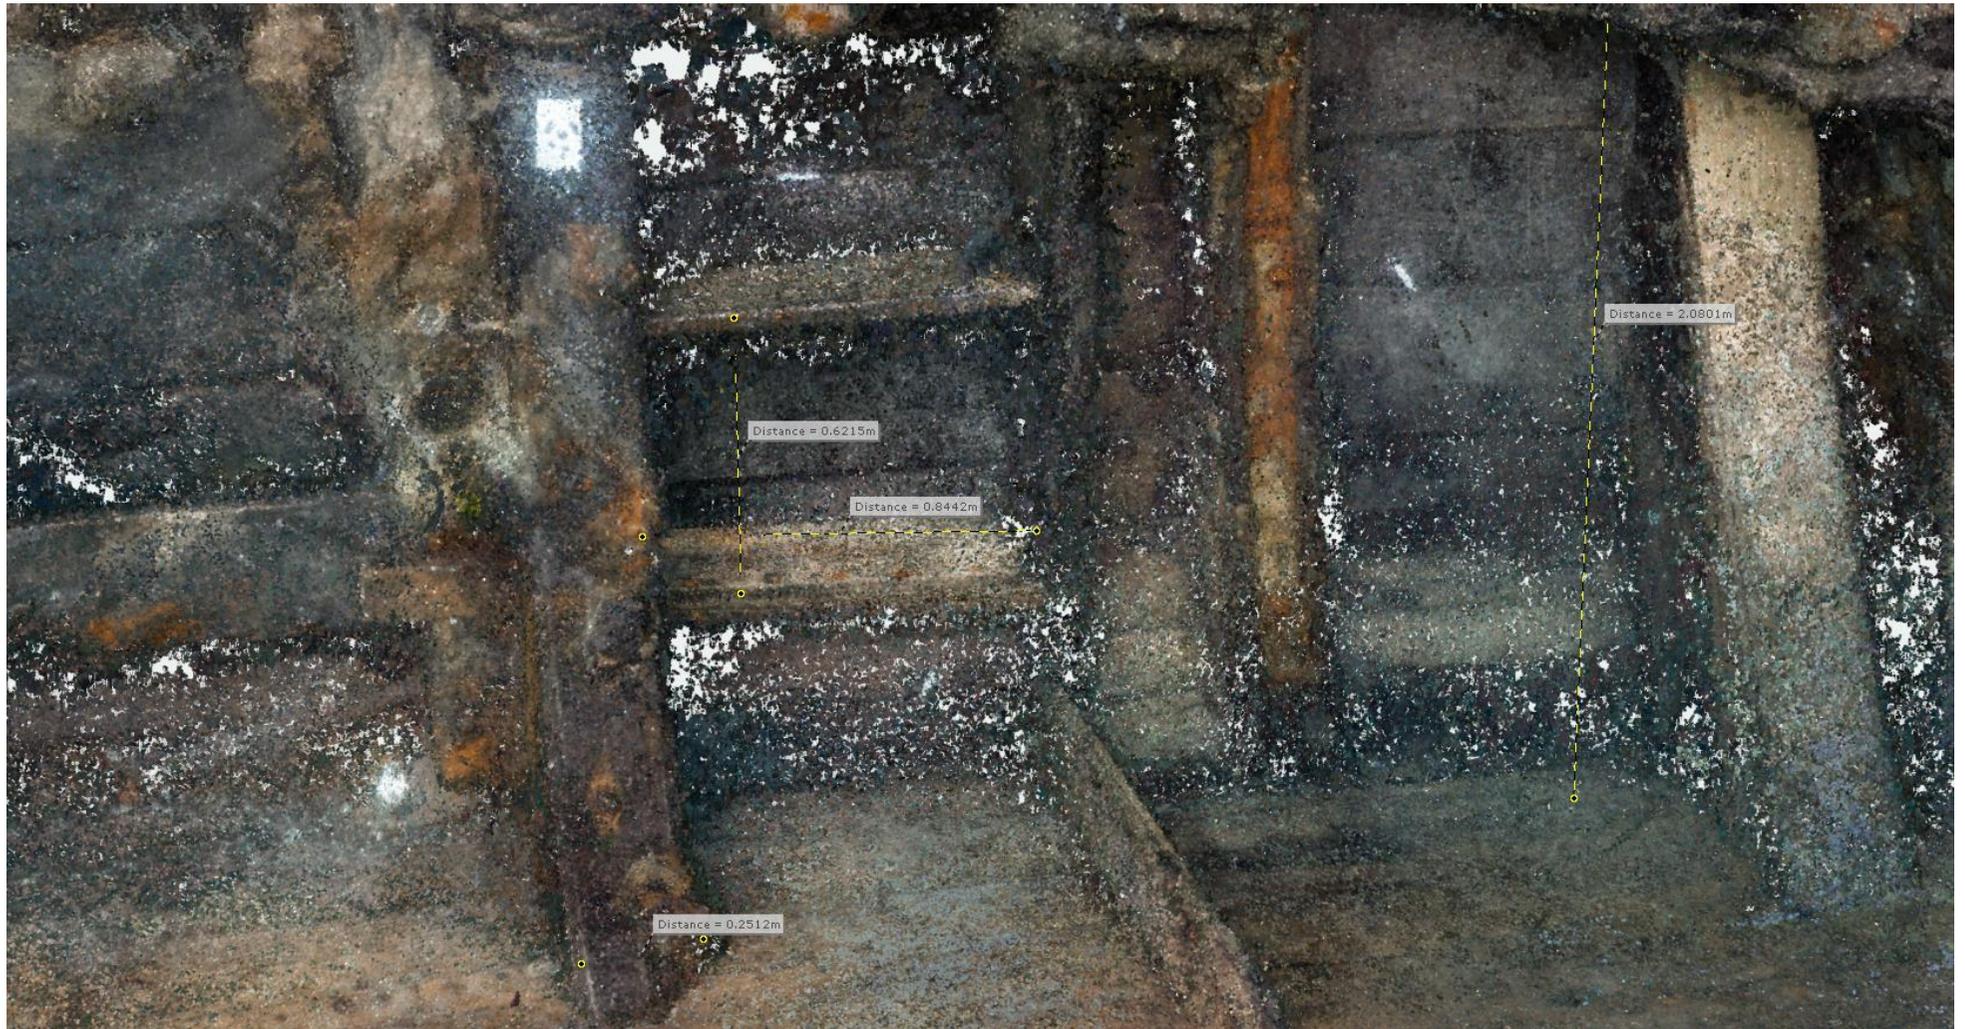
Figure 133. The figure shows a close-up of a dense cloud of Trench 1, processed with FaroScene™, set to the correct orientation, tilted on even keel. Showing measurements of the structure.

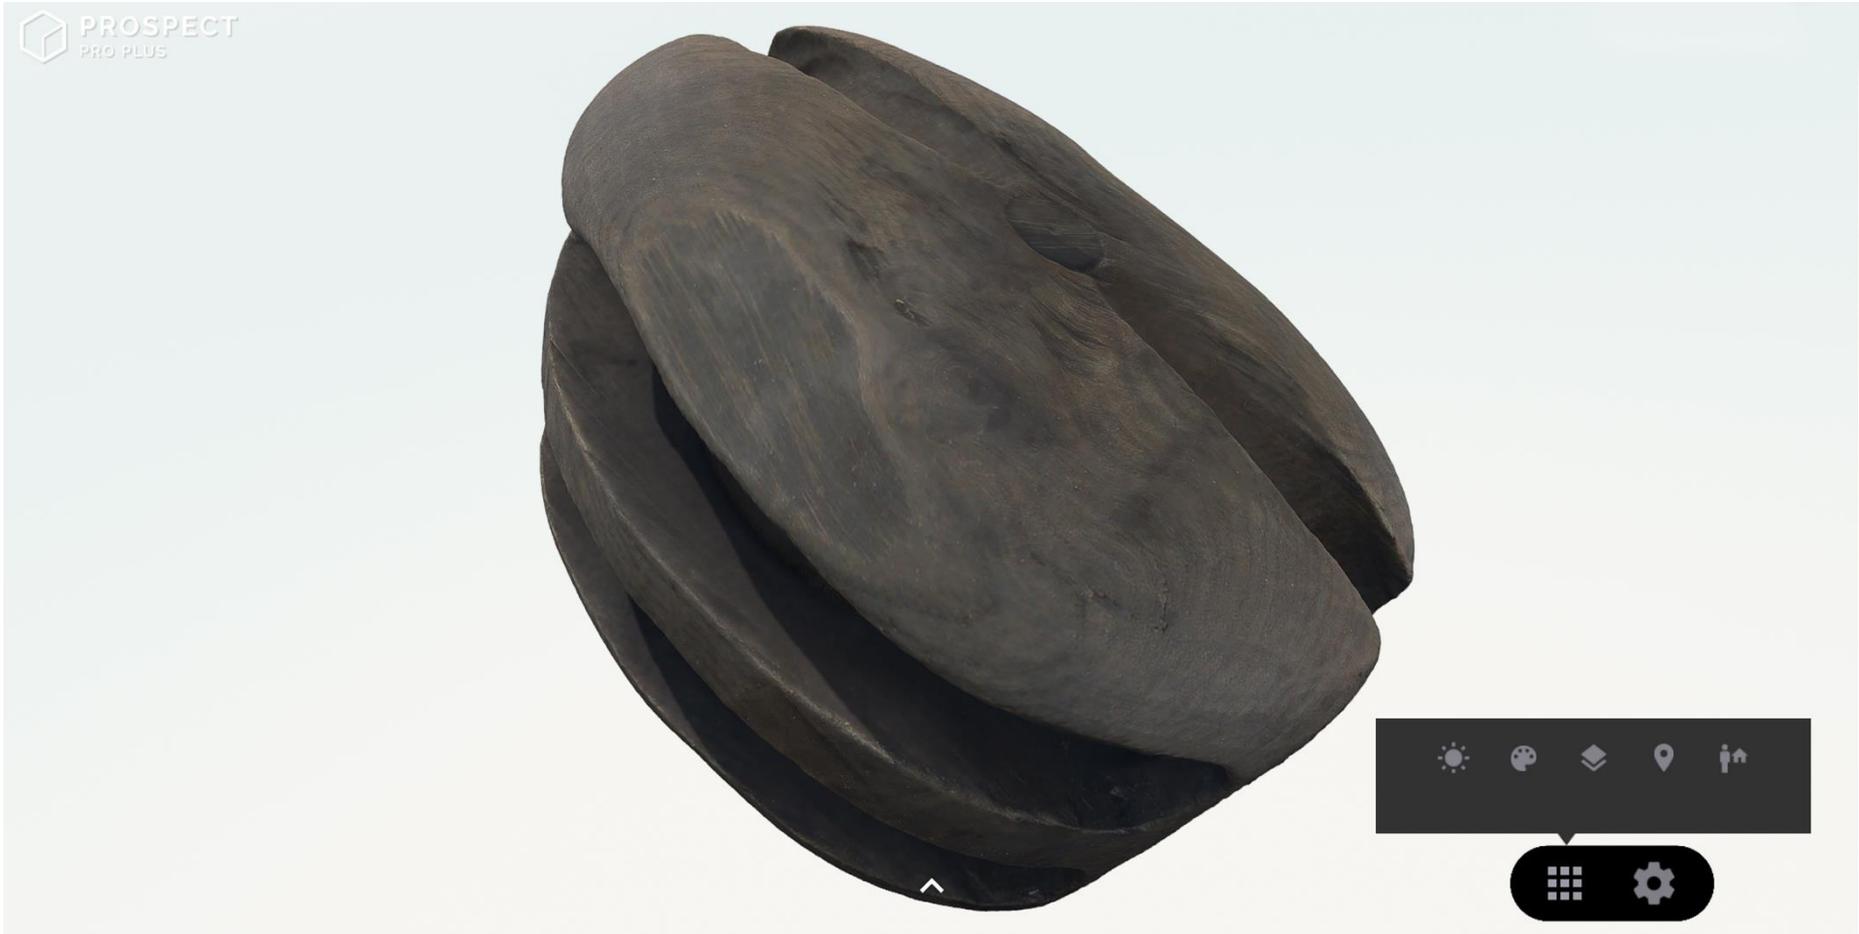
Figure 135. The figure shows a double pulley block in a VR environment. The figure was created by the author Prospect ProPlus®
