Nonlinear dynamic behaviour of severely corroded reinforced concrete columns: shaking table study

Xiao Ge¹ · Matthew S. Dietz¹ · Nicholas A. Alexander¹ · Mohammad M. Kashani²

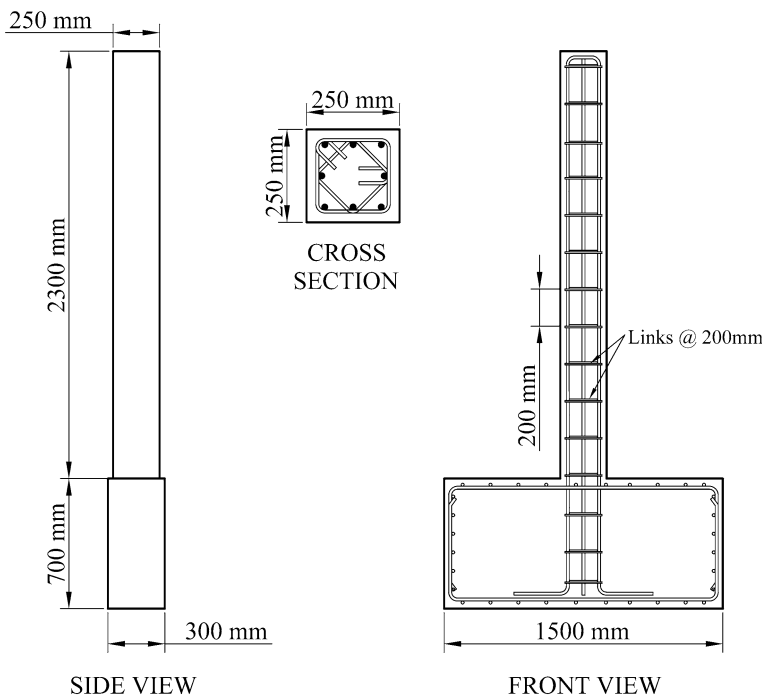
Fig. 1 Reinforcement details of experimental test specimens

aspect ratios. Eight reinforcing bars with a diameter of 16 mm are used in the vertical reinforcement. The transverse reinforcements are made of 8 mm diameter bars with 200 mm spacing along with the column height (as shown in Fig. 1). The ratio of the transverse bar/tie reinforcement spacing (confining reinforcement) and the diameter of the vertical reinforcement is 12.5, which are more spaced than recommended value of 6 in Eurocode 8 (CEN.EN 2010). The insufficient spacing of tie reinforcement makes the three specimens represent non-code conforming RC columns. The average concrete strength of 40 MPa is derived by compressive tests conducted on three concrete cylinders. All steel reinforcement used in these tests is manufactured under the requirement of the British standard B500 (2005). Three tensile, compressive and cyclic tests are conducted on sample longitudinal bars to characterise their mechanical properties including their stress–strain relationships. The mechanical properties of the longitudinal bars are summarised in Table 1. The identification of the three specimens is given in Table 2.

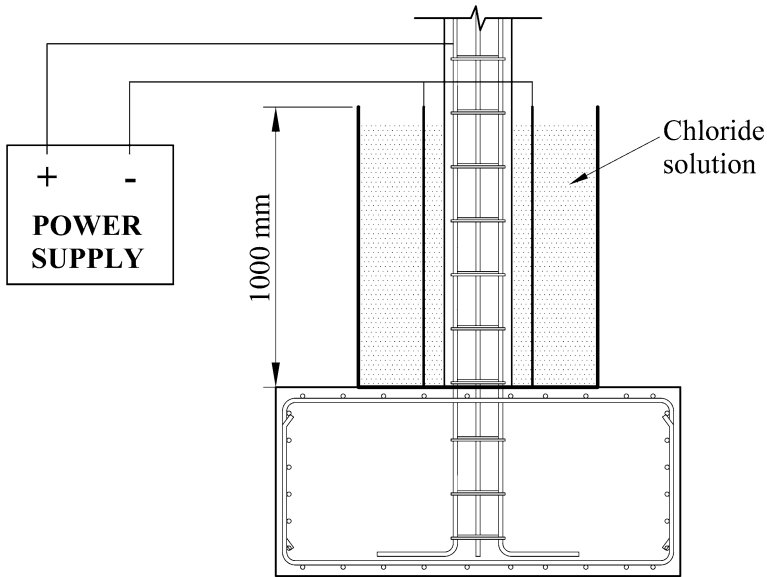
Fig. 2 Accelerated corrosion procedure setup

A polyethene pipe with 500 mm diameter and 1000 mm height was mounted on the top of the foundation to create a bath for the sodium chloride solution. Four 250 mm×1000 mm stainless plates are connected around the column as the cathode. Reinforcing bars and stainless plates are connected to the power supply by cables respectively. The sodium chloride solution contained 10% sodium chloride (i.e. salt). It is worth clarifying that no additional load (other than its own weight) is applied on the specimens during the procedure. The ACP setup is shown in Fig. 2.

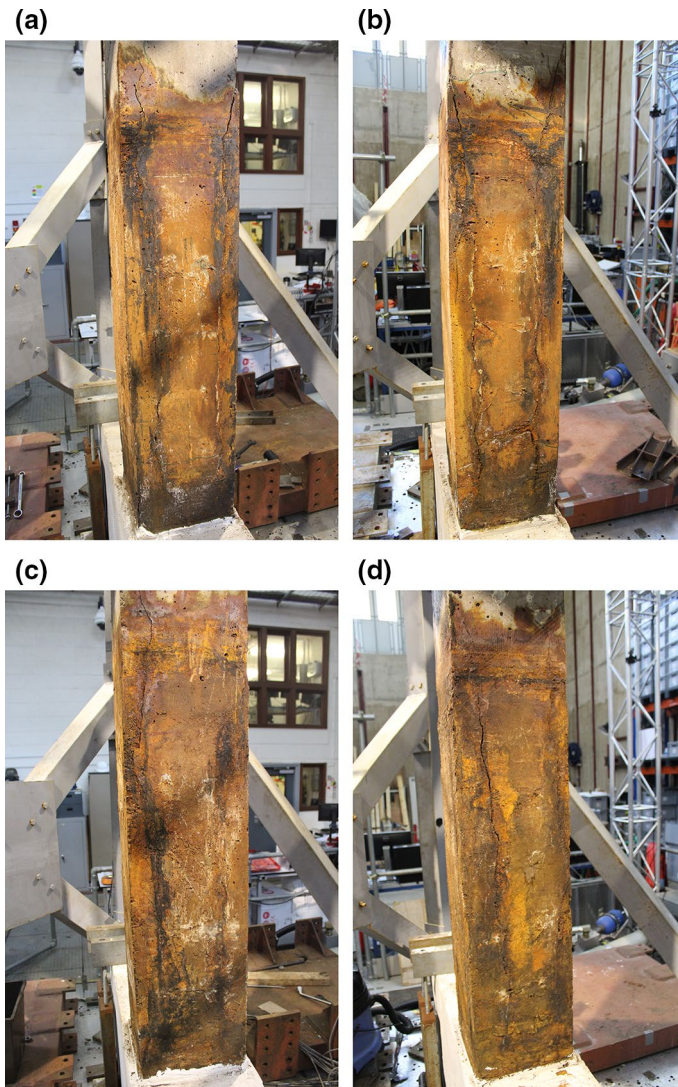
Fig. 3 Corrosion-induced cracks in Corr1 and Corr2 specimens: **a, b** front and back of Corr1, and **c, d** front and back of Corr2

is because of the volumetric expansion of corrosion product resulting in internal pressure, which subsequently causes the concrete cover to crack along the reinforcement.

This is because the additional corrosion in the corner bars results in further corrosion-induced concrete cover cracking (as shown in Fig. 3), and hence, a significant reduction in concrete strength. Therefore, concrete cover crushes earlier on one side of the column,

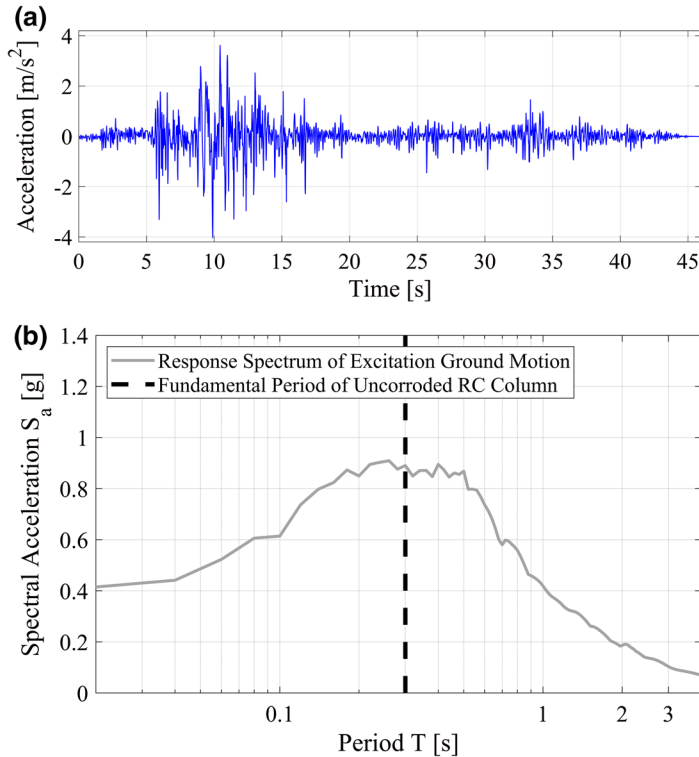
Fig. 6 Spectrally matched Manjil earthquake ground motion record: **a** acceleration time-series, and **b** elastic total acceleration response spectrum

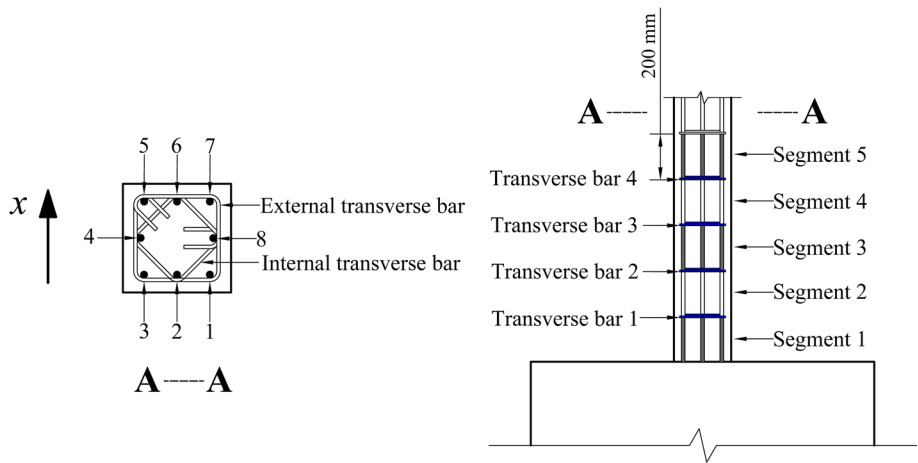
Fig. 7 Physical segments to investigate the spatial variability of corrosion

Figure 8 indicates clearly that the mass loss in the corner bars (bars 1, 3, 5 and 7 in Fig. 7) is larger than mid-face bars (bars 2, 4, 6 and 8 in Fig. 7). This is because the corner bars are exposed to bi-directional chloride diffusion, while the mid-face bars are exposed to unidirectional chloride diffusion. The synergistic effect of two-sided chloride ingress accelerates the corroding process, which leads to more deterioration and even earlier failure of the corner bars. This phenomenon is reported by other researchers (Lee et al. 2003; Khan et al. 2017). Zhang et al. (2011) conducted an experiment on fly ash concrete with two and three-dimensional chloride ingress. This finding is consistent with those summarised by Zhang et al. (2011).

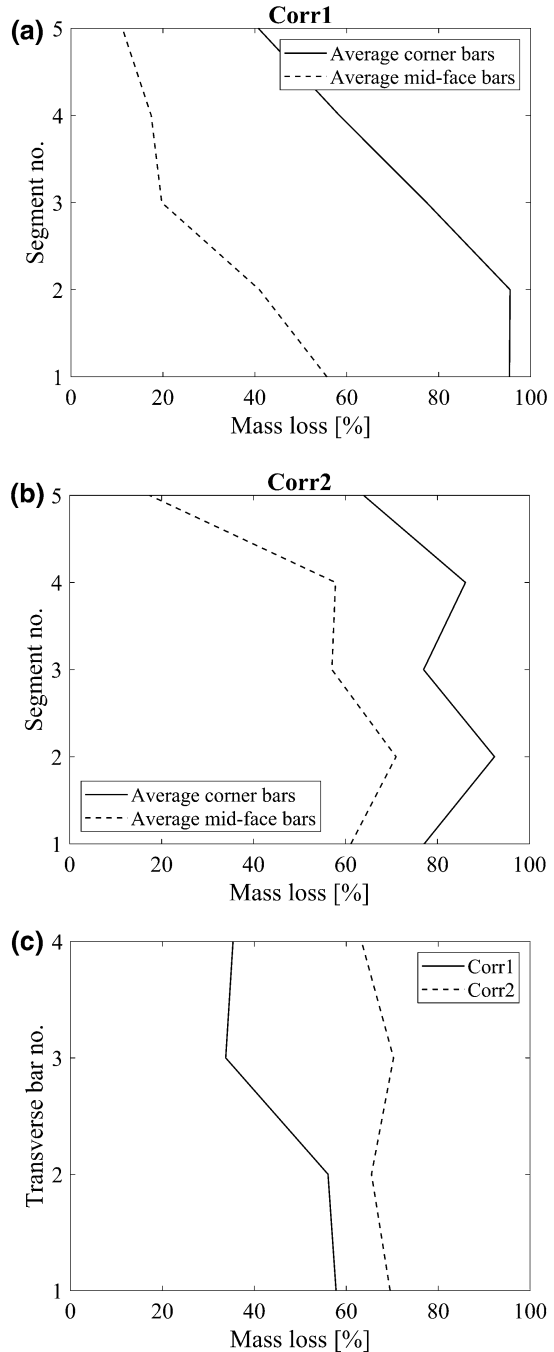
Fig. 8 Spatial variability of corrosion damage at the lowest 1 m of corroded columns: **a** vertical bars in Corr1, **b** vertical bars in Corr2, and **c** transverse ties in both columns

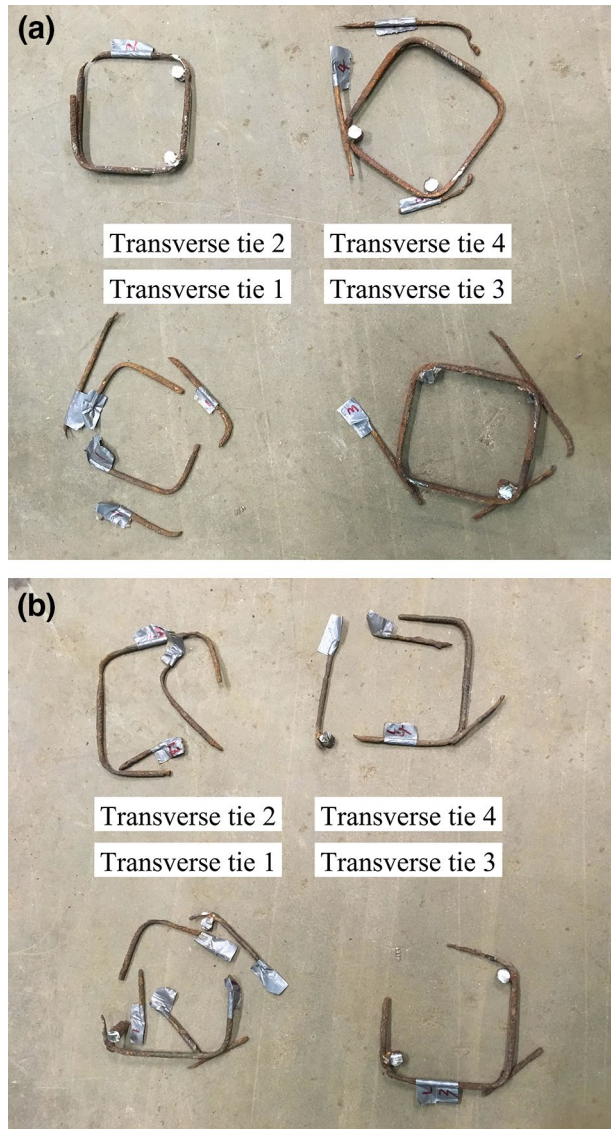
Fig. 9 Corrosion damaged transverse ties: **a** Corr1, and **b** Corr2

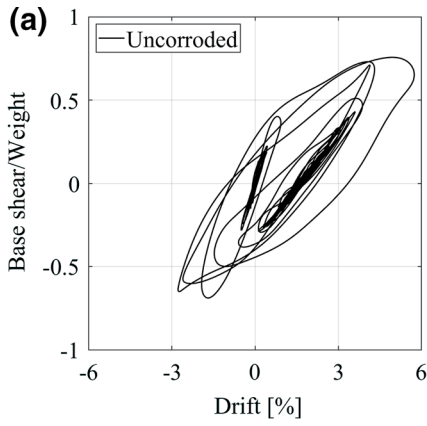
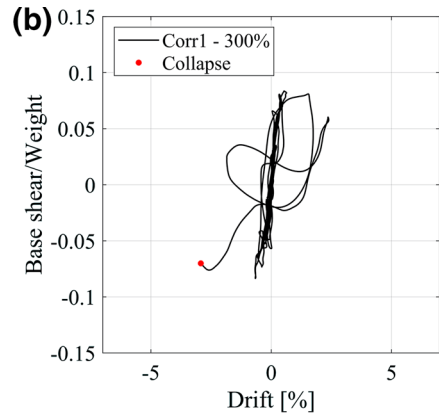
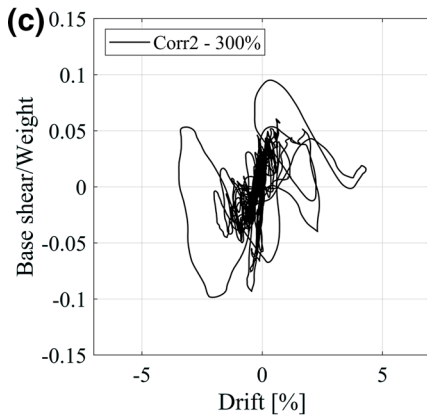
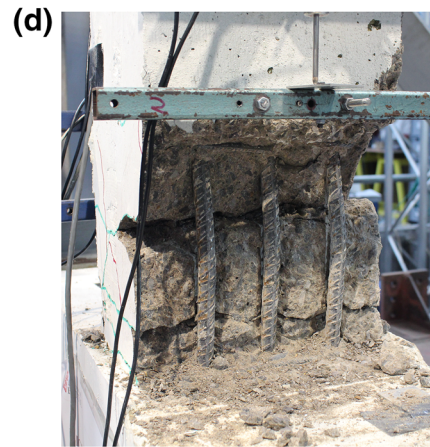
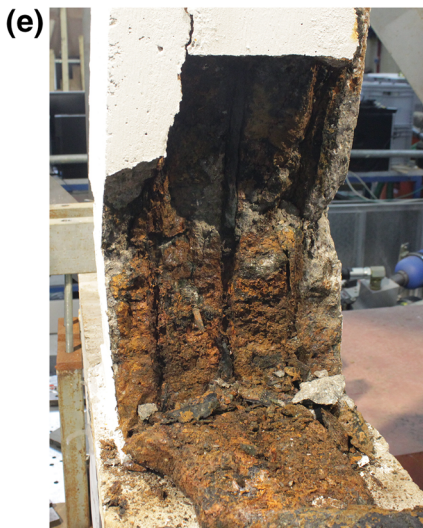
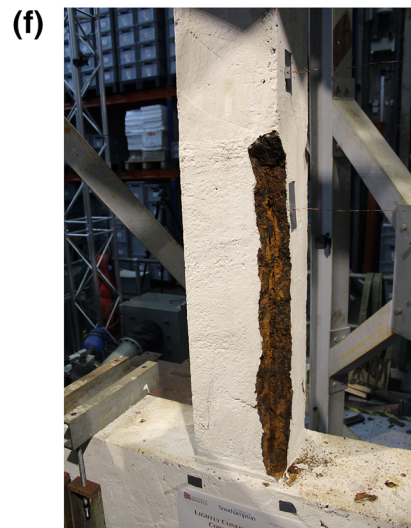
Fig. 11 Force-displacement hysteretic response and observed damage of all three columns at 300% excitation (extensive damage): **a** hysteretic response of UnCorr, **b** hysteretic response of Corr1, **c** hysteretic response of Corr2, **d** observed damage in UnCorr, **e** observed damage in Corr1, and **f** observed damage in Corr2

Figure 11 shows the force–displacement response of all three columns together with observed visual damage on tests specimen at this 300% excitation level. Figure 11a shows that the Corr1 column collapses completely at the time of 10 s. About 90% of lateral strength reduction is observed compared with the UnCorr control specimen. The Corr2 column (Fig. 11b), despite a slightly higher corrosion level (in terms of mass loss),

The force–displacement response of the Corr2 column at 300% does not show the typical hysteretic response of RC components such as Lehman et al. (2004) and Kashani et al. (2019). During the test, at 300% excitation, some of the vertical bars fractured (due to a combination of pitting corrosion, tensile strain level, and low-cycle fatigue). Therefore, the response of Corr2 does not show the hysteretic response of a typical RC column. It was observed that the column was pivoting between the edges similar to a rocking column, and hence, resulting in concrete crushing in compression. In the hysteretic rocking response (Fig. 11c), force increases without an increase in displacement until it rocks, and as soon as the joint opens force significantly drops; i.e. negative stiffness (Makris and Vassiliou 2014). A rocking column system is typically characterised by a linear negative slope (negative tangent stiffness) of the force–deflection response (during the rocking phase). This negative tangent stiffness is observed in Fig. 11c in the high amplitude loops (for positive displacements). Furthermore, Fig. 11c shows that the hysteretic response is not symmetrical, which is due to a single-sided opening rocking which contains both in-plane and out-of-plane components. Figure 11d shows the observed damage in the UnCorr column, which is mainly due to inelastic buckling of vertical bars and premature crushing of core concrete. Figure 11e, f shows the observed damage in Corr1 and Corr2 columns. Figure 11e shows that the complete collapse of Corr1 column is due to a severe loss of vertical reinforcement due to corrosion as well as corrosion-induced damage to the surrounding concrete. Figure 11f shows that the damage in Corr2 column is mainly at one side of the column, which justifies the unsymmetrical hysteretic response in Fig. 11c.

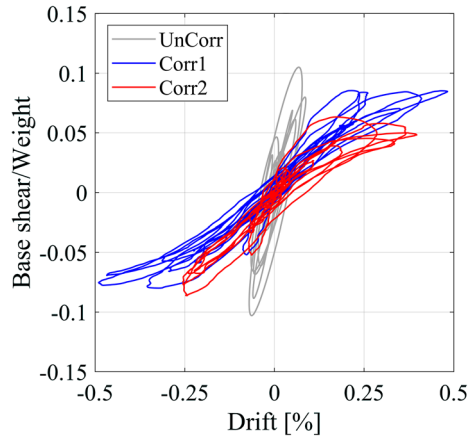
Fig. 13 Comparative force–displacement responses of all columns at 25% excitation level

A further comparison of the results is provided in Fig. 13. It shows the hysteretic curves of all three columns at 25% excitation amplitude for the strong motion part of the response. It is evident from Fig. 13 that severe corrosion can result in a significant reduction in effective stiffness of RC columns. The severe reduction in stiffness results in an increase in drift, which subsequently results in the premature yielding of the longitudinal reinforcement and crushing of the cover concrete (as shown in Figs. 11, 12). The effective stiffness of the column greatly influences the dynamic properties of the structure as well as the strength and plastic deformation capacity, which all have a significant influence on the energy dissipation capacity of RC columns under earthquake loading. In the following sections of this

compression. As it is qualitatively shown in Fig. 13, corrosion has a significant negative impact on effective the stiffness of RC columns. Here, we will quantitatively show the stiffness degradation of test specimens during the earthquake excitation.

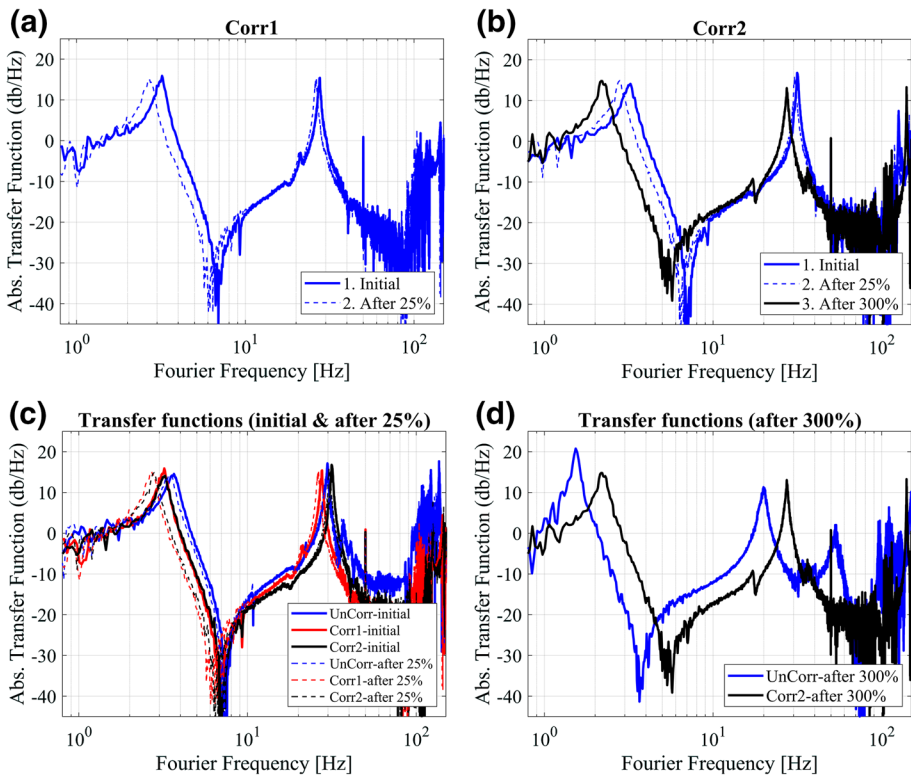
Fig. 14 Transfer function estimate of test specimens using the low-amplitude white noise excitation: **a** Corr1, **b** Corr2, **c** all three columns, and **d** UnCorr and Corr2 after 300% excitation

Power Spectral Density (PSD) of structural time-history records can extract structural characteristics in the frequency-domain (Cryer and Chan 2008). The transfer function (based on input and structural response accelerations time-series) are estimated using a MATLAB (1994–2018) toolbox (Vold et al. 1984), which employs Welch's algorithm (1967). Large peaks of the transfer function estimate modal frequencies. In this study, only the first and second modes are considered as shown in Fig. 14. Since the Corr1 specimen collapsed at 300% excitation, the white-noise tests data are not available at and beyond 300% excitation for this column.

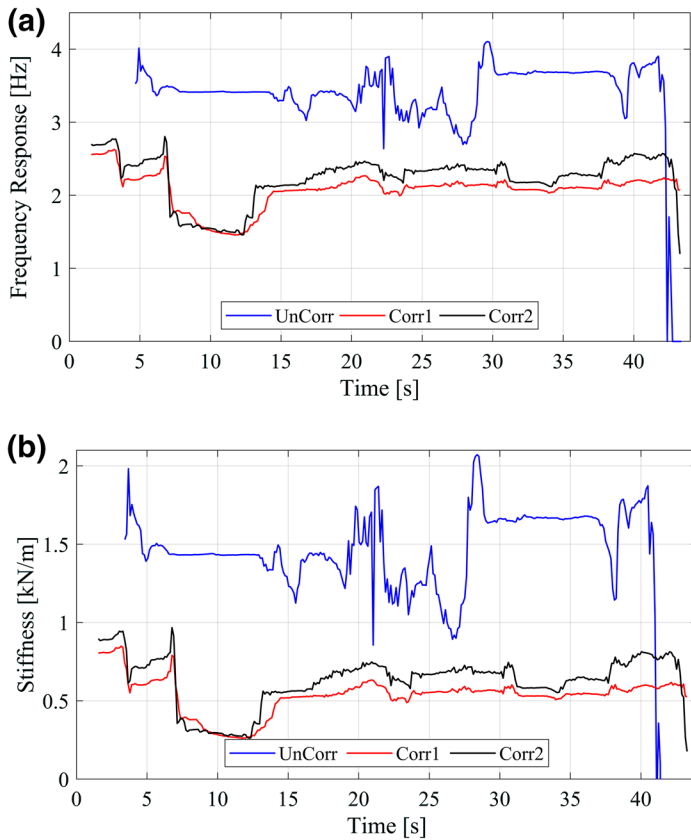
Fig. 15 Time-varying frequency and stiffness responses of all columns: **a** time-frequency response, and **b** time-stiffness response

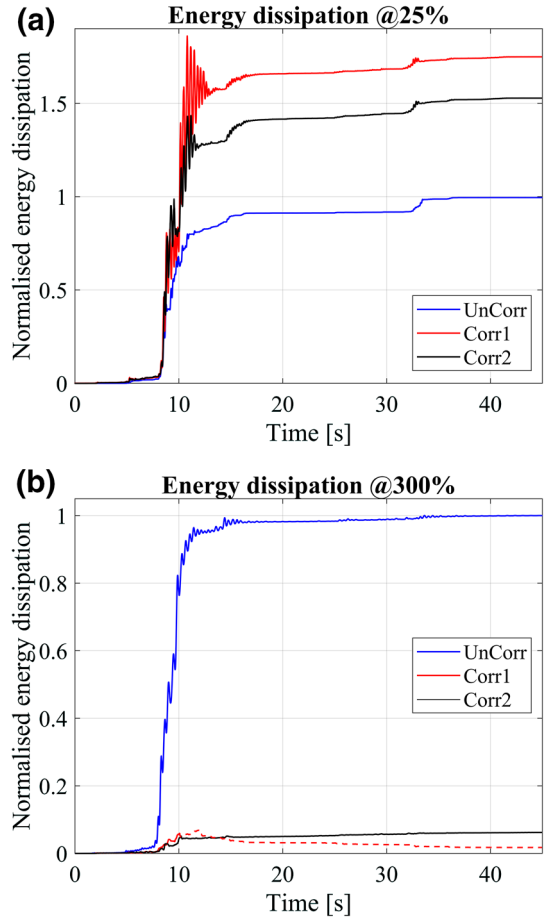
Fig. 16 Normalised cumulative energy dissipation of the uncorroded and corroded columns: **a** slight damage excitation (25%), and **b** extensive damage excitation (300%)

The cumulative energy dissipation is an important quantitative indicator of cyclic degradation of a structure subjected to seismic excitation. Cumulative energy dissipation is defined as the integration of the area inside hysteretic force–displacement loops (Chopra 2007). In this study, the cumulative energy dissipation of two corroded RC columns and the UnCorr control column at slight (25%) and extensive (300%) damage excitation levels are estimated. The results are normalised by the total dissipated energy of the UnCorr control specimen in each round of the test (shown in Figs. 10, 11, 12). Corroded columns Corr1 and Corr2 exhibit 1.53 and 1.75 times the energy dissipation of the UnCorr column at (25% of PGA). At the 300% of PGA level, both corroded columns are highly damaged and appear to dissipate much smaller energy than the UnCorr column. Column Corr1 technically fails at 10 s and would completely collapse if not for the support frame. Column Corr2 as previously discussed has transited from a flexural to a rocking typology and is also very near to collapse. This shows, that corrosion results in premature plastic deformation in the corroded columns and hence higher energy dissipation at low-amplitude excitation (Fig. 16a). However, owing to the corrosion-induced reduction in strength and plastic deformation capacity, there is a severe reduction in energy dissipation capacity at large amplitude excitation (Fig. 16b).
