Migration of Gravel Barriers over a Consolidating Substrate: Implications for Coastal Management.

Lauren Burt BSc (Hons)

MSc Engineering in the Coastal Environment

December 2016

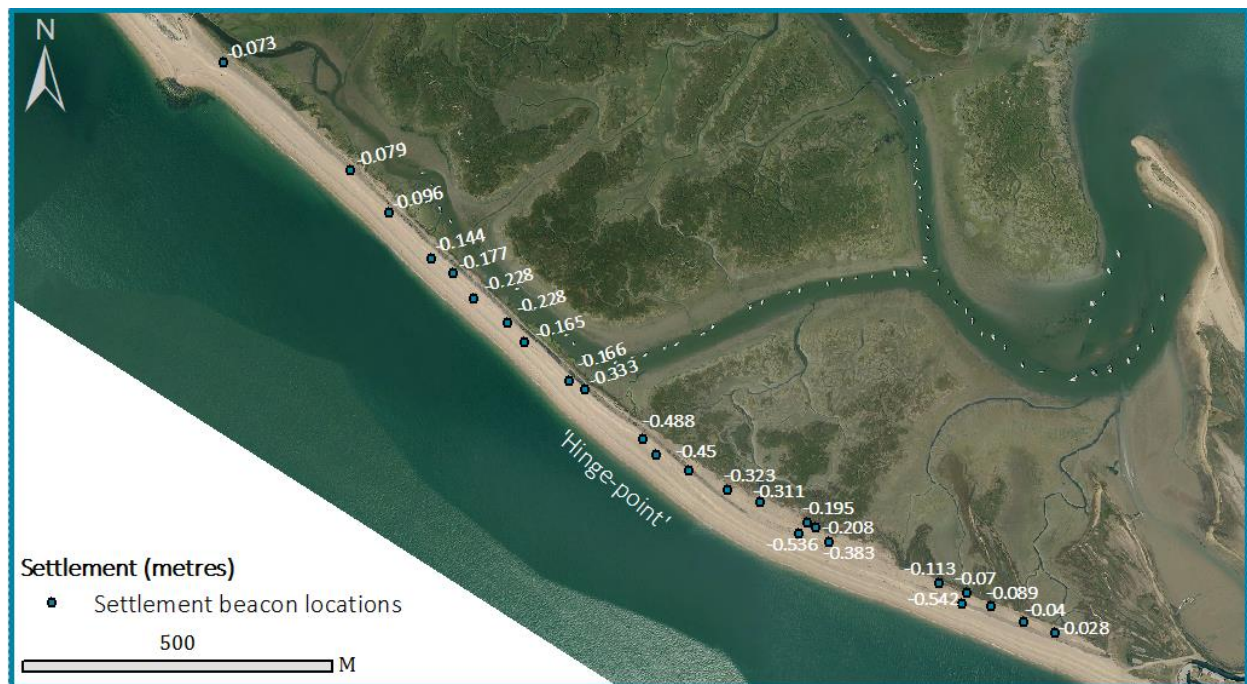
Figure 3: Post-1996 scheme settlement beacon data (1996-1999) courtesy of NFDC Coastal Group, with settlement in metres.

made, and monitored using displacement beacons. An expected subsidence of 1m proved to be an overestimate with a range of 0.3-0.7m observed during the first 10 years after construction (Brampton *et al.*, 2007). This data were provided by the NFDC Coastal Group in the form of measured displacement from settlement beacons installed after the 1996 recharge scheme, with total settlement to 1999 labelled (Figure 3). It is clear that settlement magnitude varied spatially, with an area at the 'hinge point' the most vulnerable to consolidation (<0.5m in 3 years).

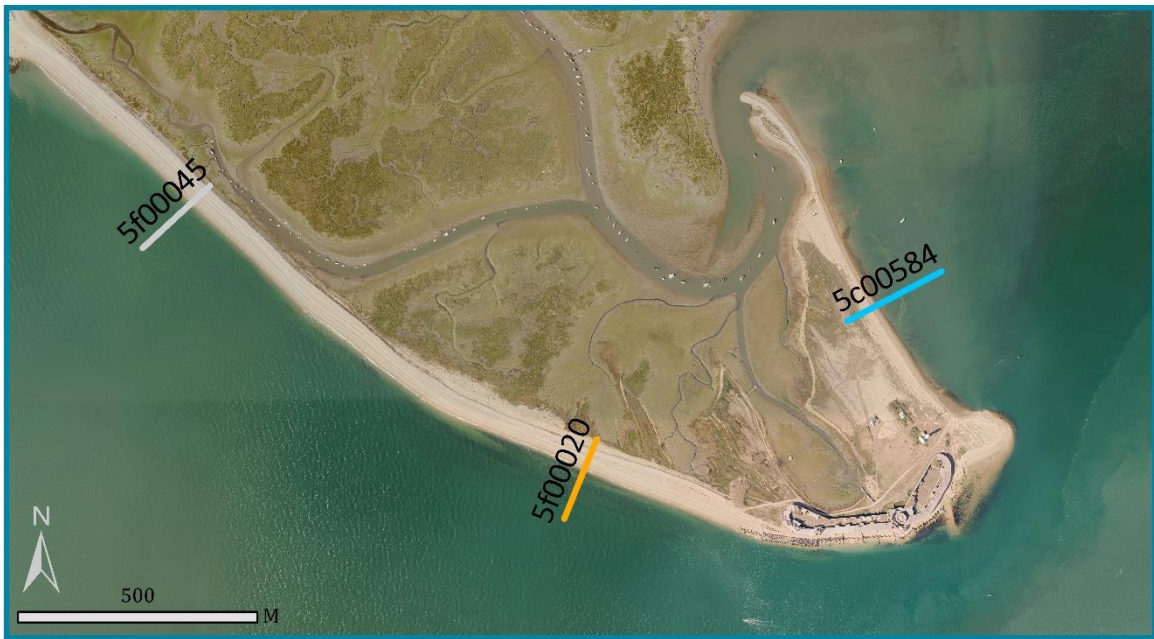
Figure 5: Map to show the locations of three key coastal monitoring profiles, to demonstrate the variability in cross section along the length of Hurst Spit. Aerial photography (2016) (C) NFDC, courtesy of the Channel Coastal Observatory.

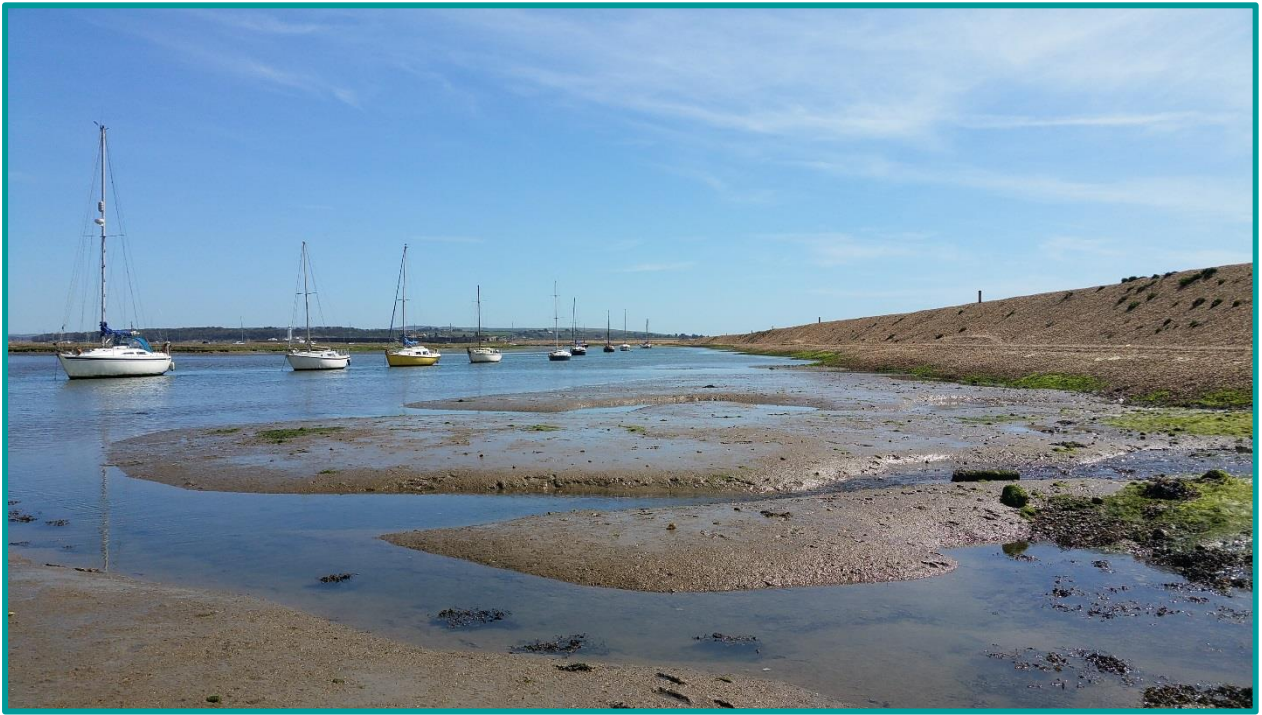
Figure 7: A view southeastwards along Mount Lake towards Hurst Castle, from the lee of Hurst Spit, showing the poorly consolidated material of the Keyhaven intertidal mudflats.

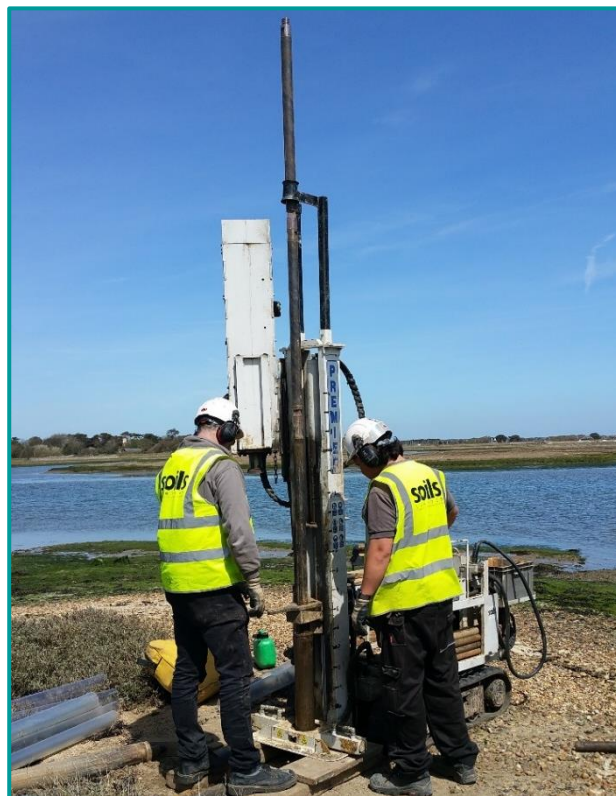
Figure 10: Image of drill rig at Hurst Spit, kindly provided by Soils Ltd.

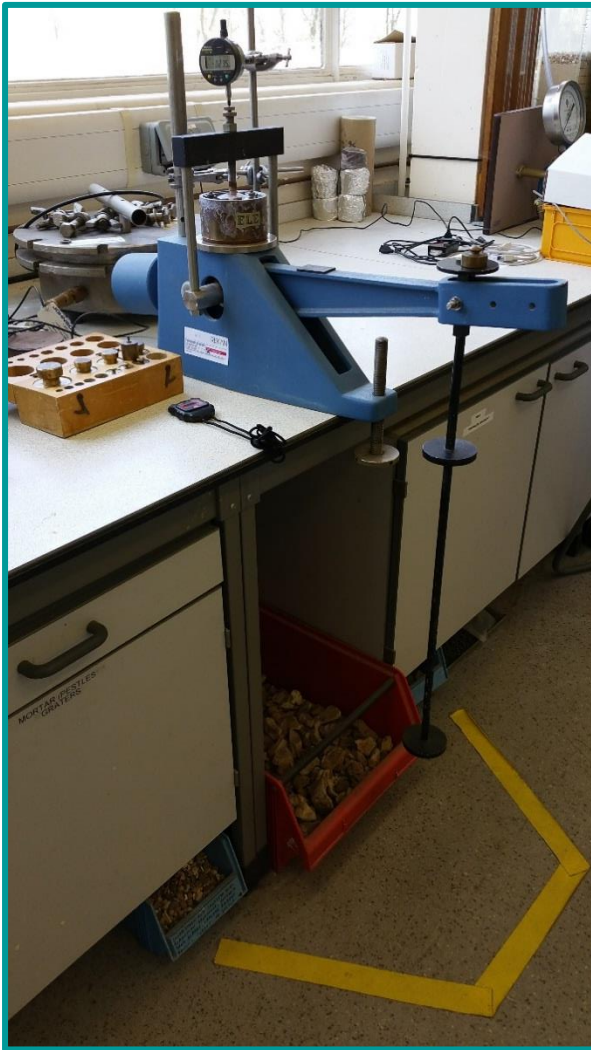
Figure 13a: Traditional Oedometer set-up.

Oedometer equipment was used to test for geotechnical properties. The principle of an oedometer is described in Section 2.23. In this section, the methodology for operation of the oedometer is described. The methodology aimed to follow the standard UK procedure given in BS 1377: Part 5 1990. Two different one-dimensional consolidation devices were used during the testing phase of this study. The traditional oedometer press (Figure 13a) applies loads in increments using hanging weights. Two new Automatic Consolidation Frames (ACF) (Figure 13b) were made available for testing.

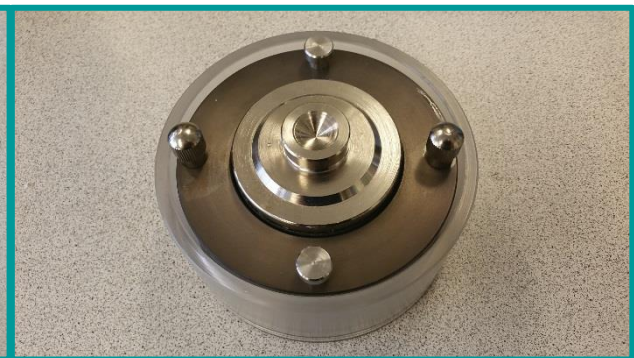
Figure 14b: Assembled component parts of oedometer cell.

3. Weigh the consolidation ring containing the finally prepared sample. Add filter paper to the top and bottom.
4. Assemble the component parts (Figure 14a and 14b): retaining ring, consolidation ring porous discs, loading cap and set in place on the one dimensional consolidation device. Set up the displacement transducer and calibrate to zero.
5. Ensure the one dimensional consolidation device is calibrated for use.
6. Set up stopwatch, recording sheet and necessary loads required.

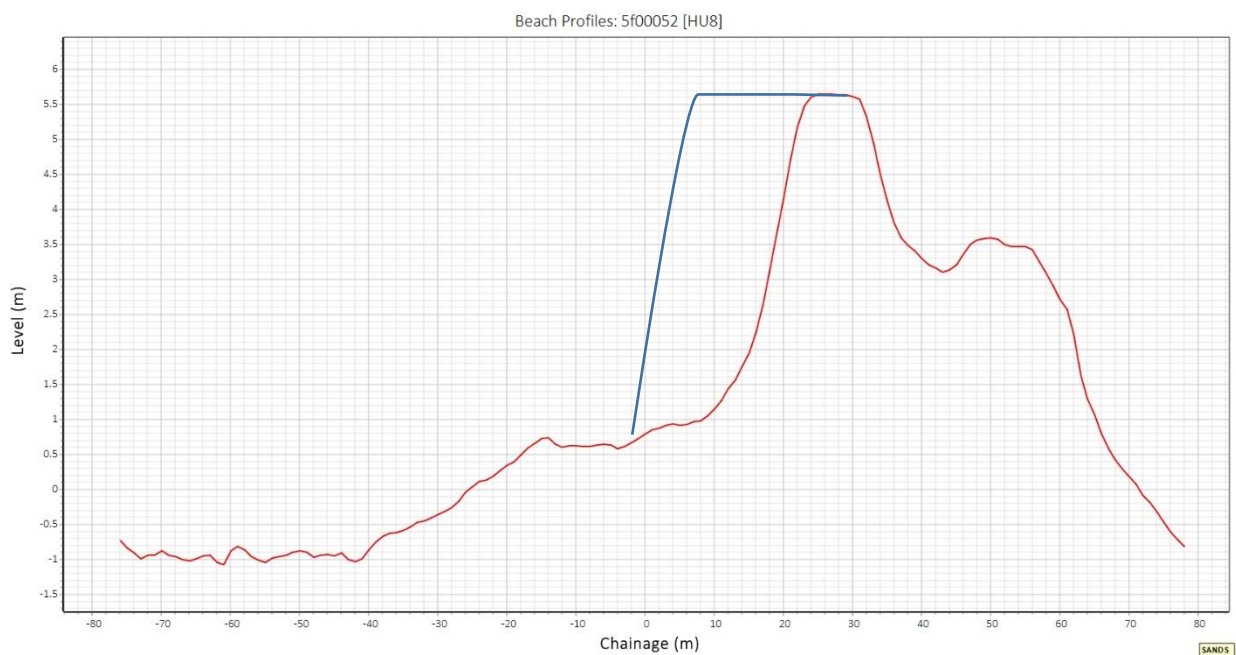
Figure 20a: Beach profile 5f00052 (HU8) (red) with potential profile of new recharge added in blue).

This section aims to estimate potential consolidation of the back barrier sediments at Hurst Spit in the event of a future recharge. Three locations were selected based on the results from the sediment analysis. These locations were HU8, HU13 and HU15. These will be used to gauge the relative vulnerability to consolidation due to addition of beach recharge material. The beach profiles are shown in red, with the profile of additional recharge material in blue in Figures 20a, b and c. By using information of substrate thickness from the adjacent core, beach height above this substrate and the resultant vertical stress that will be imposed on the substrate, a calculation of subsidence due to consolidation is made. This consolidation is presented as a range (based on the oedometer findings) and then an average magnitude.
