## 29 **1. Introduction**

112 concept of GFRP reinforcement as a means of ensuring enhanced structural performance of  
113 double-lap tension bolted joint configurations in annealed and heat-strengthened glass. Whilst  
114 the technique proposed in the present paper or other similar strengthening methods are not  
115 reported in the literature for glass–bolted joints, adhesively bonded fibre-metal laminates strips  
116 have been successfully used in aircraft structures as a means of improving damage tolerance  
117 through their contributions as a bonded crack retarder [17]. Given glass is a brittle material  
118 and glass fractures in the vicinity of the bolted joints, it is expected that the crack retardation  
119 contributions of the bonded GFRP strips will enhance the structural response of the glass-  
120 bolted joints.

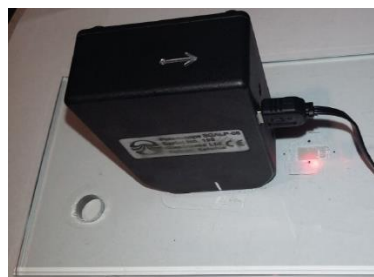
**Figure 1:** Use of SCALP to measure surface residual stress in glass

134 In the experiments, the surfaces of the glass specimens were first cleaned to remove dirt and  
 135 fingerprints, and the residual stresses were then measured by placing the polariscope at  
 136 middle region of the glass specimen. The polariscope was connected to an integrated software  
 137 via a computer where the software processed and displayed the residual stress measurement  
 138 data. A good optical contact between the glass sample and the polariscope was ensured by  
 139 using a SCLAP-manufacture-recommended oil-based immersion liquid (refraction index =  
 140 1.52) [19]. The measurements were repeated a few times (usually about six times) at the same  
 141 location in order to achieve consistent results. Details of the use of SCALP-05 to measure  
 142 stresses in glass can be found in elsewhere [18, 20, 21, 22]. Table 1 shows the measured  
 143 average surface compressive residual stress in all glass types investigated in the present

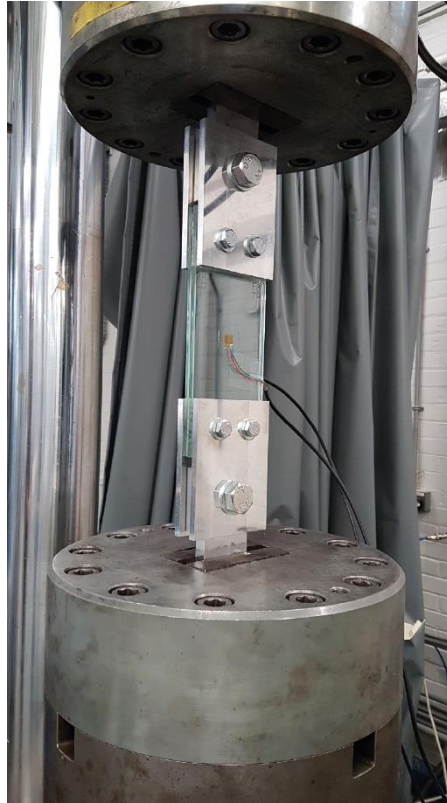
**Figure 7:** A glass-bolted joint test specimen fixed to the test machine

369 Strain data along the loading direction of the glass test specimens were recorded using two  
370 linear strain gauges fixed at middle regions of the two outer glass surfaces (see Figure 7 for  
371 the location of the strain gauges). Tests were continued until the failure of the test specimens  
372 whilst the load and strain gauge data were continuously recorded using software associated  
373 with the test machine.

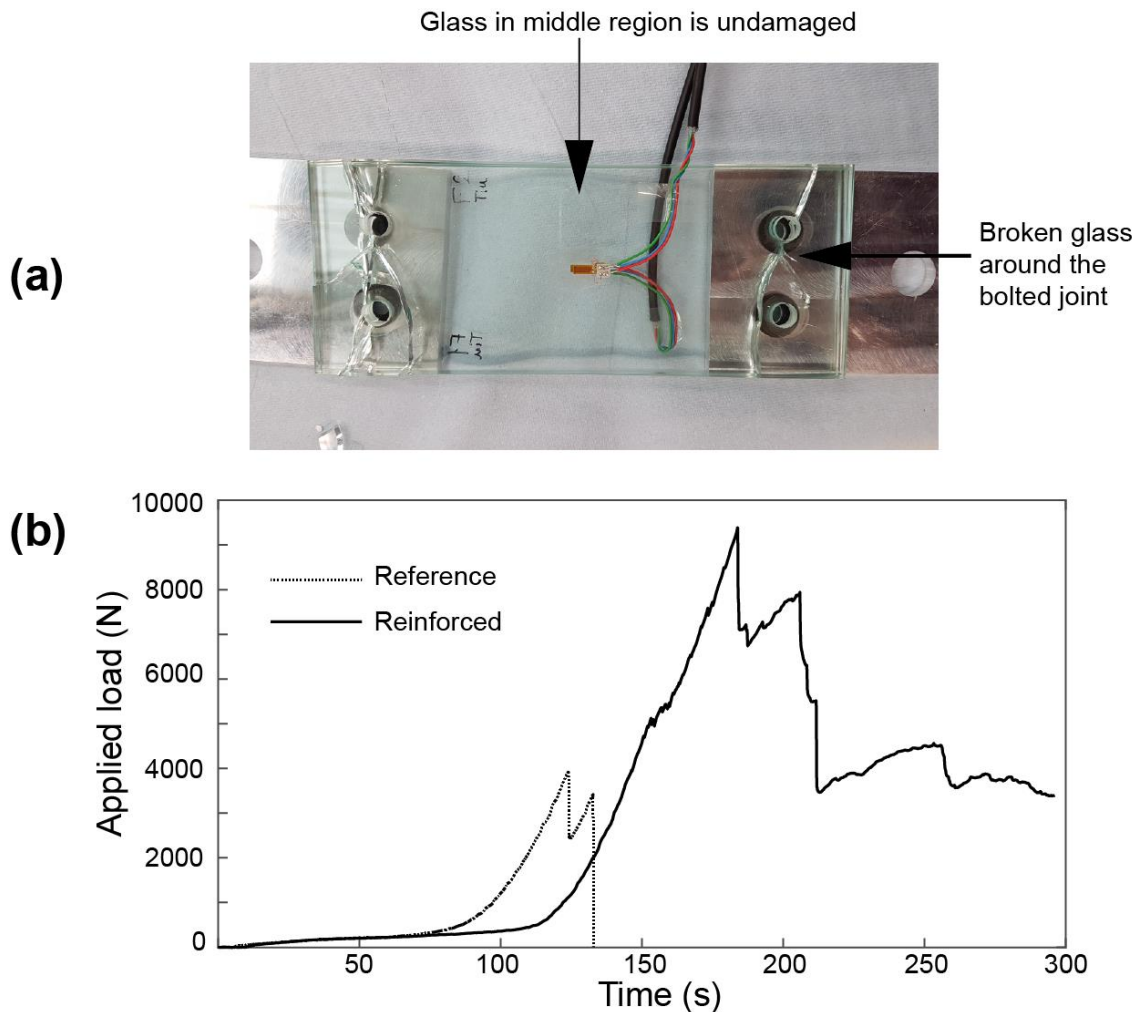
**Figure 8:** Annealed glass-bolted joints: (a) failure pattern of the reference joint, (b) load-time relationships of the reference and reinforced joints

408 The reference annealed glass-bolted joint test specimen failed due to major cracks developed  
409 in the vicinity of the bolted joint. The cracks caused a completed failure of the glass across the  
410 bolted joint; however, middle regions of the glass specimens (i.e. away from the bolted joint)  
411 remained intact (see Fig. 8a). The dotted line in Fig. 8b shows the load response of the  
412 reference annealed glass test specimen. It can be noted from the figure that during an initial  
413 time period of ~80s, no significant force was applied on the test specimen. This is due to the  
414 displacement required to establish an appropriate contact between the bolt shanks and the  
415 glass/aluminium plates to activate the bearing forces. By combining the results shown in  
416 Fig. 8b together with the visual/audio observation made during the test, it was determined that

417 one glass specimen failed at the applied load  $\sim 3920$  N (reported maximum load for other two  
 418 specimens were 3760 N and 4340 N) (average maximum load – 4007 N) and the load  
 419 resistance was dropped to  $\sim 2440$  N instantaneously. The remaining intact glass specimen  
 420 then carried the load briefly for about few seconds where the load resistance was increased  
 421 up to  $\sim 3420$  N. However, at this load the second glass specimen also failed and the load  
 422 resistance of the joint was lost instantaneously causing a complete brittle joint failure (Fig. 8b).

445 reinforced joint resisted some load (~3400–4570 N, see Fig. 8b), albeit a lower resistance  
446 compared to the uncracked reinforced joint. Fig. 9c shows the GFRP strip and the glass  
447 specimen after the broken small glass pieces were removed after the test specimen was taken  
448 out of the test machine. The visible deformation of the GFRP suggested that the GFRP strip  
449 carried the load after the glass had failed in the vicinity of the bolted joints.

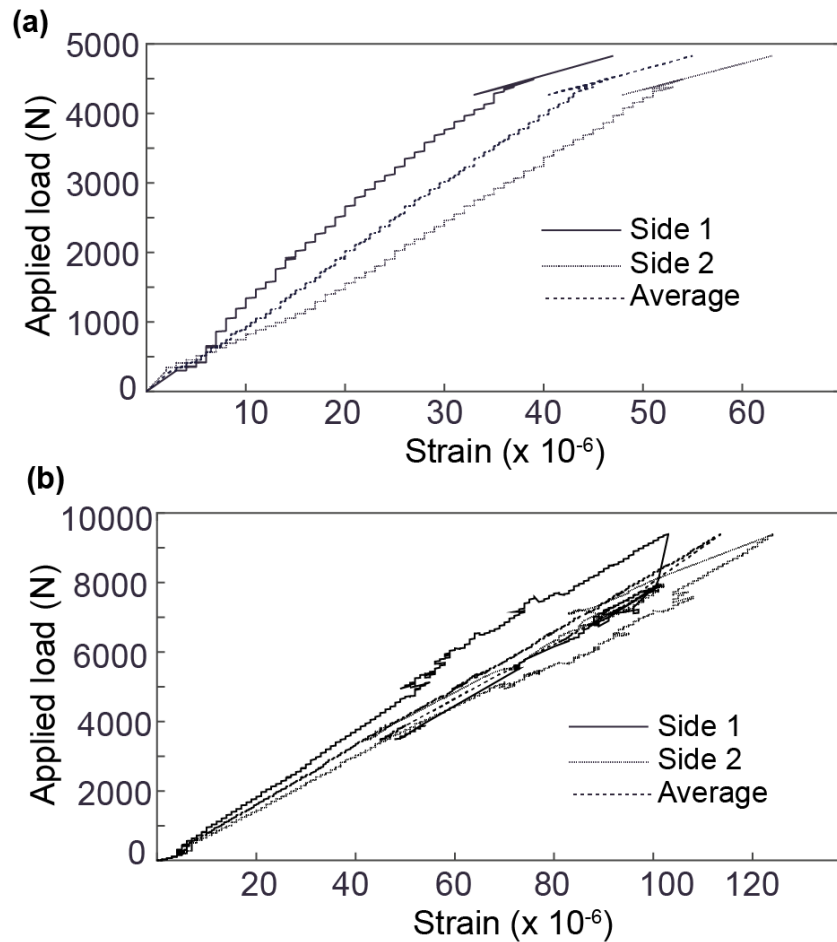
**Figure 10:** Applied load–middle region longitudinal strain relationships in (a) reference annealed glass-bolted joints and (b) reinforced annealed glass-bolted joints

463 also suggest that similar strains values were recorded in both reference and unreinforced  
 464 glass-bolted joints within the load range of the reference joint. It is believed that since the

465 GFRP strips were thin compared to the substrates of the joints (i.e. glass and aluminium), the  
466 contribution of the GFRP reinforcement to the axial stiffness of the reinforced joint within the  
467 pre-cracked regime of the glass was not significant.

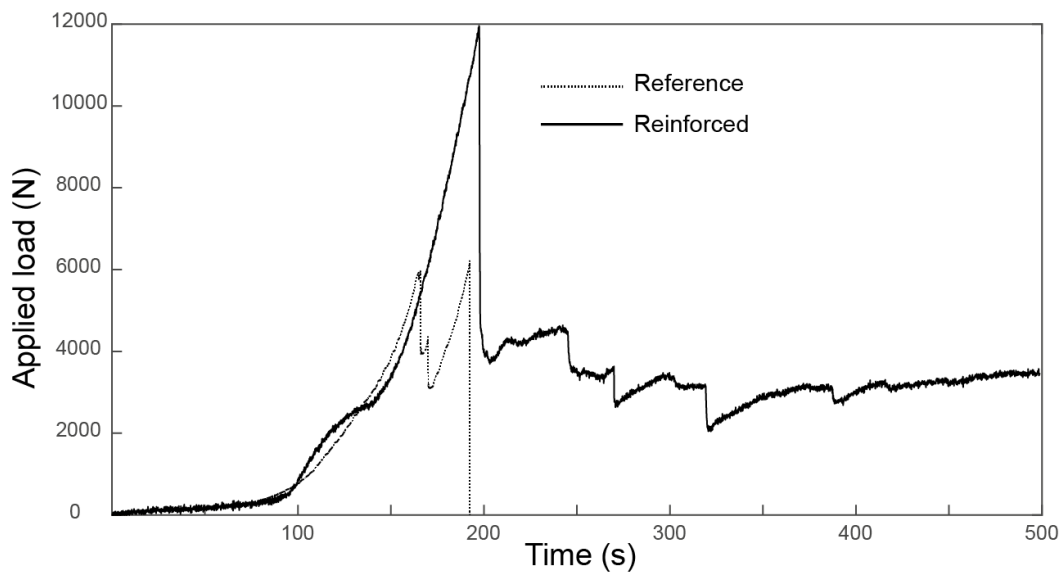
**Figure 11:** Heat strengthened glass-bolted joints: Load-time relationships of the reference and reinforced joints

Reference (i.e. unreinforced) heat-strengthened glass–bolted joints showed qualitatively very similar load response and failure behaviour to that of the reference annealed glass specimens. The joints failed due to a complete fracture across the entire width of the glass specimens in the joint area, whereas middle regions of the glass specimens were undamaged. However, as expected, the load capacity of the heat-strengthened glass-bolted joint (~5960 N) (dotted line

478 in Fig. 11) was higher compared to that of the reference annealed glass specimen (~3920 N)  
479 (reported maximum load for other two heat-strengthened glass reference bolted joints were  
480 5700 N and 6120 N) (average maximum load – 5927 N). One glass specimen fractured at  
481 applied load ~5960 N and the second glass specimen briefly resisted the increasing load  
482 before the complete brittle joint failure at applied load ~6200 N (Fig. 11).

485 The load response and the failure behaviour of the reinforced heat-strengthened glass-bolted  
486 joints were qualitatively similar to that of the reinforced annealed glass (Section 5.1.2). The  
487 solid lines in Fig. 11 shows the reported load response of the reinforced heat-strengthened  
488 glass test specimens. The reinforced joints showed a higher load capacity (~12000 N  
489 (reported maximum load for other two heat-strengthened glass reinforced bolted joints were  
490 11200 N and 12300 N – average maximum load – 11833 N) compared to ~5960 N of the  
491 reference joint) and a delayed failure behaviour, albeit a significant drop in the load resistance  
492 due to the fracture of glass, similar to that of the reinforced annealed glass-bolted joints. The  
493 GFRP strip contributed to resist the applied load after the glass has cracked in the vicinity of  
494 the bolted joints.

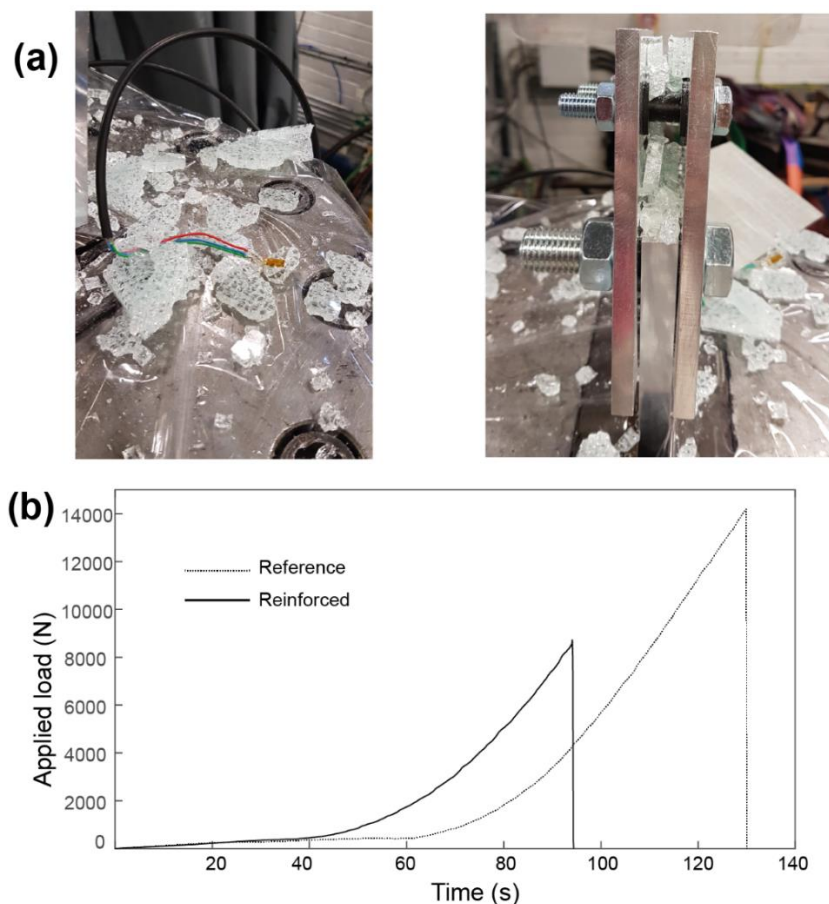
**Figure 12:** Tempered glass-bolted joints: (a) failure pattern of the reference joint b) load-time relationships of the reference and reinforced joints

498 Reference tempered glass-bolted joint test specimens were tested in the same way as the  
499 reference annealed and heat-strengthened glass-bolted test specimens. Unlike other  
500 reference test specimens (Section 5.1.1 and 5.2.1) where glass only failed across the bolted  
501 joint, the tempered glass specimens failed fully where glass shattered into small dices at once  
502 with no unbroken glass (see Fig. 12a). The load response (the dotted line in Fig. 12b)  
503 suggests the load capacity of the reference tempered glass-bolted joint test specimen was  
504 ~14120 N, a significantly higher load capacity compared to other glass specimens (reported  
505 maximum load for other two reference tempered glass bolted joints were 12000 N and  
506 14300 N) (average maximum load – 13473 N).

510 Reinforced tempered glass-bolted joints test specimens were prepared and tested in the same  
511 way as other reinforced glass-bolted joints test specimens. The solid line in Fig. 12b shows  
512 the load response of the reinforced tempered glass-bolted joints. Fig. 13 shows the test  
513 specimen after it failed. The results shown in the Fig. 12b and the visual observations during  
514 the experiment confirmed that the reinforced tempered glass specimens failed in a brittle  
515 manner similar to the reference tempered glass-bolted test specimens (Section 5.3.1). The  
516 load capacity of the reinforced test specimen (~8470 N) was lower than that of the reference  
517 specimen (~14120 N) (reported maximum load for other two reinforced tempered glass bolted  
518 tempered glass bolted joints were 8320 N and 9740 N) (average maximum load – 8843 N).  
519 All reinforced tempered glass test specimens tested in the present study failed at lower loads

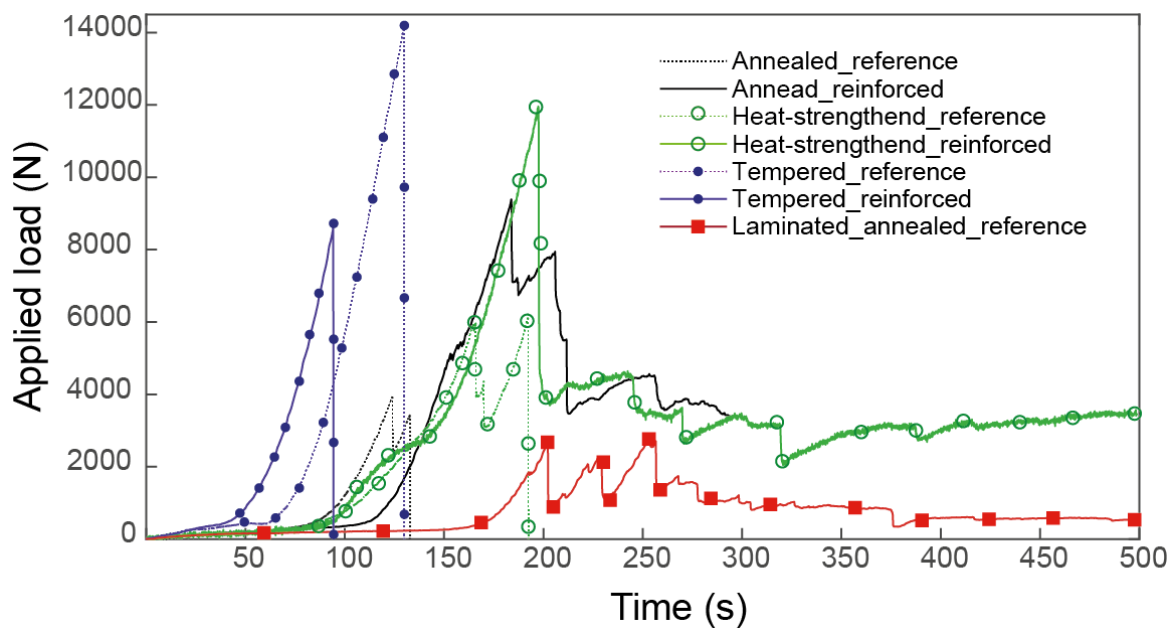
**Figure 15:** Load-time relationships of all categories of test specimens

570 Furthermore, the load capacity of the reinforced annealed glass joint (~9400 N) was ~58%  
 571 higher than that of the reference joints in heat-strengthened glass (~5960 N) despite the  
 572 usually superior strength properties of the latter. Just after the failure of the glass specimens,  
 573 the load resistance of the reinforced annealed glass bolted joint was dropped to ~3470 N, and  
 574 as can be seen from Figs. 8 and 15, the post-cracked load resistance of the joint was within  
 575 the range ~3400-4570 N. This post-cracked load resistance was either higher or comparable  
 576 to the peak load resistance (i.e. prior to any glass failure) of the reference annealed (~3920  
 577 N) and laminated glass (~2800 N) joints. The post-cracked load resistance of the reinforced
