Logboat Repairs in Britain and Ireland: A New Typology

Bob Holtzman¹

Abstract

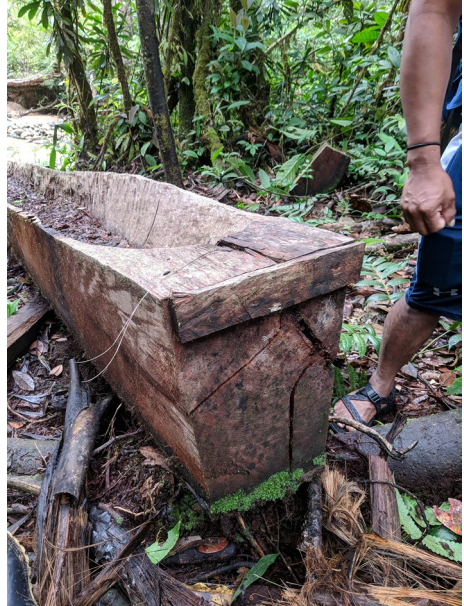
Fig. 1 A cleat nailed into the end grain to secure a split at the stern of a logboat under construction, Napo Province, Ecuador. According to the boat's owner and builder, the log split when the tree was felled. (B. Holtzman)

Repairs are often required while a logboat is under construction (Ransley 2009:117). Regardless of the care with which a tree is chosen, a trunk might contain knots that become apparent only after construction begins (Goodburn 2019:20–21), and flawed trees might be chosen knowingly due to scarcity of better ones (Goodburn 2010:100). An otherwise sound tree can be damaged when it is felled or might split during construction due to internal stresses in the log (*pers obs*) (Fig. 1). Likewise, errors by the builder might require repairs

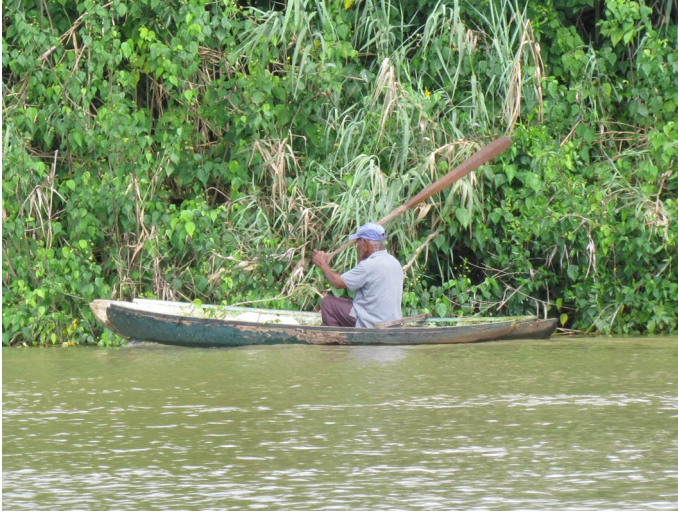
Fig. 2 A split at the bow above the waterline on this logboat significantly reduces the boat's freeboard forward but does not prevent its use. Toledo District, Belize. (B. Holtzman)

Not all damage require repair, and some might be postponed for a long time before they become necessary. When ships remain in use in spite of being badly damaged, the owner can either consciously accept an elevated level of risk (Adams 2013:17–18) or restrict the boat to less demanding uses in order to maintain a reasonable safety margin. See Fig. 2 for a probable example of the latter.

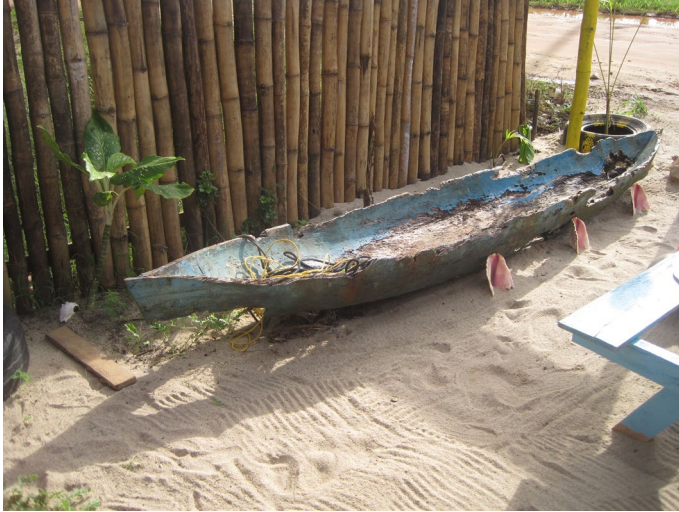
Fig. 3 A logboat beyond repair used as décor in the outdoor seating area of a restaurant in Hopkins, Belize. (B. Holtzman)

Logboats beyond repair that remain more or less intact are occasionally employed in other applications. These include use as garden planters (Fuquen Gomez 2014:194–198), seats, washtubs, vessels for food preparation, brewing vats (Yde 1965:36; Gilmore et al. 2002:12), and décor (*pers obs*) (Fig. 3).

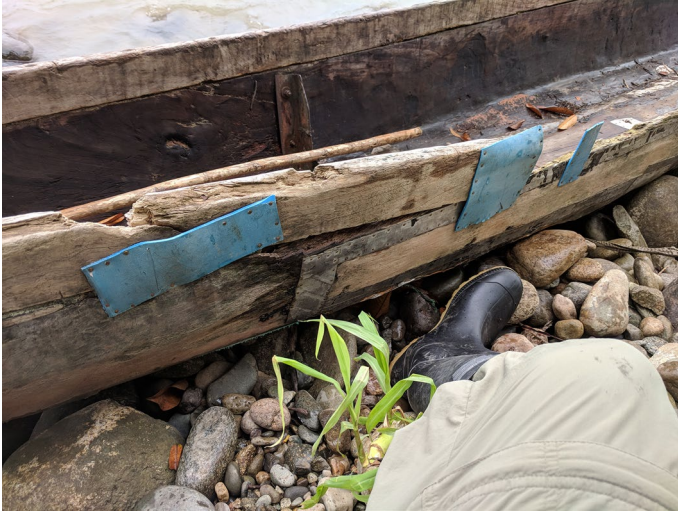
Fig. 4 Patches cut from plastic food barrels on an extended logboat, Rio Napo, Ecuador. (B. Holtzman)

Ethnography shows that logboat owners often perform repairs ad hoc, making use of any material and technique that might return the boat to service expeditiously. In Kerala, India, when integral frames which serve to separate “wet” and “dry” areas within the logboat are worn down by abrasion, owners sometimes build them up with mud, although at other times they nail in a piece of timber (Ransley 2009:126, 132). [In contrast, when these boats are repaired by Kerala professionals, the integral frames are painstakingly recreated, but when they are repaired by professionals from a different building tradition, the frames may be omitted altogether, even though the repair is made in a “shipshape” manner (Blue et al. 2017:190–191).] Other expedient repairs observed in ethnographic contexts include patches made from a discarded flip-flop in Tanzania (Blue, Lucy: *pers comm*, 7/9/19) and from sections of plastic bulk food containers (probably high density polyethylene) in Ecuador (*pers obs*) (Fig. 4).

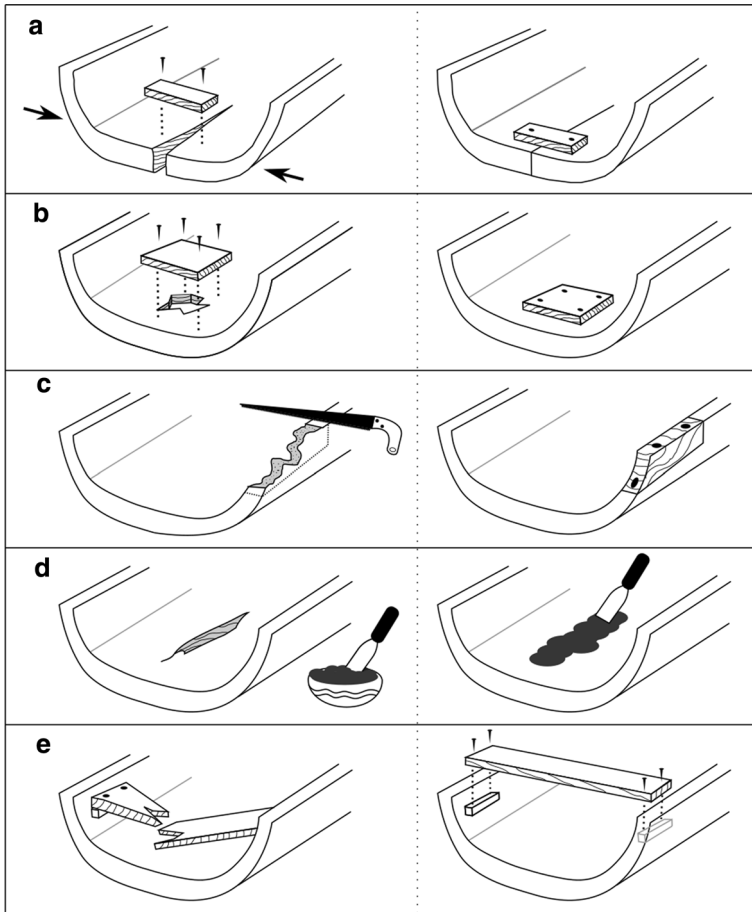
Fig. 6 Logboat repair typology. **a** Pulling repair. **b** Patch. **c** Wood insert. **d** Soft filler. **e** Replacement of damaged fitting. (Cate Monroe, B. Holtzman)

1. "pulling" repairs: in which the two sides of a split are forced together and held in place by mechanical means (Fig. 6a).

2. patches: in which damage is covered by a piece of solid material such as a board or a sheet of metal. A patch is placed over the damage and on the surface of the hull, not flush with it (Fig. 6b).

- wood inserts: in which a hole or gap is filled with a piece of new wood, cut and shaped to be flush with the hull (Fig. 6c).
- soft fillers: in which soft material is forced or molded into the damage to fill a gap (Fig. 6d).
- replacement of fittings: in which a damaged, attached component is removed and replaced with a sound one (Fig. 6e).

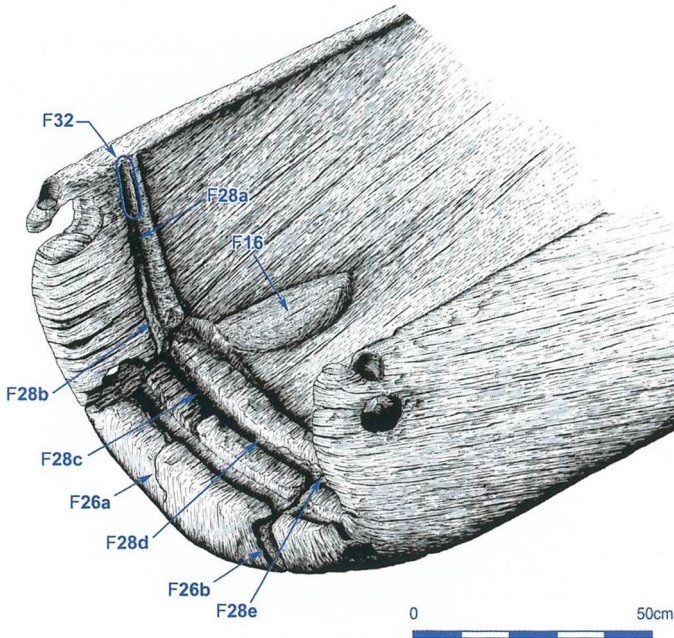
Fig. 7 Stern of the Carpow logboat. The slot for miniature repair transom is aft of the taller slot for the main transom (indicated by depth locations F28b-d and F32). The hole for the port peg that secured the top of the miniature transom is easily visible just to the right of the label F28b; the hole for the starboard peg is just barely visible near the bottom of the image. (Strachan 2010b:71/fig.100; used by permission)

It is rarely possible to establish whether fitted components are original or replacements. Although the replacement of components was probably common, only one example has been convincingly identified: The full-size transom of the Carpow logboat appears to be a replacement associated with other repairs made to the boat’s stern (Strachan 2010b:77–80). This identification was made partly on the basis of the transom’s fresh tool marks, which contrast markedly with the more worn surfaces on the rest of the boat. The replacement

was probably necessitated by spreading of the hull due to the expansion of a split propagating from the stern, so that the original transom was no longer wide enough to enclose the back end of the boat. Other “replacement” repairs may be necessitated by damage to the fitted component itself, although no such examples are known.

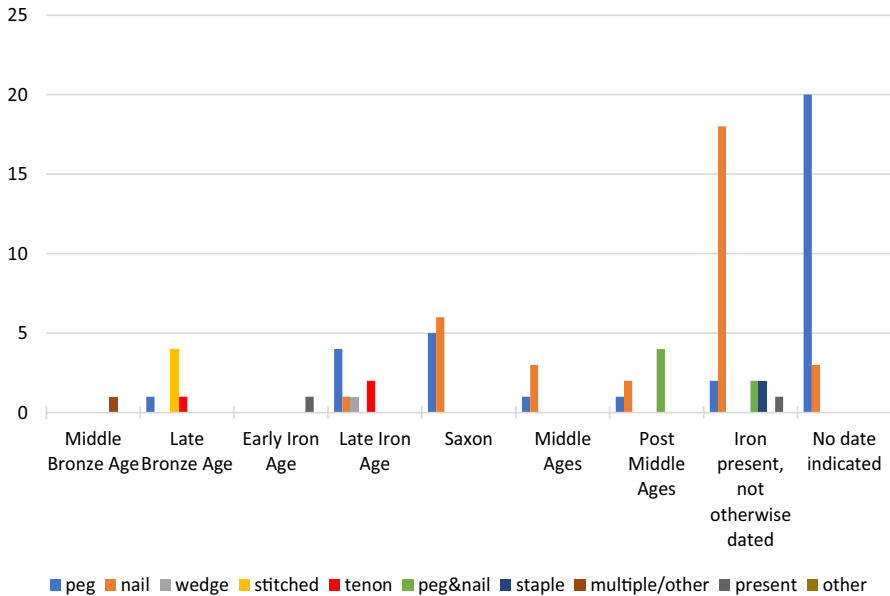
Fig. 8 Fastener use by era: number of repairs (Color figure online)
